KEKB ARES CAVITY SYSTEM STATUS

Tatsuya KAGEYAMA

KEKB ACCELERATOR REVIEW

2/23/2001

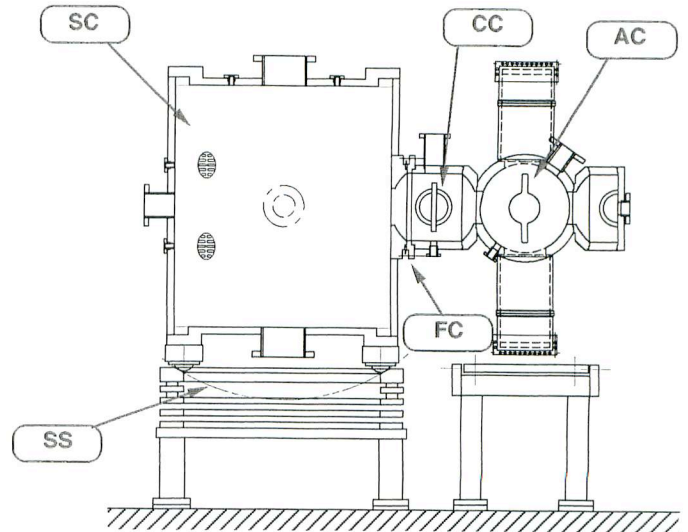
Abnormal Vacuum Pressure Rise with RF power @ LER D7C2

Cavity vacuum faults occurred during the cold start-up after the biweekly maintenance on 11/16/2000.

Finally, the RF conditioning failed to bring the cavity into operation.

The vacuum faults were probably caused by an RF contact failure at the rectangular flange connection (FC) between the coupling cavity (CC) and the storage cavity (SC).

It will take about two weeks for on-the-spot inspection and repair.

In the worst case it will take about one month to replace the cavity with a good one.

The comeback of station D7C is scheduled in the summer of 2001.

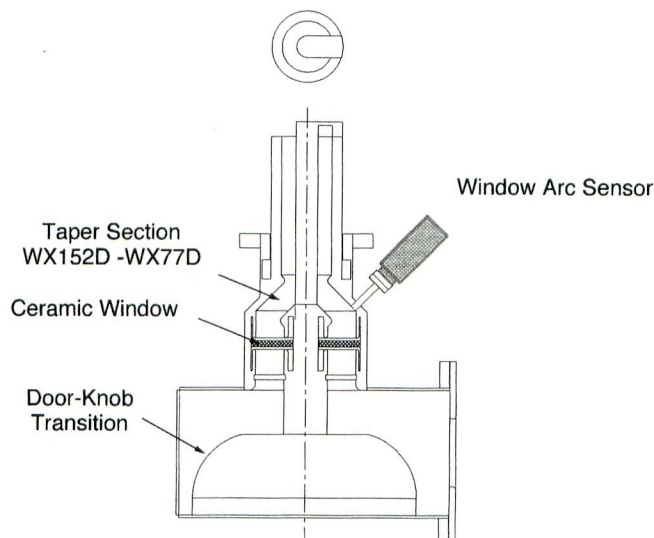
A Window Failure of the Input Coupler @ HER D5C2

The window failure @D5C2 resulting in an air leakage were caused by the following:

- The arc sensor had been installed in the wrong port with a blank flange instead of the view port.
- Recovery operations were repeated without attention to the abnormal reflected RF power trips.

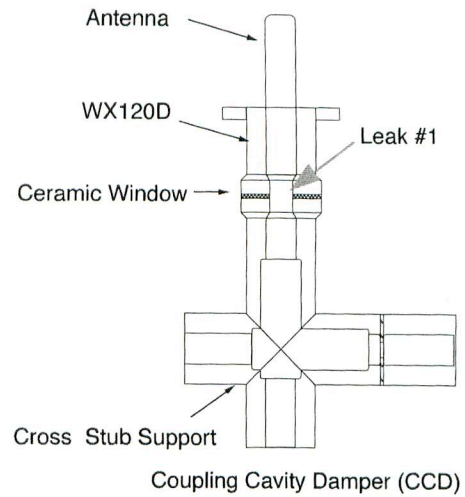
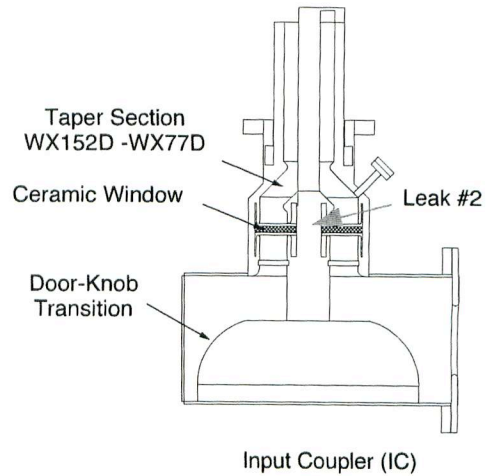
Leaks into Vacuum from the Cooling Water Circuits for the Coupler Windows @ HER D4C2

A sudden vacuum pressure rise occurred at the station HER D4C on 1/10/2001 in the last scheduled winter maintenance period. The station had not been operated from 12/28/2000.

First, a leak was located at the inner cooling water circuit for the ceramic window of the coupling cavity damper (CCD) @ D4C2.

After replacing the bad CCD with a new one, another leak was found and also located at the inner circuit of the input coupler @ D4C2.

Those serious leaks were probably caused by erosion-corrosion of copper tubes. Erosion-Corrosion arises from a combination of chemical attack and the physical abrasion as a consequence of the fluid motion. Aggressive waters do not allow a protective film (oxides) to form inside the copper tube.

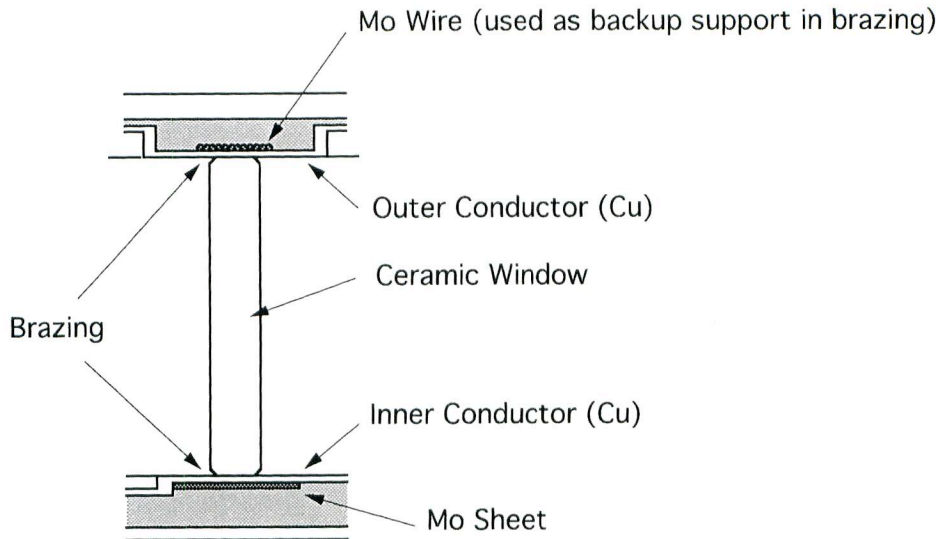
Cooling Water Channels for Ceramic Window

- Liquid velocity ~ 1 m/s
- Erosion-corrosion is probably accelerated by the presence of molybdenum oxide produced from the Mo wire exposed to the cooling water with dissolved oxygen gas.
