# Movable Mask Issues

## - History of Movable Mask System -

Y.Suetsugu, N.Akasaka, T.Kageyama, Y.Takeuchi, K.Kanazawa and K.Satoh

23/Feb/2001

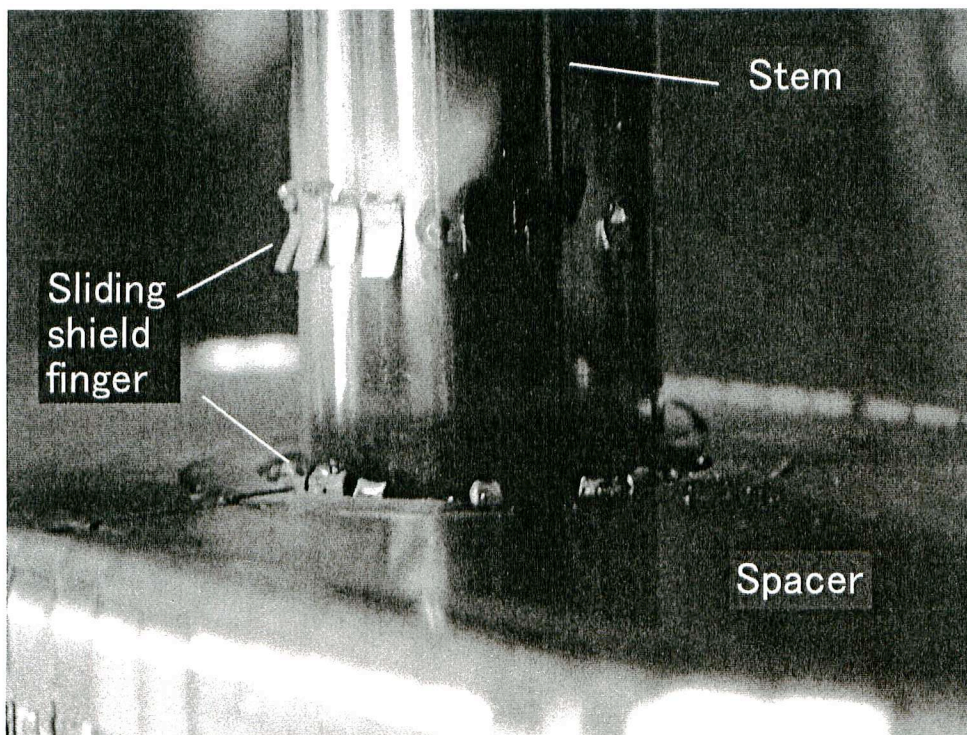
## Ver.1 Broken shield finger

### (1) Damage of sliding the shield fingers

Fingers were broken (melted) and welded to the stem.

(1) Too weak shield finger

For the time being, remove all sliding shield fingers → Ver.1's mask

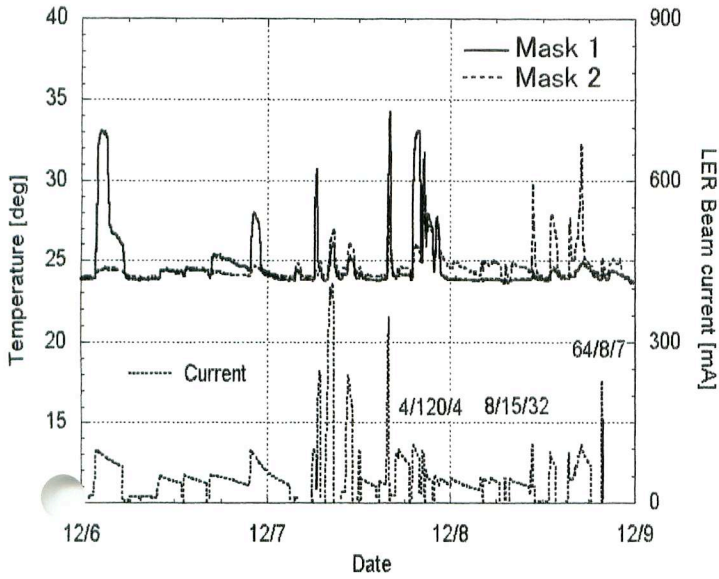
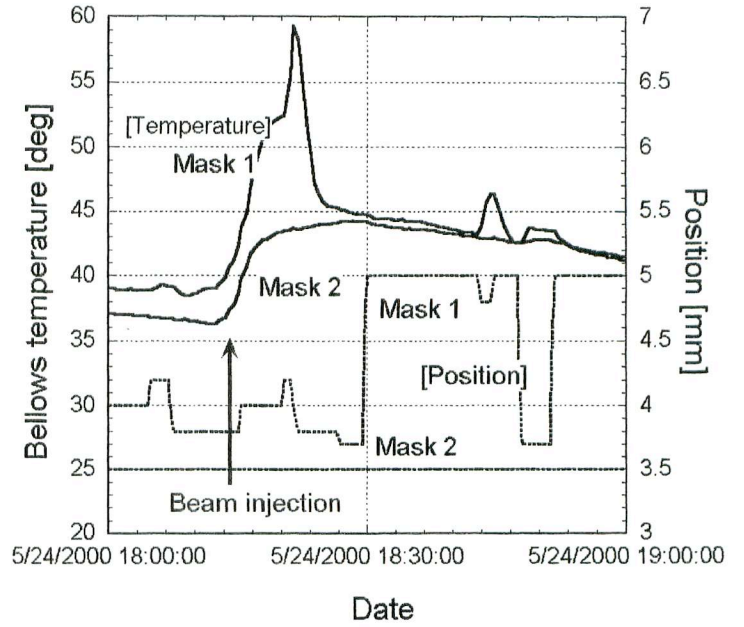
# Ver.1 Excess heating

### (2) Excess heating

Depending on the buch fill pattern and the mask position, the bellows temperature increased abnormally.  $\longrightarrow$  Vacuum leak

(2) Heating

For the time being, keep watch on temperature at bellows and cool the bellows by a blower

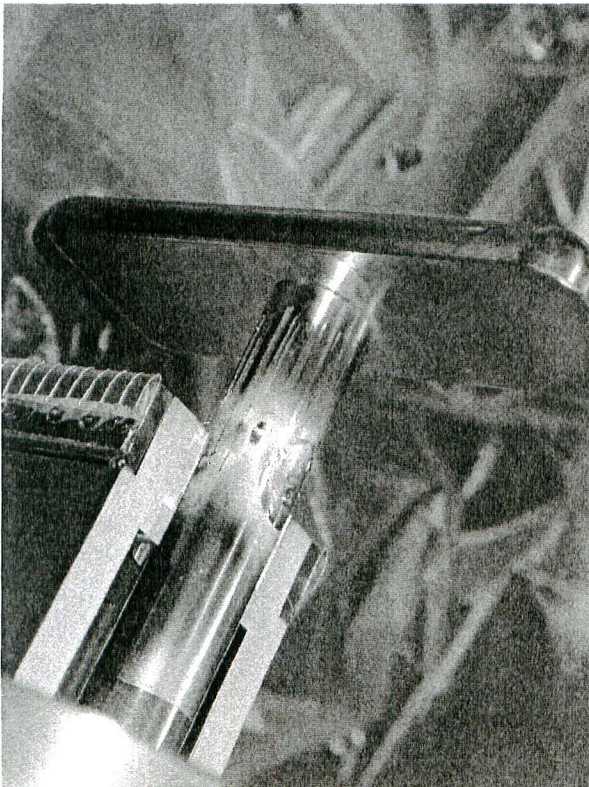
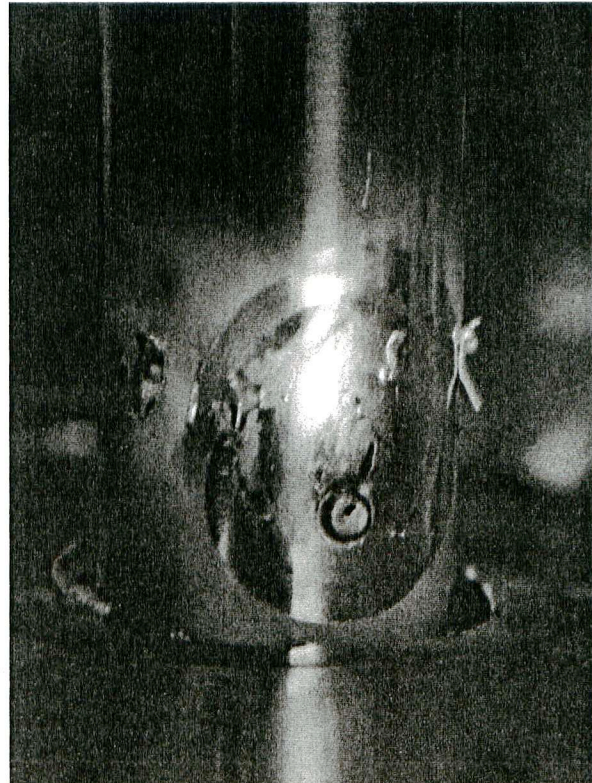
# Ver.1 Arcing between spacer and stem

### (3) Arcing

Arcing occurred between the stem and the spacer.  
Broken fingers became a sharp electrode for discharge.

$\longrightarrow$  Vacuum leak

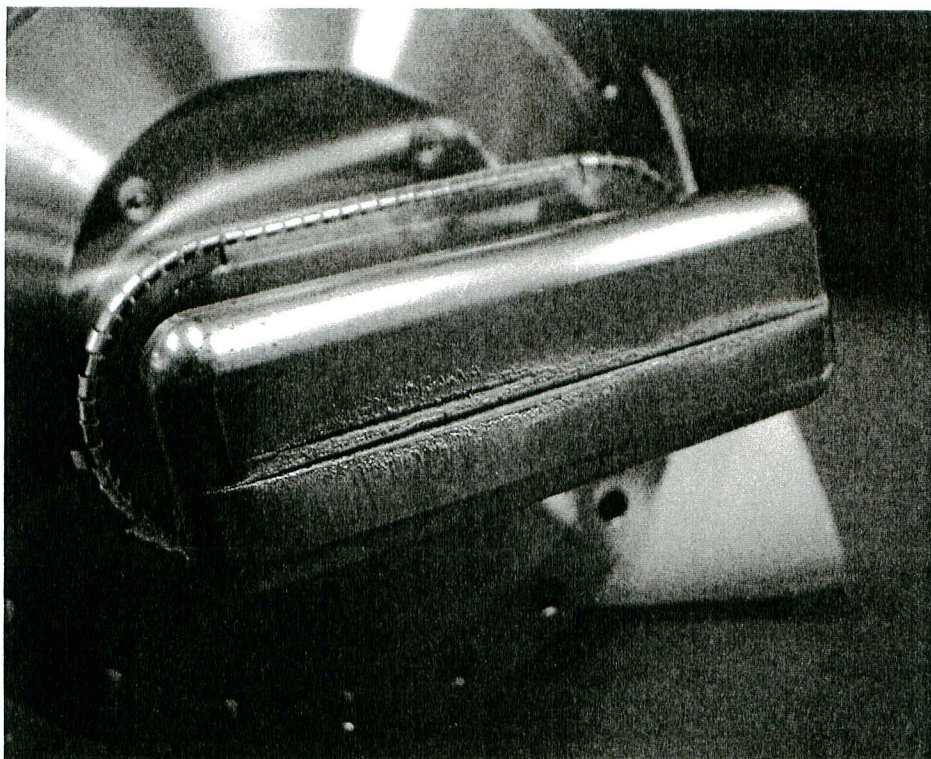
# Ver.1 Grooves on mask head

### (5) Digging of mask head

Cu-W mask head

(5) Digging of mask head → Change of mask head material  
CuW → Cu

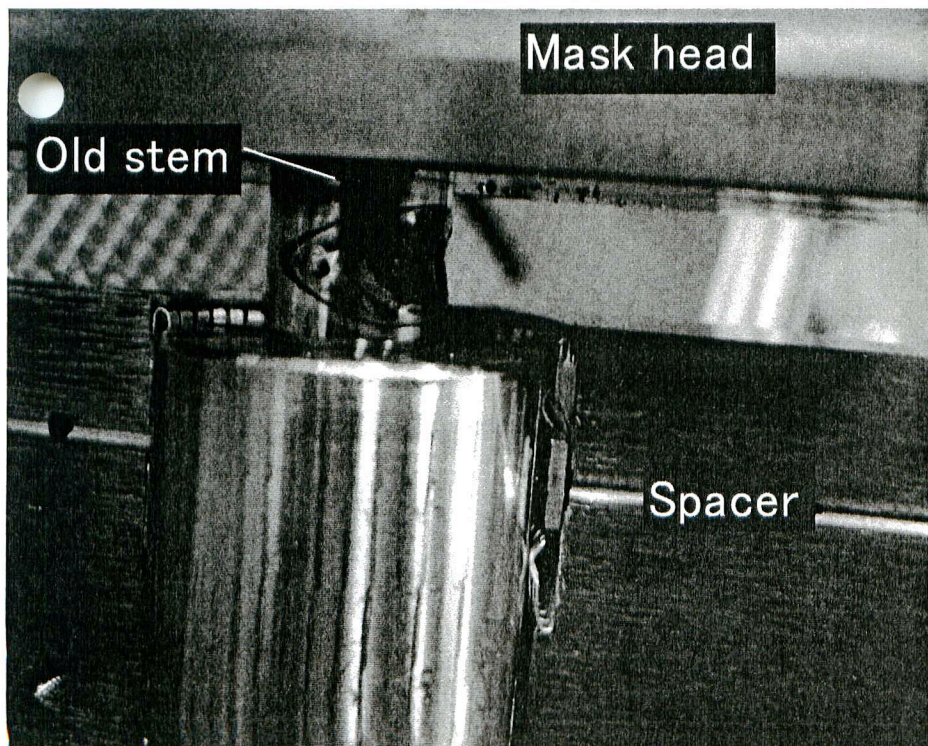
## Ver.2 Vacuum leak

Arcing occurred between the old stem (inside of collar)  
and the edge of spacer.

Vacuum leak !

Arcing between the old stem and spacer

All Ver.2 masks were  
immediately removed.

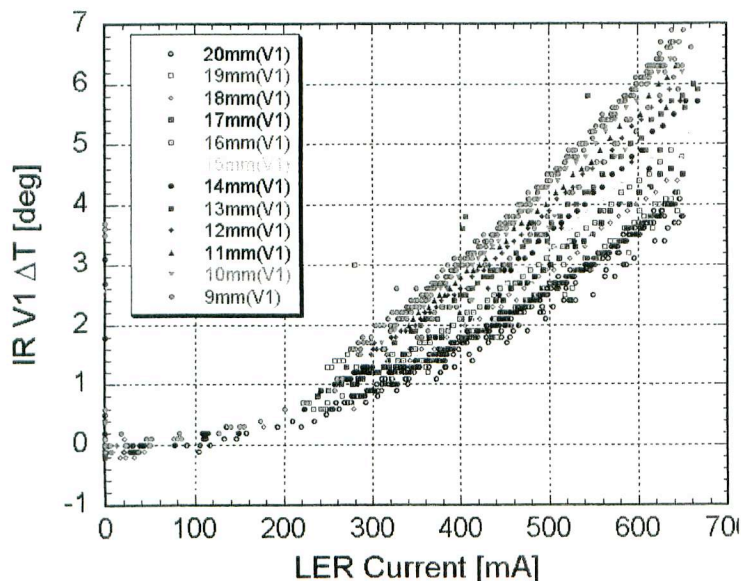
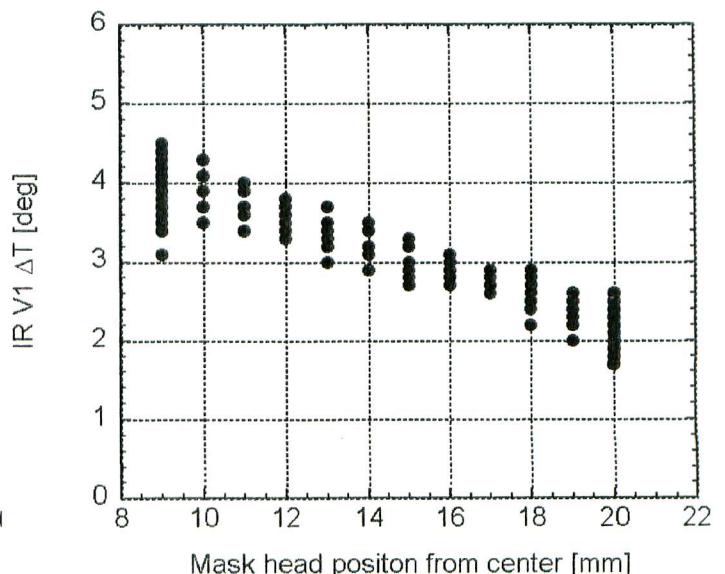
## Ver.3.1 Troubles

Larger input power than expected

~500 W/SiC at 600 mA (LER)

The temperature increased monotonically as the mask head approached the beam.

→ Not a resonance

→ The SiC is absorbing HOM generated at the mask itself.

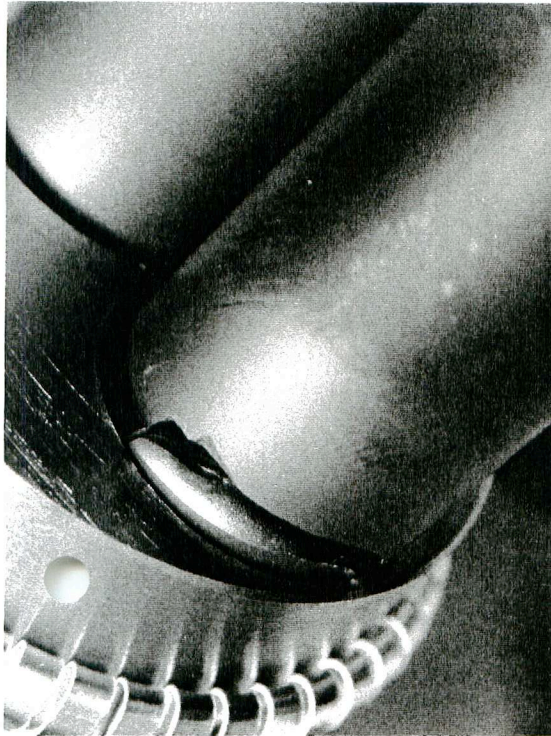
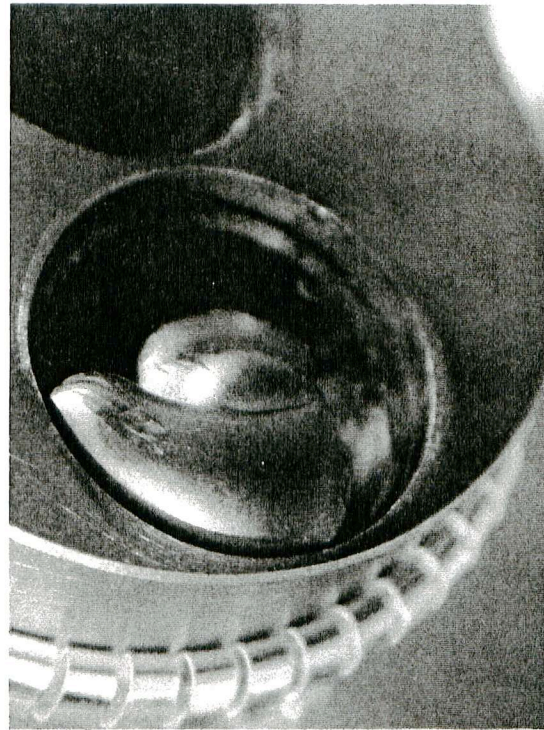
## Ver.3.1 Troubles

An SiC has broken

After the operation at 700 mA for about 2 months, one SiC was found to be broken.

Before installation?  
Too high input power?

LER beam current was limited at 500 W/SiC (larger than the past achievement)

To play it safe, Ver.3.1 cannot be used for LER anymore.

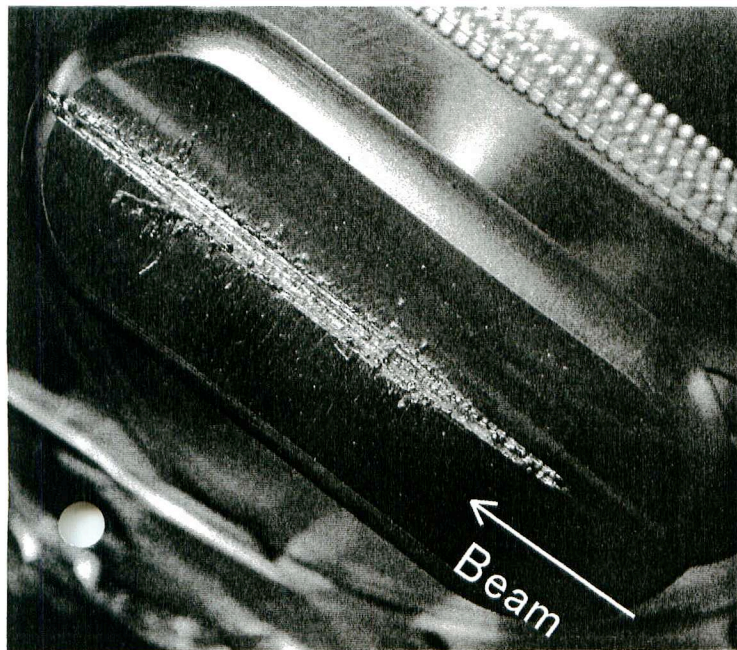
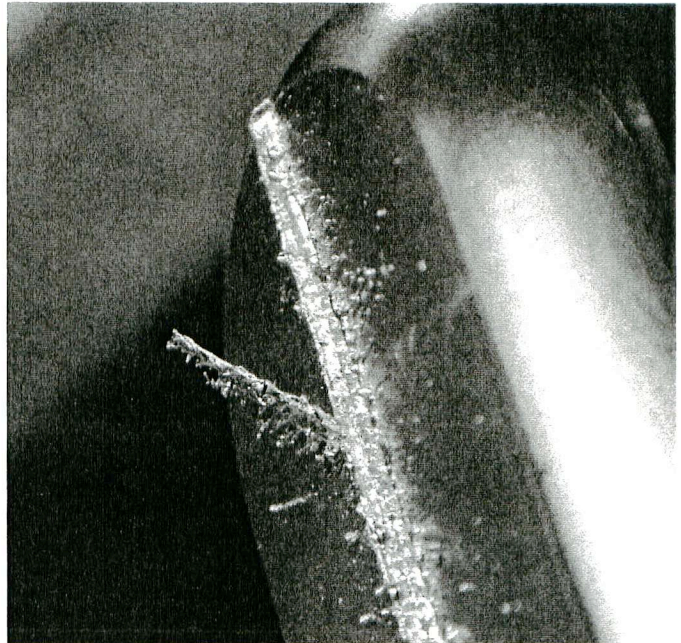
# Ver.3.2 Troubles

## Groove on the mask head (Cu)

The head has melted. The whisker was objecting the beam.

(1) Abrupt change of orbit

Setting of a abnormal bump

(2) Vertical blowup of beam size or vertical oscillation

Energy loss (a few %)

For an example, down of a  
(superconducting) cavity

Slippage from the regular optics or  
feed-back timing

Vertical blowup of beam size or  
vertical oscillation

Generation of groove (further study is necessary)

{ Fast loss monitor  
Fast sensor of RF phase

may help mask

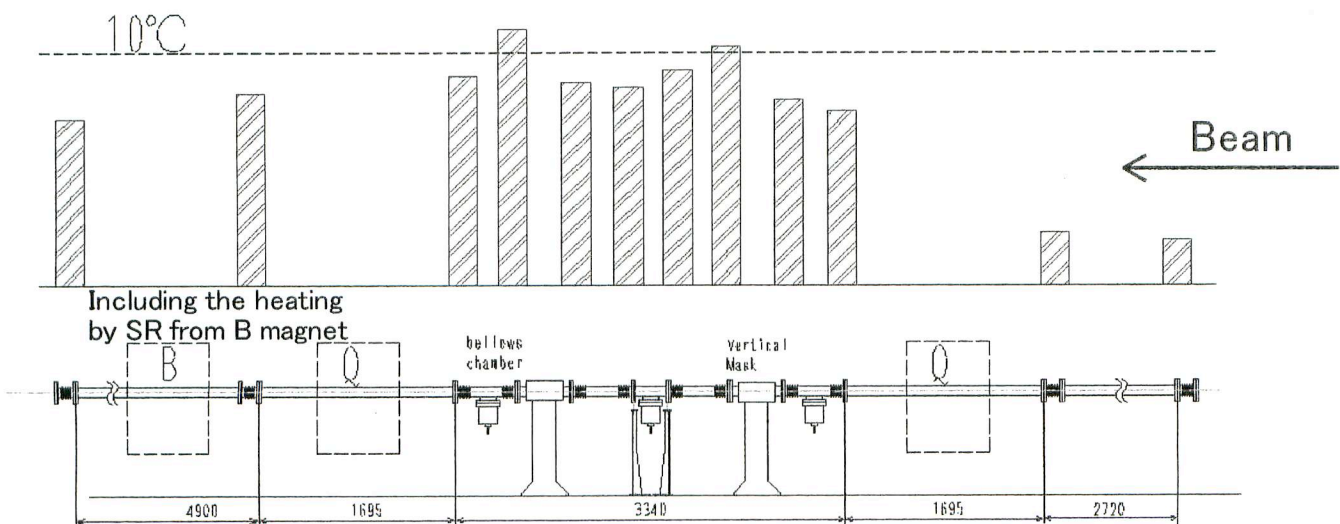
## Temperature rises of bellows around Ver.4 masks

Temperature rises at bellows around Ver.4 masks are higher than other bellows.

Temperature rise at 600 mA (LER)

Max.  $\Delta t = 35^\circ\text{C}$

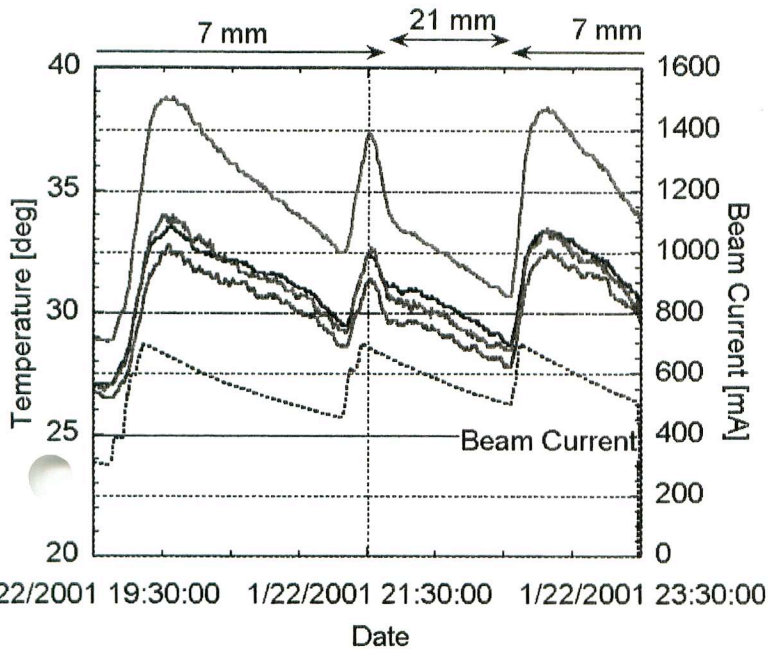
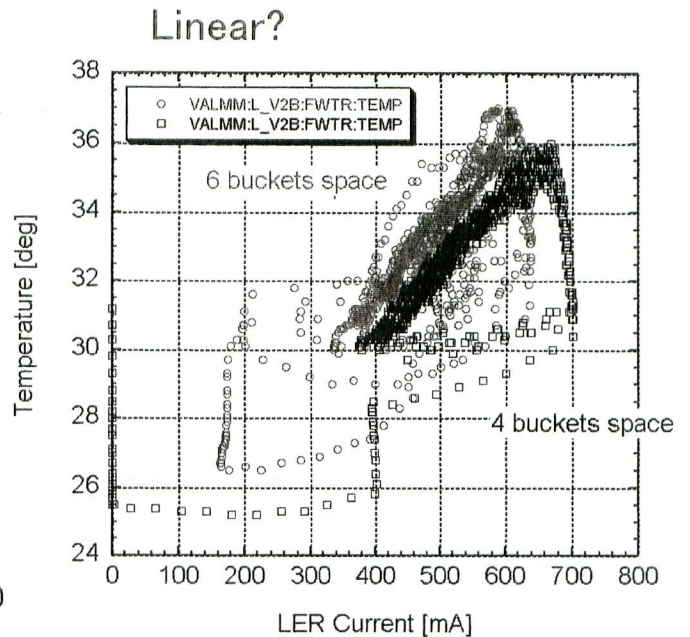
# Temperature rise of bellows

Due to { HOM generated by the mask?  
scattered SR?

Mask position dependence of bellows temperature near masks.

Fill pattern dependence of bellows temperature near masks.

(2) Temperature rise of bellows near Ver.4 mas is higher than others

- Main cause is HOM and/or scatterd SR?

Further studies are necessary.

- We have to keep watching.
