Present Status of KEKB Movable Masks

25/Feb/2002

KEKB VAC Y.Suetsugu

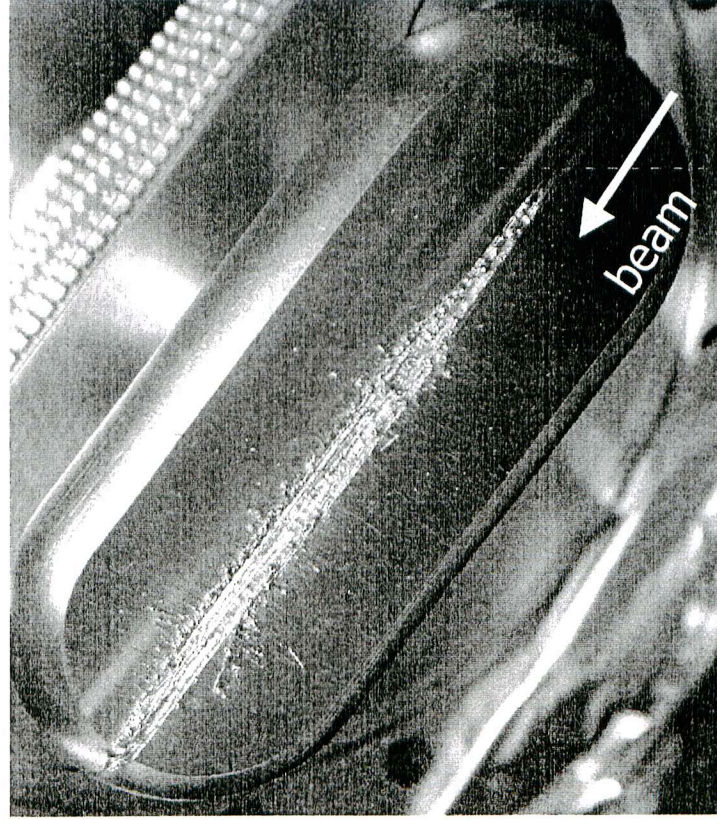
Ver.3.2 (Cu)

- Grooves were observed on Cu mask head. (both for LER,HER)
- The problem has been experienced from old masks.

Groove : width 3~4 mm, Depth 1~2 mm

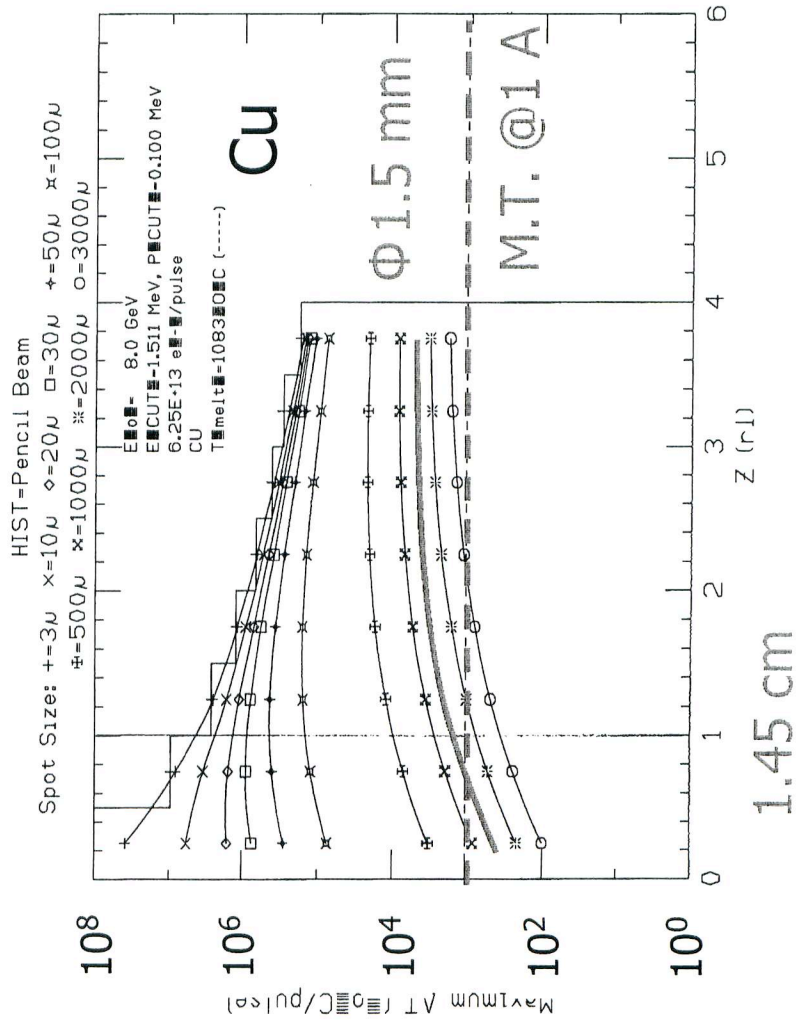
- Cause : Some portion of beam attacks mask head in an abnormal beam abort.
- Pressure burst, loss monitor signal and beam loss were observed.
- Calculation of temperature by EGS4 program indicated the possibility.

- If 1 A beam hits Cu block, Cu likely heats up to the melting point.
- From observation, the grooves started after about 10 mm from edge of head. →
- Estimated beam size is about 1.5 mm.

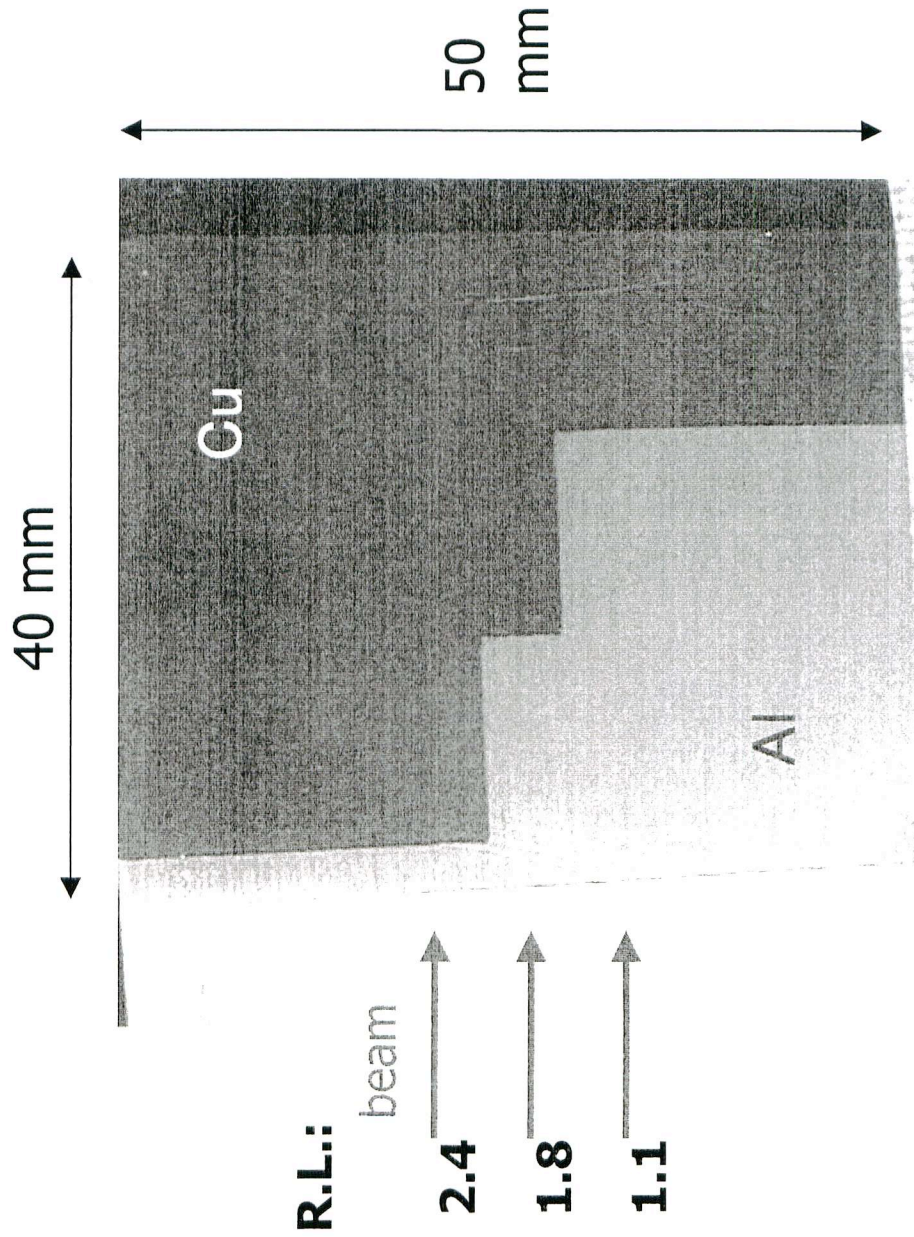
- Study on finding necessary radiation length
- Ver.4.5 with a special mask head was installed (HER).

- Different R.L. (1.1 ~ 2.4) was tested by changing beam orbit at mask.
- For the case R.L.=1.8 and 2.4, mask reduce the BELLE background but grooves were generated in Cu region.
- R.L. = 1.1 seems enough to reduce BELLE background but occasionally high radiation dose were observed.
- For such a short R.L., many masks should be installed to avoid unexpected heavy radiation damage to BELLE.

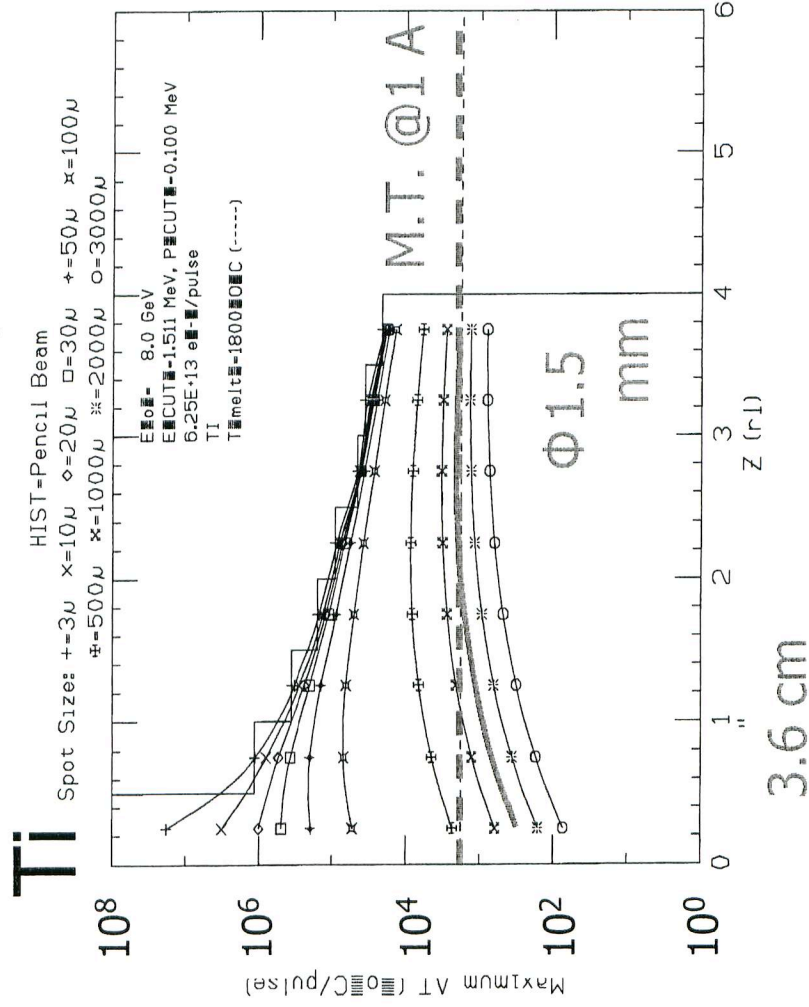
- Possible material
- Calculation of temperature using EGS4 for several materials

- For HER (1.1 A), Ti mask with R.L. of about 2 can be used.
- Four horizontal Ti mask with 2.2 R.L (80 mm) was installed in last January and any defect has not been observed yet.
- Other Cu masks will be changed to Ti masks this year.
- For LER (2.6 A), Ti mask with 1 R.L. may be possible, but the plan is not fixed yet. It depends on the results of HER.

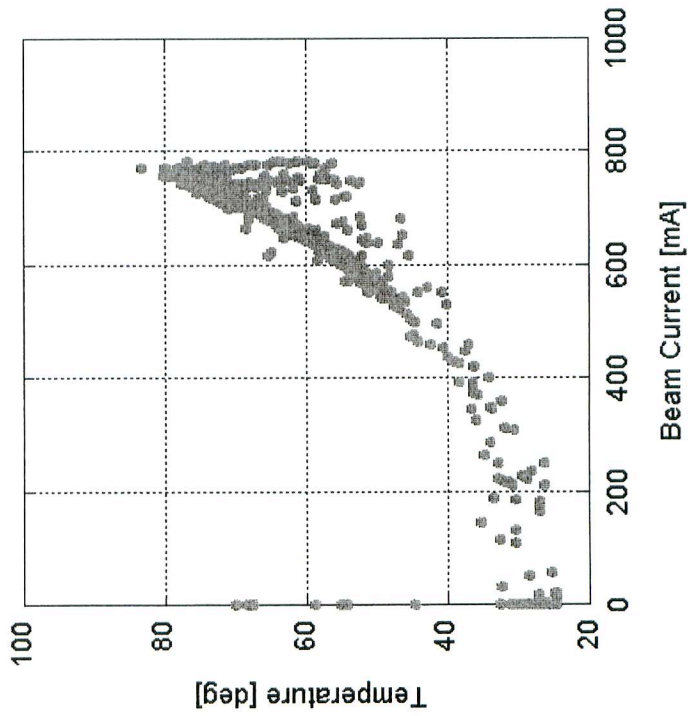
Behavior of bellows temperature against beam current

- Bellows near masks Ver.4 was heated.
 - Proportional to square of beam current
 - Depends on fill pattern
 - Shows resonant behavior

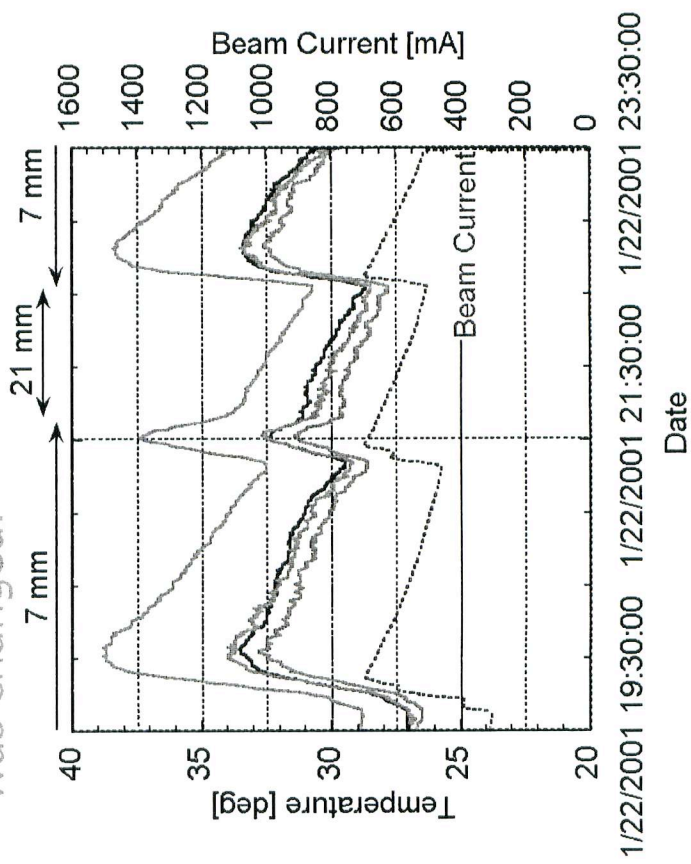
Resonant behavior of temperature.
Position of mask (= bellows length) was changed.

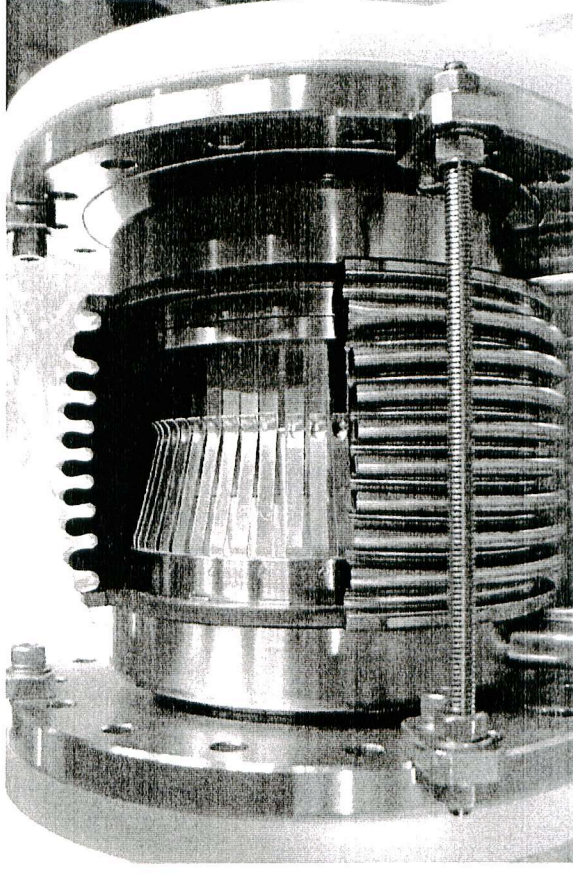
- Cause : MAFIA calculation indicates that the mask excite TE mode HOM at mask head and the HOM goes inside of bellows through slots between fingers.
 - The calculation also said there was many resonant frequency inside of bellows, that is just like a coaxial cavity.
 - Estimated input power is about 100~200 W (@40~60°C) at off resonance.
 - Estimated from the temperature of bellows assuming forced cooling by air in turbulent flow.
- Effect : Heating limited filling pattern.

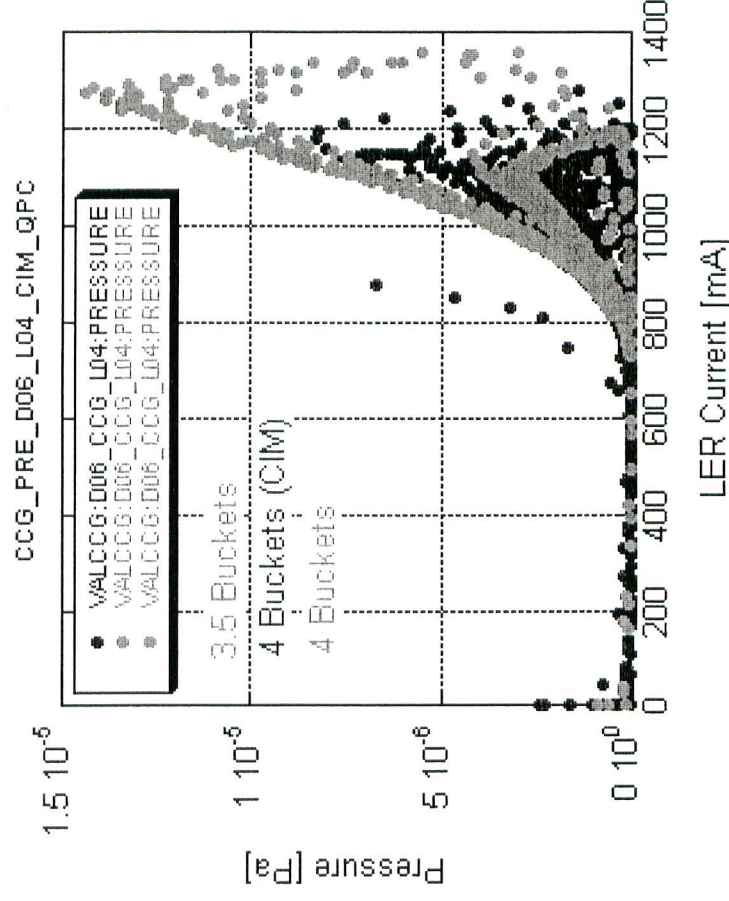
- During last autumn run, the rapid pressure rise near LER mask region was observed at the beam current higher than ~ 800 mA.
- The pressure contributes over a half of total pressure at about 1300 mA.
- The pressure began to affect the background of BELLE.

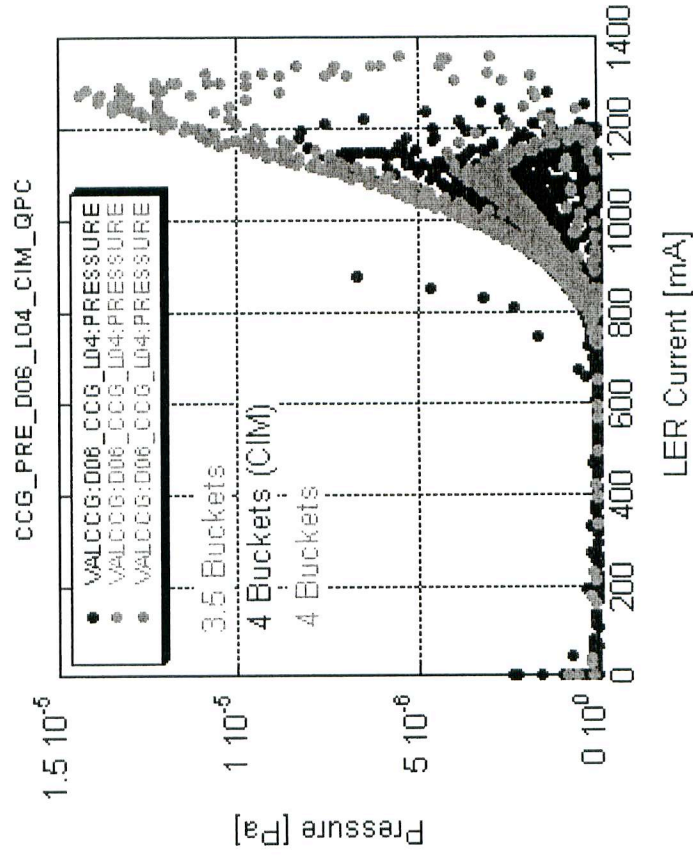
- Characteristics of the pressure rise
 - The pressure rises rapidly against the current.
 - Not gas desorption by synchrotron radiation
 - The peak does not correspond to the Max. current.
 - Heating
 - Not multipactoring
- The heating is depend of total current.
 - Not resonance
- The aging proceed slowly.

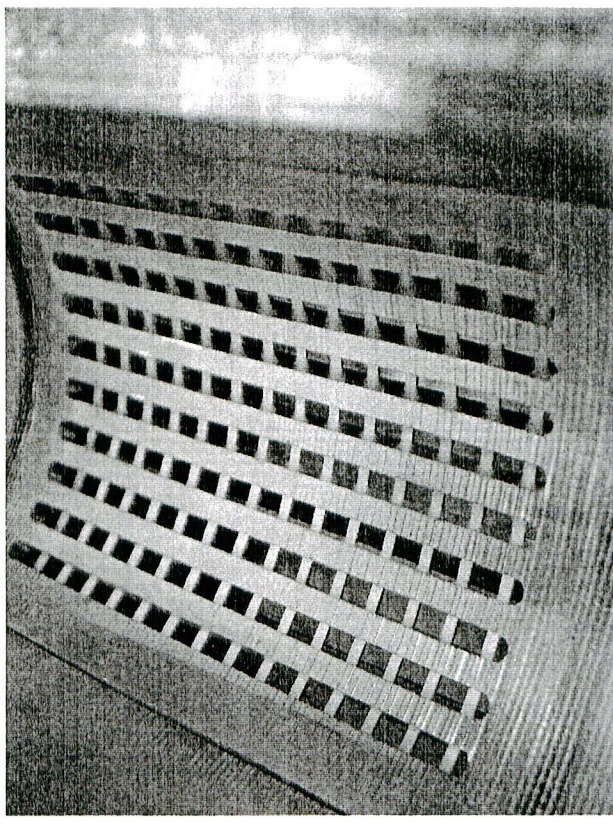
RF shield of chamber

- A suspect
 - NEG is heated by HOM generated at mask (same as bellows heating)
 - Heated NEG desorbs H₂ gas.
 - HOM intrude the NEG chamber through the RF shield at the pumping port.
 - The existing RF shield seems weak against TE mode HOM.
 - Cross bar has a thickness of only 0.5 mm. -> ~3 mm is necessary.

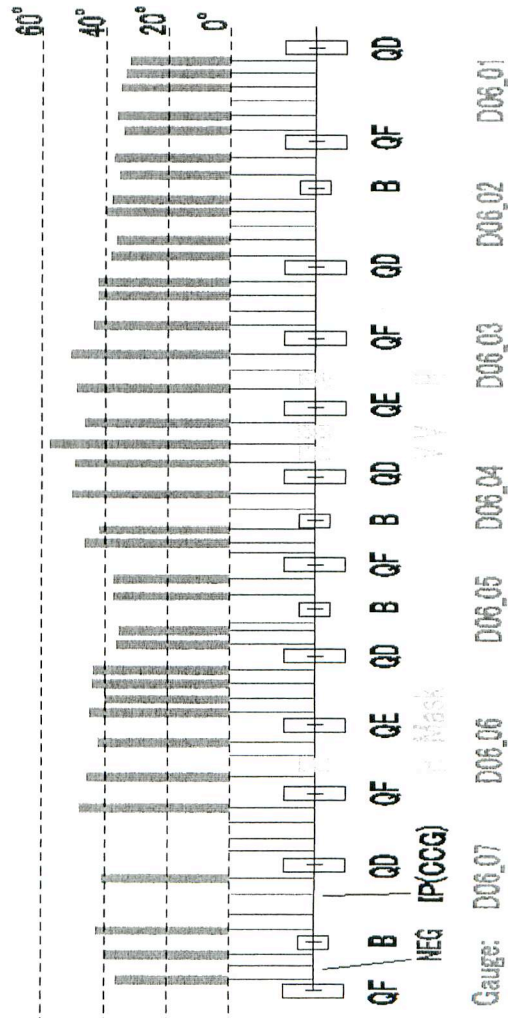
Temperature Distribution of NEG Chambers near Masks
After 30 min. from Beam Abort

- Reason_1
 - Temperature of NEG chamber near mask is higher than other ones.
 - The estimated input power is about 60W and the temperature is above 150 °C from comparison with the temperature during activation.
 - Pressure distribution is almost same as the temperature's.

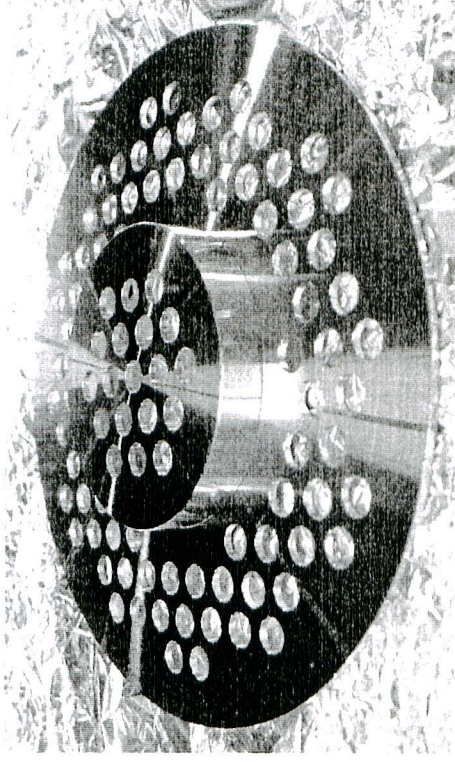
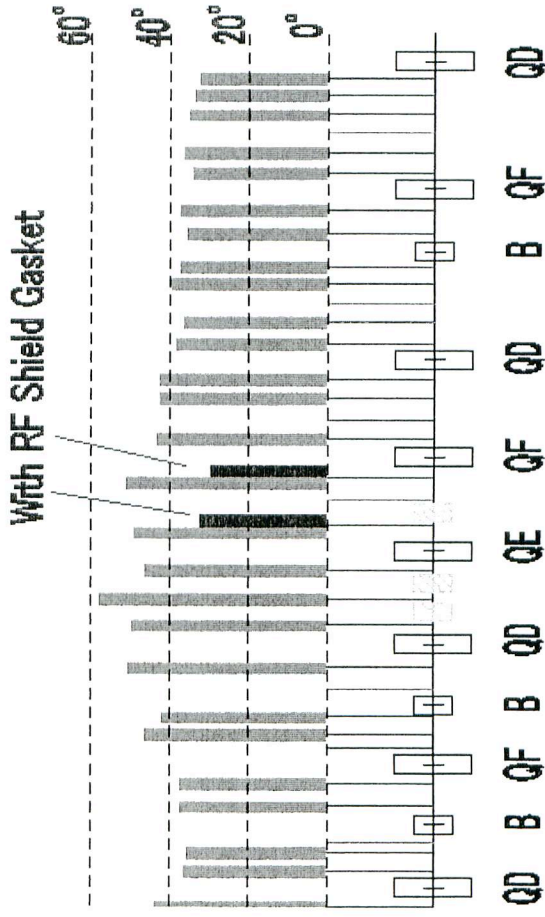
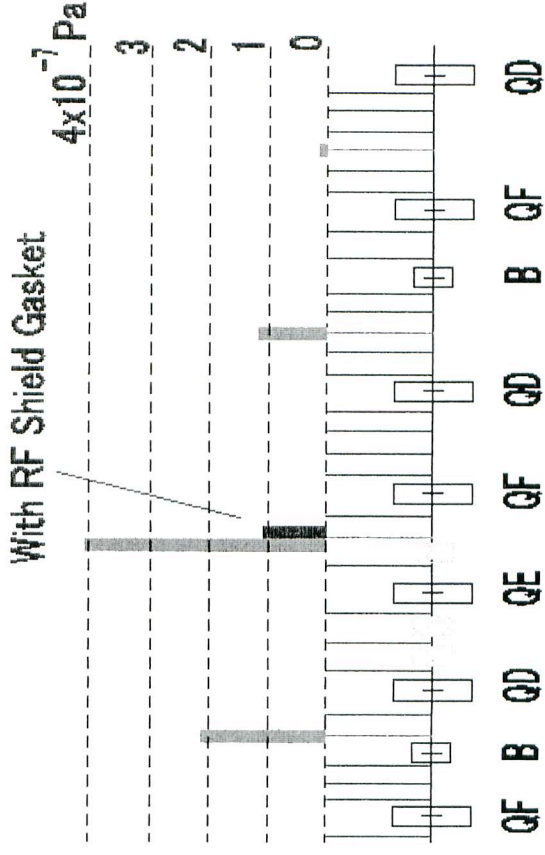
- Reason 2
 - Two RF shield gaskets with many holes of $\phi 8$ mm is installed between beam duct and NEG chamber near a gauge.
 - The effect is apparent.

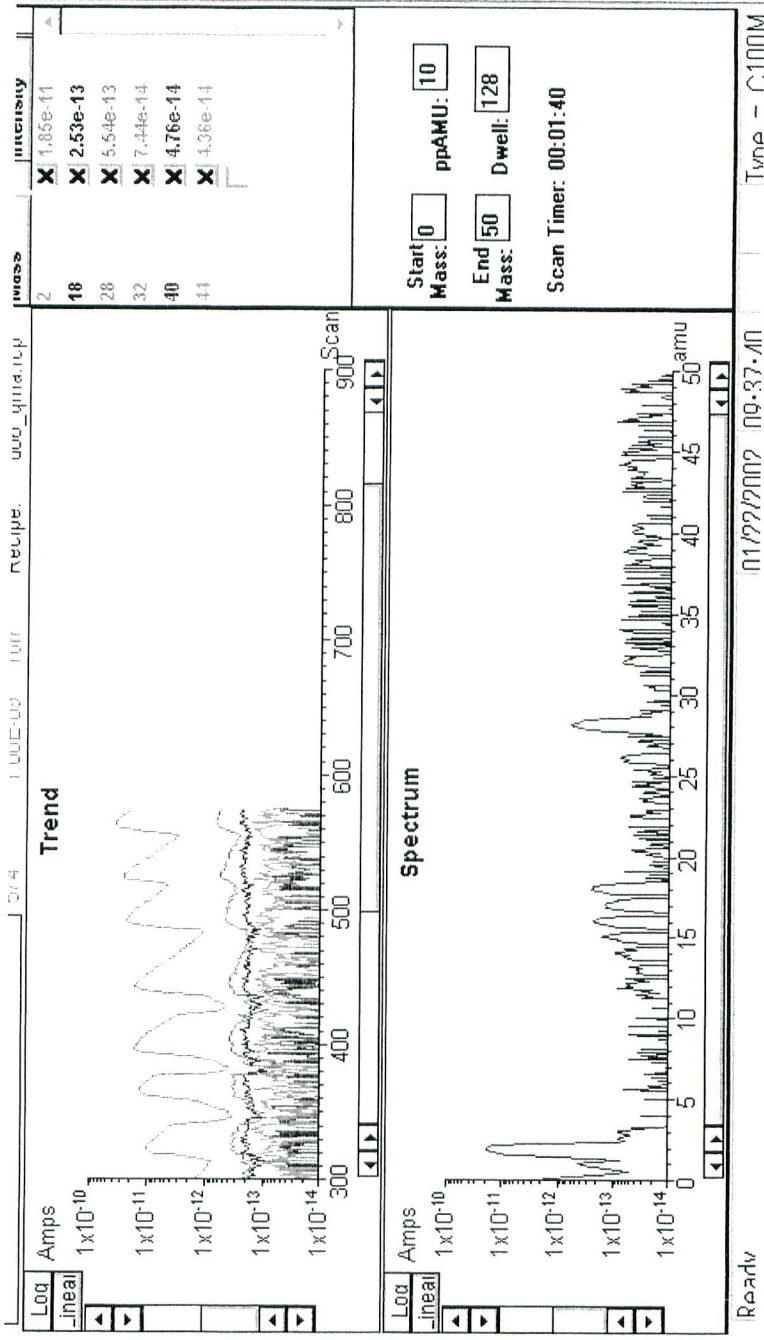
Gas from NEG

- Reason 3
 - Residual gas component
 - Main gas is H₂

- Countermeasure : Install RF shield gaskets for about 100 NEG ports near masks.
