Experiences on High Current

Y.Suetsugu, KEKB

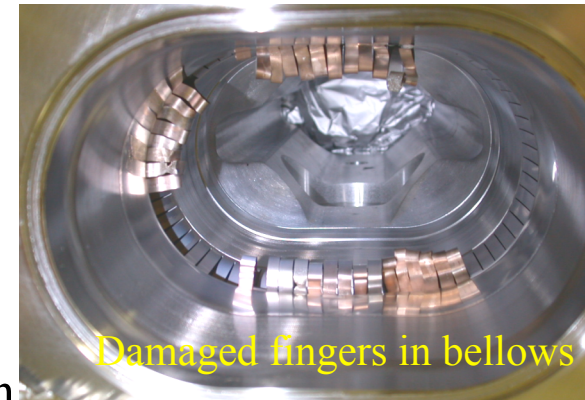
High HOM Power

- Heating of bellows and gate valves
 - Bellows near movable masks and IR (big HOM sources)
 - Especially for bellows and GV with a race-track cross section or big size
 - Shows resonance behavior
 - Objects beam injection, Beam oscillation
 - ➔ Cooling fan or exchange
 - ➔ Major problems at present

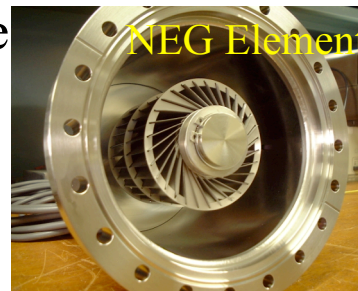
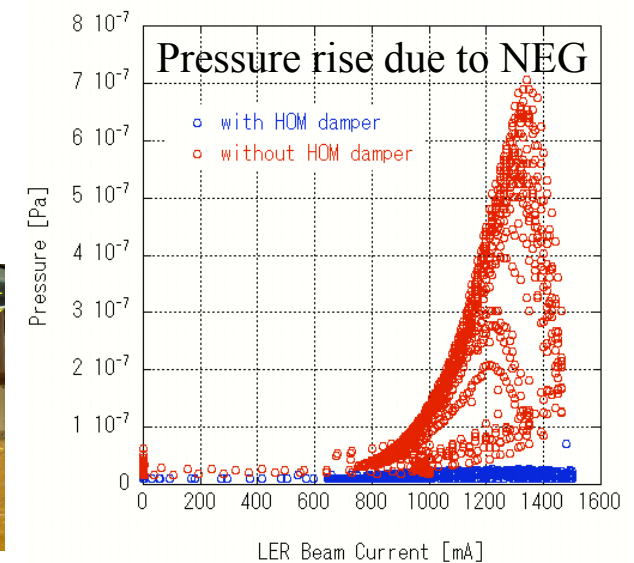
Heating of NEG elements

- Near Movable masks
- Abnormal pressure rise
- Affect background
 - ➔ HOM absorber
 - ➔ RF shield gasket

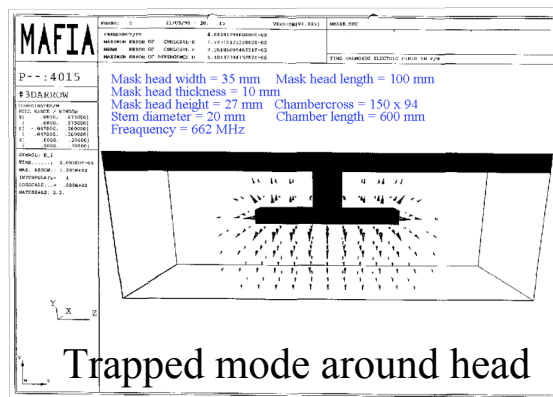
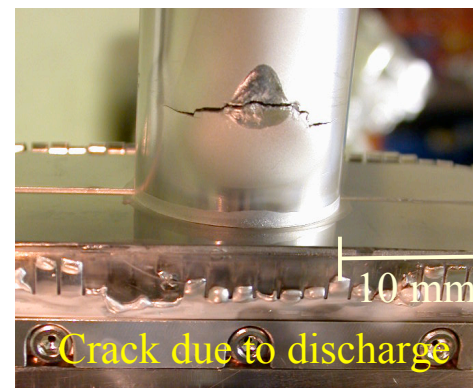
Discharges in early versions of movable masks

- Trapped mode
- No HOM absorber
- Excess heating & discharge → Vacuum leak
→ Improvement of structure (version up)

Excitation of synchrotron oscillation

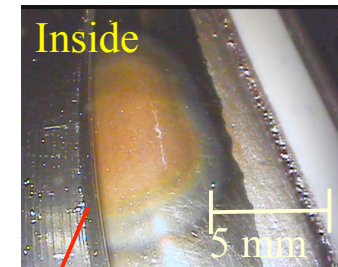
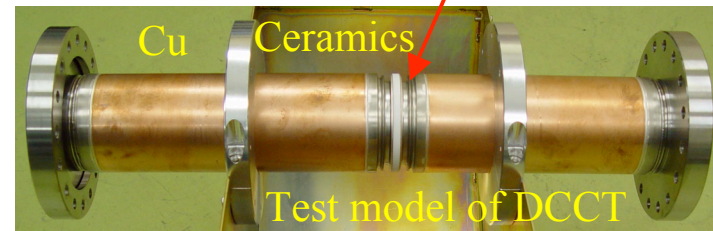
Discharge in a test-type DCCT for upgrade

- Test : stain-less steel → copper
- Discharges at Kover joint blazed on ceramics ring
- Rapid pressure rise vs. current
 - ➡ Improve structure

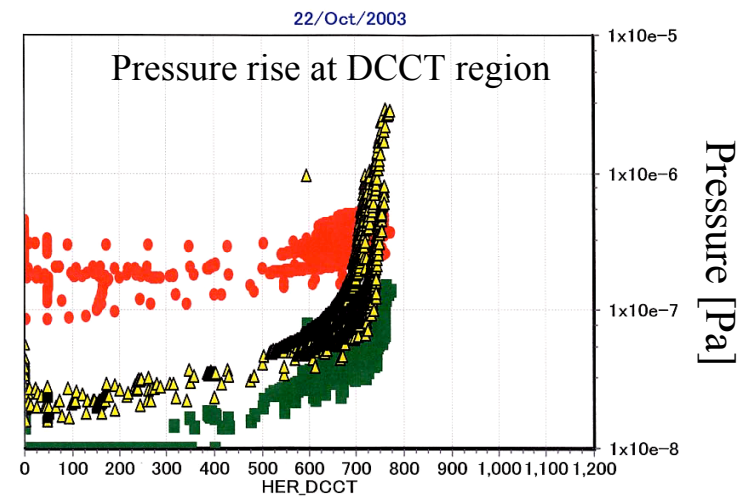
Rapid pressure rise even for present type

- Over 1100 mA
- Similar to test-type
 - ➡ keep watching

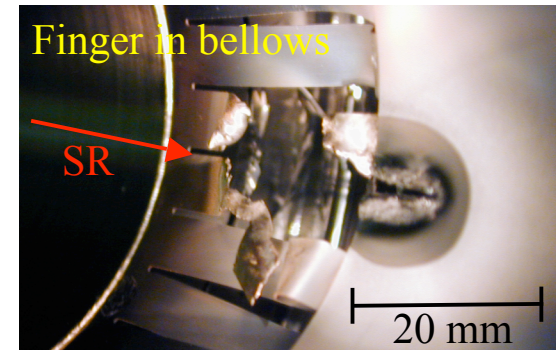
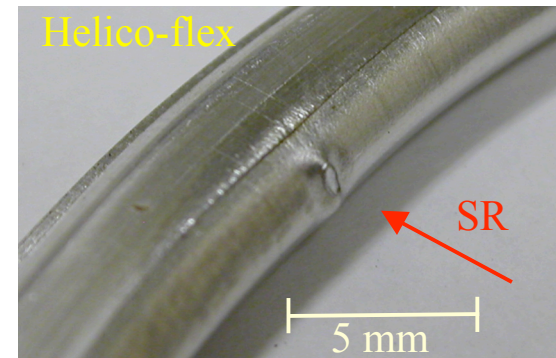
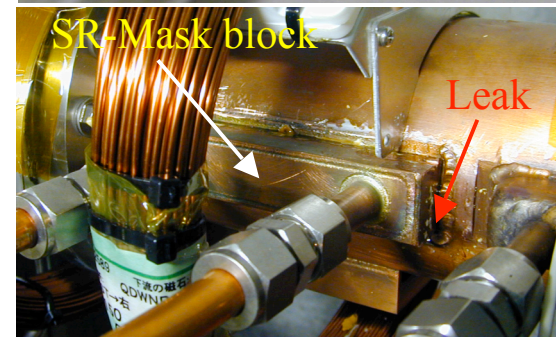
- Melting of RF shield of bellows
 - SR hit RF-shield finger in bellows → Leak
 - Re-alignment of beam chamber
 - Add SR mask at upstream
- Melting of Helico-flex
 - SR hit Helico-flex gasket → Leak
 - Re-alignment of beam chamber
 - Add SR mask at upstream
- Vacuum leak at SR Masks
 - Welding point of SR-mask block
 - Due to heat cycle and defect of welding
 - Exchange of chamber

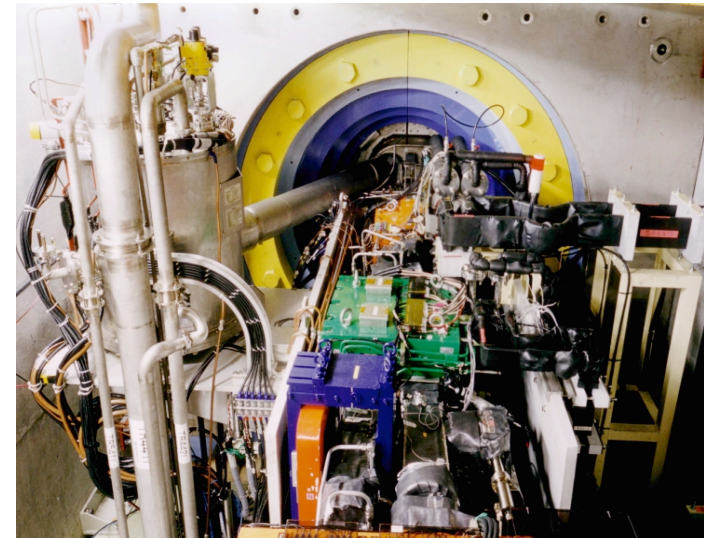
Complex at IR

- IR: Complicated configuration
- Deformation of beam chamber
 - Al chamber at downstream side of IR was heated and squashed by SR
 - ➡ Change structure & material (Cu)
- Heating of bellows and chambers
 - Due to mainly HOM
 - ➡ Increase cooling capacity
- Movement of beam chamber
 - Due to heating by HOM or SR
 - Make collision tuning difficult
 - Cause of slow recovery of luminosity after beam abort ?
 - ➡ Feedback movement to BPM signal

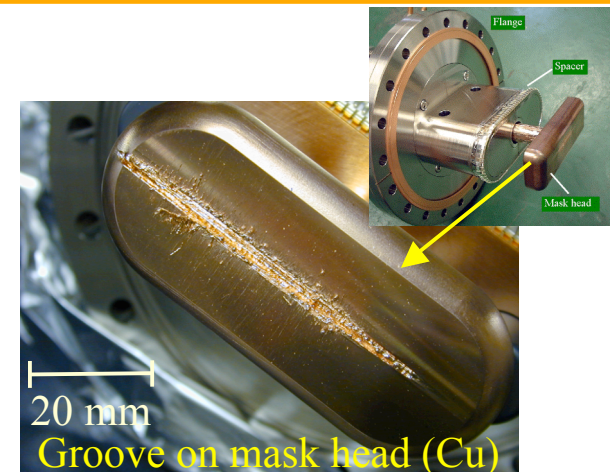
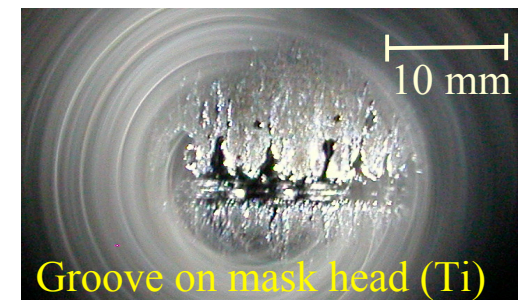
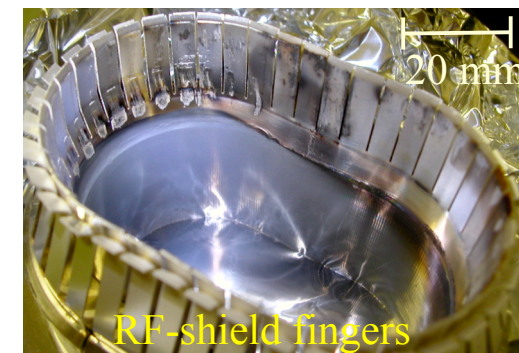
Grooves at mask head

- Damaged by steered beam
 - ➡ Change material copper → Ti
 - ➡ Rapid beam abort system
 - ➡ Not completely solved

Vacuum leak at abort window

- Beams pass just near the wall
- Leak at transition from Al to Ti (window)
- Thermal stress?
 - ➡ Change structure

Discharge at RF-shield

- Discharges due to wall current
 - ➡ Change structure & material

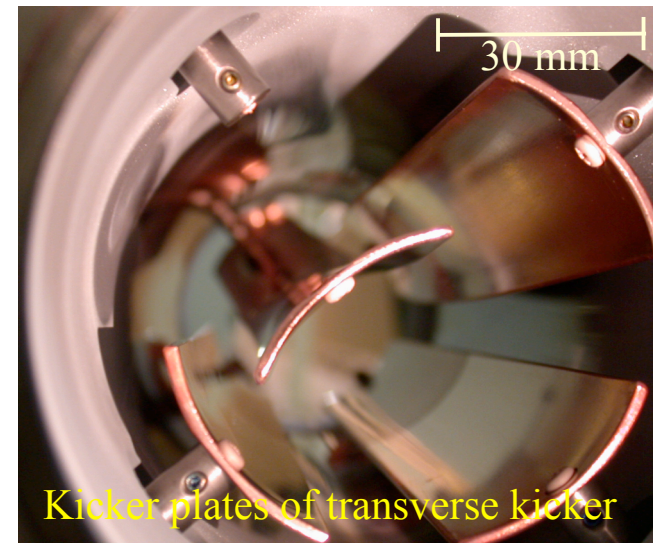
- Several problems on transverse kicker [from M.Tobiyama]
 - Damage at flexible structure of feedthrough (Ver.1)
 - Sagging of kicker plate(Cu), break down of fixing bolt (Ver.2)
 - Sagging and annealing of kicker plate (Ver.3)
 - Due to large ohm loss
 - ➡ Change of material (Cu+SUS)
 - ➡ Improve flexibility of feedthrough
- Heating of feedthrough itself is low enough up to now

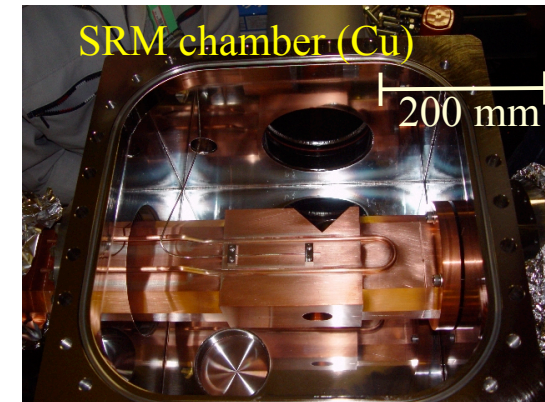
Heating of SR monitor chamber [from J.Flanagan]

- Heating at Stainless-steel chamber
- Heating by ohmic loss
- Leads to drift of mirror orientation with beam current

➡ Change to Cu chamber

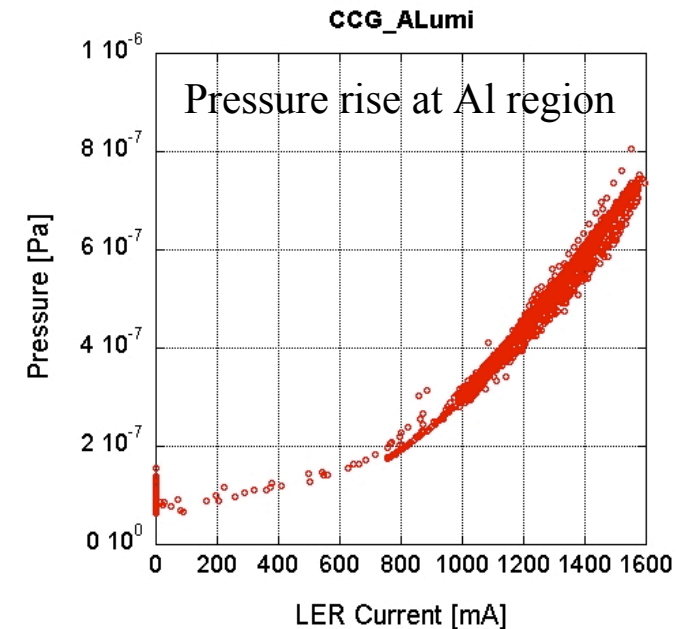
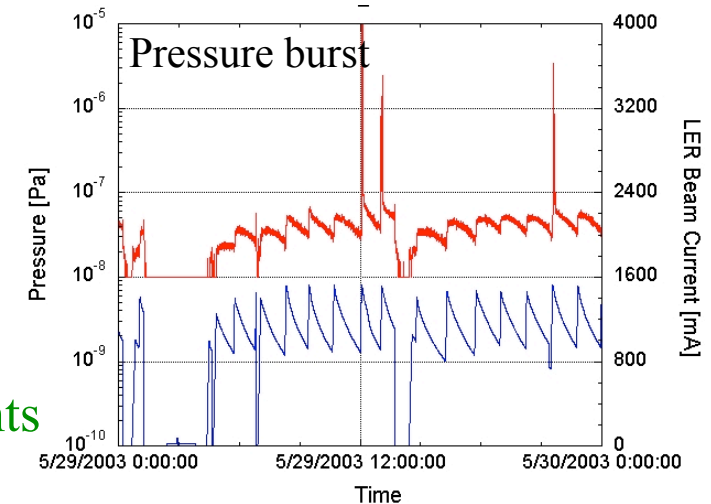
- Pressure rise due to multipactoring
 - Observed in whole LER at initial stage
 - Disappeared by solenoid
 - Especially aluminum chamber region now
 - Injection region? (both rings)
 - ➡ More solenoid

Pressure burst

- Observed at new current frontier
- Sometimes depends on fill pattern
- Sometimes causes beam oscillation and abort
 - ➡ Wait aging
 - ➡ Exchange of suspicious components

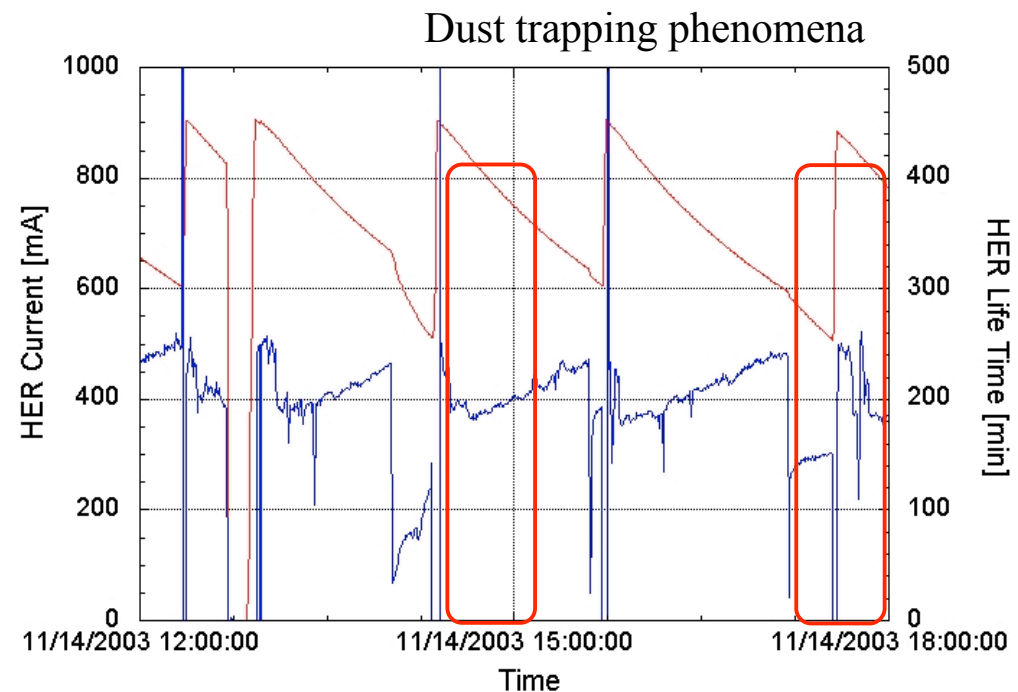
● Dust Trapping (electron ring)

- Abrupt decrease of beam life time
 - Sometimes the life time recover soon but sometimes not
 - Usually recovered by re-fill
 - Seen frequently after long shut down (lots of vacuum work)
 - ⇒ Improve environment during work
 - ⇒ Wait aging

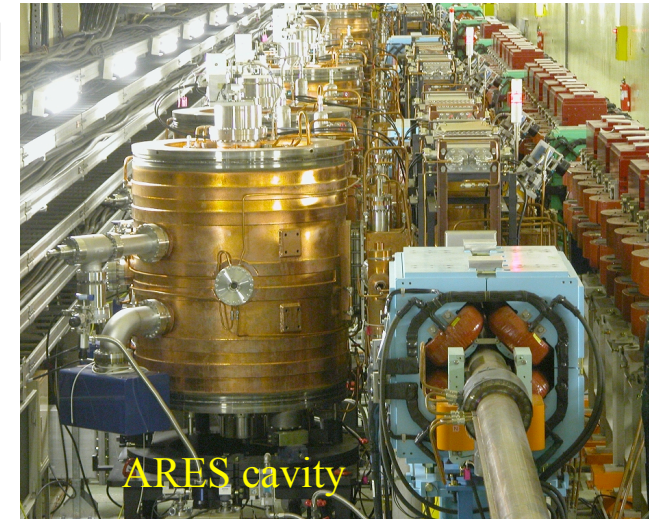
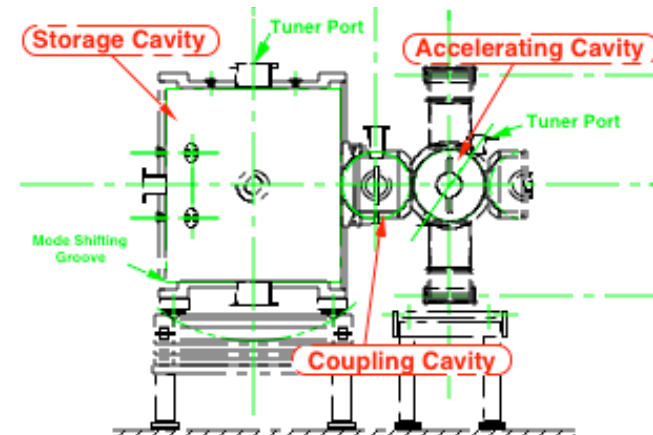
ARES Cavity : LER, HER

- Discharges at input coupler
 - Sometimes lead to vacuum leaks
 - ➡ Arc sensors in vacuum and atmosphere
 - ➡ Rapid beam abort system
 - ➡ Regular maintenance
- Burn out of RF damper at coupling cavity
 - Due to leak of cooling water or bad RF contact at dummy load
 - ➡ Improve temperature monitoring system
 - ➡ Improve RF contact
- No severe troubles these 2 years

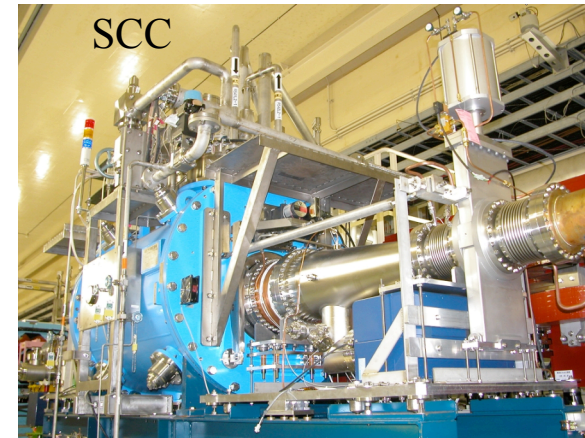
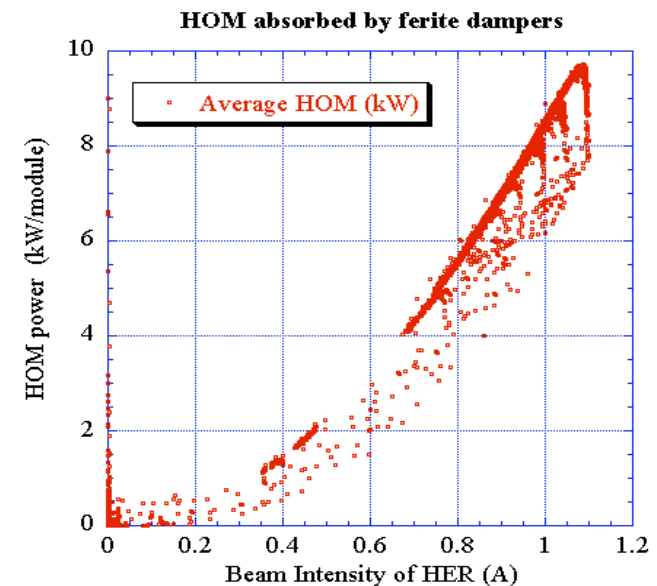
Super Conducting Cavity : HER

- No severe troubles so far
- Heating of HOM absorber
 - Due to higher bunch current than design value
 - Design: 5 kW → now: 10 kW
 - No problem up to now
→ keep watching
- Coupler
 - Design: 250 kW/cav.
→ now: 300 kW/cav.
 - No problem up to now
