Vacuum System around IR

March 9, 1999

KEKB Vacuum Group, K. Kanazawa

1. First installation
2. Vacuum
3. Collapse of QC2RE chamber
4. Summary

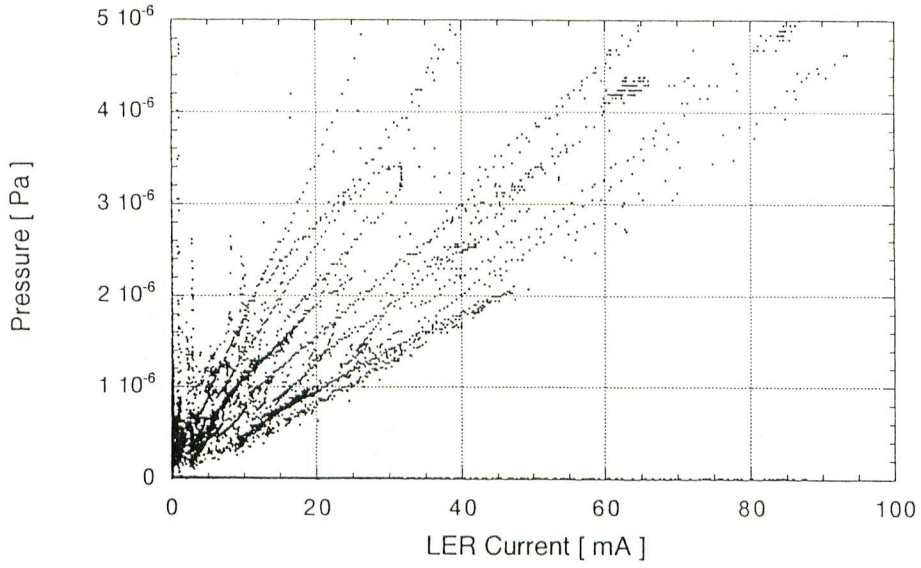
D01_CCG_H02

Feb. 3 '99 ~ Feb. 22 '99

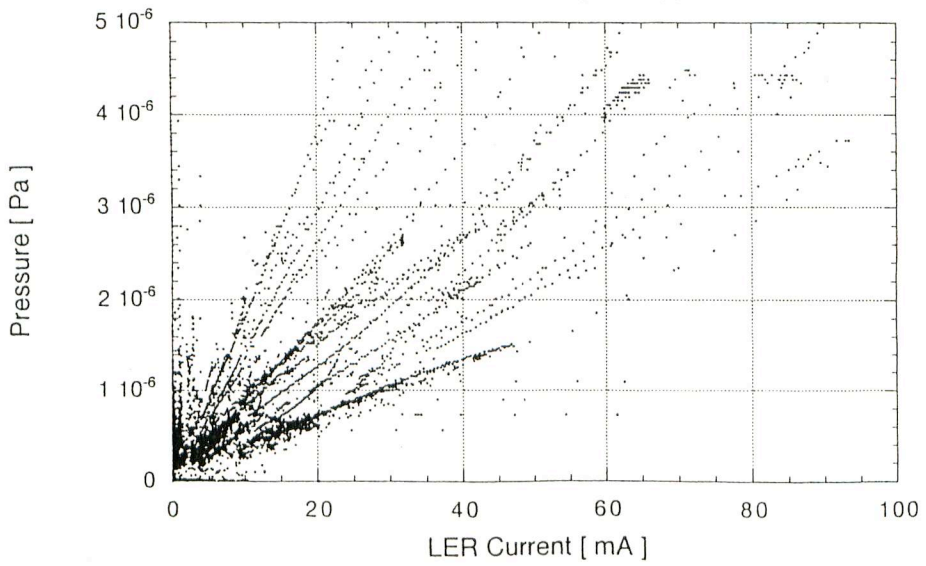
D02_CCG_H23

Feb. 3 '99 ~ Feb. 22 '99

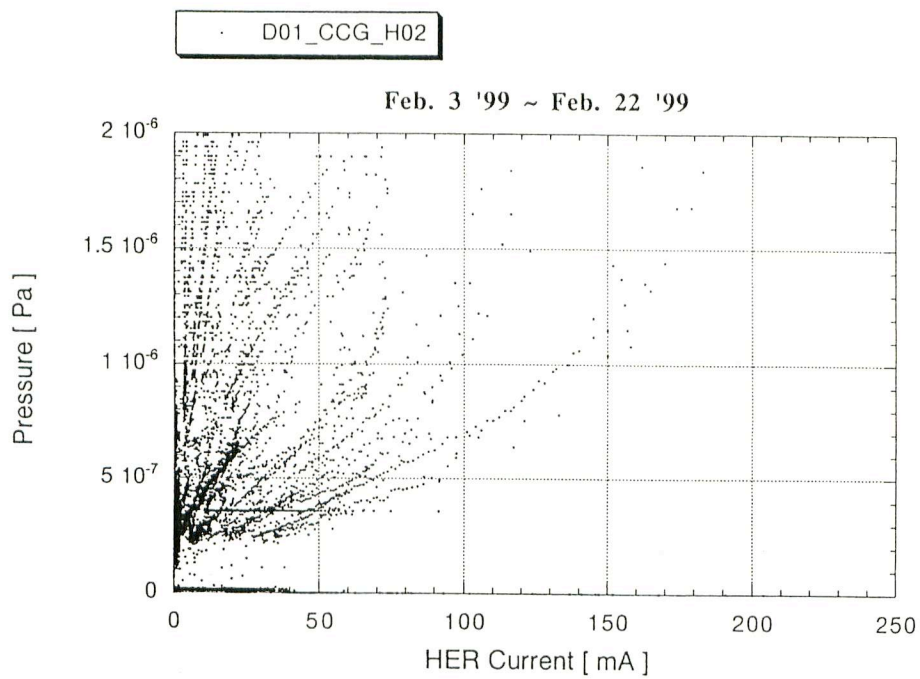
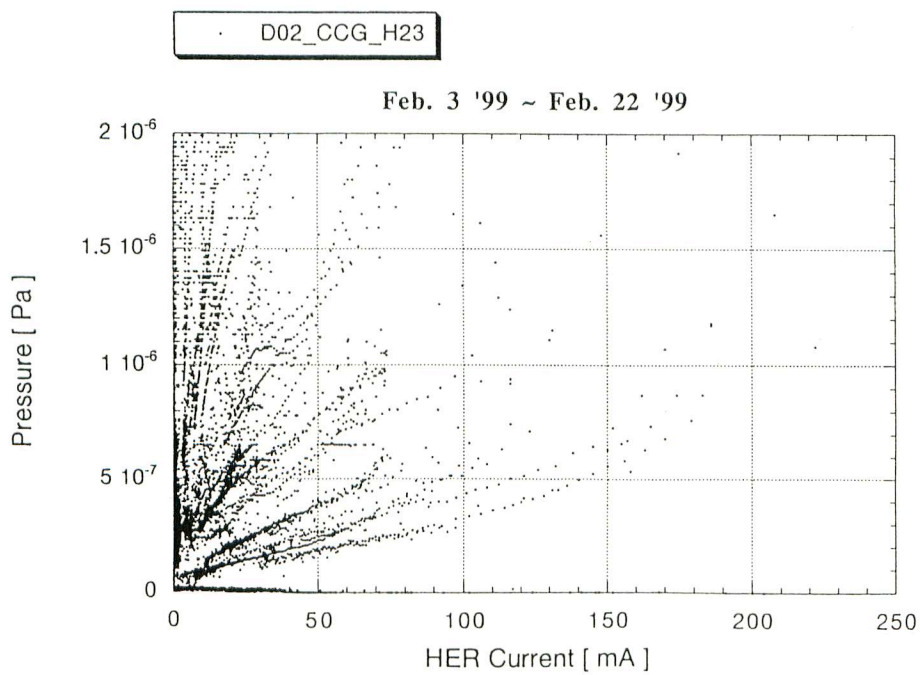
NEG modules at QC1LE and QC2LE had not been activated because of a wiring problem.

Pumping speed in the present design is insufficient.

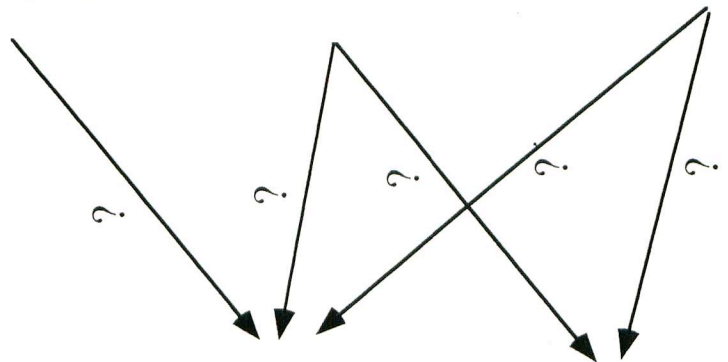
The pressure along the incoming positron line with beam is higher than expected.

HER beam causes pressure rise in the positron beam duct even at 8.5m point from IR.
