Stability Upgrade of Injector Linac

Injector linac Group

H. Kobayashi

Upgrade of Linac Stability

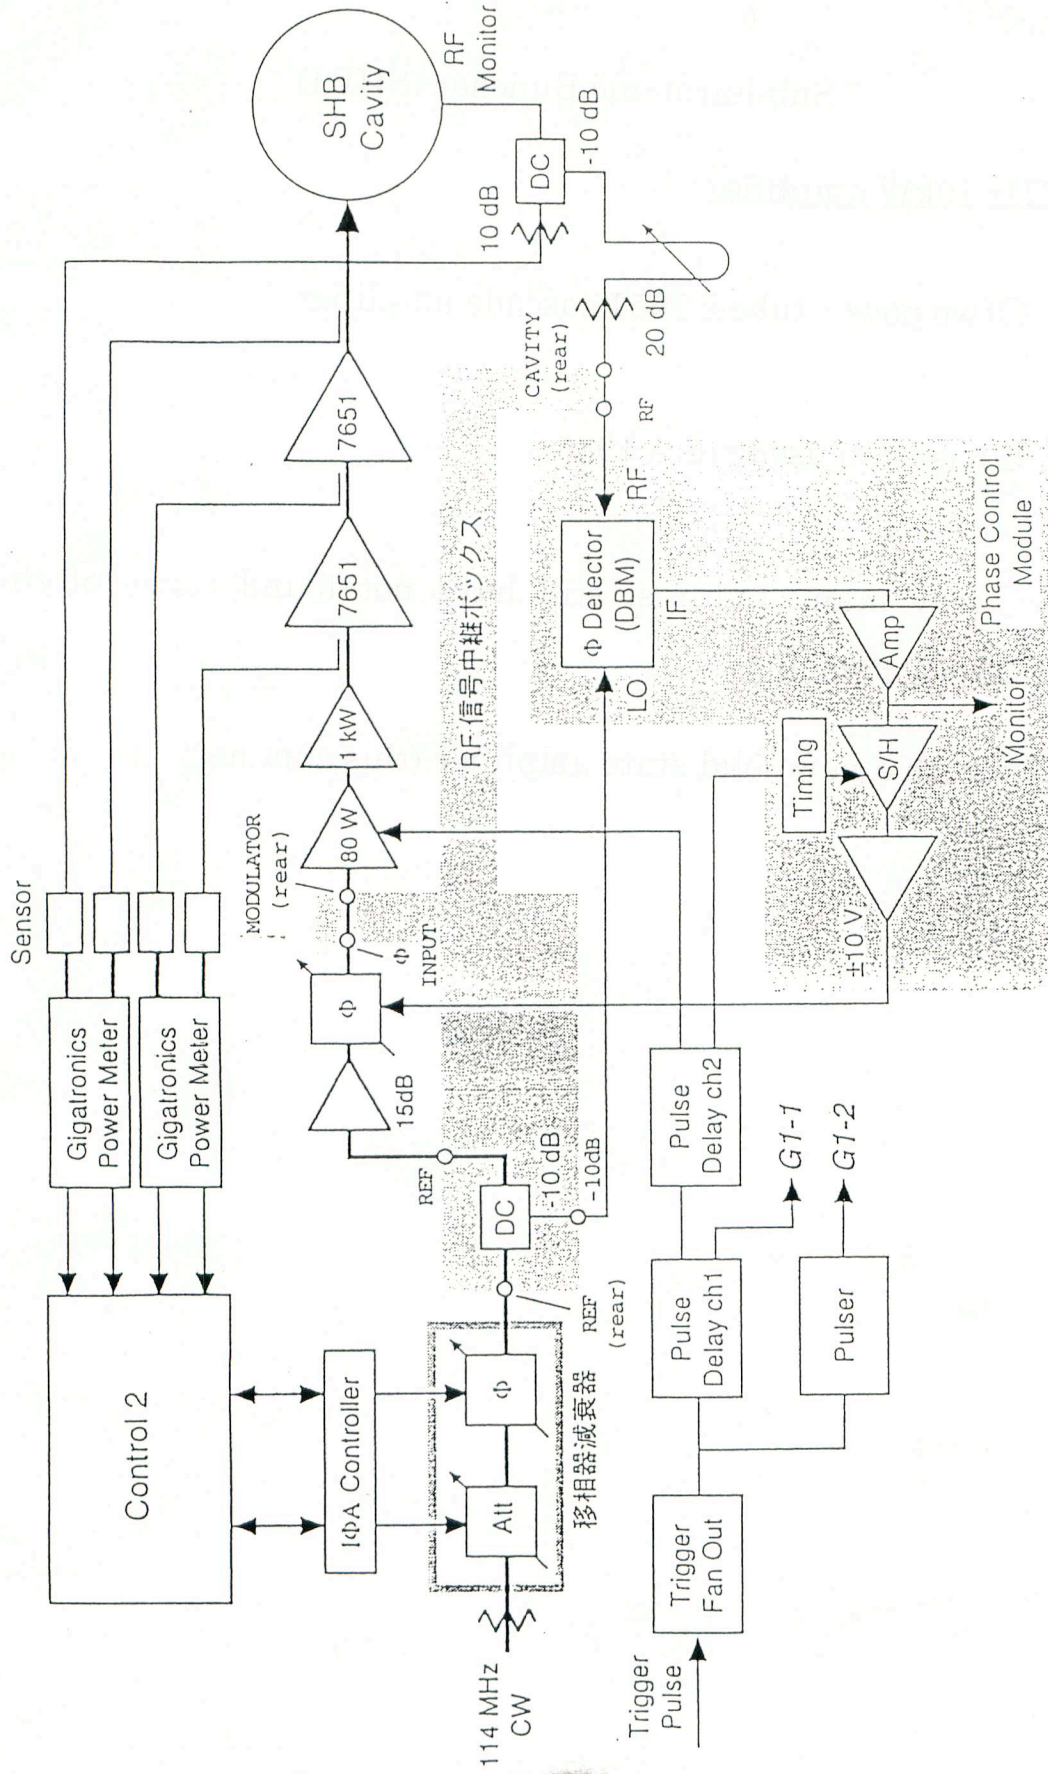
SHB 114 MHz 励振回路構成図

Sub-harmonic Buncher (SHB1)

114MHz 10kW amplifier

○two power tubes: 7651 cascade amplifier

○has been used since 1985

○very many failures: still have not found cause of this series of trouble

replace with a new solid state amplifier (this summer)

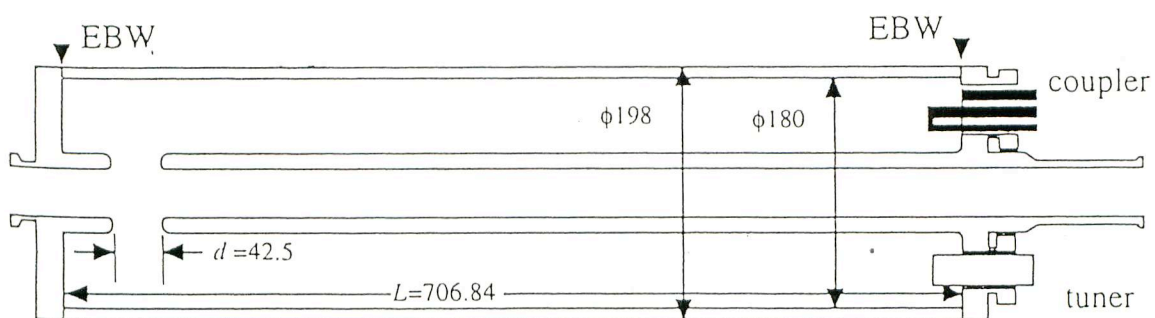
図4 SHB 空洞の断面図.

Cavity for Sub-harmonic Buncher (SHB2)

571MHz resonant cavity

tune drift (seems temperature change of inner conductor)

reflection of microwave at input coupler

input coupler will be replaced in March

replace with newly designed one (cooling channel for inner conductor)

this summer

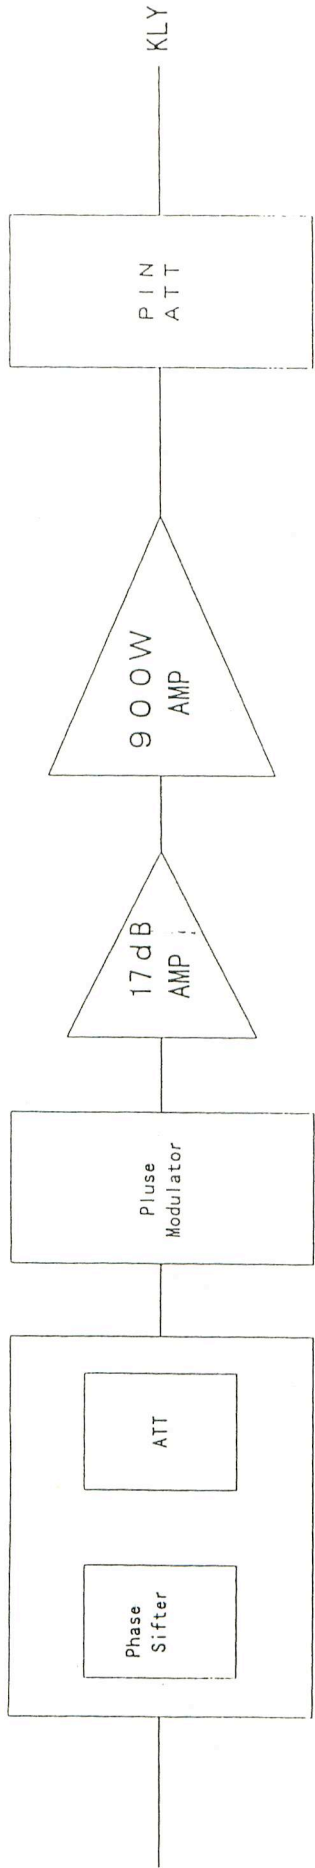
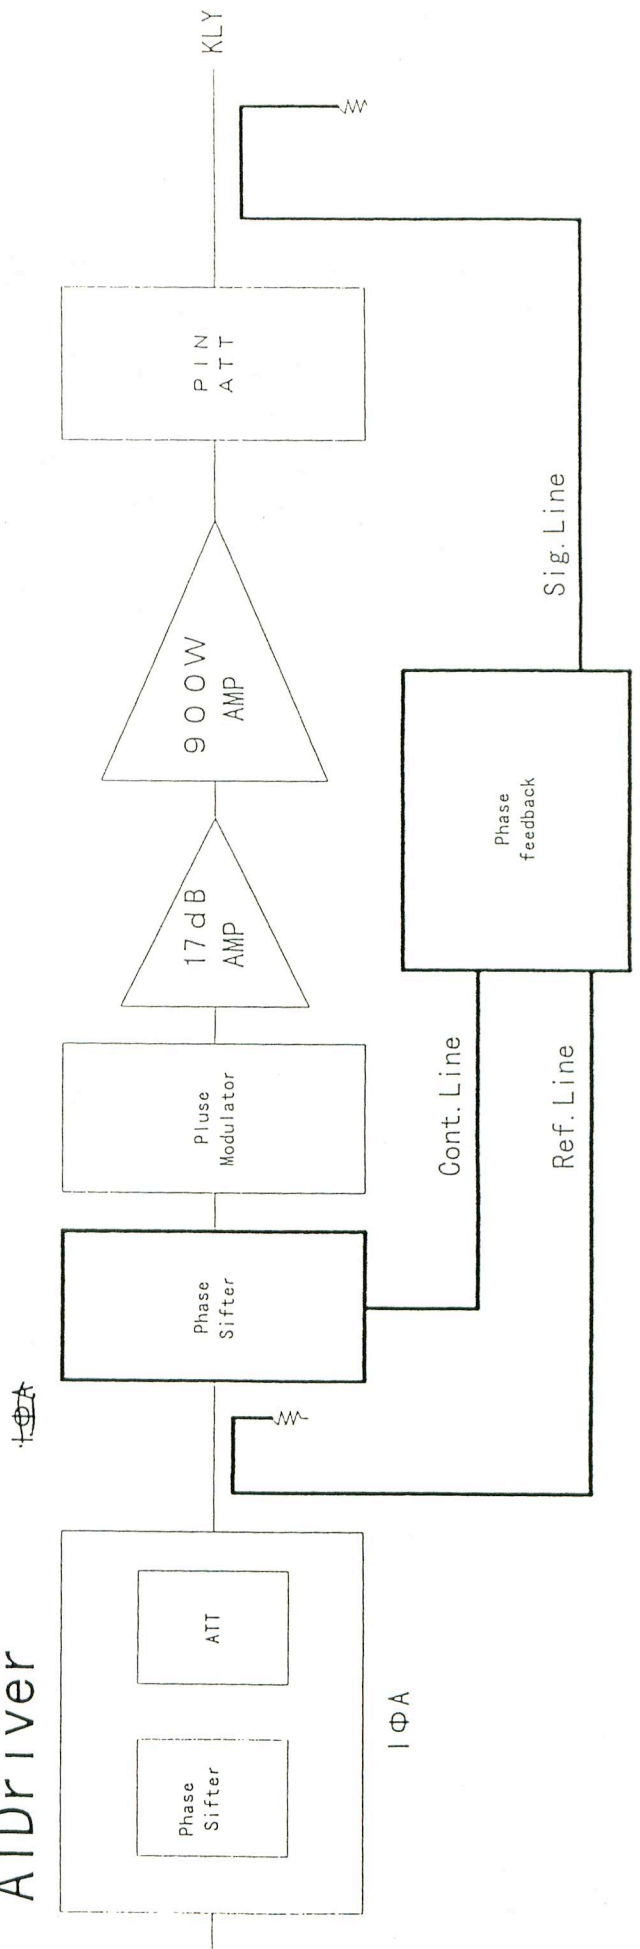
A-1 sub-booster

2856MHz Klystron drive microwave (600 watt solid state amp.)

drive only A-1 klystron without SLED
(the first klystron in injector linac)

no phase lock loop

affected with temperature shift of klystron gallery

replace with a newly designed one (April to May)
with phase lock loop

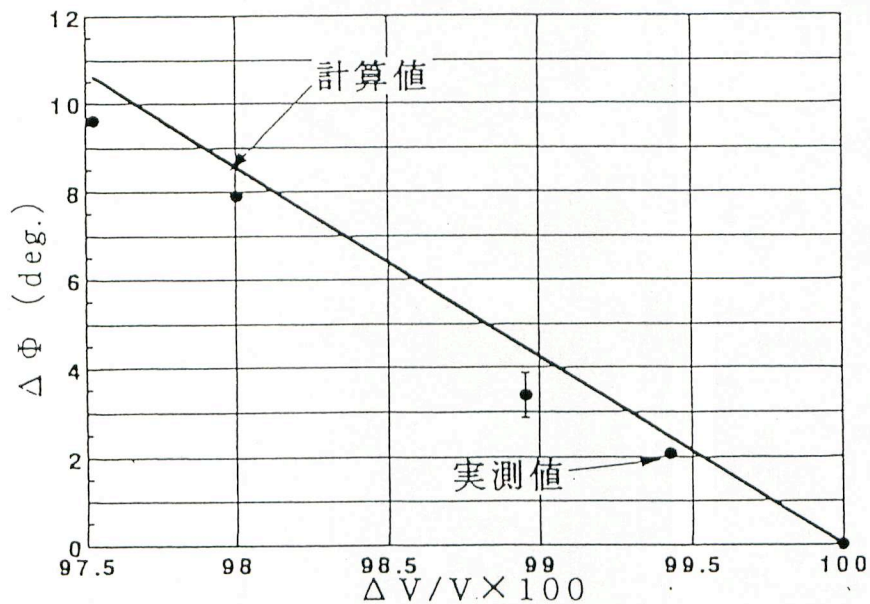
stabilize cooling water

Temperature of accelerating structures increased by 1 degree and affected beam stability.

Cause →lack of capacitor of heat exchange

Recently, heat load for cooling water for klystrons increased then the same problem as that of cooling water for accelerating structures occur

stabilize temperature of cooling water for accelerating structures finished January (1 degree to 0.04 degree).

stabilize that for klystrons during March by same process

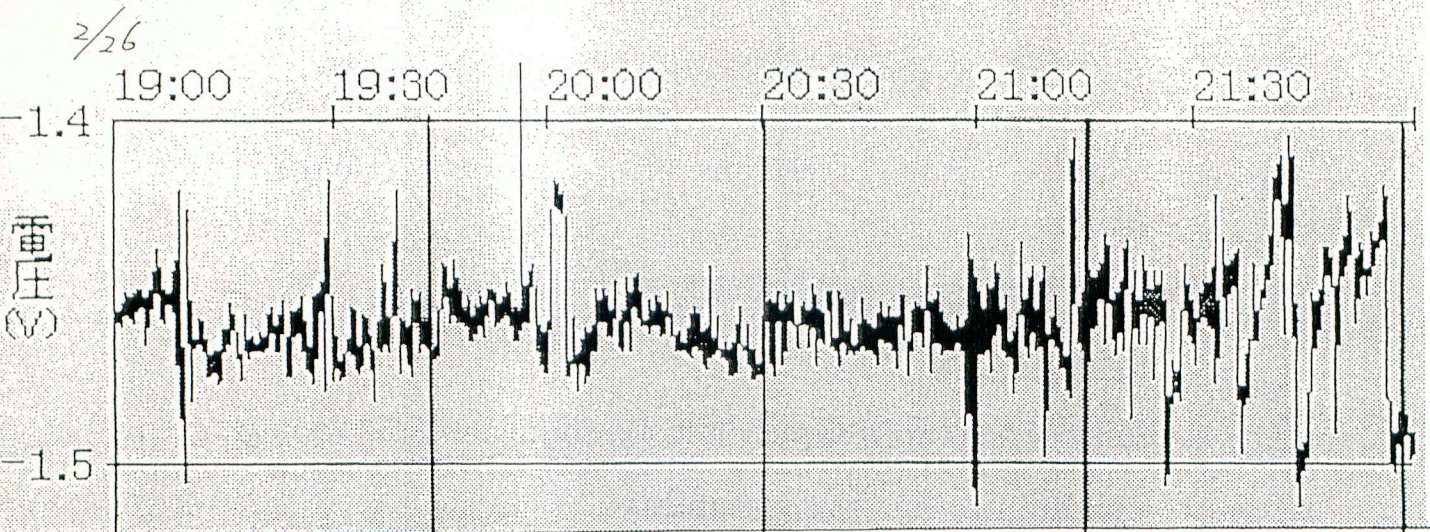
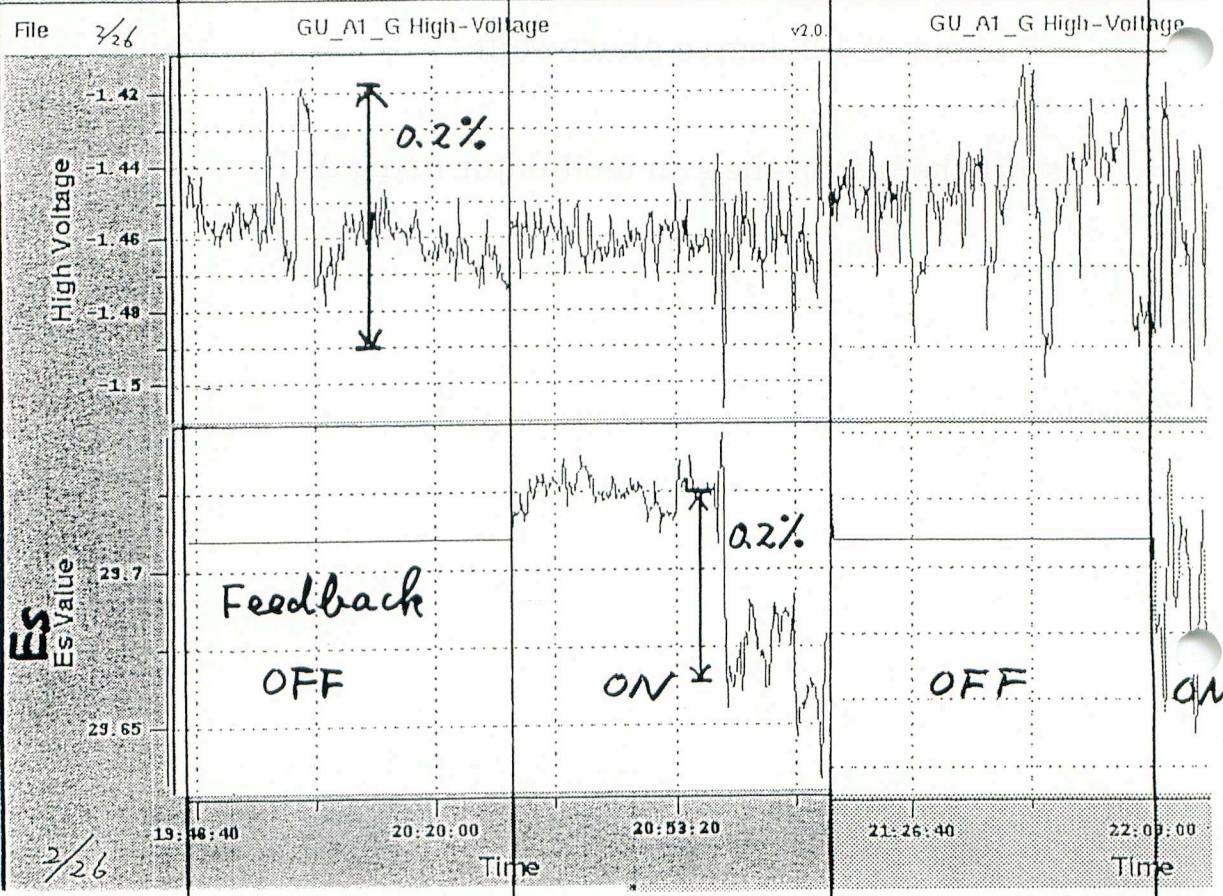
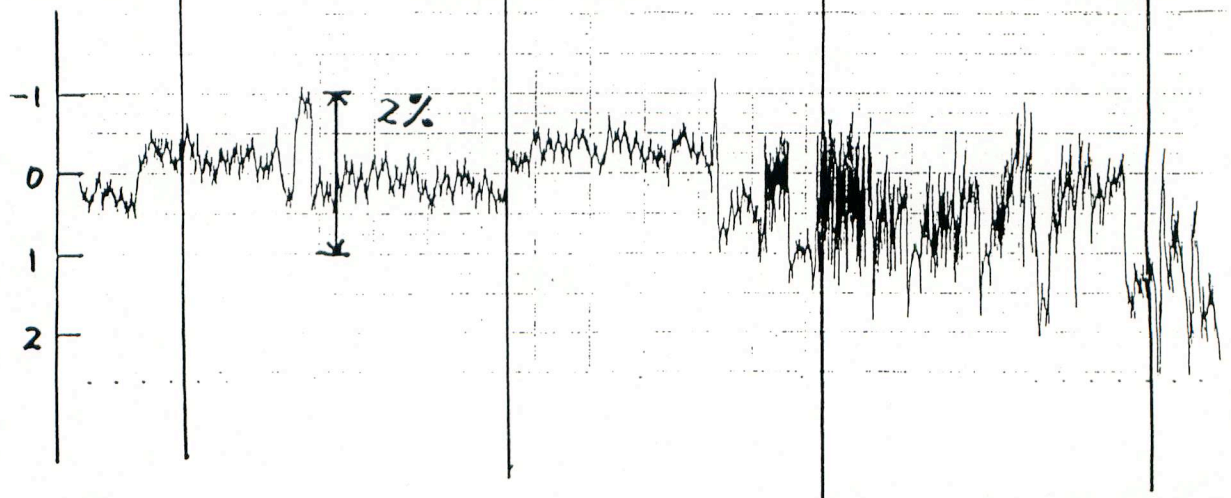
stabilize high power pulse output (injection part)

High power pulse voltage (klystrons, electron gun) is stabilized by De-Q circuit.

→ compression factor is roughly 1/10

If the stability of ac power supply is $\pm 3\%$ then $\pm 0.3\%$ for output

If klystron modulator has same stability

→ about ± 1.2 degree phase shift.

start the test in the gun modulator using AVR
