Magnet Power Supply

Summary

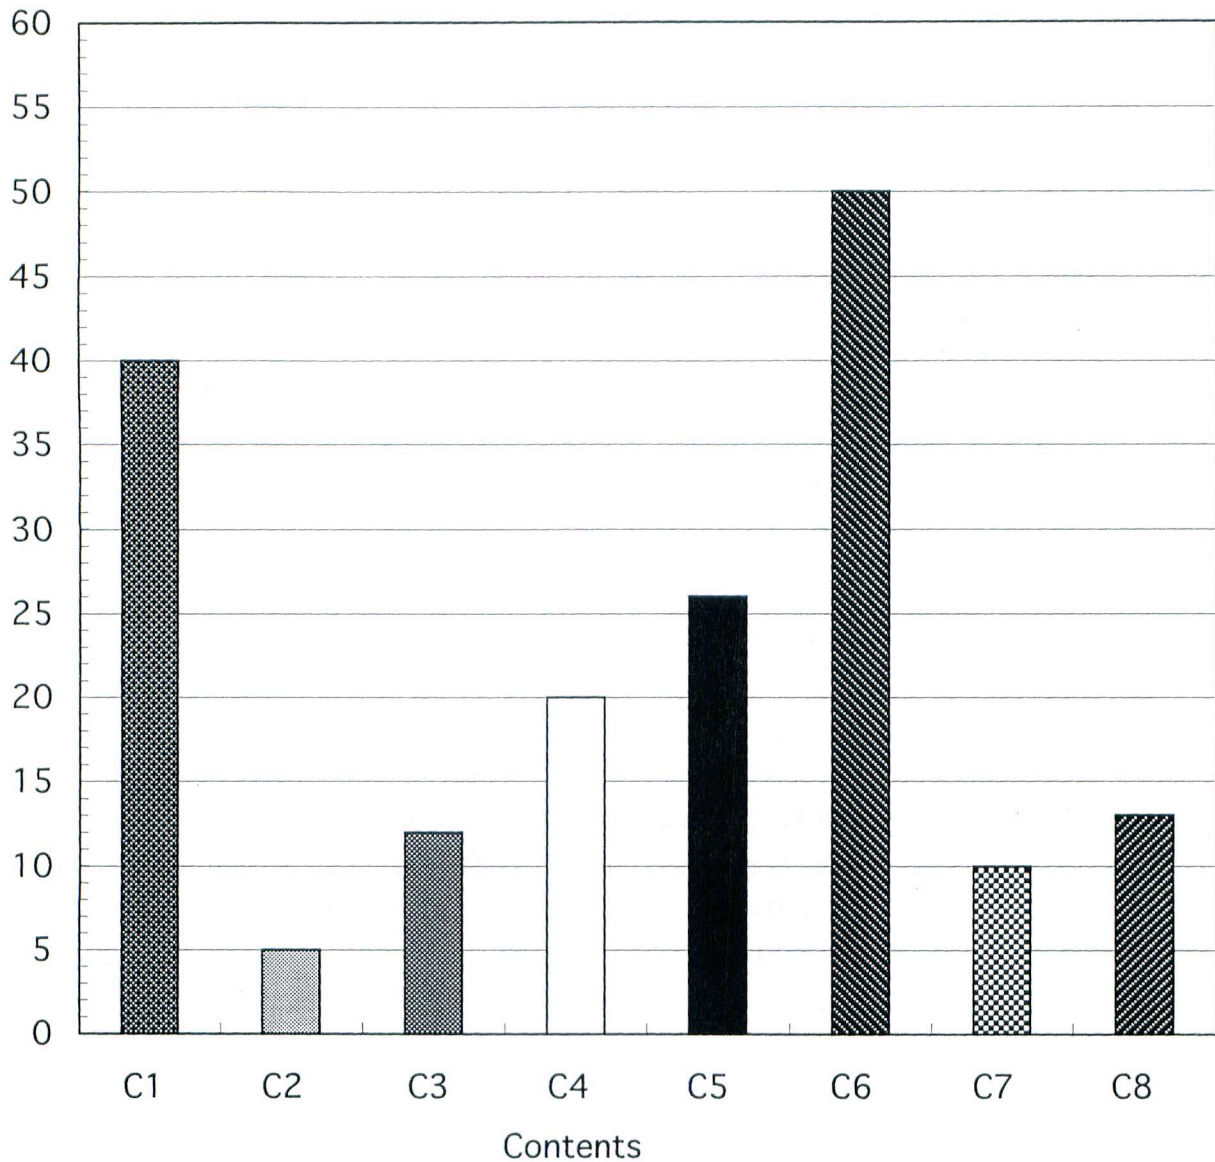
Failures in Power Supply Check Out Period

- C 1 : Power Cable Wiring Error
- C 2 : Control Cable Wiring Error
- C 3 : PLC Address Error
- C 4 : Interface Address Error
- C 5 : Current Monitor Address Error
- C 6 : Power Supply Failure
- C 7 : Magnet Failure
- C 8 : Others

Number of Failures : 176

Total Check Number : 4920

Failure Rate : 3.6%

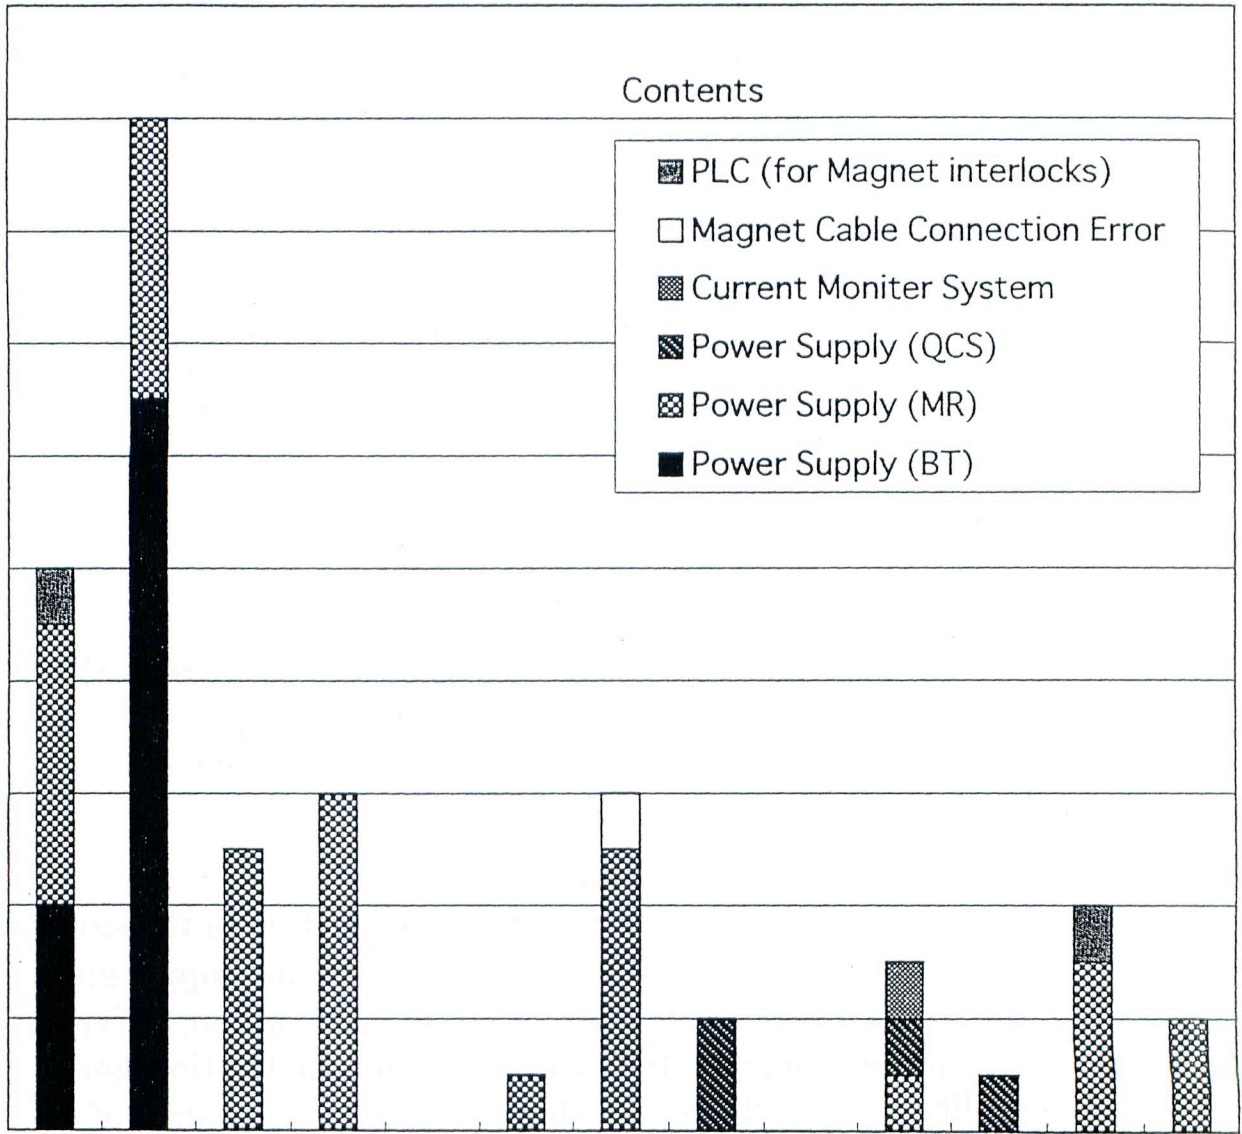
Failures in Commissioning Period [Dec 1, '98 ~ Feb 27, '99]

- 1) Cable connection error BSWFRP
- 2) Early days failures

Steering Mag. PS	12 PS	exchanged PS
Quadrupole Mag. PS	1 PS	exchanged SCR
	3 PS	exchanged Cooling Fan
	2 PS	exchanged DCCT
- 3) Failures of PLC (Programmable Logic Controller) receives magnet interlock signals
 due to the failures of communication interface module
 and the connector of communication cable
