Special quadrupole magnets for KEKB IR

2/10/00
KEKB Review
M. Tawada

QC1LE Trouble

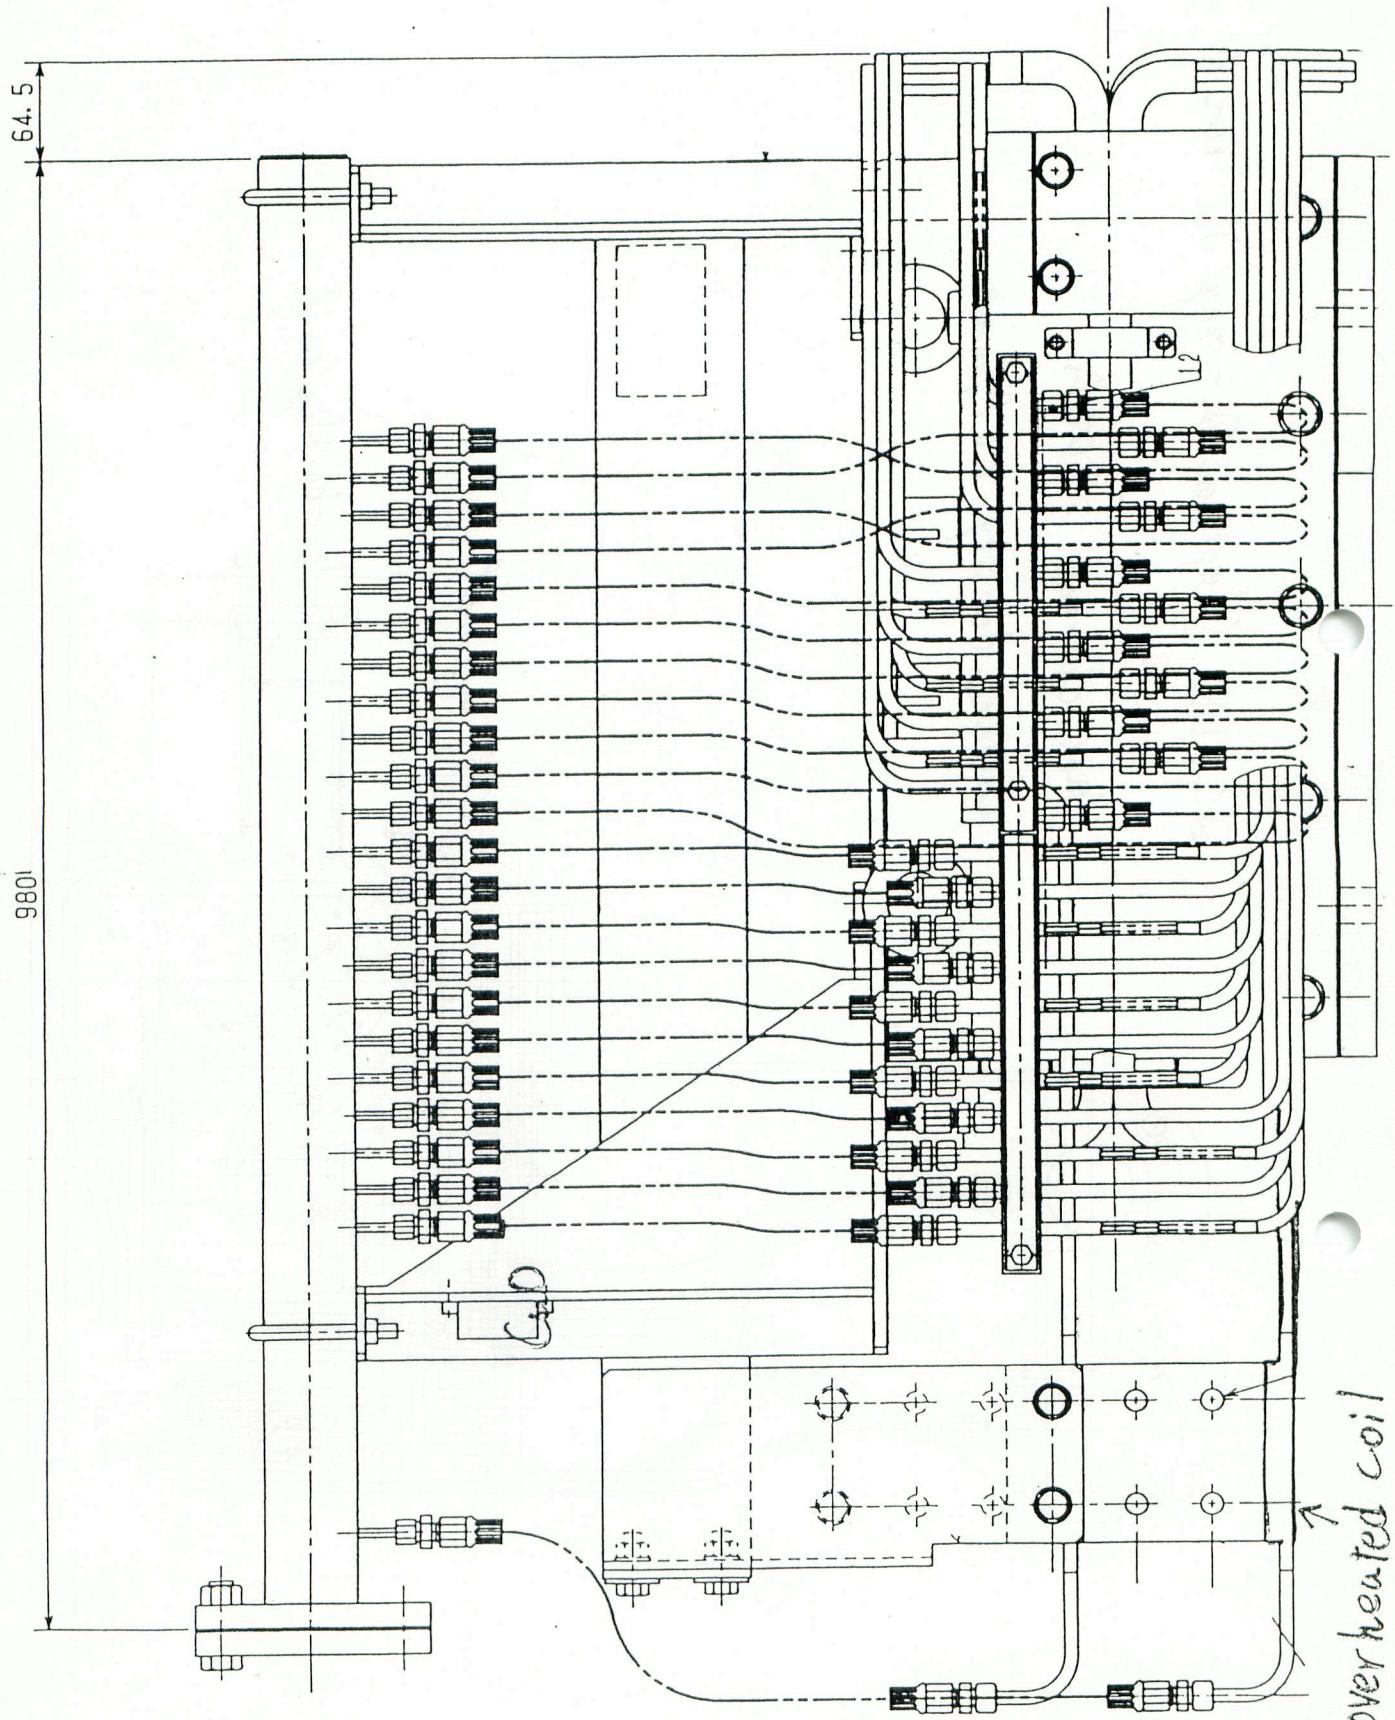
- One coil of QC1LE was overheated Dec. 16.

overheated coil

→ We attached the temperature sensor to each coil and Cu-plates to the coils connected to the bus bar to decrease power.

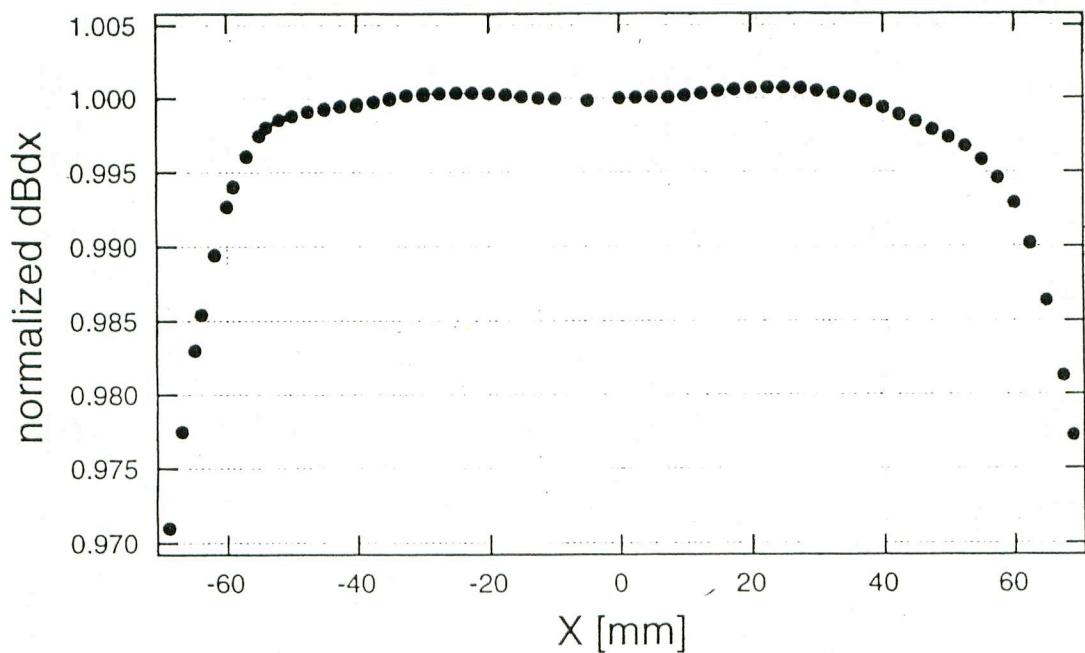
QC2LP field mapping result (10/14/99)
(preliminary result)

Since the amplitude of the β_x at the QC2 magnet is large, the required horizontal aperture of the QC2 is larger than bore radius.

normalized $\text{dB}/\text{dx} < 1\text{E}-3$ within $x_{\text{max}} = 65$ mm

Next summer we will measure the other magnets and make end-shims.
