Investigation of the broken beam pipe

Shoji Uno(KEK)

KEKB Review, Feb/10, 2003

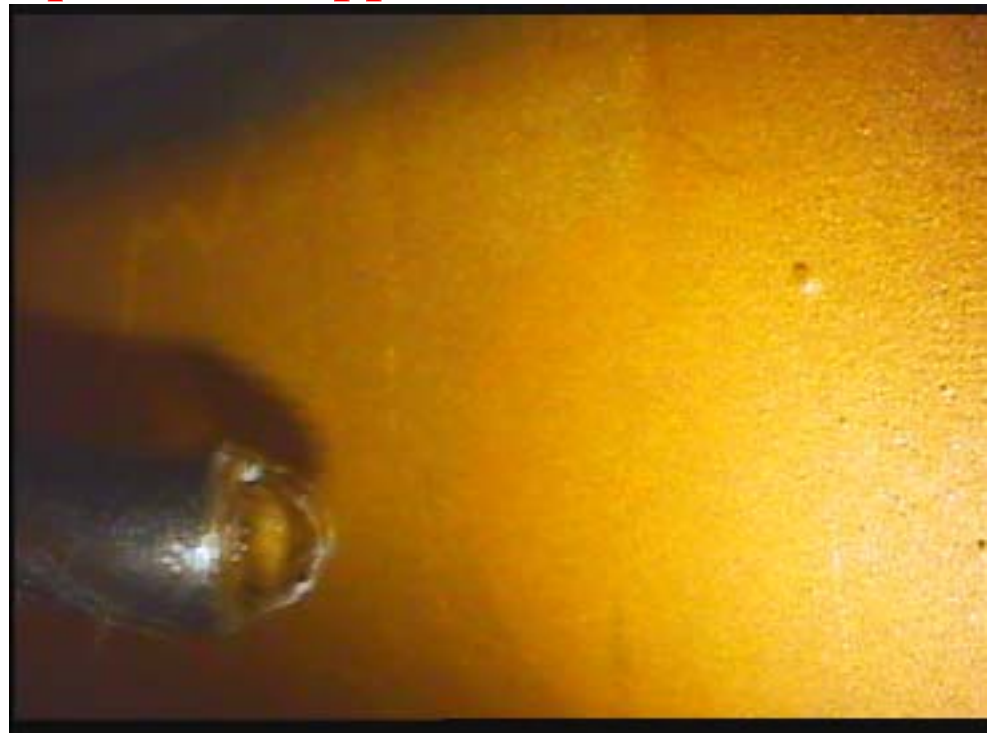
- After dismantling the beam pipe from Belle, a leak check was performed to identify the leak point.
 - He leak was confirmed in a normal leak test.
 - Bubbles could be seen on the inner gold sputtering surface of Beryllium, when liquid was supplied.
- Not joint parts.

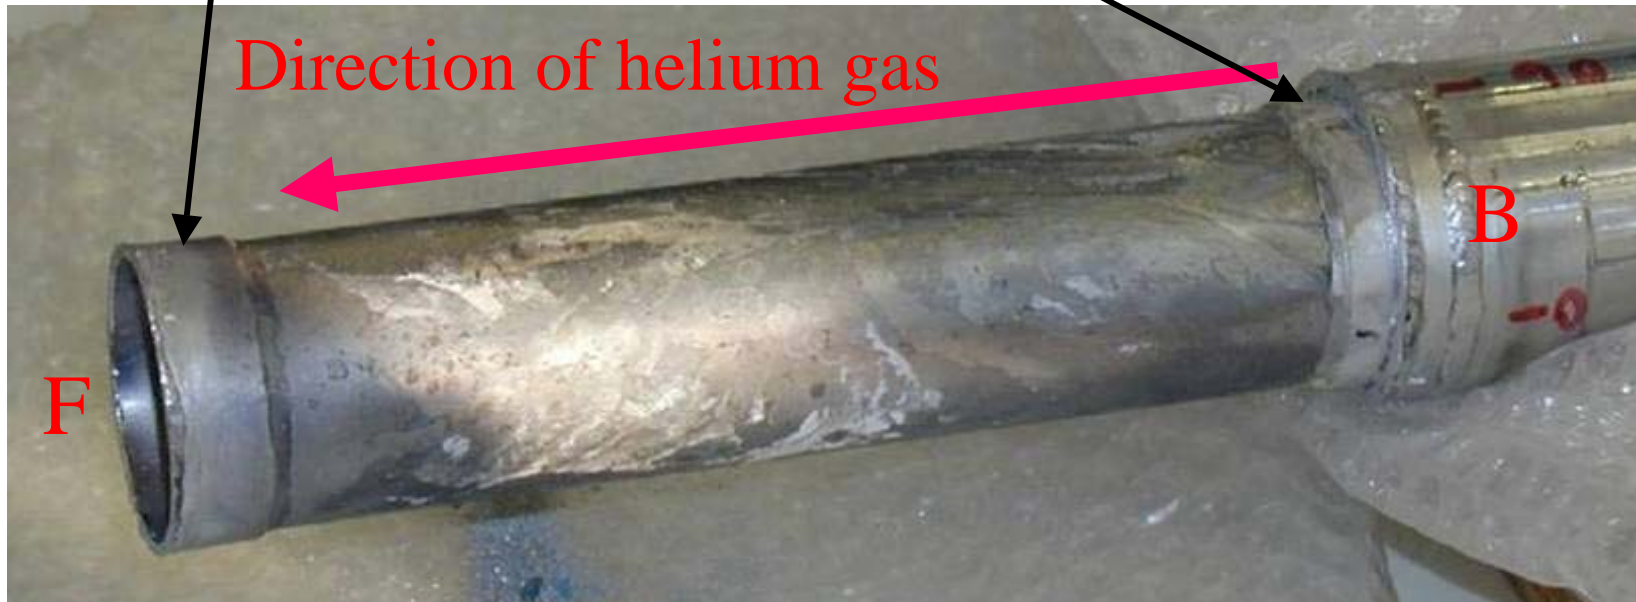
Leak points

- Leak position was confirmed from outside of inner beryllium beam pipe with various methods.
 - There are at least two separated leak points on Beryllium surface (~1cm distance).
 - It matches to position where was found from inside.

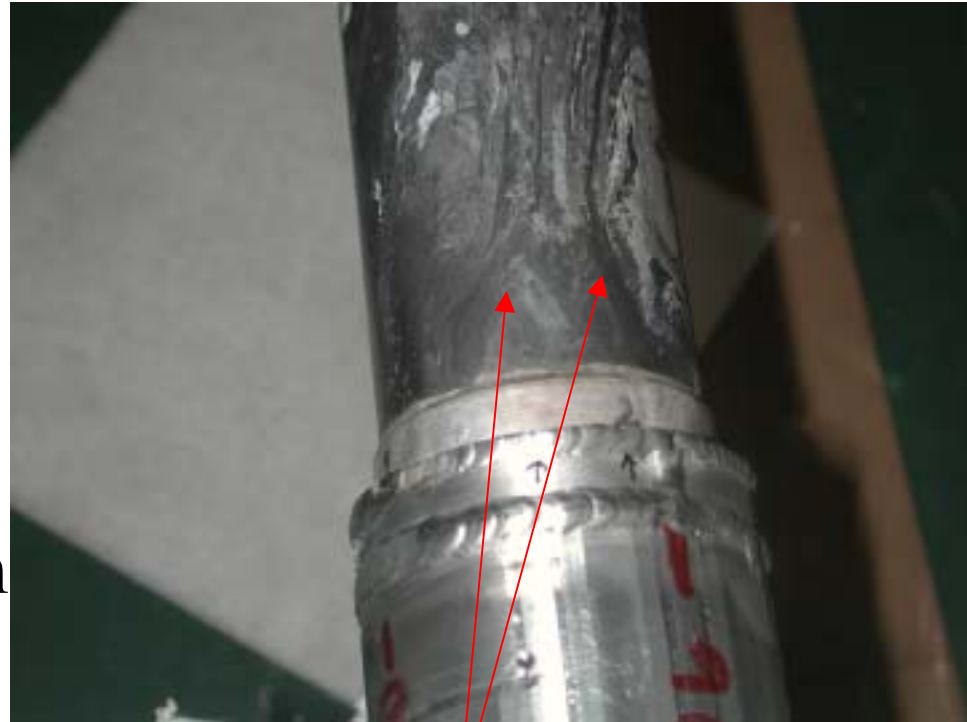
Close up view of a leak point

- Any cracks could not be found near leak points.
 - Many tiny dips are seen.

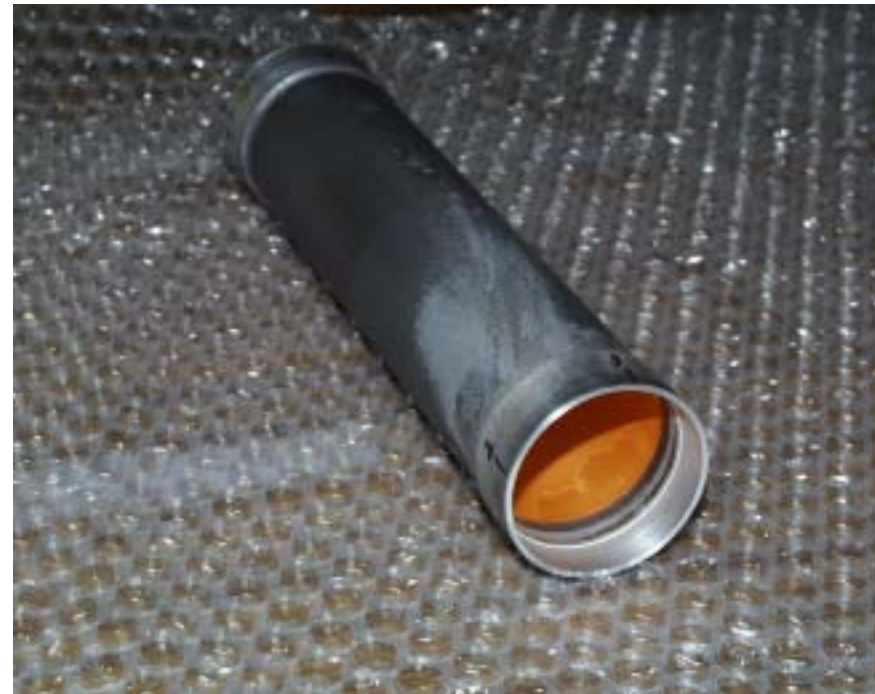
Photo before assembling

- Leaked Beryllium beam pipe is recycled from the first beam pipe, which had been used in May-July of 1999.
- Before assembling, a photo was taken.
 - White powder can be seen clearly on the Beryllium surface.
 - Amount of powder is much smaller.
 - Pattern is similar.
- At that time, we did not investigate the white powder. After that, we forgot this fact.

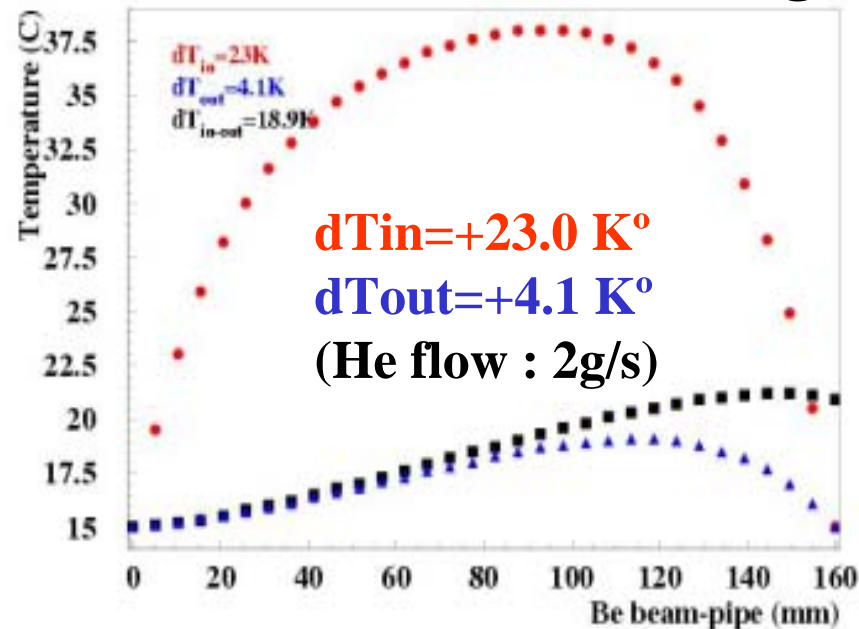
100 W with He cooling

• If He flow is 1 g/s,

$dT_{in} = +25 \text{ K}^\circ$, $dT_{out} = +5 \text{ K}^\circ$

• Present situation: 1g/s, $dT_{out} = +3 \text{ K}^\circ$

⇒ 60W?

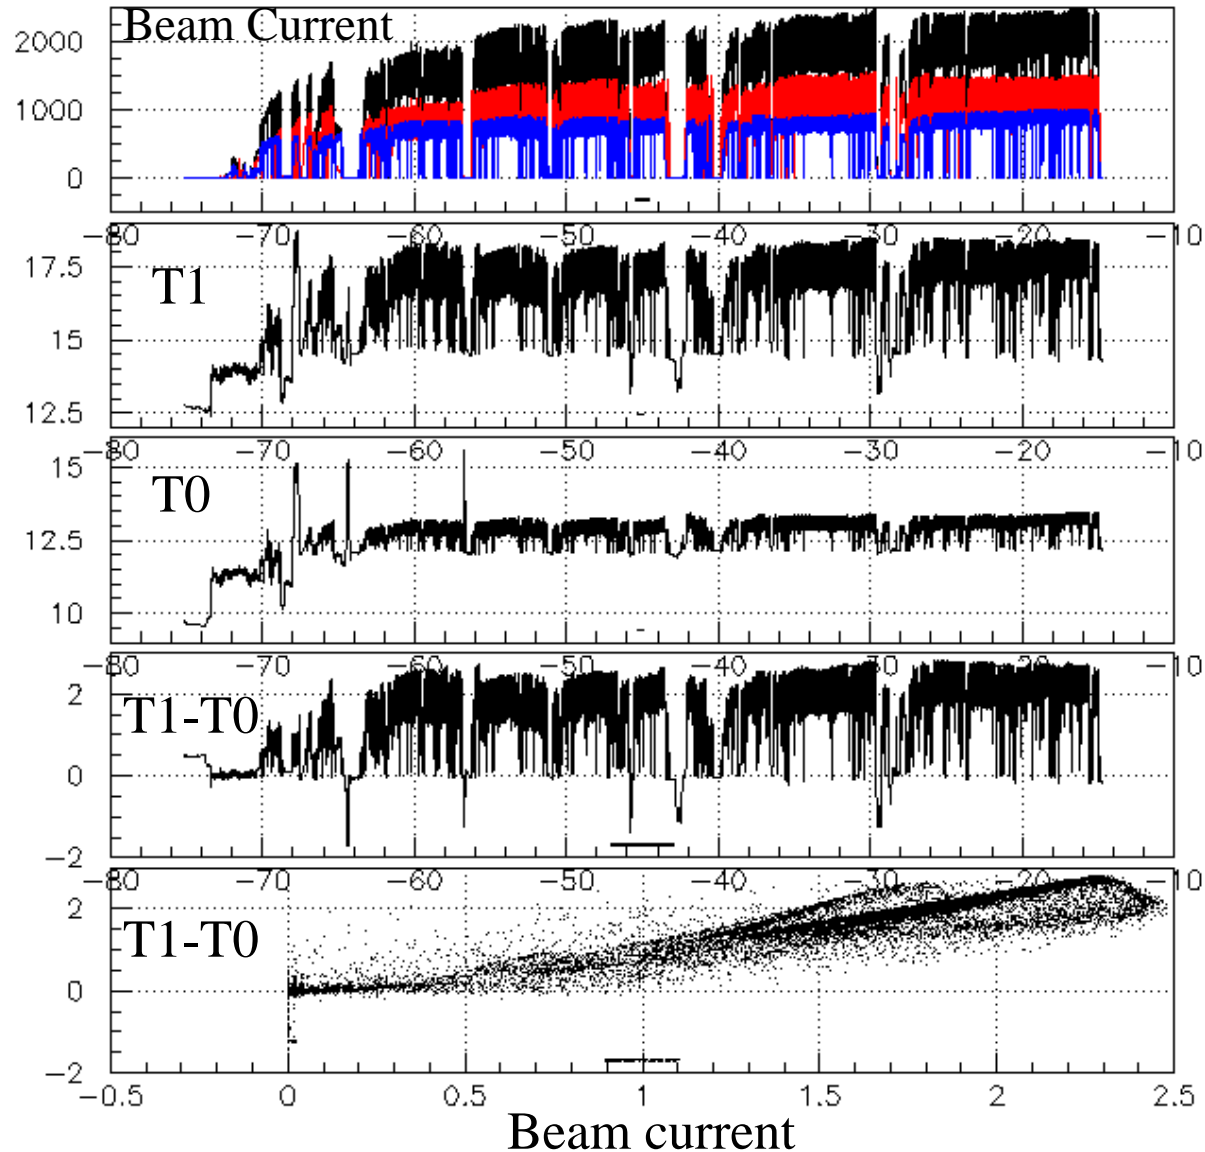
Temperature of beam pipe

- Increase of current during 2002 fall run.
- $T1(\text{center}) - T0(\text{edge})$
 $\sim 2.5^\circ\text{C}$ when a run starts
 $\text{LER} + \text{HER} = 2.5\text{A}$.

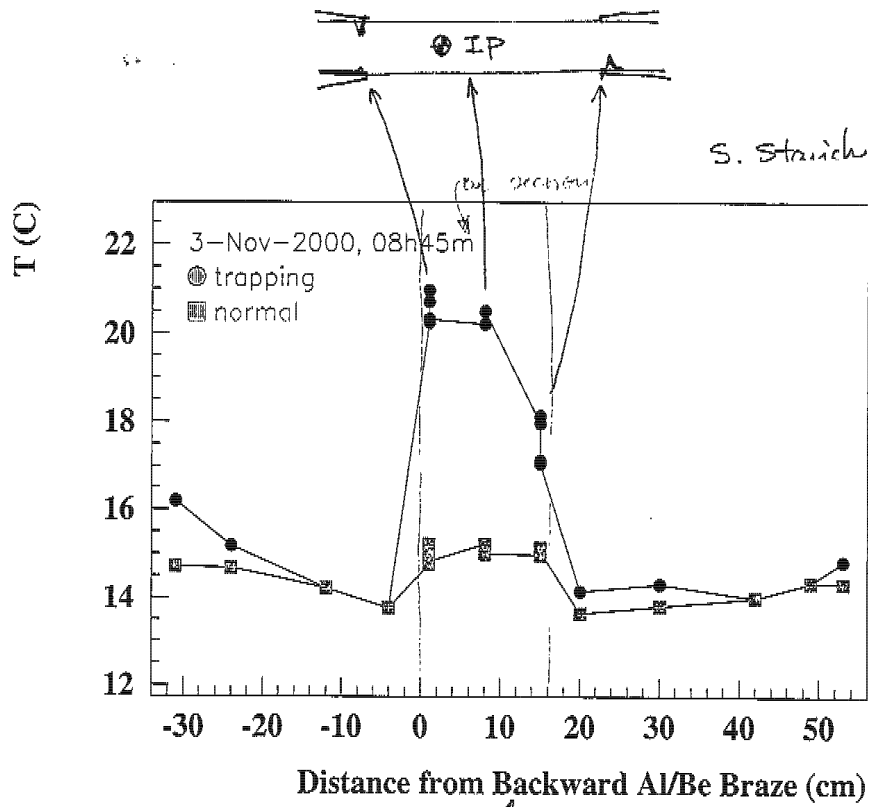
- At 8:45 On Nov. 3, 2000
- $dT_{out} = 0 \rightarrow +6 \text{ K}^\circ$ with injection in 5-bucket spacing

64~87 W?

$dT_{in} = +18 \sim 36 \text{ K}^\circ$

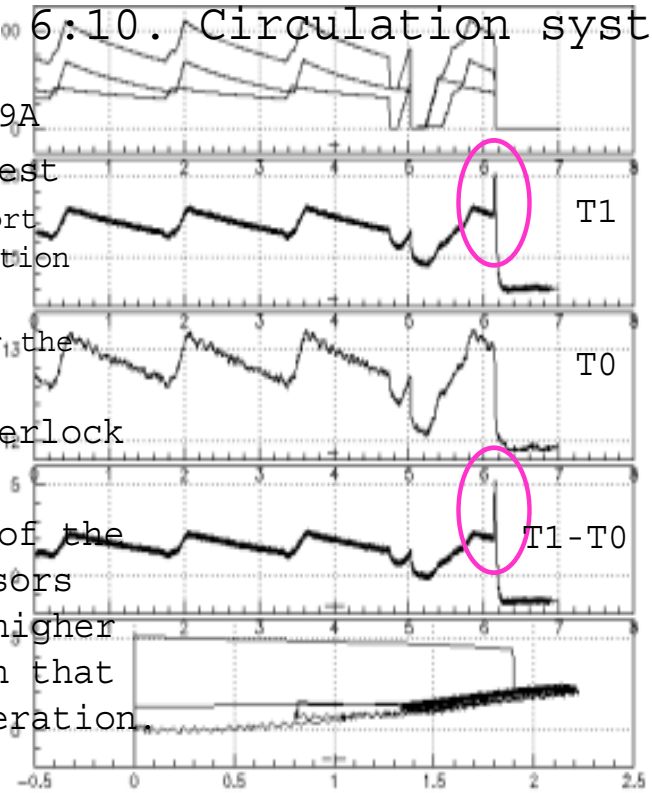
- At 6:10 On Sep. 30, 2002
- $dT_{out} = +2 \text{ K}^\circ \rightarrow +5 \text{ K}^\circ$ when He flow stopped

- Beam current ~1.9A
- Beam abort request
 - The hardware abort from the circulation system.
 - 30 seconds after the system stops.
- Temperature interlock did not fire
- Condition: One of the temperature sensors shows 3 degree higher temperature than that in the usual operation.

21~29 W?

$dT_{in} = +6 \sim 12 \text{ K}^\circ \Rightarrow +28 \sim 37 \text{ K}^\circ??$

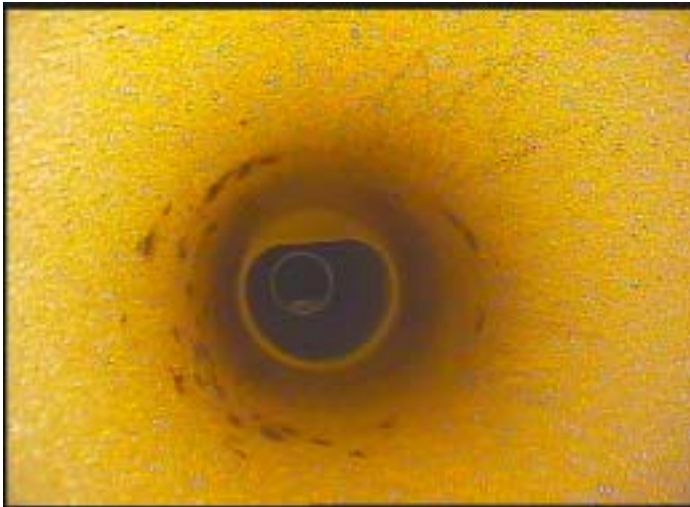
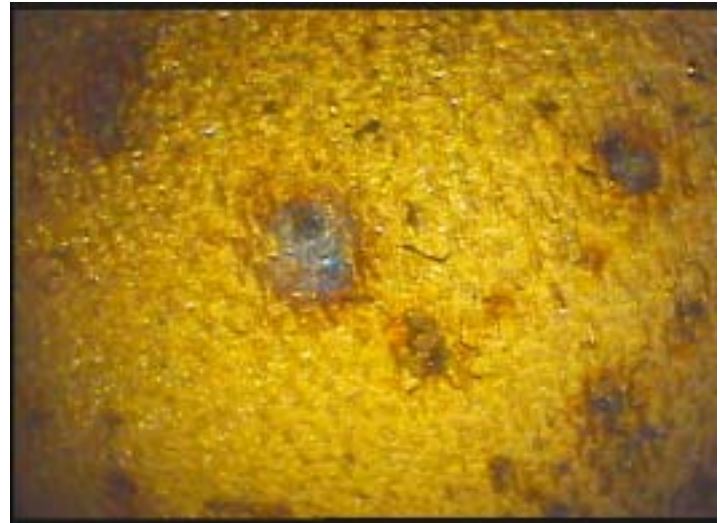
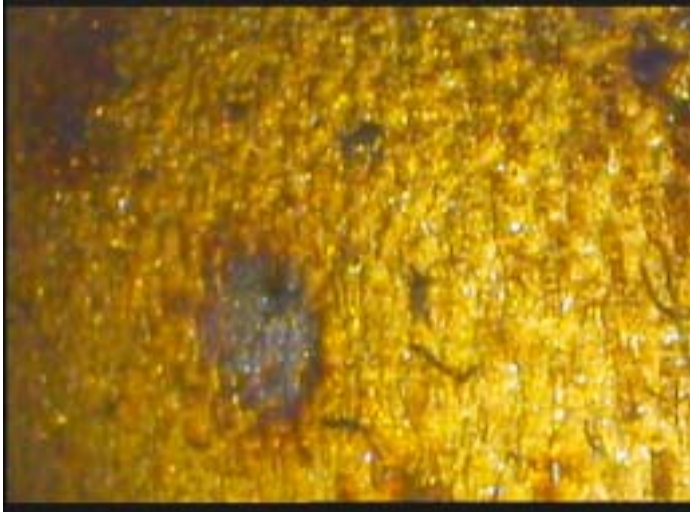
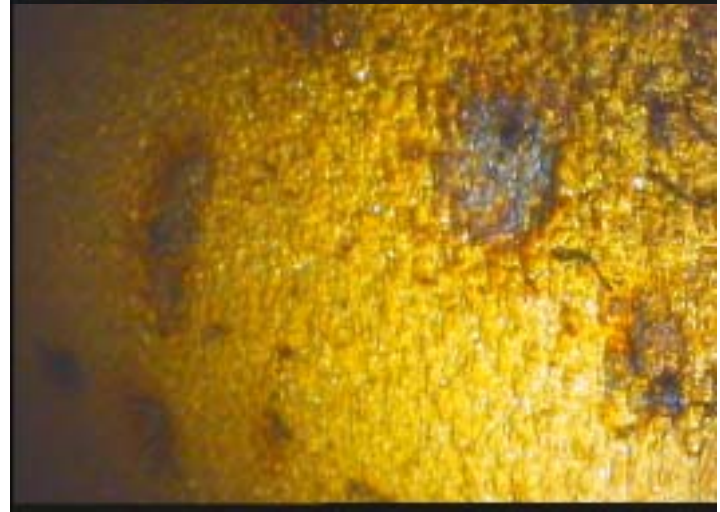
Dark spots on the Au-plating surface of forward Aluminum section were found after the Helium leak accident.

→ Large dynamic pressure?
