Recovery of injector linac

**Kazuro Furukawa
for Injector Linac group
July 9, 2019**

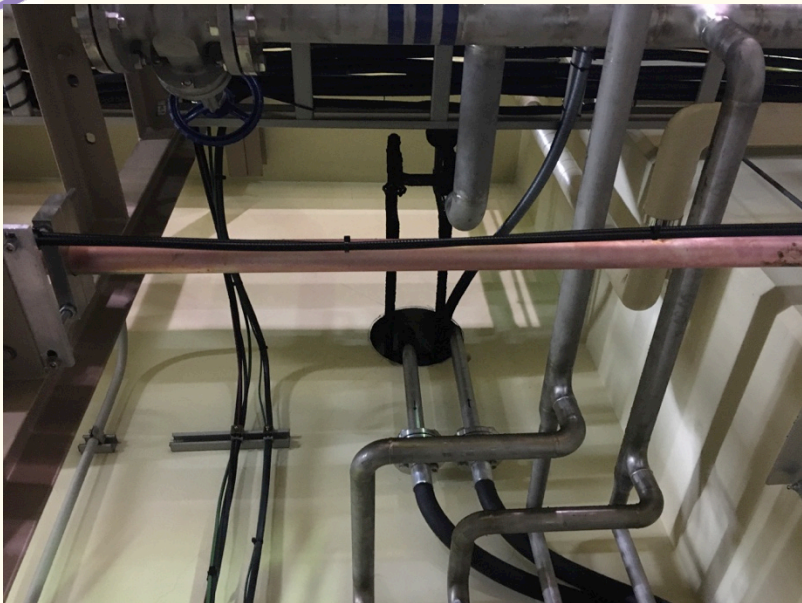
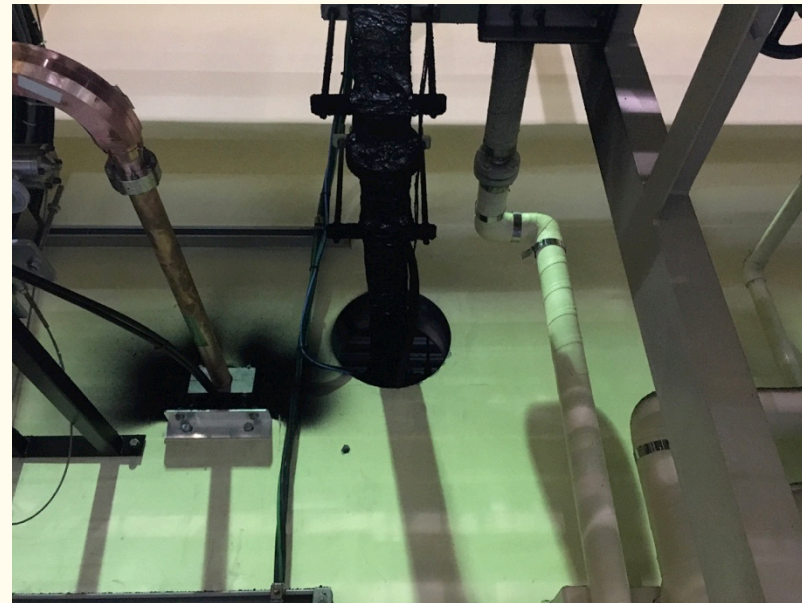
❖ Carbon soot sneaked through holes between rooms

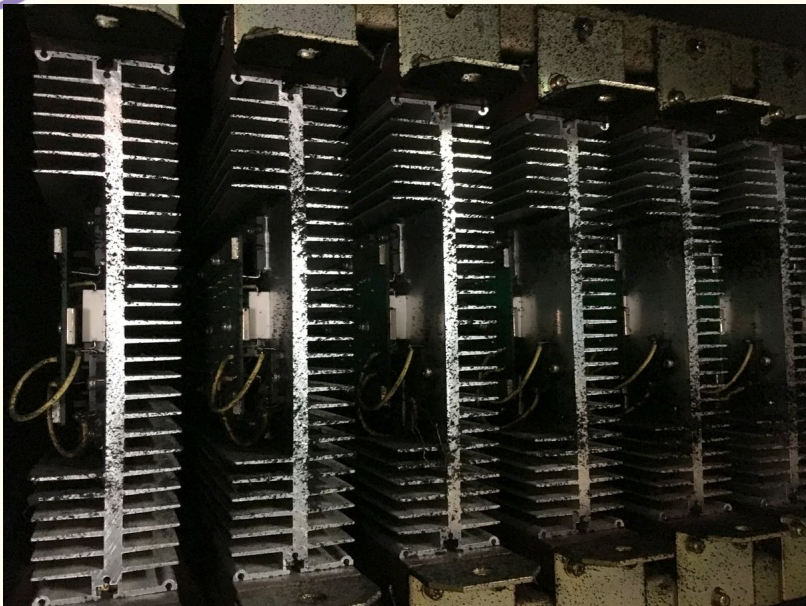
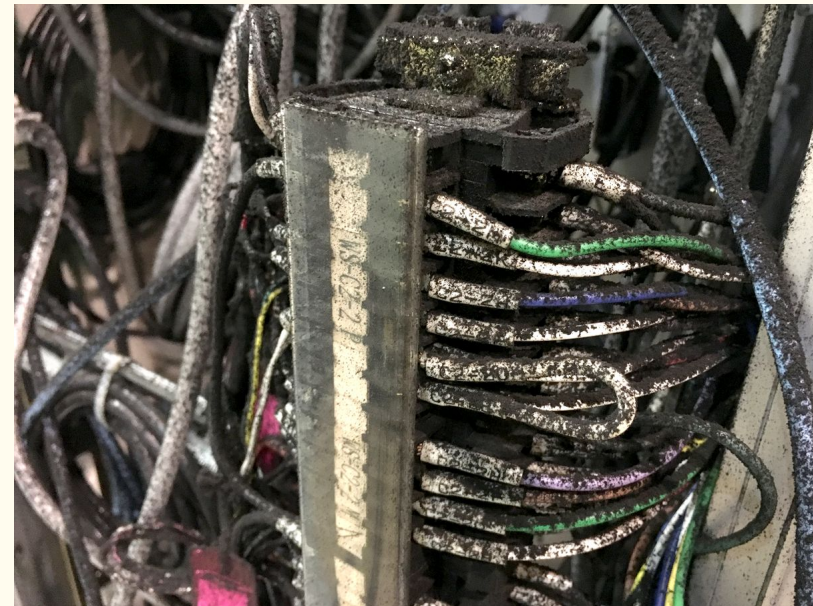
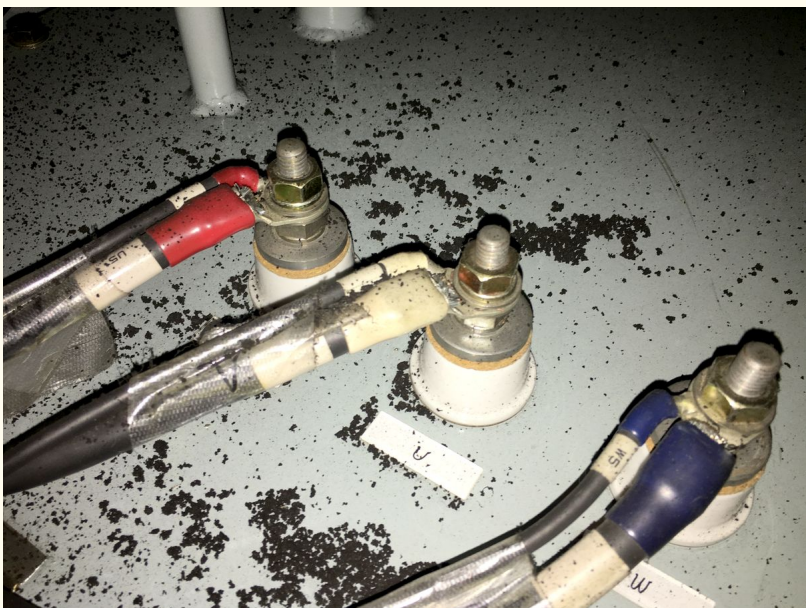
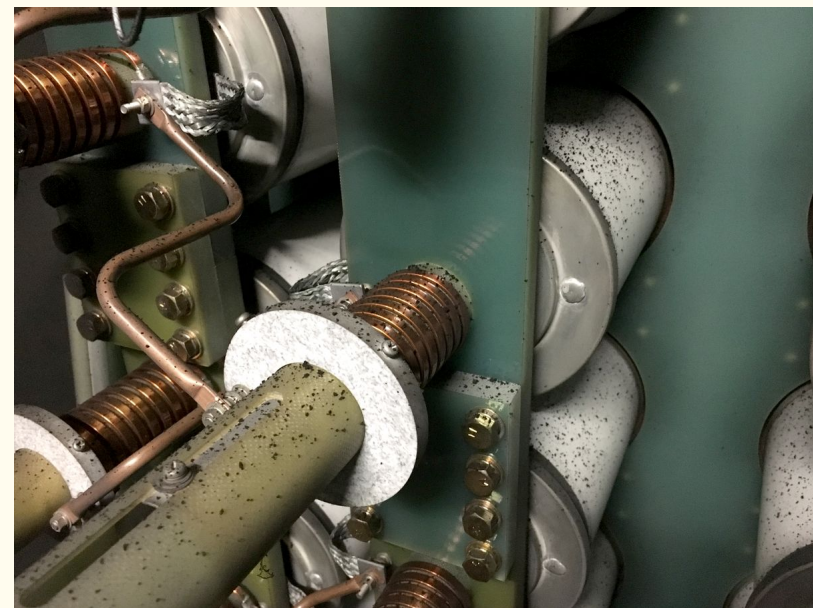
❖ Carbon soot in the equipment
