# Vacuum System Status

T. Ishibashi, KEK

on behalf of KEKB Vacuum Group

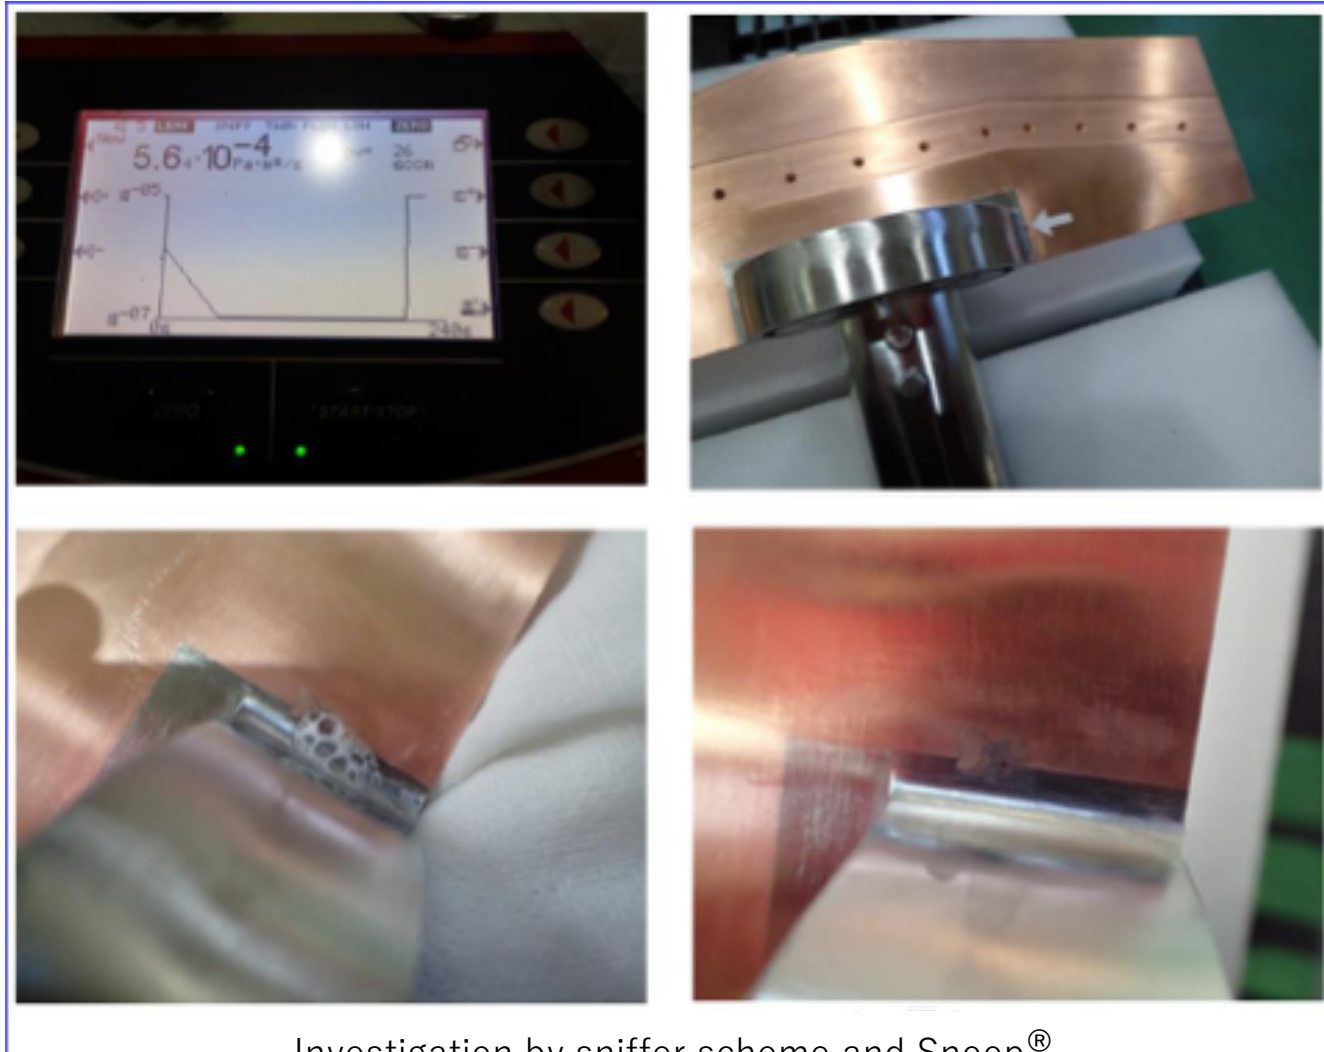
- Trouble: water leakage from a movable jaw of D02H1 collimator.
  - Changed to a backup jaw.

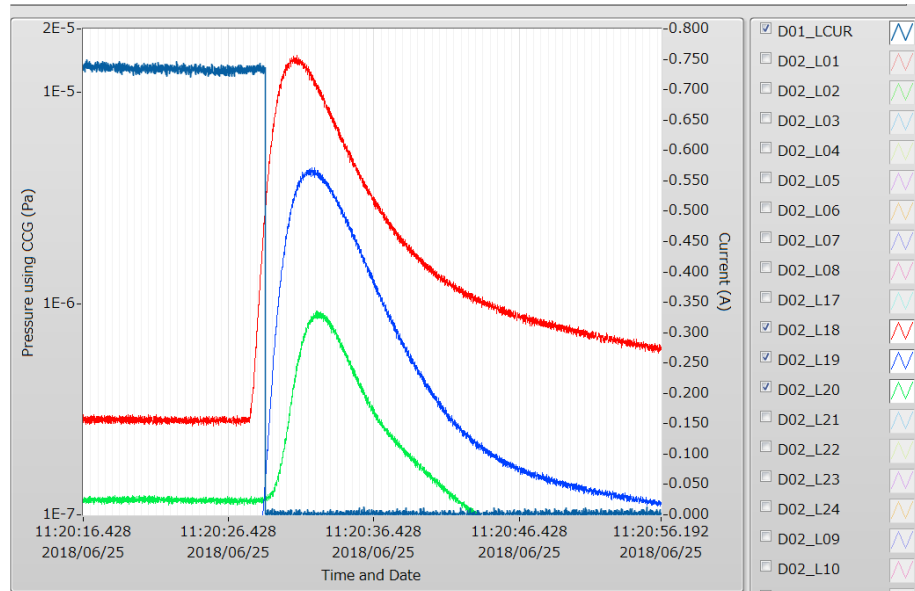
- LER: A huge beam loss and pressure burst happened near D02V1 with a QCS quench at 11:20 June 25<sup>th</sup>, 2018 in Phase-2. Stored current was 728 mA. The tungsten tips of the jaws were damaged. After that we were not able to run the luminosity mode because of high backgrounds in this condition. → move the collimator
- HER: A huge beam loss and pressure burst happened near D01V1 with a QCS quench at 11:20 June 9<sup>th</sup> in Phase-2, 2018. Stored current was 766 mA. Jaws were damaged. After that we were able to run the luminosity mode in this condition.

Pressure bursts near D02V1

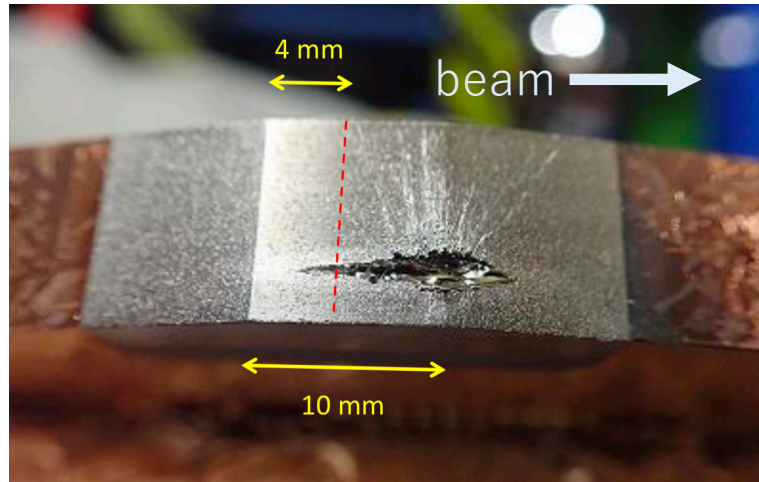
Photo of a D02V2 bottom jaw.

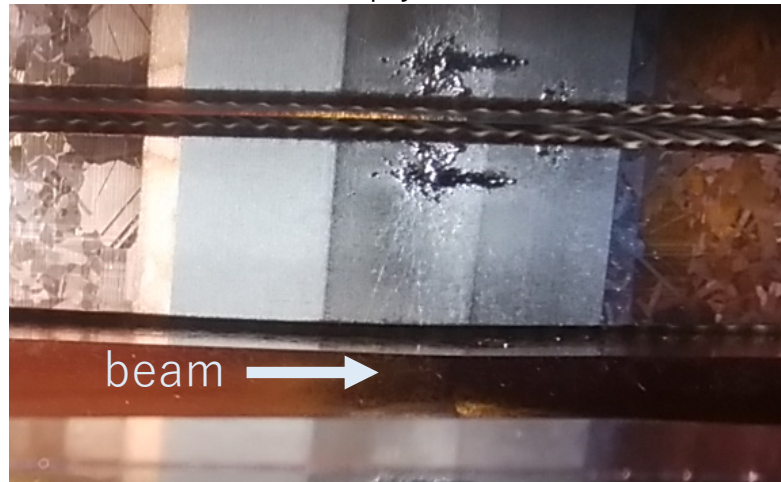
Photo of a D02V2 top jaw.

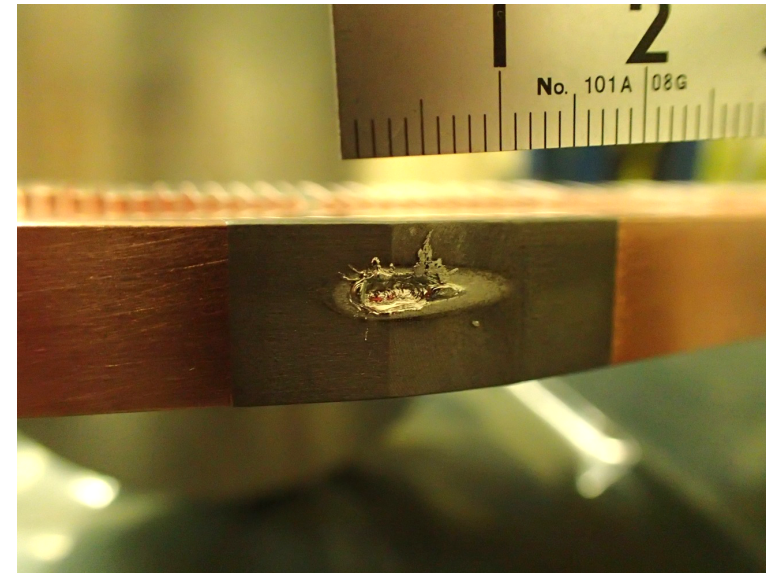
- Jaws of D02V1 top, bottom and D01V1 top were changed to new ones in the presence of Radiation Science Center.
  - D02V1:  $\sim 10 \mu\text{Sv/h}$
  - D01V1:  $\sim 30 \mu\text{Sv/h}$
- The damaged tungsten is likely to be crumbly by the embrittlement.
  - plan to change the material from tungsten to tantalum

Photo of a D01V1 top jaw.

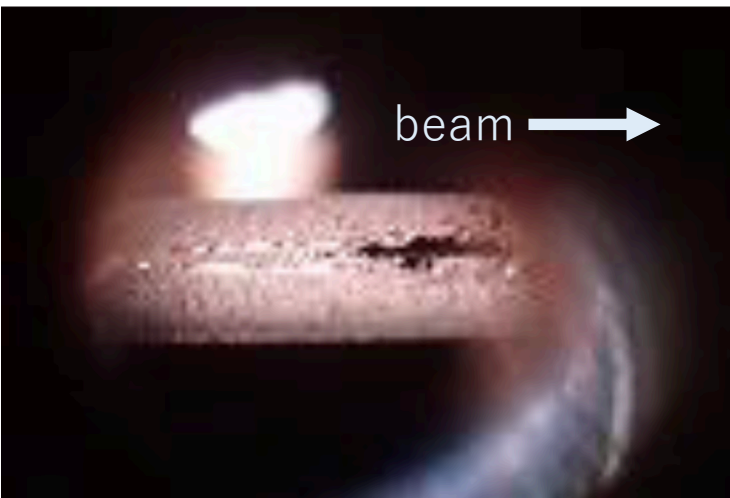
- Collimators are quite effective to reduce BG.
- Collimator damage
  - LER: A huge beam loss and pressure burst happened near D02V1 with a QCS quench at 22:11 June 9<sup>th</sup>, 2019 in Phase-3. Stored current was 660 mA. The tungsten tips of the jaws were damaged. After that we were not able to run the physics mode because of high backgrounds in this condition.
  - This is a similar situation as a QCS quench event in Phase-2, and we need the detailed analysis about this incident. One of the candidates that caused this incident is a dust event.

Photo of a bottom jaw in D02V1 taken from a view port

- Vacuum scrubbing is going well.
- Countermeasures for ECE in LER are quite effective.
- Problems:
  - Collimator damage
  - Dust events
  - BG in derived from vacuum
  - IP bellows chamber heating
- Near Future Plans:
  - Change the damaged collimator(D02V1 bottom) in the summer/winter.
  - Knock beam pipes in LER.
  - Try baking collimators in tunnel.
  - Change IP bellows chamber in this summer shutdown.
  - Add a vertical collimator at D06V1 in LER in the winter shutdown.

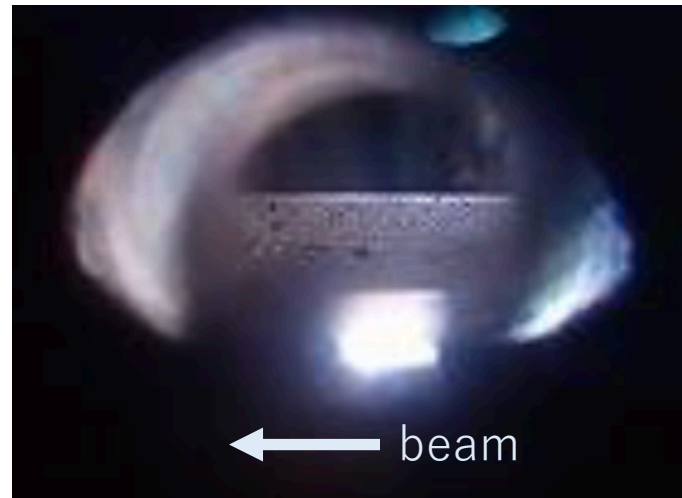
Photo of a top jaw in D02V1 taken from a view port

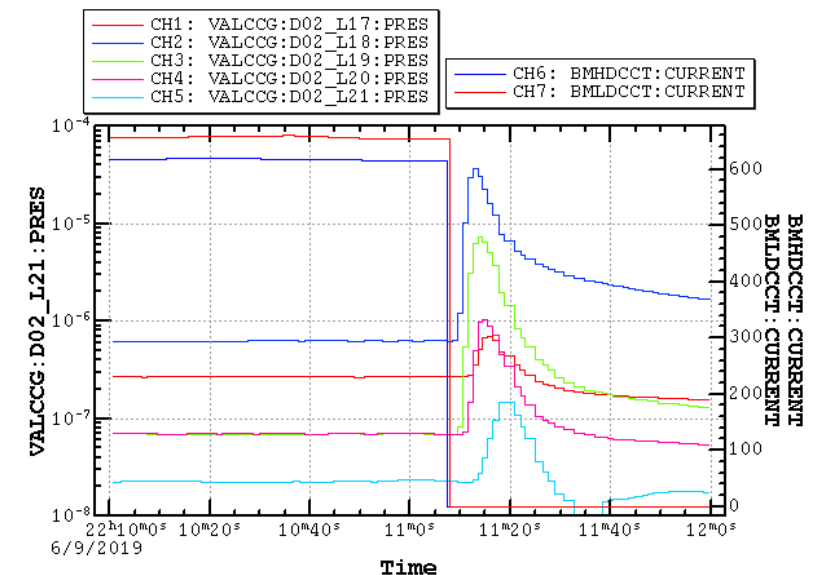
Pressure bursts near D02V1 collimator

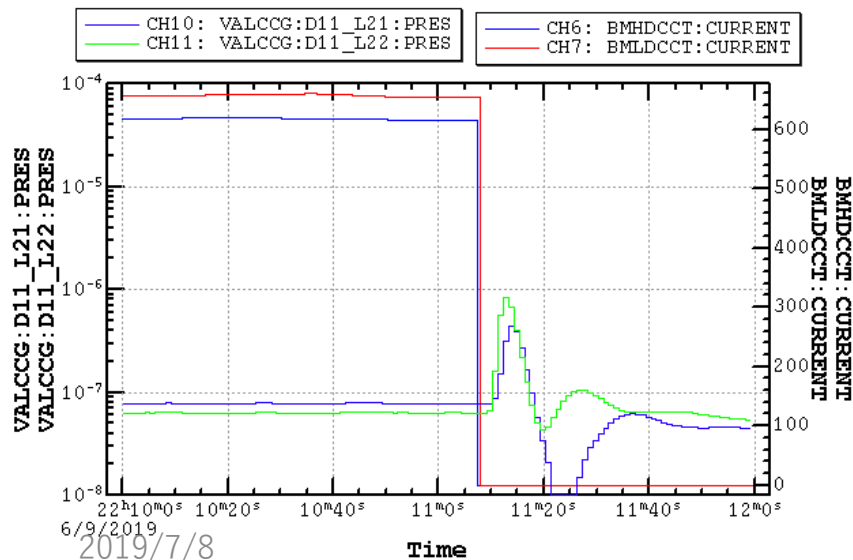
- At the same time, pressure bursts were observed in a beam pipe with a clearing electrode. → a dust event caused the beam energy loss?
- We are plan to knock the beam pipes in wiggler section by next commissioning.
- Any materials would melt if whole beams hit the jaw.
  - Need fast abort to avoid the damage!

Pressure bursts in NIKKO wiggler section

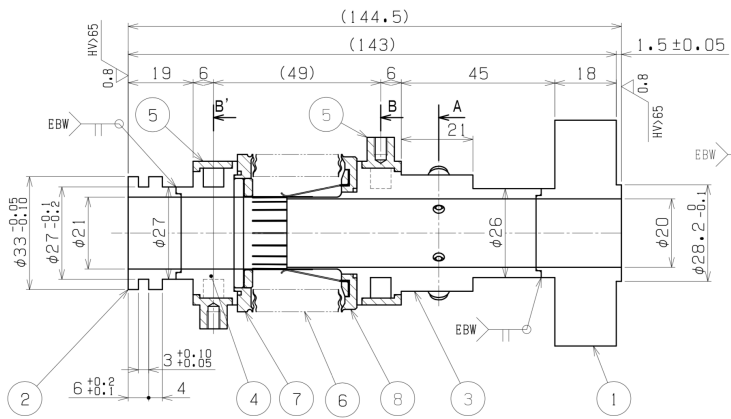
- Temperature of IP bellows chamber in HER in Phase-3, which is between a QCS beam pipe and an IP chamber.  $\sim 60^{\circ}\text{C}$  (850 mA, 3.06RF, 1578 bunches) . This happened in 1 of the 4 bellows chambers.
- The similar heating on an another one had also been seen in Phase-2. It was changed to new one before Phase-3.
- The RF shield is a conventional fingers type. Fault of the electrical contact?  
 → We have a plan to replace it with new one in this summer shutdown.

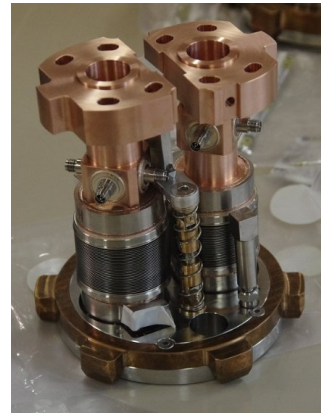
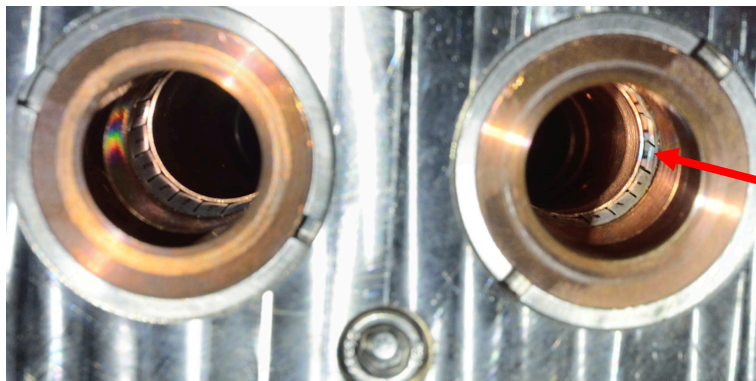
Detached IP bellows chamber after Phase-2

Discharged mark

- This finger was off after the installation and put it back before Phase-2.
- This happened in 1 of the 4 chambers.

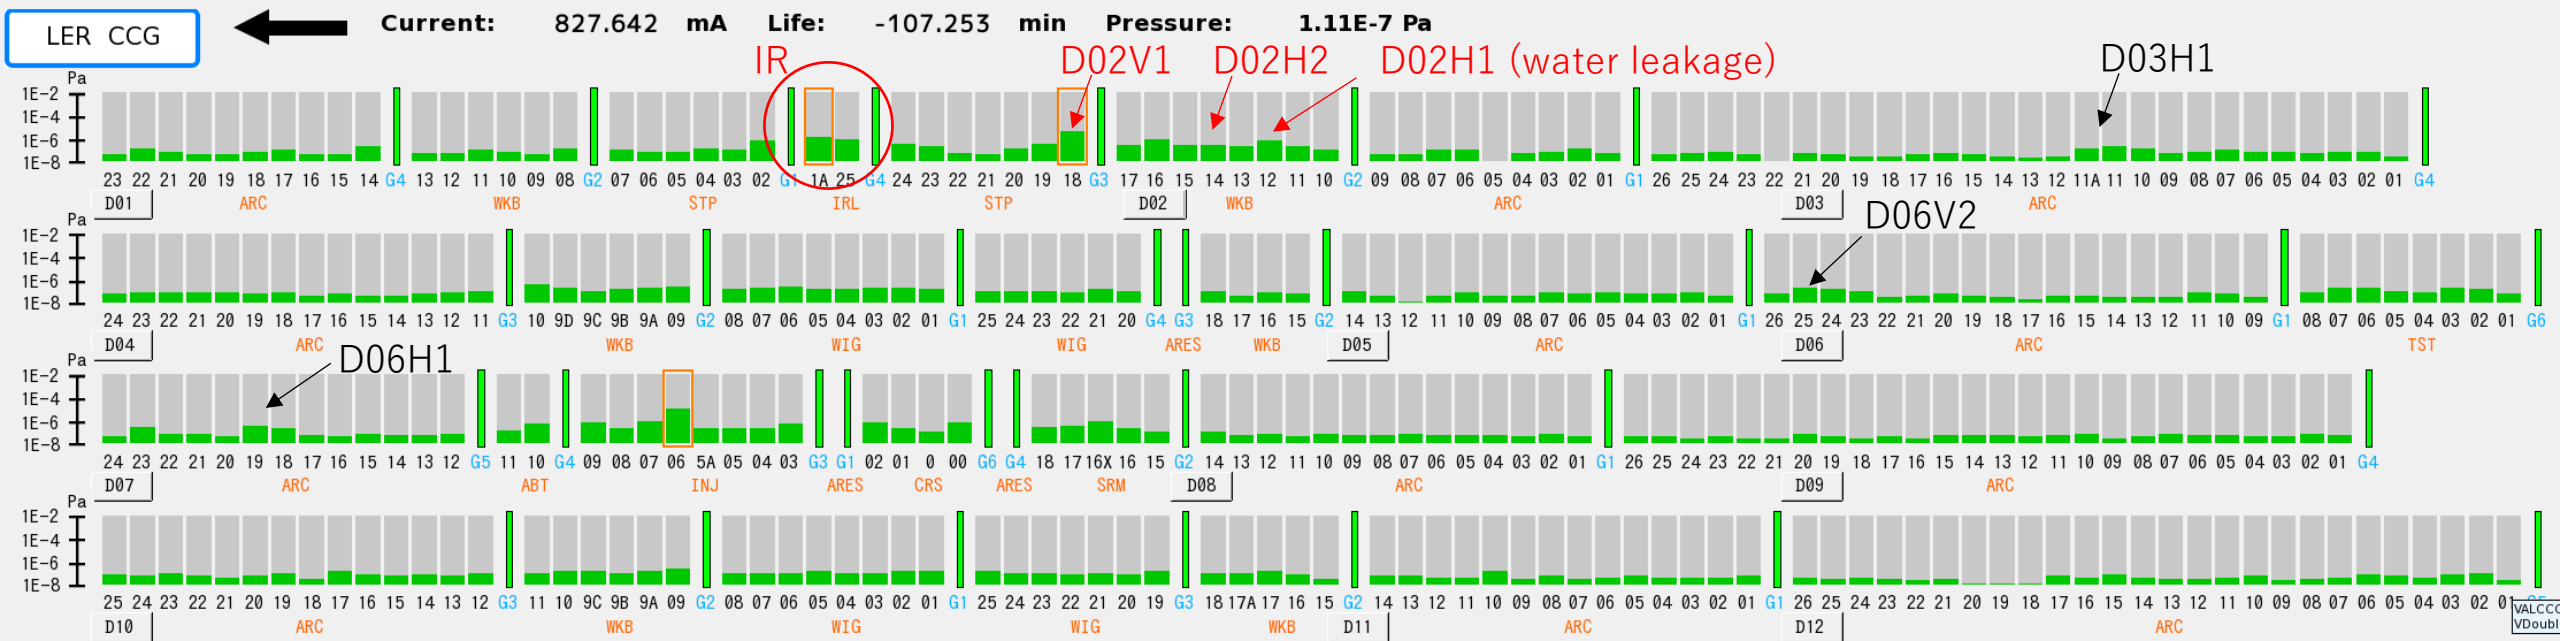
- Pressure upstream of IP in LER.
    - Vacuum component is dominant for BG in LER.
    - Especially, pressures near D02V1 and D02H1 are high.
      - D02H1 collimator had a water leakage trouble before Phase-3, so it could raise the pressure.
- try baking these collimators and beam pipes in tunnel
