# Main Ring Magnet System Phase 2 & Phase 3

Magnet group

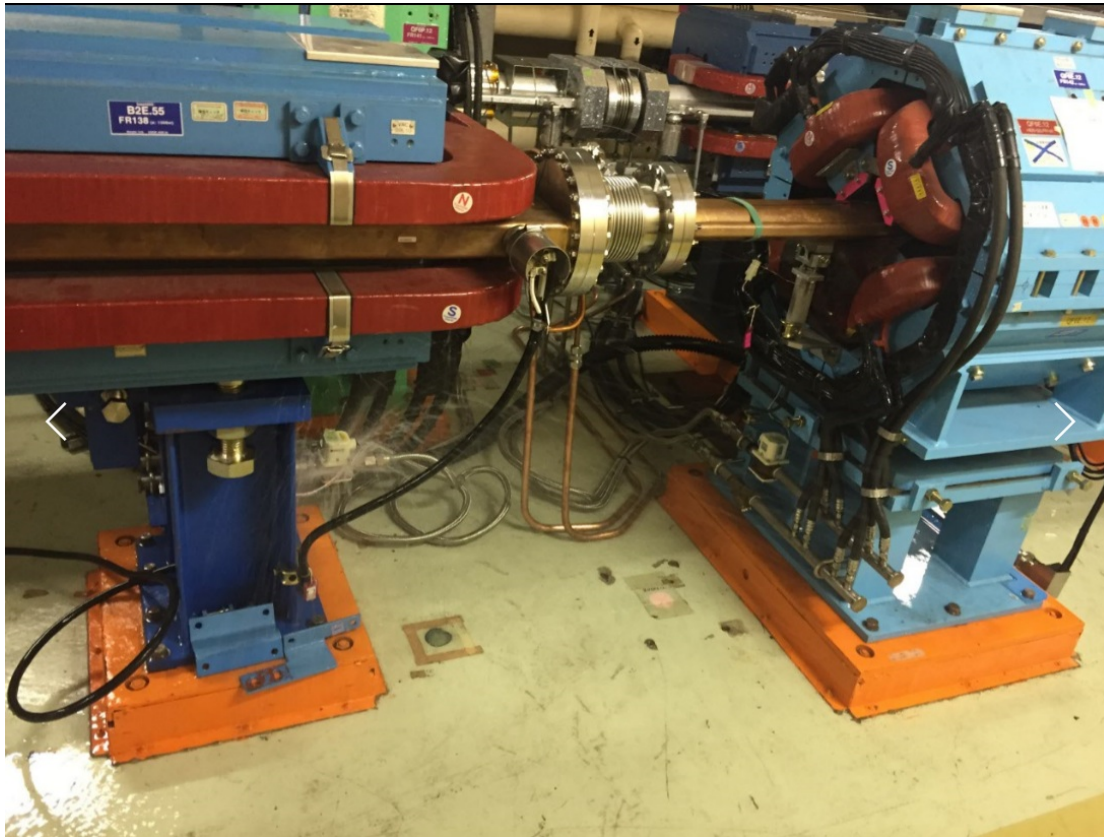
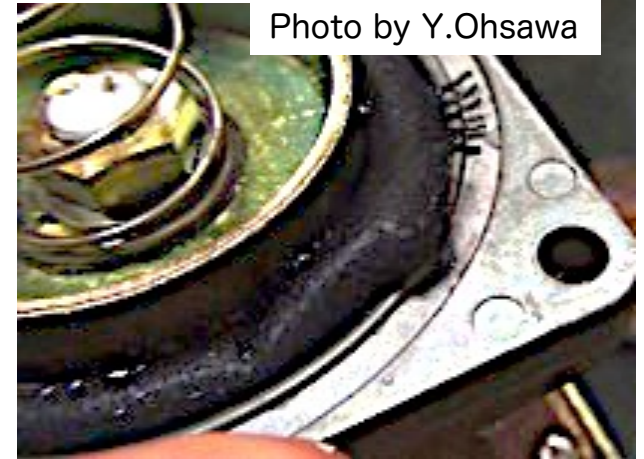
Diaphragm type flow switch

Troubles : Water leak from the flow switch of an HER dipole magnet  
→ Interlock → Beam abort on April 15, 2018 (Phase 2)

Degraded over time (~20 years since KEKB startup) is the cause of this. All of the water-cooled magnets recycled from KEKB (more than 1000 !) face this aging issue

- We replaced all the flow switches of the HER dipoles in the fall of 2018, as a start.
- We will replace the flow switches of the HER quads in this summer.

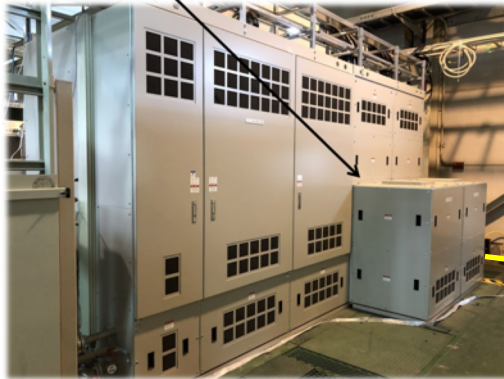
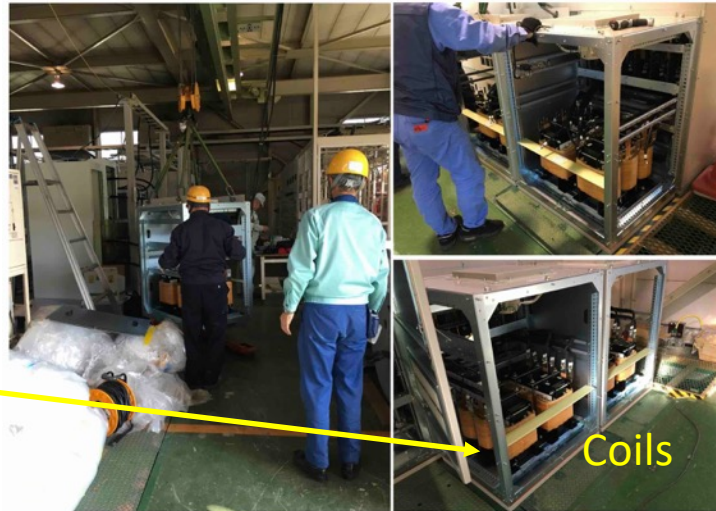
B2E電源ACリアクトル追加作業

No more PS failure from “AC input O.C. ” caused by AC line distortion.

PS stop due to AC line distortion

The current surge due to a voltage drop becomes smaller.

PS failure from O.C.  
(over current) does not happen.

Additional AC inductance

Adding reactance to the circuit

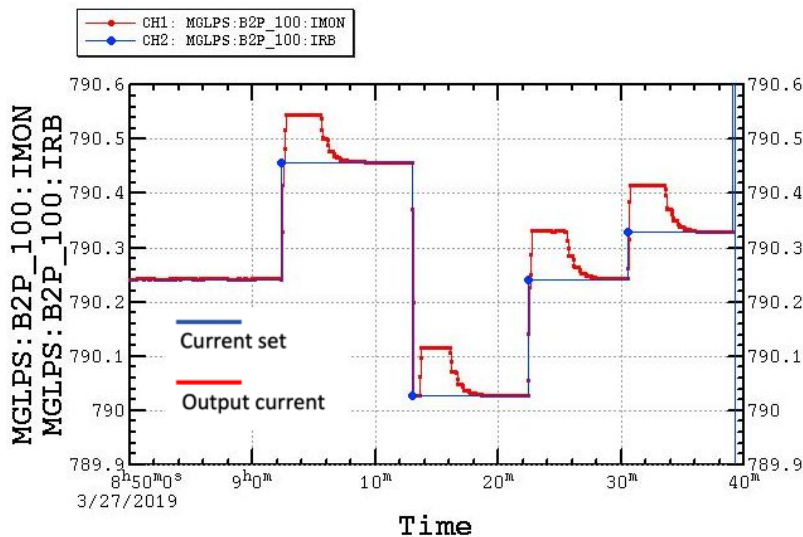
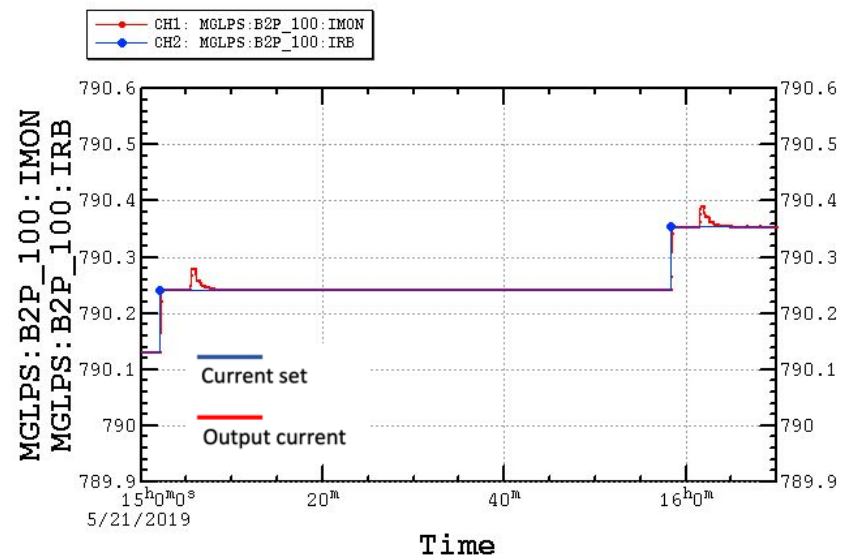
Overshoot problem with Large Scale power supplies (Hitachi) and QCS power supplies (Nichikon)

Digital feedback program is modified.  
(LER Dipole power supply case is shown as an example)  
Still some overshoot is seen in the Hitachi power supplies.  
The new program is being tested now.

There is no overshoot problem any more with the QCS power supplies (Nichikon).

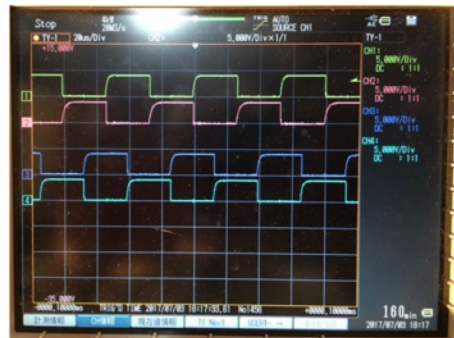
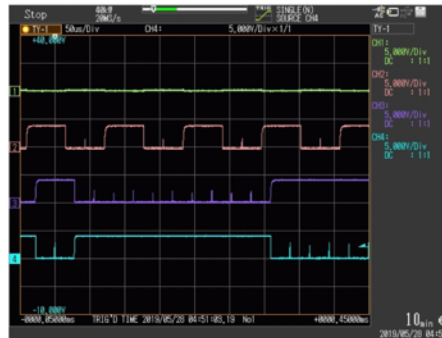
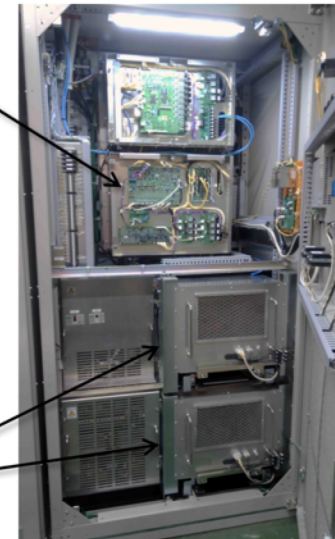
QC2LE PS

Control board  
(making gate pulses)

Not Good

Power modules  
(SW modules are installed)

- We replaced these modules, but that did not cure the "gate signal going nuts suddenly" disease. The control board sent back to Nichicon has not shown any problems so far. Investigation continues.

- For the fall run, we will prepare a fast abort signal (10 + a few  $\mu\text{s}$  and transmission time from the IP to the abort kicker) for the case where the QCS power supply self-diagnoses a problem.

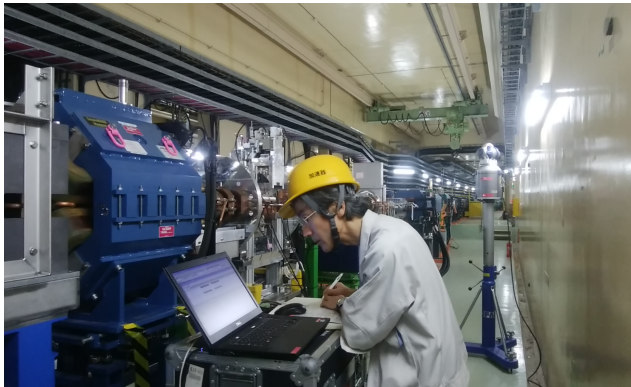
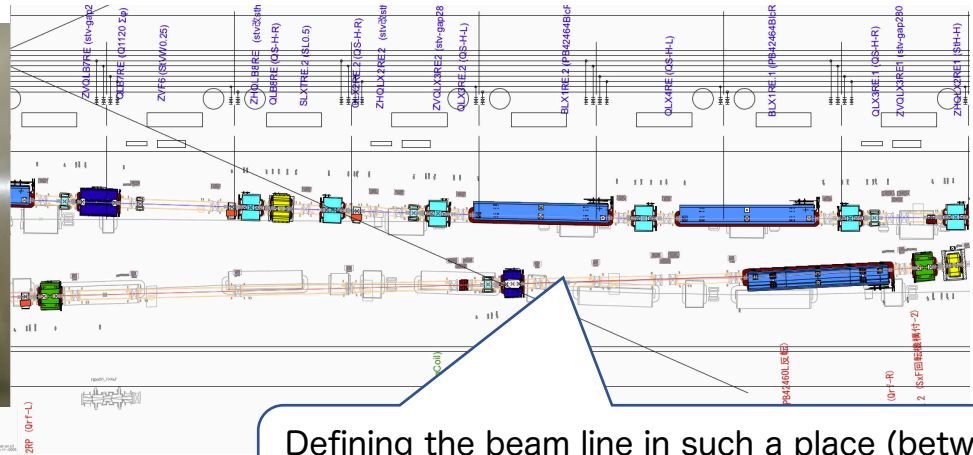
- D2V1 collimator was off by a few millimeters.
- D1V1 collimator was off by about 1mm.

Defining the beam line in such a place (between a dipole and quadrupole) is not really possible without a laser tracker.

Vacuum group will prepare holes for holding a LT target.

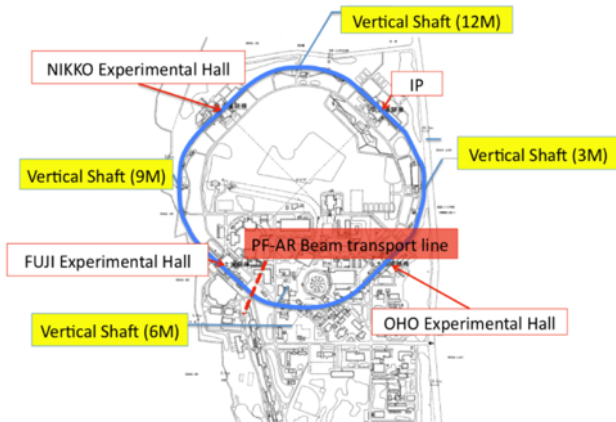
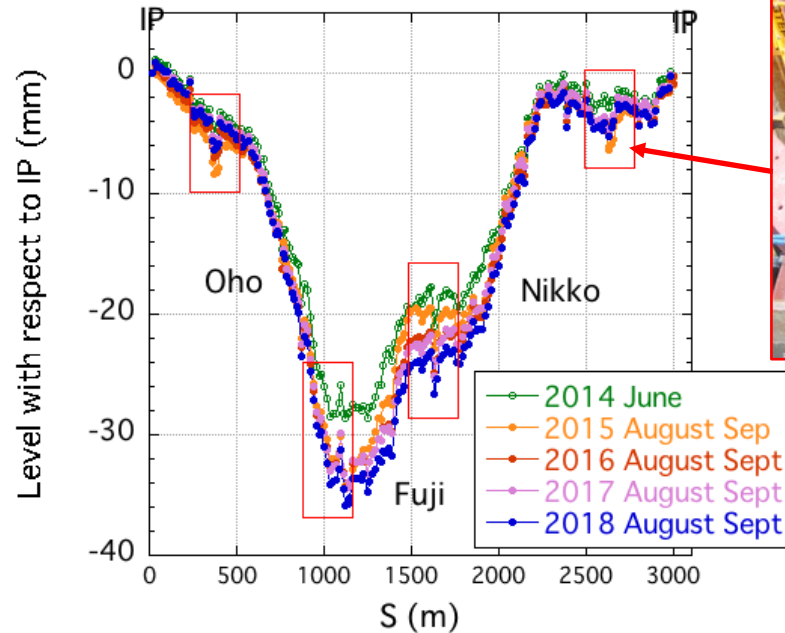
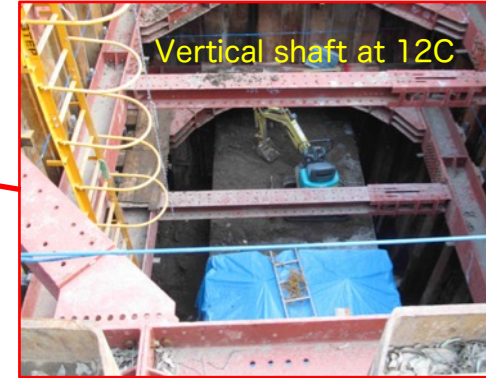
- Effects of the construction of the new facility buildings are still seen by tunnel level survey.
- Average rate of sinking is  $\sim 1.9$  mm/year.

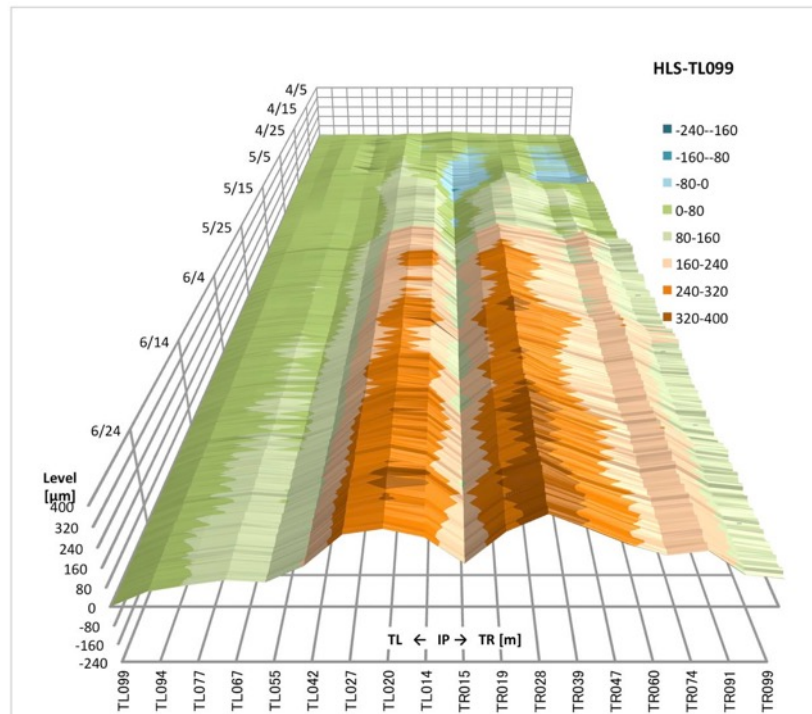
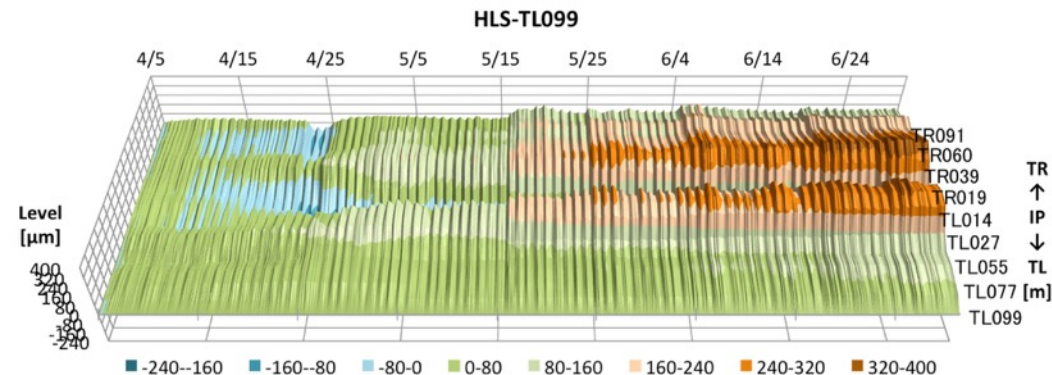
The floor level changed during Phase 3.  
IP has become a local minimum.

Some seasonal effects are seen.  
We suspect that the level change has something to do with the ground water (rain, pumping for rice planting...).
