Injector Linac Status

Masanori Satoh (KEK, Acc. Lab.) for Injector Linac Group

HER injection beam (rf e- gun) status

LER injection beam status

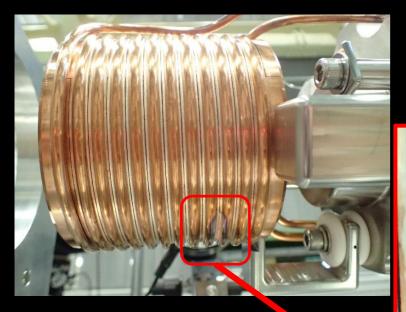
After large discharge...

Slit gap got narrow. Not possible to apply high voltage unless the gap will be expanded. After large discharge

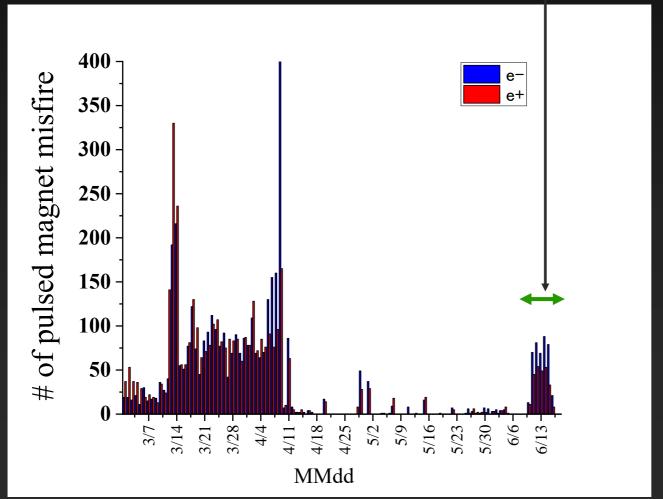
- ~ 100 misfire/day in Feb./Mar. (16 controllers)
- Main control software and event receiver driver were replaced by improved one (Apr. 9th~). # of misfire events decreased to almost zero.
- Misfire appears again (Jun. 10th 22:30~16th 3:23).

network trouble?

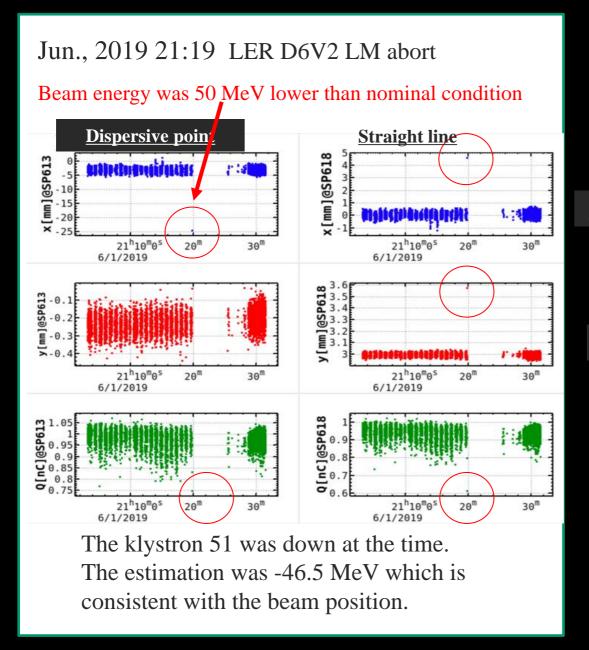
Abnormal energy beam

- Klystron down or rf phase trip could cause energy change.
- In the case of e+ beam, ECS (in linac end) can correct it to a certain extent. Beam can go through BT and into MR.
- To prevent such beam, collimator will be installed in this summer maintenance.

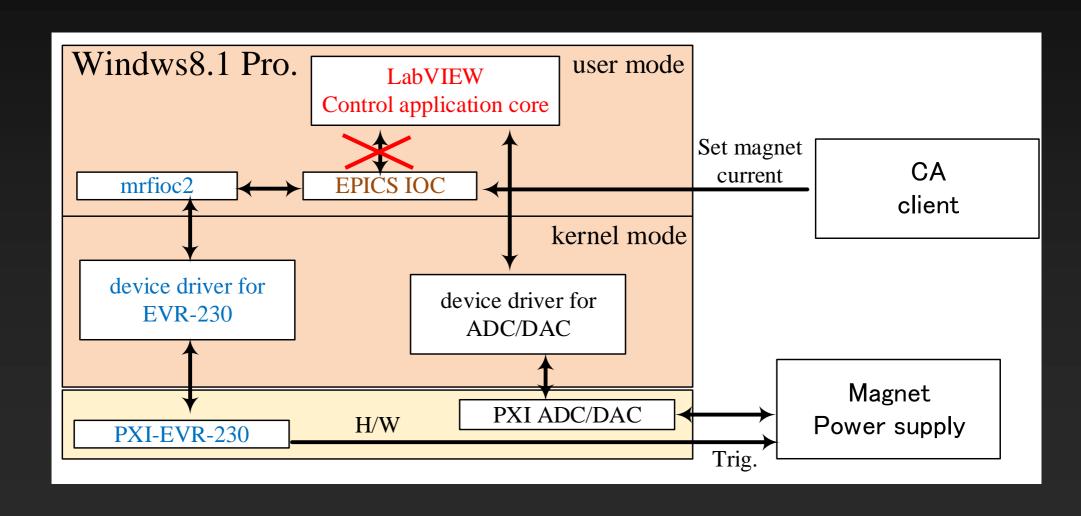
Previous software structure

In some events, LabVIEW/EPICS IOC communication is delayed or failed.

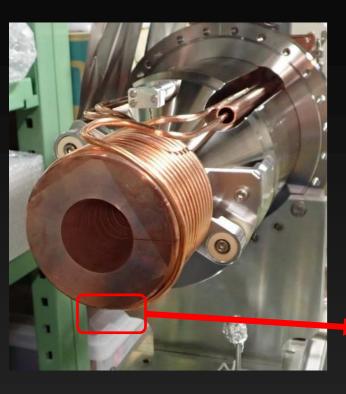
リーク箇所

リークテストでは水色の枠 部がピンポイントで反応する 目視では亀裂や穴は判別できない
