Sudden Beam Loss

The 28th KEKB Accelerator Review Committee

2025/1/14 H. Ikeda

on behalf of the SuperKEKB ACC. Group

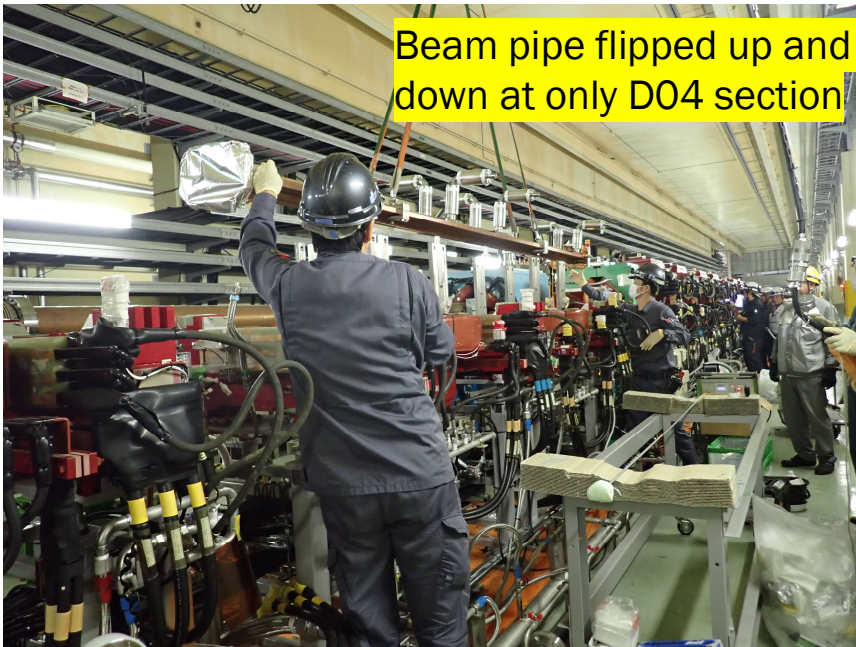
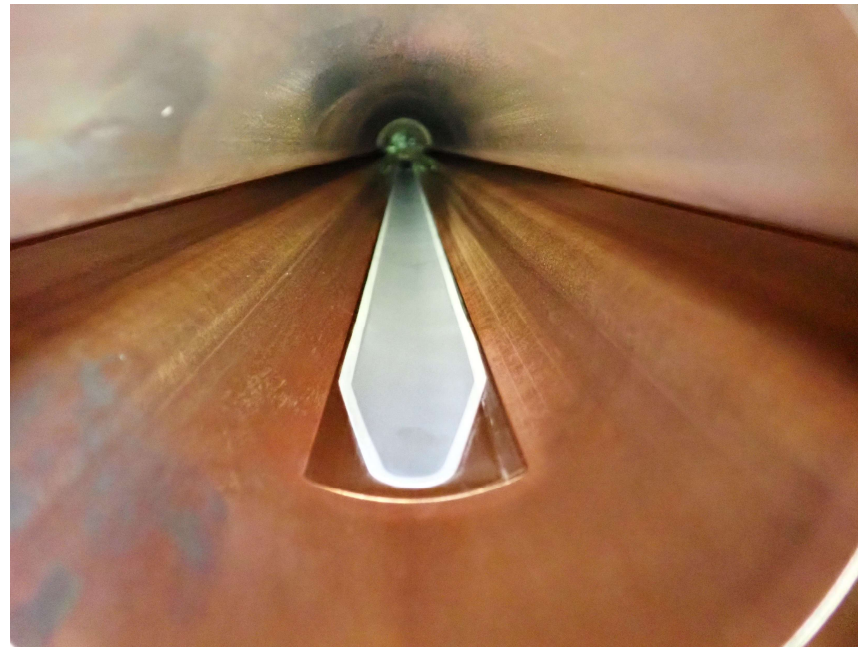
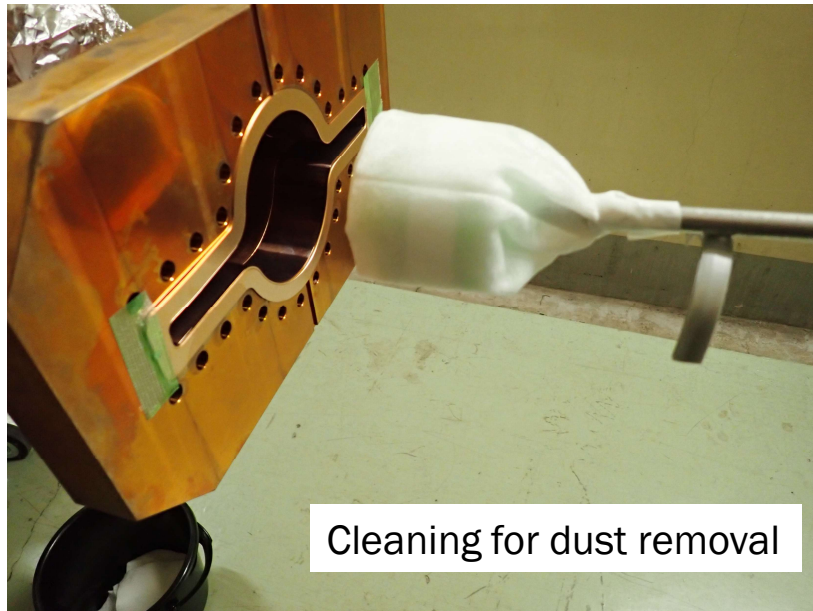
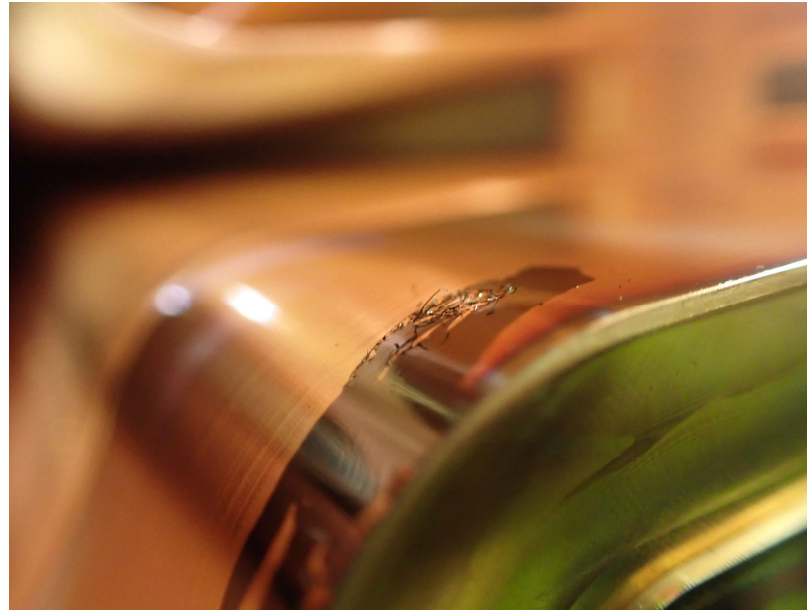
- Flipped upside down the beam pipe with clearing electrode in section D04 (13 outside the OHO concrete shield) in order to check whether dust falling from the electrode is the cause of SBL .
- Cleaned the wiggler section to remove debris.
- Knocked the grooved beam pipe and the beam pipe with clearing electrodes, at all around the ring.

There was a black stain near the flange of the beam pipe. To be safe, the black stain was removed in D04 (the TiN coated area was not removed).

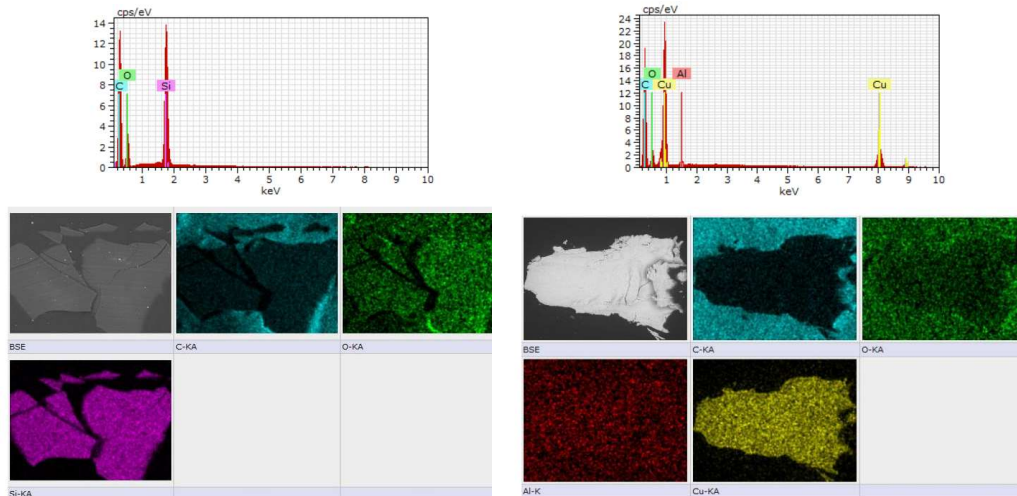
Silicon, Copper, Iron, and Aluminum were collected from inside the beam pipe.

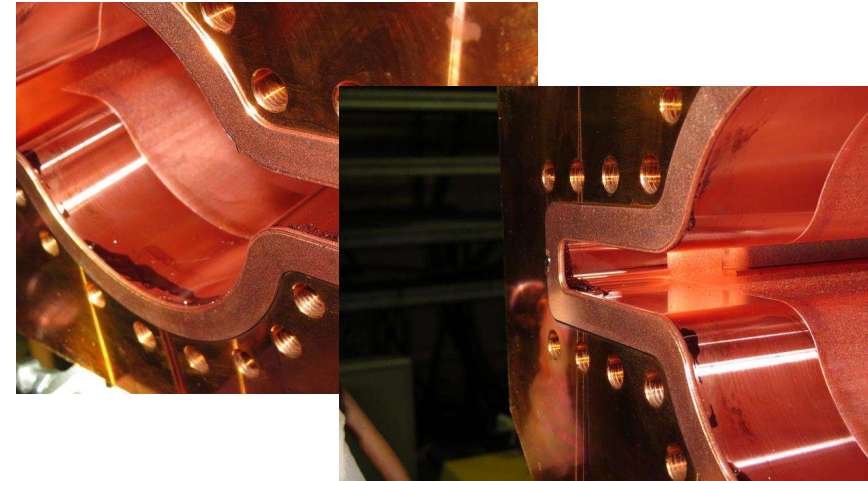
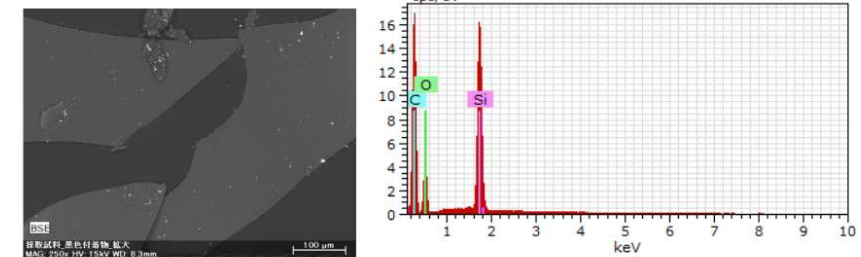
- There are many SBLs with pressure bursts at **D10L02/L03**. This place was opened to check the inside during the summer shutdown.
- 11/16**: Opened the bellows between L02 and L03 and found the black stain.
- After replacing the bellows and clean up the beam pipe, SBL with D10L02 or L03 pressure burst has not been observed.
- The main component of the black stain in the beam pipe was silicon, and since the main component of the vac seal is also silicon, this black stain is considered to have originated from the vac seal.

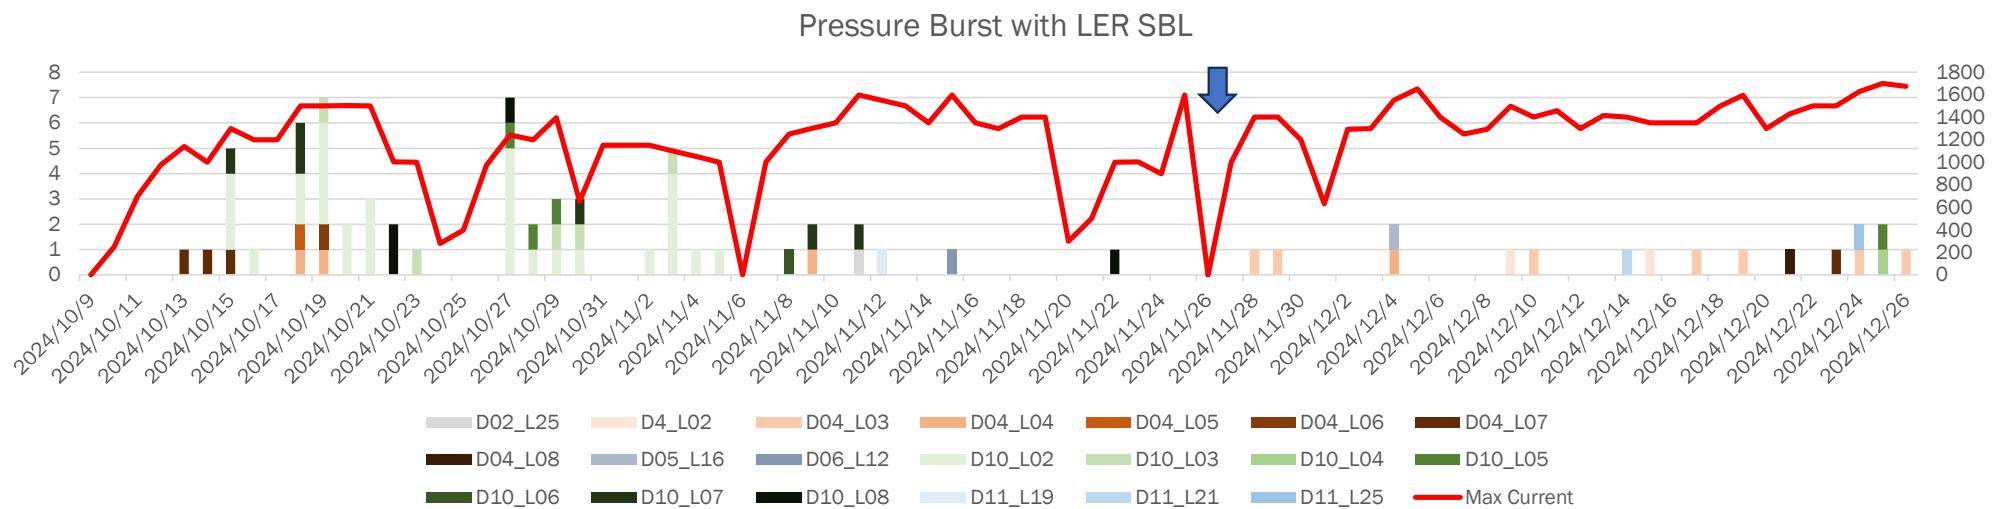
- SBL with pressure bursts in other D10 place started.
- **11/26**:Clean up **D10(L03,L07,L08)** bellows.
- After that, SBL with D10 pressure burst has not been observed.

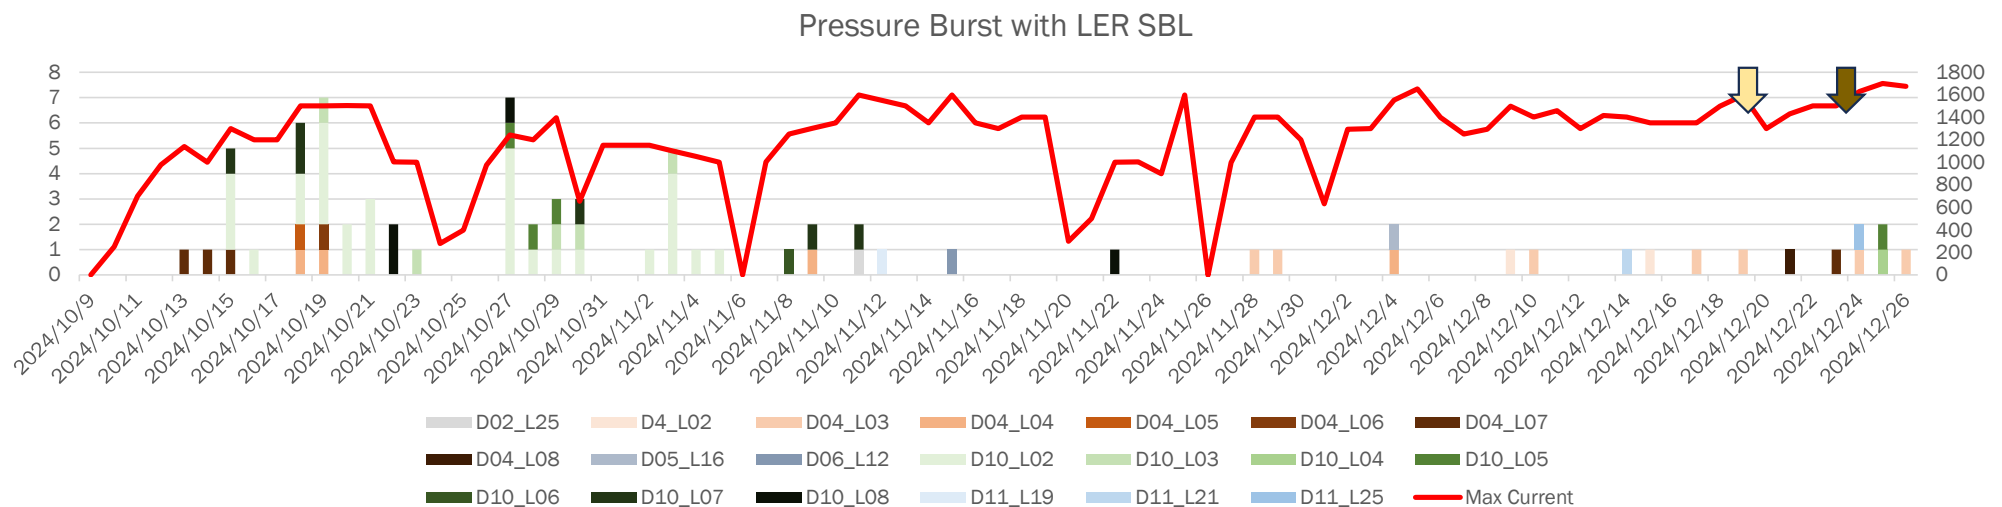
- SBL with D04 pressure burst started again.
- Pressure bursts were mainly observed in D04L02 to L04, which were turned over during the summer shutdown. This is a place where we did not apply a vac sheal.
- 12/19: Knocked 5 places around D04L02~L04 100 times.
- 12/23: Knocked 3 places around D04L07~L08.
- The pressure burst at that location seemed to disappear, but it has reoccurred in some locations.

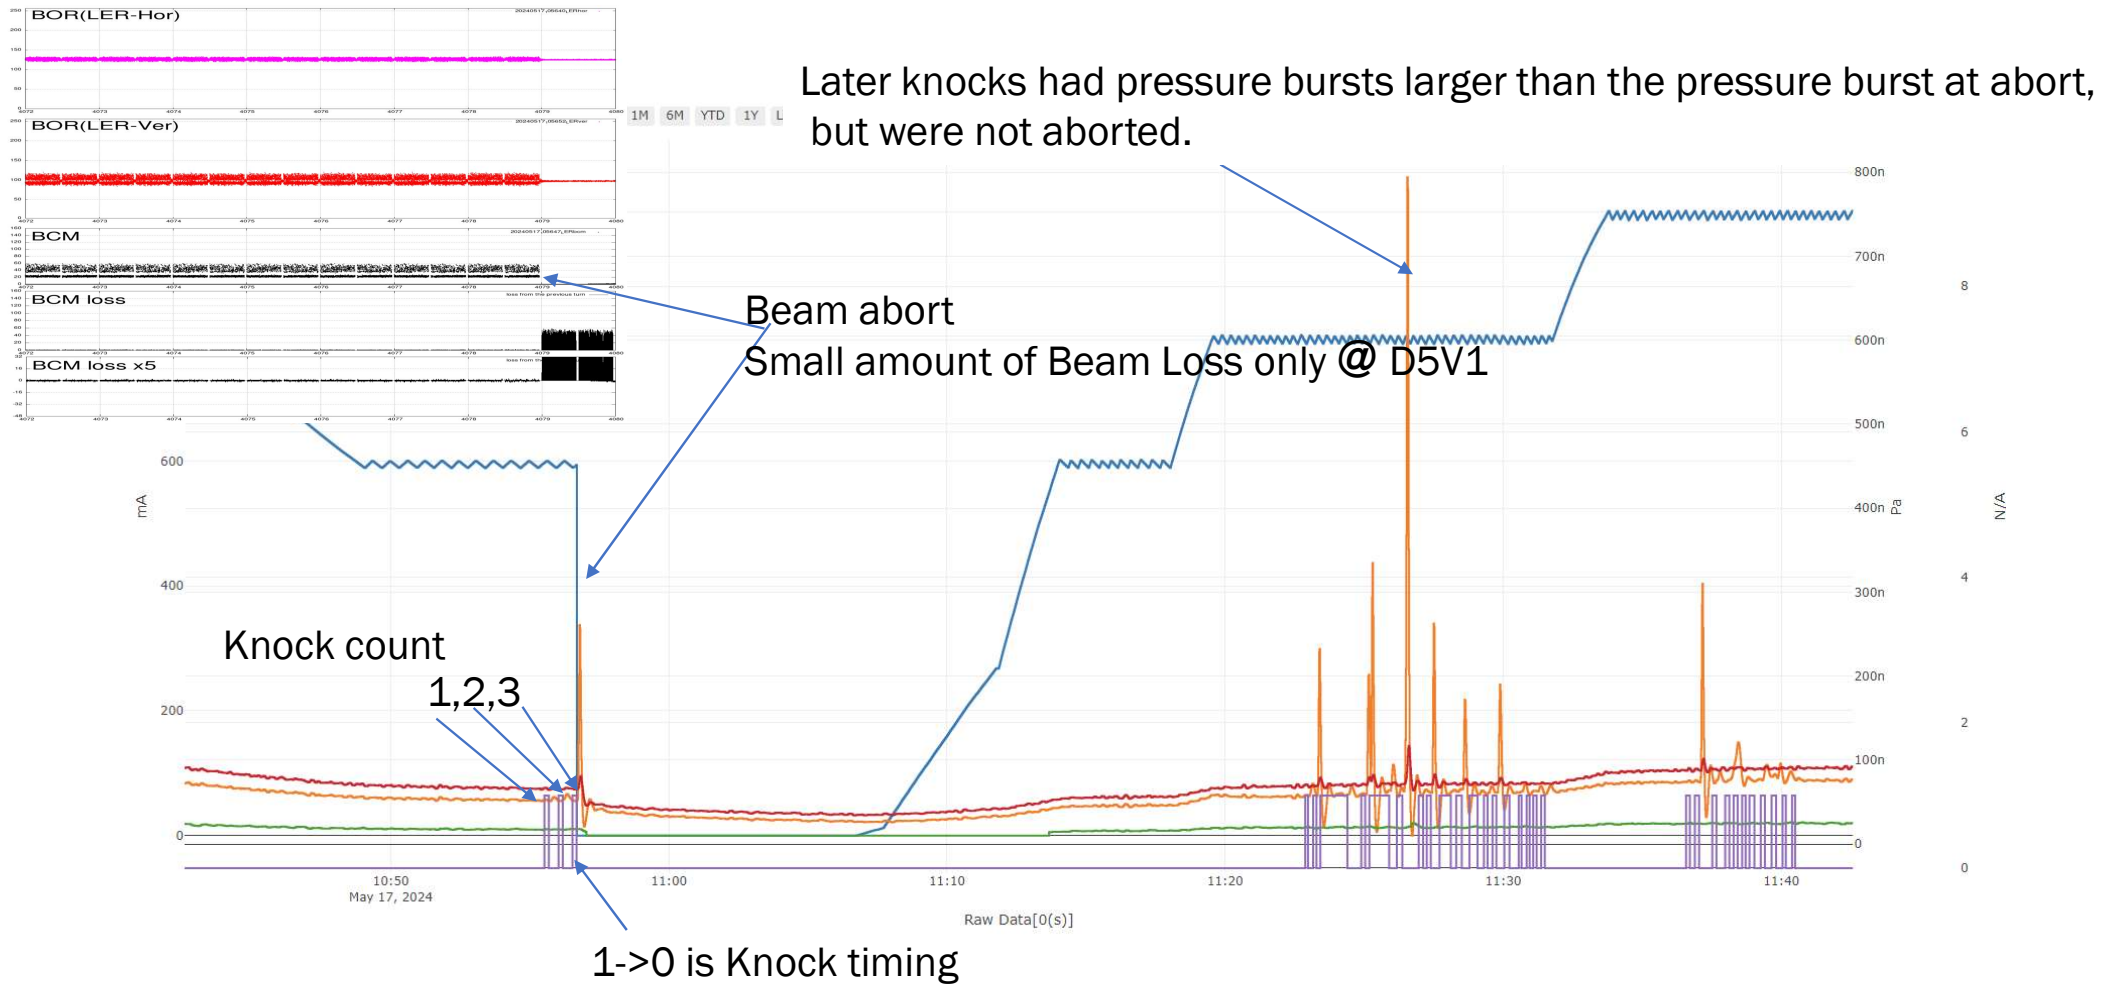
Aluminum beam pipe with grooves

Beam was aborted on the knock count =3.
However, it was not an SBL.
Pressure burst observed.

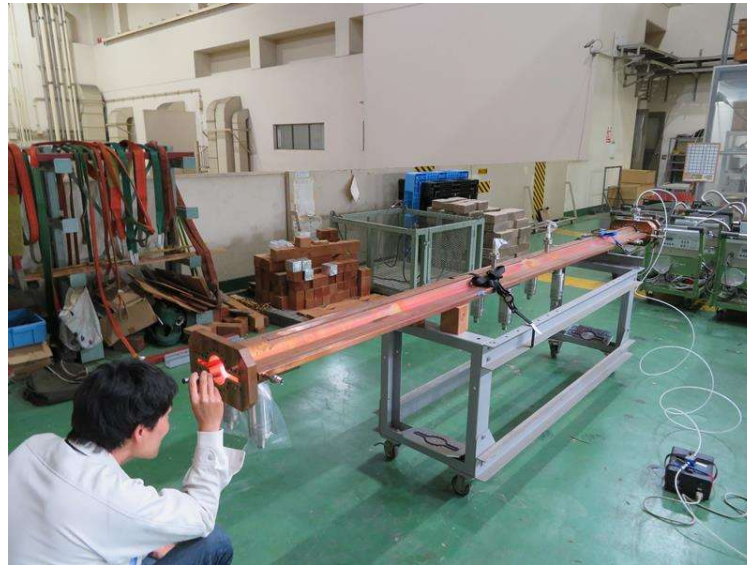
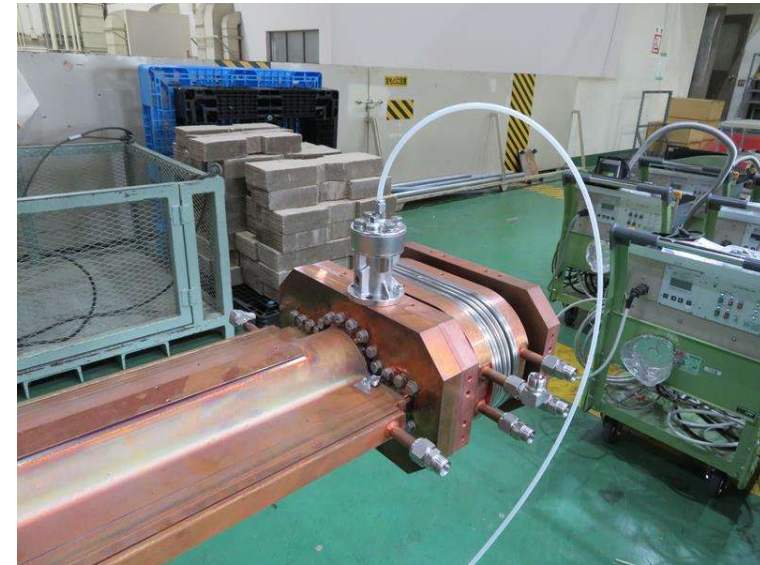
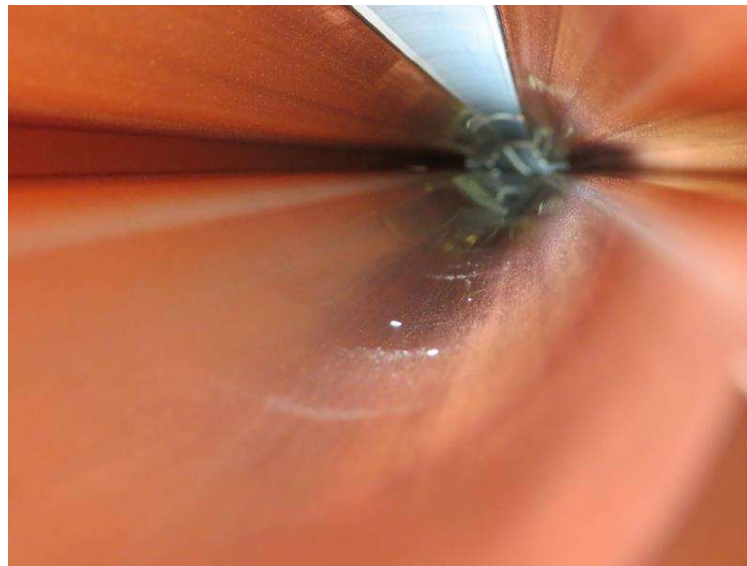
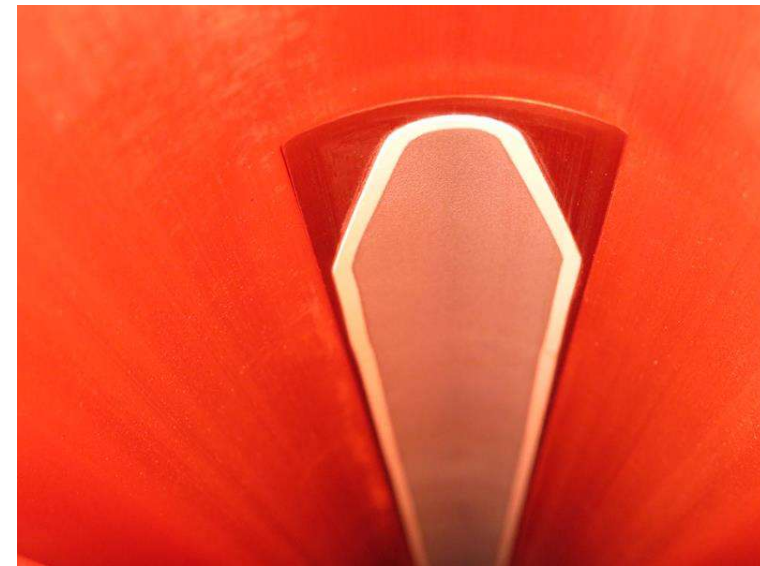
There seems to be a problem with the beam pipe with clearing electrode, so the vacuum group investigated in the experimental room with test-chamber (Chamber with electrodes taken out from tunnel at LS1).

Dust from chamber gotten by knocking was sent for chemical analysis, but no tungsten was detected in the dust.
