Summary of the SuperKEKB beam monitors

Gaku Mitsuka (KEK Acc. Lab.)
on behalf of the KEKB beam monitor group

The 28th KEKB Accelerator Review Committee

14 Jan 2025, 08:00 → 16 Jan 2025, 17:00 Asia/Tokyo

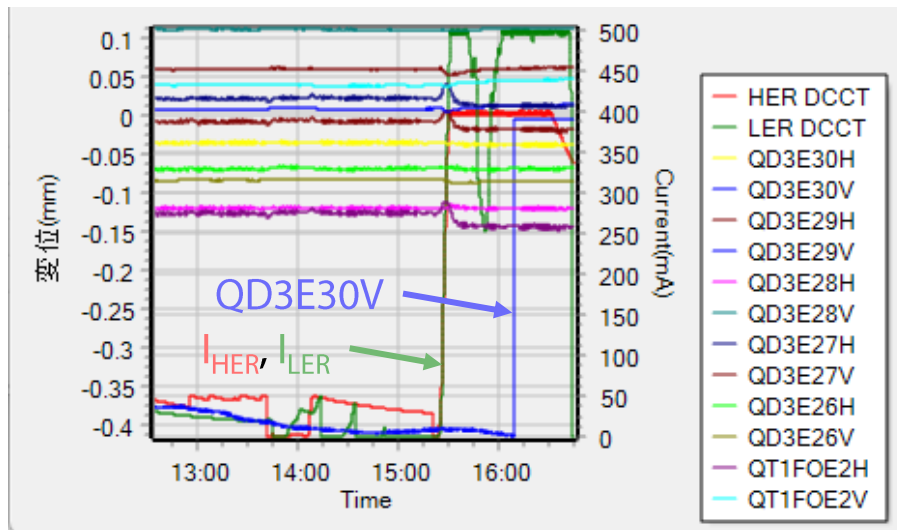
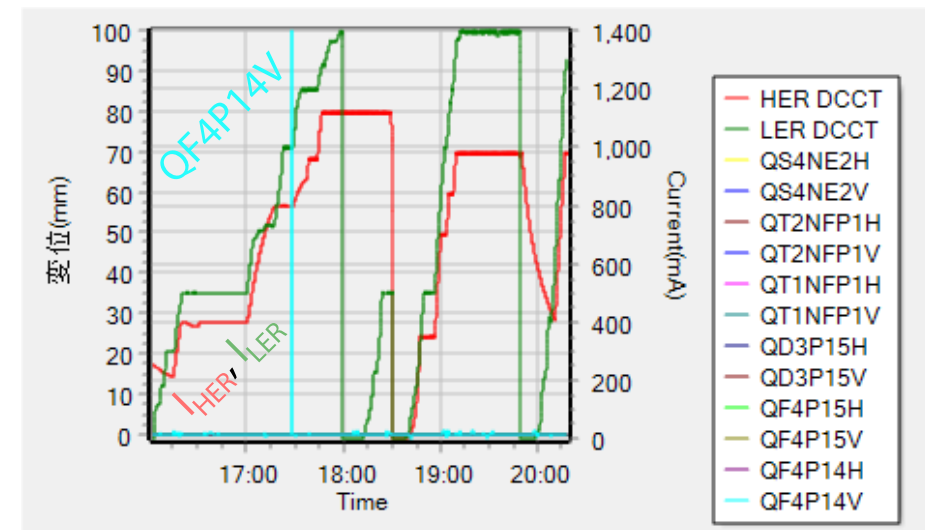
- Displacement meters worked well overall.
- Troubles
 - HER QD3E30V suddenly jumped and drifted. QD3E30V was temporarily disabled.
 - Re-fixing the sensor physically solved the drift.
 - LER QF4P14V suddenly jumped ~100 mm. QF4P14V was masked in the operation.
 - BNC connector seems healthy. ADC unit of the logger will be replaced.
 - The displacement meter logger (+Ras. Pi-based thermo-hygrometer) at LC4 hung up frequently.
 - Needs adding lead shielding.

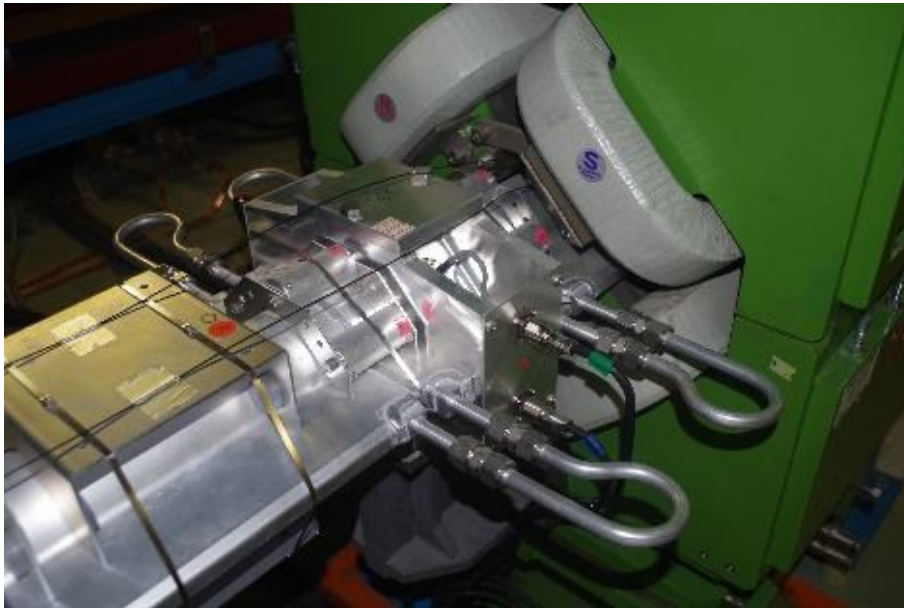
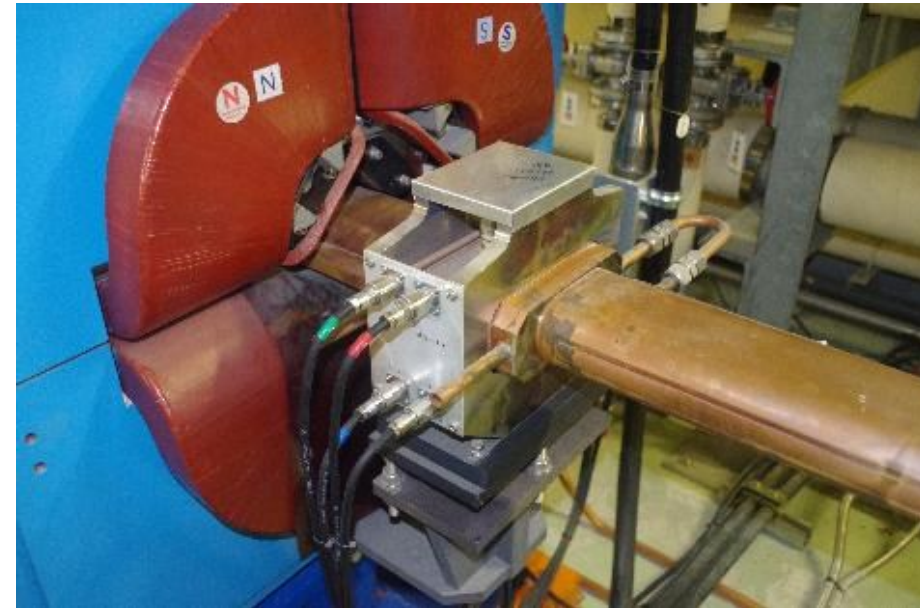
- During the 2024 summer shutdown, we found many loosely tightened N-connectors at the BPM relay panel. LER has been in this condition from the beginning of SuperKEKB??
 - LER: minor (79/445), **major (250/445)**
 - HER: minor (34/467), major (68/467)
- All connectors were re-tightened with torque wrenches.
- No significant change in the gain before/after tightening.

minor: 1 loose connector
major: 2-4 loose connectors

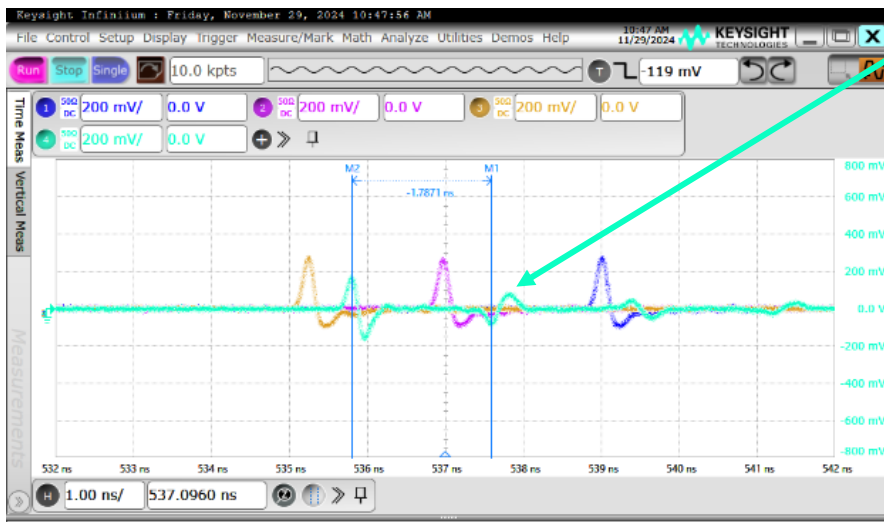
- “NaN” data contained in the BPM data
 - Restarts the VME IOC at LC6
- PLL unlock of 508 MHz detectors
 - Restarts after the power cycle of the VME (MXI) system
- QS2NP2 D channel gives low output.
 - Bypassing turn-by-turn BPM and changing the cable from FT to BPM panel did not work.
 - TDR measurement indicates a short circuit near the 5D cable and the N connector.

Small output pulse and large reflection only in D channel

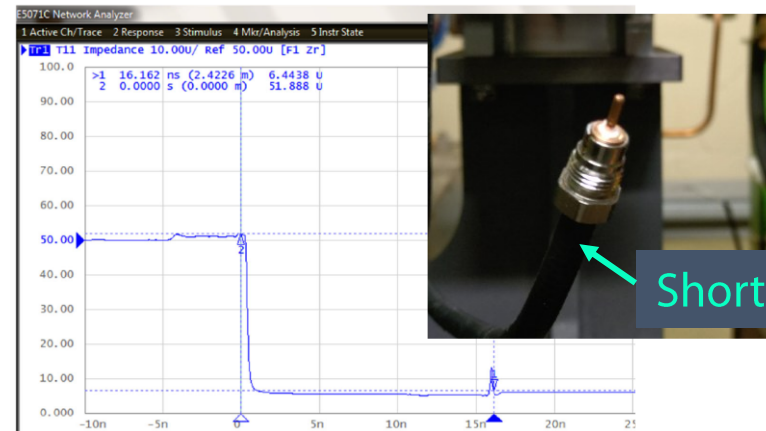
Short circuit at the 5D-cable end

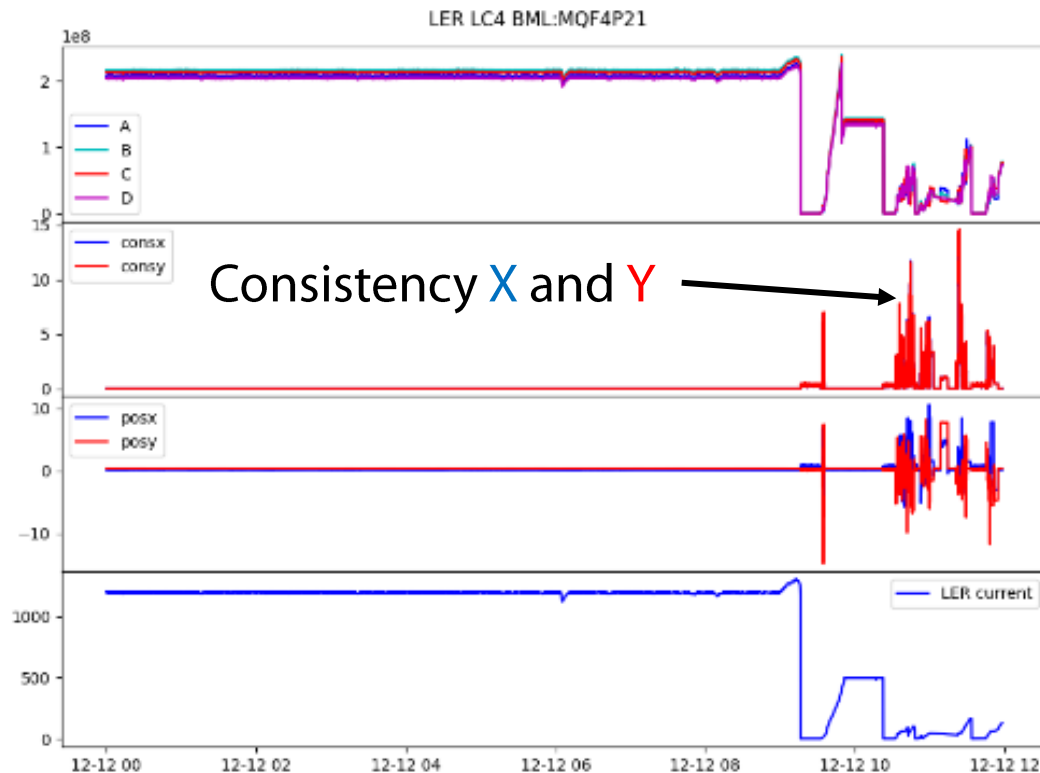
- A total of six Libera BPMs give strange positions (bad consistency) at the lower current.
- Suspecting internal attenuator errors
- Repair (with a considerable cost and several months) or replace with narrowband detectors??

- “Consistency” is defined as the root-mean-squares of the four beam positions obtained by combinations of the three voltages.
- A large consistency suggests malfunctions in some signal channels.

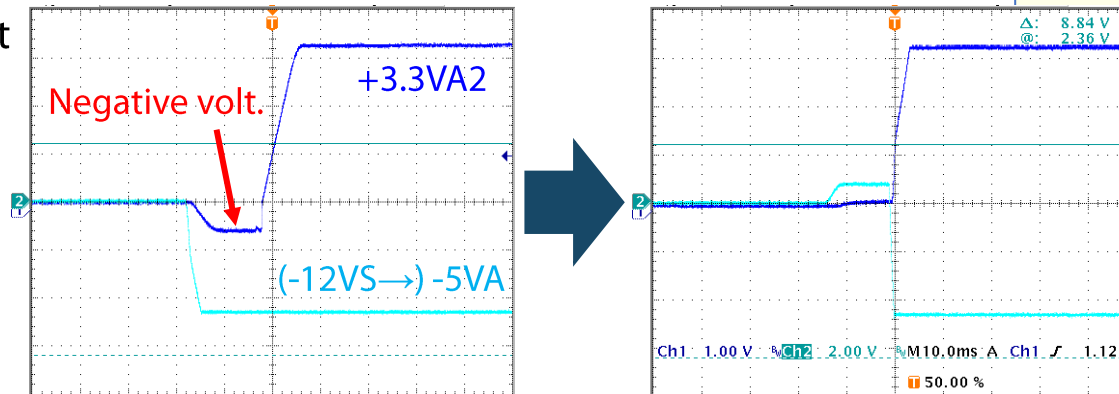
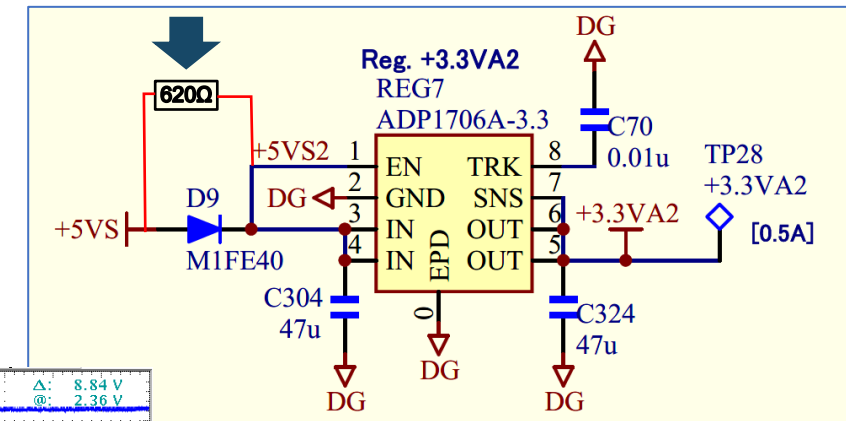
- GTBTs (~70 detectors for each ring) have worked well overall.
- **Troubles in 2024ab**
 - 3.3 V regulator gave abnormally low voltage~1.3 V. C and D-ch ADCs came too low/high counts.
 - ~10 GTBTs seemed malfunctioning. Some of the malfunctioning GTBTs somehow recovered later.
- **Maintenances**
 - Add register for discharging (D9 diode leaves charge.)
 - Enable/Disable sequence comes to work correctly.
 - Add trigger circuit to turn on -5VA by the rising edge of +5VS
 - Avoid negative voltage damage to the regulator

Turn-on sequence is different for each power output in new PS unit replaced in LS1.

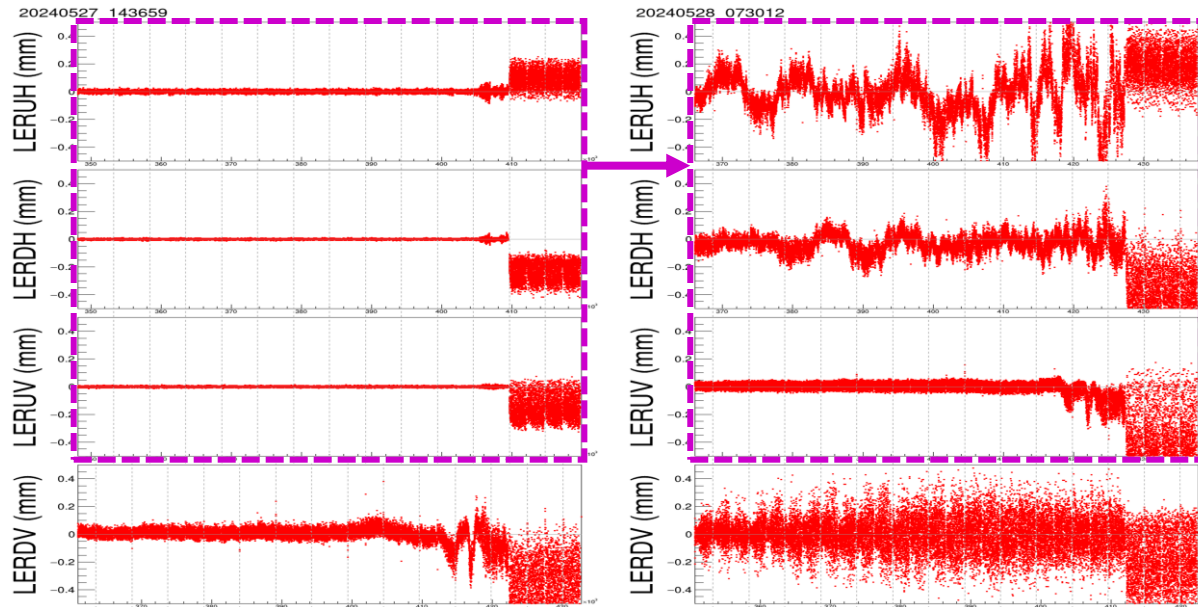
UH, DH, and UV are delayed by 1 event in 2024ab

- Bug fixed in the firmware of the iGp12 processors, applied only to the transverse FB system
 - Data acquisition/transfer at BRAM comes to working correctly.
 - Post-mortem data acquisition (i.e., bunch oscillation recorder) has been stable in 2024c.

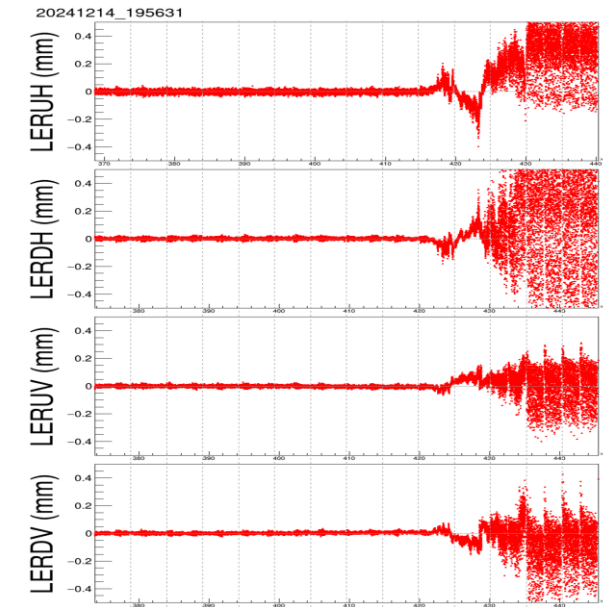
Correctly aligned in 2024c

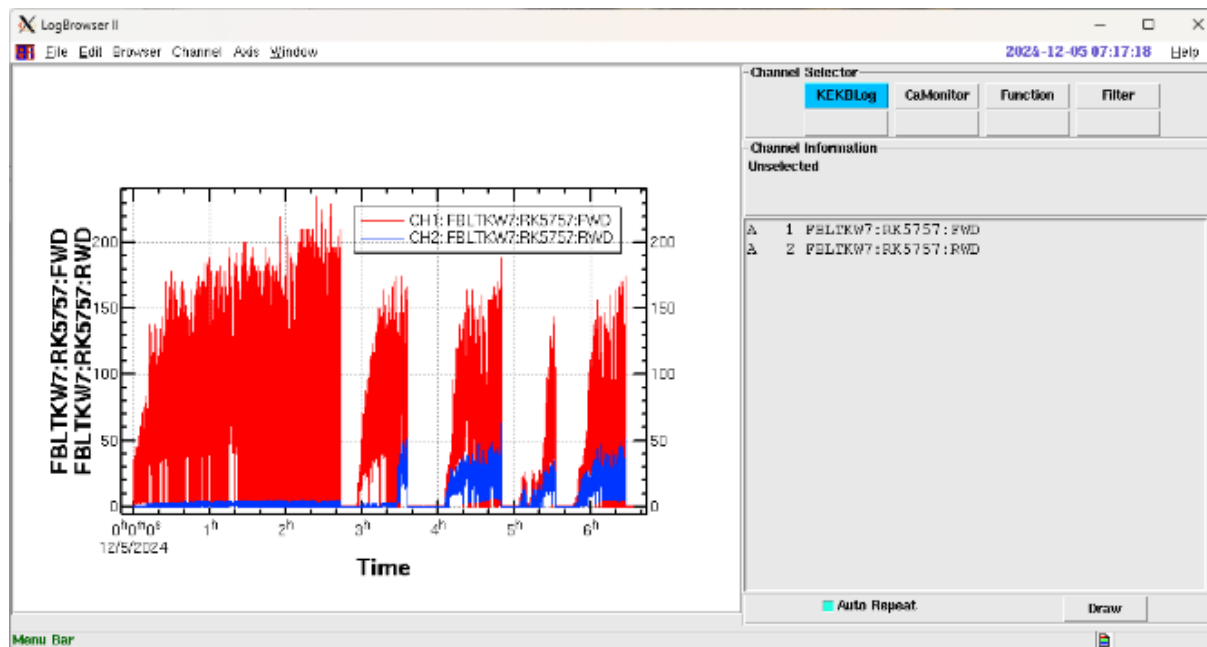
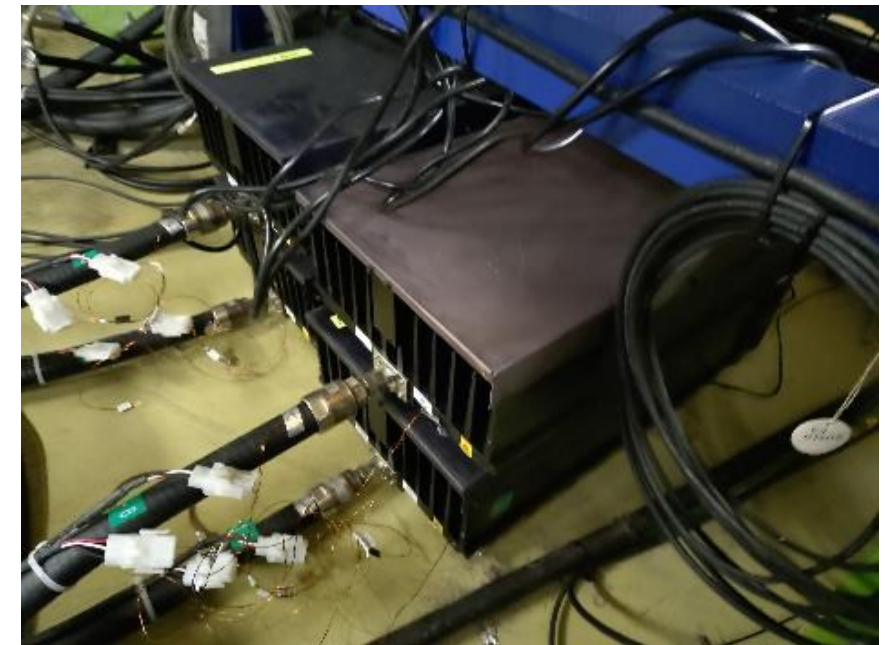
- 1.5 kW attenuators for the transverse kicker broke in both HER and LER.
 - Beam aborts due to increased reflection to the final high-power amplifiers
 - Replaced with the spears. We have four spears presently.
- The temperature logger in the tunnel hung up several times due to radiation damage.
 - Power-cycled and returned to operation

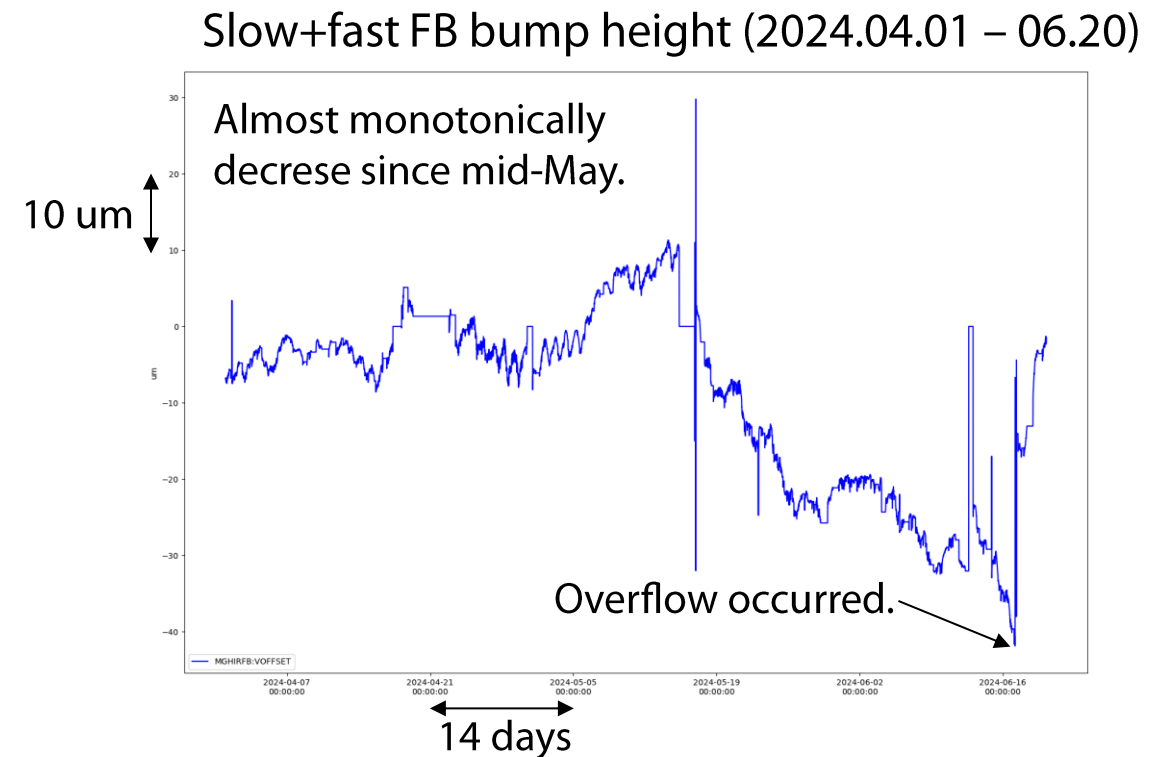
- **IP-FB is working well.**
- DAC value overflow (27 Jun. 2024 5:00-7:00)
 - Setting (DAC) value of the corrector ZVF2RE overflowed and jumped to positive value.
 - Beam injection in HER came to difficult and operation was interrupted for ~2 hours.
 - The overflow was eliminated by adjusting the orbit with other steering magnets.
 - “iBump damper” automatically absorbs a part of the bump height with CCC correctors. (It was OFF, while it had been ON before LS1.)

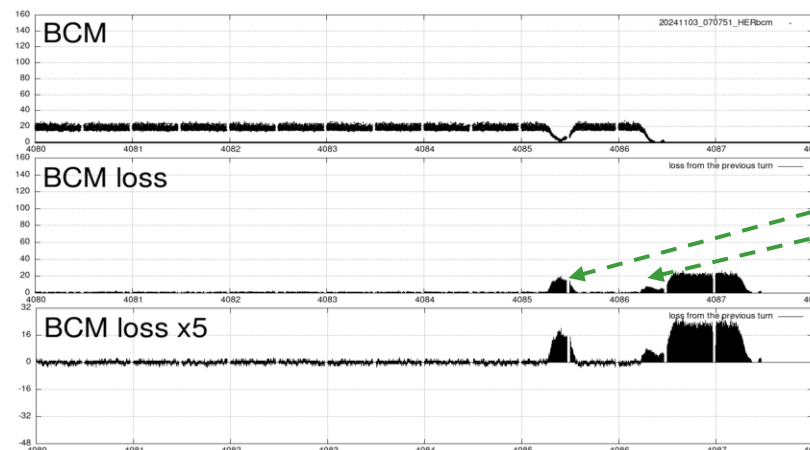
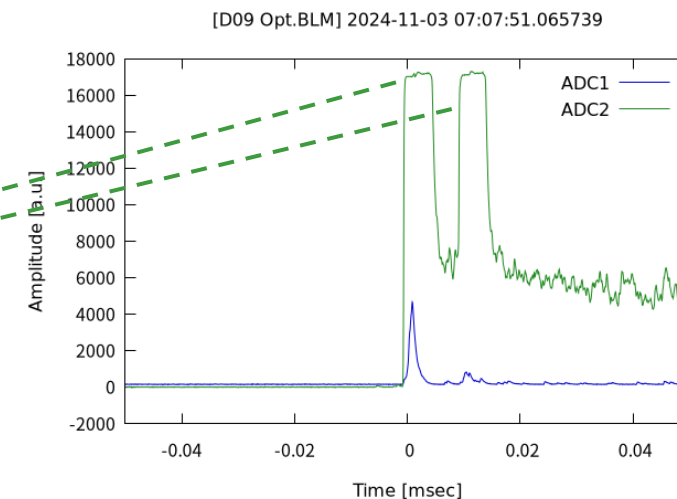
- **The system overall worked well.**
- **Maintenances**
 - The 5D signal cable of the PIN near the D12V4 collimator was replaced with an 8D cable.
 - Signal was noisy (owing to the long cable~450 m) and sometimes issued unintended beam-abort triggers at high beam current.
 - Replacement solved the problem, which no longer happens after the replacement.
 - Optical fiber LM was placed near the D9V1 collimator (close to the HER abort kicker).
 - Out of 18 SBLs in HER, 13 were also triggered by the optical fiber LM; of the 13, 6 received the fastest abort-trigger signal from the optical fiber LM.

- Done.
- R13.1: Continue the effort of adjusting the threshold of the beam loss monitors to avoid unnecessary beam abortion due to small beam losses.
 - The 5D signal cable was replaced with an 8D corrugated cable for the PIN near the D12V4 collimator.
