Vacuum

The 28th KEKB Accelerator Review Committee
14th January 2025

Mu-Lee Yao
On behalf of KEKB Vacuum Group

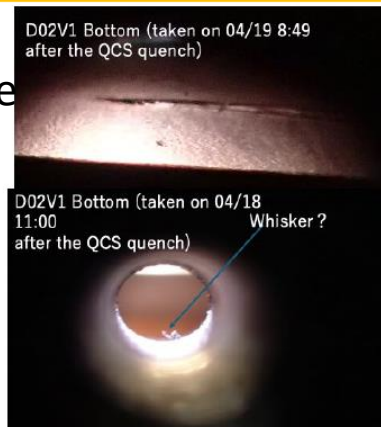
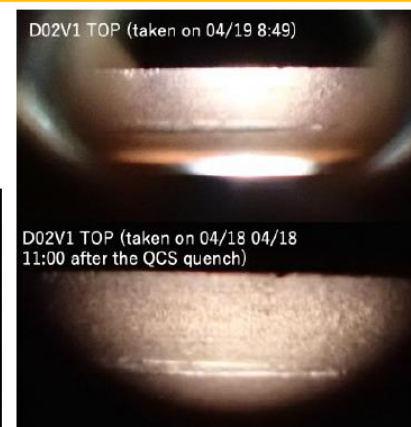
D02V1 Damage

- Collimator head damage
 - LER: D02V1, D05V1(due to frequent SBL)
 - HER: D09V1(Other: LVDT malfunction)
LVDT = Linear Variable Differential Transformer of gap sensor

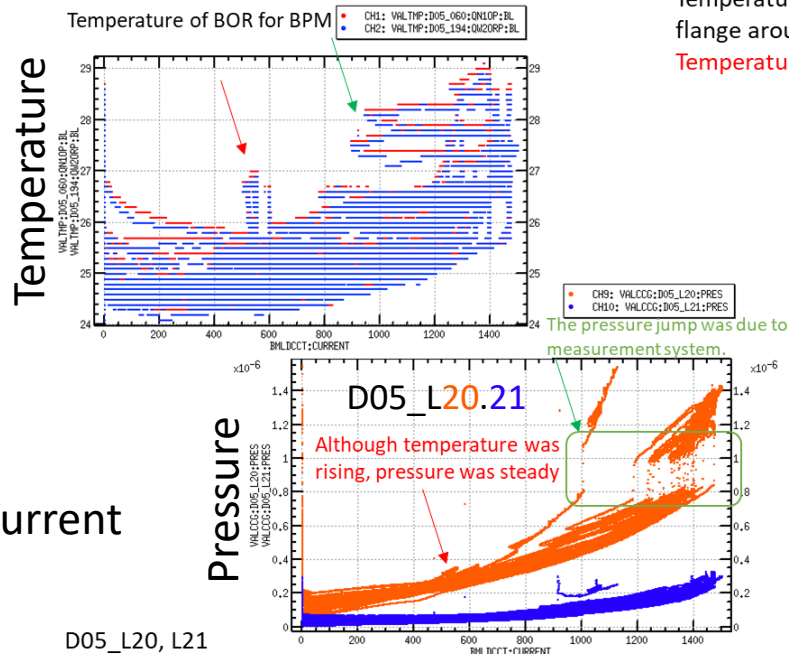
- The temperature and pressure increases are dependent on the number of bunches. At a certain beam current, the pressure rises sharply. Occasionally, L26 exhibits pressure spikes during injection. Aging effects have been observed.

Temperature near the beam pipe and flange around L26 was high

Temperature on the NEG pump was high.

- Gaskets with small holes (RF shielded) were installed on nearby ion pumps (D05_L25 and L26) in the summer shutdown.

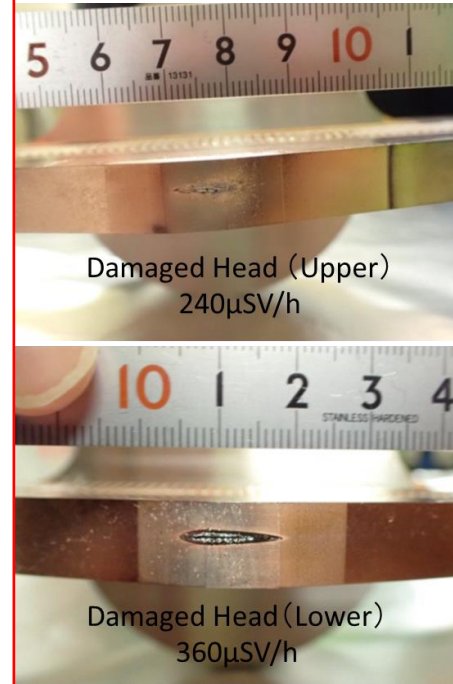
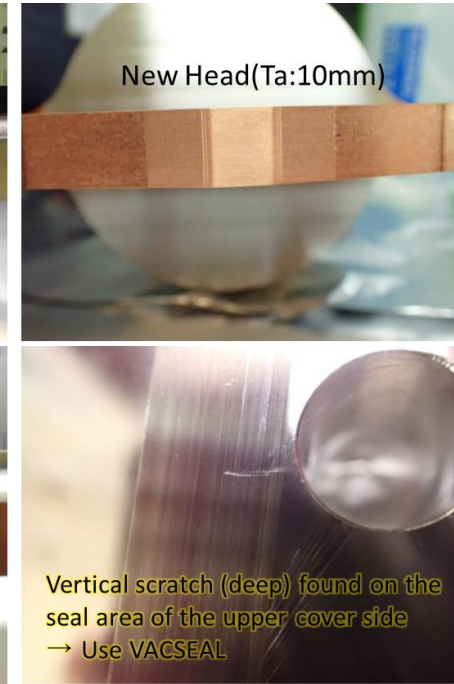
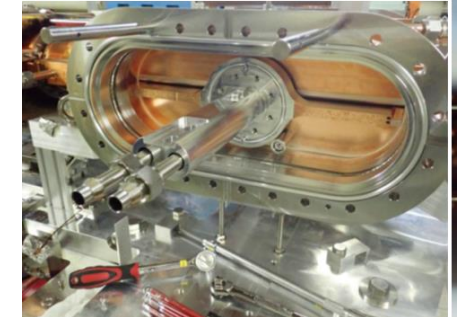
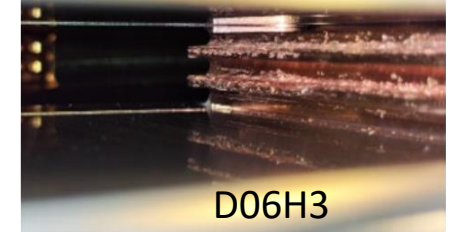
Receiving part of the H3 head/container (severely damaged)

- Collimator Head Replacement: D02V1
- Collimator Head Status Check:
 - D05V1: The lower head was damaged.
 - D06H4: The inner head was damaged slightly.
 - D06H3 (Graphite head):
 1. Movement mechanism has become difficult to operate (due to the copper shavings)
 2. But the graphite head, which has been used since 2024a, remains healthy even after several accidental firings of the injection kicker

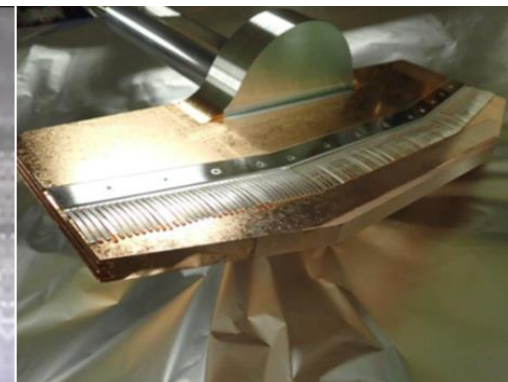
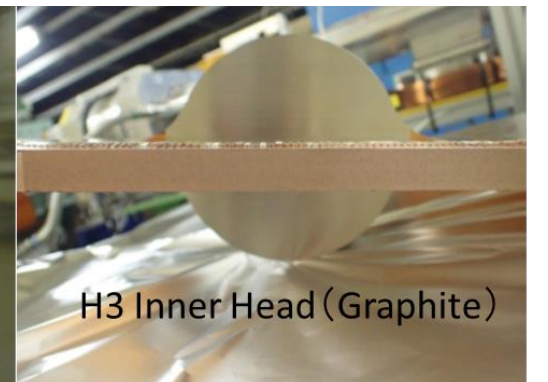
D06H4 Melt Mark

H3 Inner Head (Graphite)

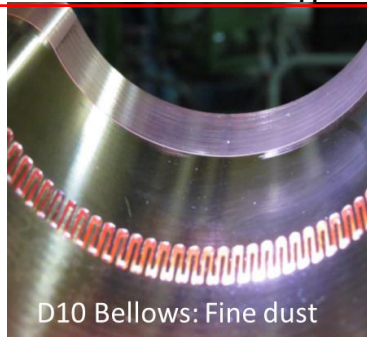
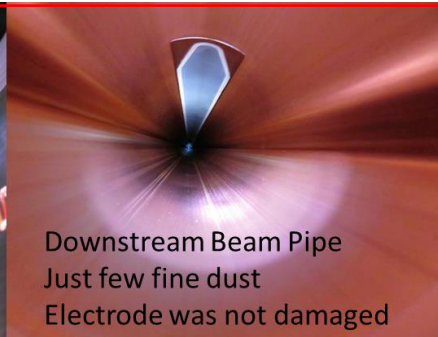
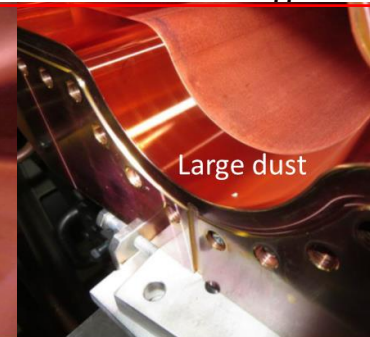
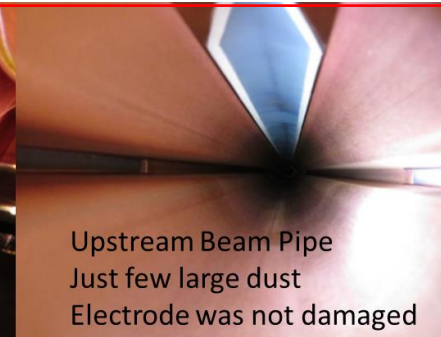
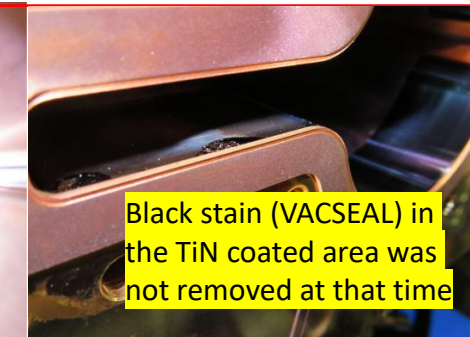
- LER D11 Chicane Q Chamber (QW5NRP) was replaced with new one.
- Beam Pipe Inspection and Cleaning:
 - D10 Clearing Electrode Beam Pipe: Interior was inspected and cleaned.
 - D04 Clearing Electrode Beam Pipe: Flipped upside down and cleaned. 13/16 beam pipes outside the Oho concrete shield were flipped.
- Result of inspection:
 - D10: No obvious damage to the electrode. Some dusts at the bottom of beam pipes.
 - D04: No obvious damage to the electrode. Black traces of (probably) burnt VACSEAL were found inside near most of flanges. Severe traces were cleaned before restoring.

D10: VACSEAL was used for sealing flange as before.

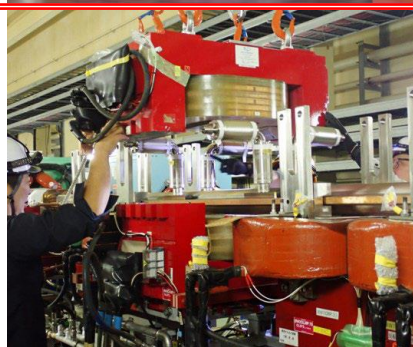
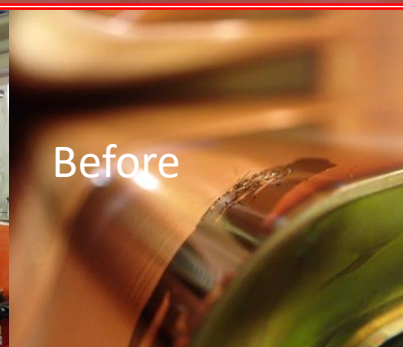
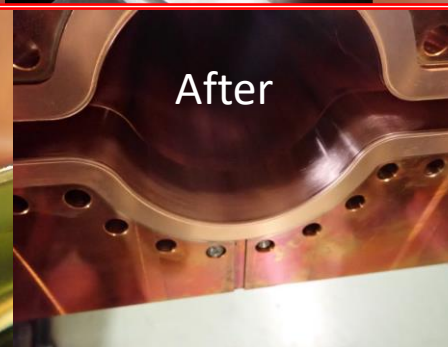
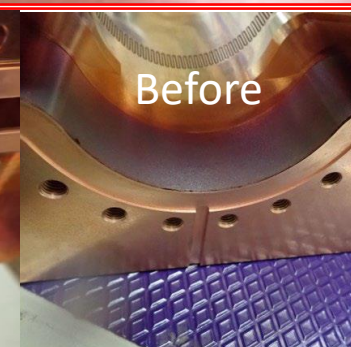
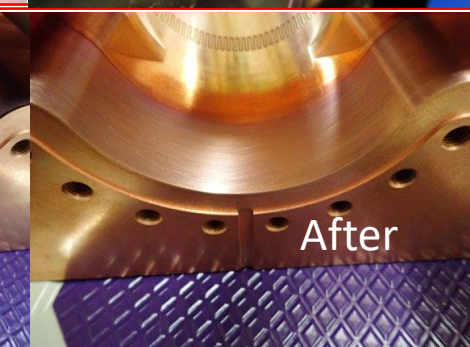
D04: VACSEAL was **NOT used** for sealing flanges, but the black stain of them were **not COMPLETELY removed** to preserve the TiN coating.

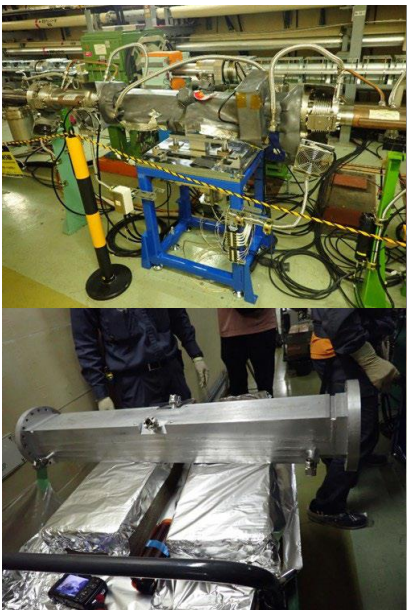
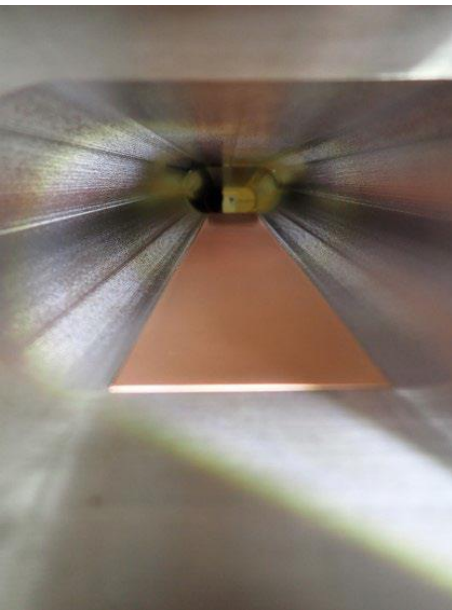
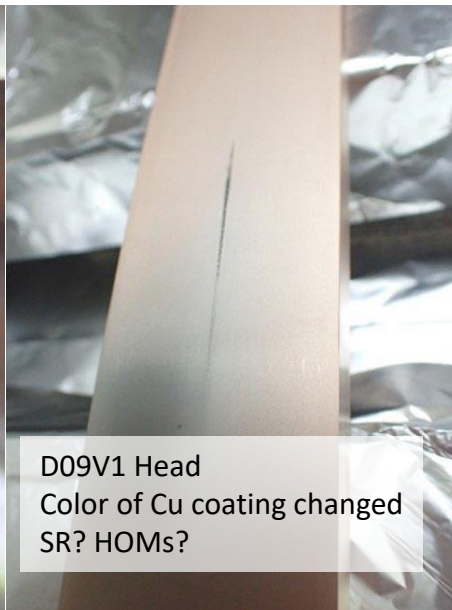
D09V1 Head
Color of Cu coating changed
SR? HOMs?

- Collimator Head Replacement: D09V1 (14.4 mSv/h)
- Installed RF-shielded gaskets on Ion Pump D08_H05 and the NEG pump near D09V1.
- Install thermometers on D09V1, D09V3, D12V3 (for nonlinear pressure rise study)
- Note: No knocker work was performed in HER
