### Vacuum Progress and Troubles of Upgrade Works

The 20<sup>th</sup> KEKB Accelerator Review Committee

February 23, 2015

Kyo Shibata (on behalf of KEKB Vacuum Group)

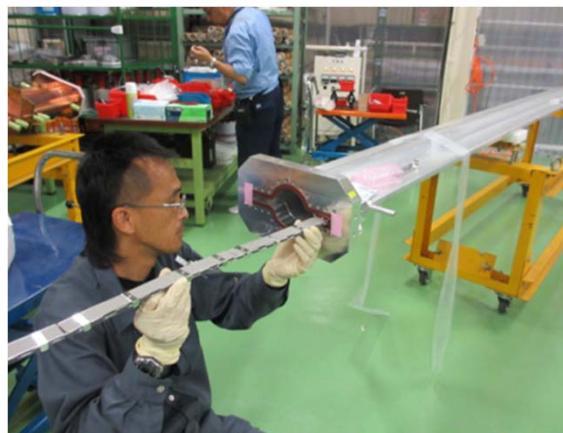
NEG with heater installed into beam pipe

- Trouble 2 : Leak at ceramic brazing of sheath heaters for NEG activation.
  - Cracks at the brazing between ceramics and stainless steel sleeve was found.
  - Gas desorption from the cracks leaded to high ultimate pressure even after NEG activation.
  - Low insulation resistance was also observed.
- Cause :
  - Fastening of ceramic block for insulation was too strong, and the excess stress (moment) was applied to the brazing part, if the ceramic was brazed with a slight angle.
- Cures :
  - Insert a thin spacer between ceramic blocks to avoid the excess stress on the brazing part.
  - Cracked heaters were re-fabricated.

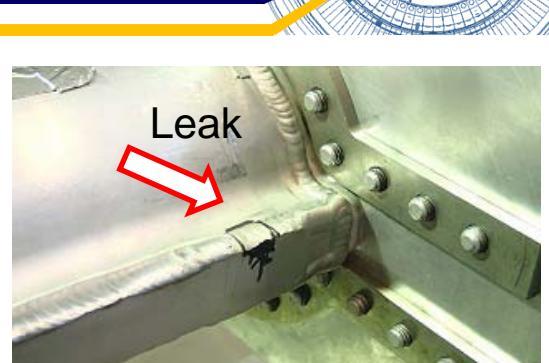
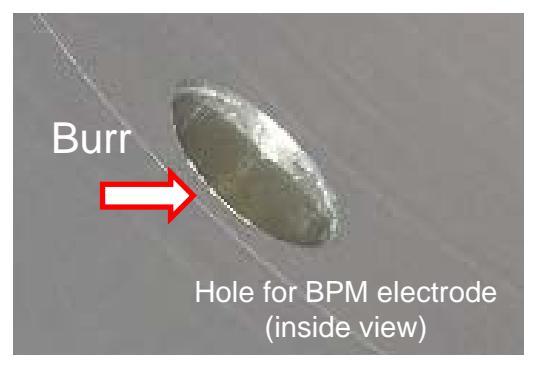
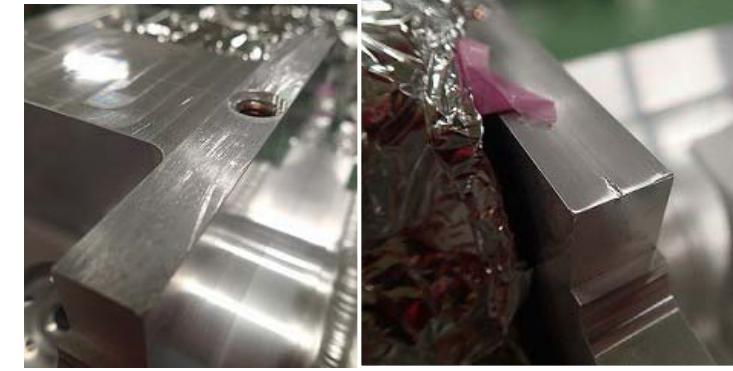
#### Scratches and defects

- Defects or scratches on the standard surface of BPM block
    - Cause : Bad quality control at the manufacturer
    - Cure : Check all holes by KEK staff of beam monitor group Polishing the defects to remove "projection" Deburring

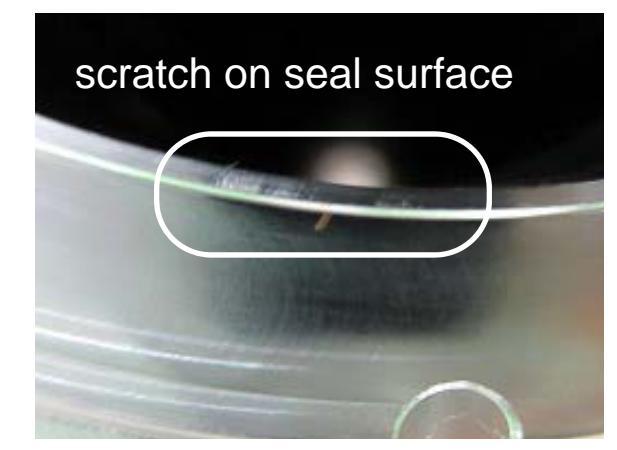
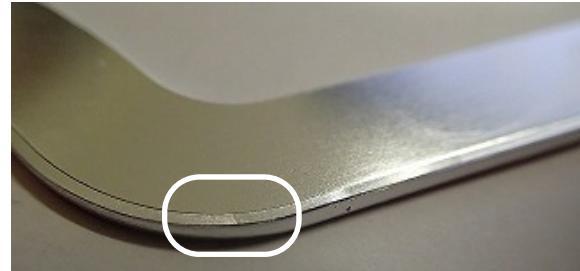
Trace of machining transcribed on used gasket

- Trouble 1 : High rate of air leak at connection flanges (reported in last KEKB Review)
  - In the initial stage of bellows connection in the tunnel, the rate of air leak at the connection was higher (~10%) than that experienced in the pre-installation work (<5%)</li>
- Possible causes:
  - Scratches or traces of machining (small steps and rolling) on the seal surface of bellows chambers
  - Difficulty in alignment of flanges (bellows chamber and beam pipe)
    - Bellows chamber is heavy.
    - Some beam pipes are already fixed to magnets
  - Oxide layer of aluminum gaskets?
- Cures:
  - Polish of the sealing surfaces with abrasive cleaning pads (Scotch-Brite)
  - Polishing of gaskets (also effective sometimes)
  - The rate of leak decreased to less than 5% finally.
  - Tool to make the alignment easy (in preparation)

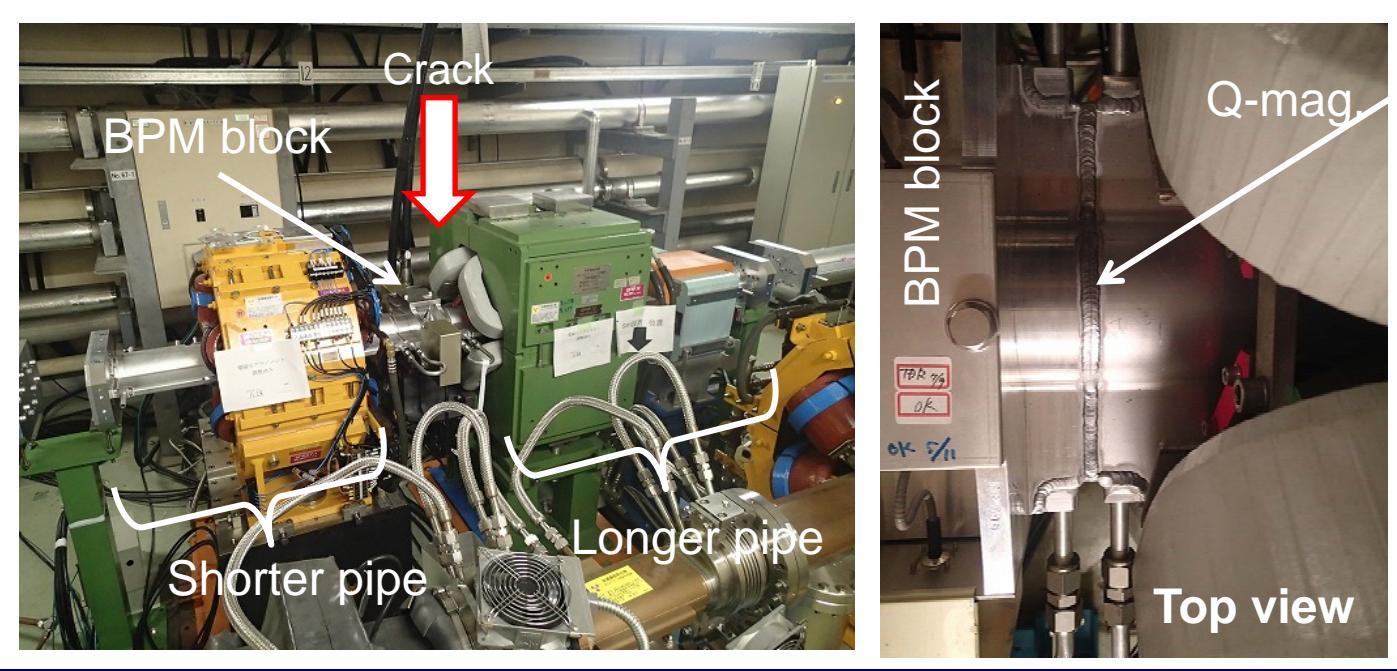
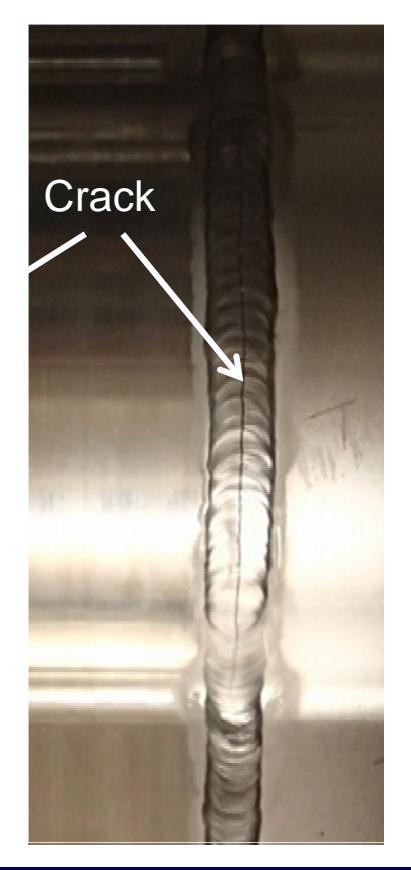
- Trouble 2 : Cracks on the welding line (Case 1)
  - Welding line of BPM block of aluminum beam pipe cracked just after starting the evacuation in the tunnel. (3 beam pipes)
  - BPM block was rigidly fixed to Q-mag. via support.
  - Crack occurred on upper welding lines at Q-mag. side, where the longer beam pipe is welded.
  - No problem was reported in the pre-installation work.

- Possible cause 1 : High moment due to the weight of bellows chamber at end.
  - It is suspected that the bellows chambers at ends was not rigidly fixed to the support.
  - There is also a possibility that the flange was aligned with some vertical excess-force to connect the bellows.

- Cures
  - Surely fix the bellows chambers to the supports before evacuation.
  - Avoid forced alignment of flanges.
  - Re-welding of the welding lines with a height of excess metal less than 0.5 mm.
  - Re-welding of the welding line with some defects, that were found in the investigation of excess metal.
  - No crack at this position has been observed since then.
    - However, great cares should be paid during the final alignment of magnets, where the beam pipes can move with magnets.

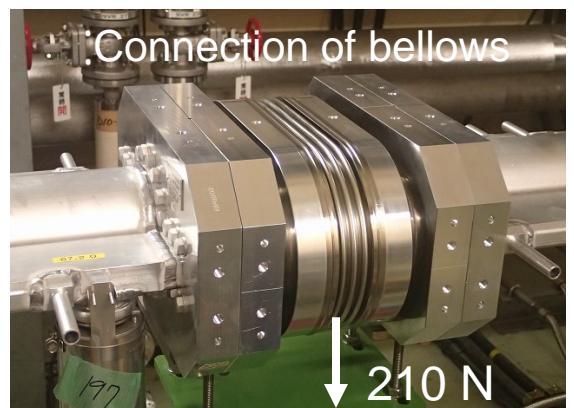
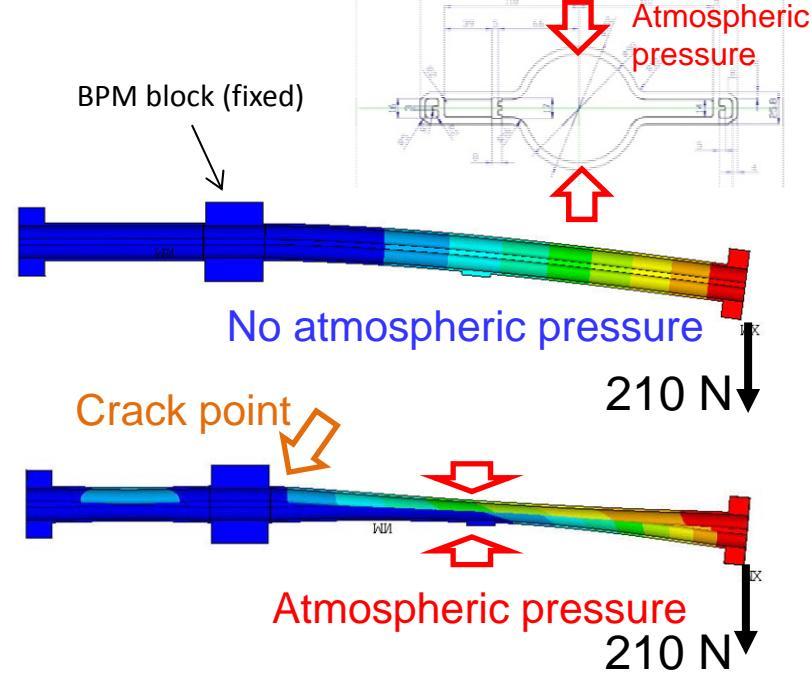
- The stress at top and bottom side further increase by the atmospheric pressure due to the antechamber cross section.
- The stress at upper welding line is doubled with atmospheric pressure.
- If the welding thickness is insufficient, such as less than 2 mm, the welding is likely to be cracked.

#### Possible cause 2 : Thin welding thickness

- With decreasing the welding thickness, the degree of cracking risk increases as shown in the simulation
- The investigation using X-ray and cut samples revealed that the penetration depth is 1.5~2 mm, whereas the design value is 2.5~3 mm.
- We checked the height of excess metal of most of beam pipes with BPM blocks (1254 welding lines in total).

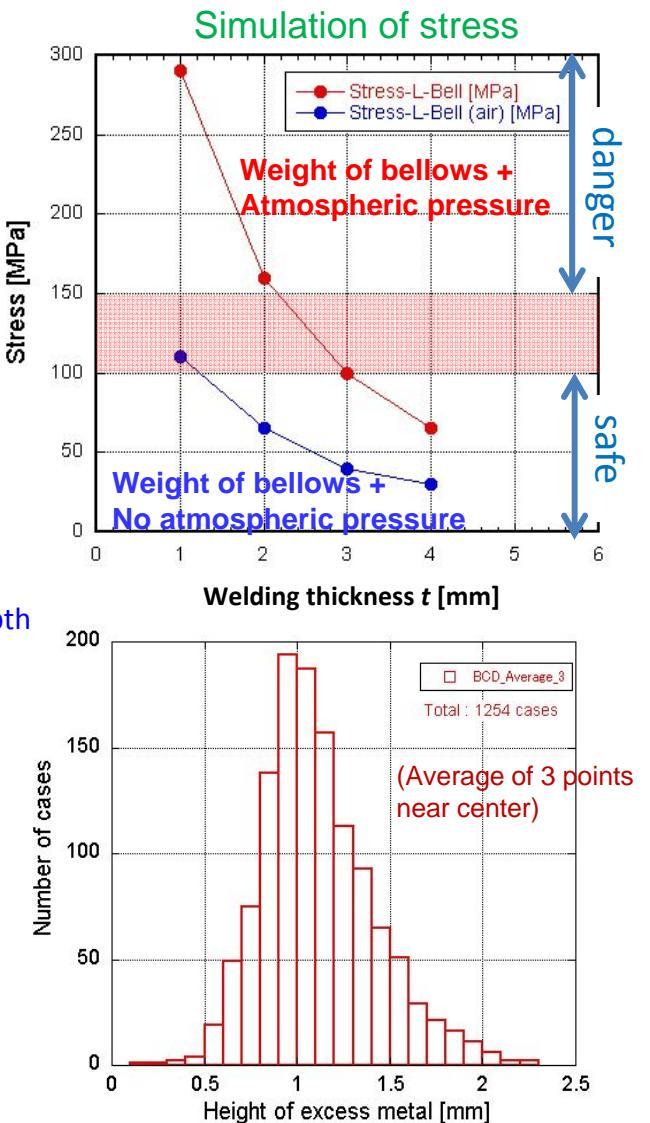
#### Measurement results:

- The height of excess metal are mostly in the range of 0.5~2 mm.
- If the height is less than 0.5 mm, the welding thickness can be less than 2mm.
- It should be safe to re-weld these beam pipes.

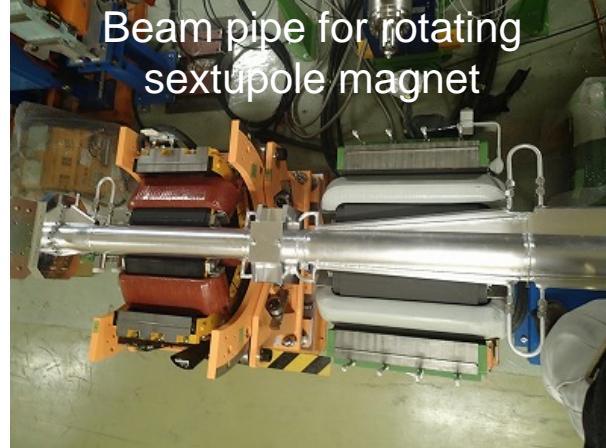
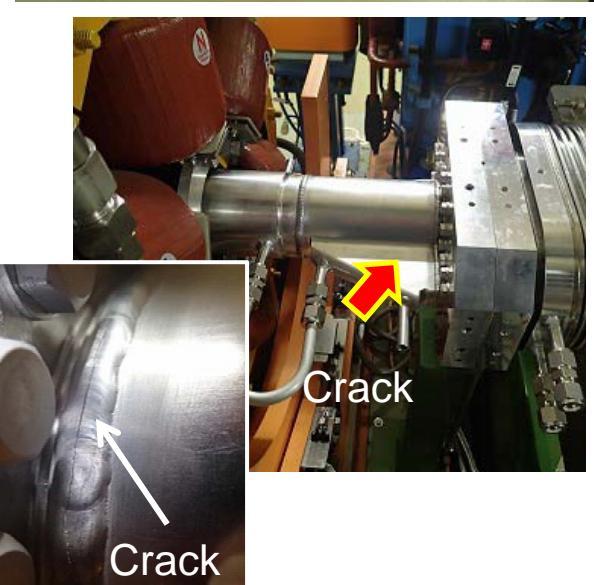
- Crack was found on the welding line of flange in the special beam pipes for the rotating sextupole magnet, with a taper section from antechamber to circular cross section. (2 beam pipes)
- No moment by the bellows. Not top or bottom. Not in the evacuation timing. (i.e., different case from Case-1)
- In 2013 the similar crack at the same positon (but different beam pipe) was found in Oho Lab. Some of them were re-welded. (But this trouble occurred.)
- There are 8 beam pipes with the same structure.
- Cause:
  - Unclear (wrong welding condition? Structural stress?)
- Cure:
  - Re-welding with other new flange.
  - We have to keep watching.

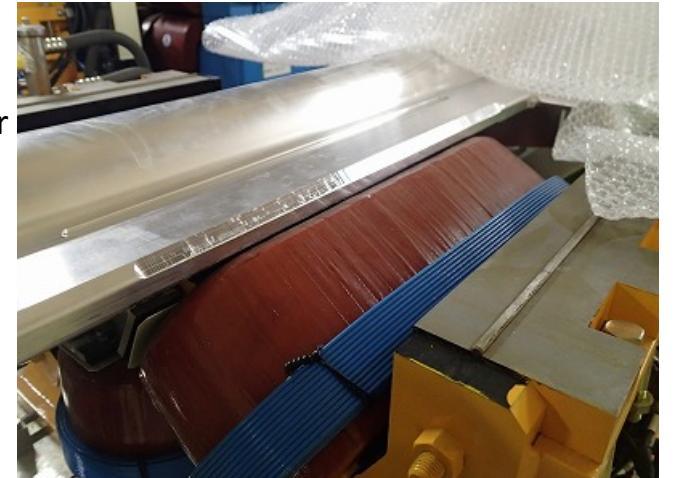
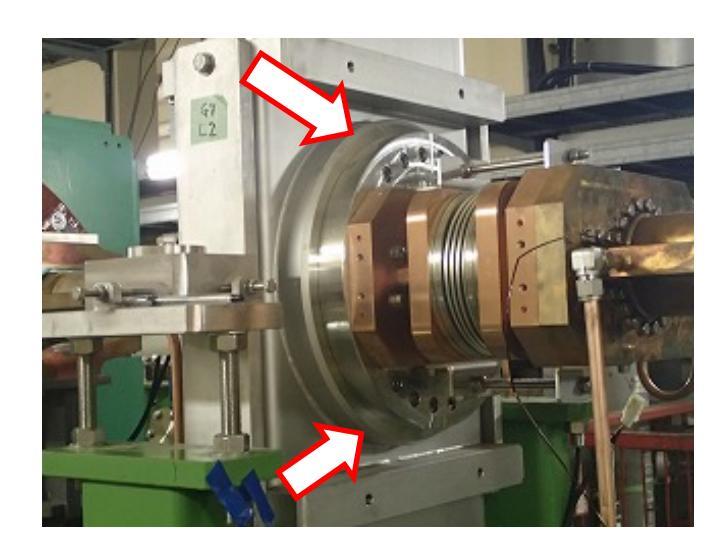
- Air leak at welding line of gate valve (2 gate valves)
  - Cause :chemical cleaning solvent was remained at the welding line during the assembling process.
  - Cure :Re-welding at the manufacturer Change of structure
- Air leak in bellows chamber (2 bellows chambers)
  - Cause : unclear. Bad HIP condition?
  - Cure : Replaced by a reserved one. Asking the investigation and re-manufacturing to the manufacture
- And so on.
