# Present status of the SuperKEKB Vacuum System

### Y. Suetsugu, KEK on behalf of KEKB Vacuum Group

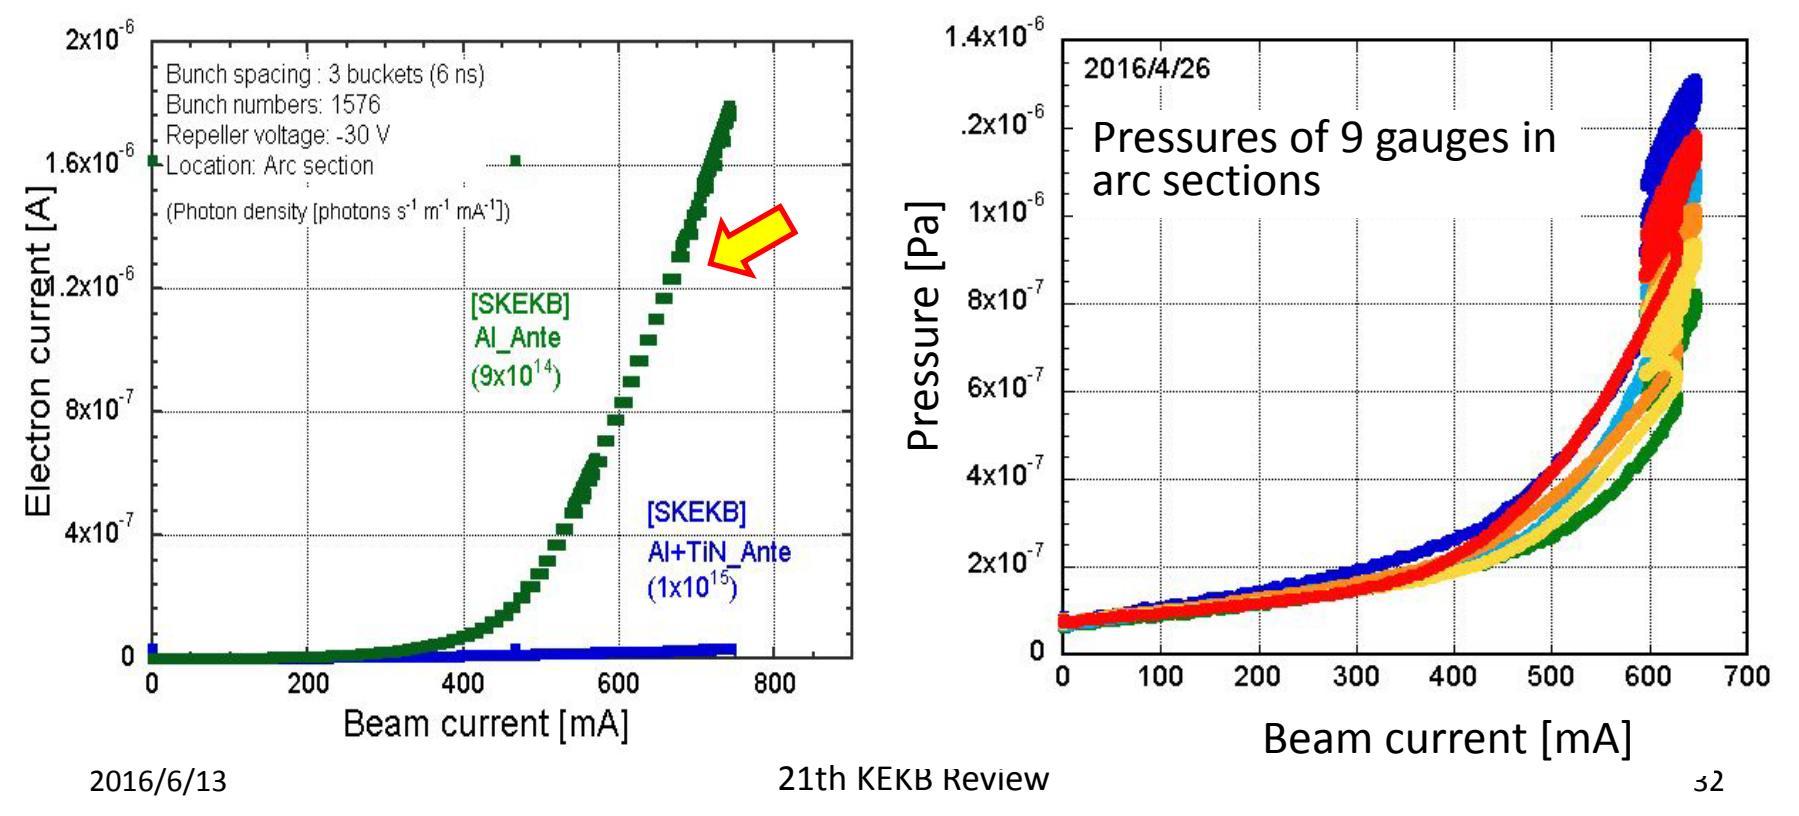
- Non-linear pressure rise against the beam current in LER -1
  - The pressures at whole LER ring showed a nonlinear behavior against the beam current over ~500 mA.
- The behavior is quite similar to that of electron currents measured at aluminum region without TiN coating.
  - Electron current in Al is much large that that in TiN, over 20 times!

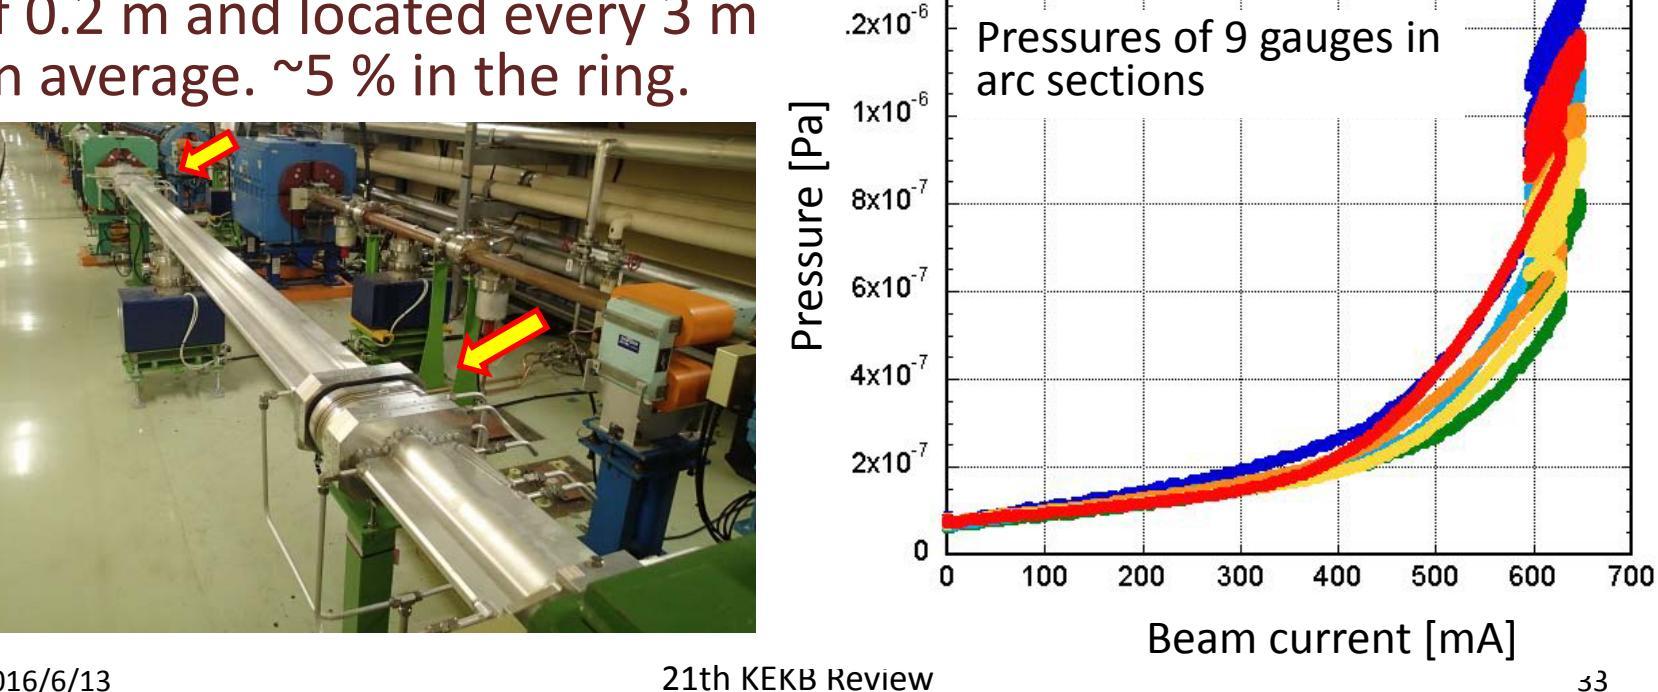
- Non-linear pressure rise against the beam current in LER 2
- The behavior is quite similar to that of electron currents measured at aluminum parts without TiN coating.
- Actually, we have aluminum bellows chambers without TiN coating along the ring. The bellows chamber has a length of 0.2 m and located every 3 m on average. ~5 % in the ring.

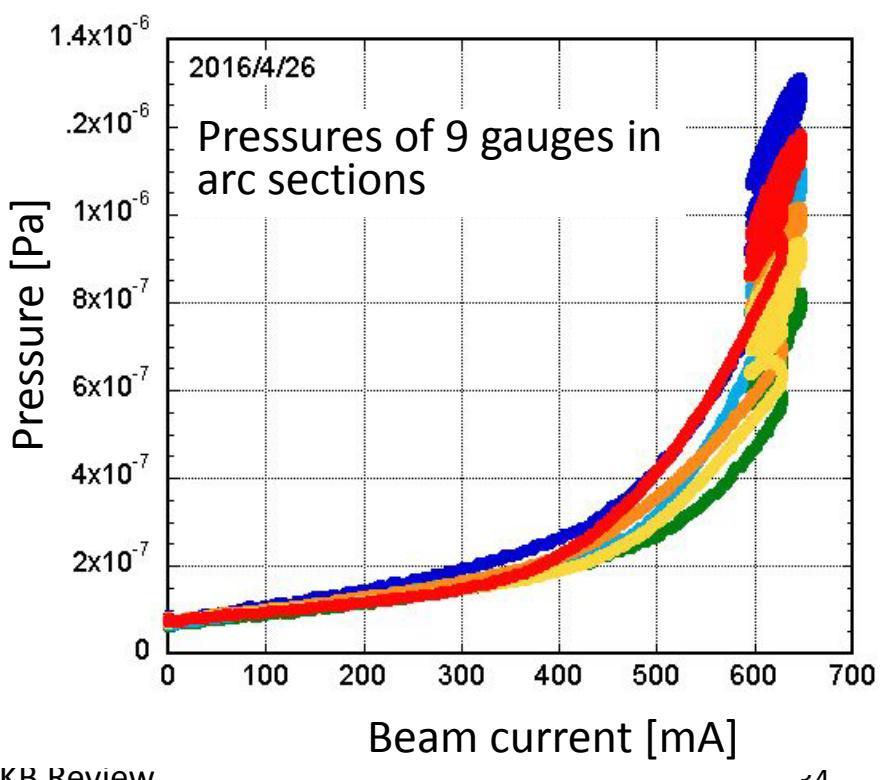
- Non-linear pressure rise against the beam current in LER 3
- The behavior is quite similar to that of electron currents measured at aluminum parts without TiN coating.
- Actually, we have aluminum bellows chambers without TiN coating along the ring. The bellows chamber has a length of 0.2 m and located every 3 m on average. ~5 % in the ring.

- Electron stimulated desorption (ESD) in the aluminum bellows chambers by electrons (electro cloud)?
- Actually, beam size blow up wa also observed at the same time

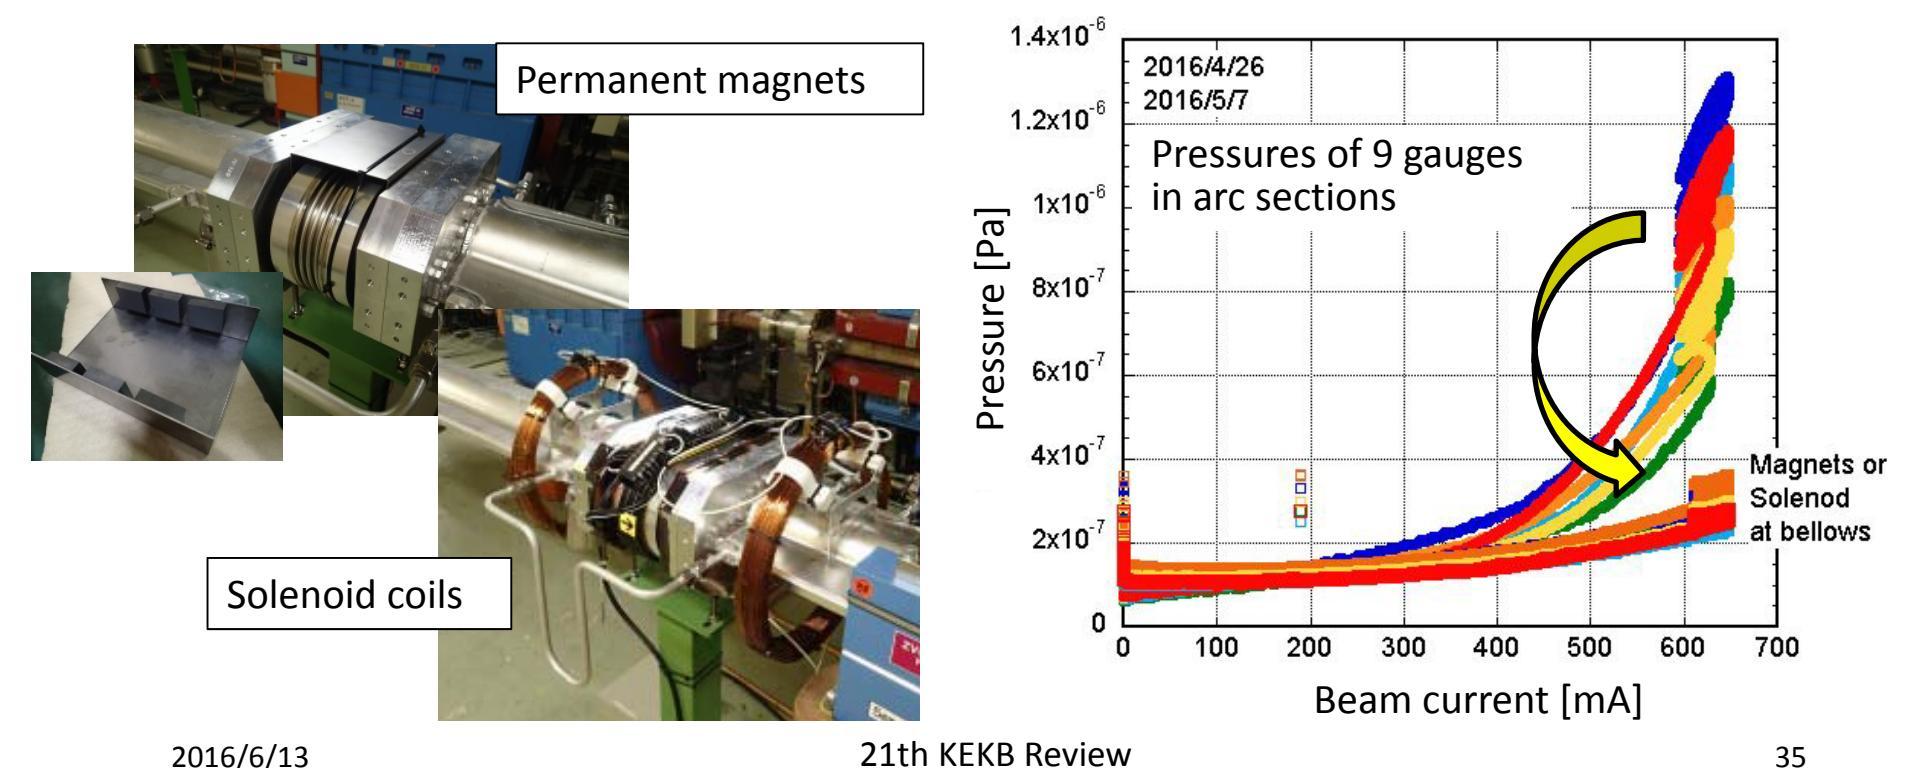
- Non-linear pressure rise against the beam current in LER 4
- As a test, we applied a magnetic field of axial direction by solenoids or permanent magnets at nine aluminum bellows chambers (~30 m section). The strength is 40 ~ 100 G near the inner wall at the center of bellows.
- As a result, the rate of pressure rise at this section relaxed!

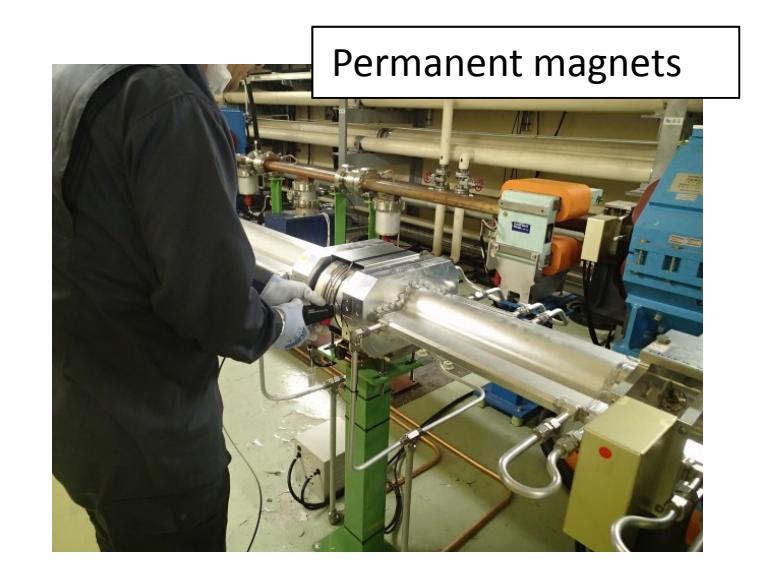
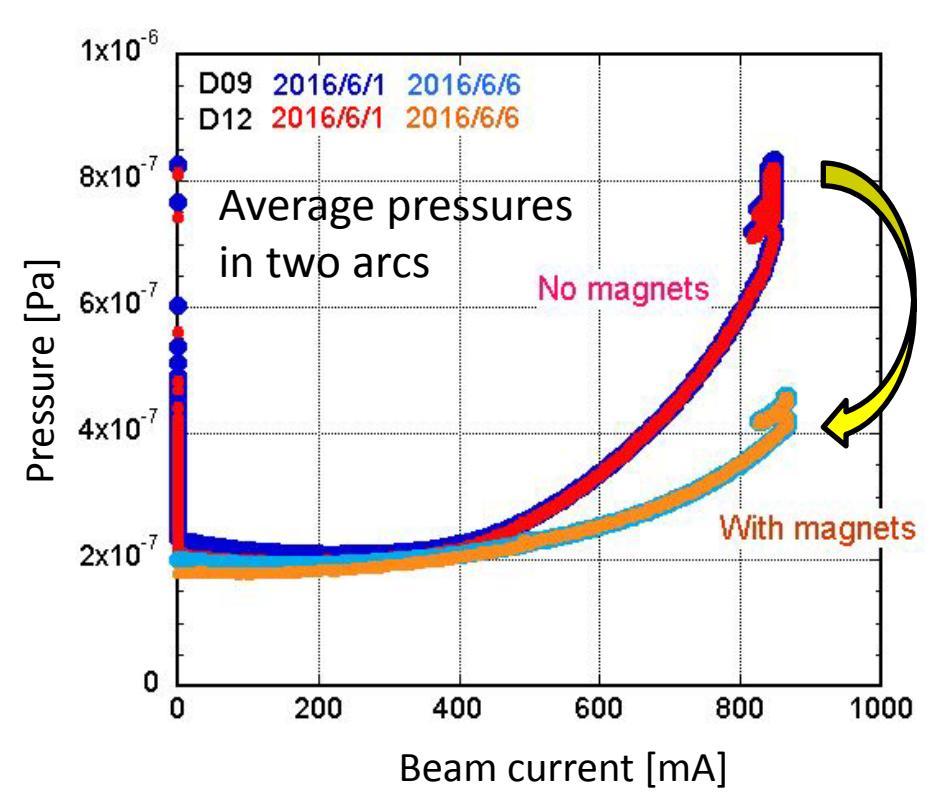
- Non-linear pressure rise against the beam current in LER 5
- We put permanent magnets on most of aluminum bellows chambers (~800) all around the ring (arcs) on 2 - 4, June.
- As a result, the rate of pressure rise relaxed in whole ring!

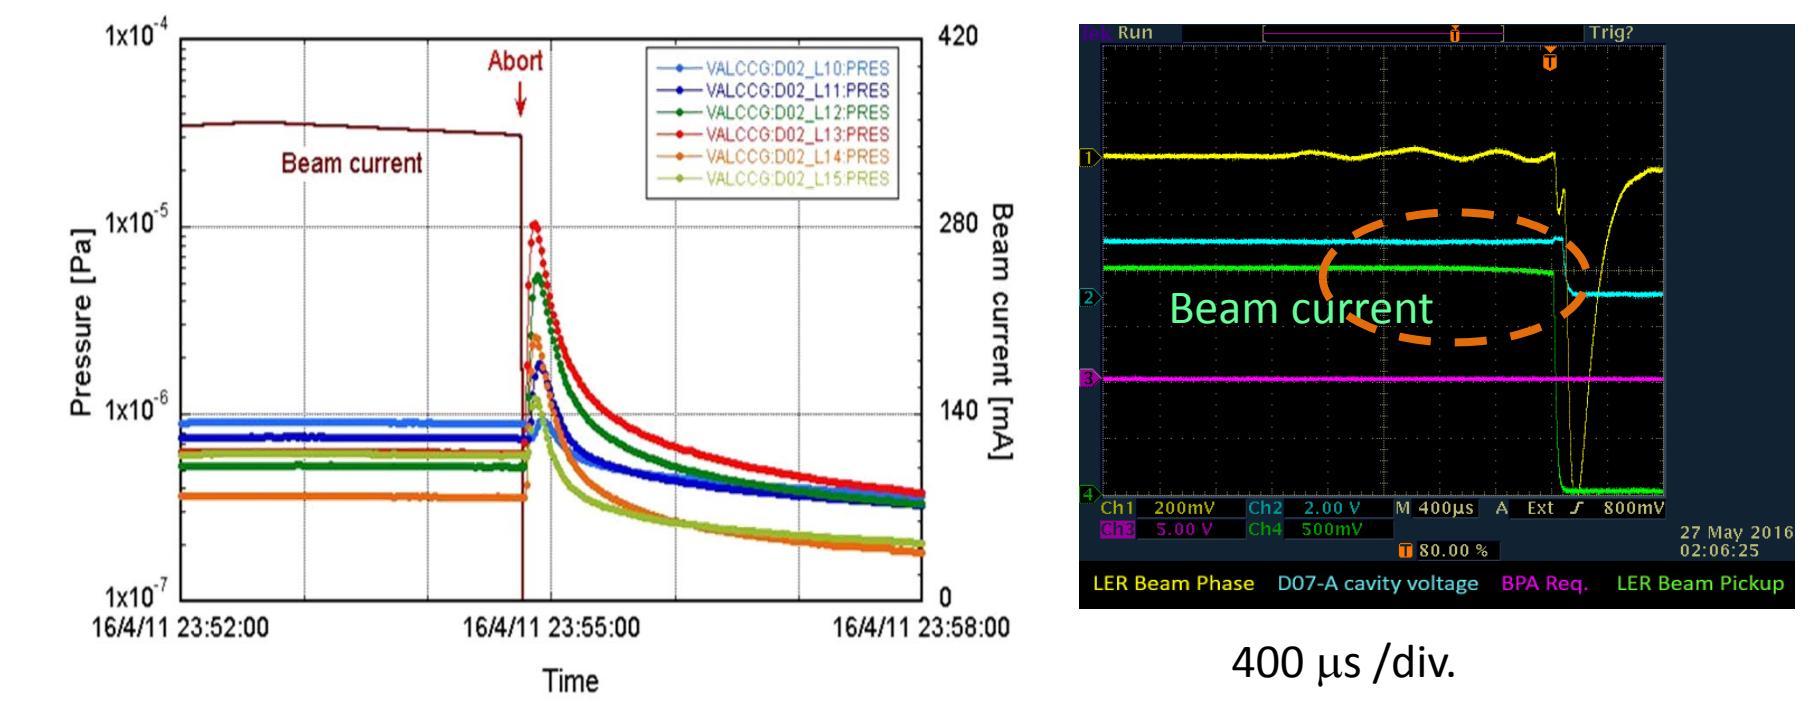
- Pressure bursts accompanying beam loss in LER -1
- Beam aborts accompanied by local pressure bursts have been frequently observed in the LER.
  - The beam loss monitors trigger the beam aborts
  - Beam loss started at several hundreds microseconds before the beam abort.

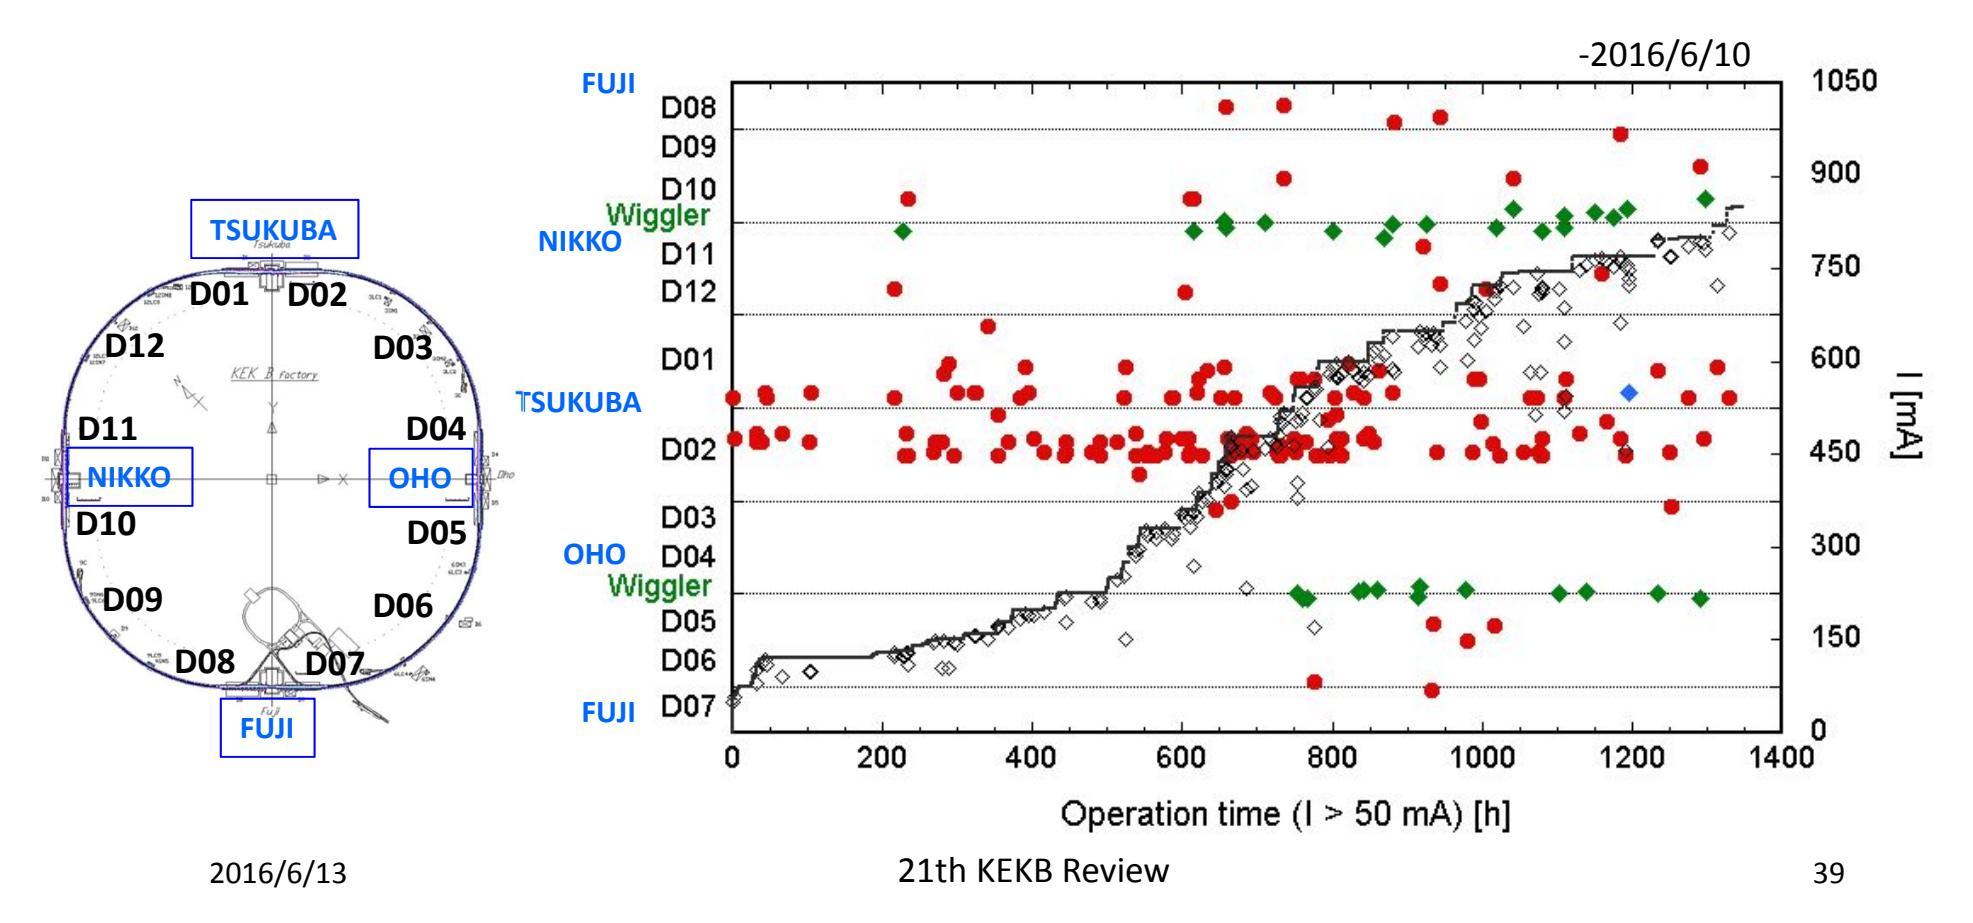
- Pressure bursts accompanying beam loss in LER 2
- Features
  - The locations of the pressure bursts have spread to more than 20 points along the ring.
  - More frequent in the Tsukuba straight section.

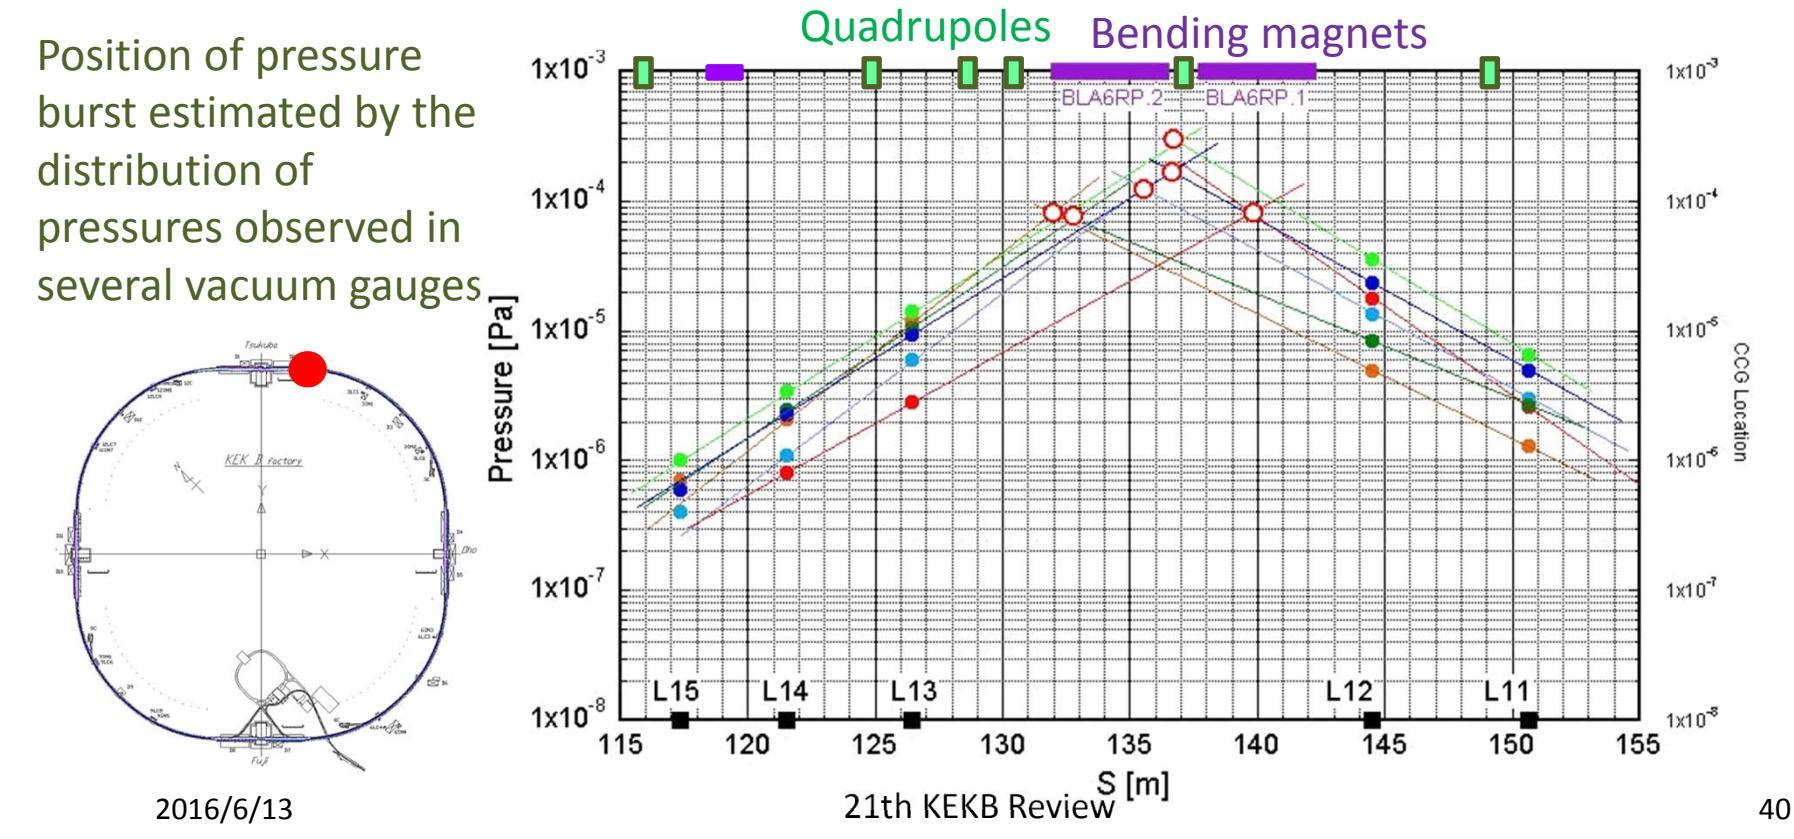
- Pressure bursts accompanying beam loss in LER 3
- Features
  - The locations of the pressure bursts have spread to more than 20 points along the ring. More frequent in the Tsukuba straight section.
  - In most cases, the bursts were observed near aluminum beam pipes in dipole magnets, with groove structure. (except for wiggler section)

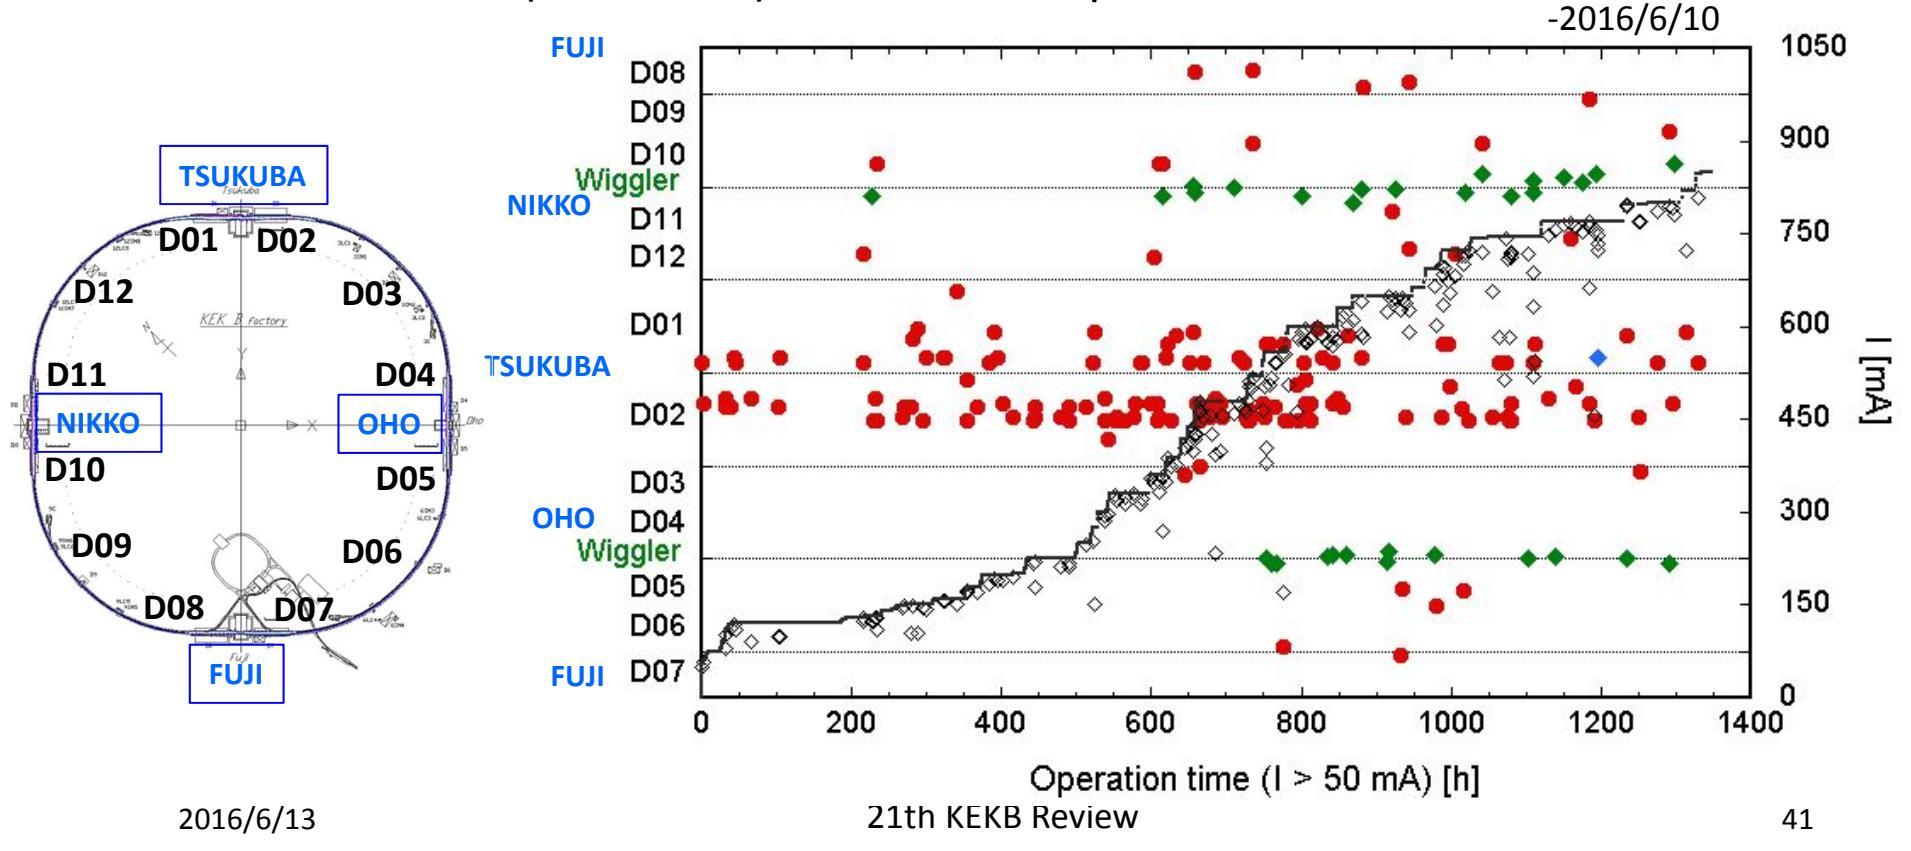
- Pressure bursts accompanying beam loss in LER 4
- Features
  - The bursts seems likely to occur when the maximum beam current is increased.
  - The locations spreads for high beam current, but still near bending magnets.
  - Beam orbits (horizontal) and bunch fill patters had no effect.

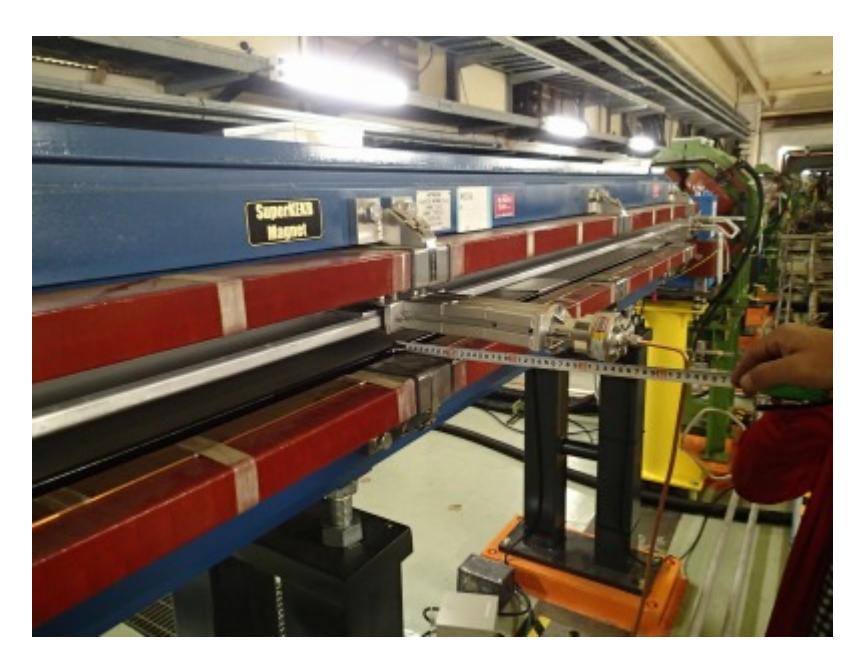
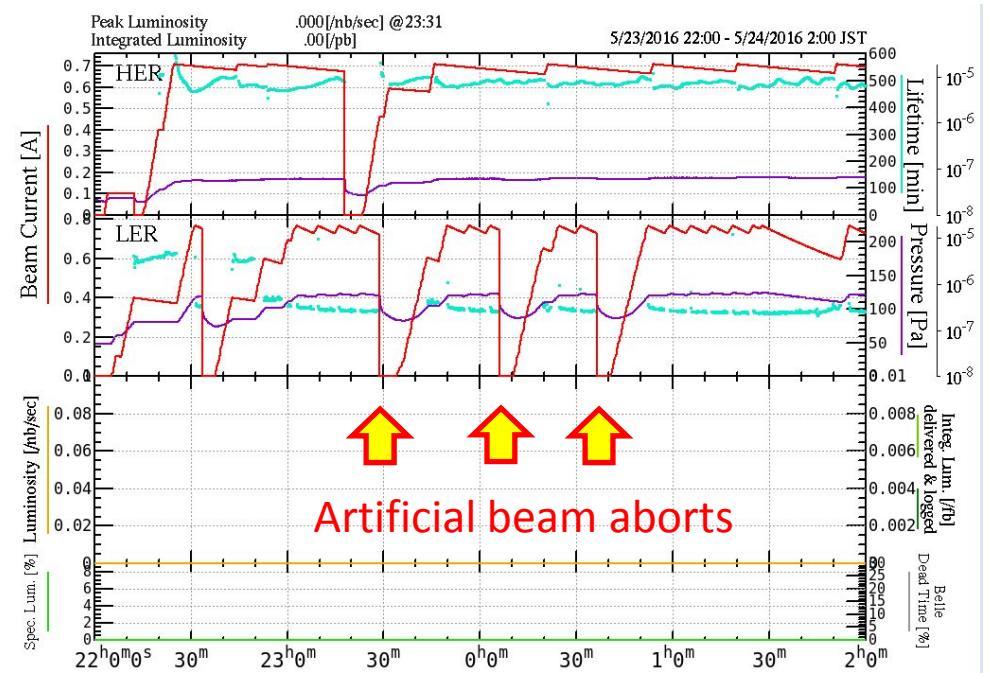
- Pressure bursts accompanying beam loss in LER 7
- Knocking test
  - A "knocker" was set at a beam pipe in a bending magnet, where the burst had been observed frequently.
  - We succeeded in reproducing the phenomena three times by knocking the beam pipe!

- Collision with dusts is the most possible cause of the pressure bursts, and then the beam aborts.
- However, It is not yet clear whether the dusts are falling or attracted by the positive beam.
- Countermeasure is now in consideration.
  - Wait? : Dusts should be limited. Fortunately, the frequency of bursts seems to gradually decrease.
  - Knocking all beam pipes during a long shut down.?

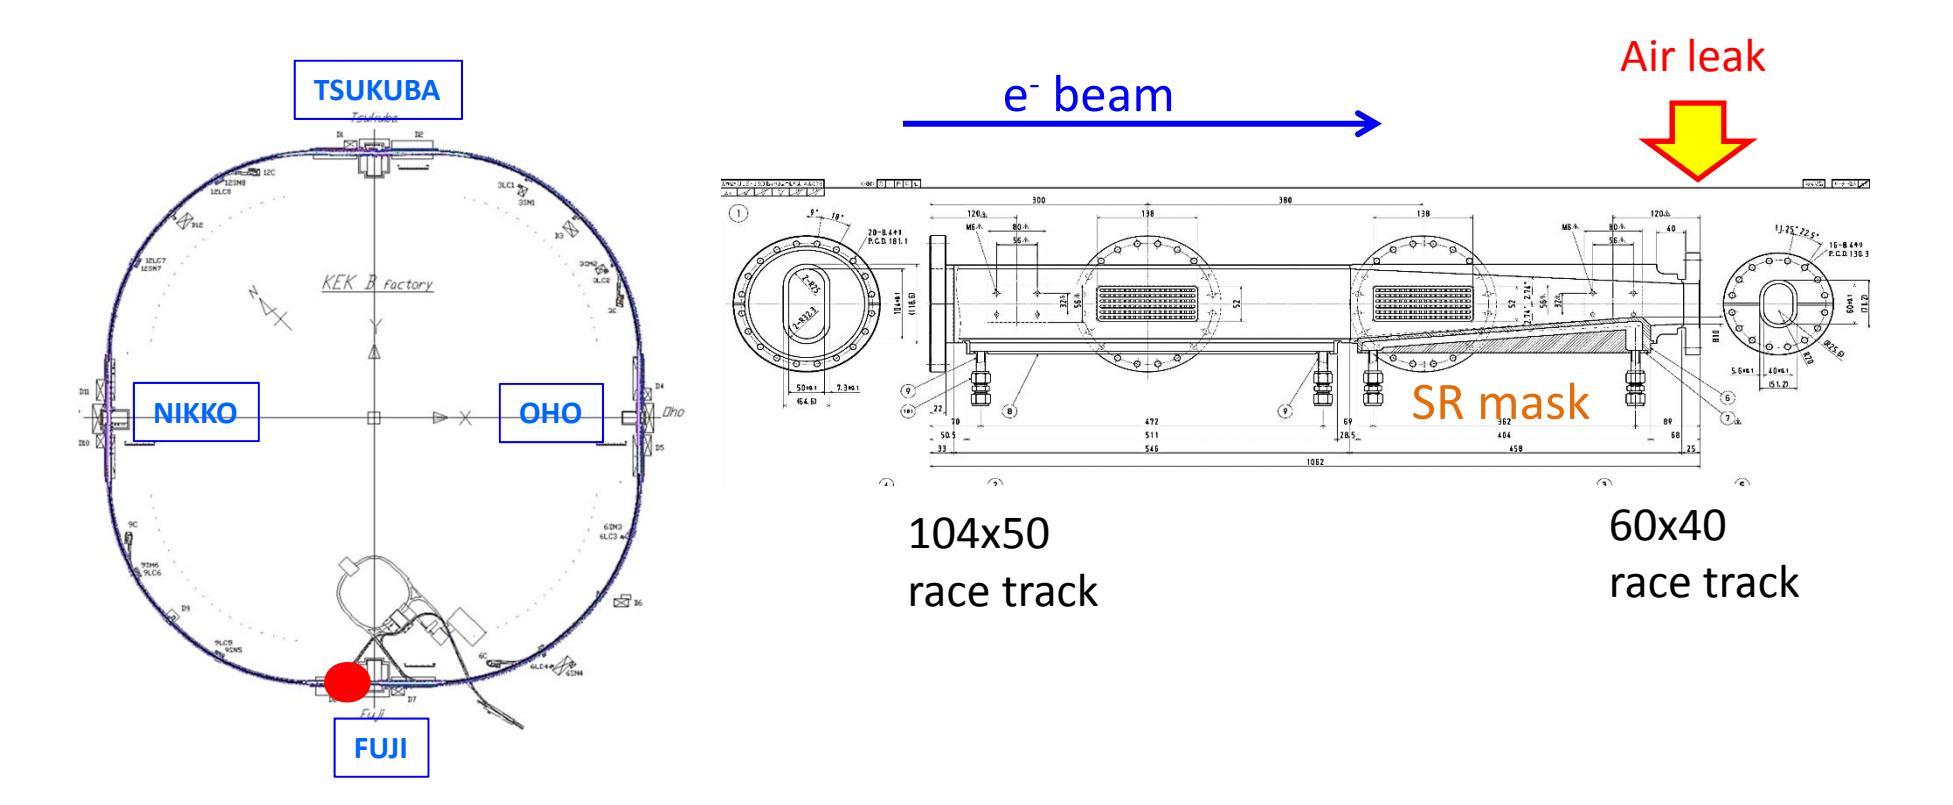
- Air leak at a flange of a tapered beam pipe -1
  - Occurred at a flange of a tapered beam pipe where the cross section of 104 mm x 50 mm reduces to 60 mm x 40 mm.

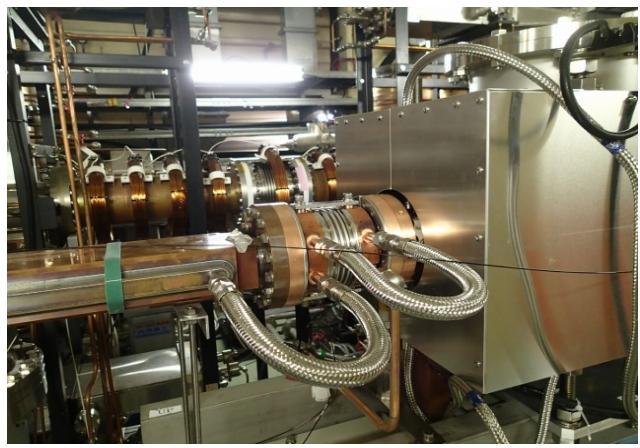
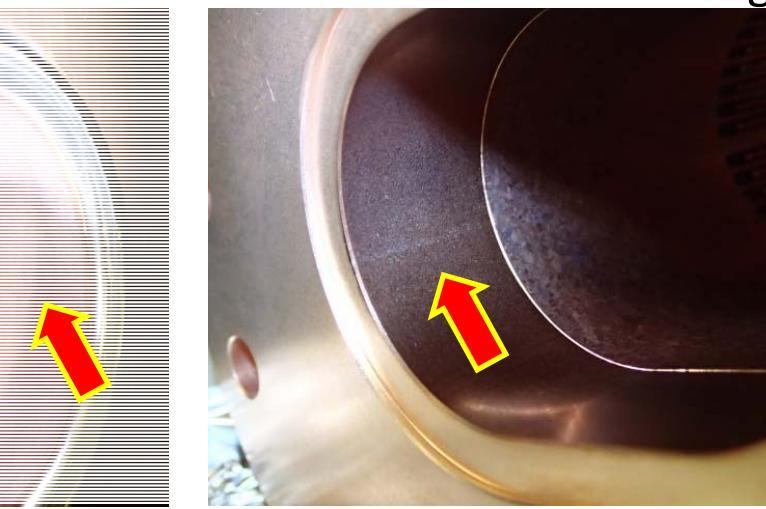
- Air leak at a flange of a tapered beam pipe -1
  - Occurred at a flange of a tapered beam pipe where the cross section 104 mm x 50 mm reduces to 60 mm x 40 mm.
- A trace of "beam" was found on the inner wall across the flange.
  - The SR from the bending magnet hit the opposite side.
  - High residual radioactivity had been reported.
  - Instantaneous temperature rise was observed at the flange at the timing of beam abort.
  - Loss monitor (PIN diode) signals were observed at this point.
  - Pressure bursts have been sometimes observed around here at the timing of beam aborts.

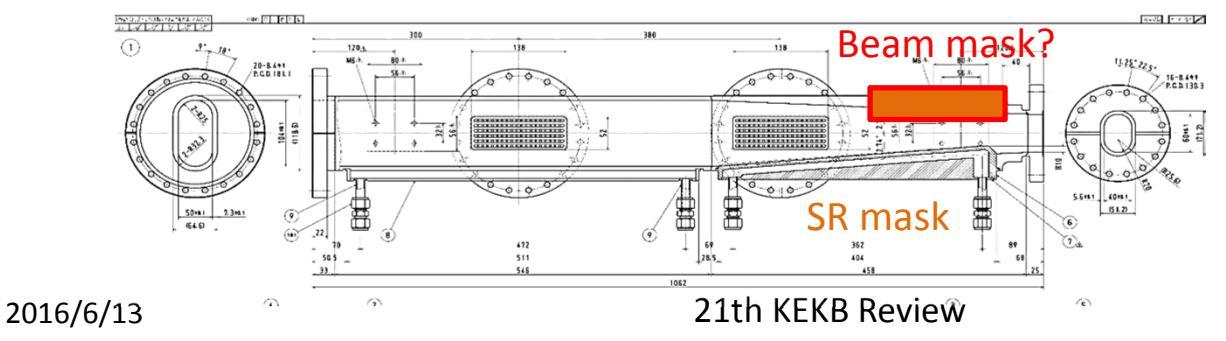
- Air leak at a flange of a tapered beam pipe-2
  - Occurred at a flange of a tapered beam pipe where the cross section 104 mm x 50 mm reduces to 60 mm x 40 mm.
- The cause is not completely understood yet.
- One possible process is
  - The beam loses the energy at other point -> veers from the normal orbit (oscillation?) -> hit the pipe wall.
- Countermeasure
  - Optimize the collimator positions.
    - We closed the horizontal and vertical beam collimators after the accident. The pressure bursts still remains, but the magnitude becomes small. -> seems working!
  - Add mask in the tapered beam pipe in the future.
