Status of High-power rf system for MR and DR

High-power RF-G Ken Watanabe (3rd division)

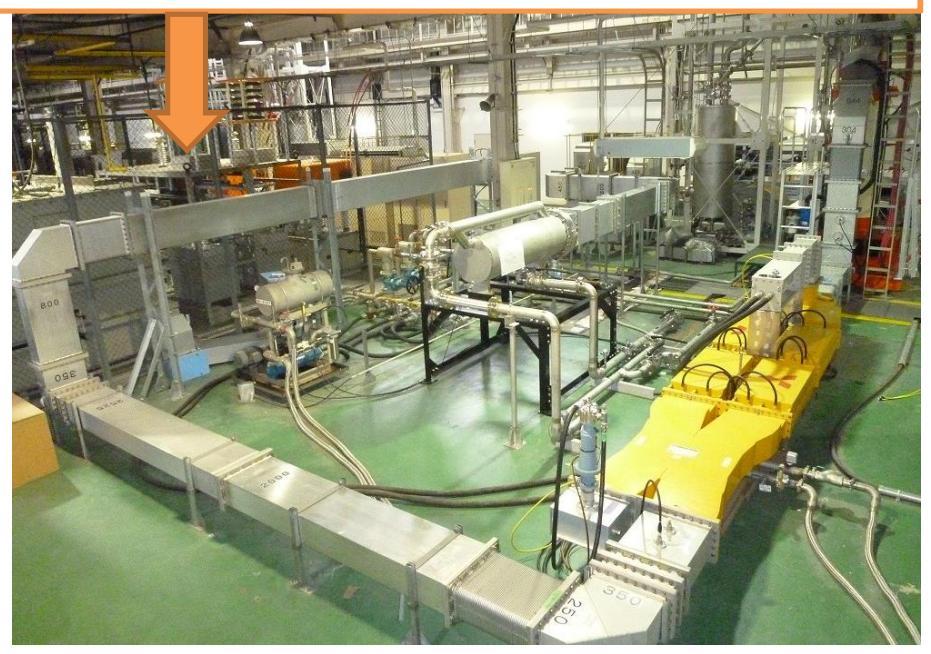
KPS: Crowbar work happened without notice for particular KPSs. D7-AB (4), D7-CD (4) and D5-FE(2) : <u>total 10 times (it happens on from KEKB)</u> It occurred between PM 19:00 to AM 9:00. It did not occurred during the day time. -> Why ?

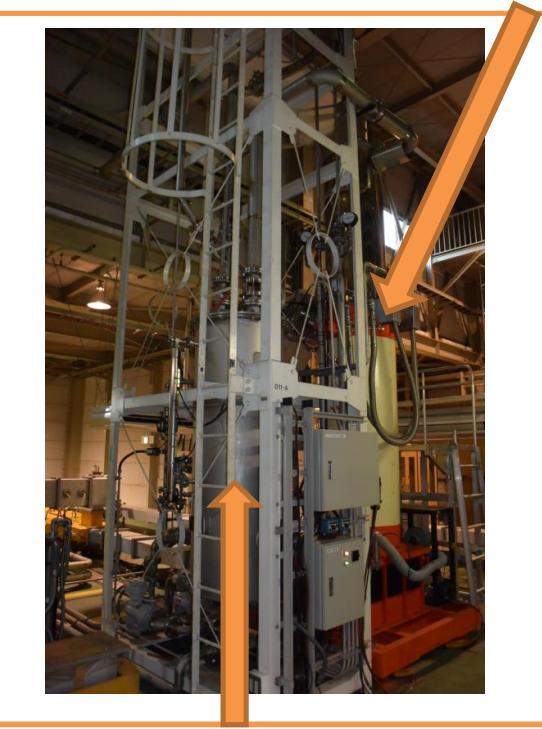
Thermo-sensor trouble in cooling channel of klystron (D11-A): <u>1</u>

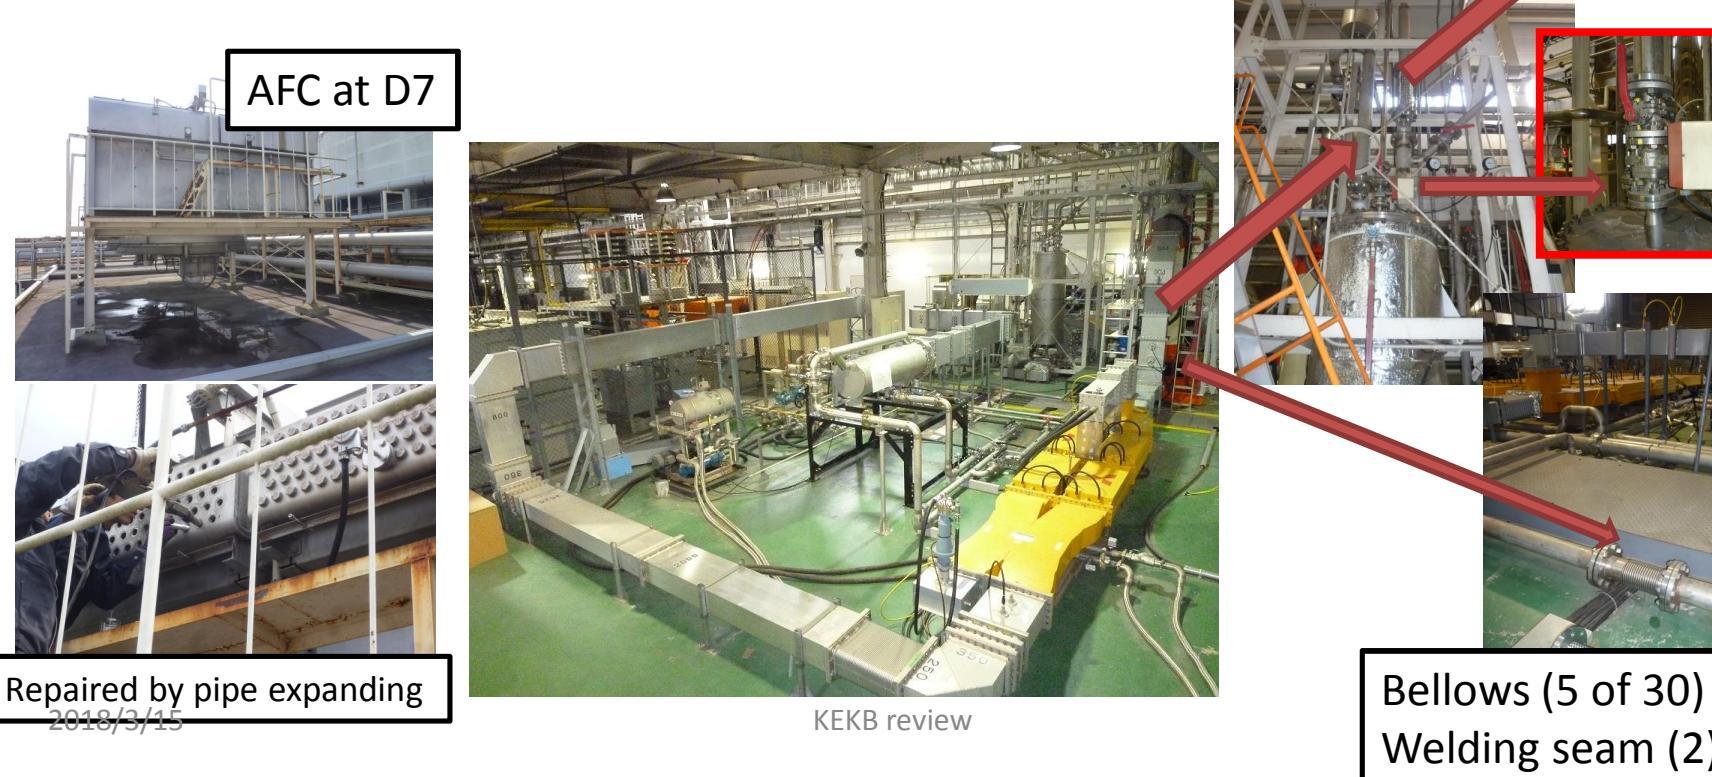
Sight glass (10 of 66)

Cooling system for klystron (Vapor cooling) * Water leaks were happened from cooling systems for the collector of klystron. The components were broken due to aging. * Connection point of fin-tube in AFC (Air fin cooler) was also happened water leak at D7 (1 of 6).

These water leaks were repaired on the maintenance day.

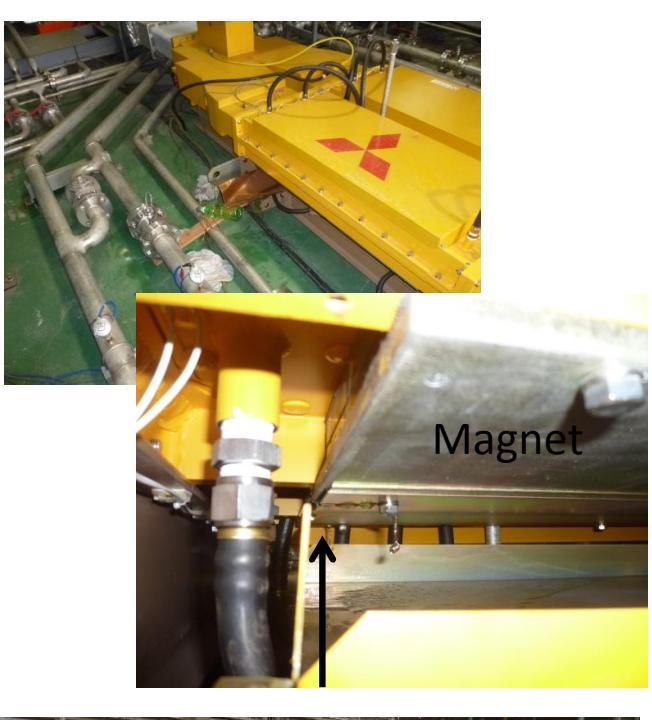
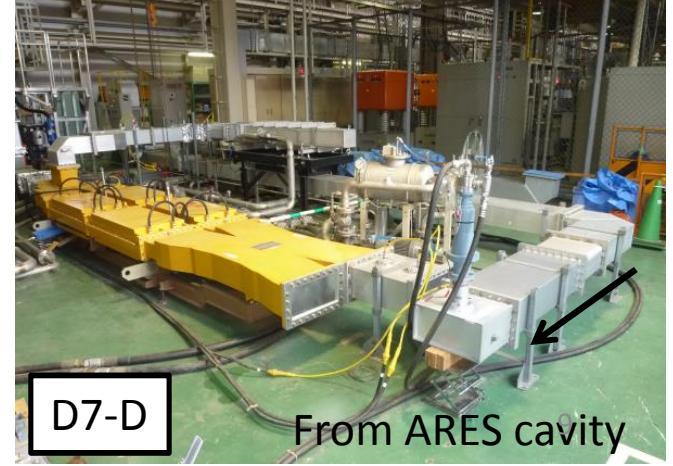
: Total 30 circulator were used for RF stations. 22 of 30 circulators, these are fabricated at 1984-1987. 11 of 22, these circulator were done the overhaul for repair the water leak from cooling channel.

: Small water leakage was detected from <u>five circulators</u> before starting operation. <- it can operates while supplying water to reserve tank of cooling system (1-4 weeks).

: <u>Two more water leak</u> were happened at D7-C (March 23, small) and D7-D (May 18, serious). <u>At D7-D, the water leak rate grew to inoperable</u> <u>amount in a few days. It was **disconnected** form <u>the operation (May 24).</u></u>

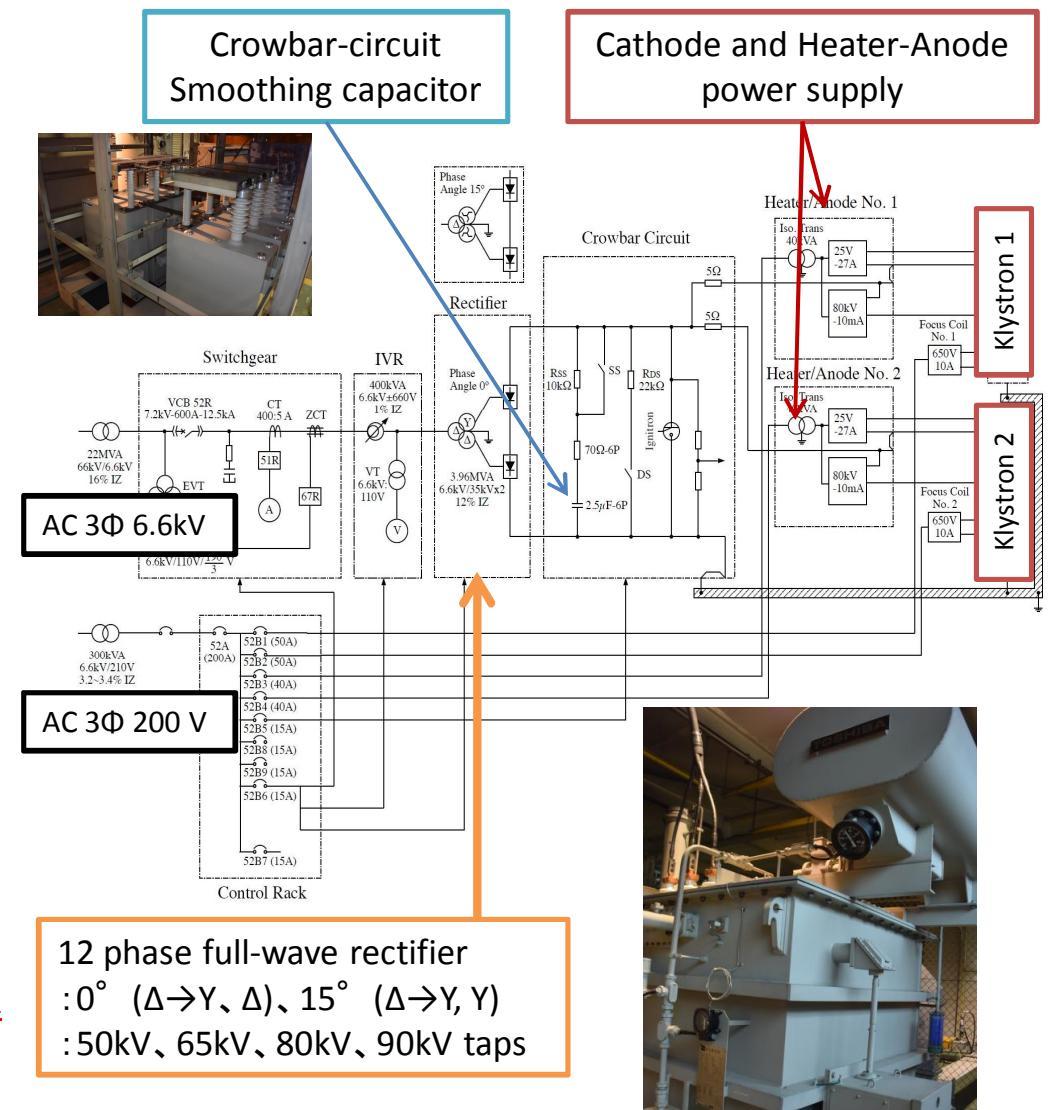
12 phase full-wave rectifier

The concern at this time is the failure of <u>the rectifier on high</u> <u>voltage section</u>. In the analysis of insulating oil in rectifier, no abnormality is found in electrical characteristics, but ethane, which is one of the items showing aged deterioration, is increasing.

<u>Frequent inspection for the high</u> <u>voltage section is necessary to check</u> <u>the inside rectifier.</u>

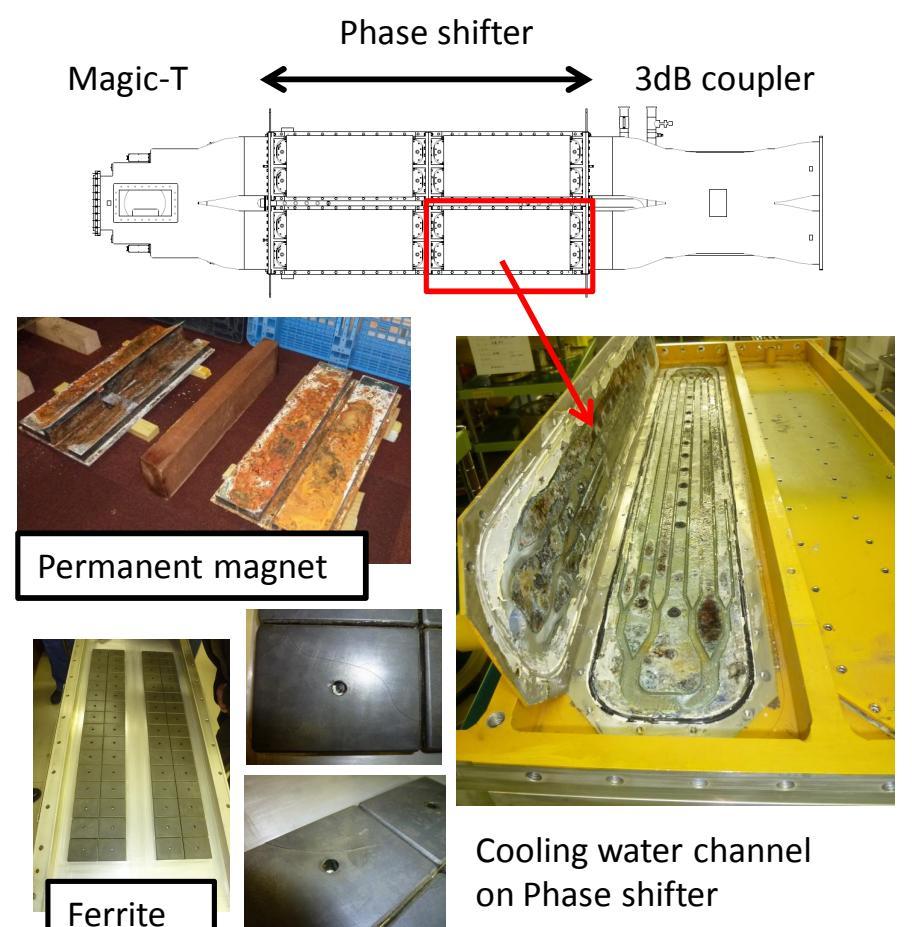
: As time goes on, the number of cooling water channel that cause leakage of circulator which have not overhauled is increasing due to corrosion by aging.

For repair, there is a limit on the cuttable range of cooling water channel. So, new production is desired.

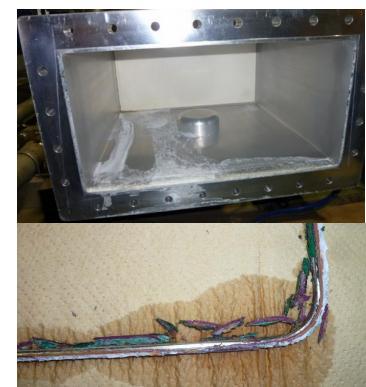
: The water leakage due to corrosion of seal material was detected for all Rectangular-type water loads after the end of KEKB. The cause of corrosion is that tap water (~ 360 μ S/cm) was used as a microwave absorber. For the long operation without corrosion, "Water quality changes to mixed water (~ 20 μ S/cm) and controls the conductivity in water. " Gold coated on the surface of metal seal for improving sealing performance and corrosion resistance.

Water leak due to corrosion of metal seal

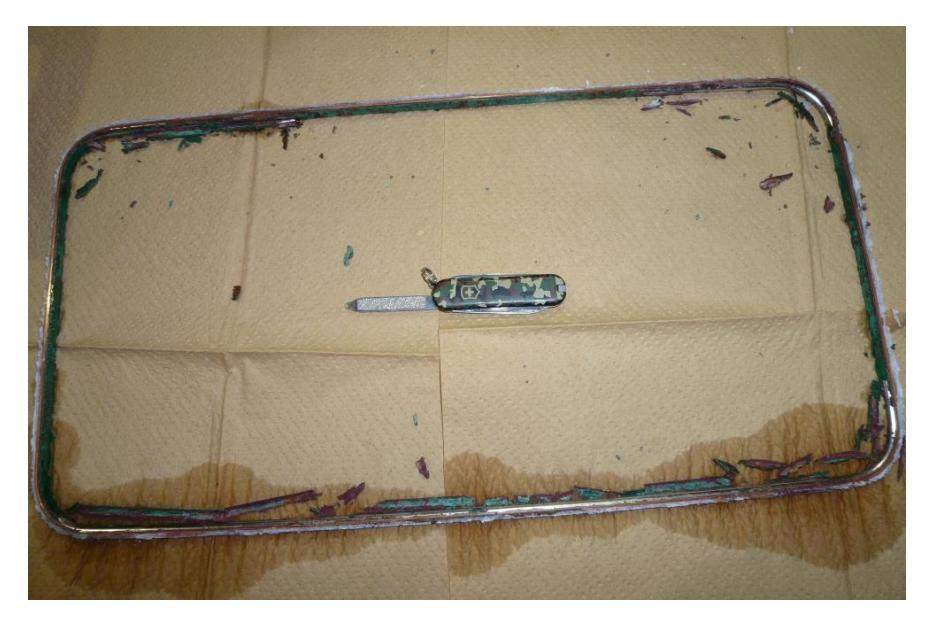
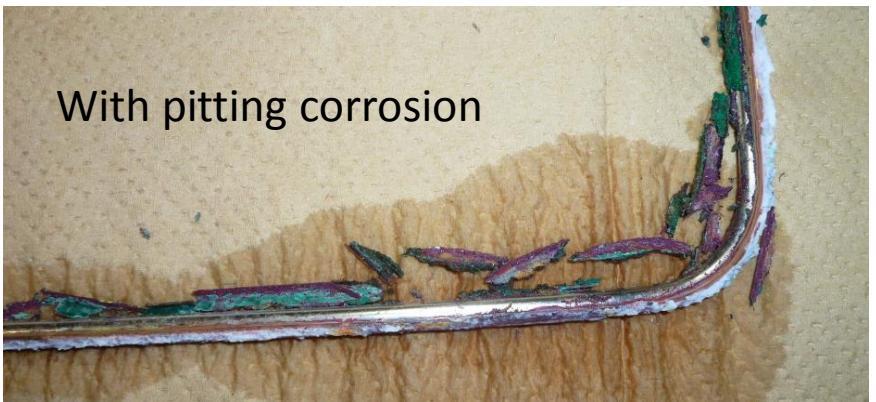
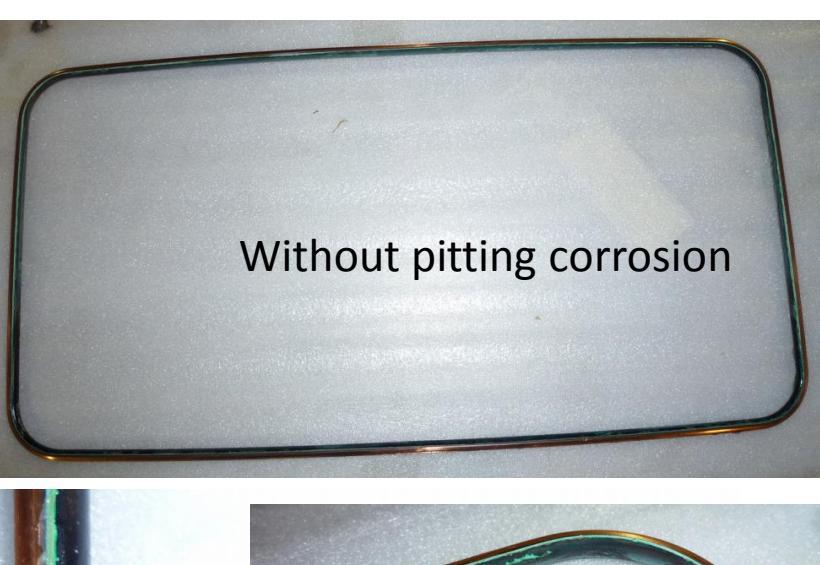
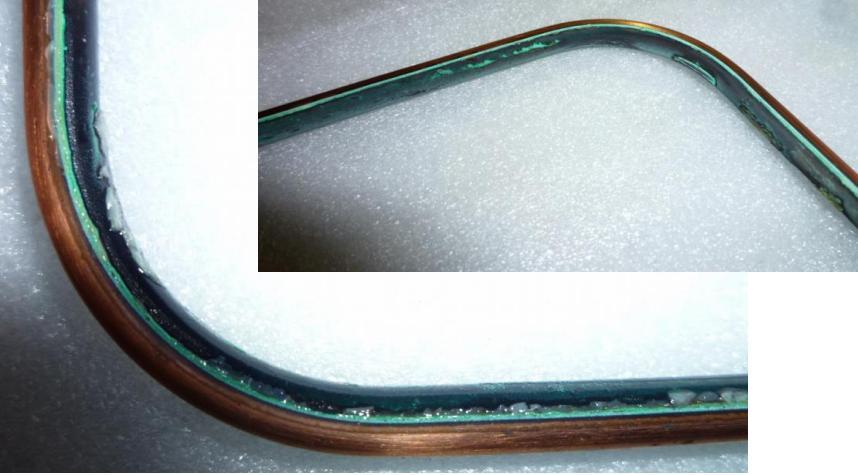
D10-A Operating time: 13 years (tap-water) D11-F Operating time: 7 years, pure-water

Corrosion of the metal seal compare with tap-water and pure-water

タール面まで浸食していた箇所があり、そこ 角とE面の外皮が剥がれた。H面は剥がれ から微量の水漏れあり。緑青のみ。孔食には る割含が少ない。緑青の他に孔食あり。 KEKB re 空っていない。 30
