Beam Instrumentations

Makoto Tobiyama

for SuperKEKB Beam Instrumentation Group

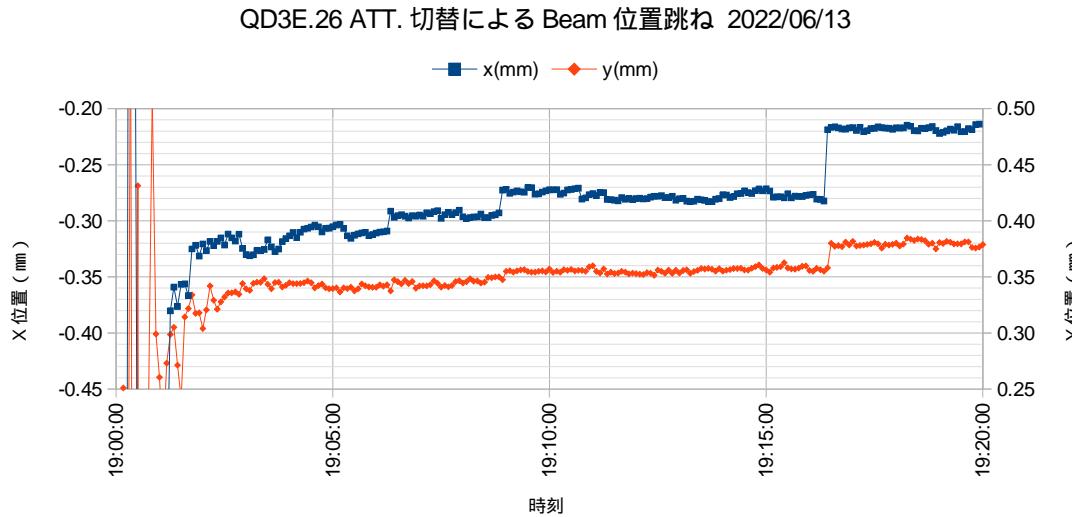
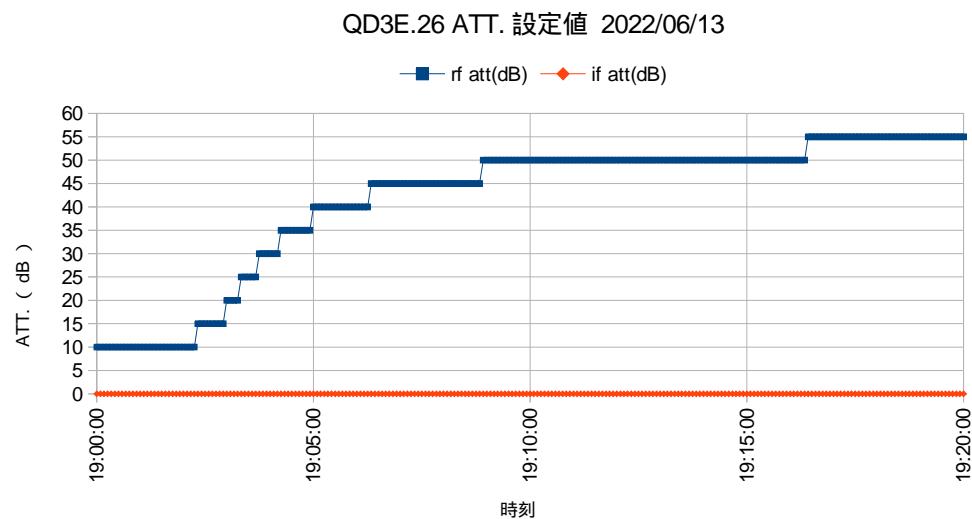
HER beam position change with beam current

Similar behavior of four BPMs in the same narrowband detector (D6 QF2E32 QD3E26 QF4E26 QD1E16) have been observed.

Suspected to be caused by the HP 1GHz narrowband detector's characteristics.

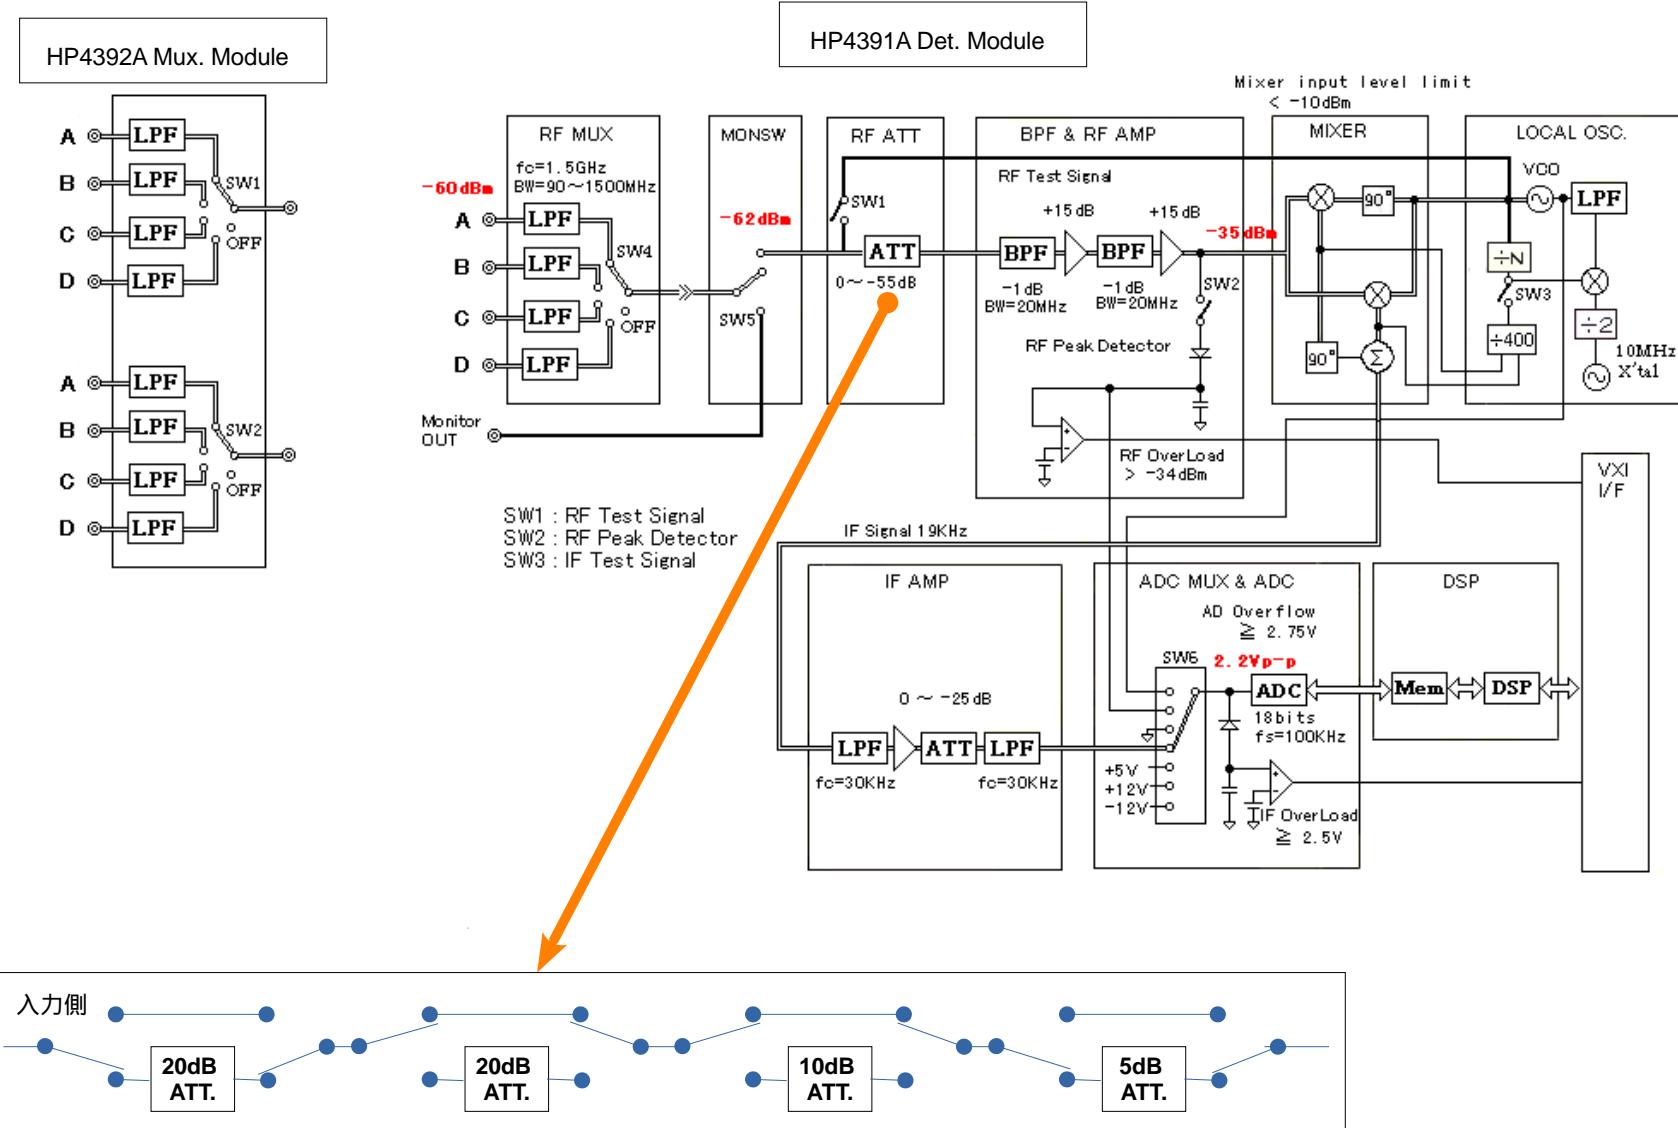
HER 1GHz BPM detector

Suspected source: Impedance mismatch

- We will try to insert 1GHz isolators between the MUXs and the detectors at the “important” BPMs.
30 isolators have been ordered. Waiting for delivery.
- Another way might be to use 500MHz detectors (newly developed for SuperKEKB) used for LER BPMs.
6 spares are available now.

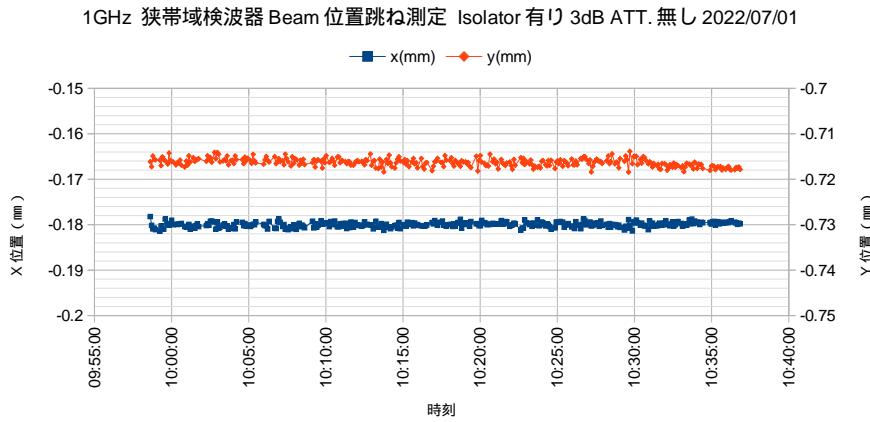
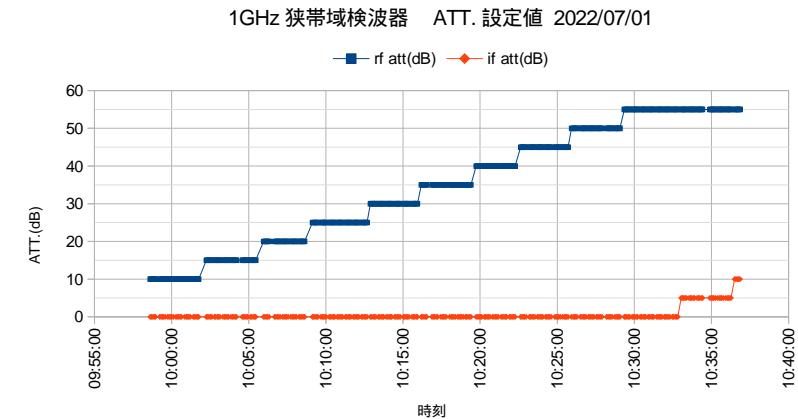
with isolator

CW measurement at the bench did not show large position jump

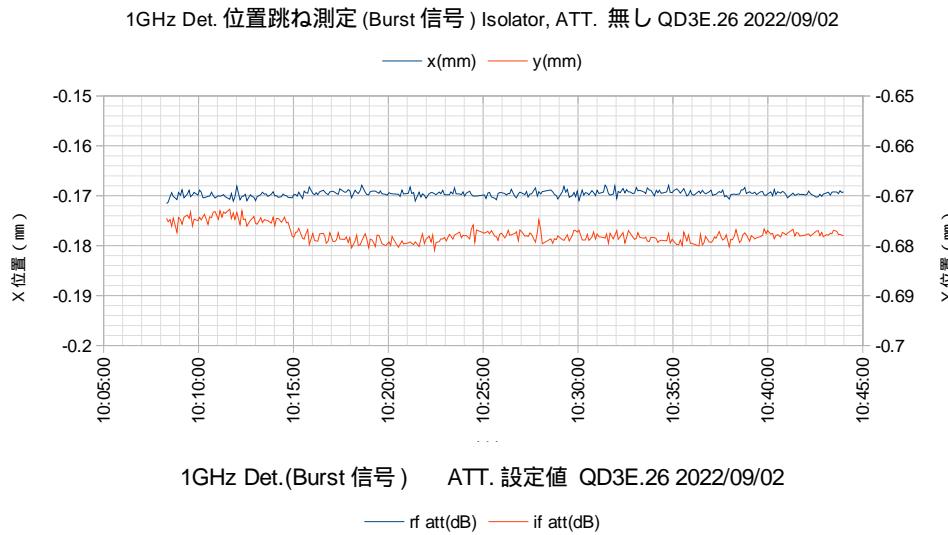
Original detector

Burst signal response

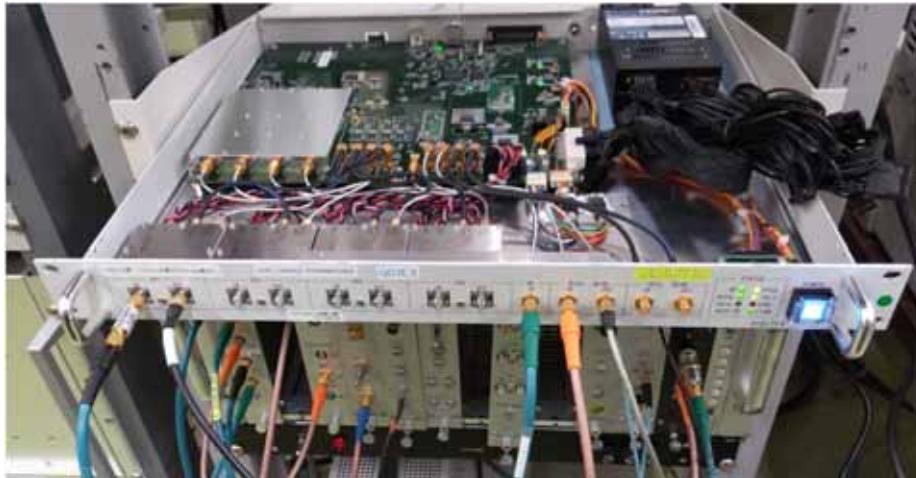
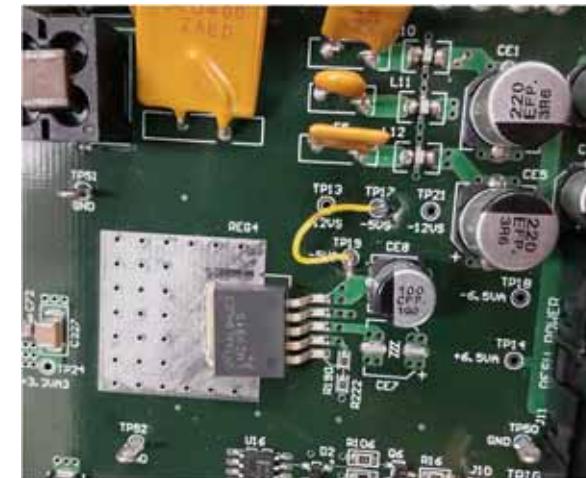
Turn-by-Turn BPMs

Building	BPM	Date	Broken	Repaired date	Repaired parts
LC5	QD3E18	2022/1/4	PS	2022/1/4	PS replacement
D07	QEAP25	2022/3/23	PS	2022/3/23	PS replacement
LC4	QD3E23	2022/3/23	LAN	2022/3/23	Power on/off & IOC reboot
D7	QM2E	2022/5/3	Gated sw.	2022/5/11	Under investigation

- The power supplies have been malfunctioning for the recent two years; 3 BPMs in 2021abc and 2 BPMs in 2022ab. Broken PSs were replaced every time by us (not in a beautiful way).
- PSs of 55 BPMs in total (1/3 of all turn-by-turn BPMs) were replaced by a circuit maker.
The rest of the replacements are planned for the next FY.

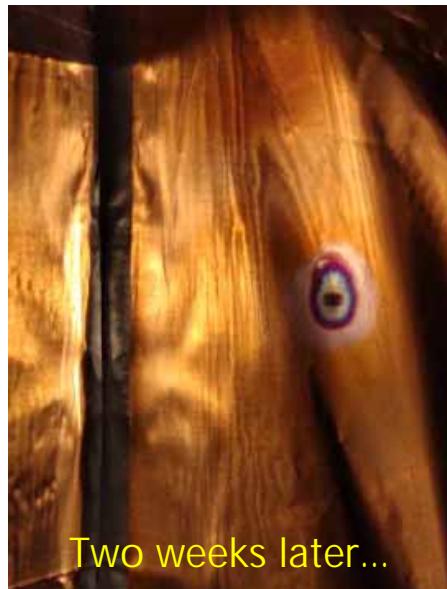
X-ray irradiation inside the detector box was so severe at ~ 1 Å.

- Malfunctioning of the CMOS cameras became frequent, and we replaced the cameras two times in HER and once in LER in 2022ab.
 - The new “big” detector box makes enough room for the Pb shielding.
- Scintillation efficiency of the YAG:Ce scintillator in HER decreased above 0.9 Å. A visible check on maintenance day found no significant damage on the scintillator and the CMOS camera.
 - Quick solution: we added the Cu filter upstream from the scintillator, and it looked OK.
 - A diamond scintillator would be a good alternative.

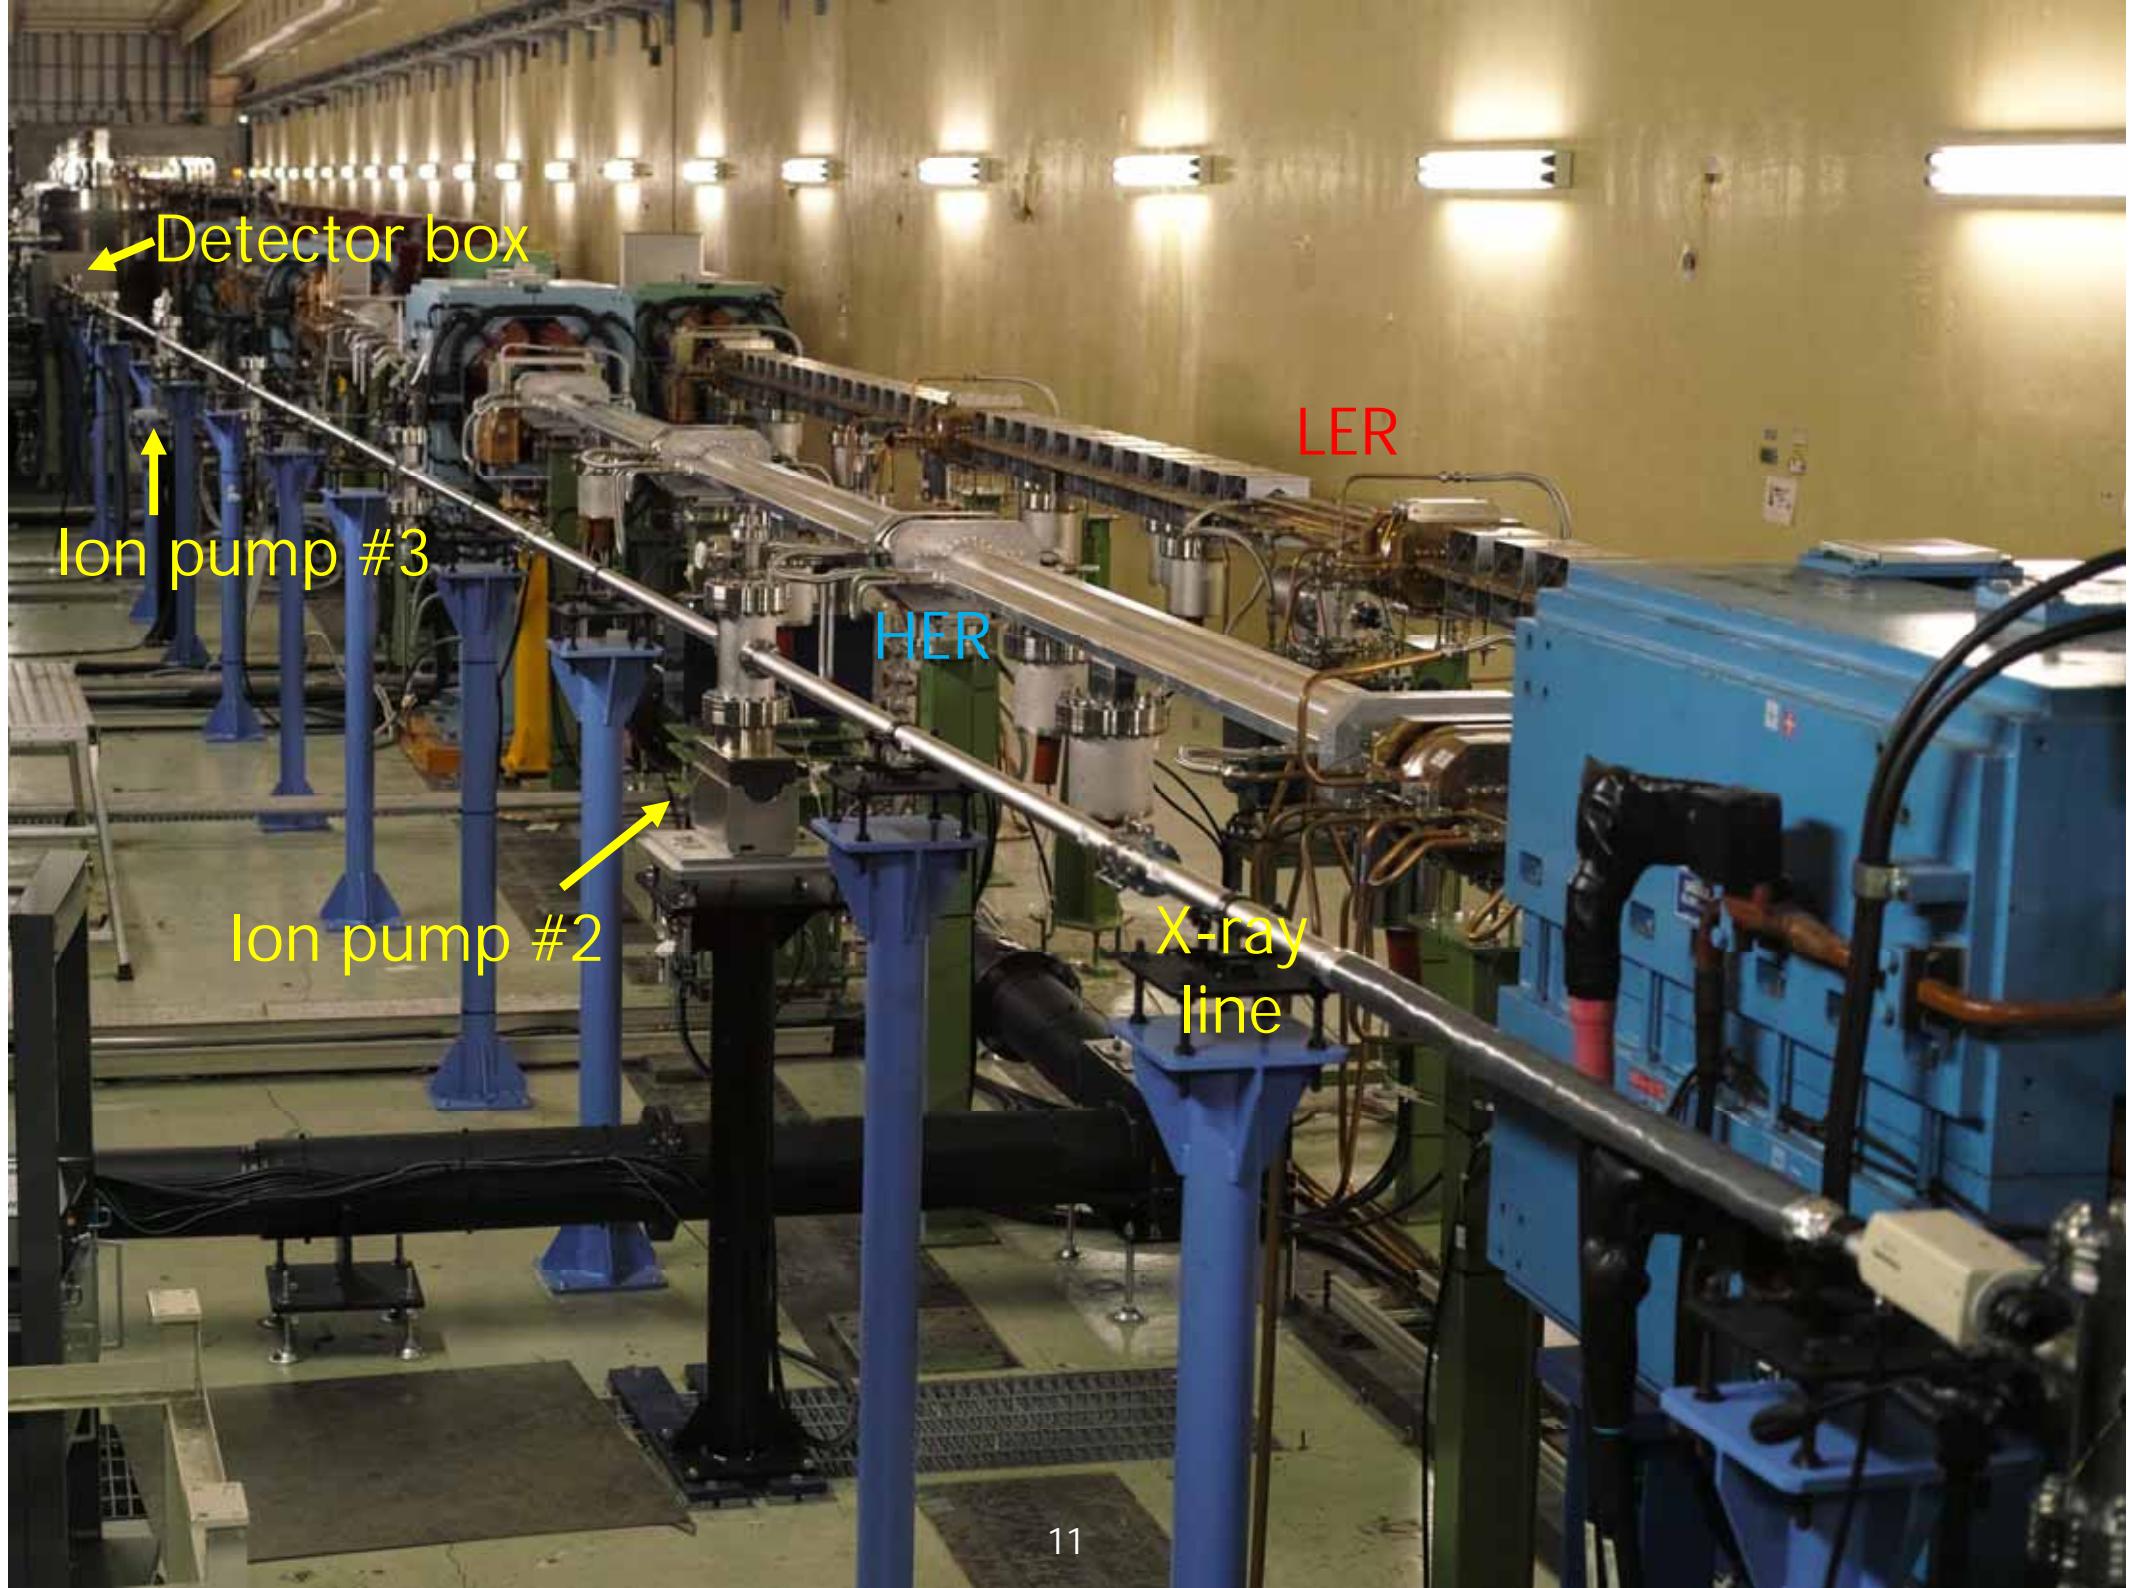
A large leak in the HER X-ray line

1. Two (middle #2 and downstream #3) out of the three ion pumps didn't turn on at the beginning of August after the power maintenance.
→ Though the pressure was good, there should have been a small leak in 2020b.

2. We suspected the humid atmosphere in the OHO straight section, where ceiling repair work has been ongoing, caused an electrical leakage around the HV connector.

3. We tried to turn on the ion pump #2 and #3 several times, and finally, the ion pump #2 started though the ion pump #3 still stopped.
→ This trial was a problematic action to make the ion pump #2 and #3 broken.

4. Shortly later, we replaced the detector box as scheduled and found a significant leak in the downstream Be window.
→ Did something make a big hole, or did a small hole widens gradually?

5. Once we stopped all the ion pumps and replaced the leaked downstream Be window with a new one. At the same time, we replaced the upstream Be window (confirmed to be healthy) for sure. In this work, we found that the ion pumps #2 and #3 were failing.

6. After replacing the ion pump #2 and #3, we believed everything was OK and tried to turn on all the pumps. But the upstream ion pump #1 didn't wake up and turned out to be broken.
→ It seems natural to think the pressure inside the X-ray line has been at the atmospheric level since 3.

7. Consequently, we replaced two Be windows and three ion pumps #1-#3.

- We don't yet clearly understand when and why a large leak occurred.
- We got where the leak occurred on the Be window: brazing between the Cu holder and the Be window.
 - Did severe copper oxide make the Be window peel off?
 - A Be-window maker investigates a reason for leakage in detail.
- What we must do in LS1:
 - Production of spare Be windows
 - CCG-based interlock systems to protect the ion pumps

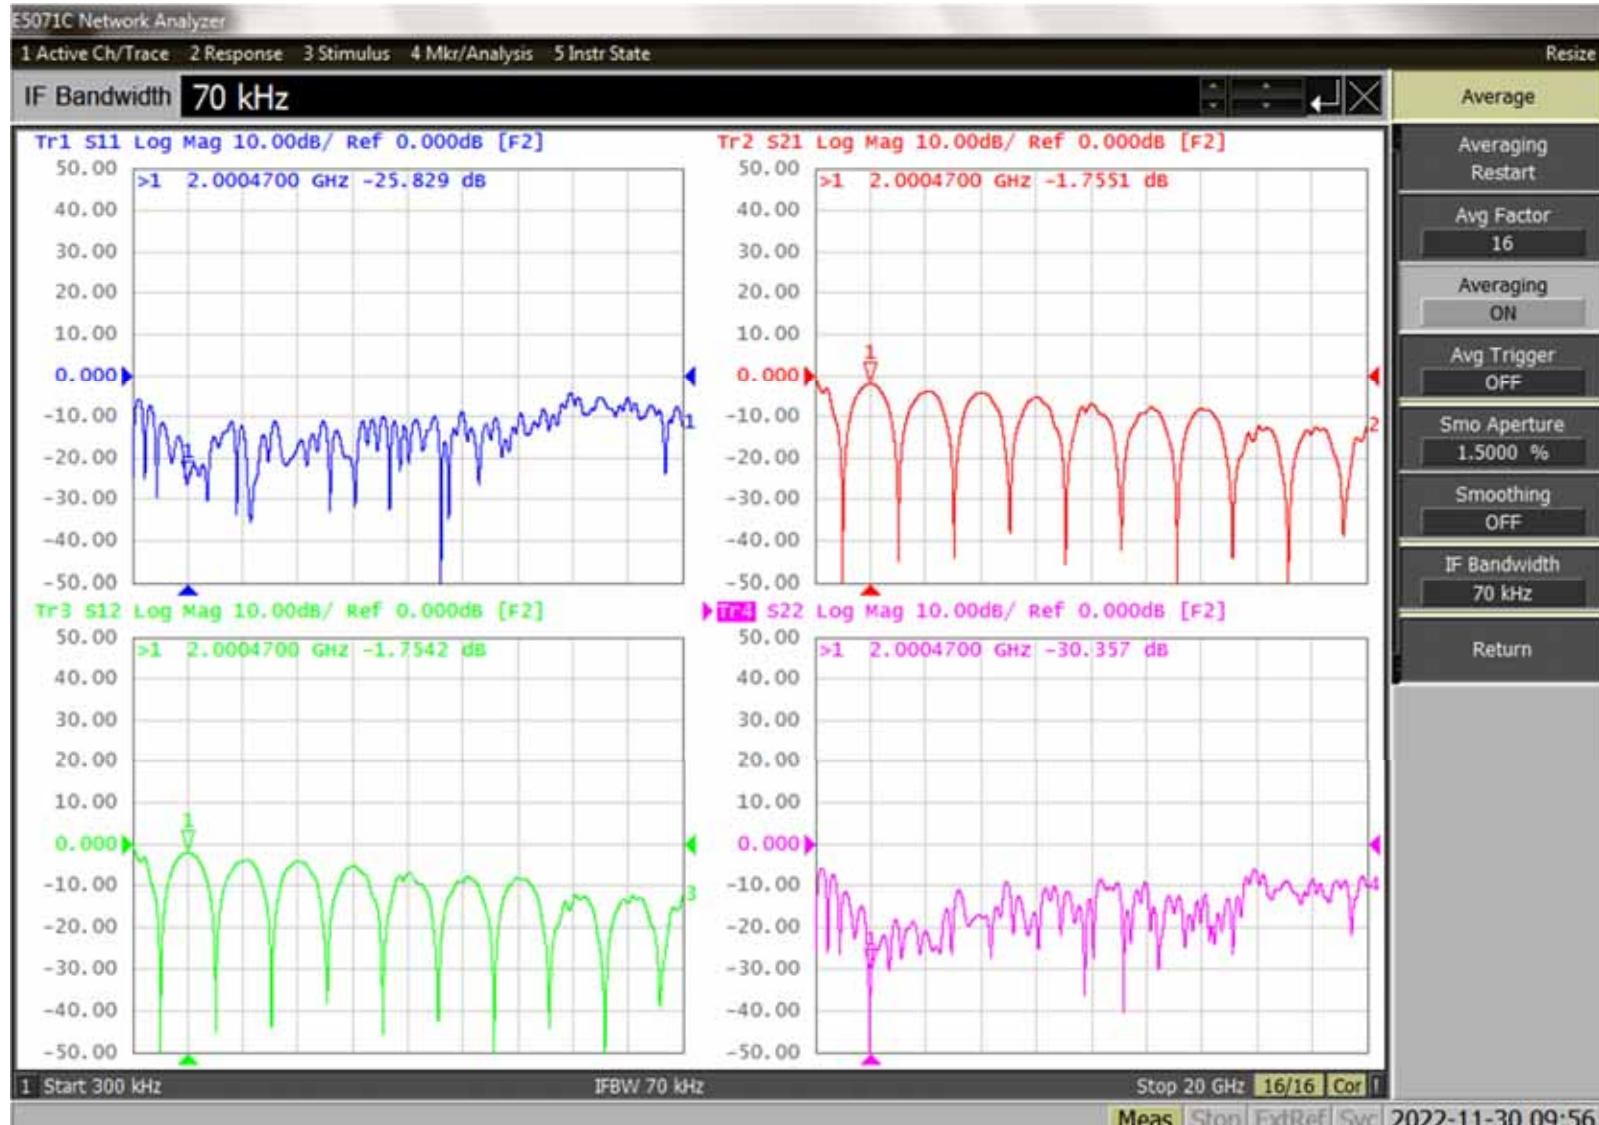
2 tap 2GHz BPF (up to 20GHz)

- Planned to reduce broadband noise in the FB front-end circuit by changing the first 2GHz BPF.
 - Replace 2GHz-3tap comb filter with 2tap cable-type comb filter.
 - Similar gain at the front-end
 - Expected to have $\frac{1}{2}$ of broadband noise
 - Much severe timing margin need much longer tuning time after restart of the beam operation.

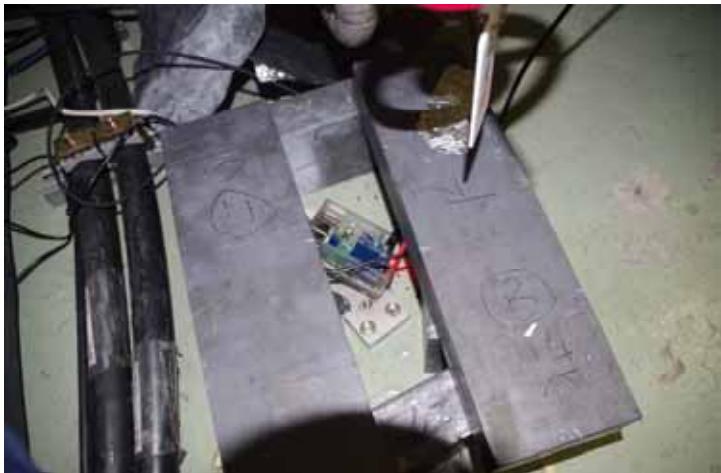
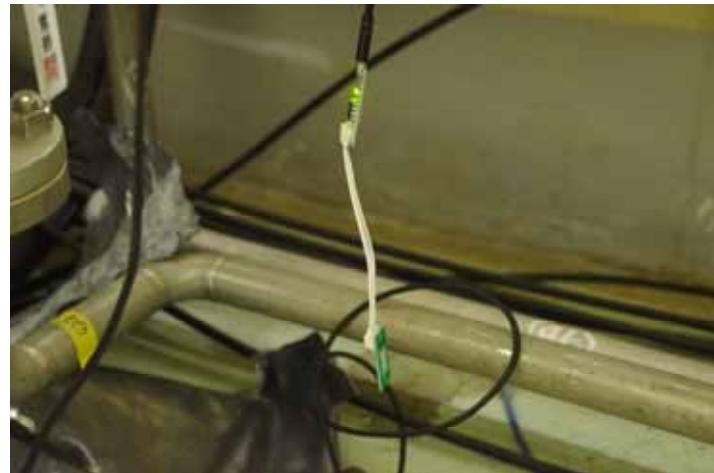
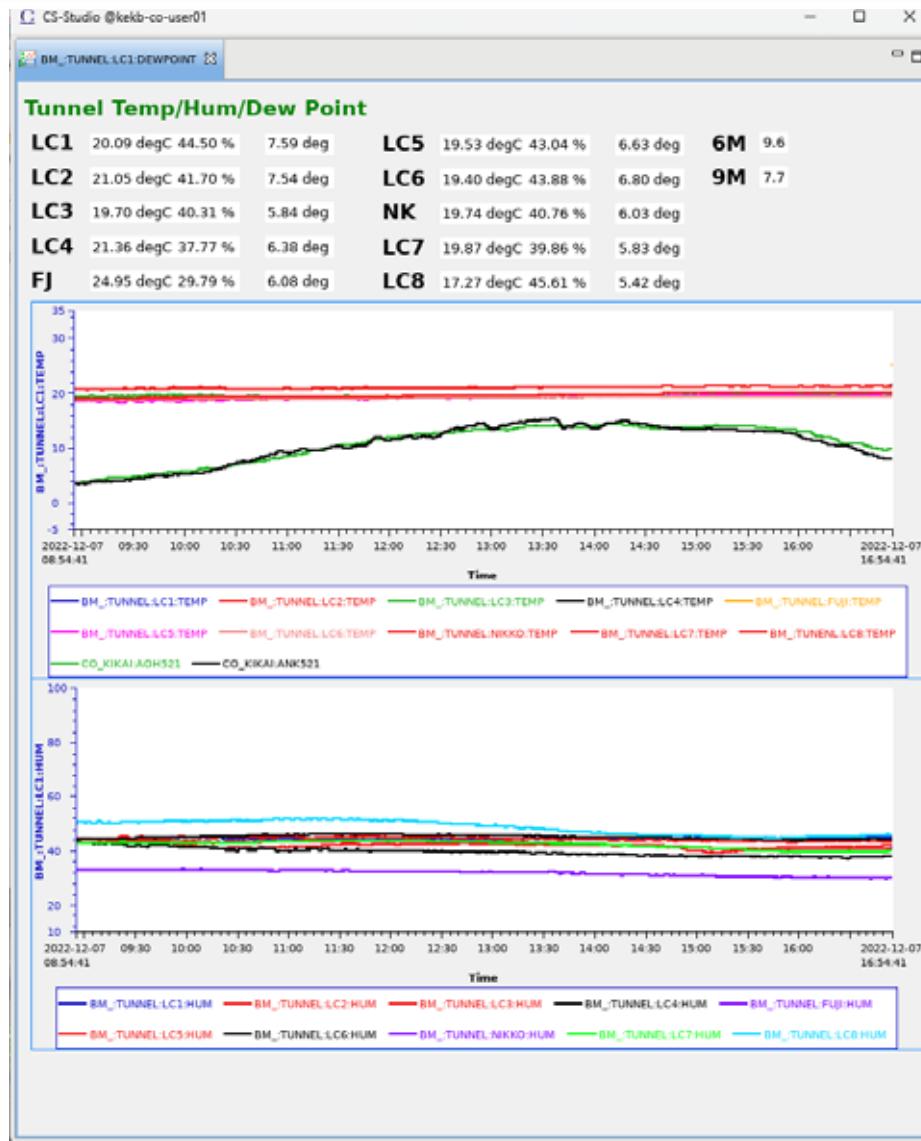
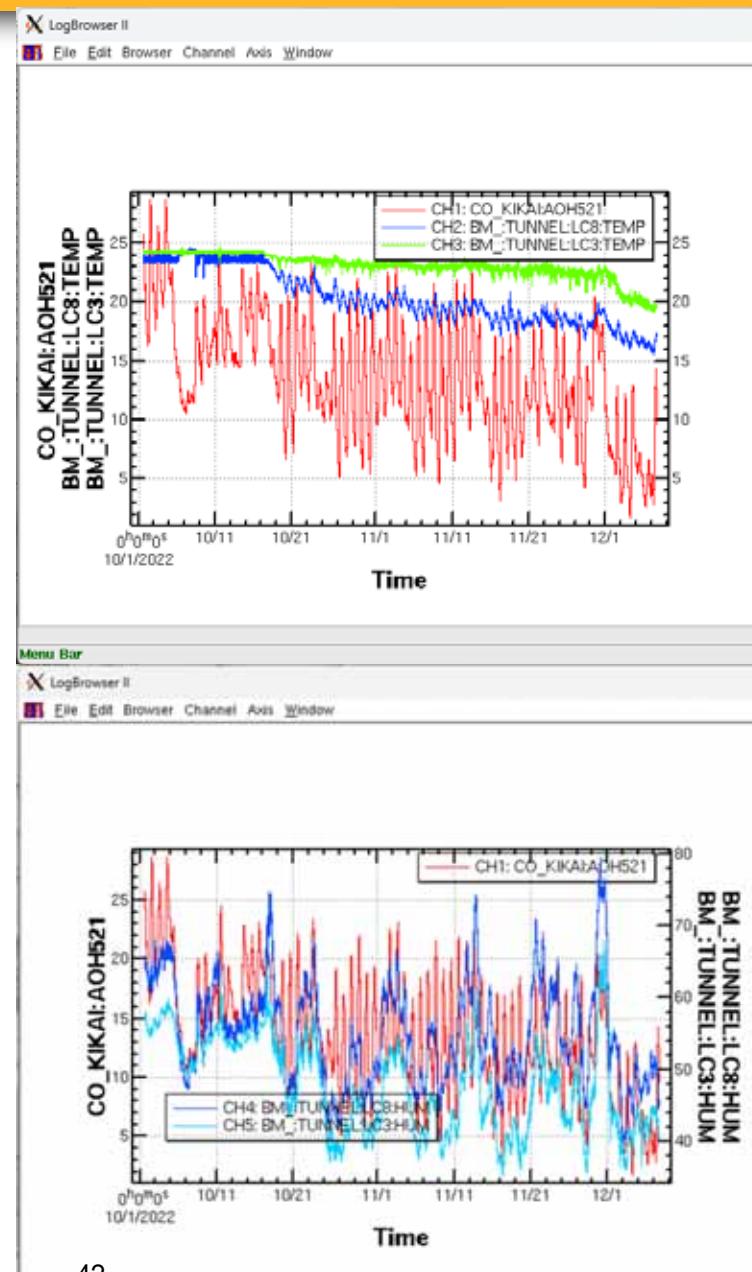
Environment monitor

- Raspberry Pi + home made USB sensor (temperature and humidity)
- LC1-LC8, Nikko, Fuji (planned OHO and Tsukuba)
- Easily hanged-up during beam operation (LC6 and LC7), even with thick Lead radiation shield.
