Installation of Crab cavity

KEK M. Ono

Present Status of Tunnel
; Nikko Straight Section

Installation Procedure

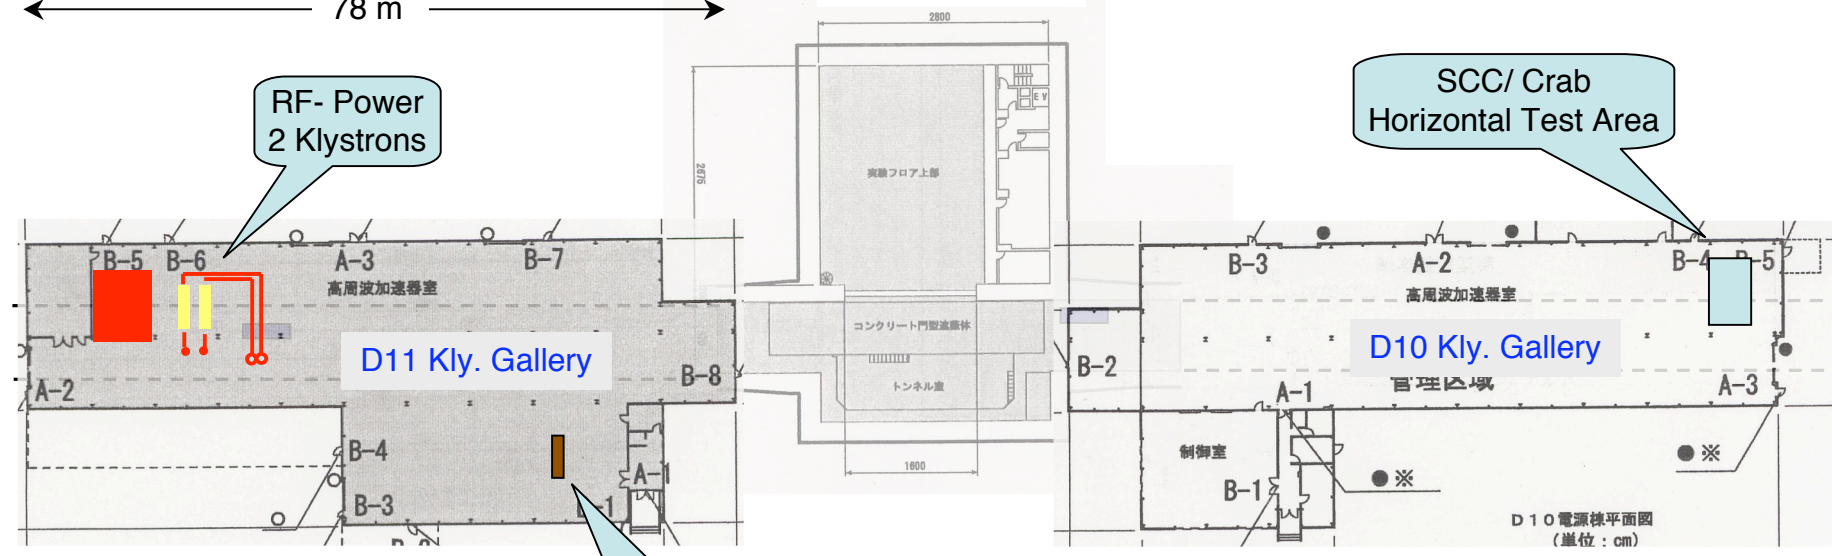
Crab RF-driving System : Plane View

Nikko
Exp. Hall

78 m

RF- LL Cont.

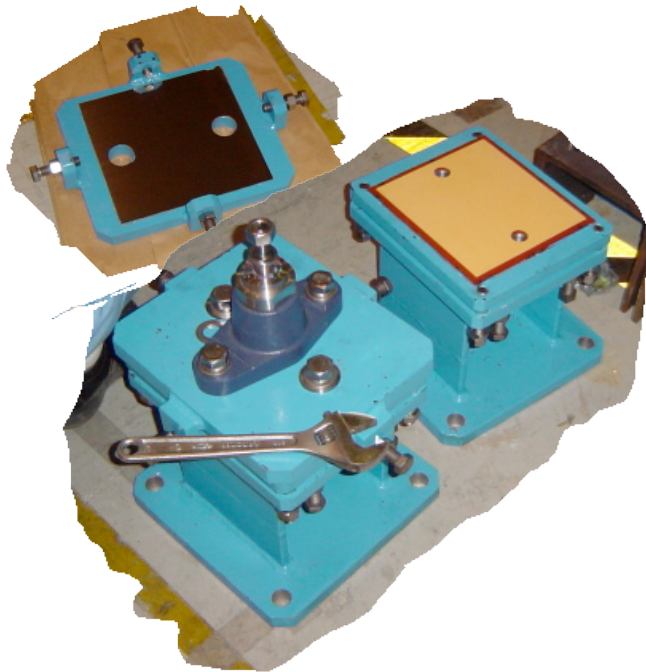
HER; D10
Alignment

07/01/08
Installed

Support leg;
with Sliding pad

07/01/12
After Inst.

1.0
1.0	×
0.1	×
	0.75

Upward(V)

Coupler(H)

Deviation
:mm

1.7	
×	0.5
0.0	×
	1.0

06/12/27
Before Inst.

Alignment at Installation:

Ref. line was defined by Q-magnets.

Rotation was checked by a water level (~100μrad).
[can't measure opposite side deviation]

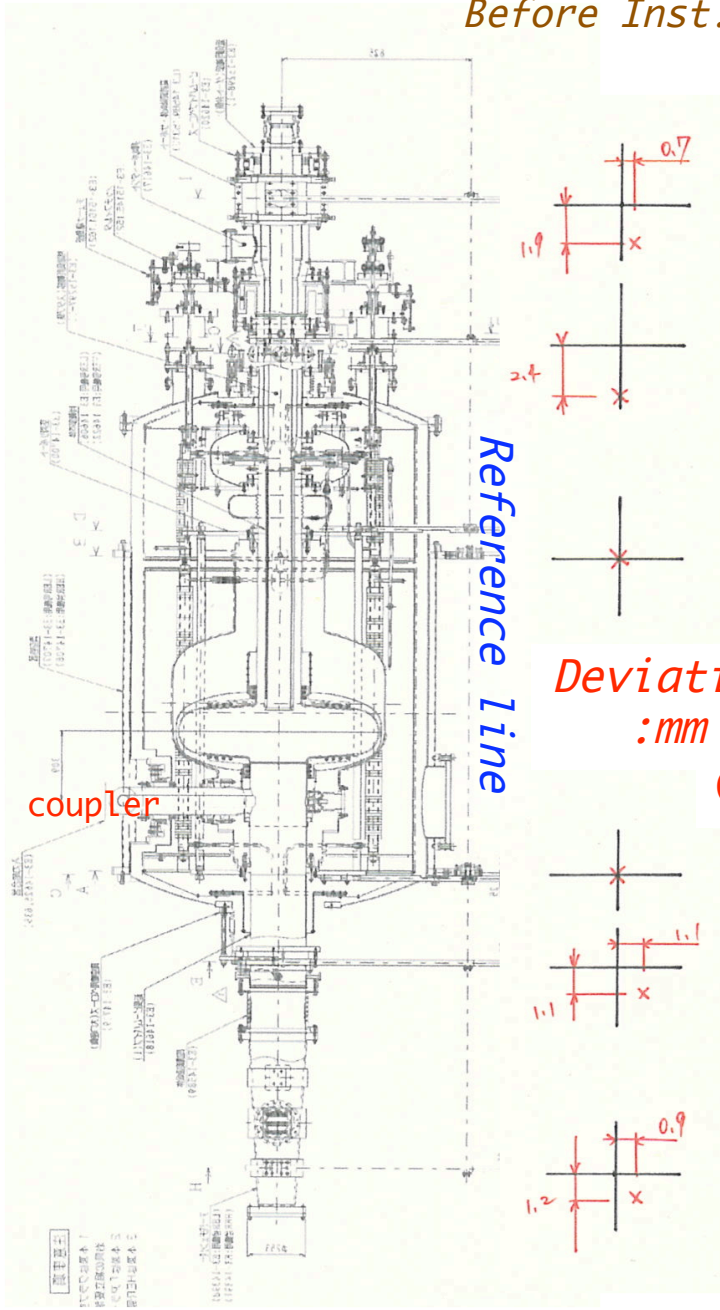
LER; D11
Alignment

07/01/11
Installed

Upward(V)
Coupler(H)

Deviation
:mm

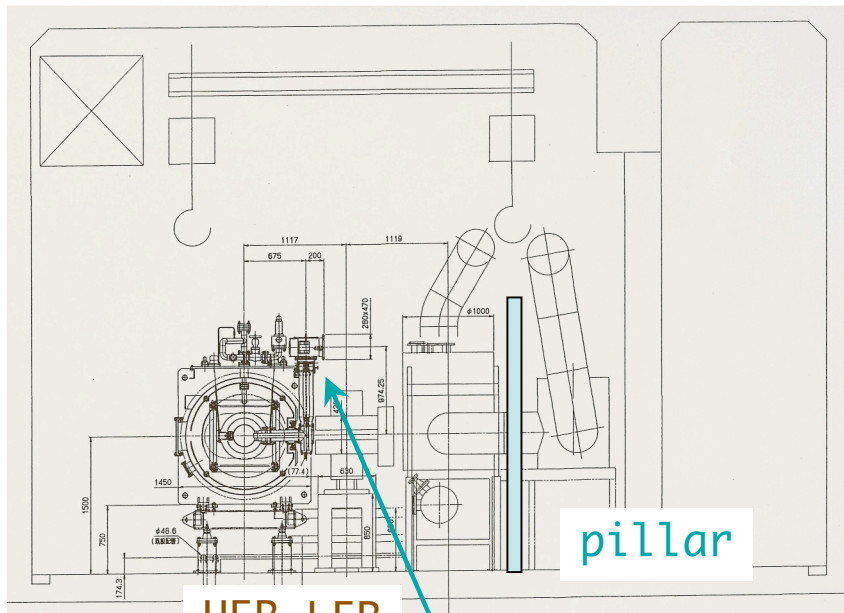
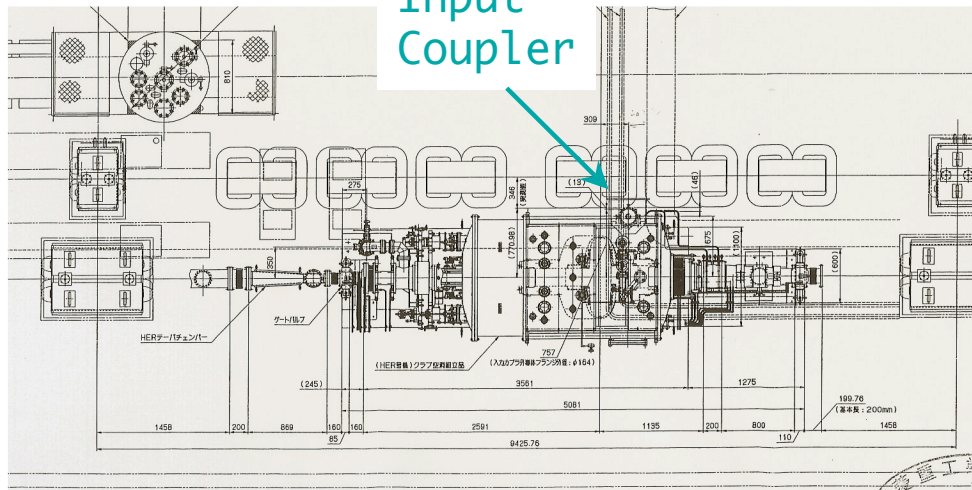
Crab Installation : How to

HER LER

pillar

Input Coupler

LER

HER

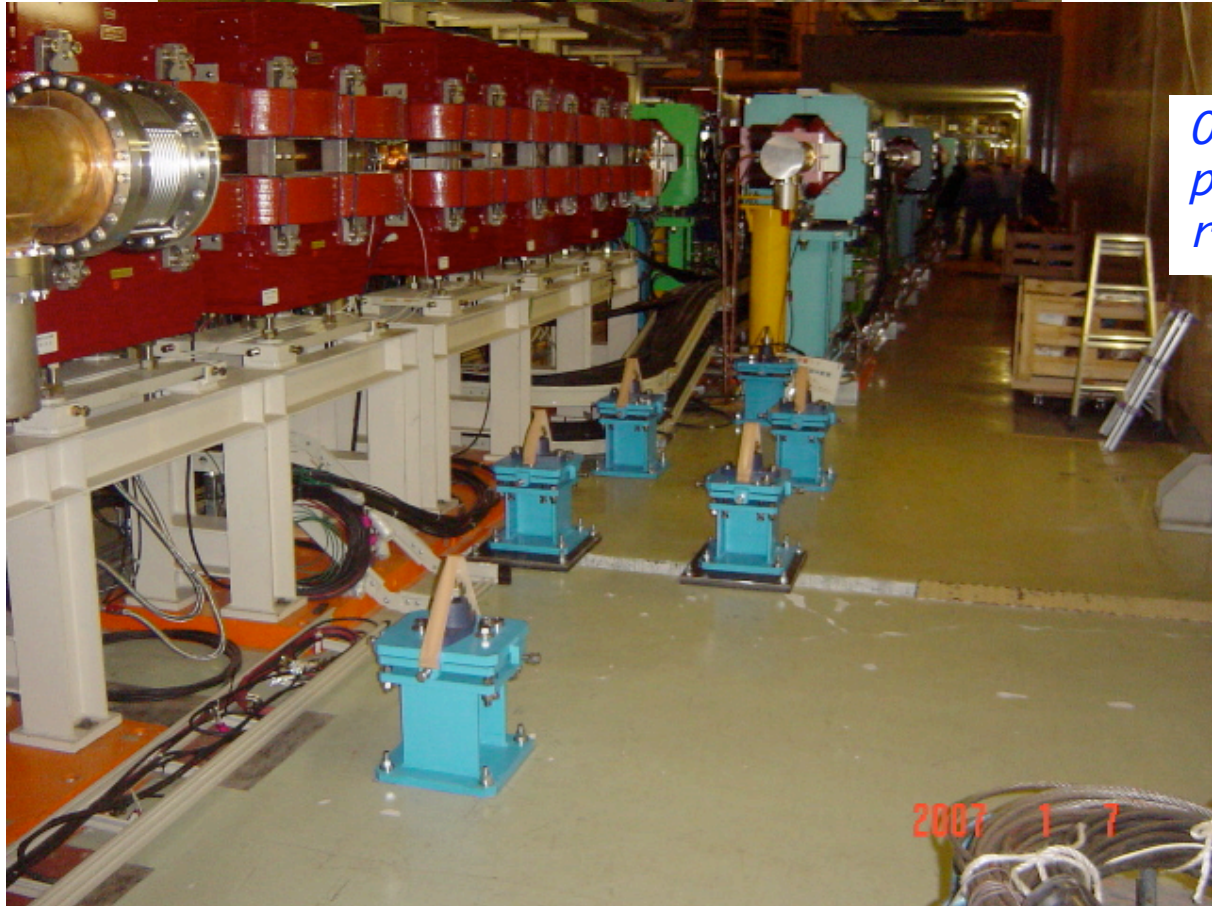
HER; D10
Preparation

Only HER beam pipe was removed.

Support legs: 4 for weight support/ 2 for flatness

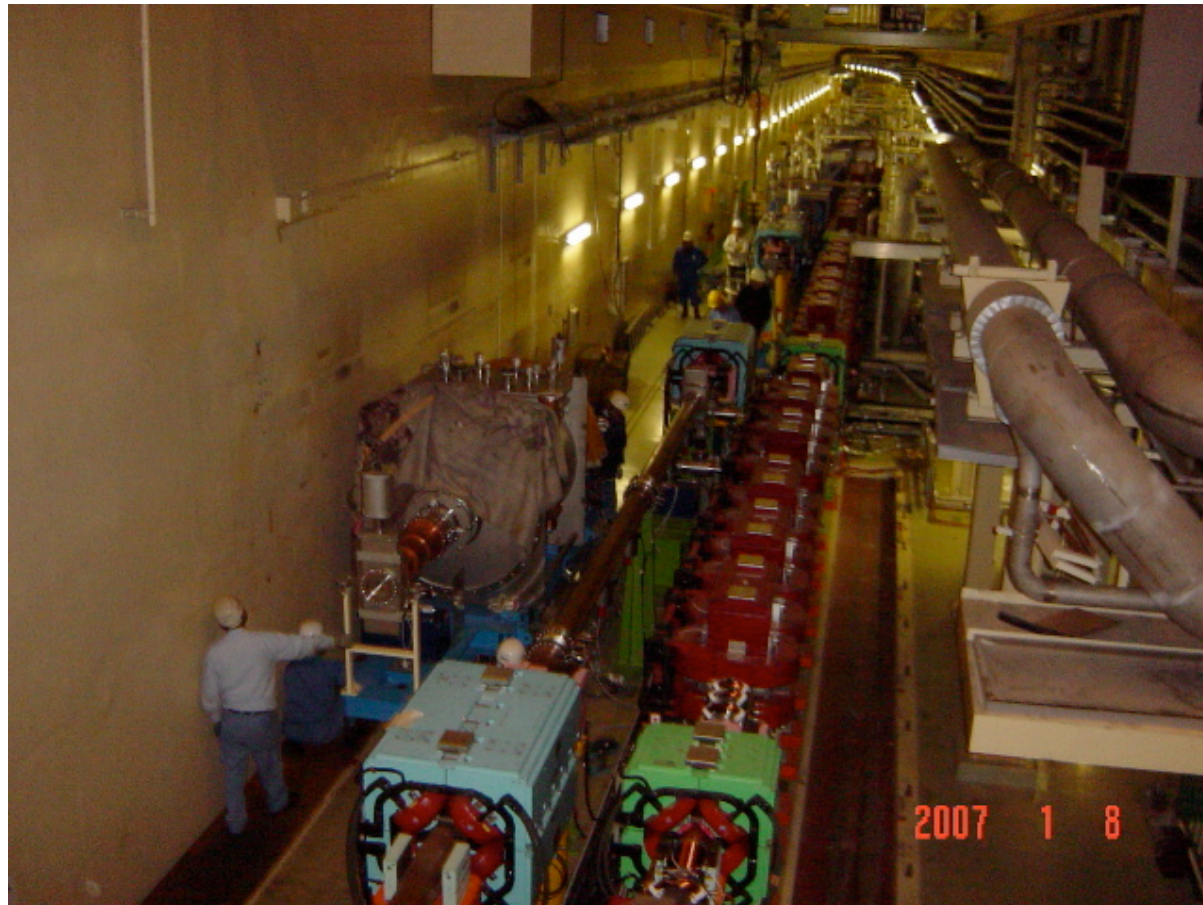
HER; D10
Pulling

10:54; Lifting

11:08; Landing

11:20; Pulling

11:45; Reach

Crab was put on wooden block to keep higher level above support leg. No crane available.

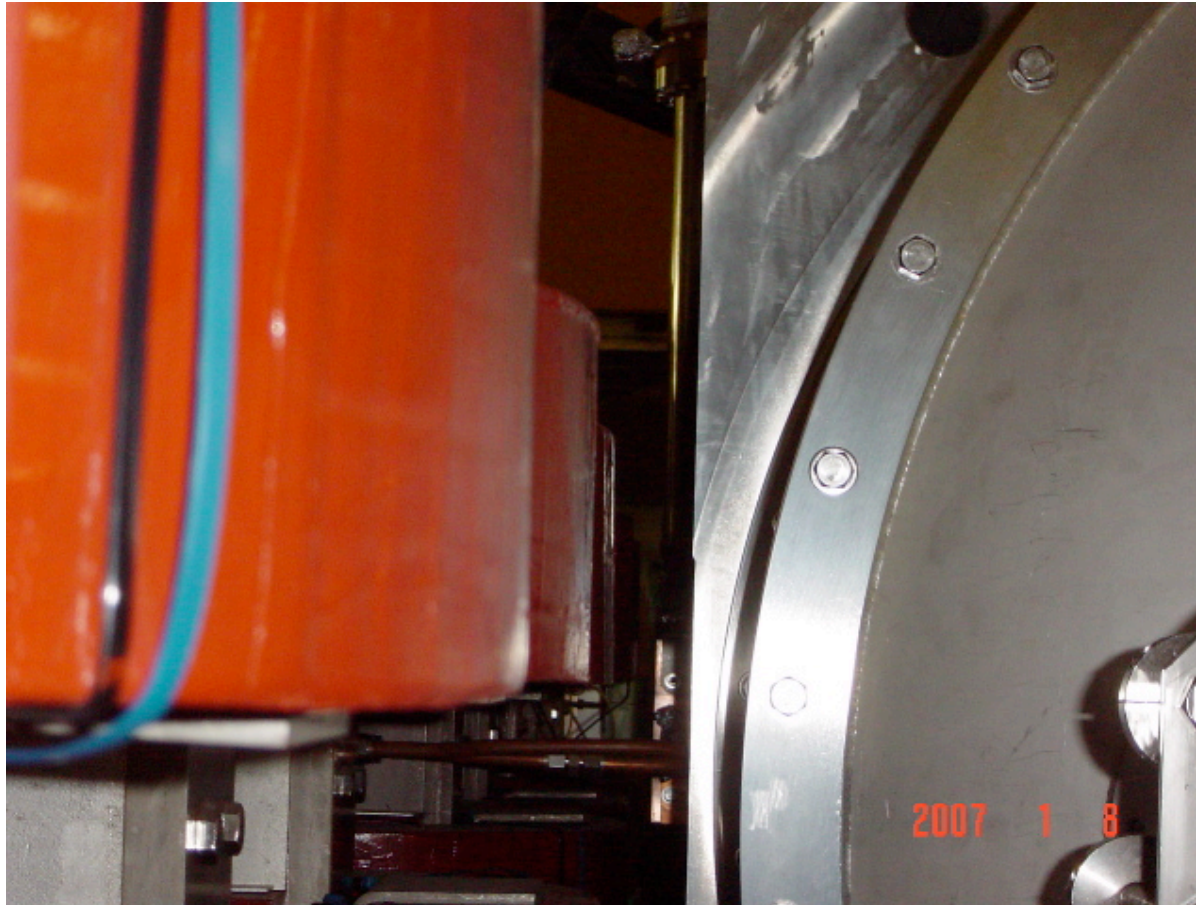
HER; D10
Final
Destination

11:49; to Lateral

12:14; Close to

12:22; Close up
to; ~3cm

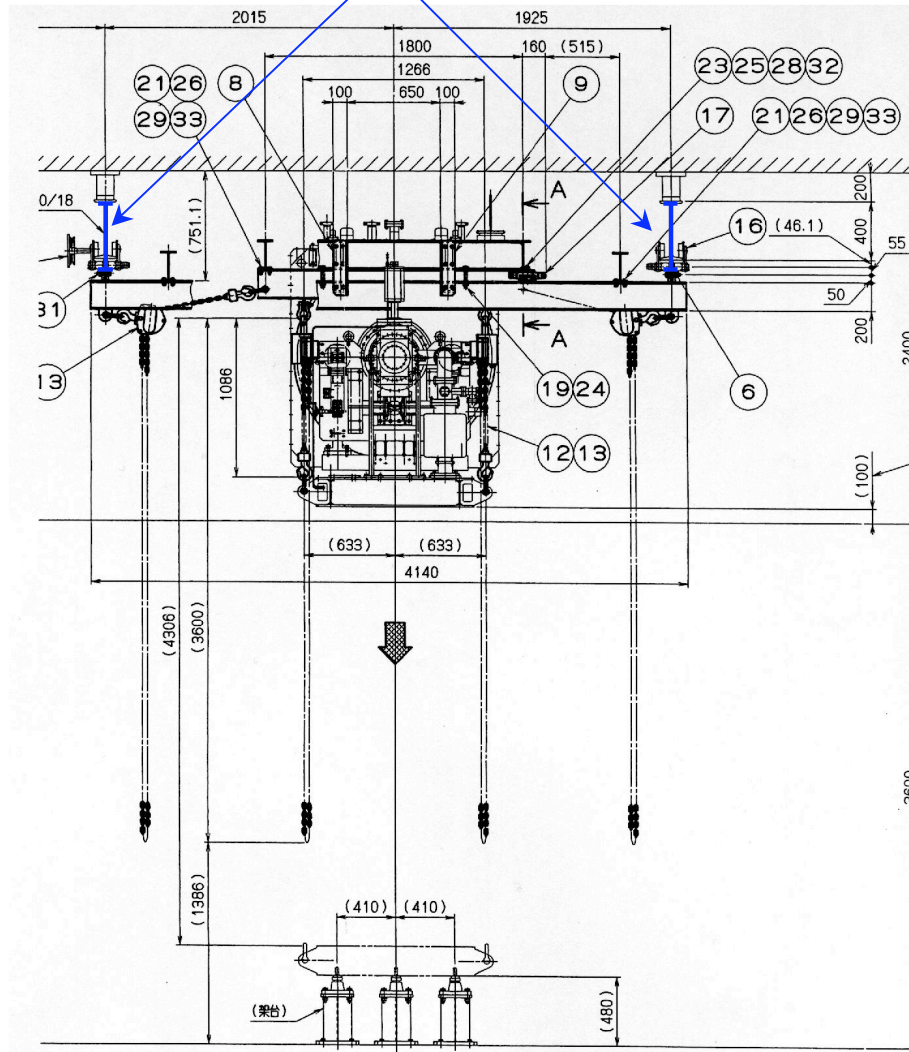
Narrow Passage
Low Crane Lifting Height
---> Interfere with SCC

Can use neither the Crane
nor the Tirroller;
---> Need Carrying Tool.

Installation Area is far away
from the Nikko Exp. Hall;
~ 60 m.

Crane Rail

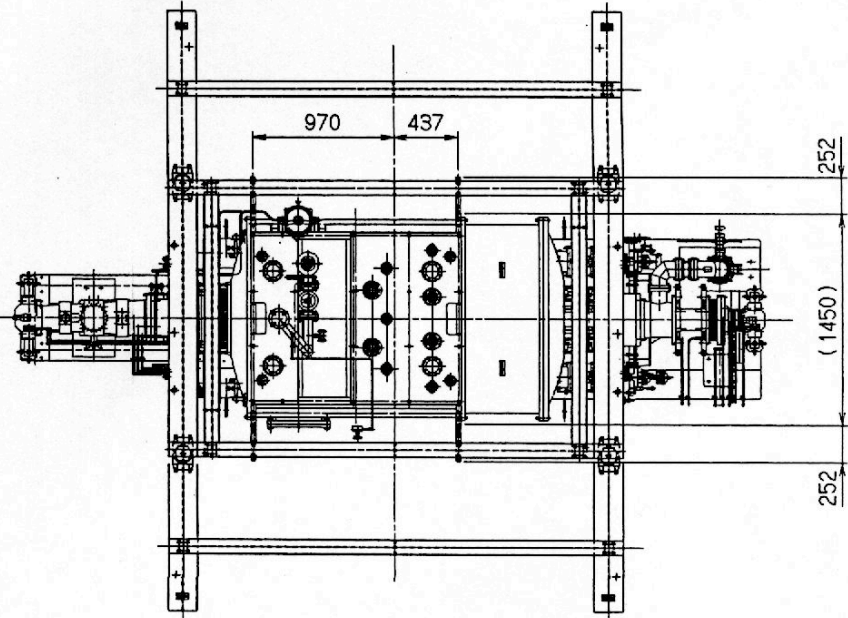
Crab Installation : Carrying Tool

The Carrier ; hanging to the existing **Crane Rail**.

Moving along the rail and perpendicular to it.

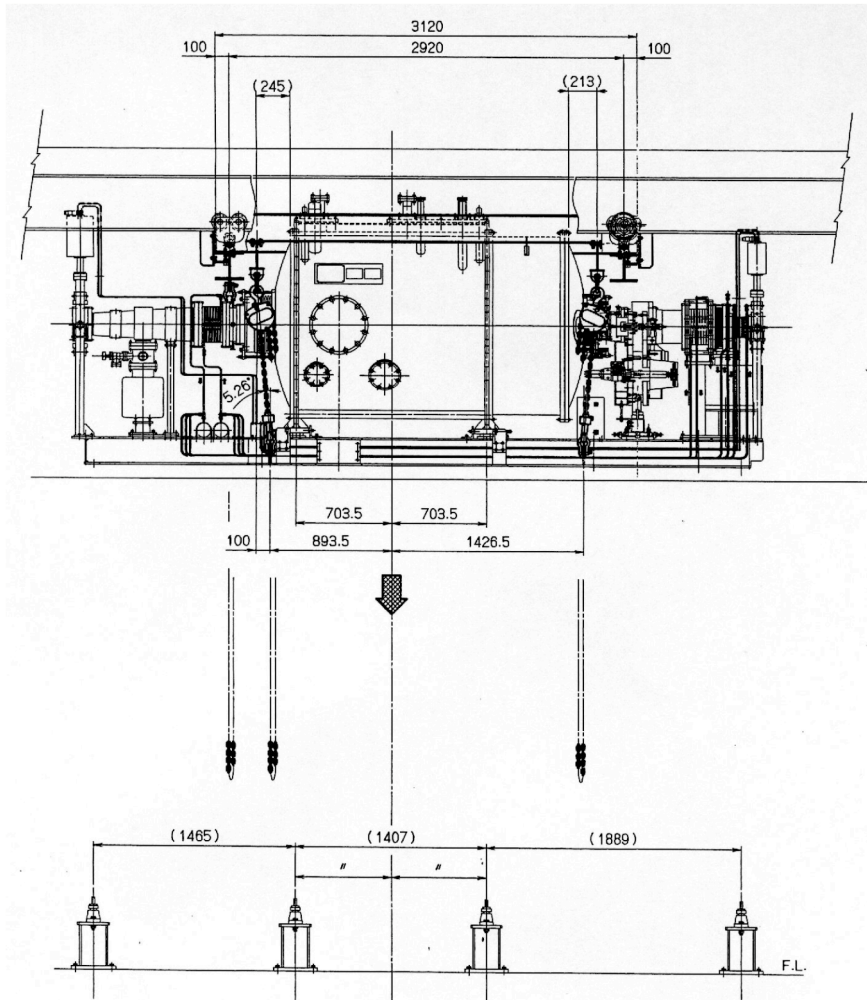
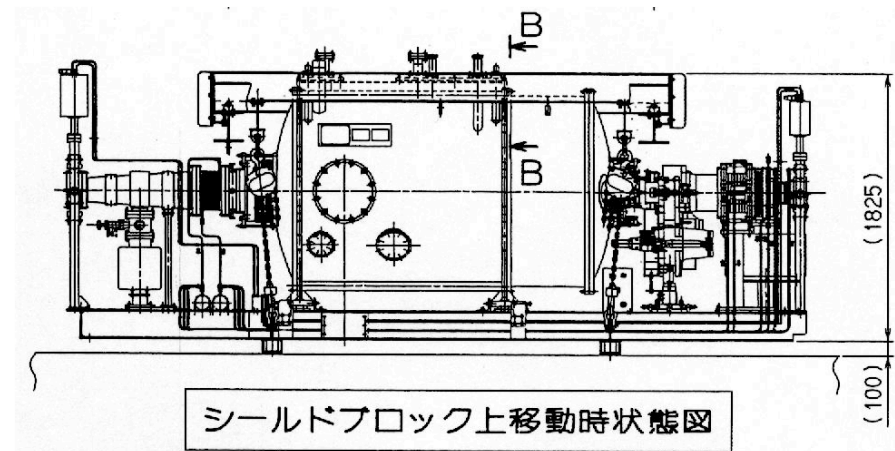
Crab Installation : Carrying Tool

Move to the installation area, then hang down
; using chain block(pulley).

Setting the Crab to the carrier;
Carried out on the Concrete Shield.

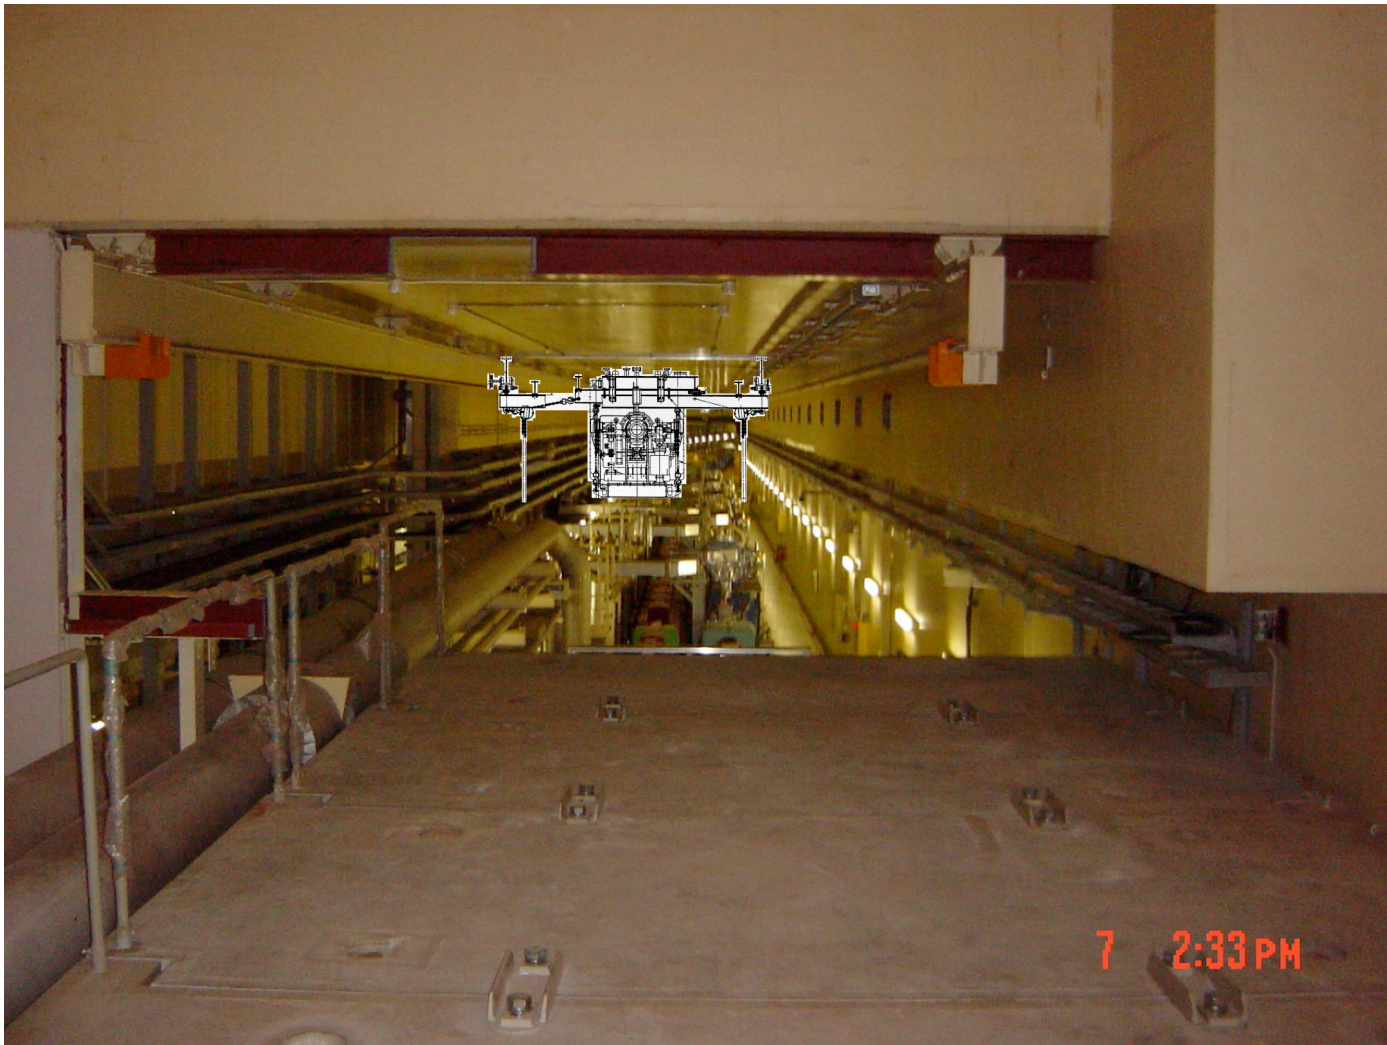
Crab Installation
: D11 Area
“Animation
Shown Last Year!”

Hours wasted because the strategy changing to cap the carrying frame.

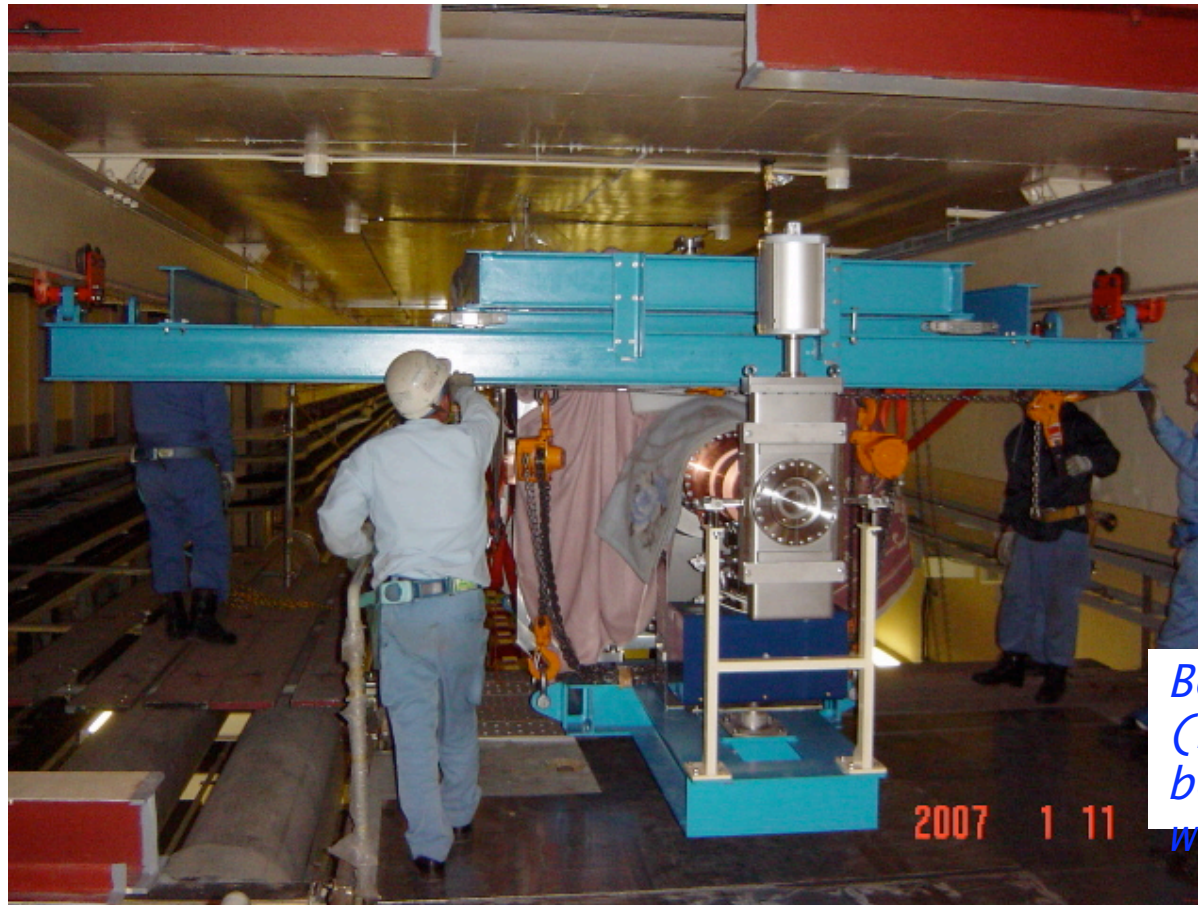
LER; D11
Preparation

10:05; at tunnel

12:04; setting

14:22; hang
forward

15:36; ready
to move

*Both
(LER/HER)
beam pipes
were removed.*

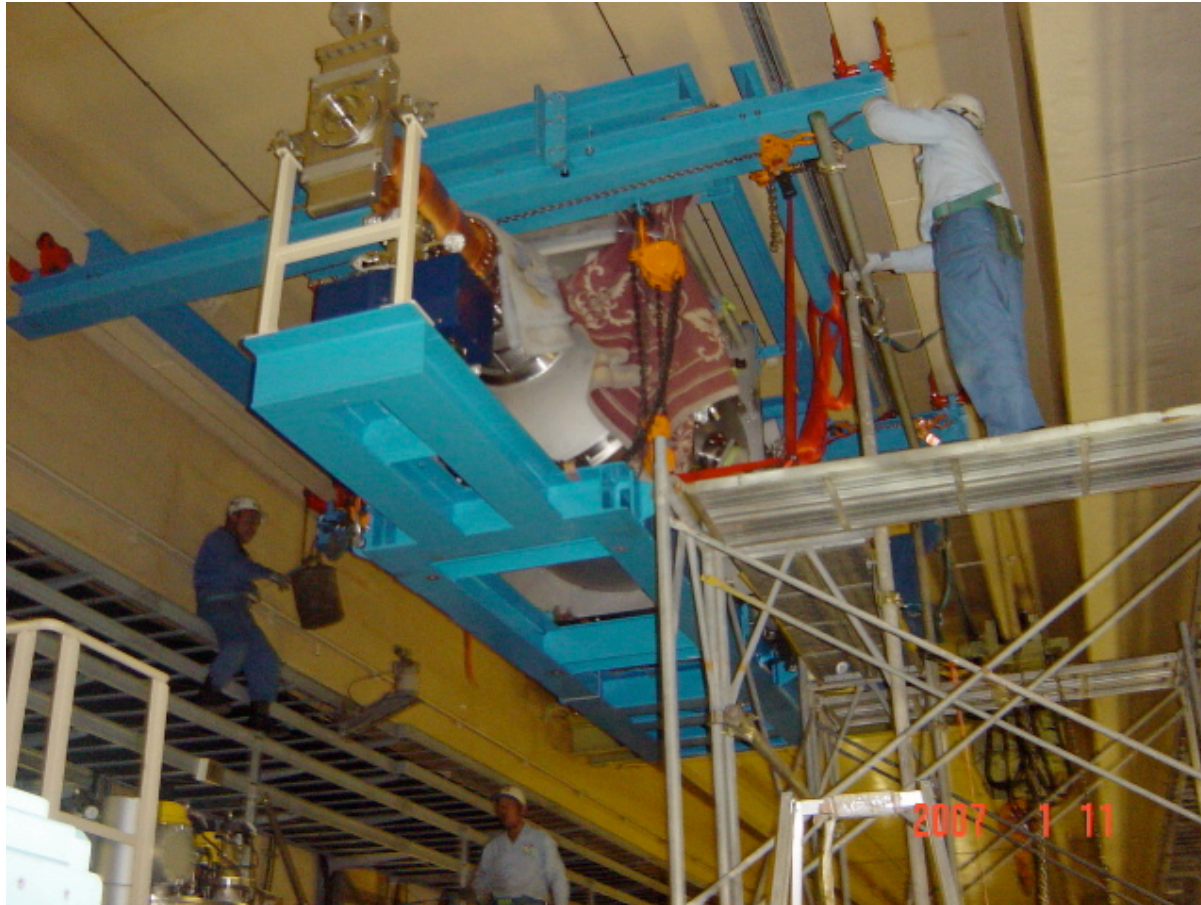
LER; D11
Air
Transport

15:37; take-off

15:52; arrive

During Transport, Crab was fixed by pulley and sling wires in order to prevent swing motion.

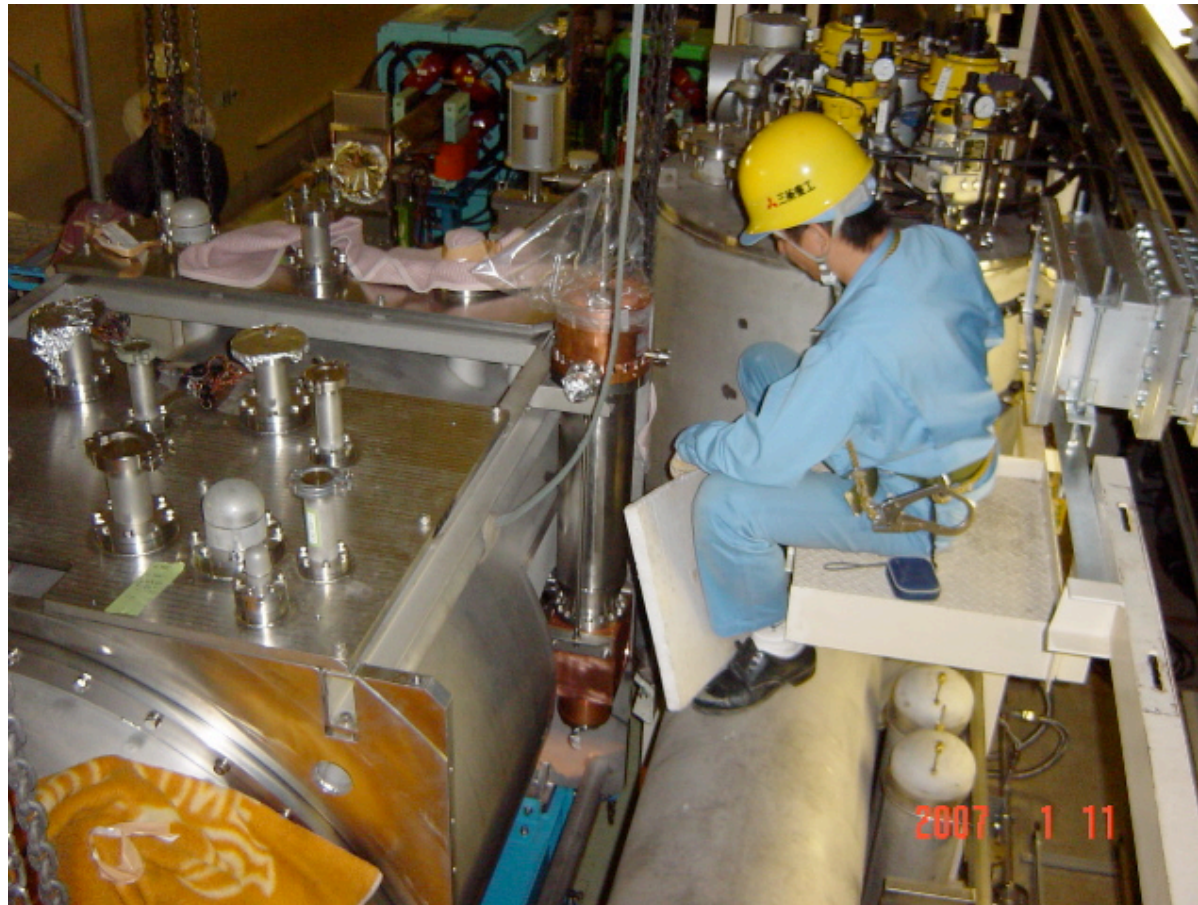
LER; D11
Landing

- 15:52; arrive
- 16:06; release wire
- 16:13; ready to down
- 16:27; down by pulley
- 16:44;
- 17:11; Close to head of support
- 17:18; Rough Adjustment

Support legs

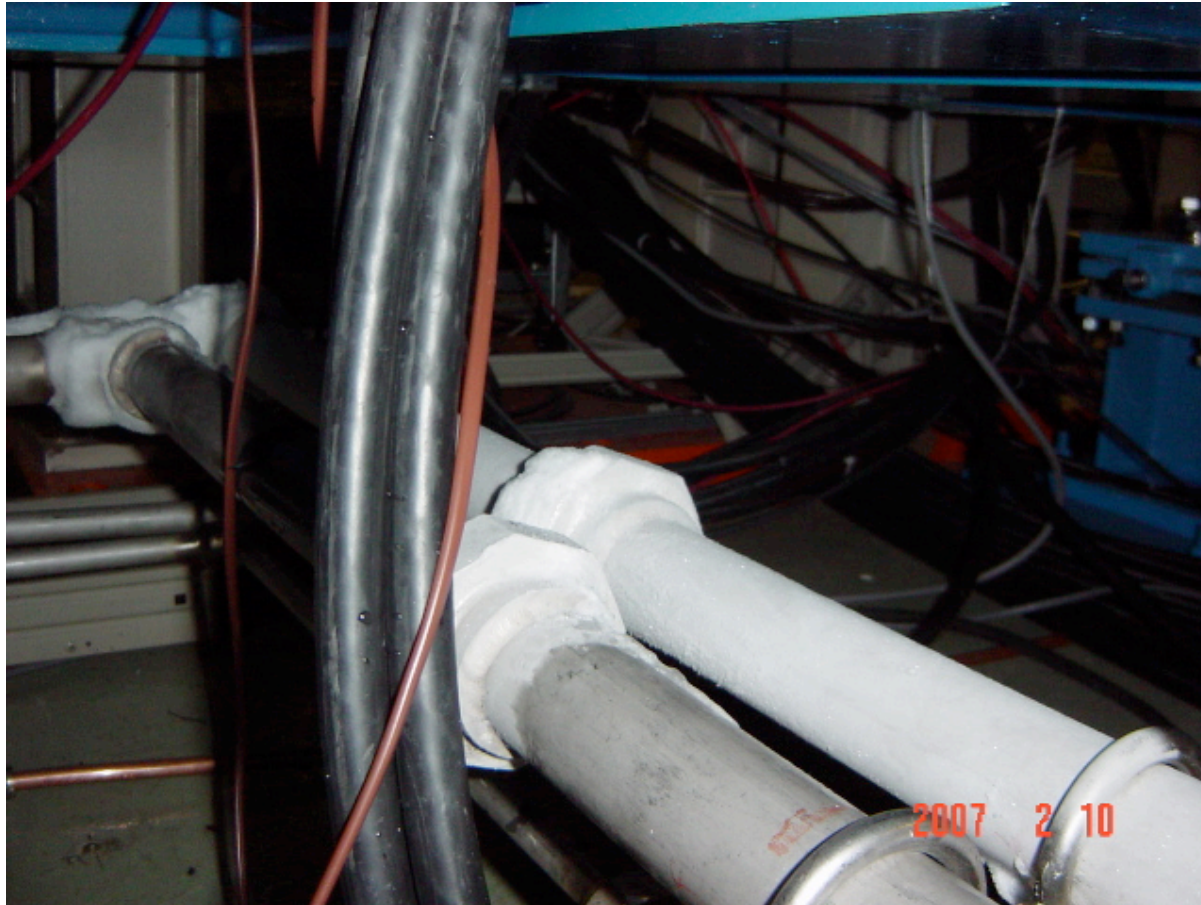
Rubber O-ring became hard.

Feb/10; During conditioning
