Horizontal Tests for Crab Cavities

During the first horizontal test, it found that the cavity had a problem which the tuner performance was not good. Therefore, we needed to reform the mechanical structure of the coaxial beam pipe. (It must be **smoothly driven** by the tuner.)

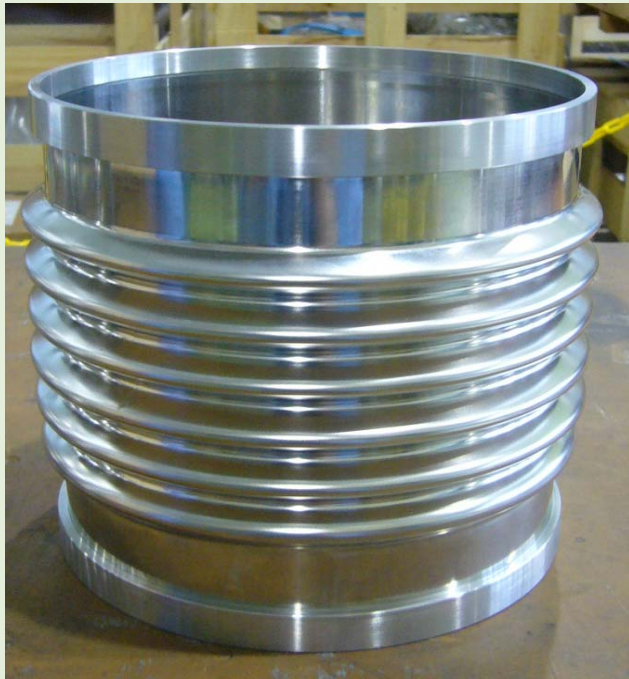
After shaping...

Bellows

Material : Cu ⇒ SUS316L
Thickness : 0.4mm ⇒ 0.2mm
Stroke : ±3mm ⇒ ±10mm

The stroke was short,
as the copper bellows was rigid.

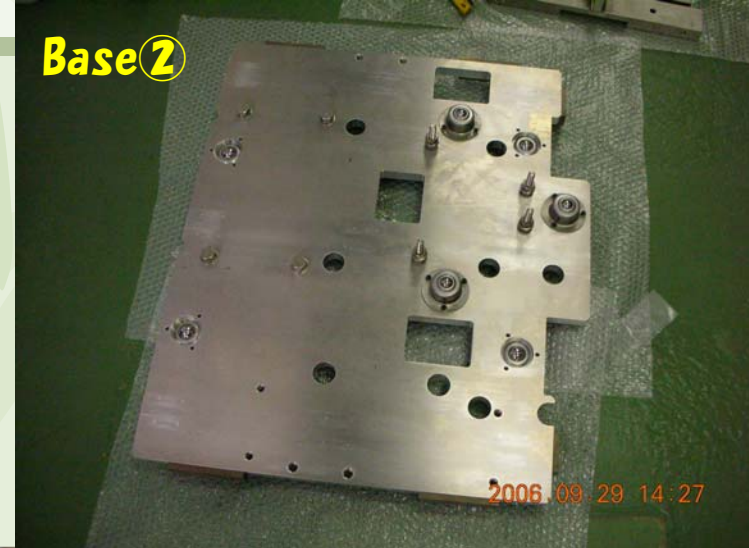
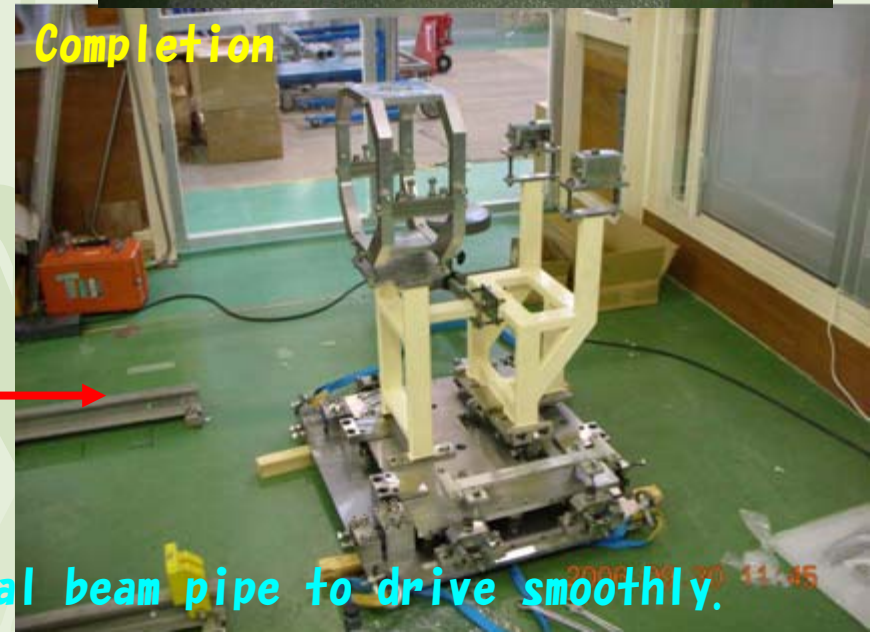
Movable Base

This movable base enables the coaxial beam pipe to drive smoothly.

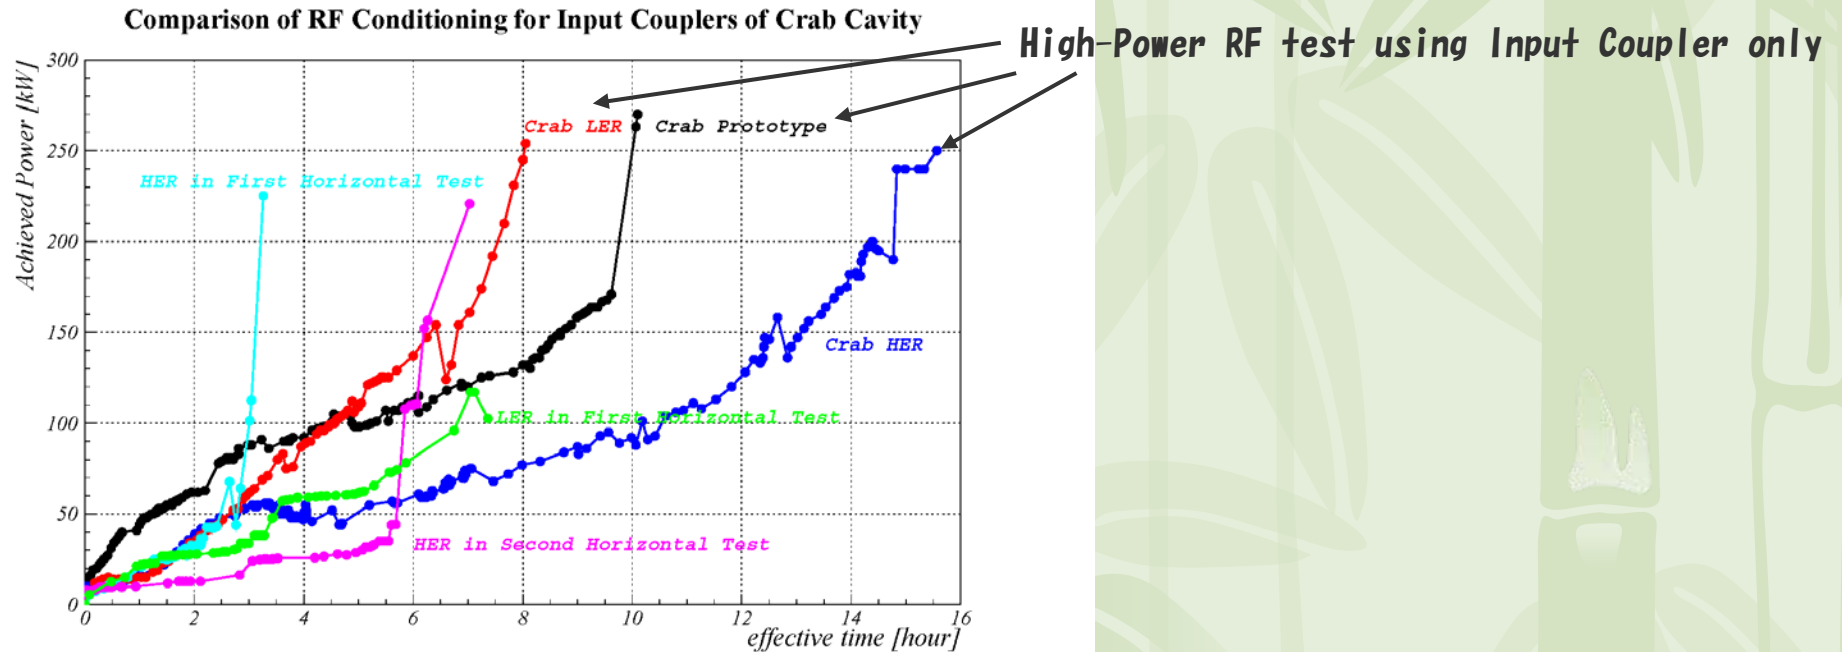
Input Coupler Conditioning

The achieved power was above 200kW for HER, but we stopped at 100kW for LER. Because we had no time!

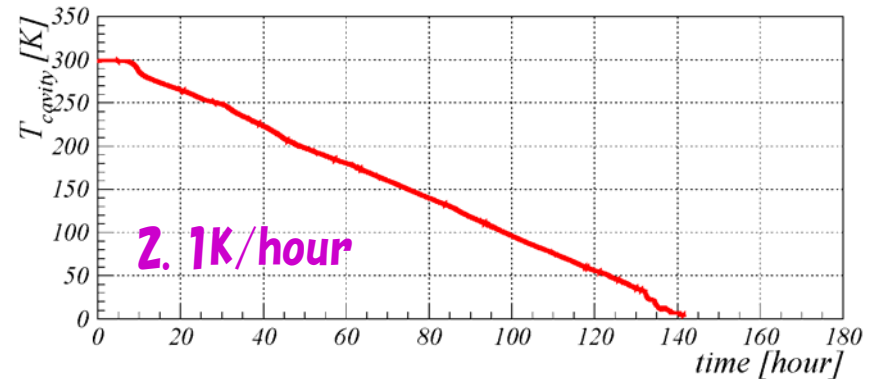
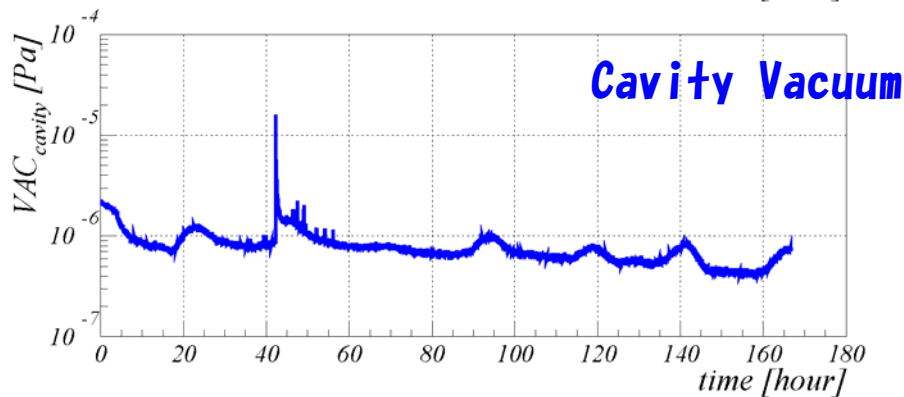
Time Profile of Cool-Down

**We were afraid of the vacuum leakage from the cavity!
Therefore, we decided the cool-down rate of **2K/hour**.**

Although HER Cavity vacuum became good, LER became higher.
As we were afraid of the vacuum leakage, we did the leak check many times.
After the cavity temperature reached 50K, the vacuum pressure was lower.

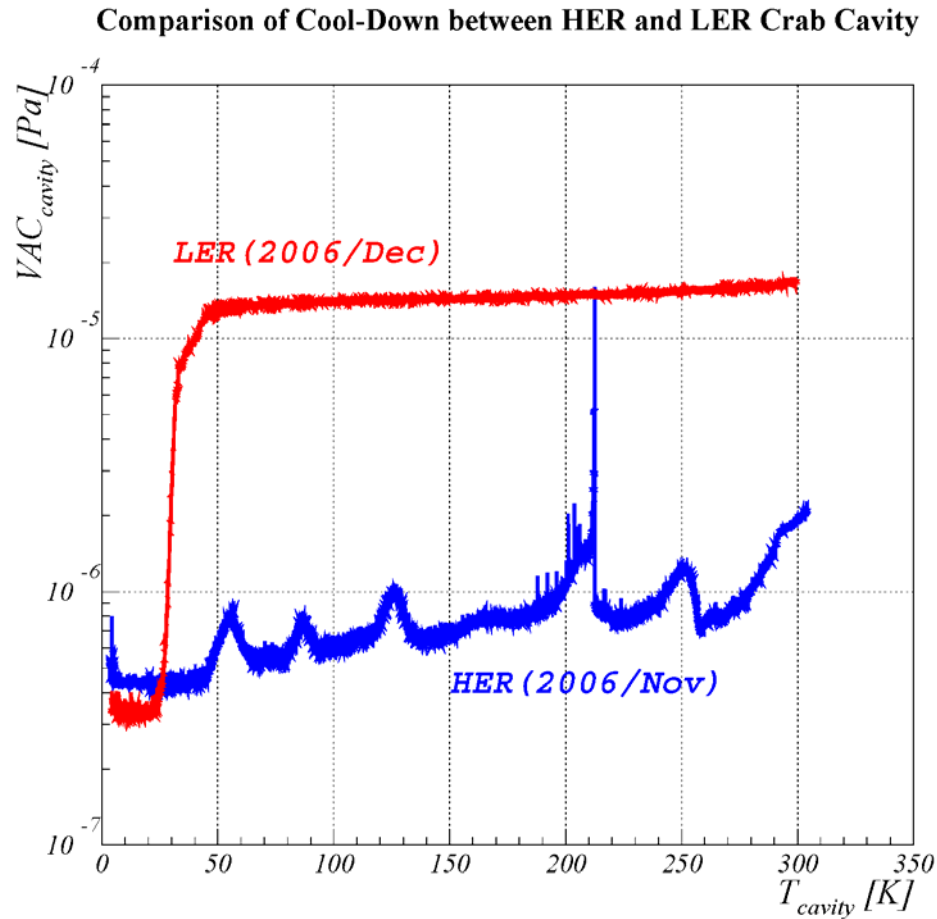
Correlation between Vacuum and Temperature during Cool-Down

Although the behavior of the vacuum pressure was much different between both cavities during cool-down, the pressure level around 4K was almost same.

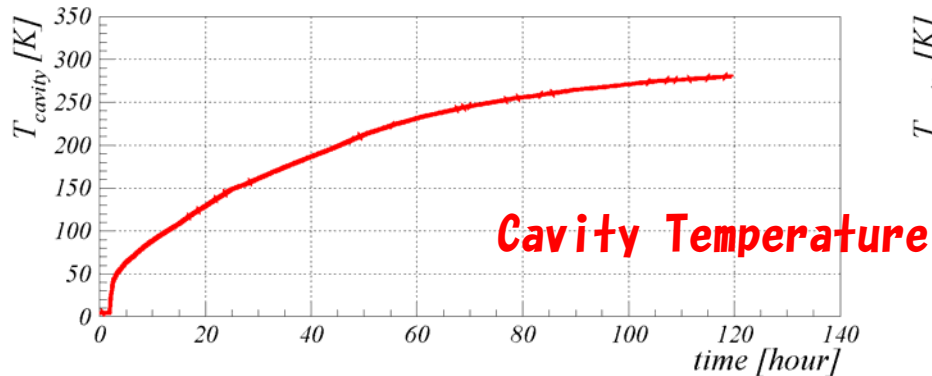
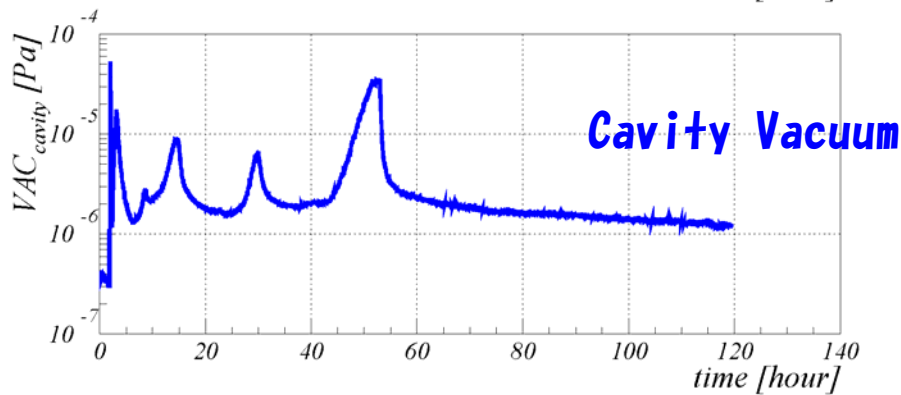
Time Profile of Warm-Up

The vacuum pressure for LER Crab Cavity became higher during warm-up. After the cavity temperature reached the room temperature, the pressure level was almost same as before cool-down.

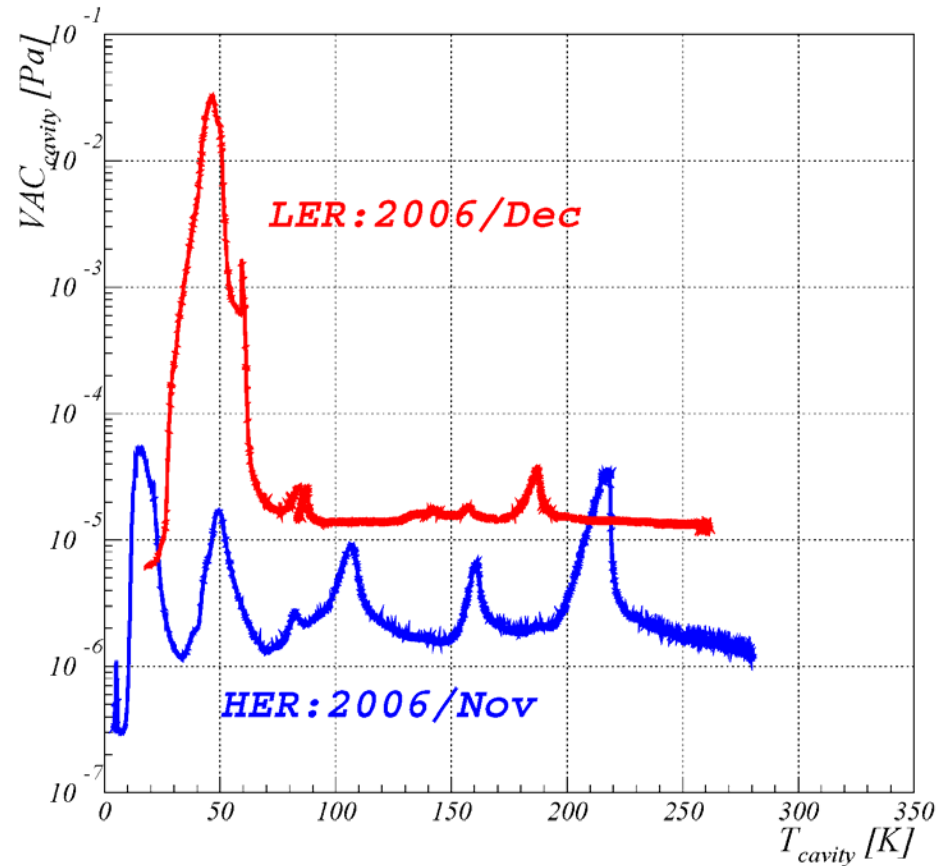
Comparison of Warm-Up in the Horizontal Test between HER and LER

The vacuum pressure was different by 3 orders between both cavities around 50K!
The pressure level of the coaxial beam pipe for LER was always higher at 4K.
We think that this part was the outgas source.

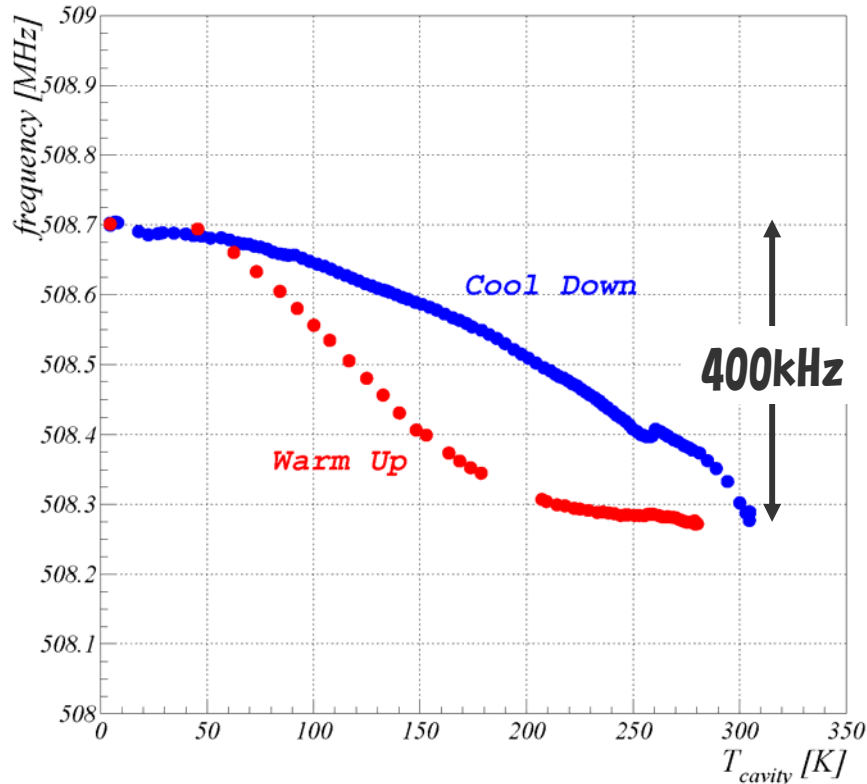
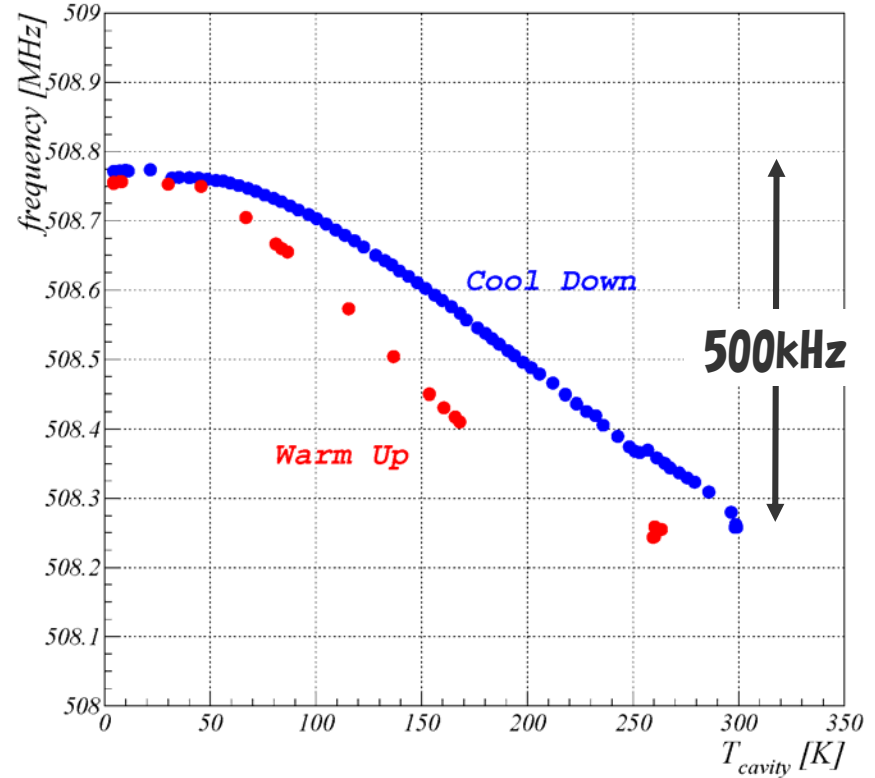
Frequency Trend during Cool-Down & Warm-Up

We think that the difference of the change of the frequency between both cavities is due to the mechanical property of the cavity.

The change of the frequency was 600kHz in the case of the cavity only without the coaxial beam pipe.

After the cool-down, we set the frequency to 508.8875MHz by another way.

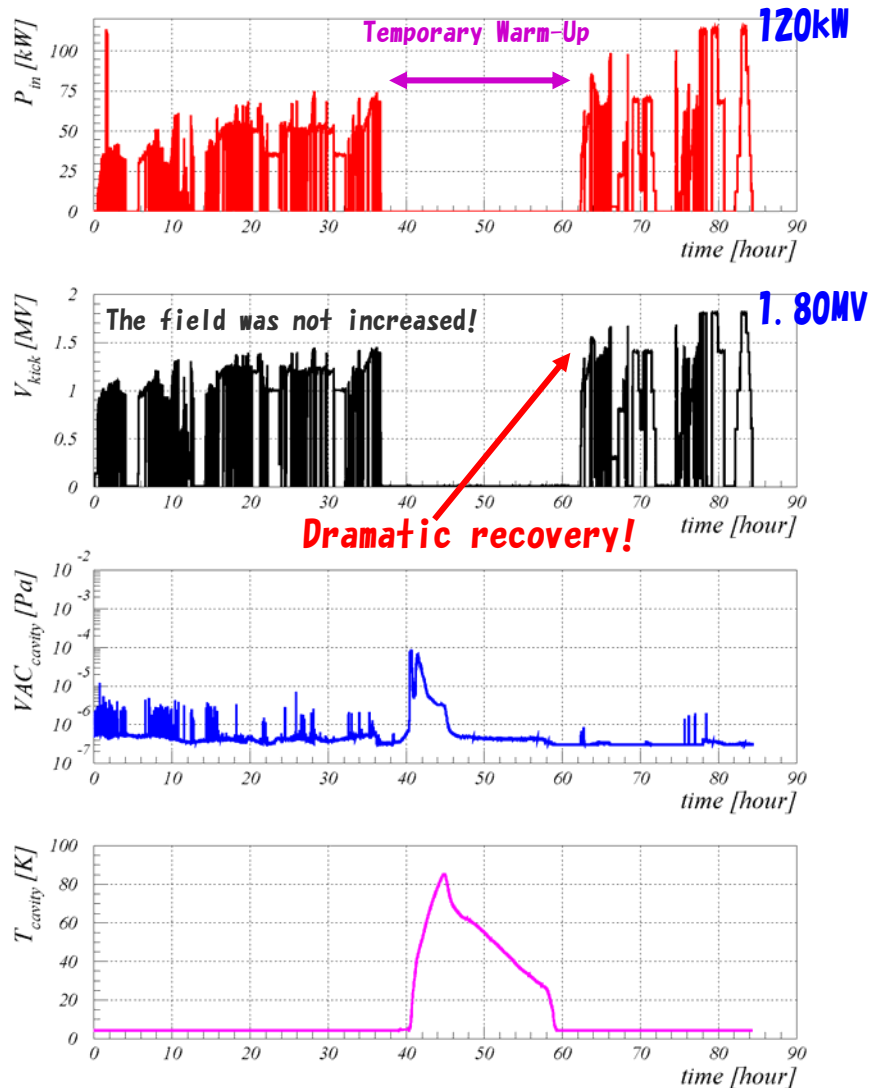
During the High-Power Conditioning

We decided the temporary warm-up of the HER Crab cavity again, as the field was not increased.

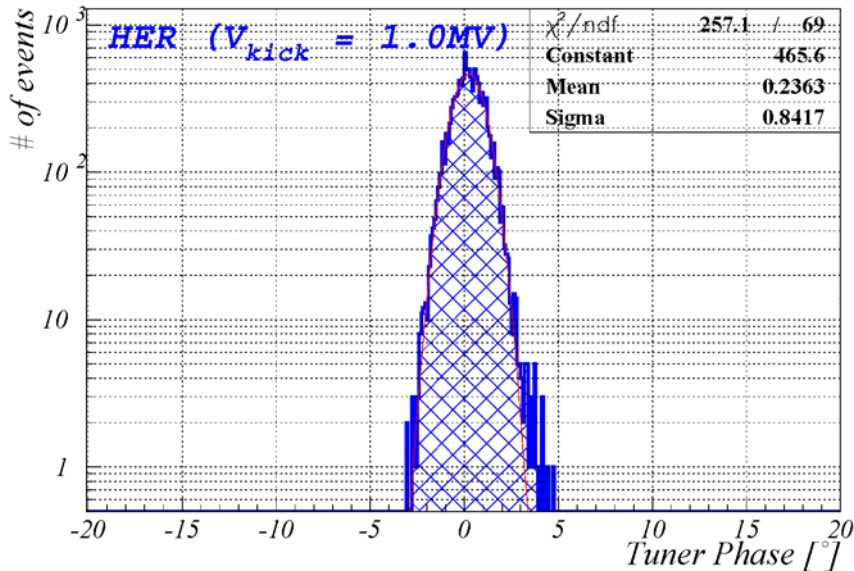
Comparison of Tuner Performance between HER and LER Crab Cavity

Although HER Tuner performance had no problem, LER Tuner performance was not good. The behavior was unstable and it had the hysteresis. We were afraid that this behavior prevent the cavity from operating stably.

And then, we tested the tuner drive of LER Crab so many times by the various ways. But unfortunately, we didn't understand the reason.

The expansion of the tail was twice HER.
