SCC upgrade ~ Superconducting Accelerating Cavity ~

KEKB-MAC2005

Feb. 22, 2005

KEKB-SCC

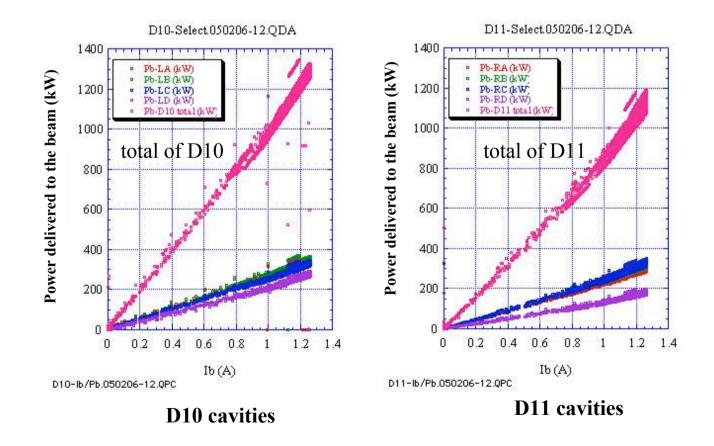
RF power at 1.27 A

-RF power of 2.4 MW was transferred to the beam by 8 SC cavities.

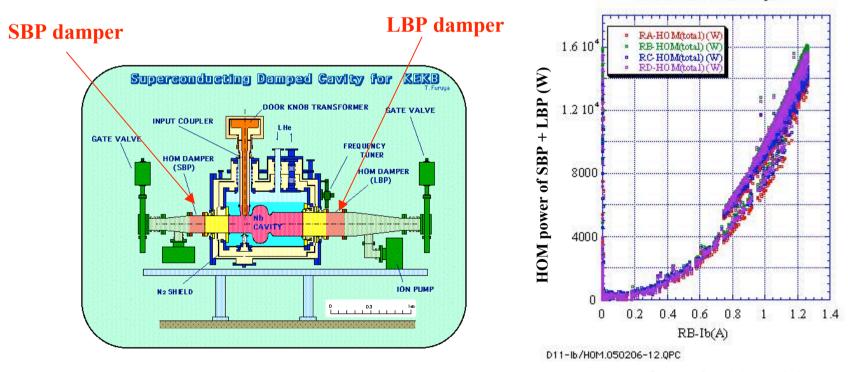
HOM of D11 cavities

RF power absorbed by HOM dampers at 1.27 A

- A beam of 1.27 A in 1293 bunches induces the HOM of 14 - 16 kW for each module. (σ_z =7mm) - The ratio of SBP / LBP is 7 kW / 9 kW.

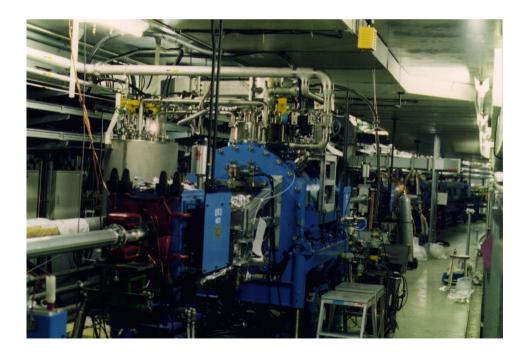
- * Because of the increase of a beam current, the SC system has no margin of RF power.
- * A prototype module constructed for the beam test in 1996 was modified as a spare module of KEKB in the last summer.
- * The module will be cooled at a test stand soon.

Prototype module in TRISTAN AR.

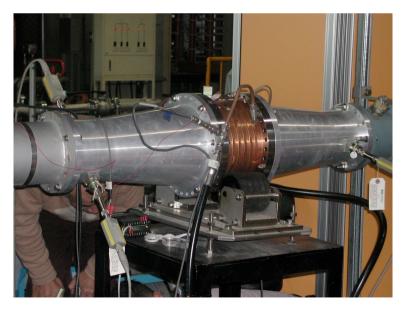
Small Beam Pipe HOM Damper

- * Power test was carried out to the spare dampers of SBP and LBP.
- * Absorbed power up to 18 kW for SBP damper and 25 kW for LBP damper did not damage the ferrite surface, which correspond to the HOM power at 2 A in 1300 bunches in HER.
- * The surface temperature reached near 200C.
- * Out gas rate should be measured as the next step.

the dampers with a thin ferrite cylinder (2-3 mm) will be fabricated and tested.

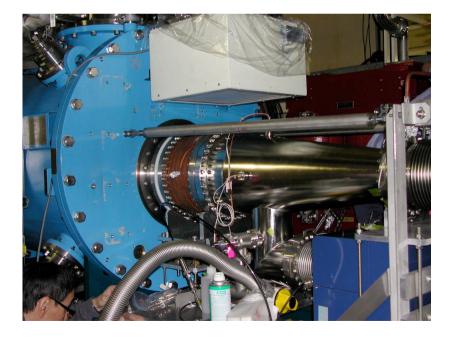
- * At the end of the last year, one of the HOM damper had a vacuum leakage at a welding seam of the flange. (D11A-LBP)
- * Troubled damper was replaced to new one in this winter shutdown.

Troubled damper was replaced to new one in the tunnel.

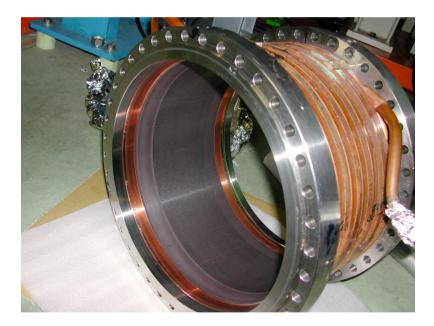
* During replacement of the dampers, we could inspect the ferrite surface.* No damage or cracking was observed on both SBP and LBP dampers.

Vacuum leakage happened at EB-welding between SUS and Cu.

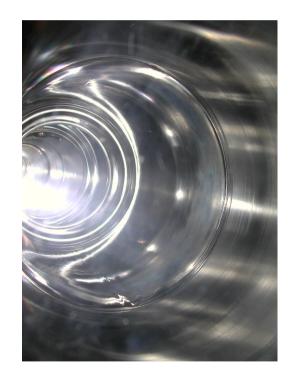
Inside view of the D11A cavity

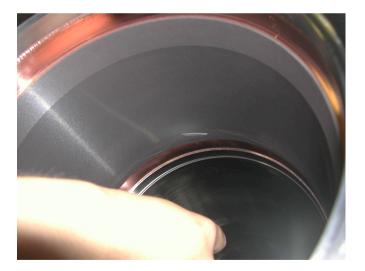
- * Both SiC and ferrite absorbers had been installed in crab-dummy chambers of D01-section and D02-section in Tsukuba-area.
- * The damage of these dampers were found in October and December.
- * Ferrite size: 170 mm ferrite cylinder with the diameter of 240 mm.

Ferrite damper of D01 section.

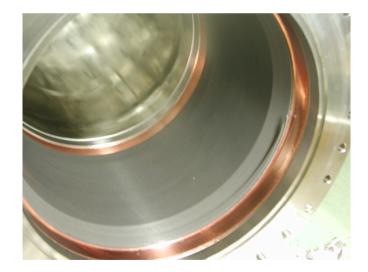
Ferrite damper of D02 section.

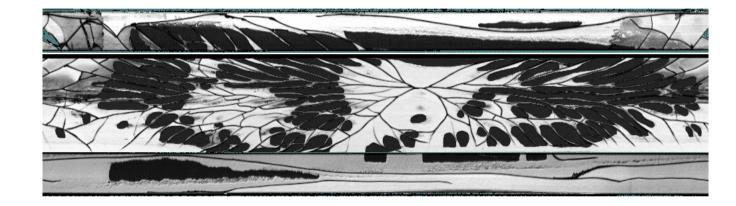
D01 ferrite

Ultra-sonic scanning showed a lot of cracking of the ferrite.

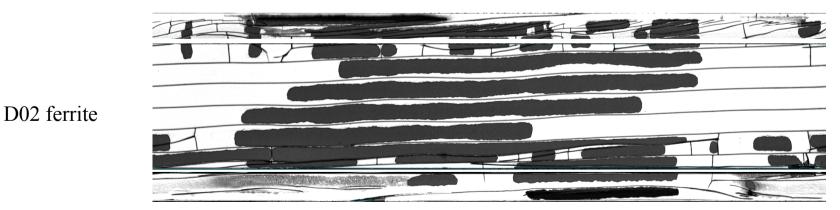
Spiral cracking suggests that caused by winding of cooling pipe from the out side.
