HOM damper for CRAB Cavity

Yoshiyuki Morita

HOM damper

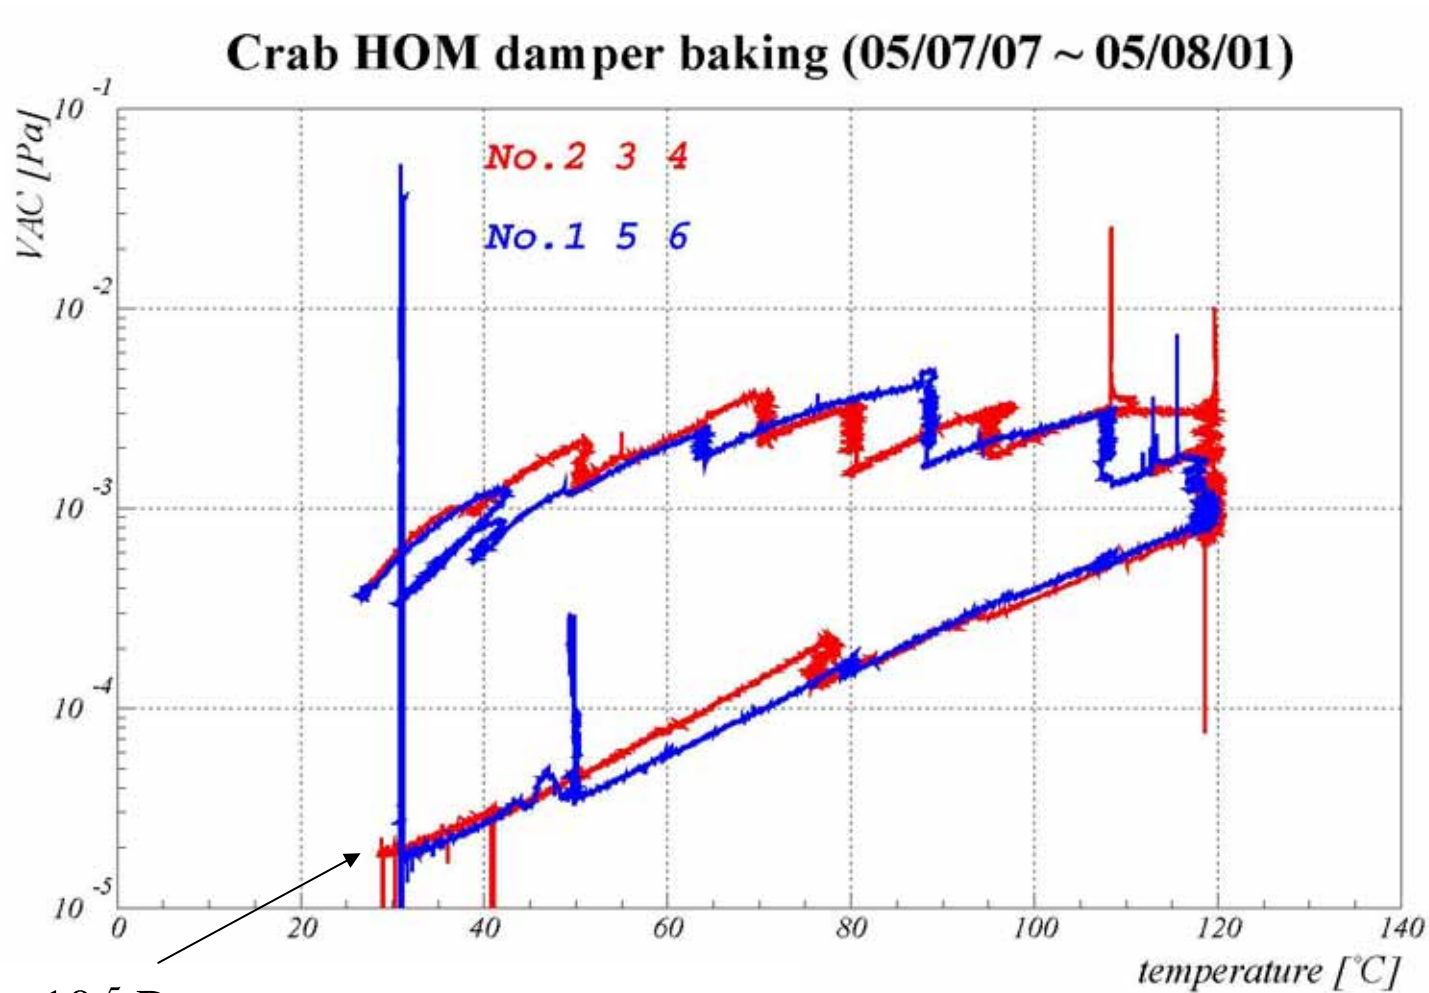
Temperature vs. pressure

2×10^{-5} Pa

Out gassing rate: 6×10^{-10} torr L/s cm²

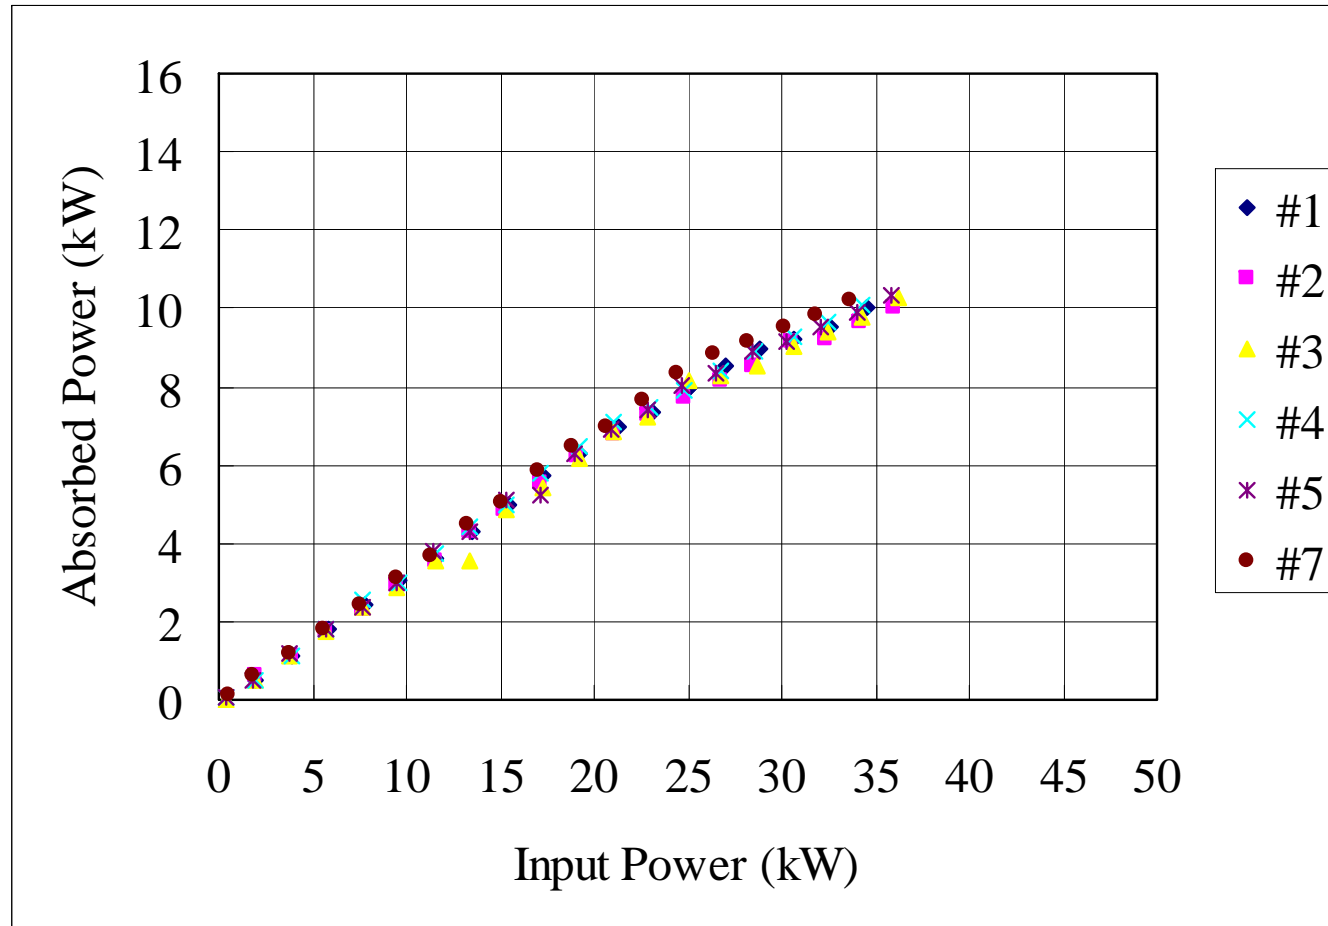
Absorbed Power

Up to 10 kW

Evaluated by cooling water temperature rise

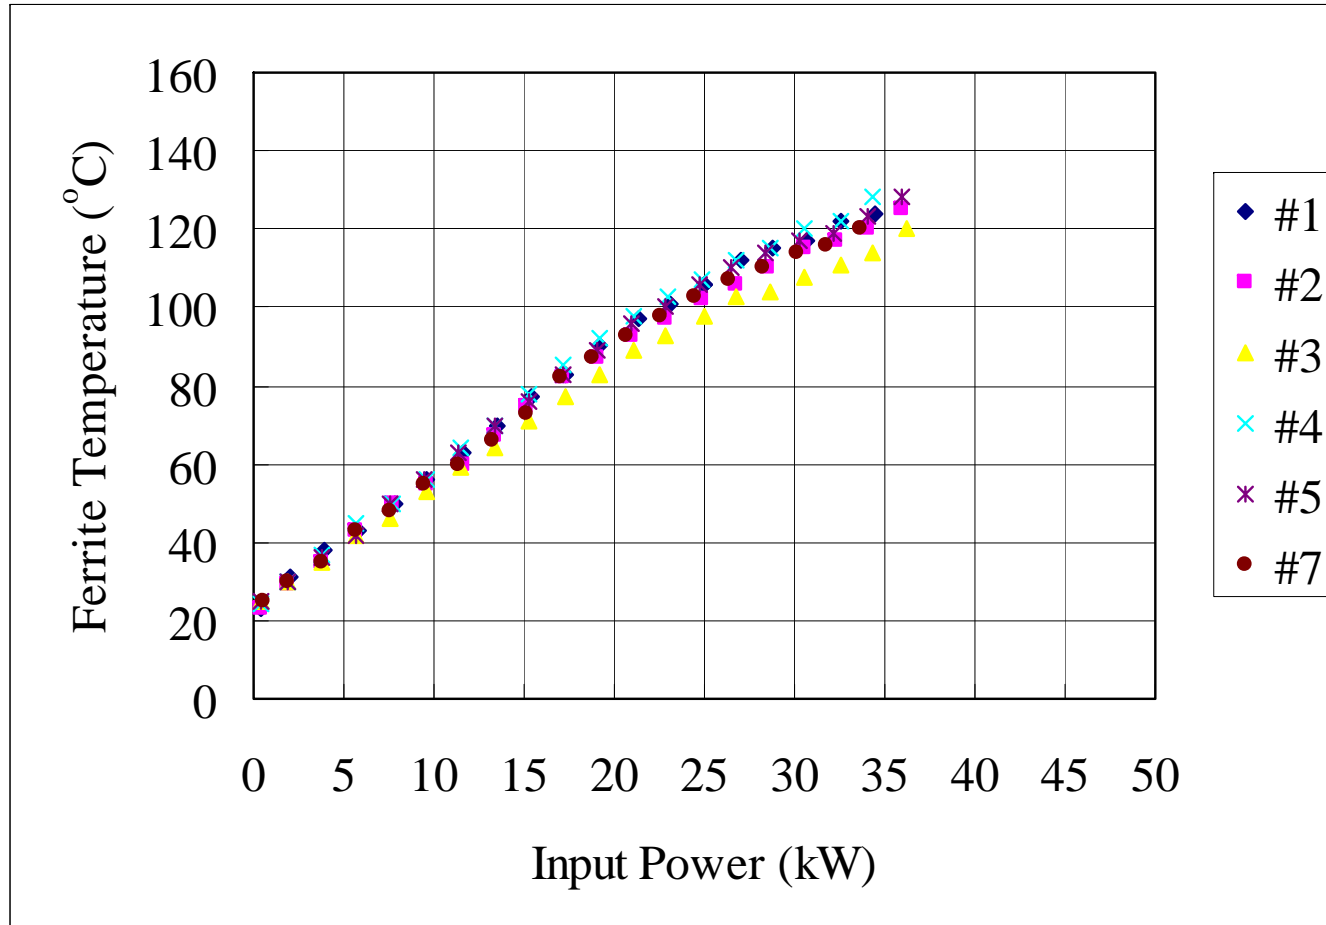
Ferrite temperature

Measured by radiation thermometer

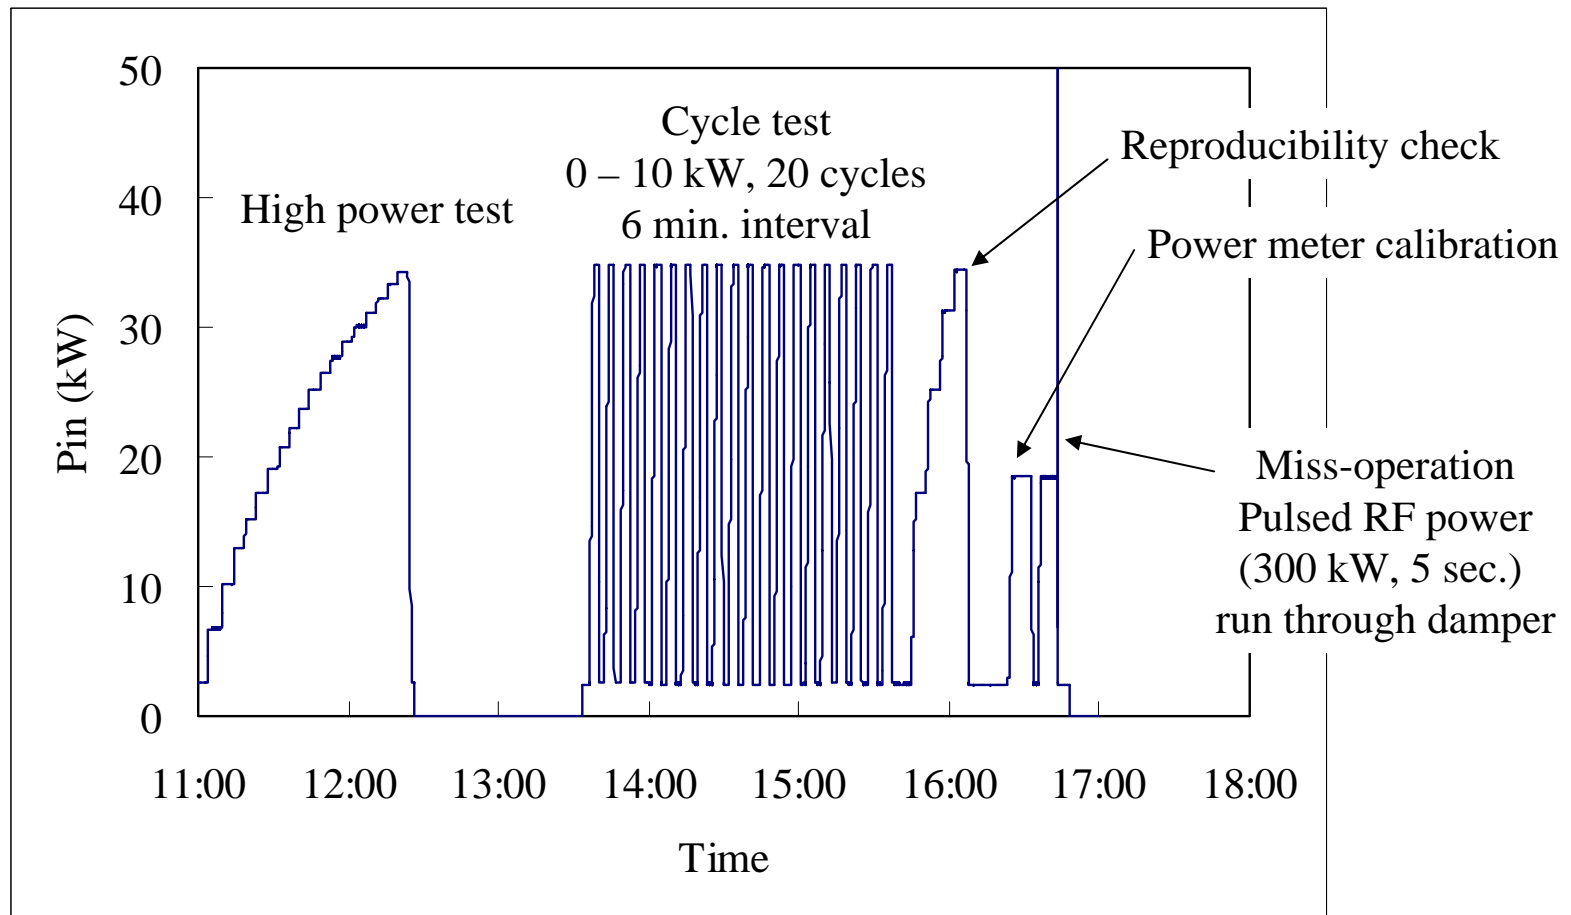
Cycle test

#4 damper experienced 300 kW

Heard cracking sounds

This is the first evidence that the damper has cracks by RF power

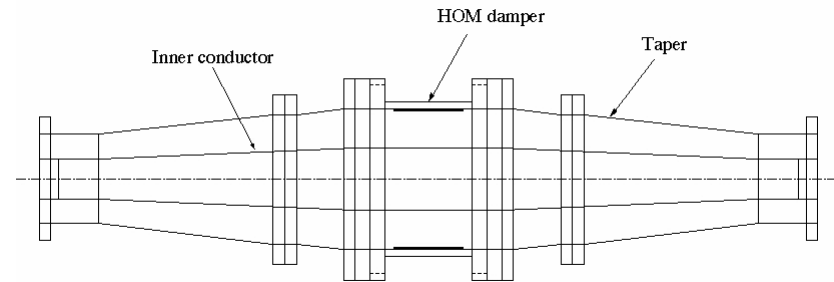
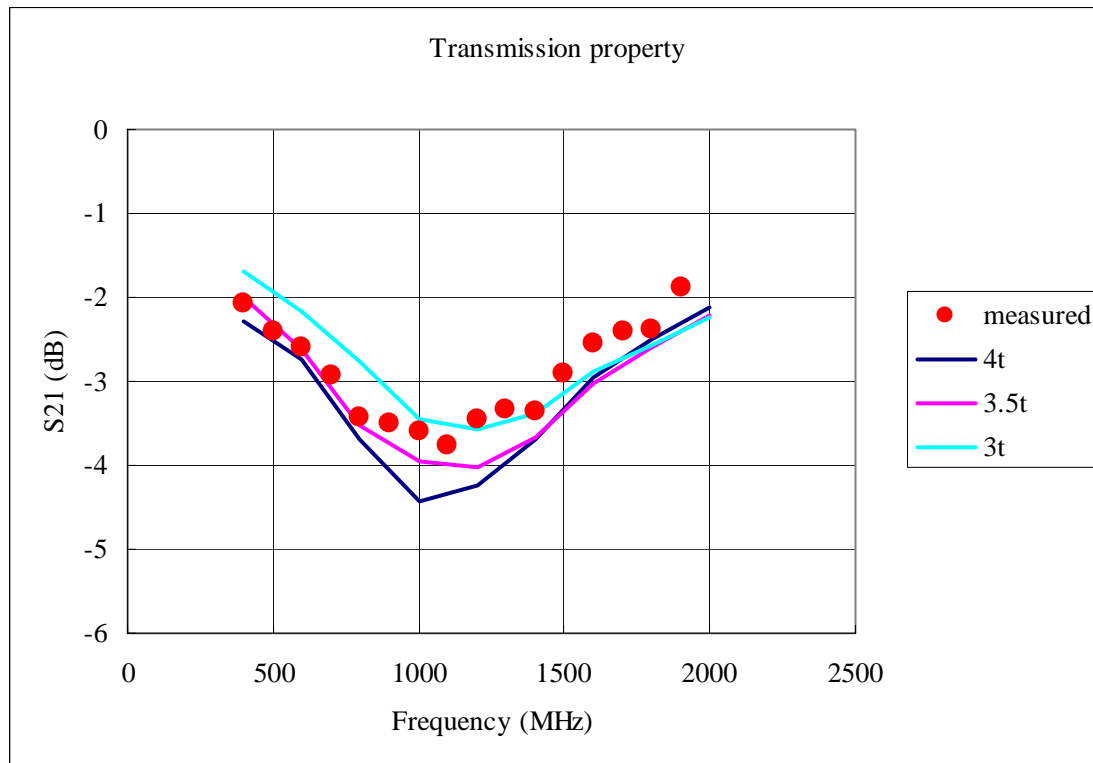
Transmission property

S21 was measured from 400 MHz to 2000 MHz.

S21 was calculated using HFSS for several thickness of the ferrite (nominal thickness: 4 mm).

Simulation with the thickness of 3.5t agrees with measured data.

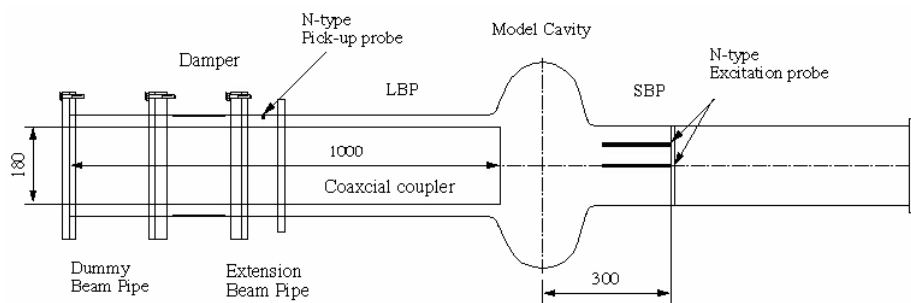
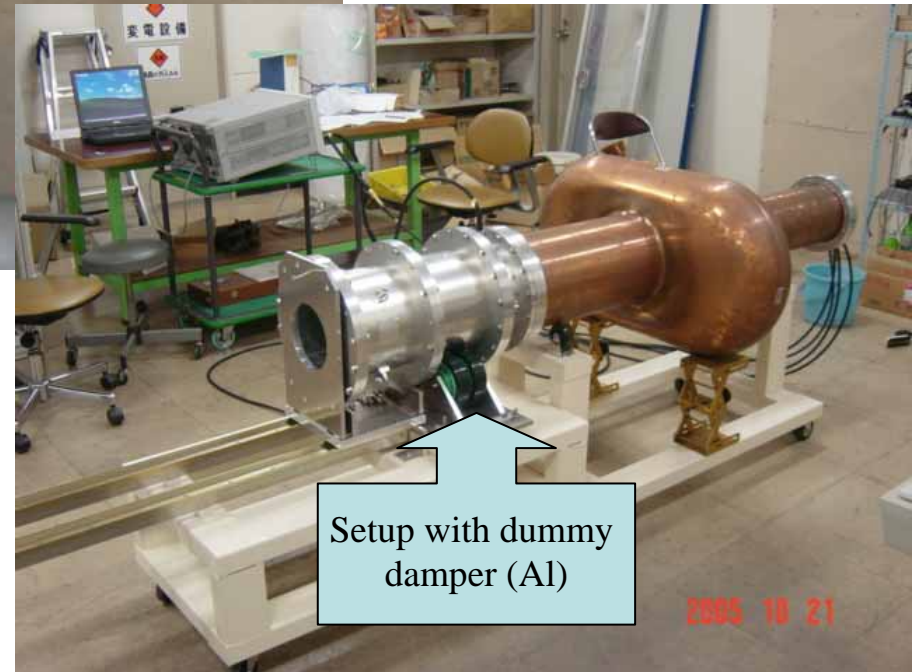
Mode damping

Check damping of LOM/HOM
Check validity of simulation

Setup with dummy damper (Al)

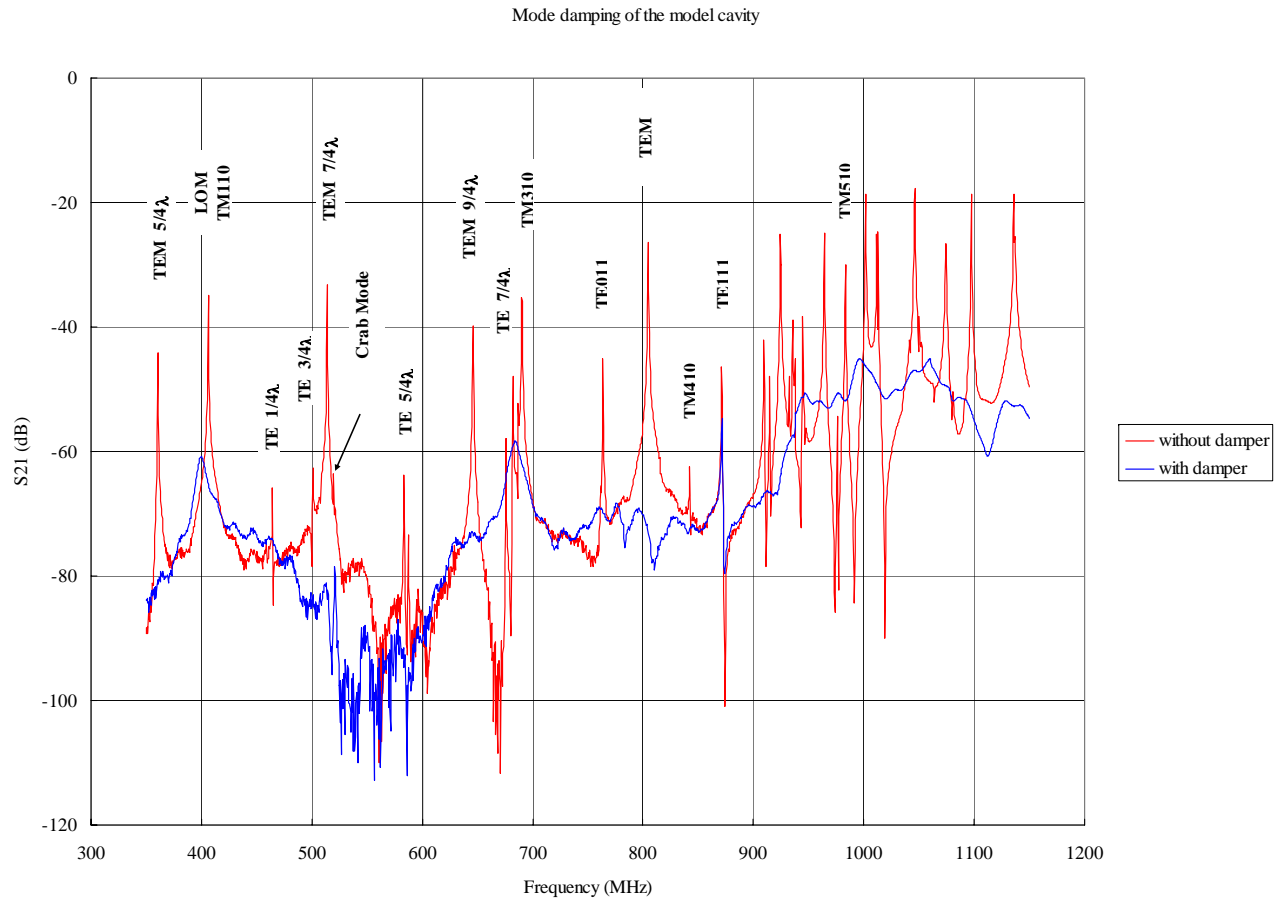
Mode damping of the model cavity

Transmission property of the model cavity with/without the HOM damper. The LOM and HOMs are sufficiently damped. Q factor of the TE111 is still high, because of its weak coupling to the coupler.

Frequencies and Q factors of several modes.
HFSS simulation agrees with measured data.

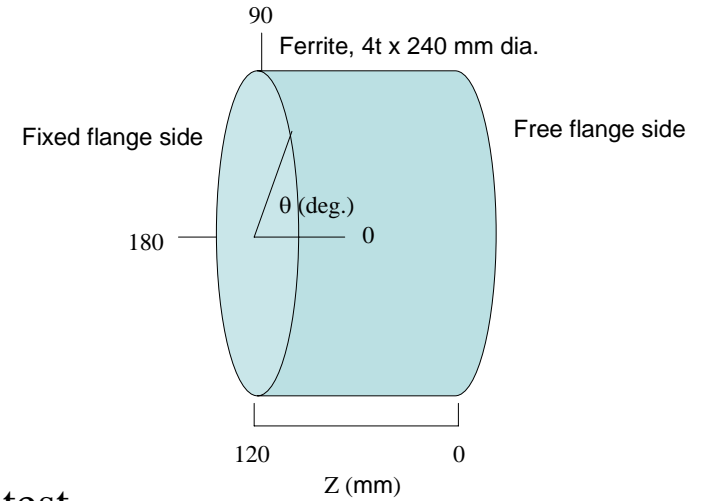
Crack mapping

A map of cracks was made after cracking using a micro-scope
 #4 damper was high power tested and cycle tested again
 Cracks were inspected once again
 No significant growth of cracks was found

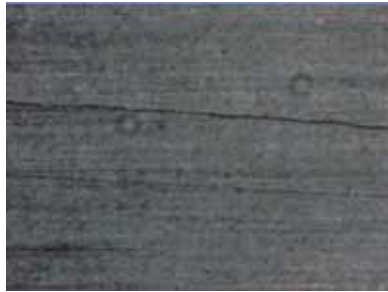
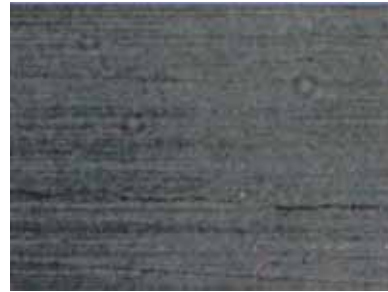
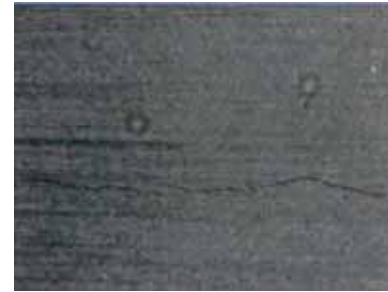
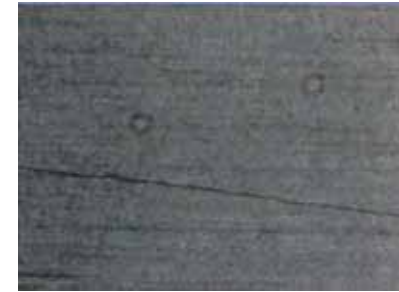
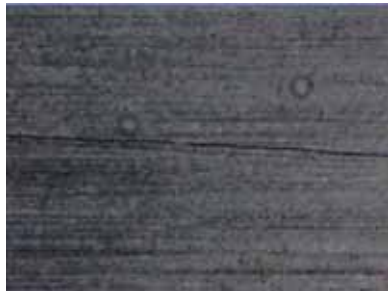
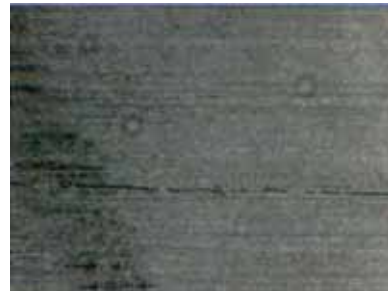
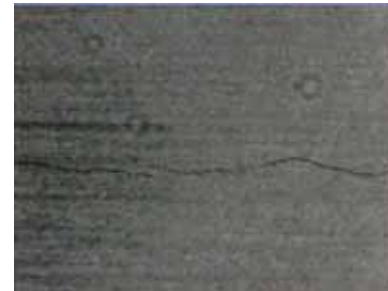
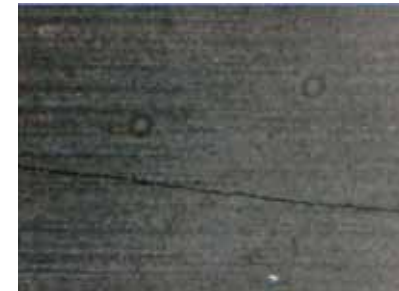
Pictures taken before/after the cycle test
These pictures show no growth of cracking
