# The Horizontal Test of the Prototype Crab Cavity

2006.02.17 11:03  
Crab Cavity Group  
Y. Yamamoto

# Purpose

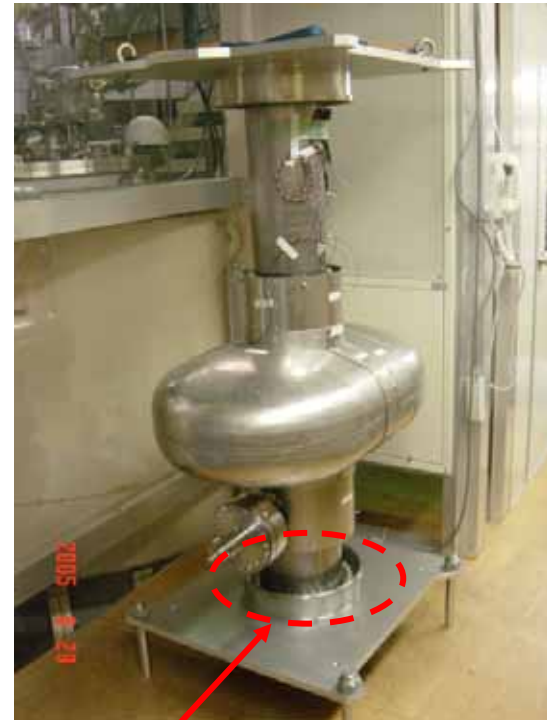
After pulling up the cavity from the cryostat ...

A few screws at the indium flange loosened after the vertical test. Then we re-tightened them.

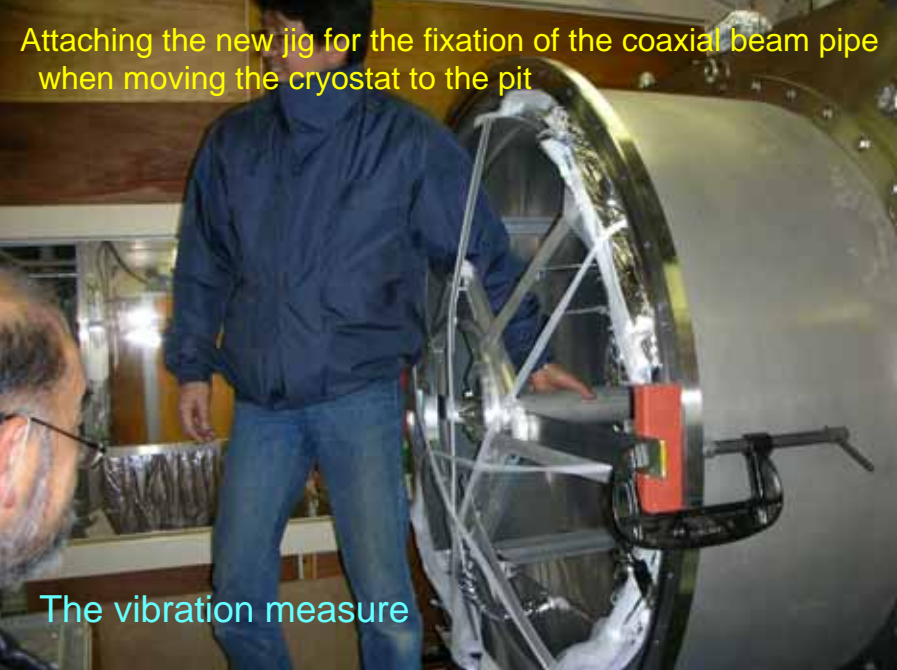
Attaching the new jig for the fixation of the coaxial beam pipe when moving the cryostat to the pit

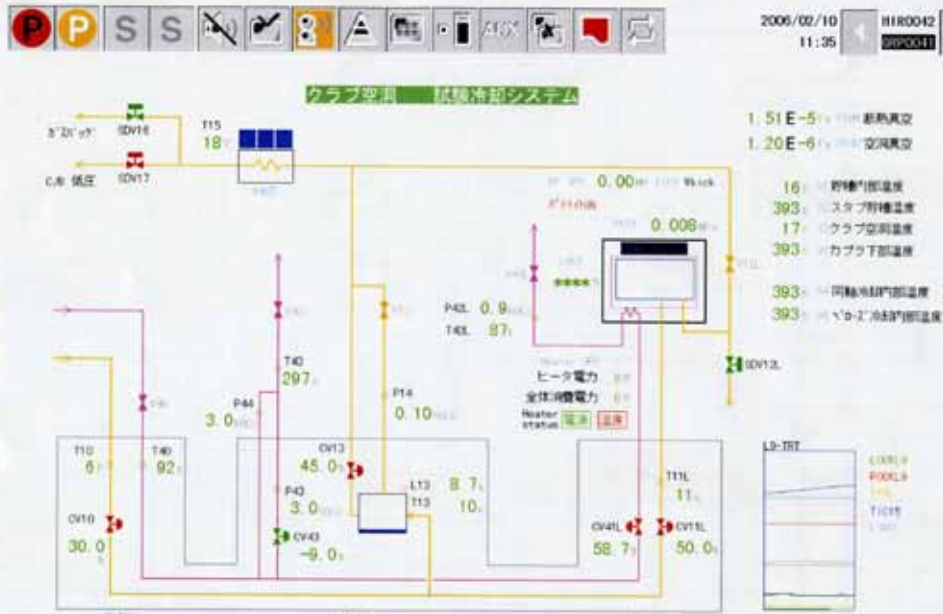
HITACHI EX 5000 System

HITACHI refrigerator group enabled the cryostat to cool down all day. And, they recorded each measurement value per 1 hour during the cold test.

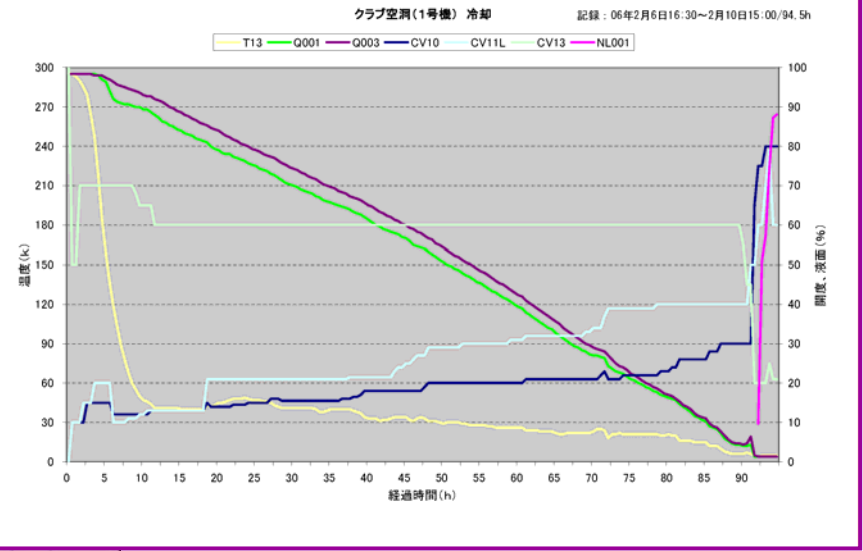
Temperature at each valve

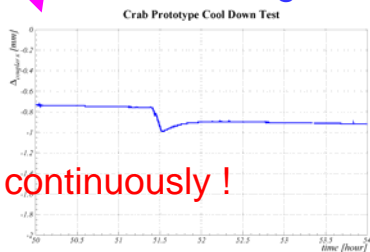
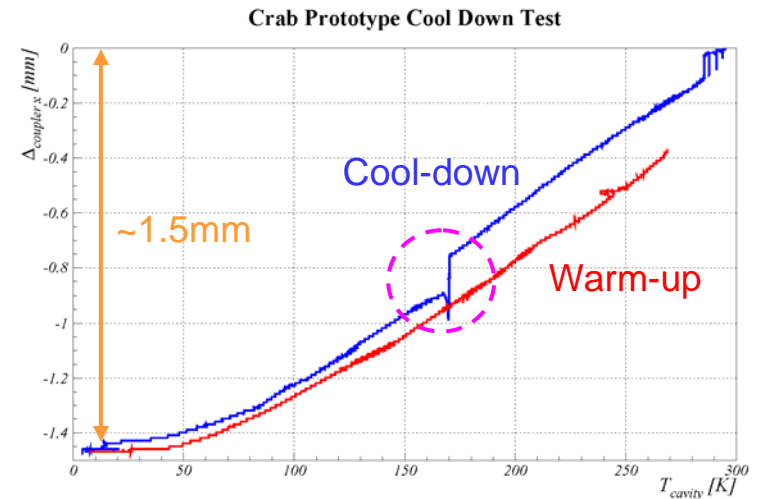
The input coupler was pulled down to the cavity side, because the cavity shrank during cool-down. The sudden change occurred during the cool-down, and it was the continuous change, not accidentally.

Sudden change

Changing continuously !

The cool-down rate was changed from 2.8K/hour to 3.5K/hour around this time.

And the cryostat vacuum also became bad.

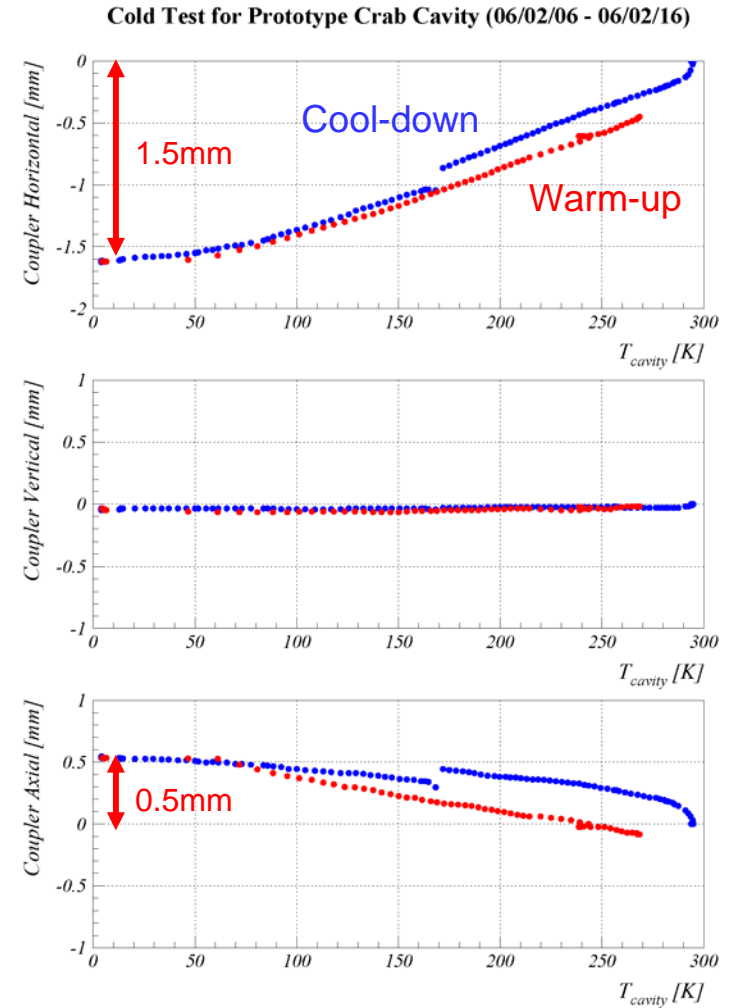
The input coupler was pulled down to the large beam pipe totally.

LBP was not moved due to the fixed end.

- The cold test was completed **successfully** without the leak.
- The resonant frequency was changed by about **0.6MHz** from the room temperature to 4.2K.
- $Q_L=8.6 \times 10^5 \sim 1.3 \times 10^6$  @ 4.2K (estimated  $1.0 \times 10^6$ )  
We don't understand the reason for the changing  $Q_L$ .
- Static loss was about **30W**.
- The input coupler was drawn to the fixed end (LBP).
- The refrigerator system had **no problem**.

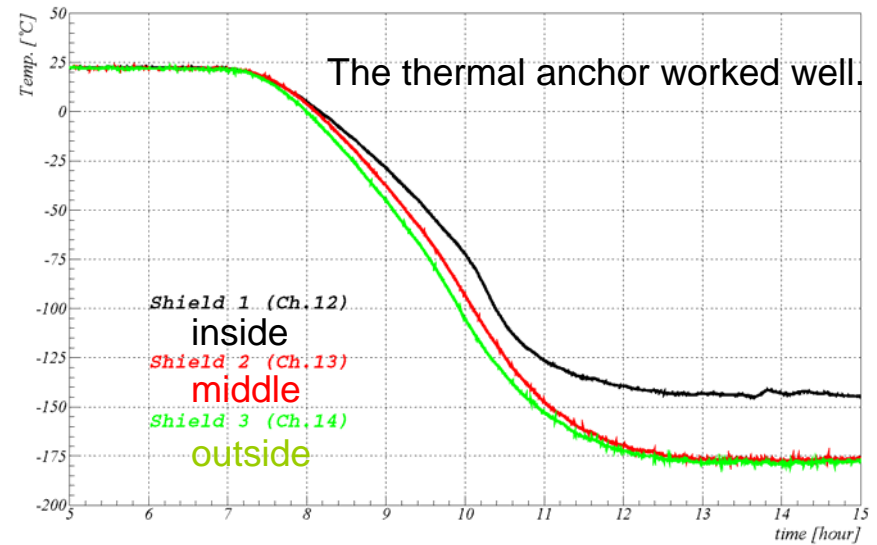
Temperature on the thermal anchor

Temperature Time Trend During Cooldown

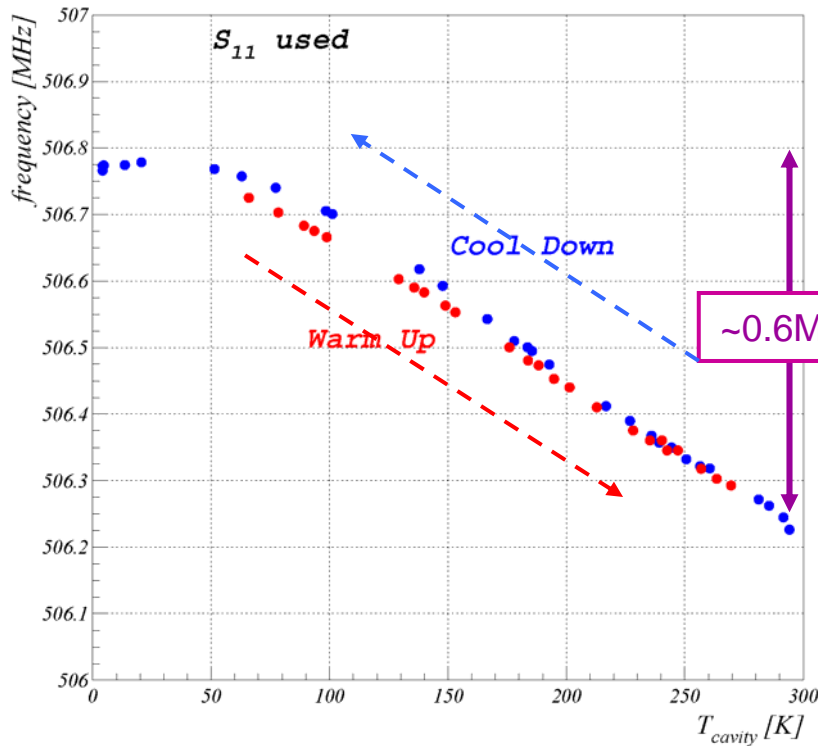
Cold Test for Prototype Crab Cavity (06/02/06 ~ 06/02/16)

The cavity was **not pre-tuned**, because it is not used for the operation.

The resonant frequency was changed by about **0.6MHz** from the room temperature to 4.2K.

The measurement by  $S_{21}$  also became possible below  $T_{cavity}=60K$ .

The both resonant frequencies were same below  $T_{cavity}=60K$  for the measurement used by both  $S_{11}$  and  $S_{21}$ .

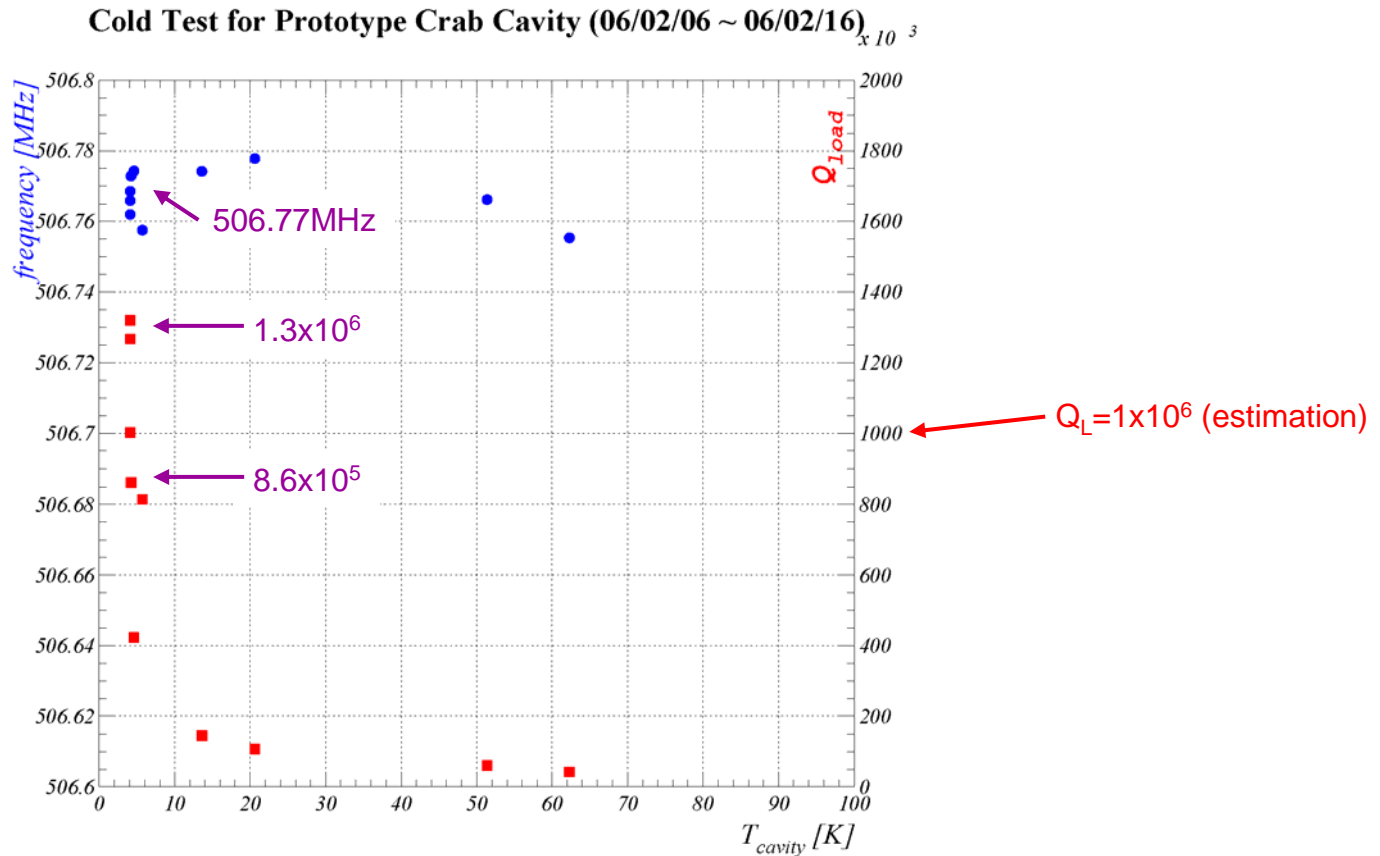
After the cavity reached 4.2K, the resonant frequency and  $Q_L$  were changed considerably (8.6  $\times 10^5$  1.3  $\times 10^6$ ).

The inner conductor of the input coupler was cooled down ?
