Recovery of Linac after the Earthquake

SuperKEKB Accelerator Review, 2012. 2. 20

KEK e-/e+ Injector Group

Recovery of Linac

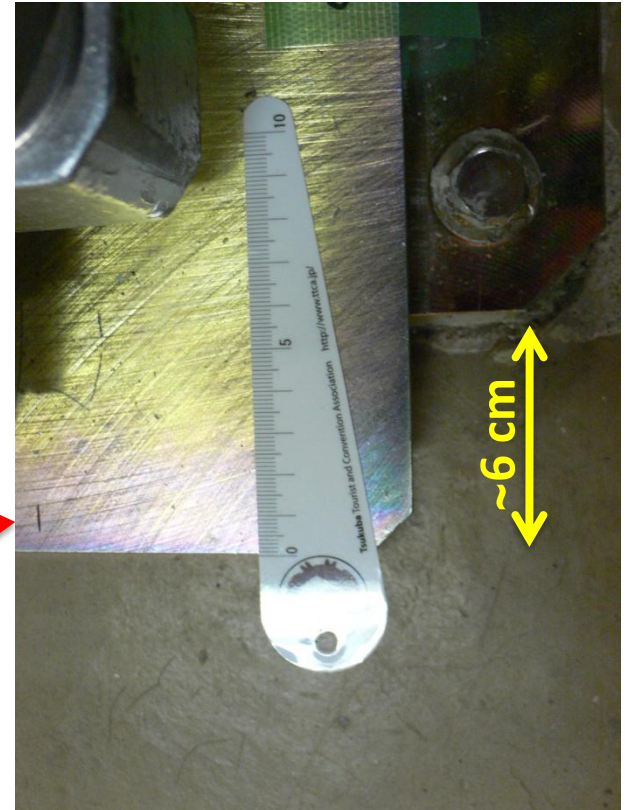
Transverse Shifts

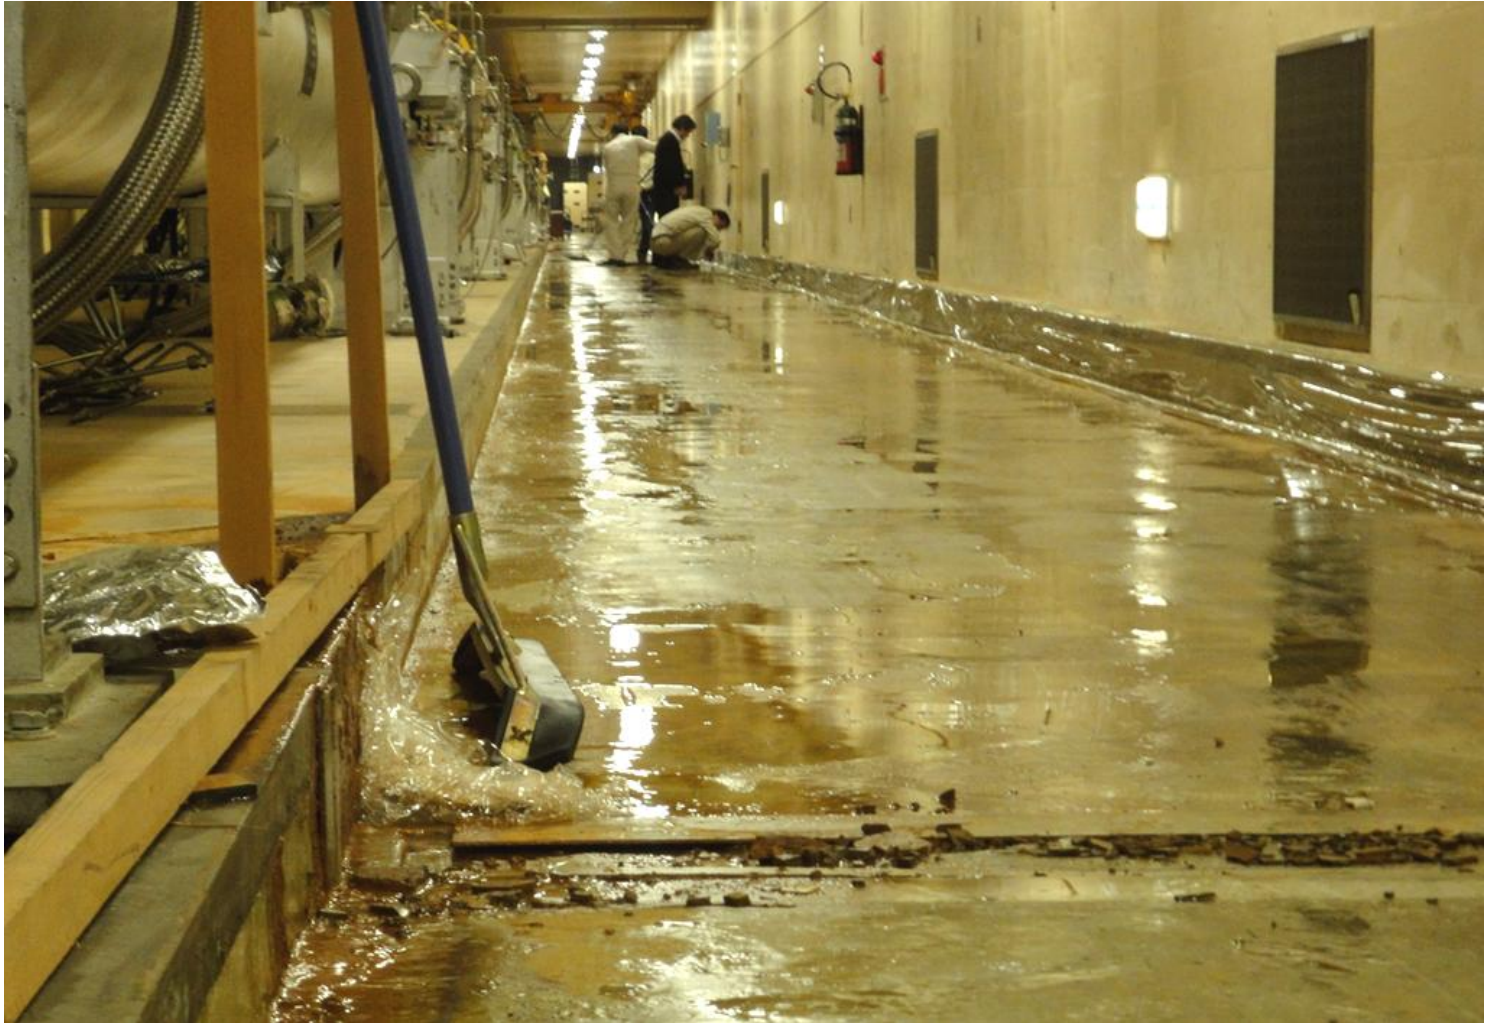
Inflow Water through Tunnel Joints

- **Inflow water from the tunnel joints exceeded 50 t per day after the earthquake; however, by grouting materials into joints several times it has been reduced less than 2 t per day since autumn, 2011.**

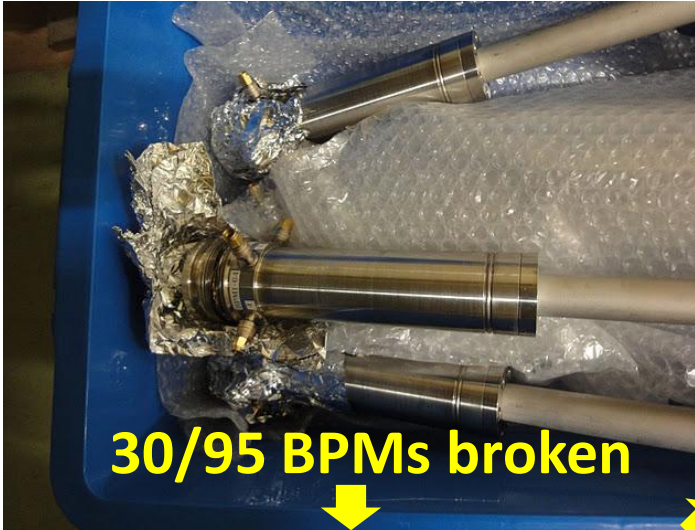
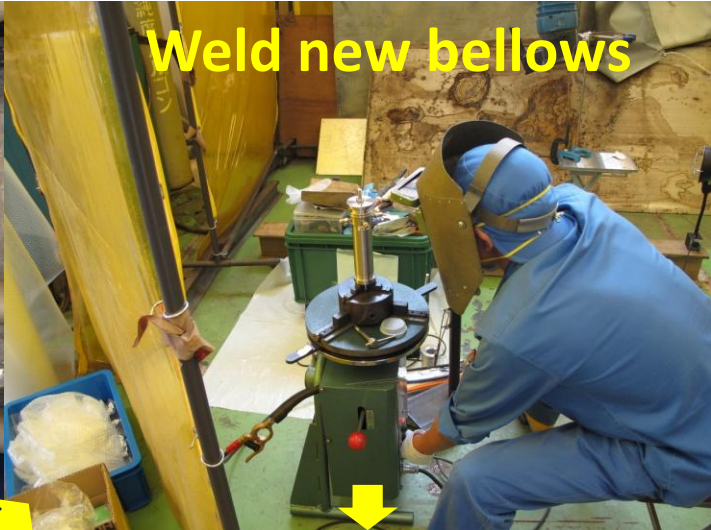
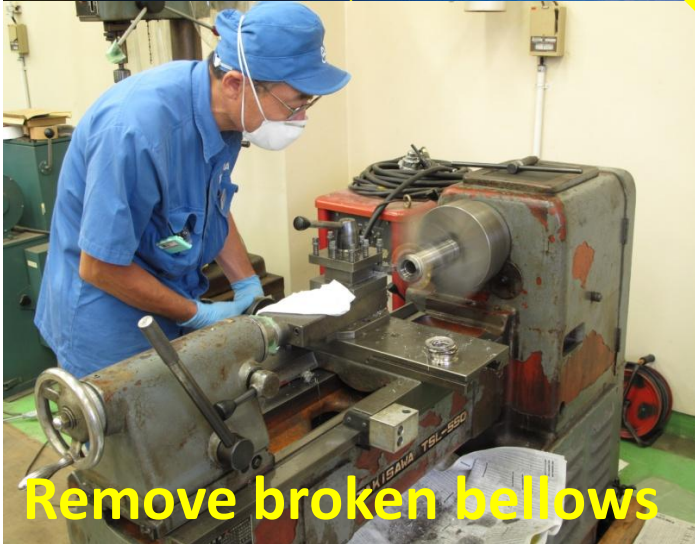
BPMs Repaired in KEK Workshop

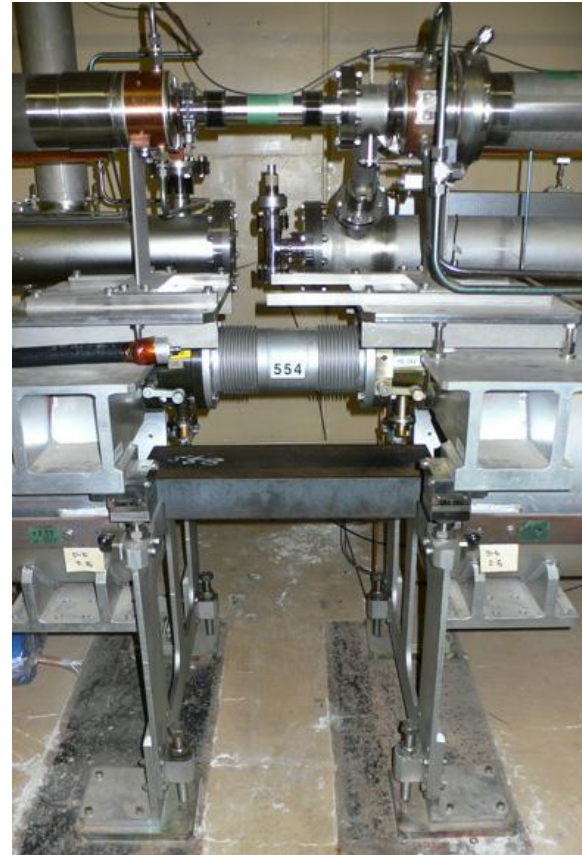
Reinforced Accelerator Girders Against expected strong aftershocks

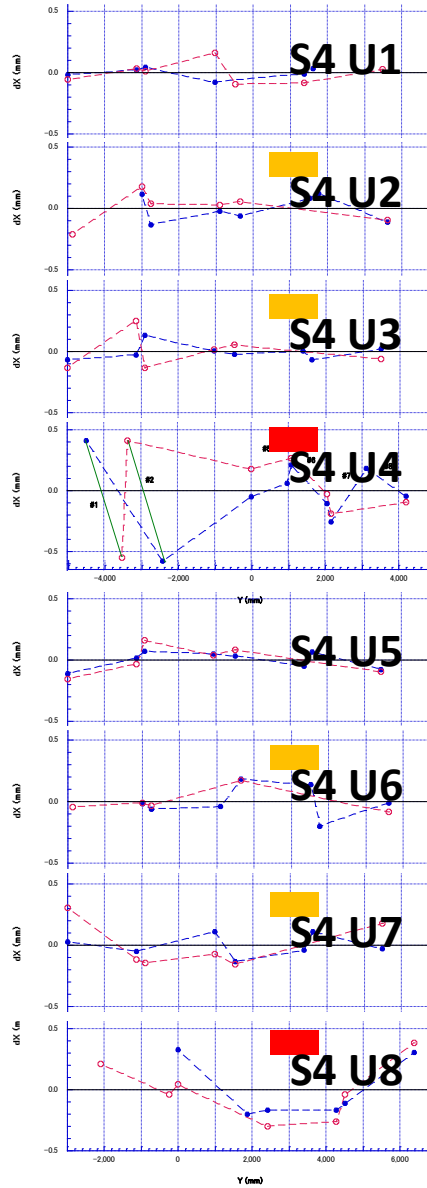
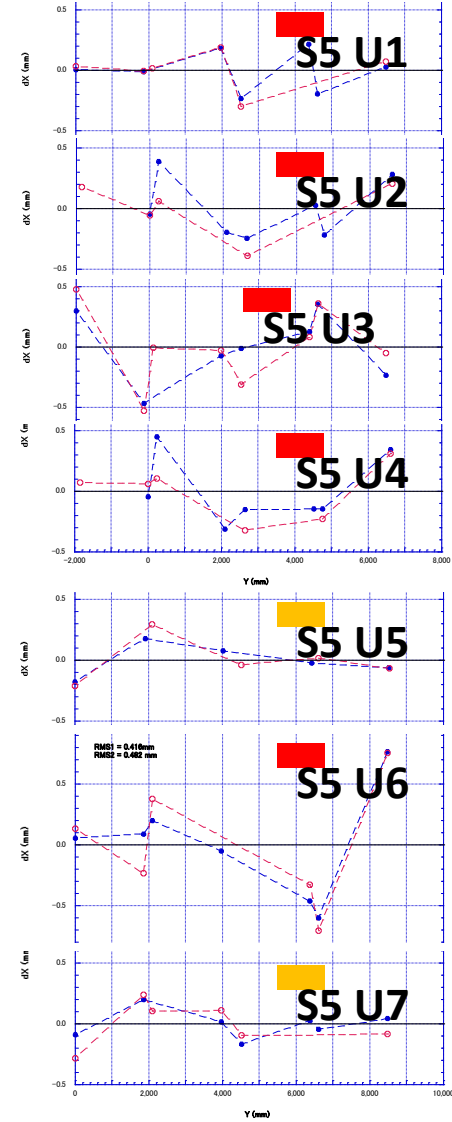
Only large discrepancy corrected

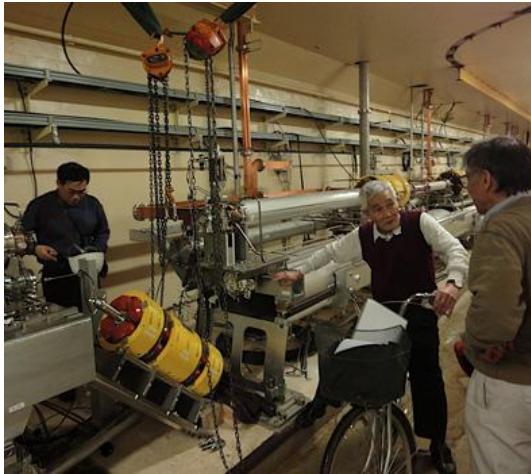
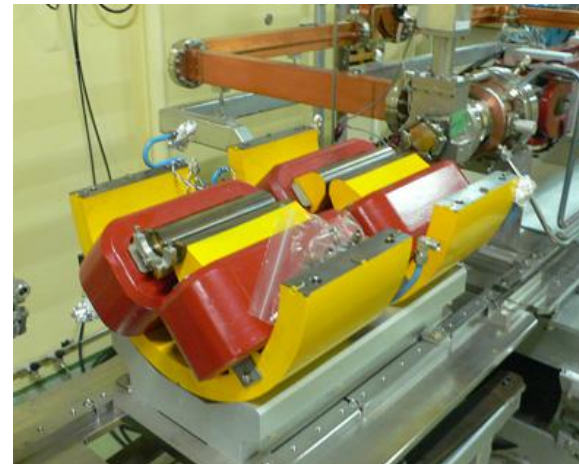
- The magnet dropped was temporarily placed on the floor.
- The broken boms were all removed and already repaired.

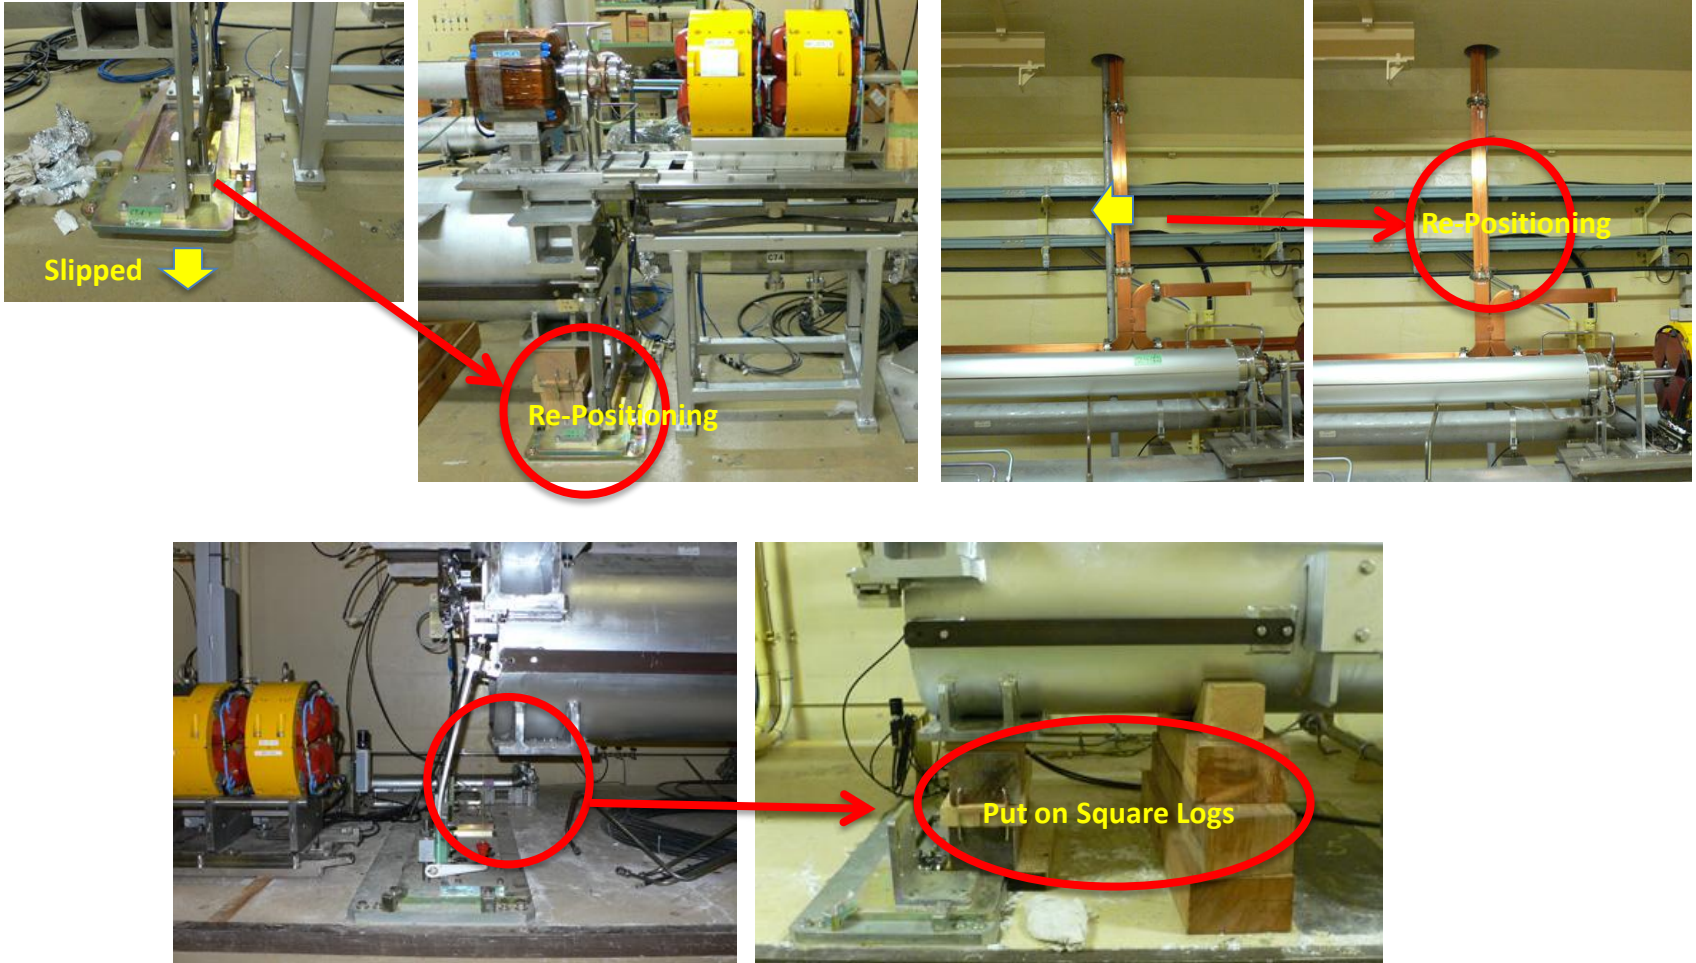
- The accelerator units were roughly corrected to their original positions.
- The broken girders were temporarily put on square logs.
