TiN Coating and Baking of Beam Pipes

The 18th KEKB Accelerator Review Committee
March 4, 2013

Kyo Shibata (on behalf of KEKB Vacuum Group)

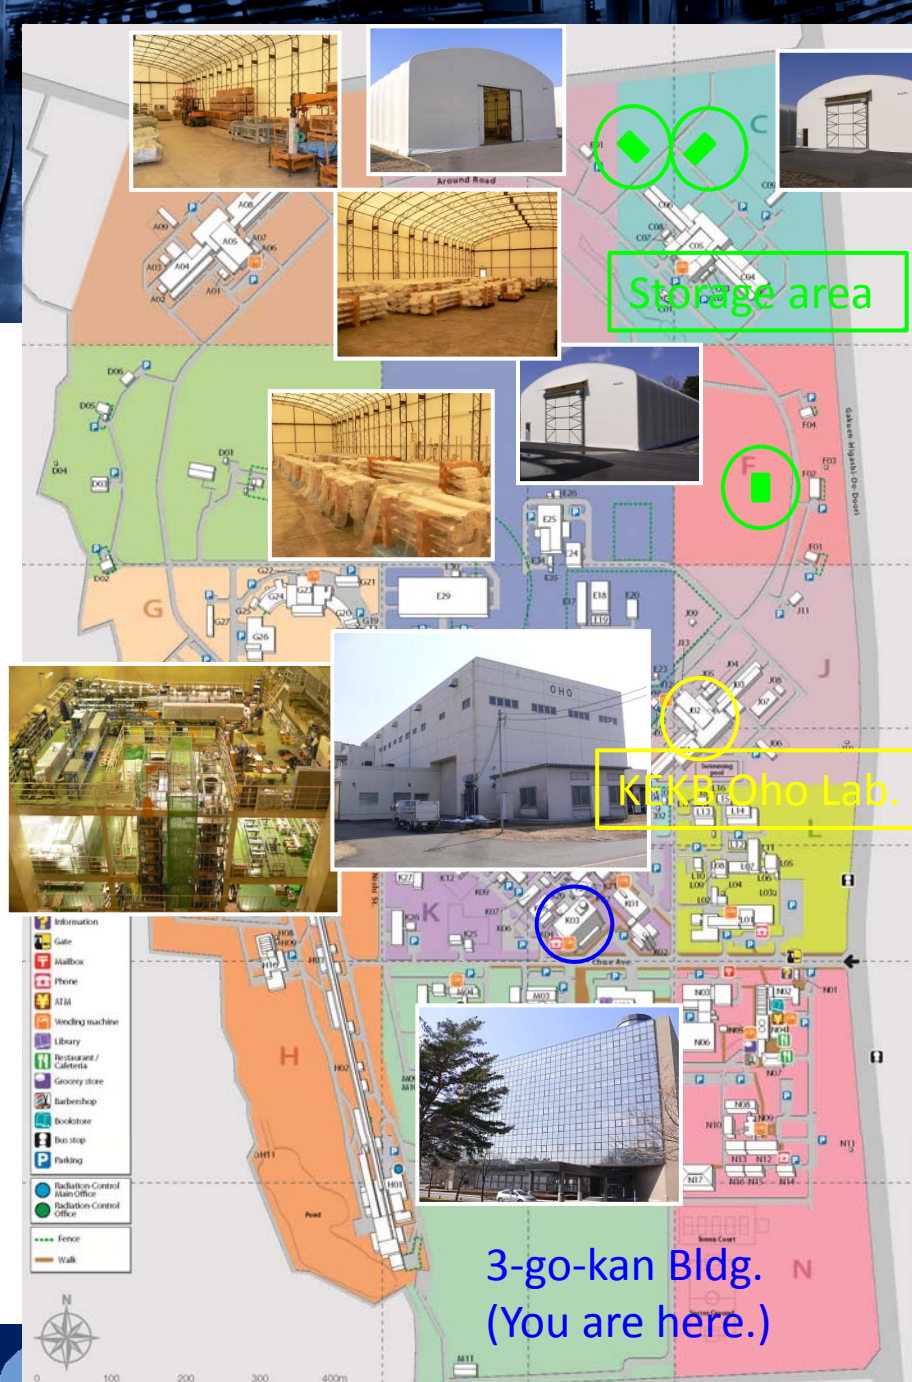
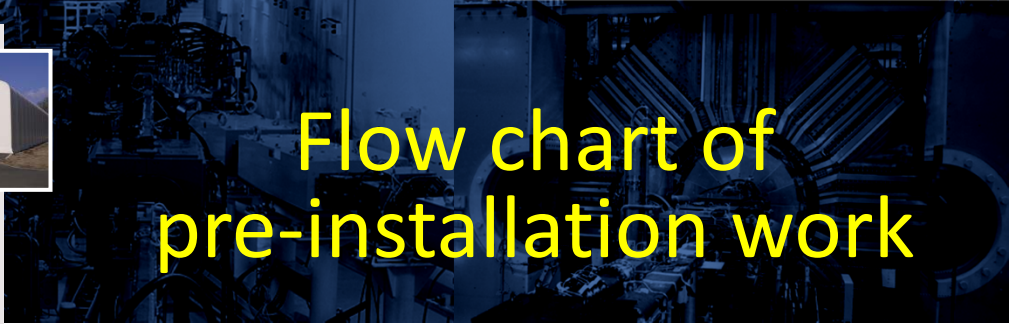
Flow chart of pre-installation work

- What should we do before the installation of new beam pipes?
 - For HER (e-) : Baking at the laboratory(not *in-situ*)
 - For LER (e+) and Damping Ring : Baking & TiN coating at the laboratory
- How many beam pipes should be processed?
 - For HER (e-) : ~180
 - For LER (e+) : ~1000 (of which ~ 25 have electron clearing electrodes and TiN coating is unnecessary.)
 - For Damping Ring : ~100
- Pre-installation works (coating and baking) started on last April.
 - Pre-installation work means:
 - Bringing beam pipes to KEKB Oho Lab. from storage area -> Coating (only for LER, 3days) -> Baking (3days) -> returning the beam pipes to storage area
 - Large-scale works by 10 workers with 4 coating equipments and 4 baking equipments started on last September.

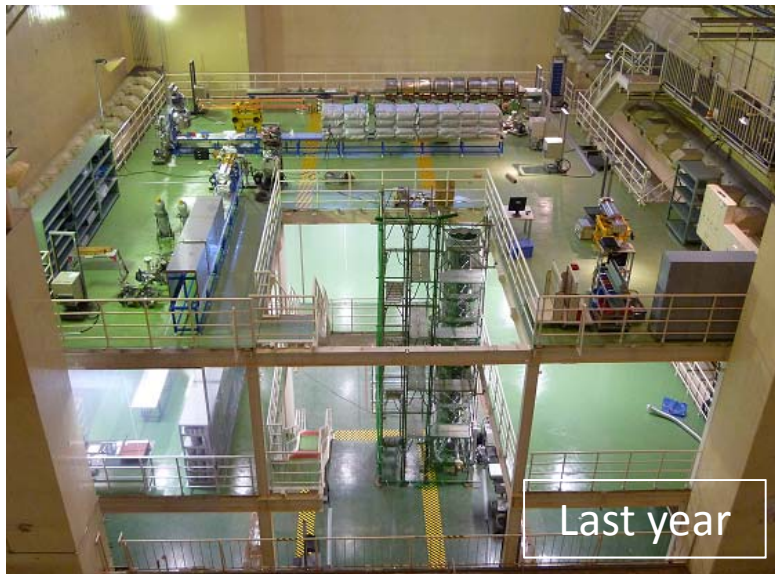
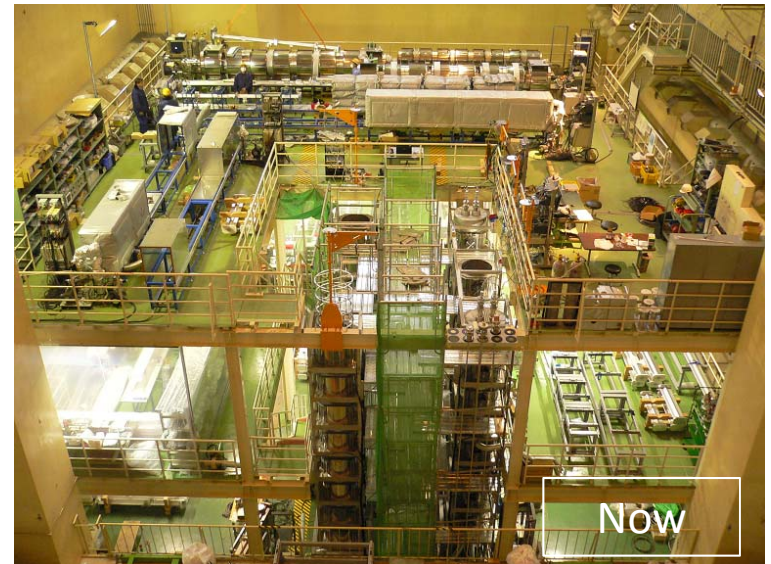
Layout of Oho laboratory 1

- 4 baking equipments : 2 long type (~5 m) and 2 short type (~3 m)
- 5 vertical TiN coating equipments (for straight beam pipes. one of them is back up.)
- 3 horizontal TiN coating equipments (for bent pipes. In preparation now.)

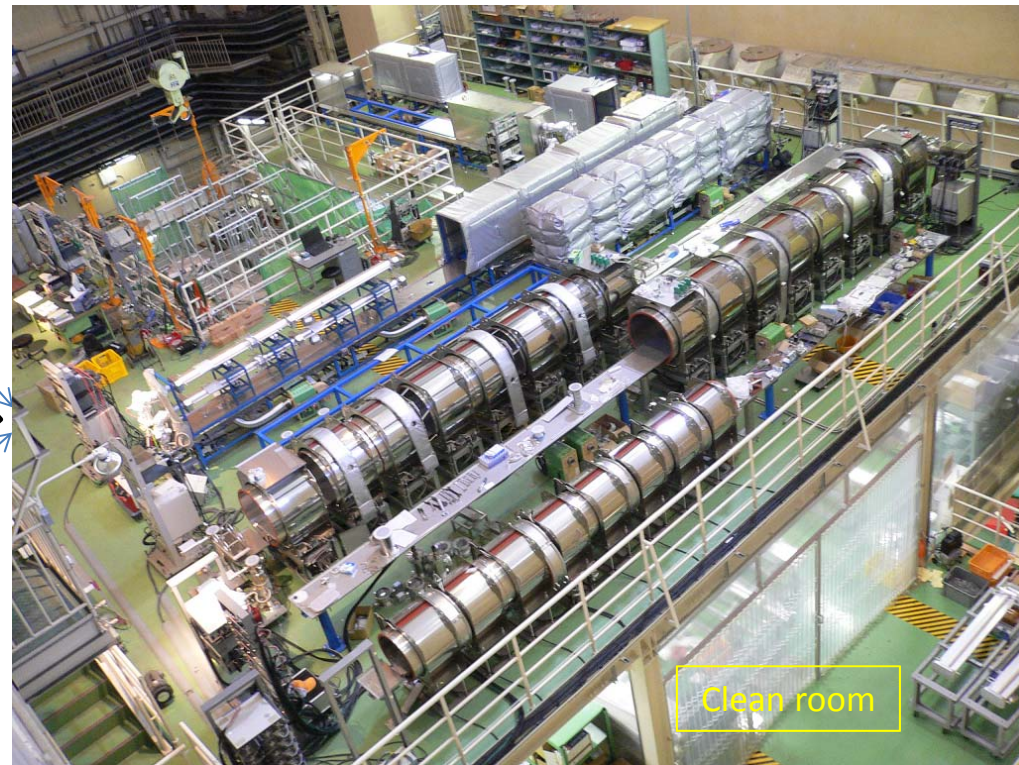
- Hot-air heating method was adopted.
 - Two beam pipes are mounted up and down in one hot-air oven.
 - Hot-air oven consists of movable insulated walls and insulated frame.
 - Hot air is circulated in the hot-air oven.
 - Each pipe is evacuated by a turbo-molecular pump (0.3 m³/sec) during the baking.

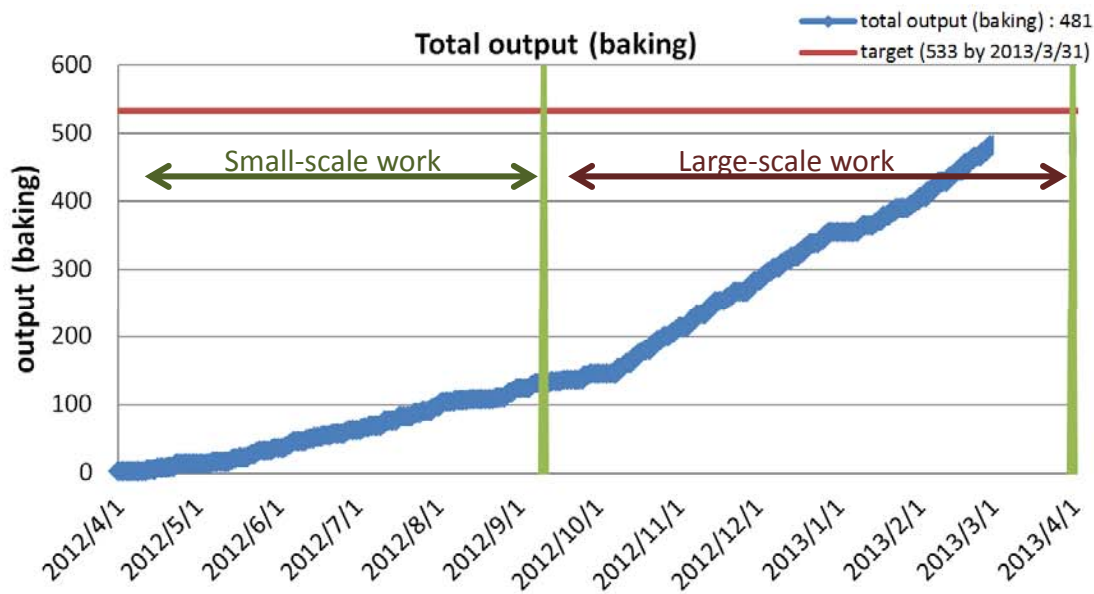
Baking 3 : Rate of baking output

- Baking work started on last April.
 - Baking work started on small scale with 2 baking equipments on last April.
 - On last September large-scale works with 4 baking equipments started.
- Total output by last month (2013/2/28) is 481.
 - Averaged daily output : 0.8 (small-scale), 2.0 (full-scale), 1.4 (total)
 - Averaged weekly output : 5.5 (small-scale), 13.9 (full-scale), 10.0 (total)

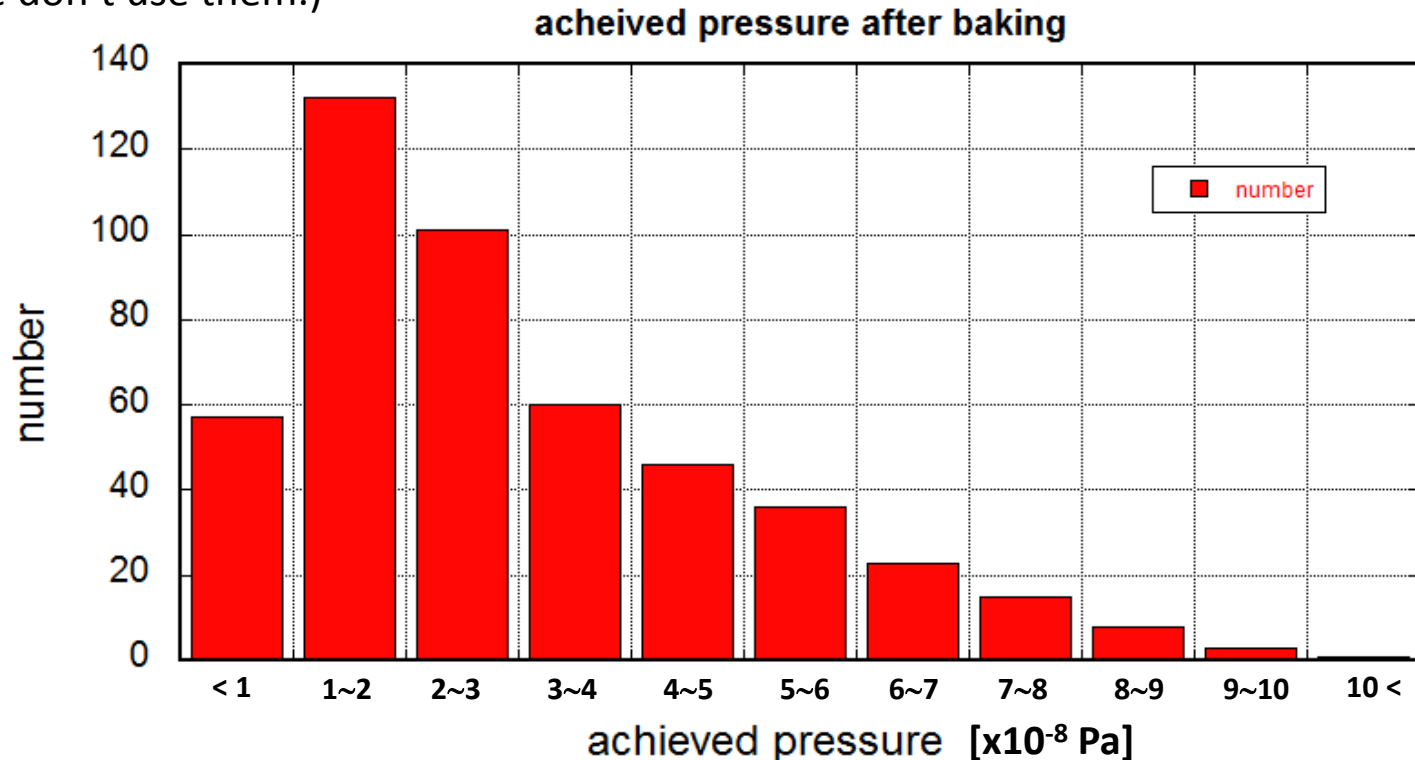
Baking 4 : Achieved pressure after baking

- For almost all beam pipes, achieved pressures after baking are below 1×10^{-7} Pa.
 - If achieved pressure is higher than 1×10^{-7} Pa, the beam pipe is baked again. (only 3 cases so far)
 - Mass pattern after baking is not monitored. (Although 2 of 4 baking equipment have RGAs, we don't use them.)

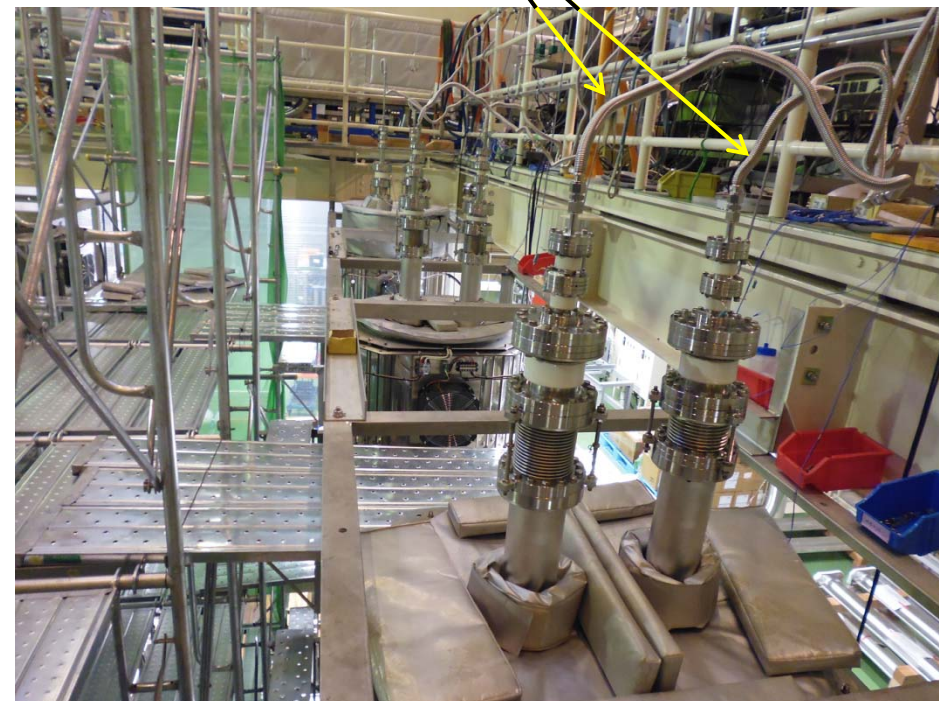
TiN coating 4 : View from top floor

Introduced gas line

Mass flow controllers

Control desk

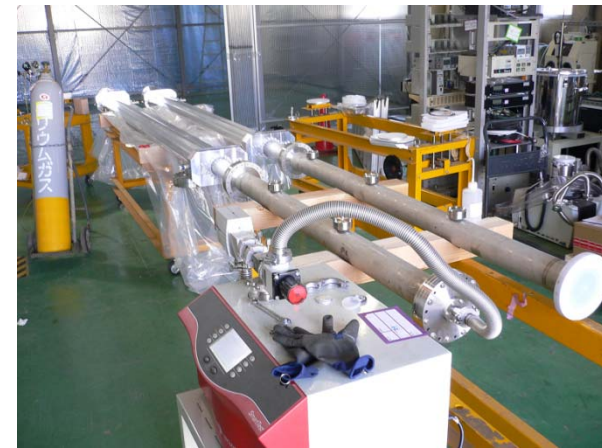
Leakage test before installation

- Before coating (at Oho clean room)
 - Visual check on the beam pipe.
 - Putting blank flanges on pumping ports and BPM ports.
 - Connecting beam pipes and dummy pipes for length tuning. (if necessary)
 - Leakage test
 - Installation of beam pipes on coating equipment.
- In coating equipment
 - Leakage test
 - Pre-baking (~ 150 °C, ~ 24 hours)
 - TiN coating (Discharge duration : ~ 80 min.)
- After coating
 - Filling with dry nitrogen up to atmospheric pressure.
 - Dismantling beam pipes
 - Installation of NEG pumps and BPM electrodes at Oho clean room.
 - Baking

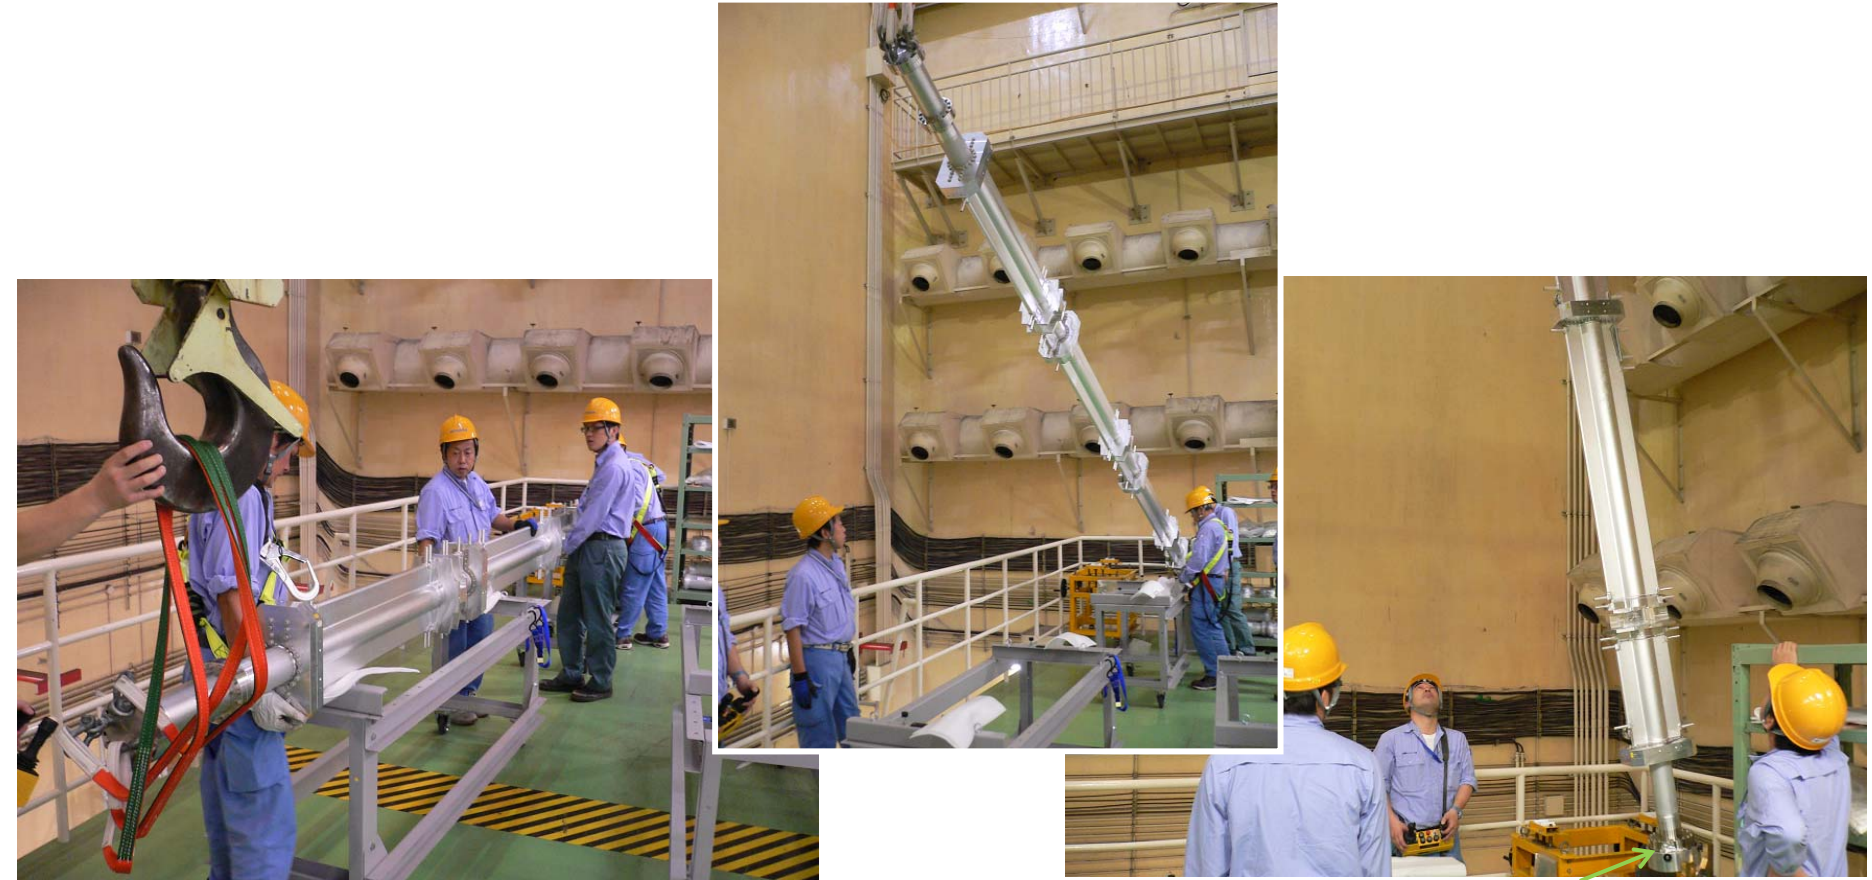
Hinge assembly to get beam pipe upright

- Beam pipes are transported and installed on the coating equipment by crane.

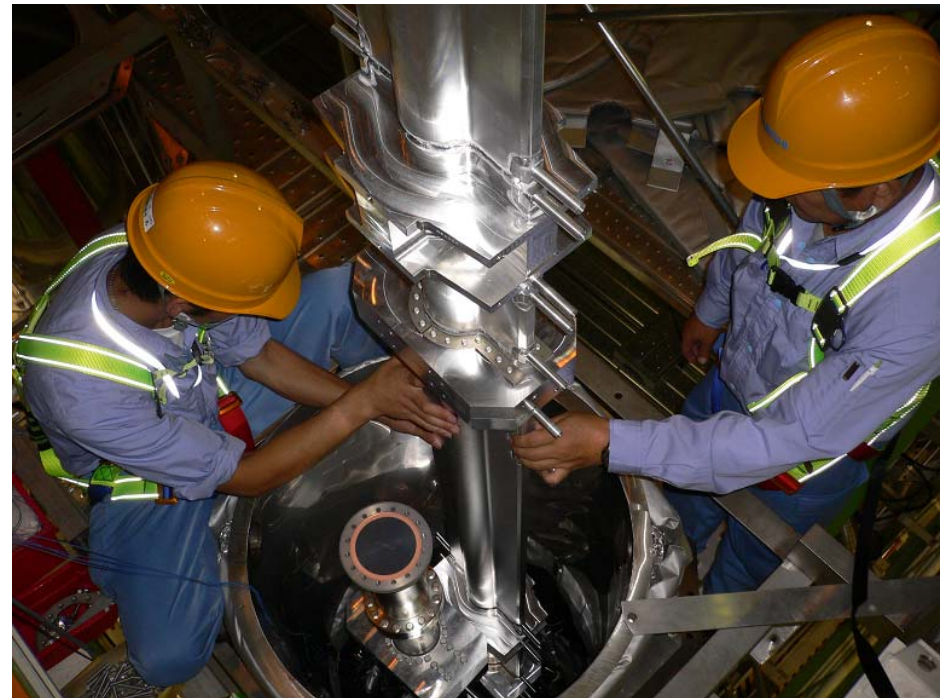
TiN coating 7 : Installation of beam pipes 2

- Beam pipes are transported and installed in the coating equipment by crane.

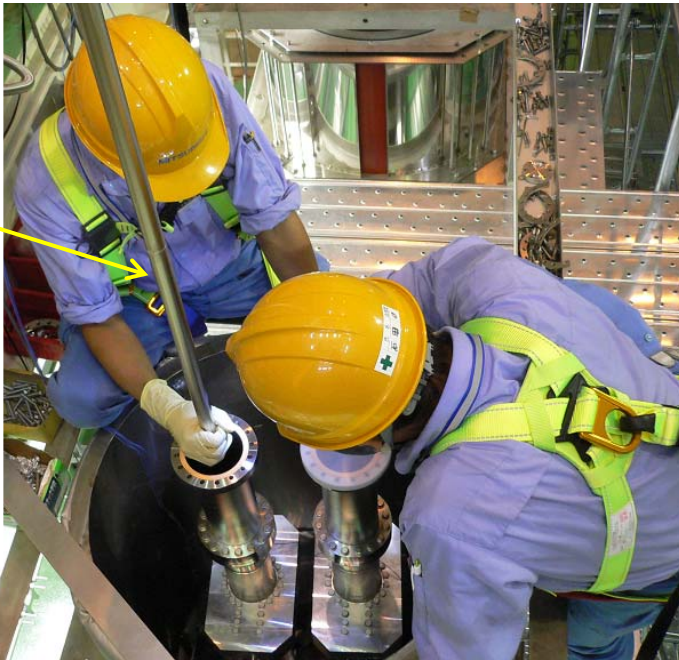
TiN coating 8 : Installation of beam pipes 3

- Ti cathode rod (~6m) is also installed by crane.

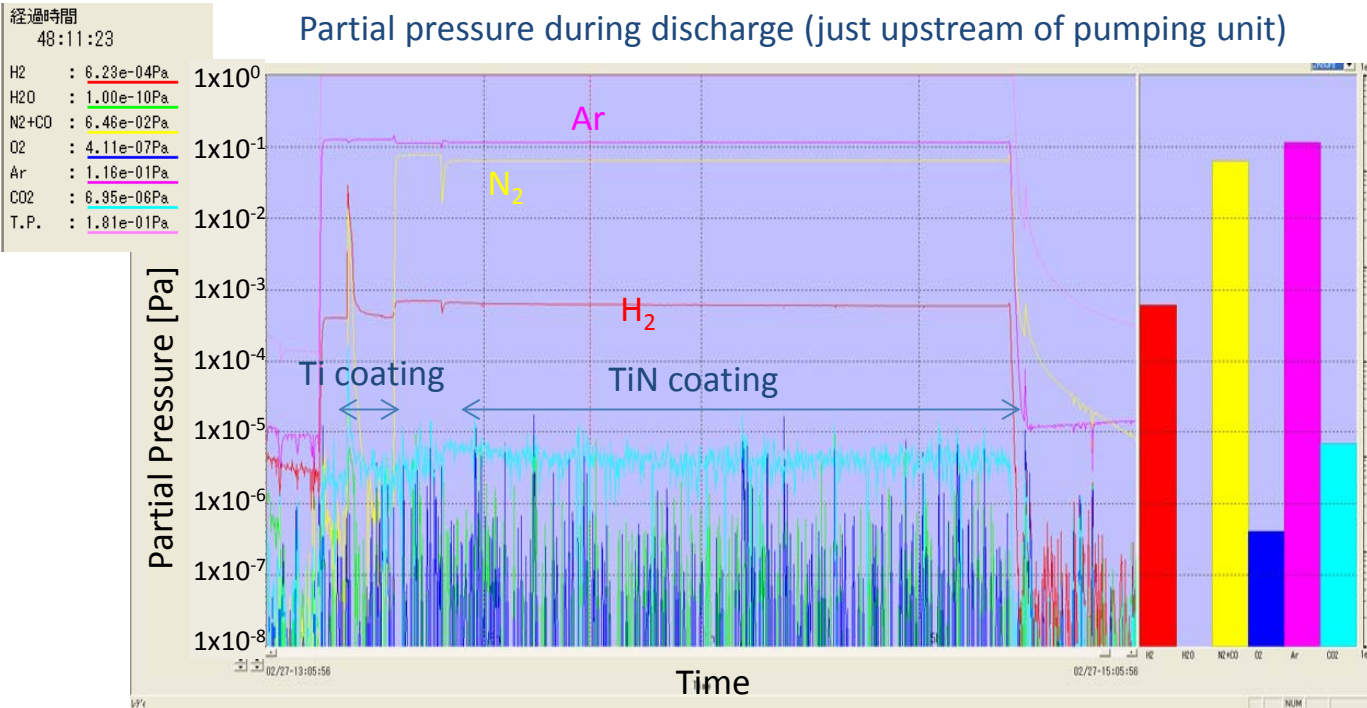
- Introduced gases : Ar (~ 2.2 Pa), N₂ (~ 1.8 Pa)
- Discharged current : 6.3 A
- Required time : 5 min (Ti coating for base of TiN) + 75 min (TiN coating)

View from viewport
at the bottom

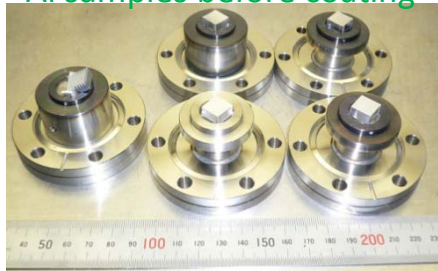
TiN coated samples

- SEY of Al samples coated with TiN at this facility were measured.
 - It was confirmed that SEY of TiN coating drops to below 0.8 after electron irradiation (incident electron energy : 250 eV)
 - It was also confirmed that the cylindrical cathode rod is available for grooved surface adopted in bent pipes.

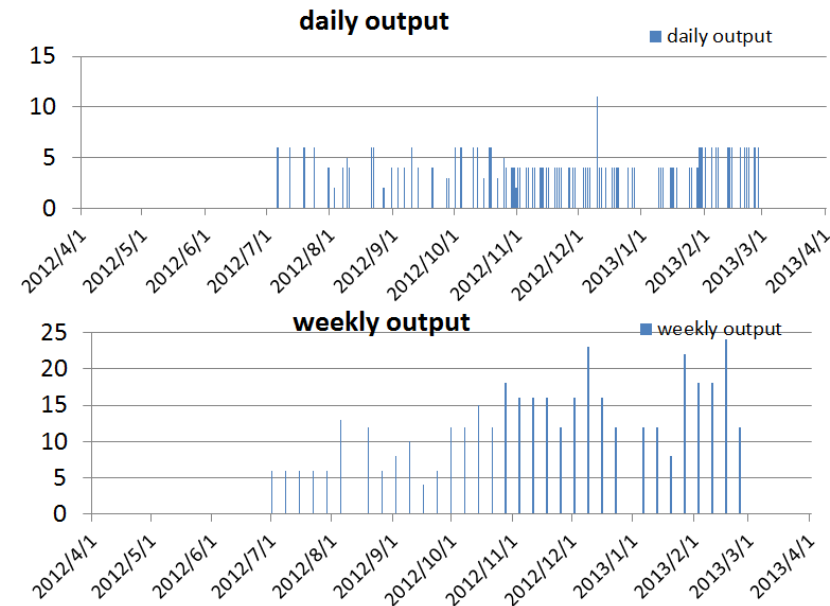
TiN coating 12 : Rate of coating output

- Coating work started on last July.
 - Coating work started on small scale with 1 coating equipment on last July.
 - On last September large-scale works with 4 coating equipments started.
- Total output by last month (2013/2/28) is 411.
 - Averaged daily output : 1.0 (small-scale), 1.9 (full-scale), 1.7 (total)
 - Averaged weekly output : 6.9 (small-scale), 13.6 (full-scale), 11.8 (total)

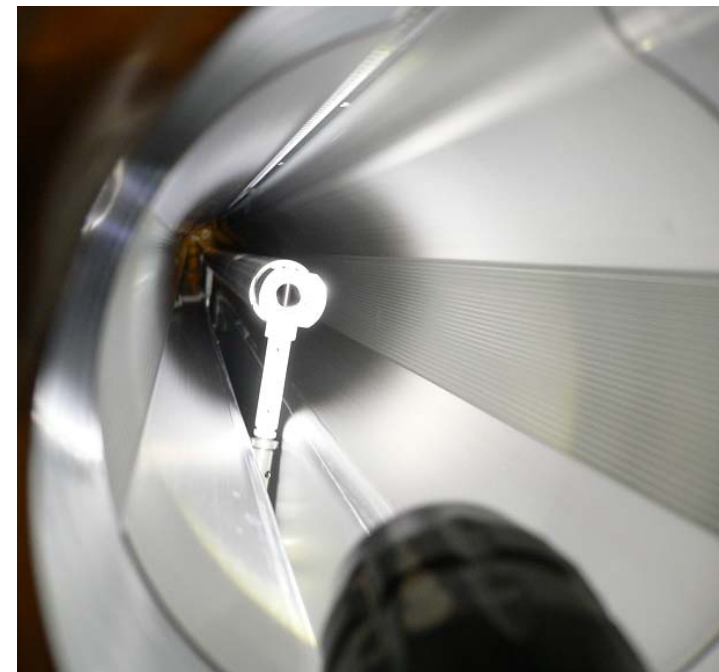
Installation test of Ti cathode rod in bent pipe

- Discharge test will be done this month
- Large-scale work with 2 equipment will start on April.

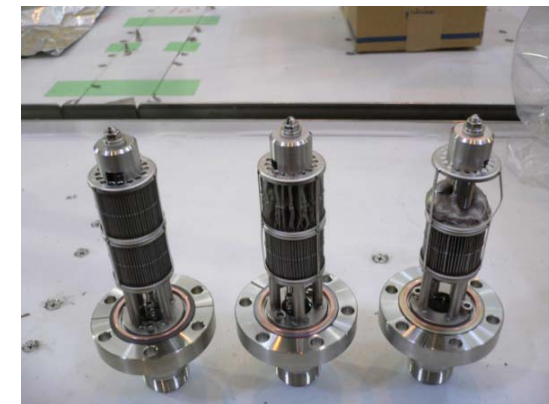
- Melting of NEG pump (GP50) during activation
 - Change in power feeding method.
 - Abnormal discharge during TiN coating.
 - Caused by insulation failure.

Melted NEG pump
