Main Ring Magnet system

Mika Masuzawa

Contents

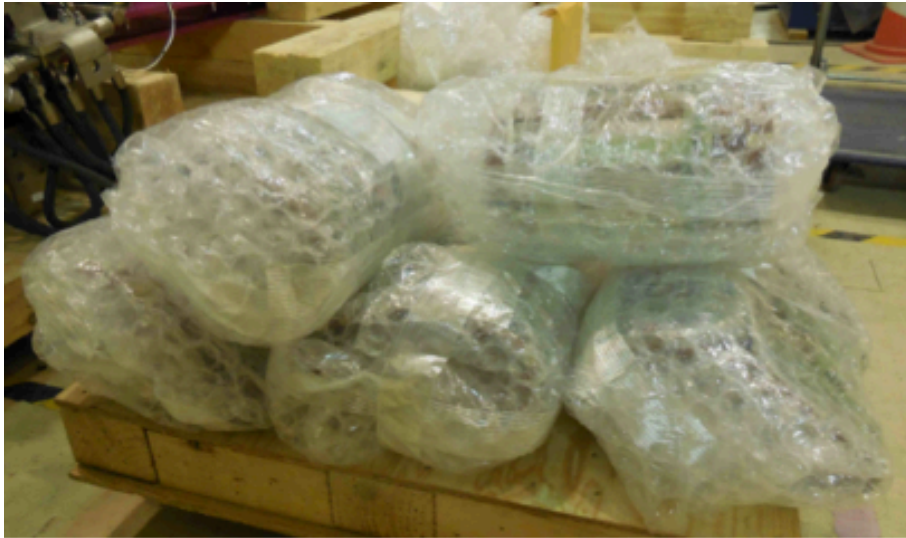
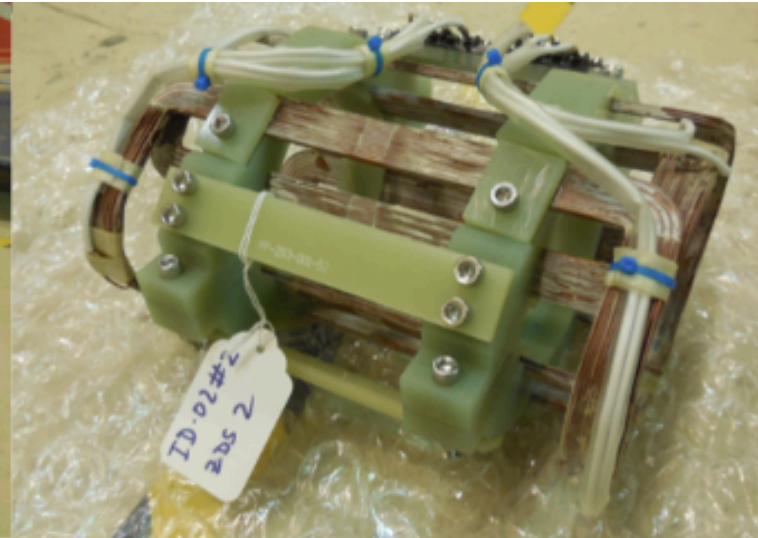
Dithering coils (SLAC)

- The coils for dithering were designed, fabricated, field measured and shipped to KEK in April.
- We will install them in late May or June with Uli, following his instructions.

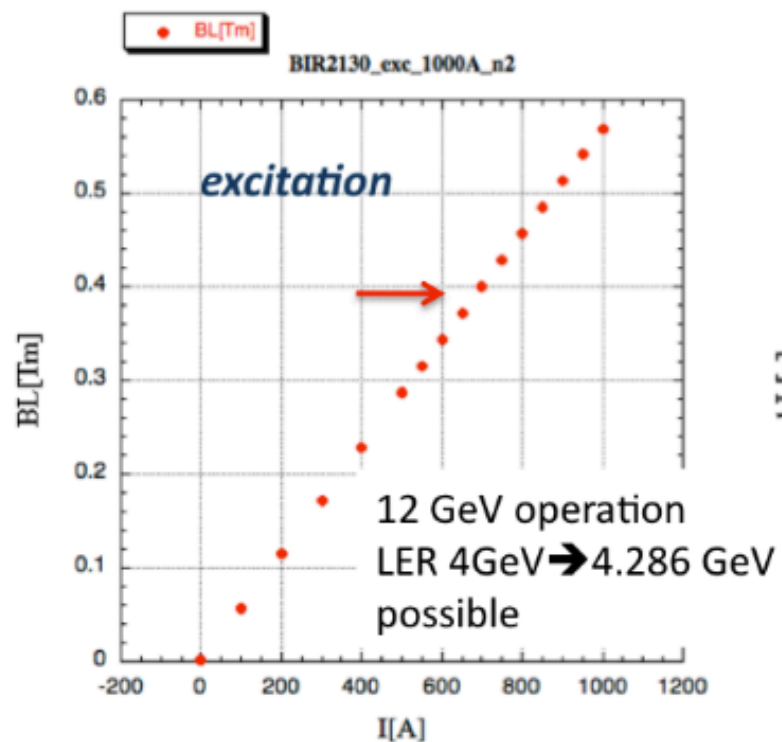
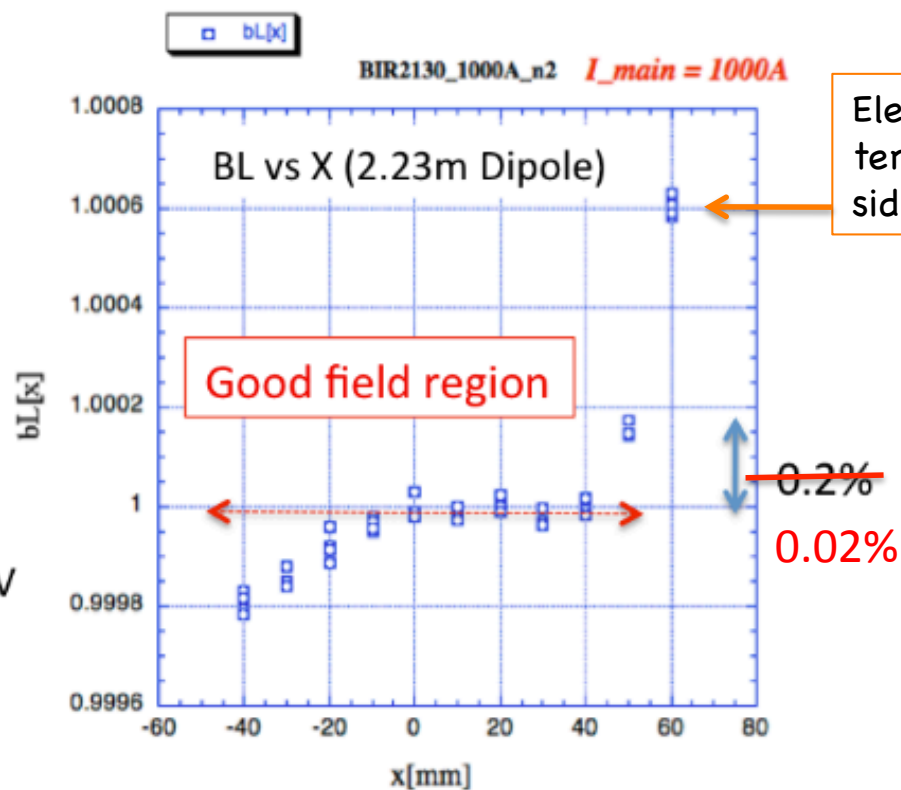
IR Dipoles specifications & 2.2 m results

1670_2 / 5735b	L (m)	BL (Tm)	$\Delta BL/BL$ (%) $r=50$ mm (6極成分)
BLC1LP	3.99	0.493	± 1.0
BLC1RP	2.23	0.385	± 1.0
BLCWRP	2.23	0.199	± 1.0
BLC1LE	3.6	0.138	± 1.0
BLC2RE	2.23	0.138	± 1.0

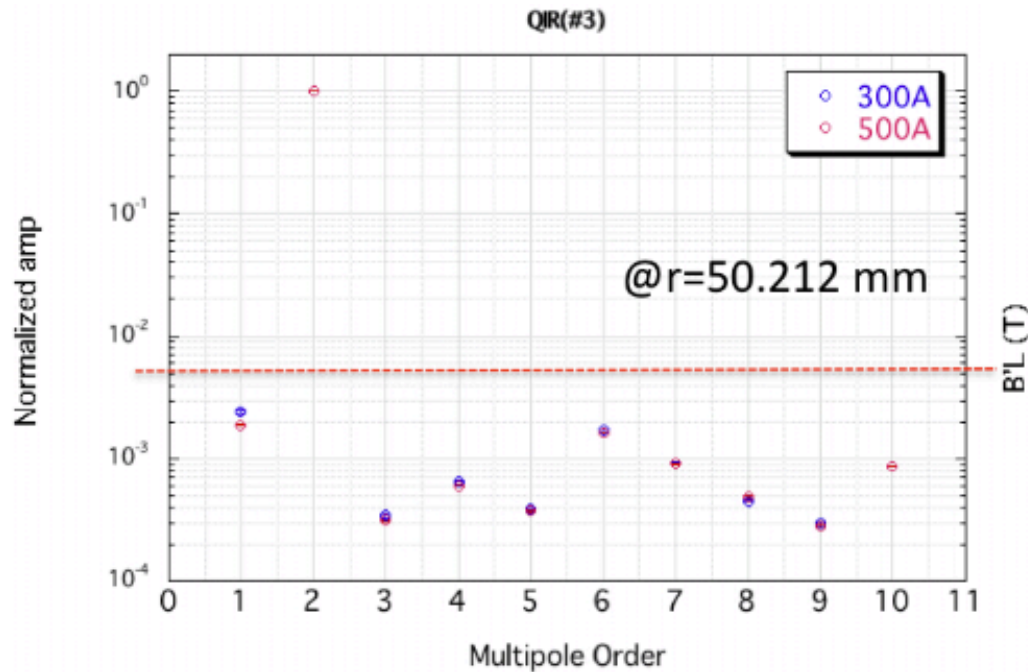
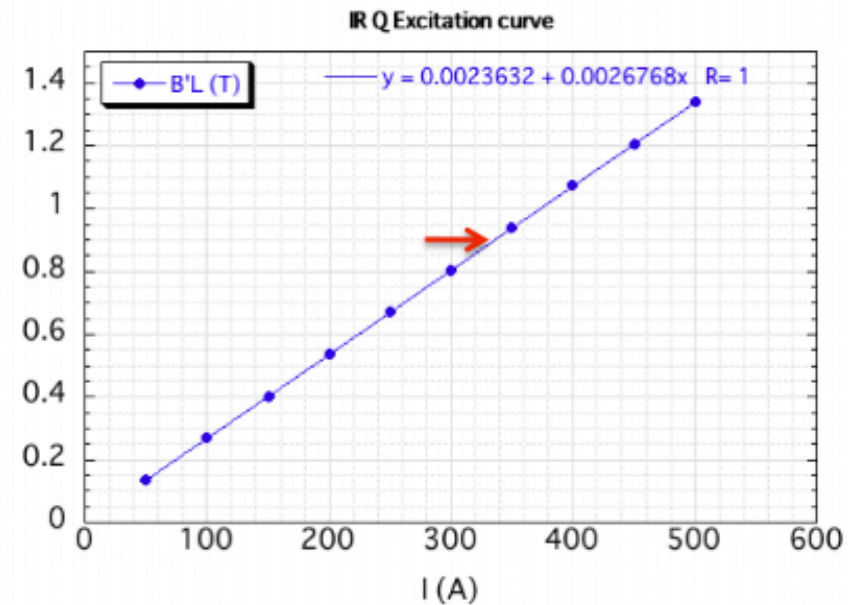
IR Quadrupoles (QLC2LE, QLC2RE)

5735b	L (m)	$B'L$ (T)	$\Delta B'L/BL$ (%) r=50 mm (12極成分)
QLC2LE*	0.56	0.38	± 0.5
QLC2RE*	0.56	0.89	± 0.5

- IR conventional magnets (2 quads and 6 dipoles) satisfied the specifications.
- They showed no magnetic field problems, though did show some non-field-related problems.

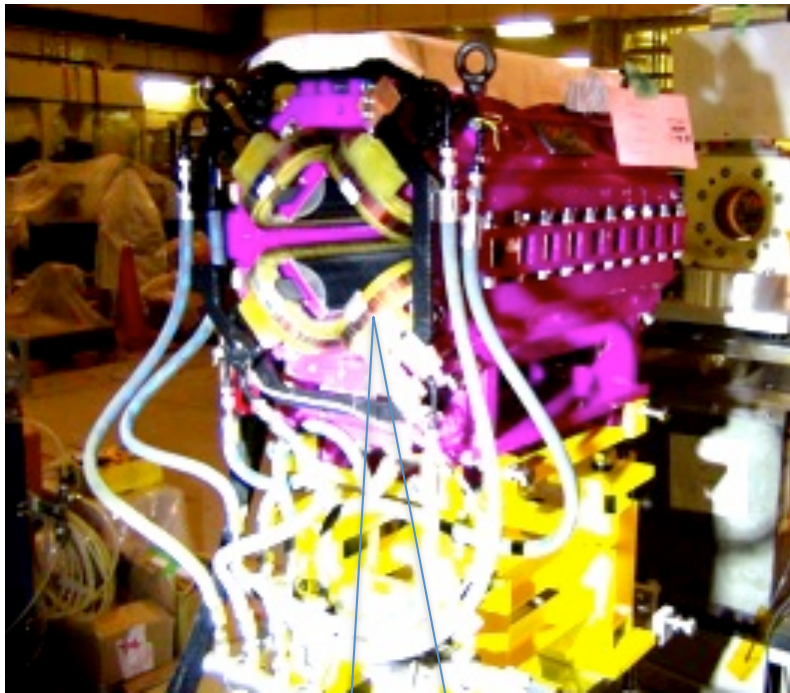
QLC2* water leak

Bad silver alloy brazing.
A hole (> 1 mm in length) can be seen.

Water leak found
at the joint of the lower
right coil during field
measurement of No.2
quadrupole magnet on
Apr. 15, 2014.

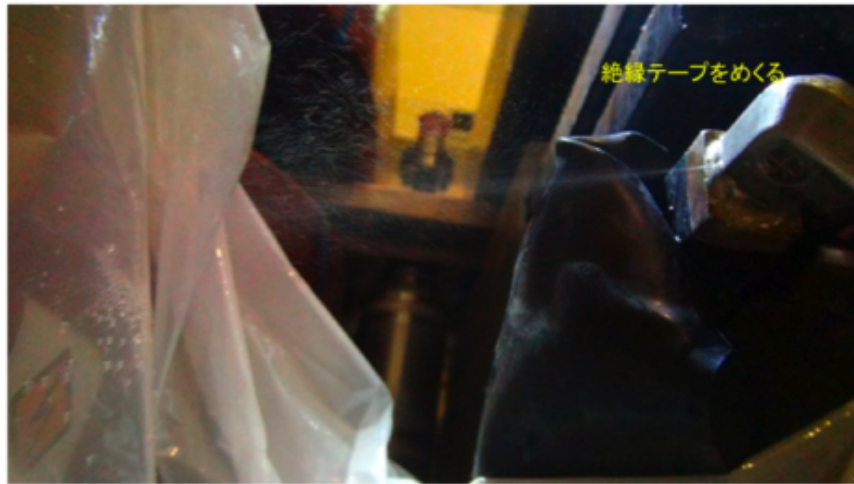
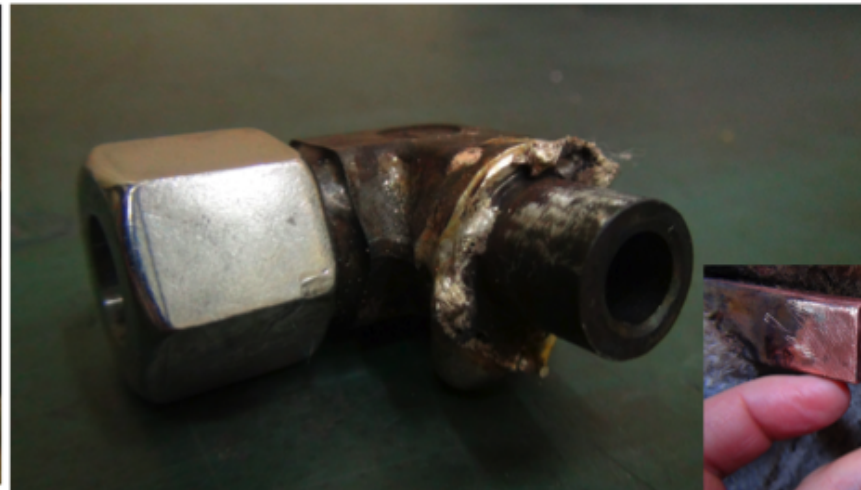
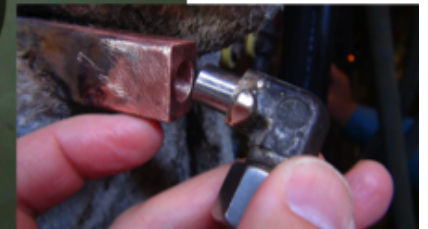
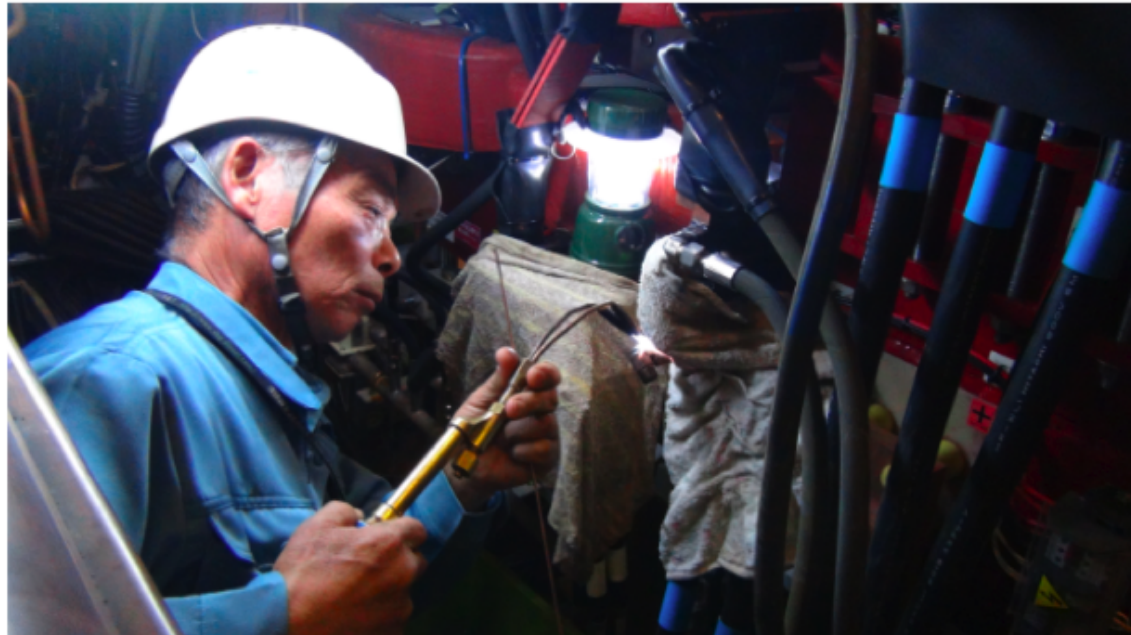
Bad silver alloy brazing **also** found in a newly fabricated wiggler magnet, casing water leak

The hole was fixed in situ.

We hope that this is just an isolated case, as there are 168 newly fabricated wiggler magnets.

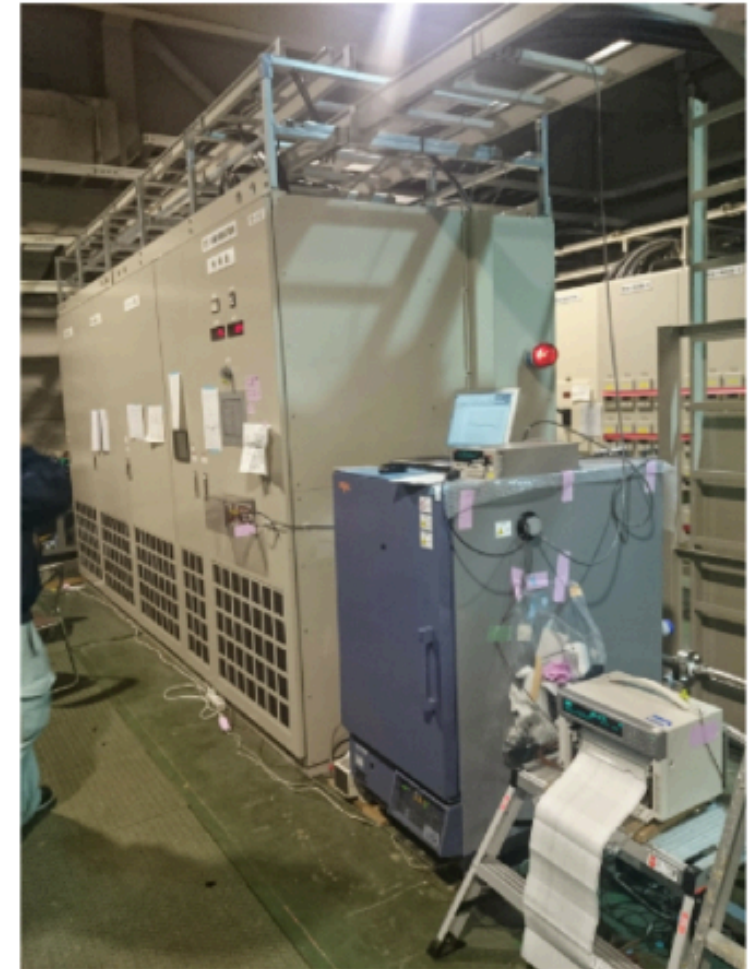
Power supply for the HER dipoles (“B2E”) being tested while hooked up to the actual magnets

- Measurement of the output current ripple by DCCT :
Below 2 kHz ~ 2.1 ppm. From 2kHz to ~ <10 kHz Max. 50 ppm @~7kHz ➔ Acceptable.
- Stability (~9 hour operation on Feb.6 2015) test:
FB parameters need to be adjusted but overall looks like we can achieve 2ppm/24 hours.
Some effects of RF Klystron power on/off in the same building are seen (a few ppm) though the propagation path needs to be investigated.

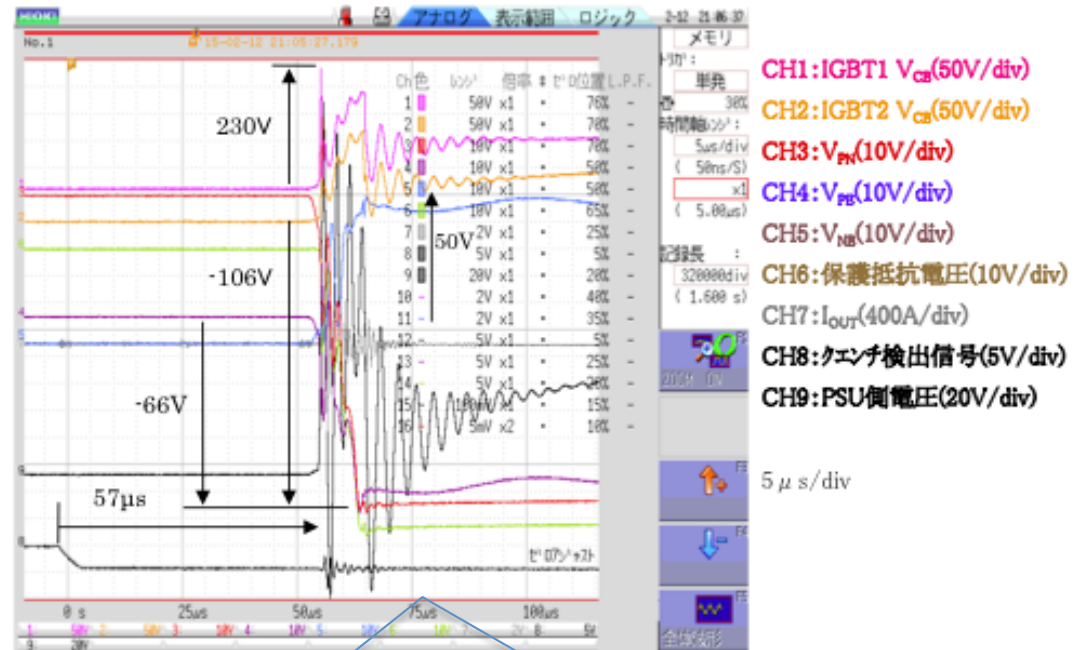
Quench detection in 57 micro seconds!
(much faster)

Induced voltage less than 200V

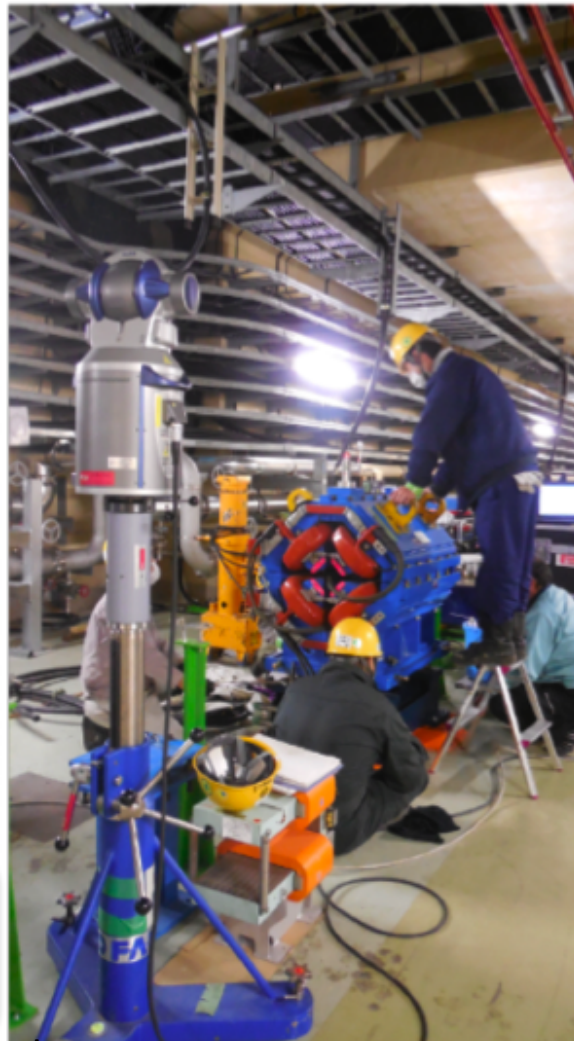
Magnets newly installed in the tunnel were aligned to the surrounding magnets using a laser tracker.

The newly installed magnets are:

- HER quadrupoles in the mid-arc sections
- IR magnets
- Tsukuba straight section
- Parts of the north and east tunnels.

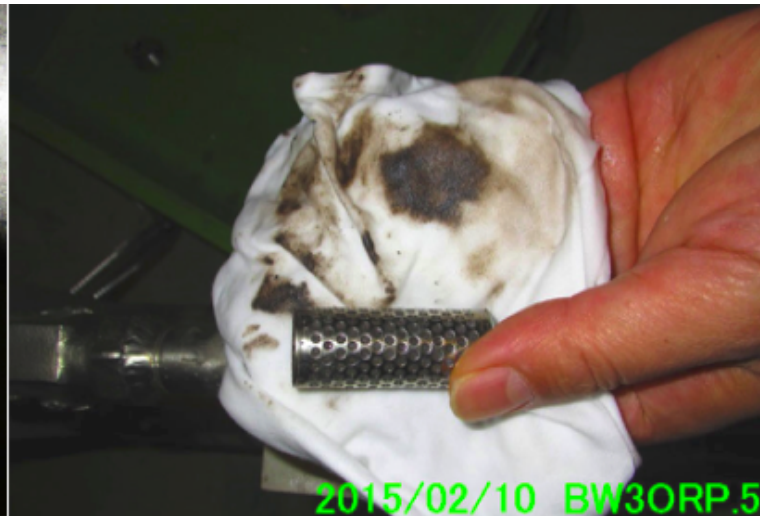
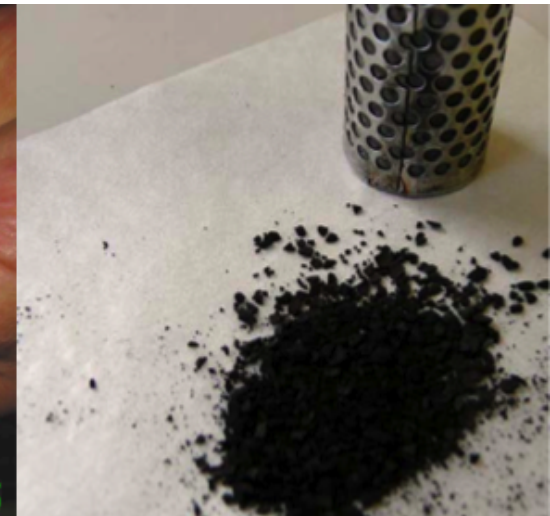
Cooling water problem

A few wiggler magnet strainers got clogged and caused a water flow interlock while the wiggler PS was being tested.

Silicon oil

copper oxide
