IR Assembly

22nd KEKB Accelerator Review Committee KEK, 14-16 March 2018 Accelerator Laboratory Ken-ichi Kanazawa For All persons working at IR

Contents

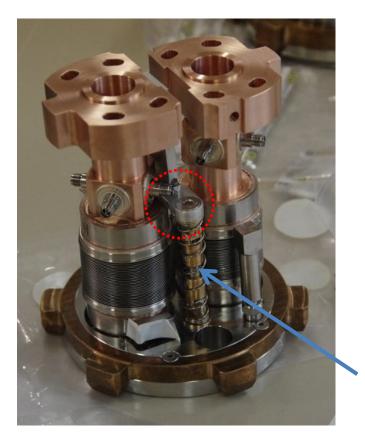
BPM-bellows tubes (about 14 cm long) set on a flange for RVC Beast II assembling group strongly suggested that it is practically impossible to connect BPM-bellows tubes to the IP chamber after BEAST II is installed into Belle (especially in FWD). Therefore, The tubes were connected to the IP chamber before BEAST II installation.

Travel limiter to limit the longitudinal displacement of the bellows.

It was found a cable for the nearby BPM feedthrough must be connected before this limiter is set.

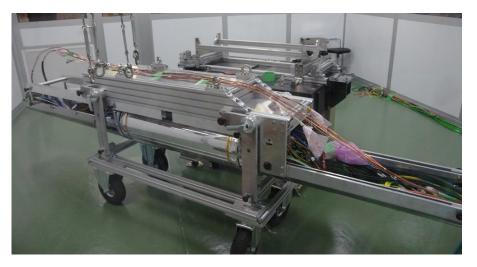
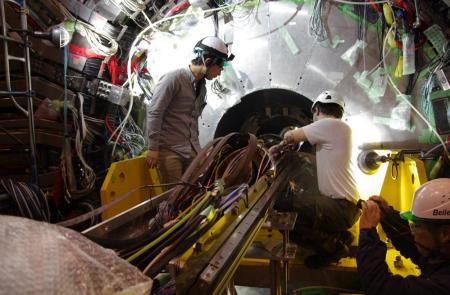
Beast II installation (Nov. 18, 2017)

Work summary Not a few issues didn't follow an original scenario. Serious discussion based on this experience is necessary for Phase 3.

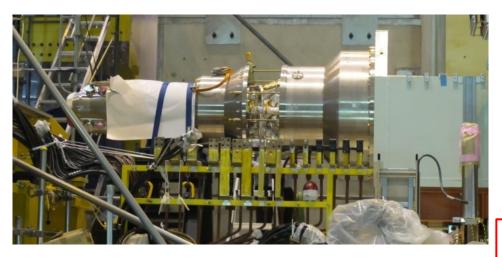
Since QCSL has no service windows, the cryostat was disassembled for this work. Magnet group checked marker positions on the cryostat after re-assembling. Roughly speaking, the front body is rotated anticlockwise by 0.7 mrad seen from IP. The consistency of the measurement with the mechanical tolerance of the cryostat design is not yet given.

- The front nitrogen-shield of QCSR were not in the correct position, and interfered with beam pipes. The interference was removed by remachining the shield.
- 2. The outside space of G10 spacers was different from available drawings. The spacers were remachined.

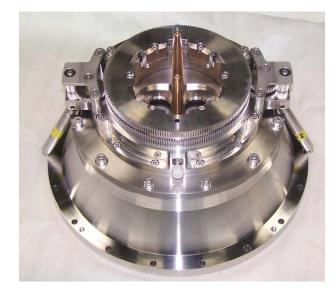
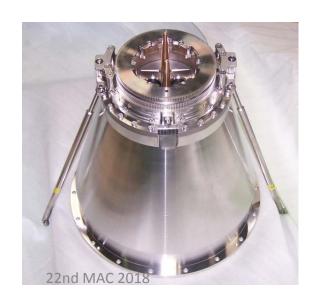
RVC on the new QCS head

RVC is a mechanism introduced by Belle group to disconnect QCS from VXD by a remote manipulation. RVC was designed and produced by DESY.

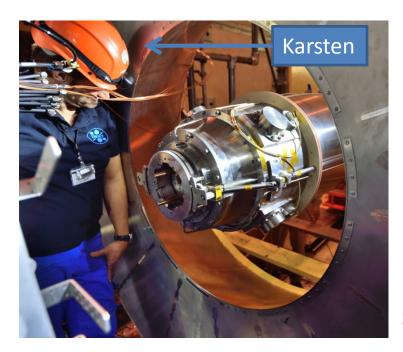
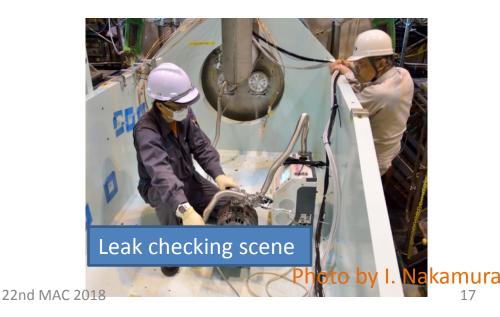
Trouble!! A number of contact fingers are out of place.

Contact fingers were miraculously put in order by Karsten (DESY)

- Just before QCSL-Beast II connection, it was found that contact fingers of one BPMbellows tube were out of place. This seems to be caused by an accidental large turning of the RVC flange. Happily enough, this was repaired by Karsten. We should be careful not to cause the same trouble for Phase 3.
- At the first trial of QCSL move-in, cooling pipes for the BPM-bellows tube designed by KEK interfered with RVC, and RVC was not able to catch the flange of BPMbellows tubes. This is caused by miss-estimation of the RVC volume in designing the cooling tubes. The interference was not serious to cause any mechanical damage. The cooling tubes were replaced with those prepared by DESY.
- RVC worked completely well.
