Fire at Nextef

The 23rd KEKB Accelerator Review Committee Meeting

2019-07-09

Fire on April 3rd, 2019

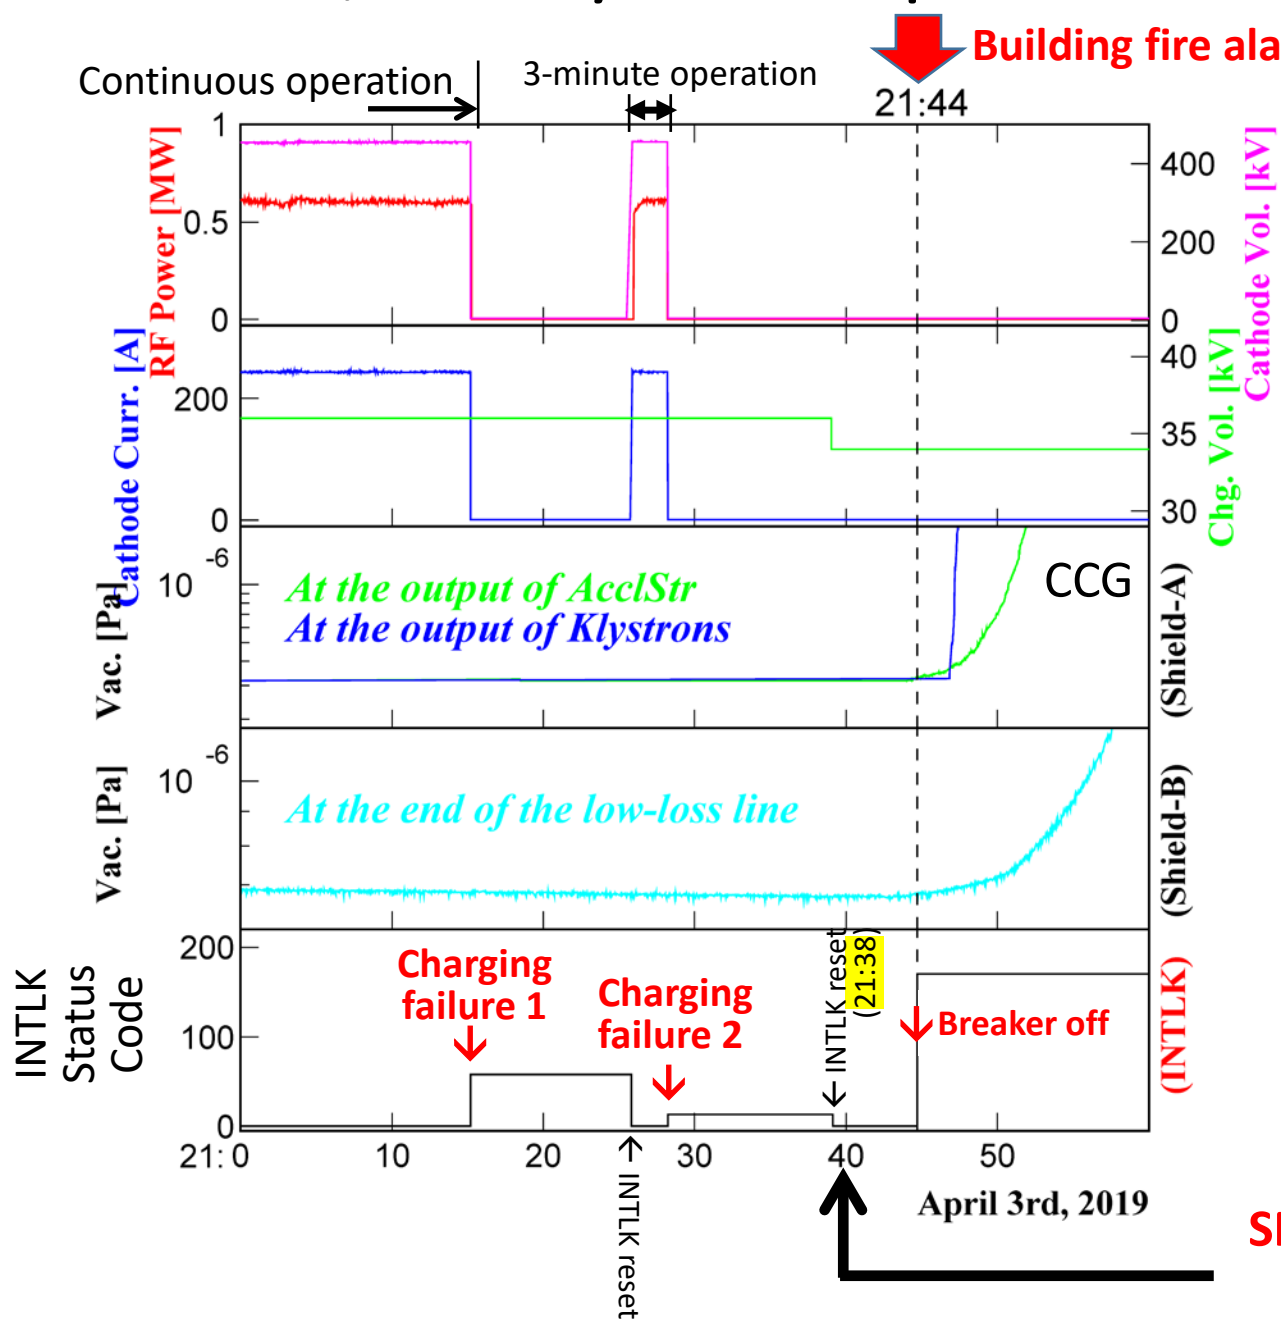
Just before the fire, History of the operation and INTLK messages

No particular until 21:38
(nobody in the site of Nextef)

SMOKE and CUBICLE TEMP activated
(for the first time)

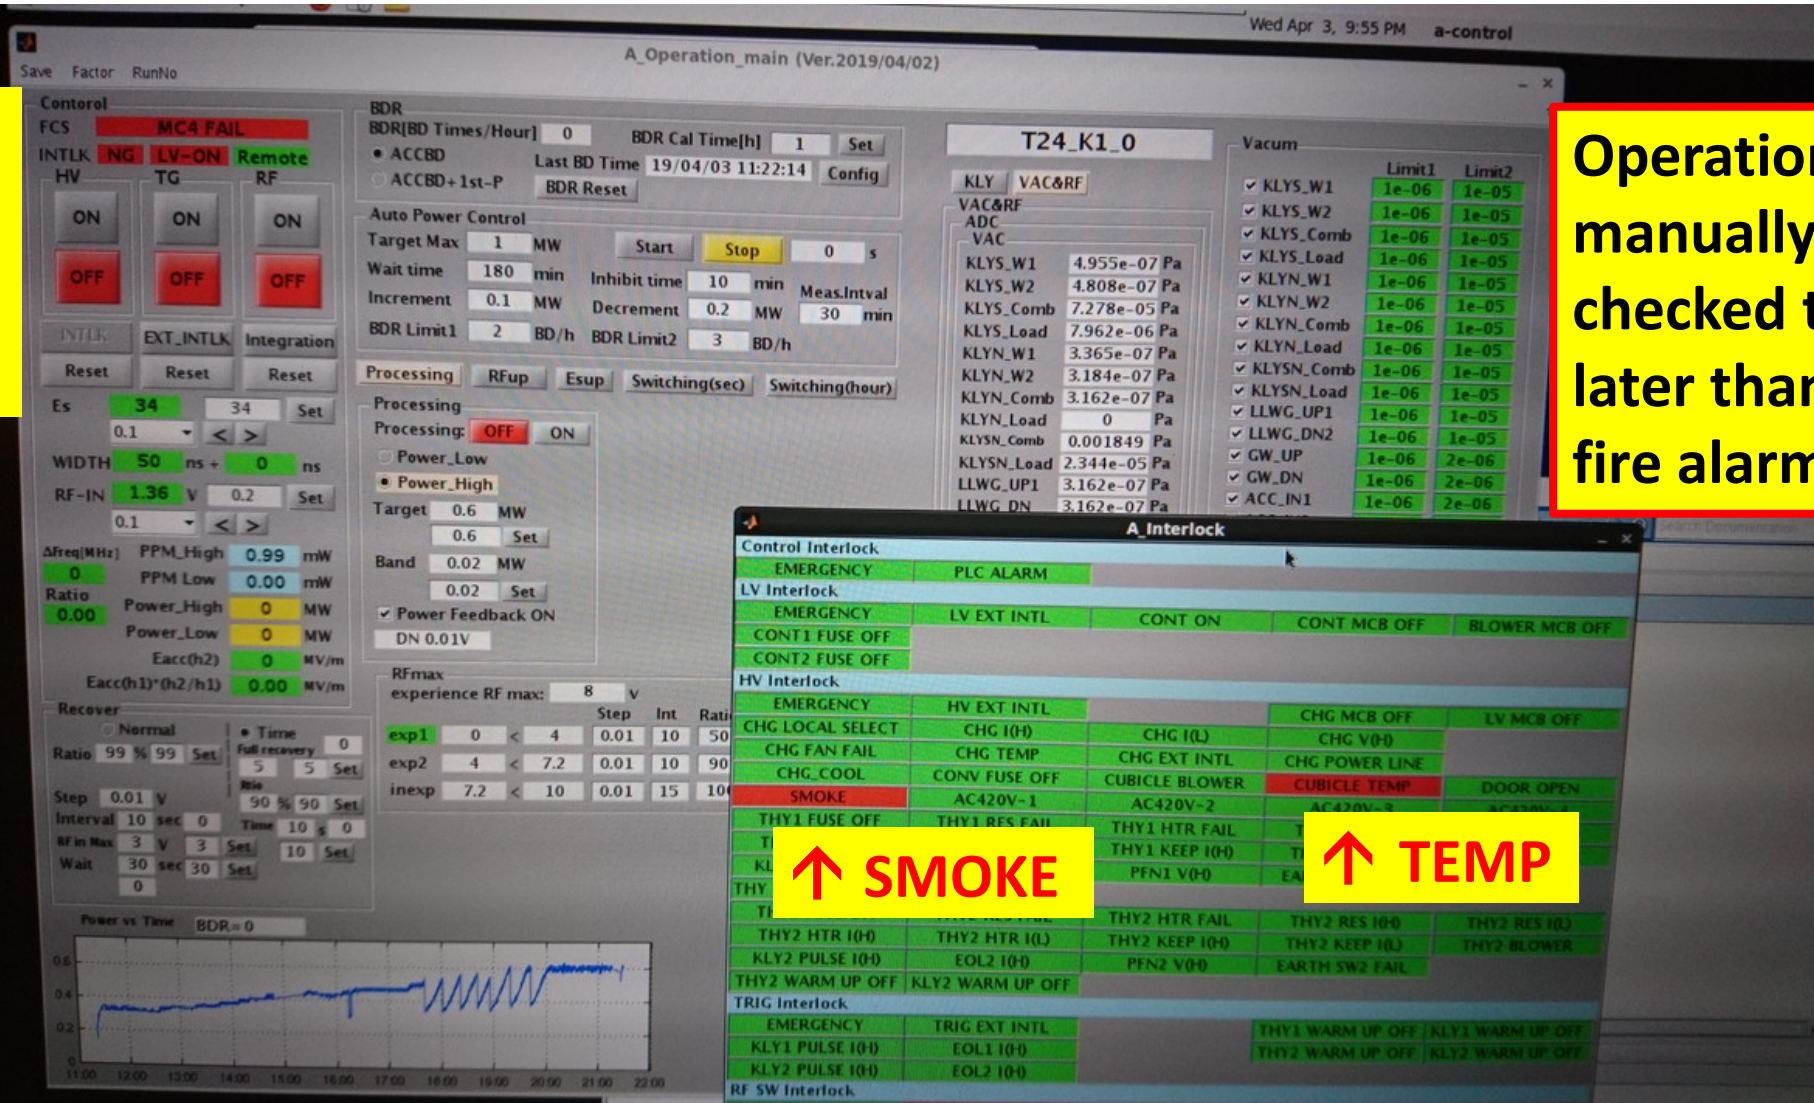
Operation Panel with the final INTLK messages

At 21:55 on April 3rd, 2019

LV-ON
HV-OFF
TRG-OFF
RF-OFF

Operation panel manually opened and checked ten minutes later than the building fire alarm.

↑ SMOKE

↑ TEMP

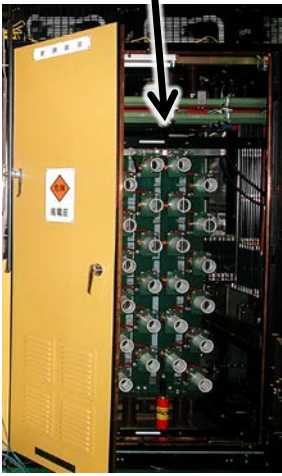
B-B cross-section

Made by NISSIN
(NKD-06900)

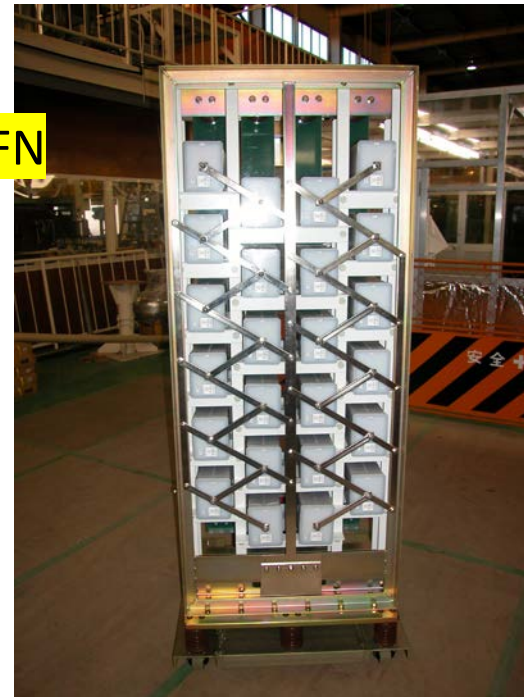
Puncture of plastic-case capacitors in the Nextef modulator

- No deterioration of the modulator performance observed
- The most likely cause is puncture of the plastic-case capacitors (although there is no direct evidence).
 - Fire occurred at other facilities using modulators with plastic-case capacitors.
 - At Nextef, such puncture occurred twice.

破裂したコンデンサと絶縁油飛散の状況

- The winding method to form a capacitor from films was improved to reduce the appearance of wrinkles and make the electrode gap uniform.
- The potential gradient in operation was reduced to make the lifetime longer.
 - $75 \rightarrow 48.9 \text{ V}/\mu\text{m}$
 - lifetime $\propto (\text{potential gradient})^n$ ($n \gg 1$)
- The fabrication process was improved to suppress foreign matter inclusion into the insulating oil.
 - Foreign matter inclusion was observed in the previous versions of plastic-case capacitors.
 - Foreign matter inclusion is known to induce partial discharge.
- Various sizes were reviewed and re-optimized.
- etc.

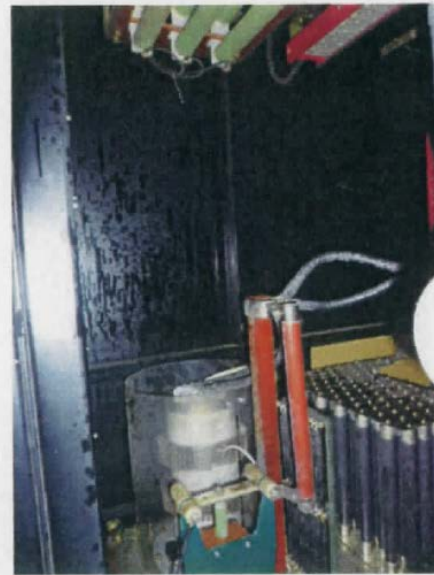
PFN の東側壁

Oil splash

No fire

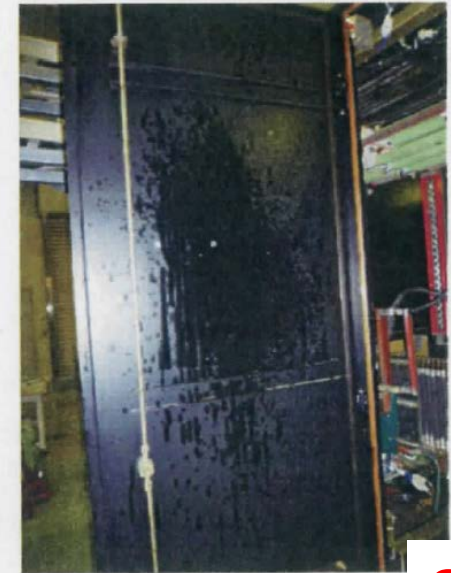
PFN の北側ドア

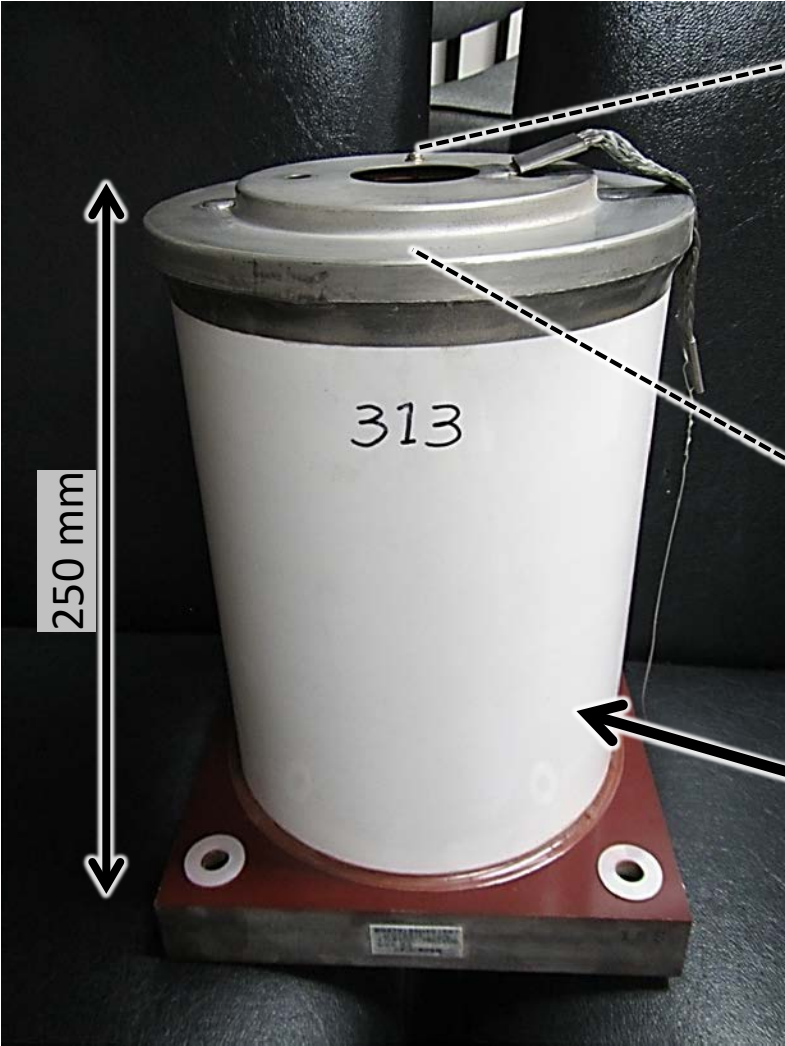
Puncture protection mechanism in the capacitors for Injector Linac

Capacitor elements
