SuperKEKB RF Accelerating Cavity System

(Improvements during LS1, etc.)

The 27th KEKB Accelerator Review Committee

2024-03-26

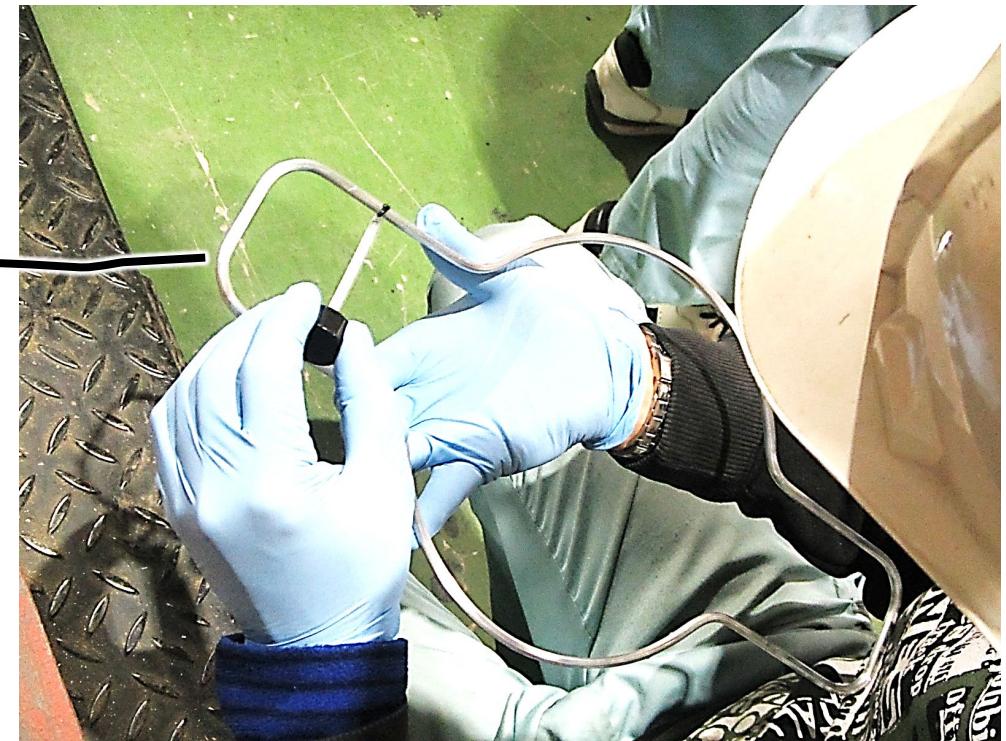
Vacuum leak test using the prototype cavity (No.0)

Vacseal applied

- ✓ Heat cycles with $\Delta T = 20^\circ\text{C}$ applied using ribbon heaters
- ✓ No vacuum leak demonstrated
