Reports on SuperKEKB RF System

The 28th KEKB Accelerator Review Committee

2025-01-15

RF Accelerating System for the SuperKEKB Main Ring (MR)

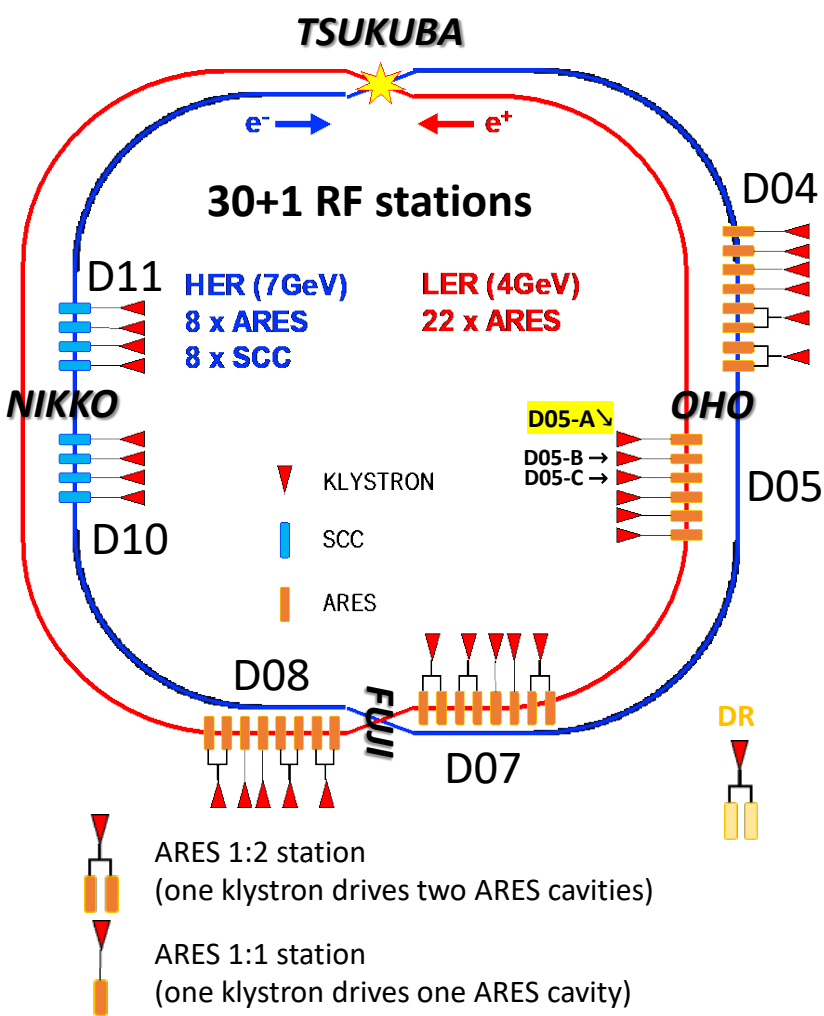
Present RF Cavity Layout

LER		HER		
Energy [GeV]	4.0		7.0		
Beam current [A]	1.632		1.259		
Number of bunches	2346				
Bunch length [mm]	~6		~6		
Total beam power [MW]	~3.2		~3.4		
Total RF voltage [MV]	9.3		14.2		
Cavity type	ARES		ARES		SCC
Number of cavities	12	10	4	4	8
Klystron : Cavity	1:2	1:1	1:2	1:1	1:1
Cavity voltage [MV/cav]	0.40 or 0.45		0.40 or 0.45		1.35
Input RF power [kW/cav]	~200	~400	~200	~400	~300

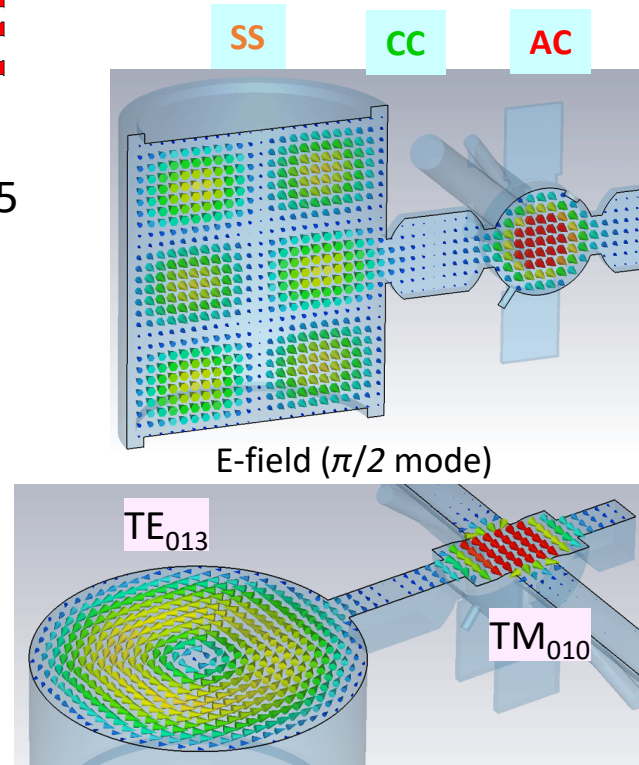
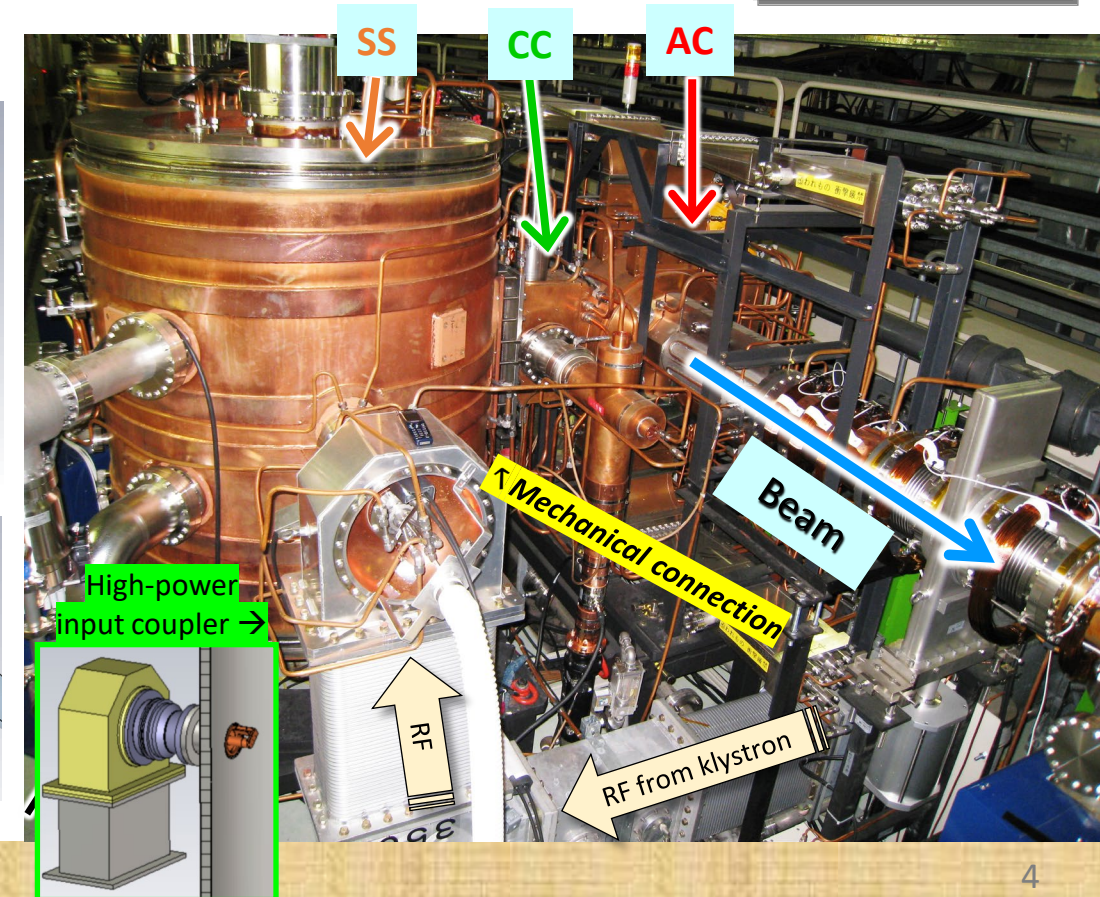
ARES

Accelerator Resonantly-coupled with Energy Storage: “ARES”

- Unique three-cavity system operated with the stable $\pi/2$ mode
- Accelerating $\pi/2$ -mode frequency : 508.9 MHz
- $Q_0 = \sim 11 \times 10^4$ ($\pi/2$ -mode), $\sim 17 \times 10^4$ (only for SS)
- Vacuum pressure : $\sim 10^{-7}$ Pa
- Cavity voltage (spec.) : 0.5 MV/cav ($\Leftrightarrow E_{acc} \approx 2$ MV/m)
- Wall-loss dissipation power: ~ 150 kW (for 0.5 MV/cav)

SS: Storage Cavity
CC: Coupling Cavity
AC: Accelerating Cavity

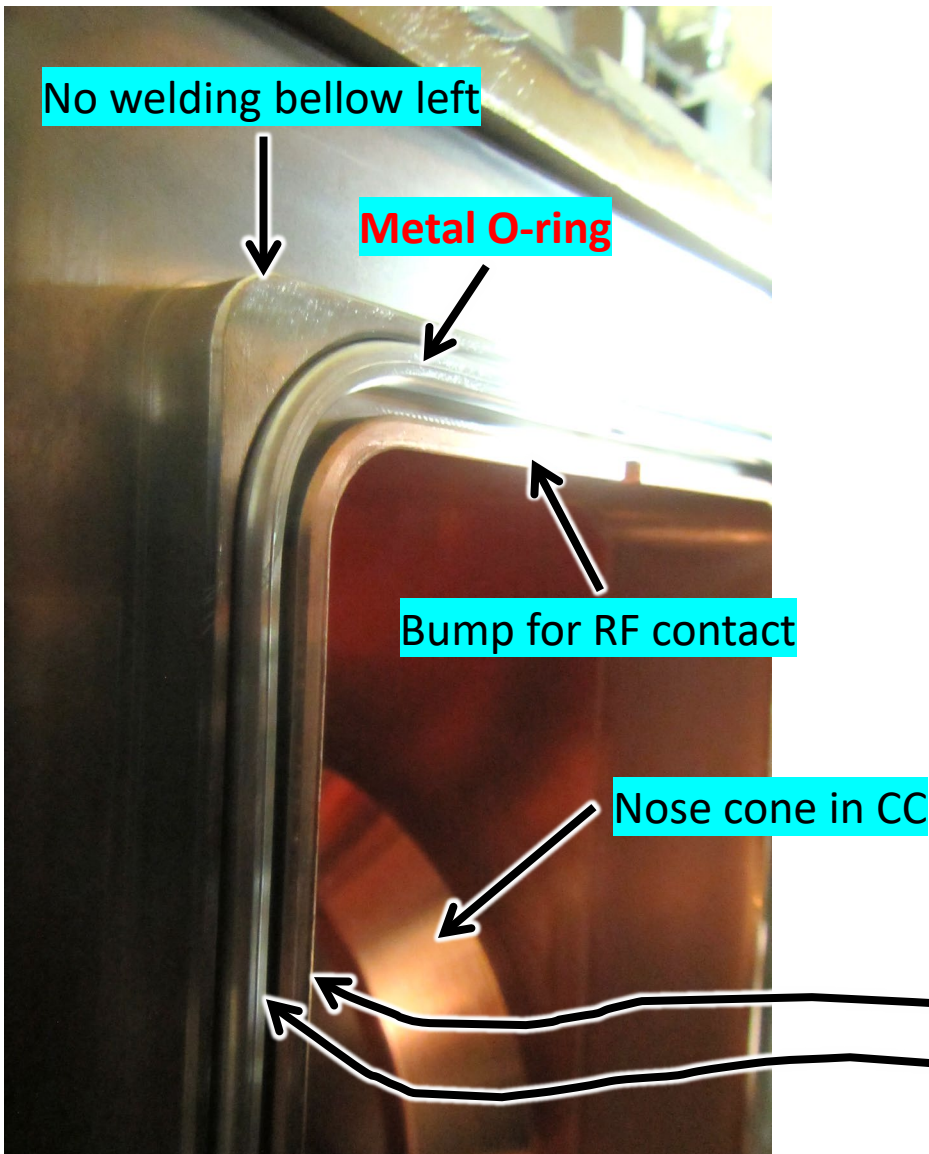
The vacuum sealing made with a metal O-ring

Mechanical connection surface in the coupling-cavity side

- The vacuum is designed to be sealed at the connection between SC and CC with outermost bellows welded.
- After the cavity replacement during LS1, no welding bellow left due to:
 - First welding during the KEKB era
 - Second welding during the relocation (HER → LER) between KEKB and SuperKEKB
- From the test bench result, vacuum leak occurs if we make a perfect contact at the bump for RF contact between SC and CC.
 - ARES cavity was not designed for using metal O-rings
- Decided to make a gap of ~ 0.7 mm at the bump for RF contact
 - No RF contact here
 - RF contact made through the metal O-ring

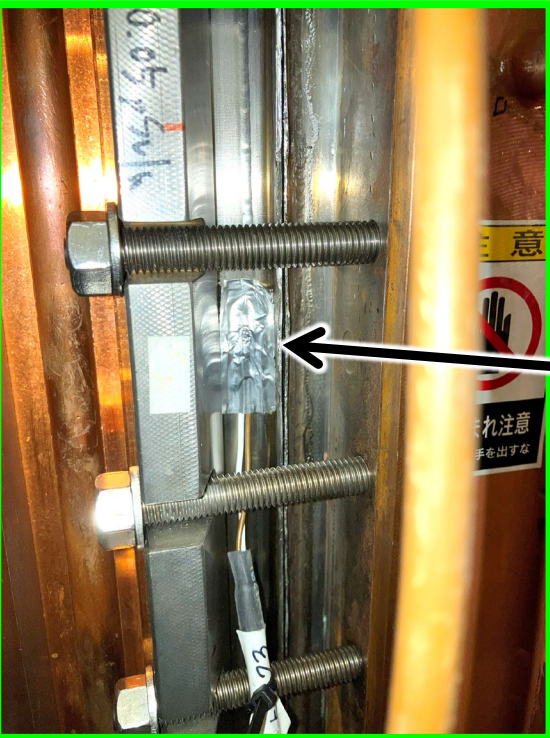
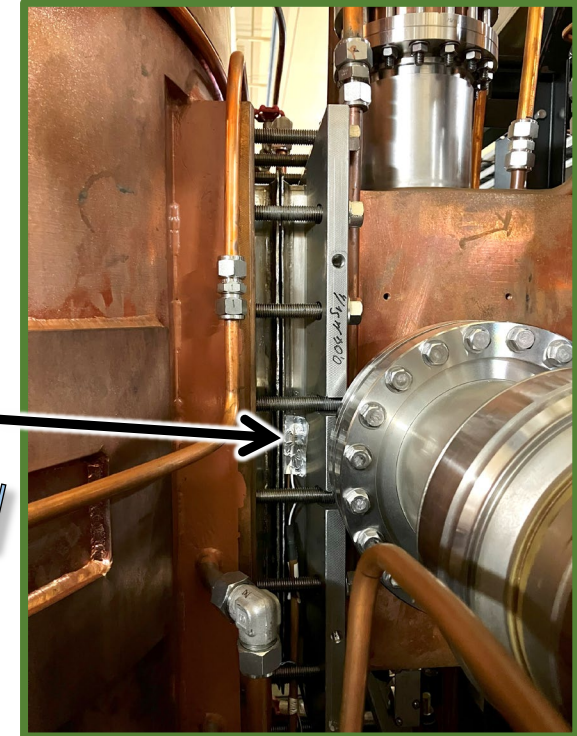
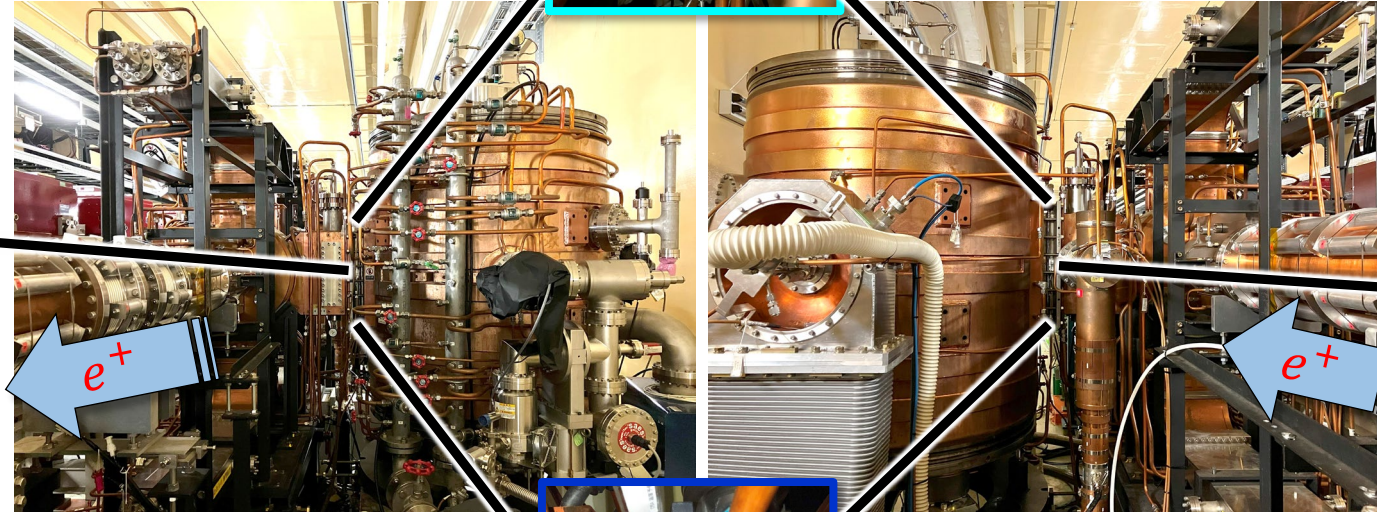
Four thermocouples attached to the connection flange per cavity

Midpoint on the side
(downstream of e^+)

Midpoint on the top

Midpoint on the side
(upstream of e^+)

Midpoint on the bottom

For comparison, thermocouples were also attached to the D05-B and D05-C cavities in the same way, where the two cavities have no gap at the RF contact.

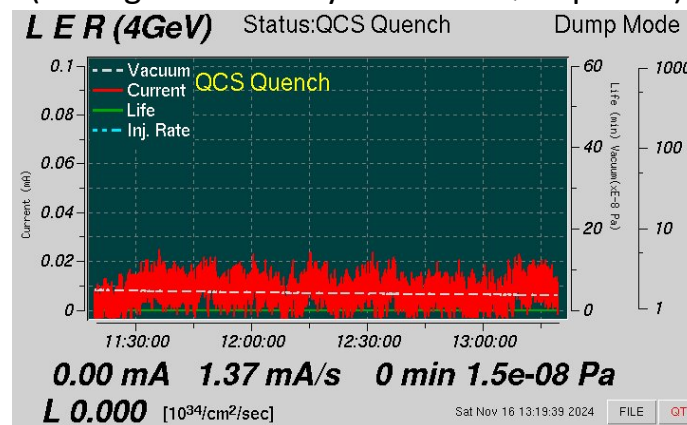
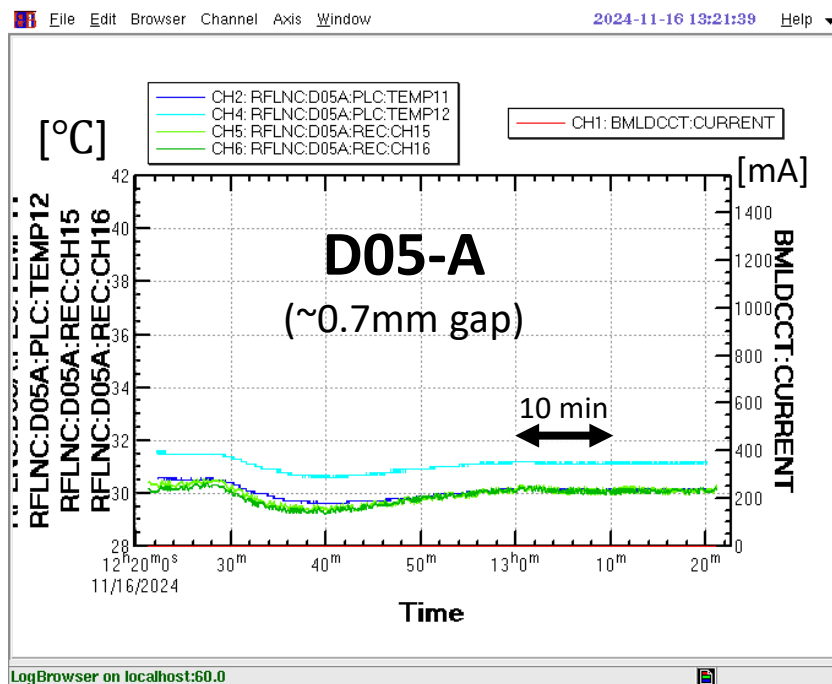
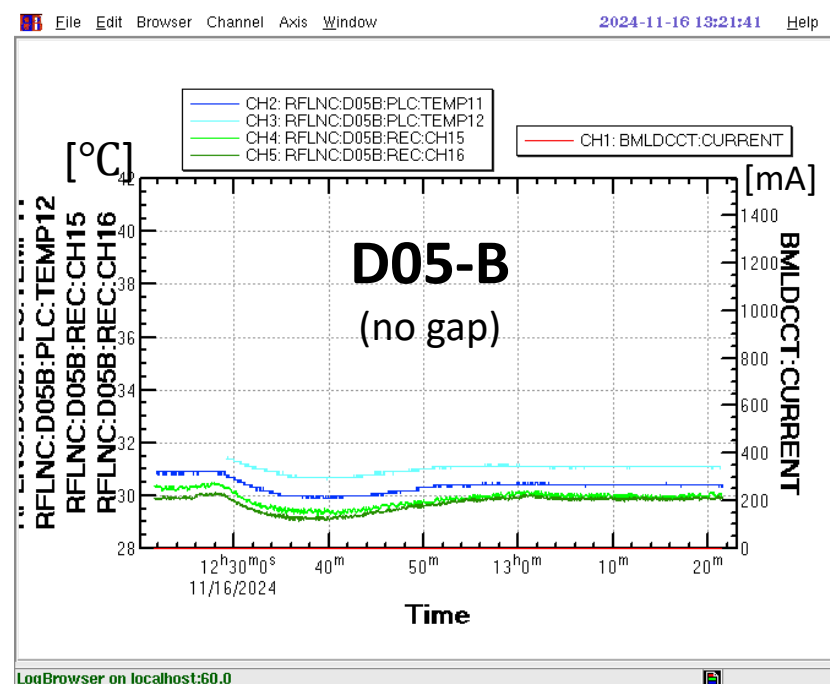
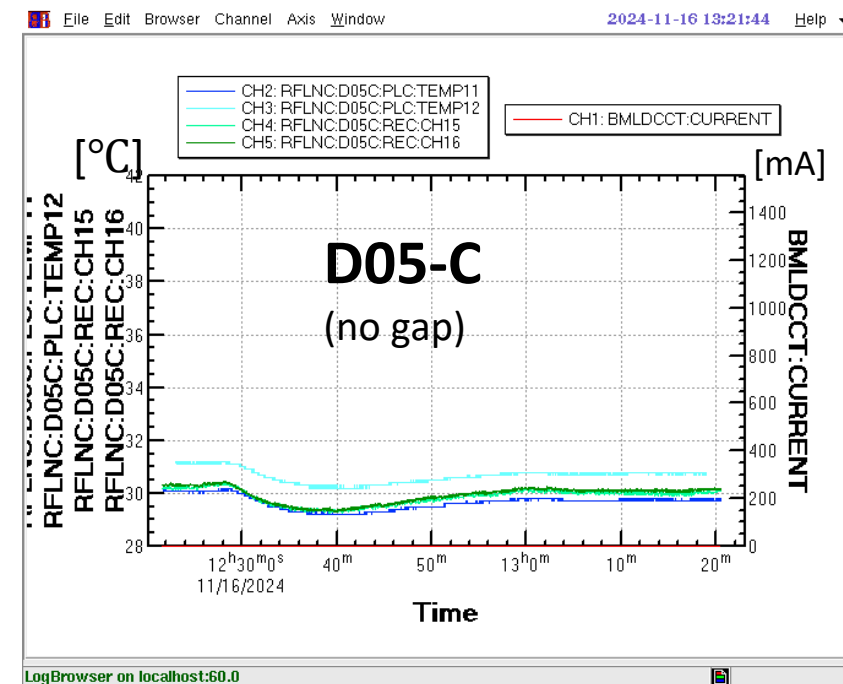
Temperature measurements in 2024c (1/2)

- ✓ No beam
- ✓ Input RF power: ~ 25 kW/cav
- ✓ Cavity voltage: 0.15 MV/cav

--- Midpoint on the top
--- Midpoint on the bottom

--- Midpoint on the side (downstream of e^+)
--- Midpoint on the side (upstream of e^+)

~ 30 degC (\approx temperature of the cooling water)

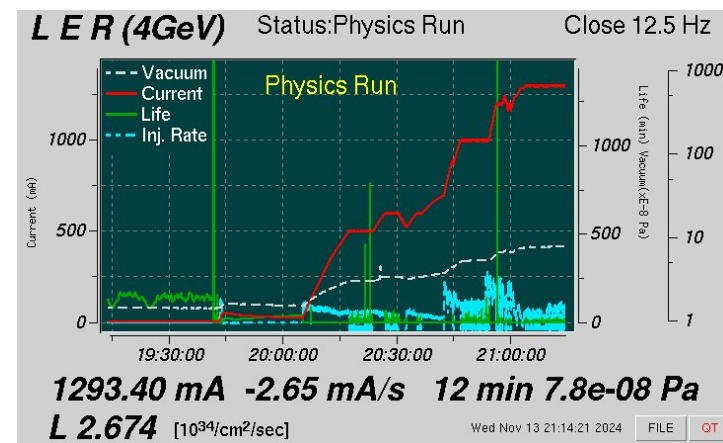
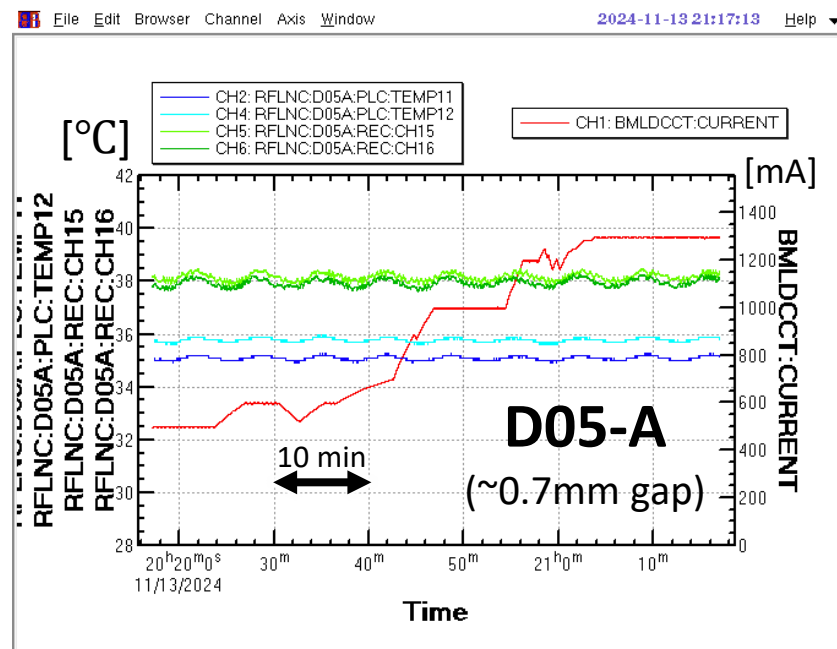
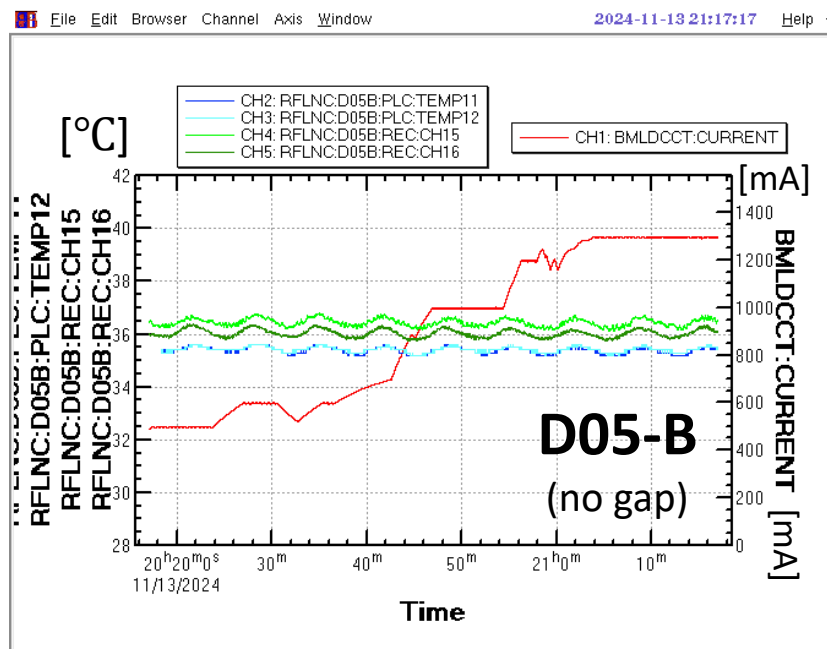
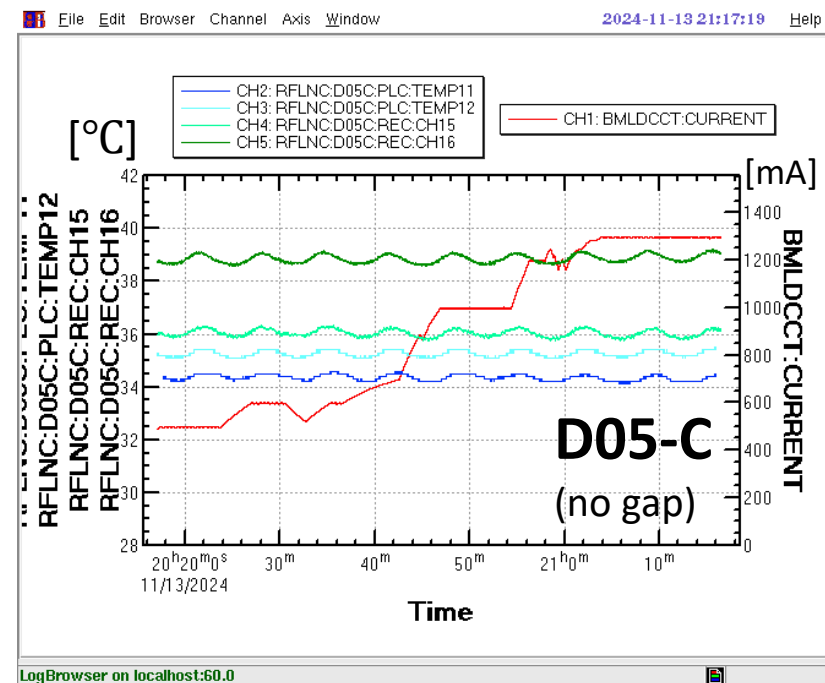
Temperature measurements in 2024c (2/2)

- ✓ With increasing the LER beam current up to 1.3 A
- ✓ Input RF power: ~400 kW/cav
- ✓ Cavity voltage: 0.45 MV/cav

--- Midpoint on the top

--- Midpoint on the bottom

--- Midpoint on the side (downstream of e^+)

--- Midpoint on the side (upstream of e^+)

--- LER beam current

- ◆ No beam current dependence at all
- ◆ No anomalous heating found

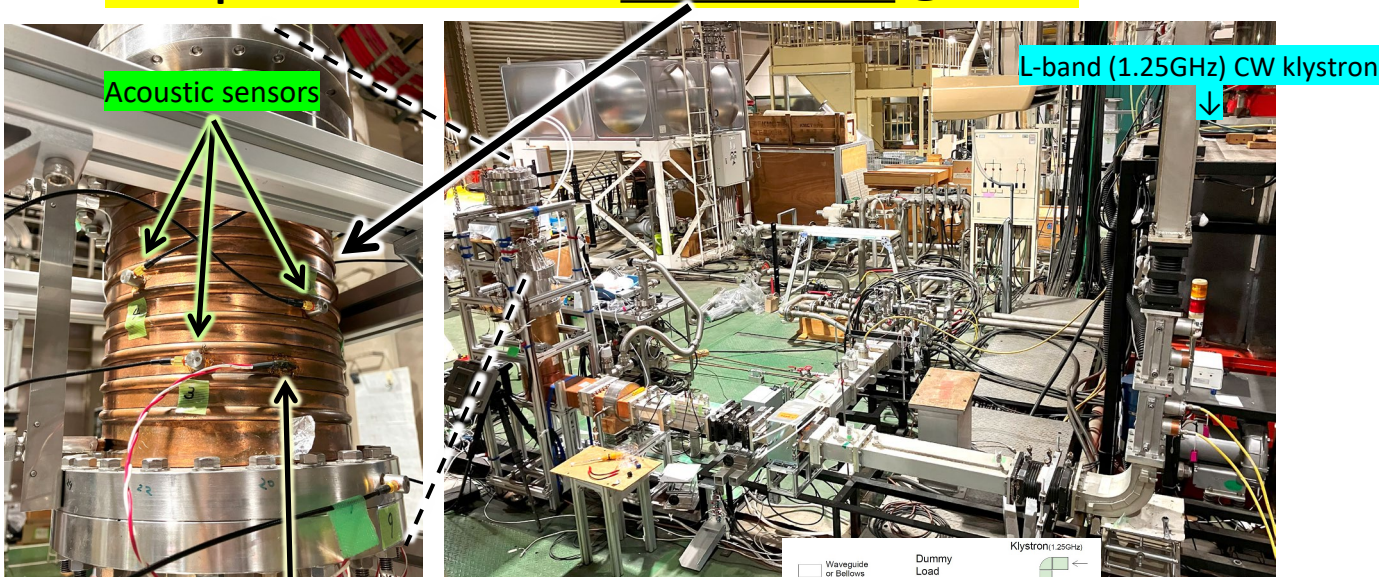
Figure 4: Schematic view of the high power test setup in D1-CT for the SiC-HOM duct.

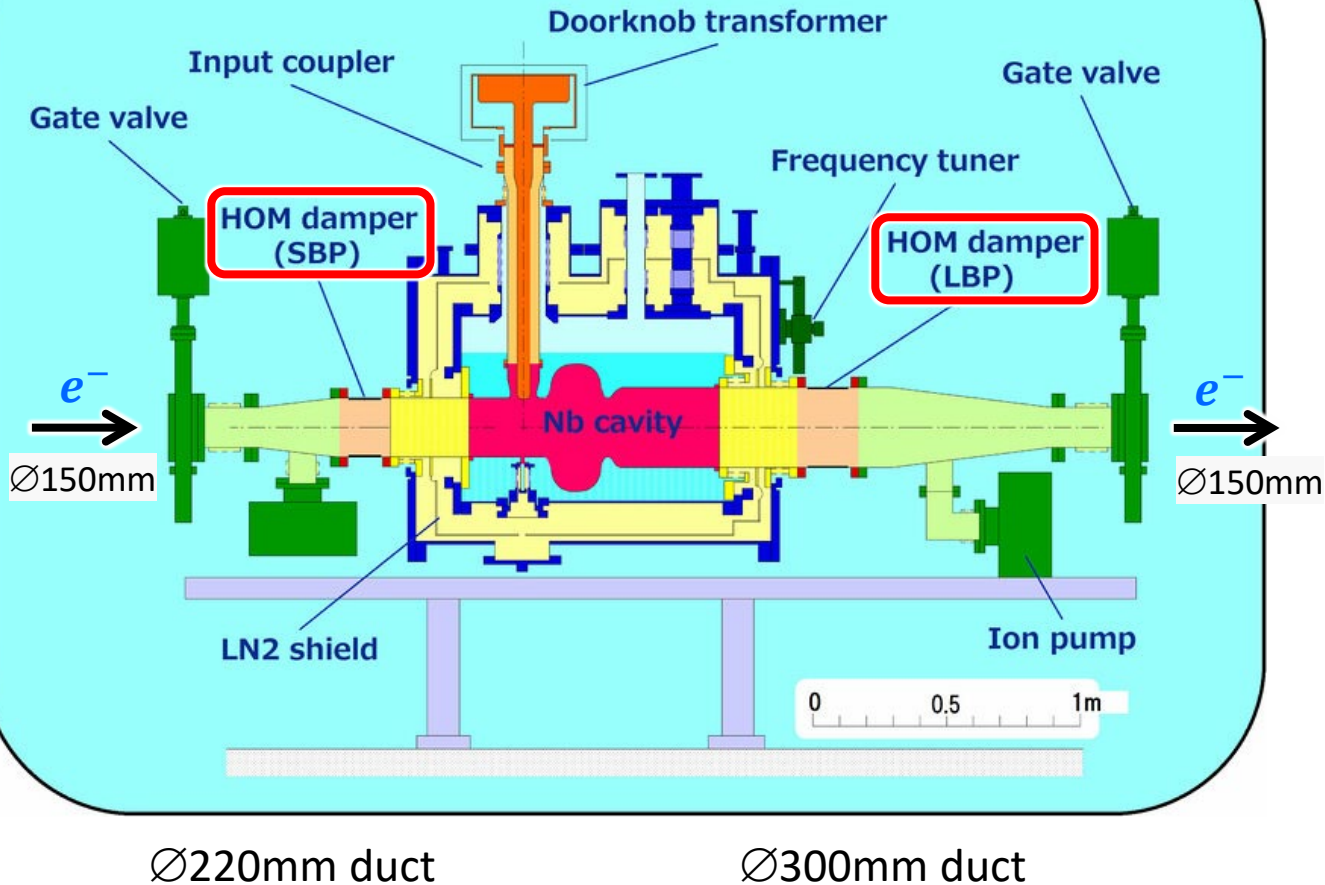
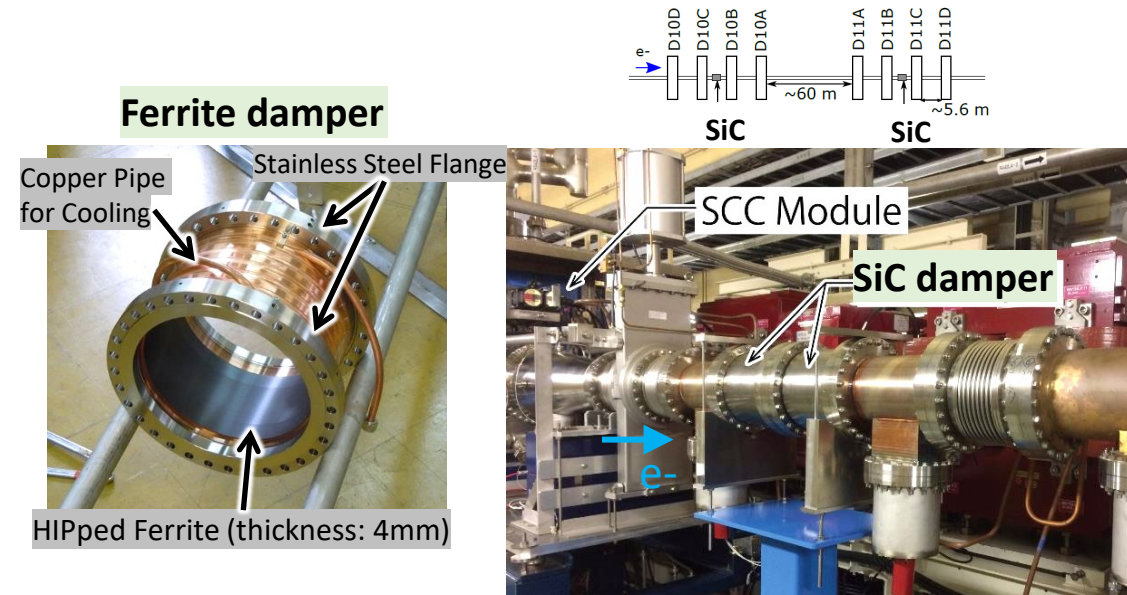
Superconducting Damped Cavity for KEKB

■ Single-cell single-mode 508.9 MHz cavity

- All the HOMs are extracted to the beam ducts.

■ HOM dampers with:

- **Ferrite** (used since KEKB)

- 4mm-thick Ferrite (IB-004) bonded on the inner surface of a copper duct by HIPping
- Ferrite Length: 120mm (150mm) for 220 (300) mm diameter damper as “SBP” (“LBP”)
- Power-handling capability demonstrated: 11.7 (14.8) kW for 220 (300) mm diameter damper

- **SiC**

- Added for higher HER beam currents at SuperKEKB

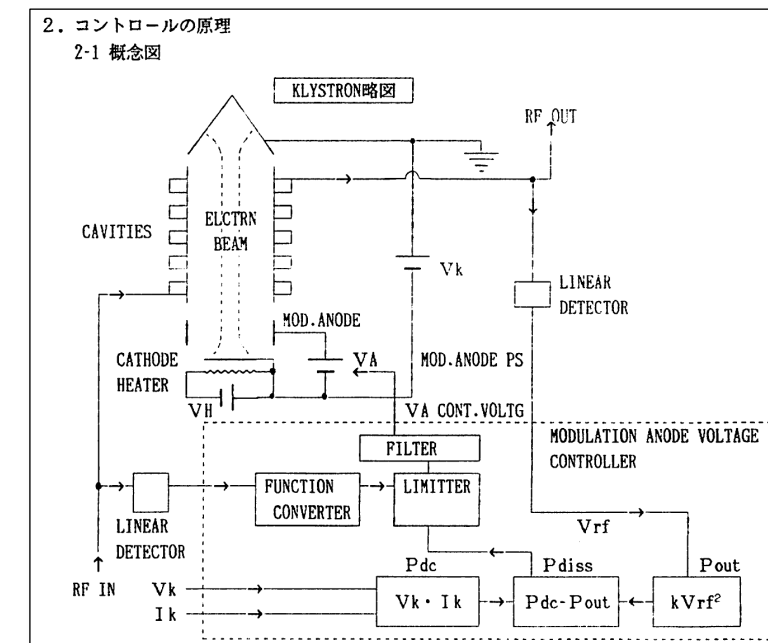
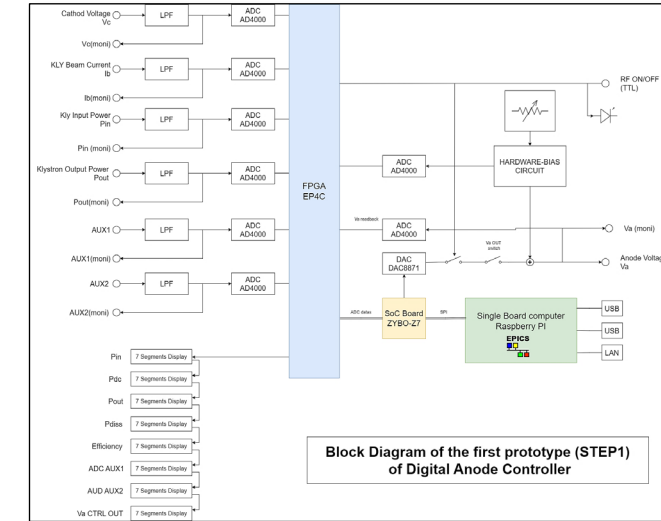
The current anode controllers are very old, developed in 1970's.
Consists of only analog circuits with:

- **No flexibility** for control method
 - Precise control to improve power efficiency can't be implemented.
- **No remote control**
 - Adjustments must be made on-site and too complex.
(the controller is in each of the 38 RF stations.)
- **Difficulty in future maintenance**
 - End of production of some parts
 - Redesigning with alternative parts is costly.

New Klystron Anode Voltage Controller (*Digital* control)

- **EPICS based remote control**

- **Flexible control with FPGA**

- Initially, the current control method will be followed.
- More sophisticated and efficient control is to be developed and implemented.
(for improving power efficiency and reducing operational costs.)

~90kW/klystron saving expected for ~500kW output from klystron
➔ ~2.7MW saving in the MR (⇔ ~27 million JPY saving /month)
(Cf. The 30 digital anode controllers cost ~30 million JFY.)

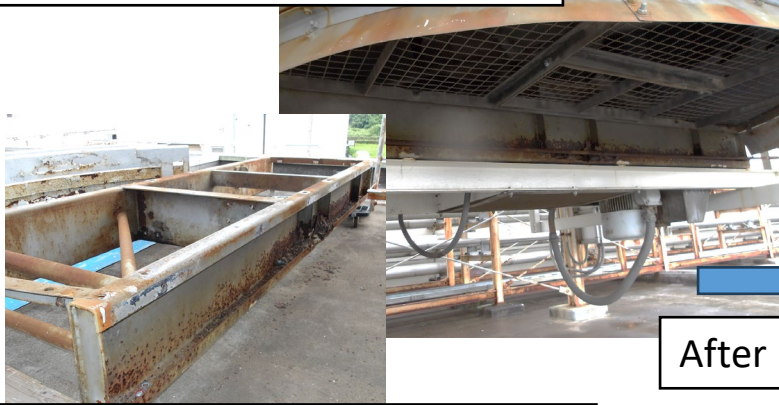
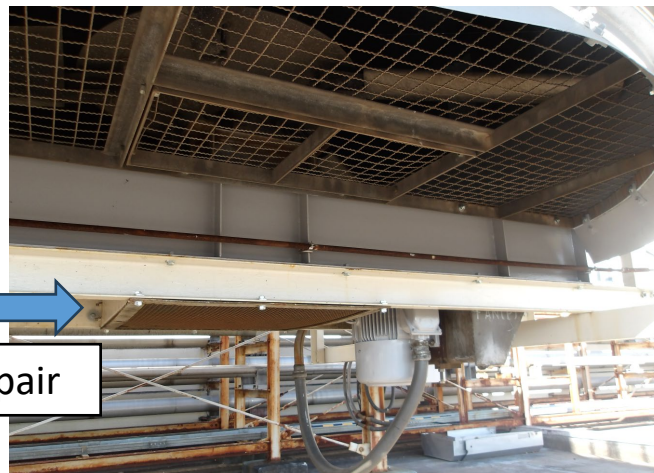
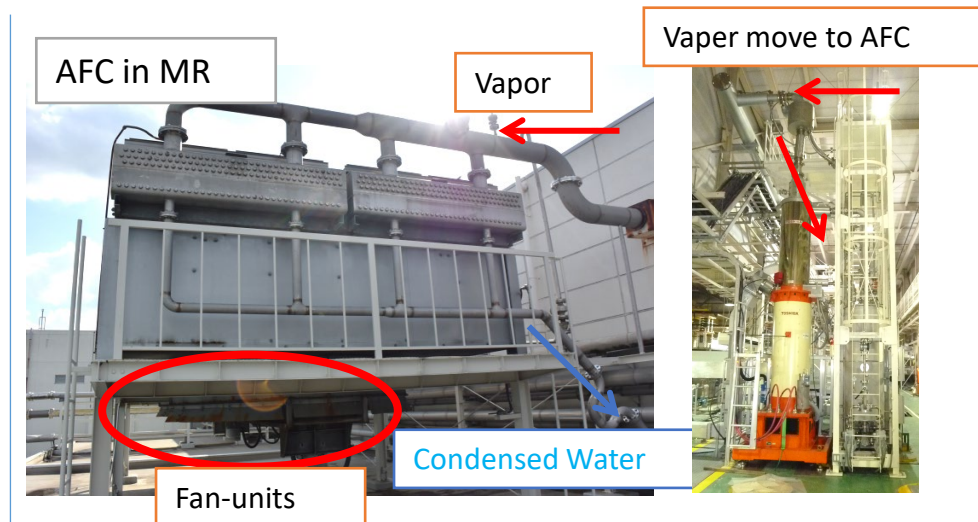
Renovation work for fan-unit

The main work will be the renewal of the aging fan-hoods and beam for mounting cooling fans. (One unit will be completed by Mar. 2025). The remaining 5 units for the MR will be renovated in stages over a period of 4-5 years.

Beam for mounting cooling-fan

After repair

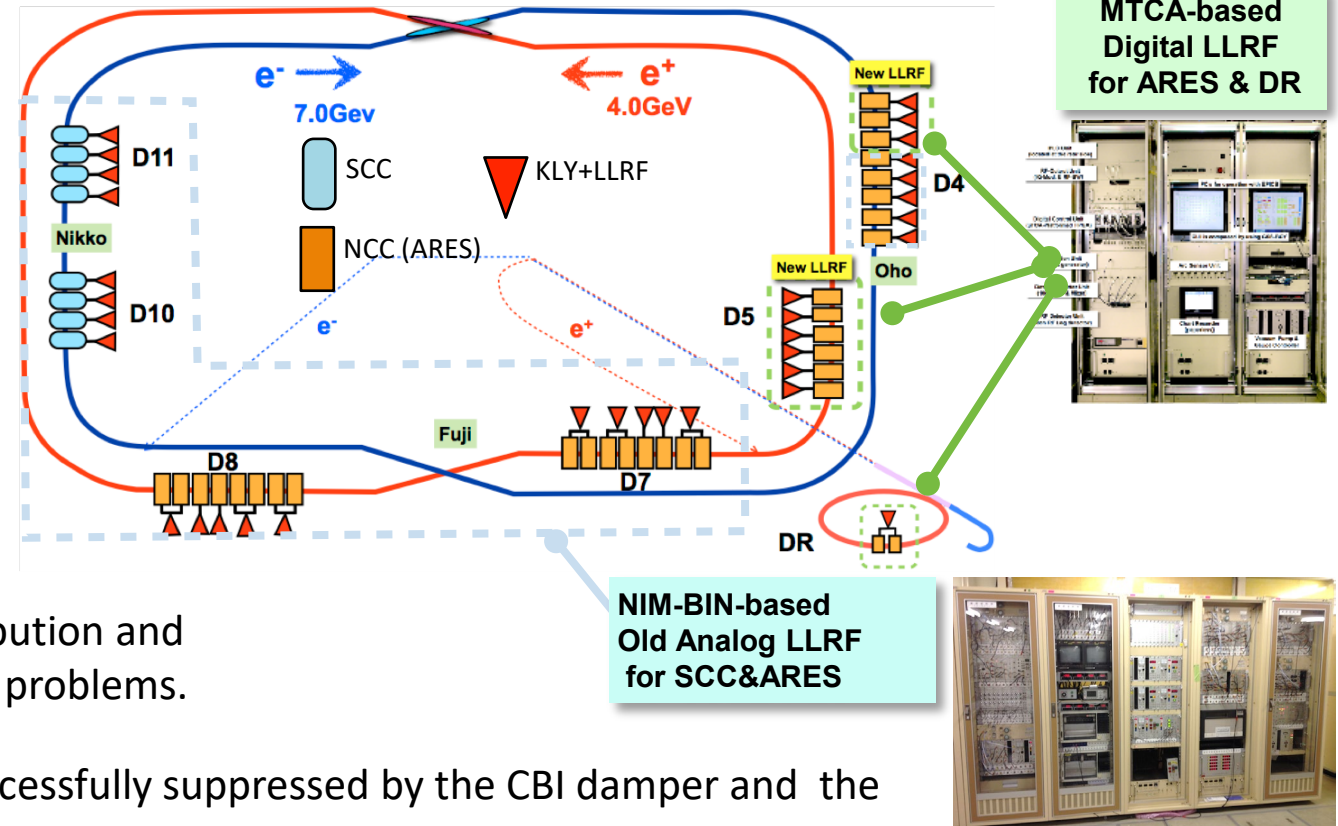
MTCA-based Digital LLRF Systems, which was developed for SuperKEKB, are applied to **10 RF-stations** for ARES & DR.

In the other stations, **NIMBIN-Based Old Analog LLRF Systems**, which had been used since the KEKB era, still used.

- All the LLRF systems, including the reference signal distribution and instability-dampers have been working well without fatal problems.
- Beam instabilities driven by the accelerating mode are successfully suppressed by the CBI damper and the Zero-mode damper. (CBI : Coupled Bunch Instability such as $\mu=-1$ mode)
- Recent concerns are increase of failures of NIM-BINs and the modules due to aging of the old systems including CAMAC. (The most devices are discontinued, and the spares are not enough.)
Even the digital systems with FPGAs&linux, developed in 2012, are becoming out-of-dateness.

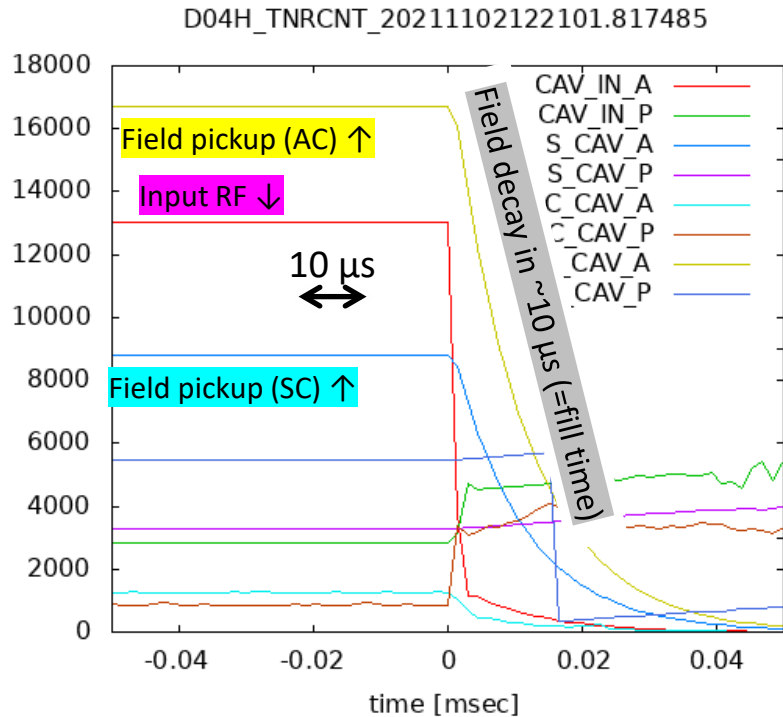
RF switch manually turned off

Tail in the RF-field decay
determined by the fill time ($\sim 10 \mu$ s)

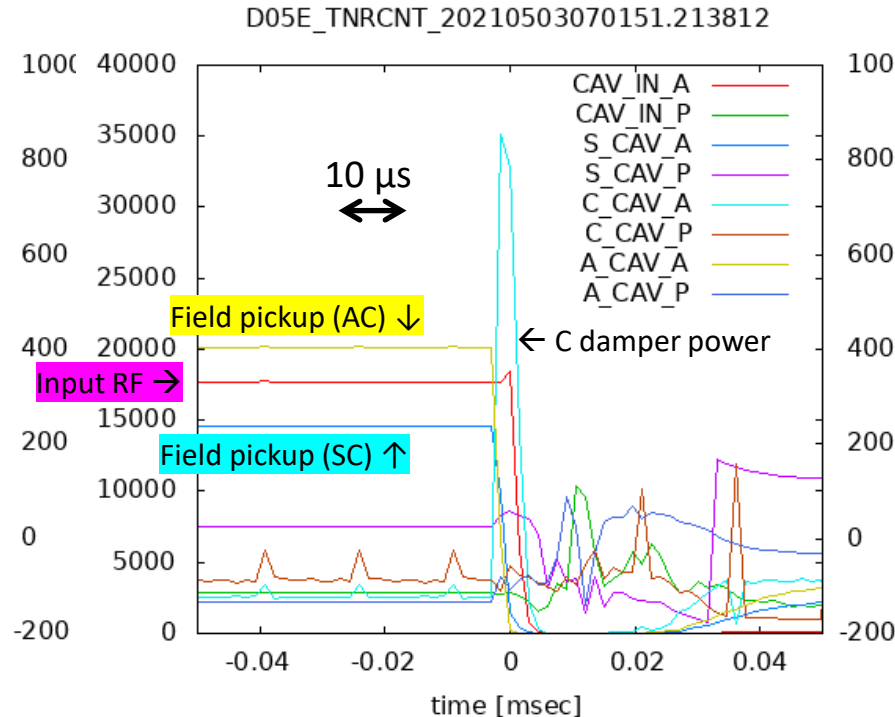
Usual cavity breakdown

Rapid drop of the RF field,
which is explained
as “Fireball Breakdown” in AC

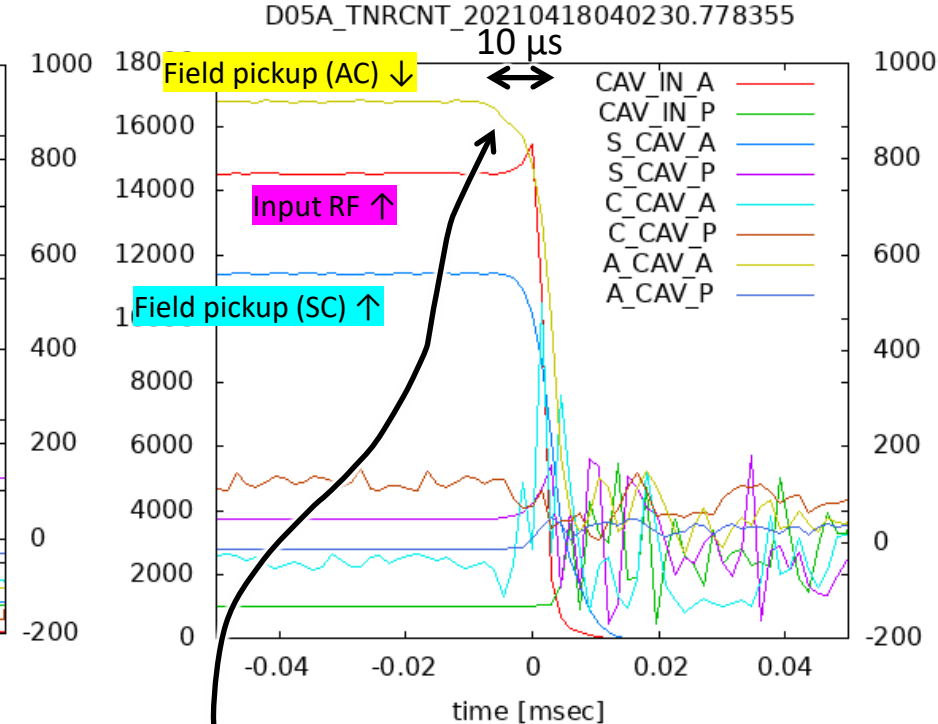
Unusual cavity breakdown seen only in the D05-A cavity

Slow drop prior to
the rapid drop of the RF field

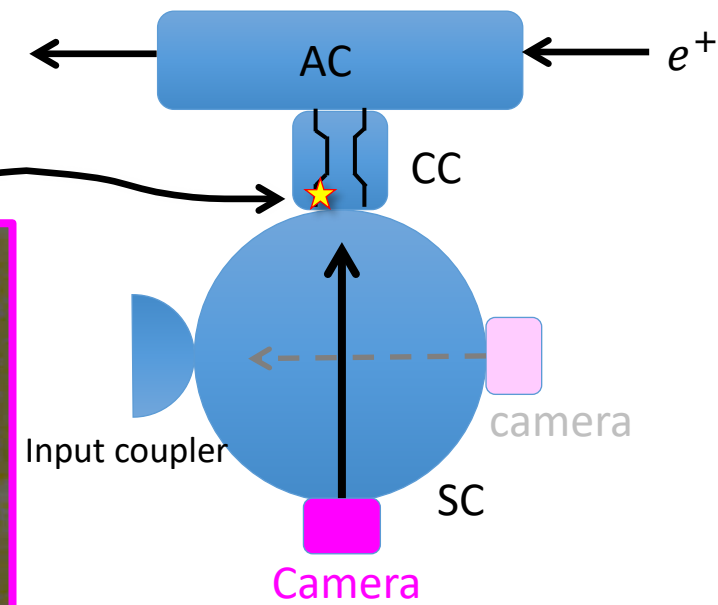
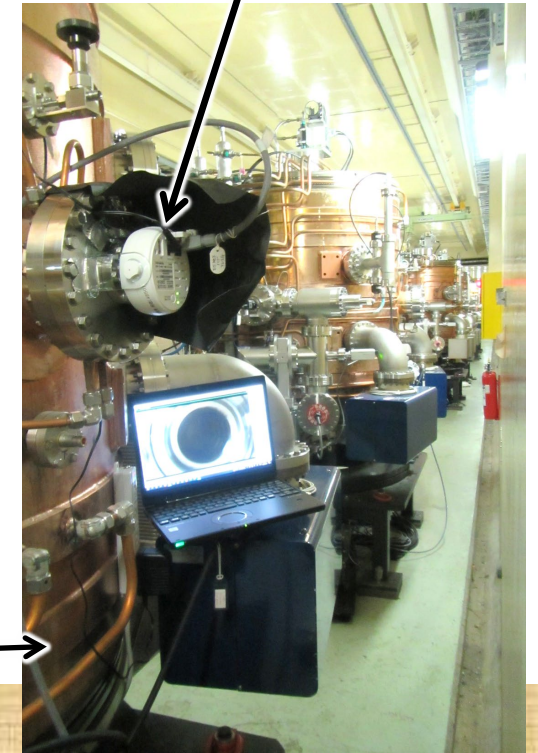
Unusual breakdown
at 2021-10-30_16:21

- ✓ All the light emission at the same point
- ✓ Vacuum arc in the coupling cavity (CC)

During stable high-power operation with 340 kW input

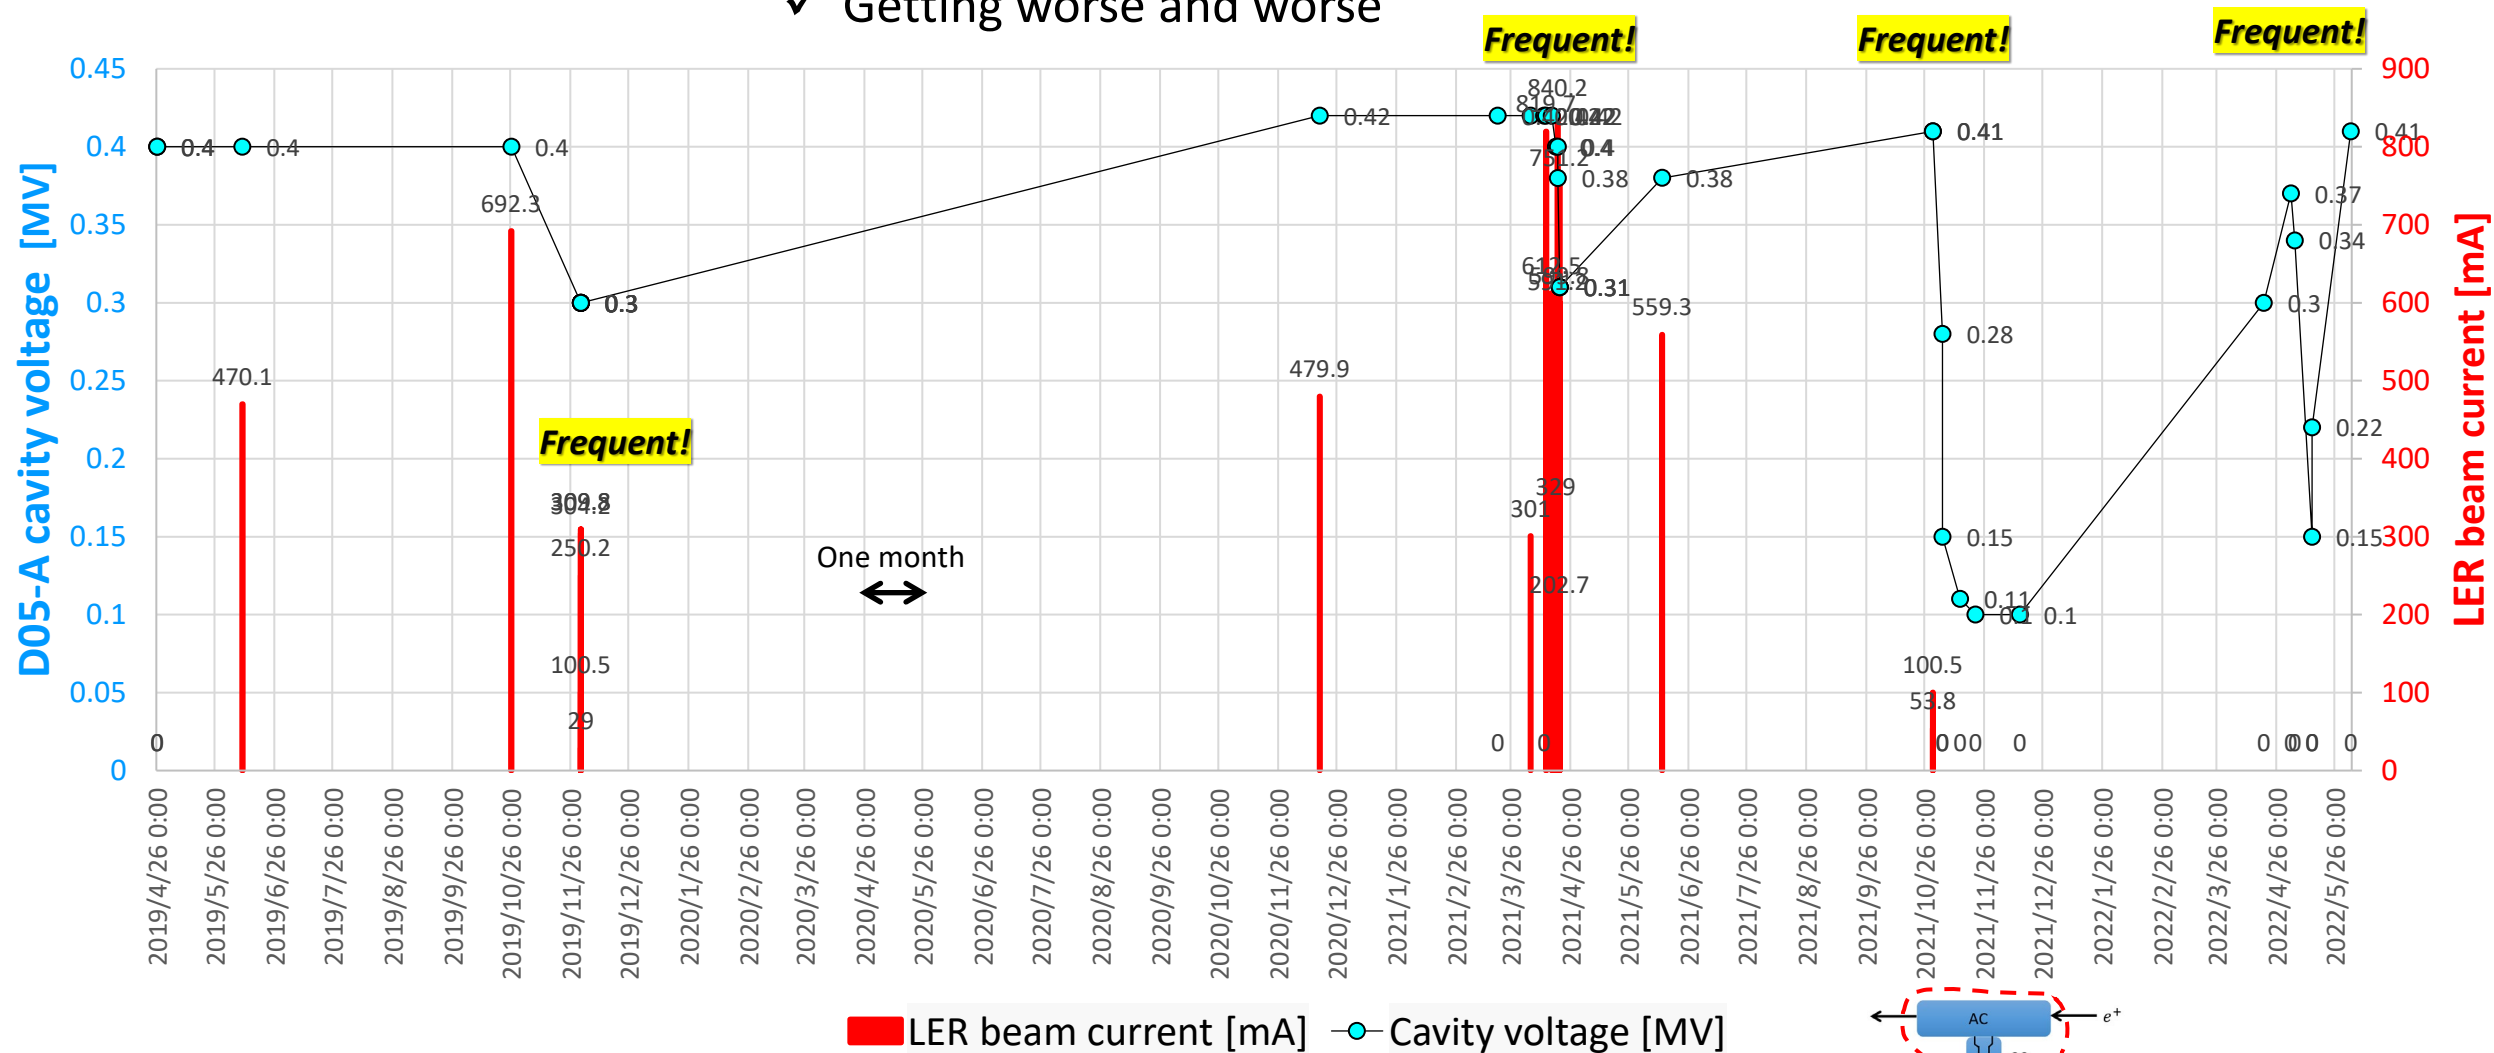
History of the D05-A unusual breakdowns ●

- ✓ Occurred even with no beam
- ✓ Getting worse and worse

➔ Decided to replace the D05-A cavity (CC+AC)

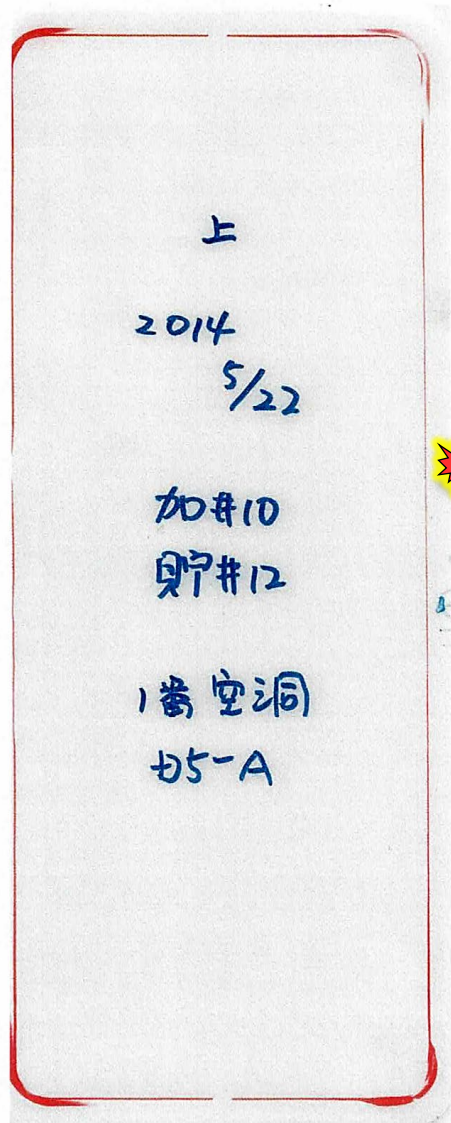
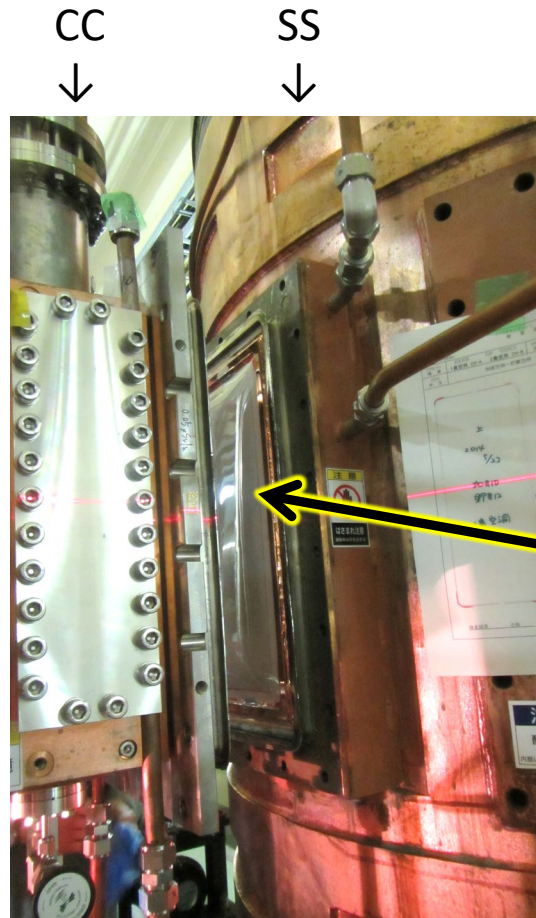
Check of the RF contact in the connection between SC and CC using pressure-sensitive paper

2014-05-22 (just after the relocation: HER→LER between KEKB and SuperKEKB)

- Perfect contact around the vacuum arc point
- Any contact failure was not a cause of the unusual cavity breakdown of the D05-A cavity.

Pressure-sensitive paper
