Reports on SuperKEKB RF System

The 28th KEKB Accelerator Review Committee

2025-01-15

RF Accelerating System for the SuperKEKB Main Ring (MR)

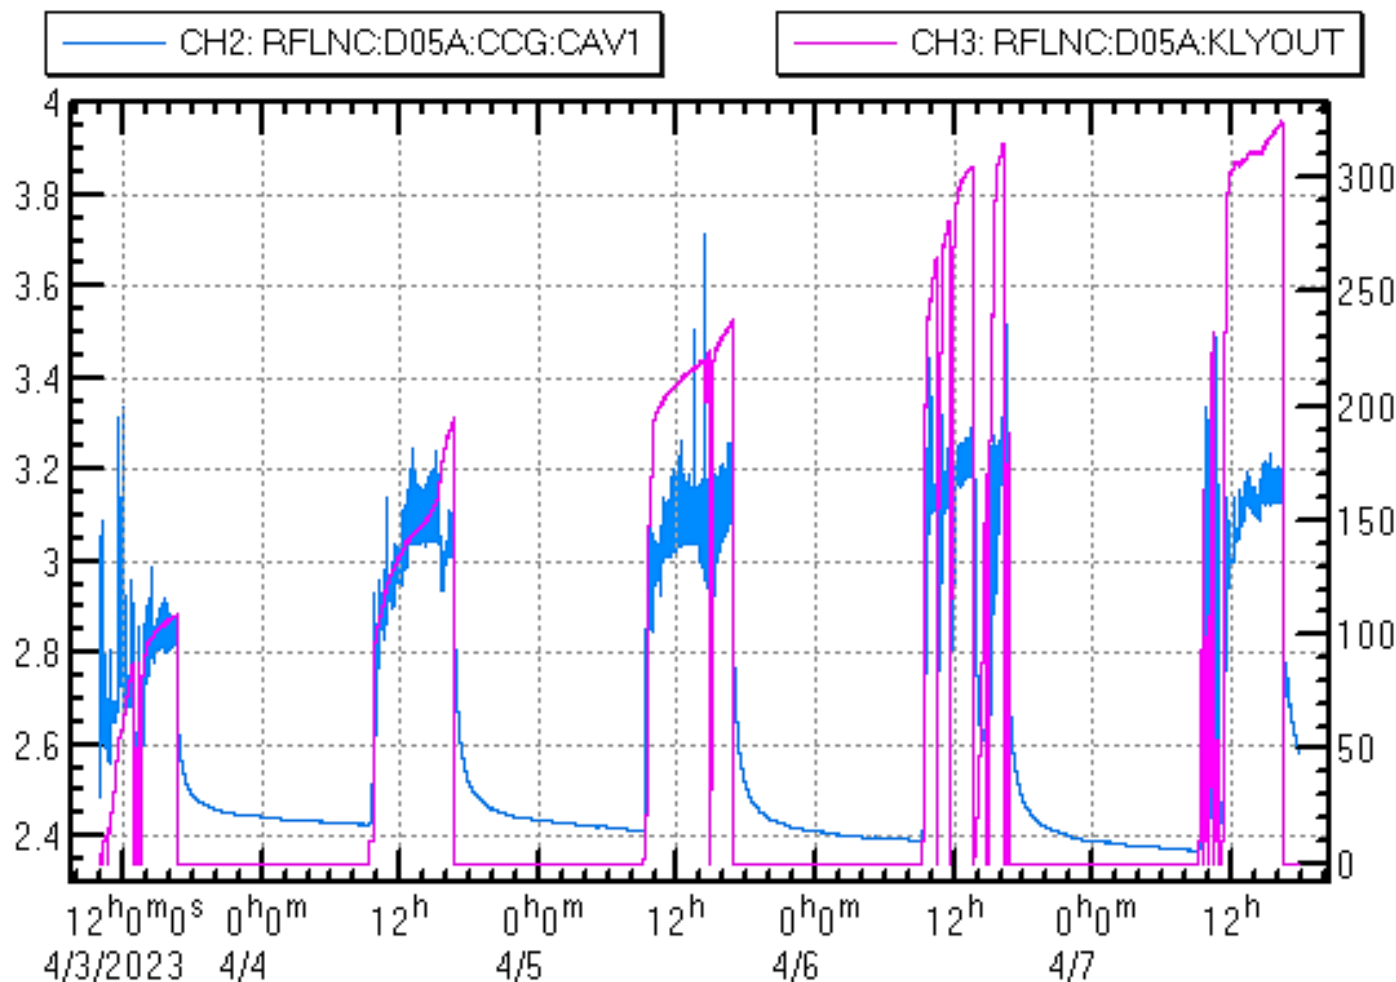
High-power test of the new D05-A cavity up to 0.5 MV/cav

Vacuum pressure [CCG V]

Klystron output RF power [kW]

Successfully finished
✓ No vacuum leak
✓ No vacuum arc

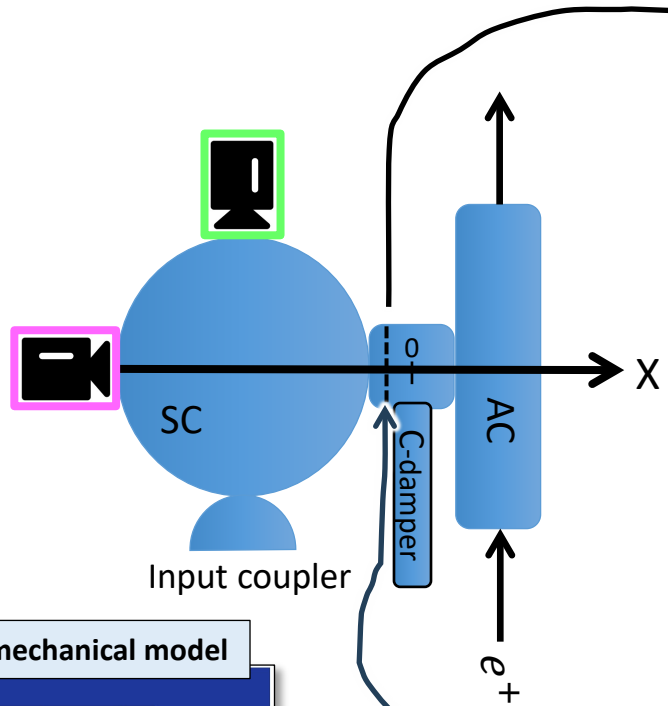
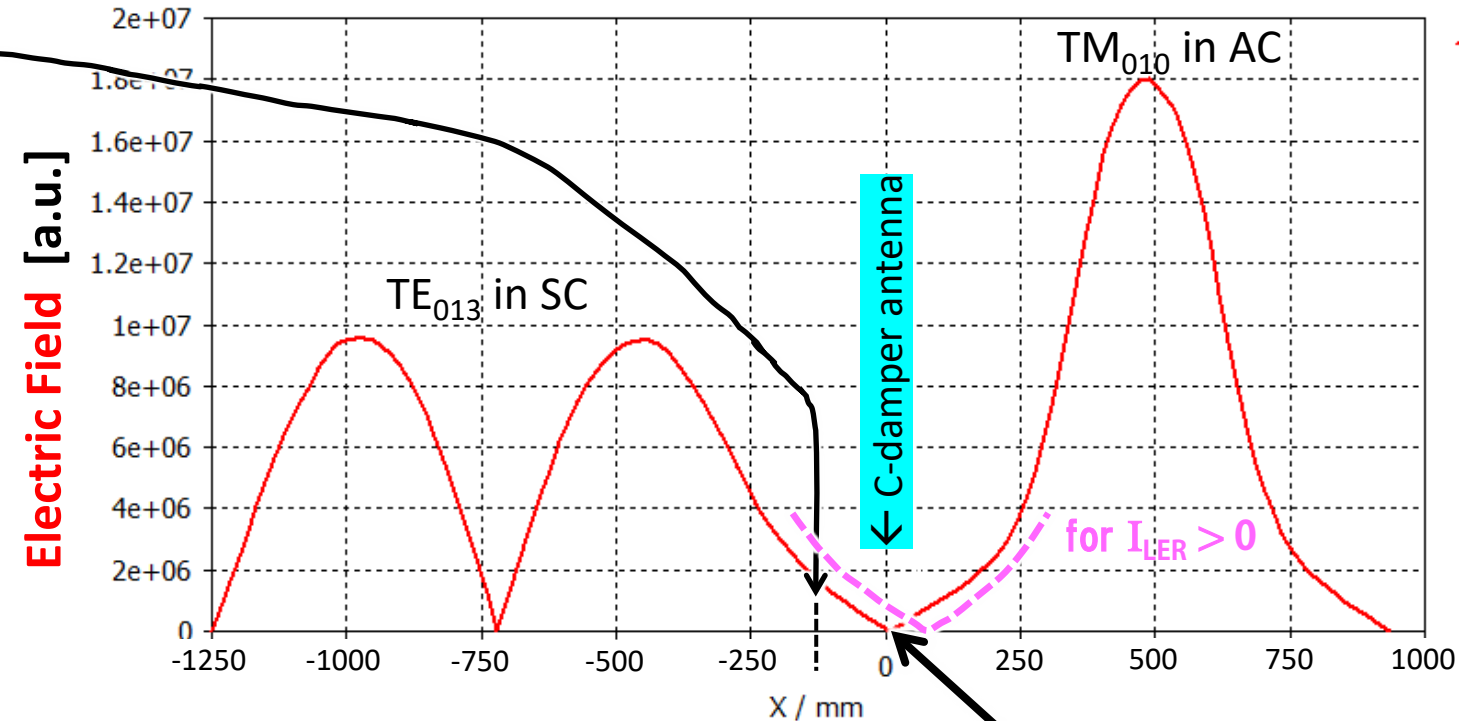
ARES three-cavity system

Accelerating $\pi/2$ mode in the ARES cavity system for $I_{LER} = 0$

Equivalent mechanical model

This node shifted toward $X > 0$ for higher beam currents
→ Higher C-damper power
→ Higher RF field applied to the connection at $X = 0$

Surface electric field during operation with 0.5 MV/cav and $I_{LER} = 0$

- At the connection ($X = -130\text{mm}$) : $\sim 0.3\text{ MV/m}$
- In AC: 7.2 MV/m (max.)

(The surface field at the connection between SC and CC) \propto (square of the C-damper power)

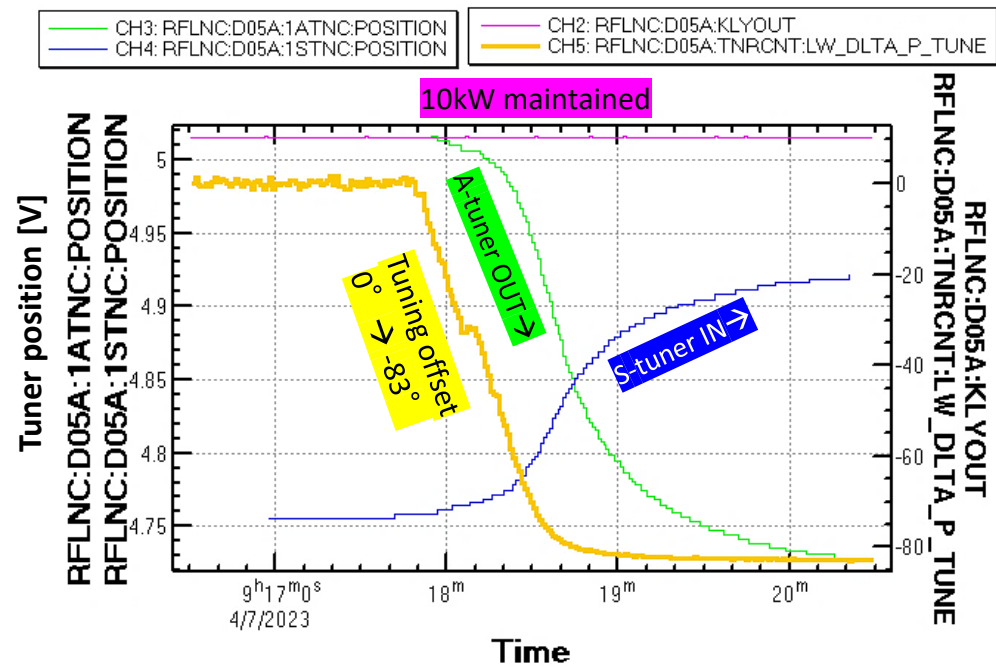
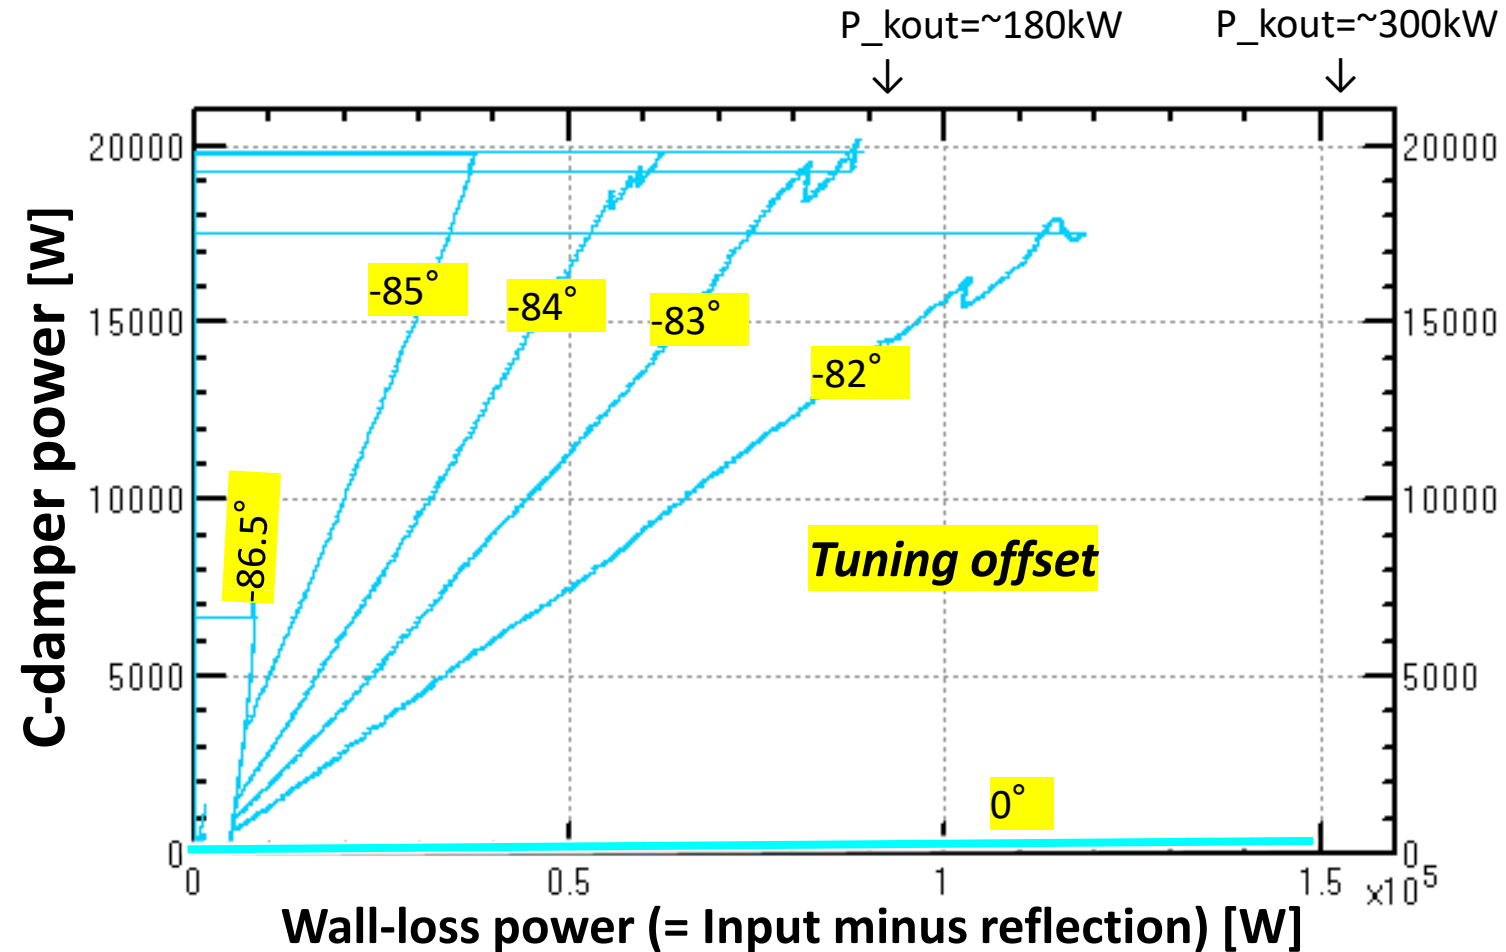
D05-A high-power test with a large tuning offset

20 kW C-damper power corresponds to beam loading with LER 3.6 A

➔ **Successful simulation of the beam loading of a 3.6 A LER beam current with a 20kW C-damper power!**

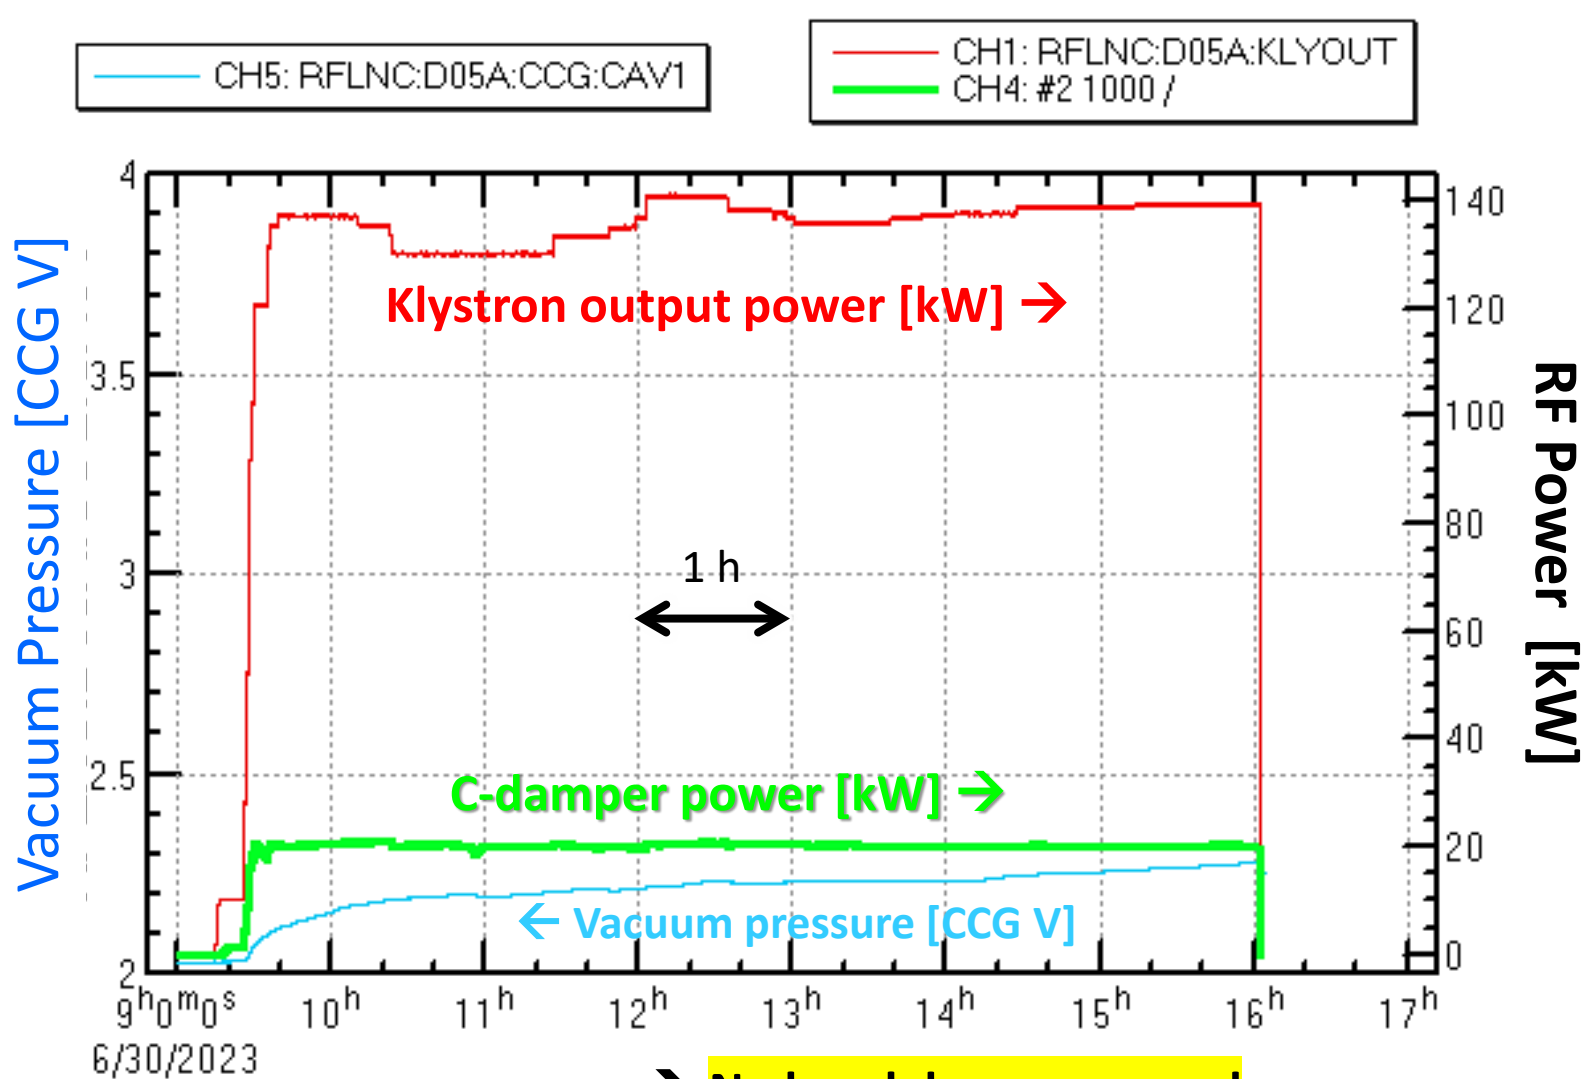
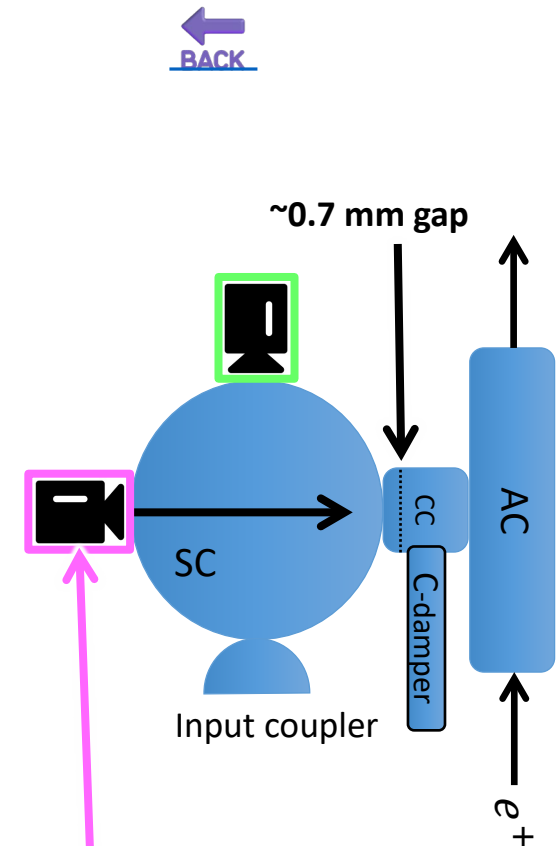
D05-A high-power test with 20 kW C-damper power maintained for 6.5 h

- ➔ No breakdown occurred
- ➔ No vacuum arc observed in any frame of the recorded video
- ➔ No breakdown during the 2024a+bc beam operation so far

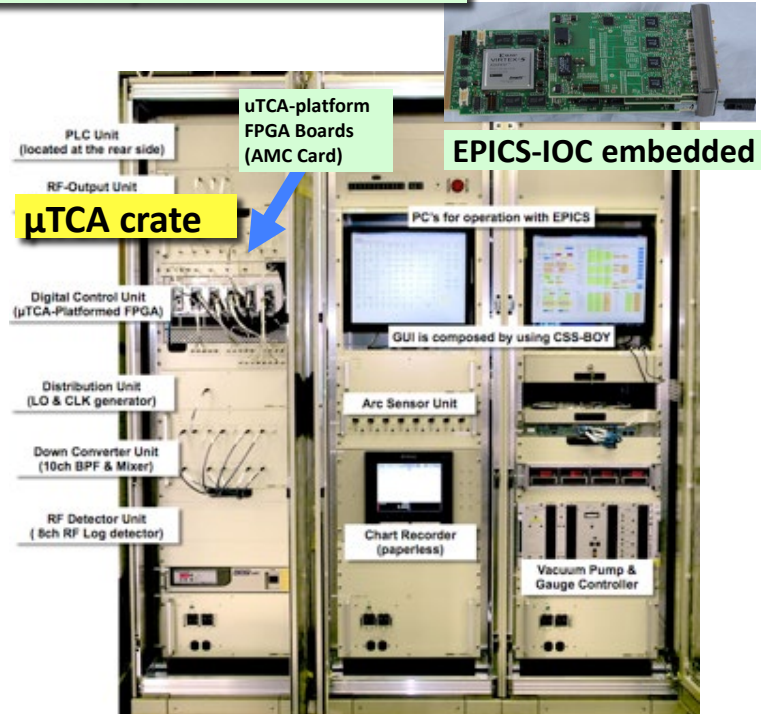
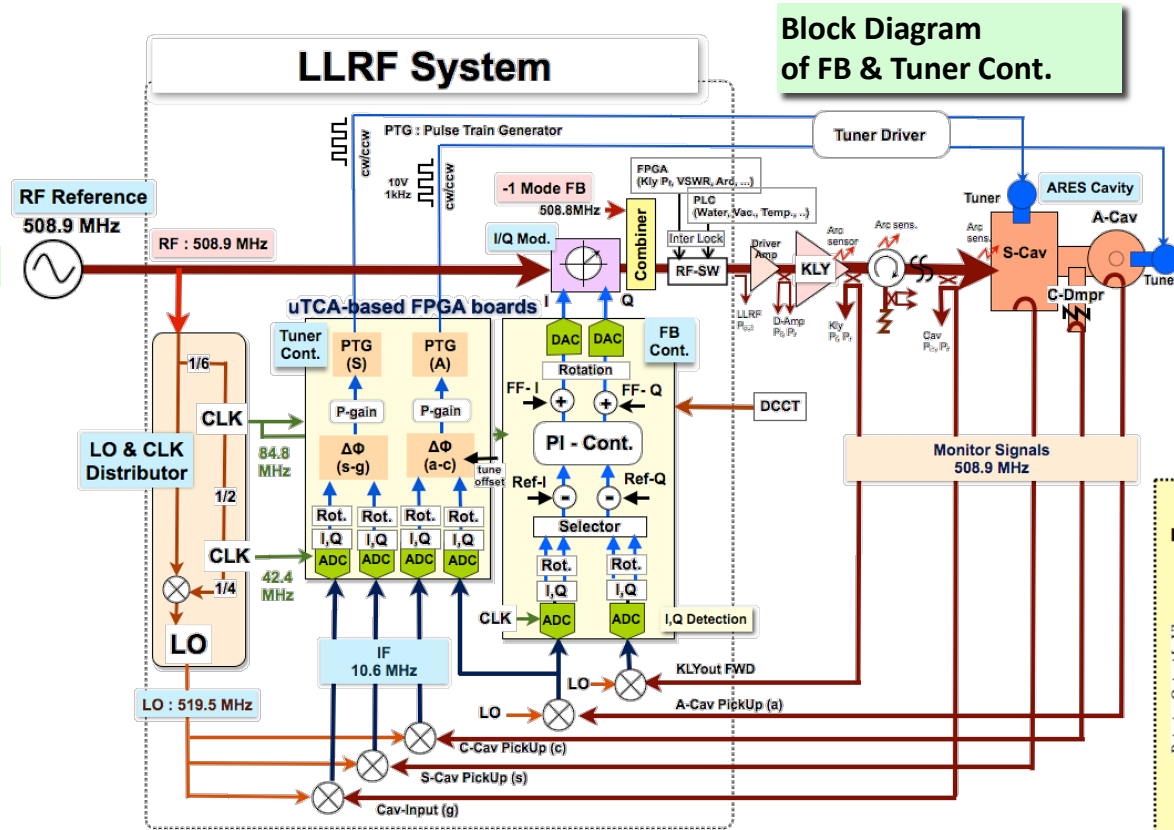
New LLRF System for one klystron

16-bit ADC x 4ch,
16-bit DAC x 2ch

uTCA-platform
FPGA Boards
(AMC Card)

EPICS-IOC embedded

μTCA crate

- Consisting of μTCA-platformed FPGA boards (AMC), & PLC.
- EPICS-IOC with Linux-OS is embedded in each of them.
- Common hardware for both of ARES & Superconducting Cavity.
- Klystrons (LLRF) : Cavity unit = 1 : 1 (SuperKEKB)

- It is dominated by μTCA-platformed FPGA boards for higher accuracy and more flexibility.
- In this system, I/Q components are handled by FPGA for vector control instead of amplitude and phase.
- The good performance was demonstrated in the high power test with ARES cavity. The regulation stability was 0.02% in amplitude and 0.02 deg. in phase.

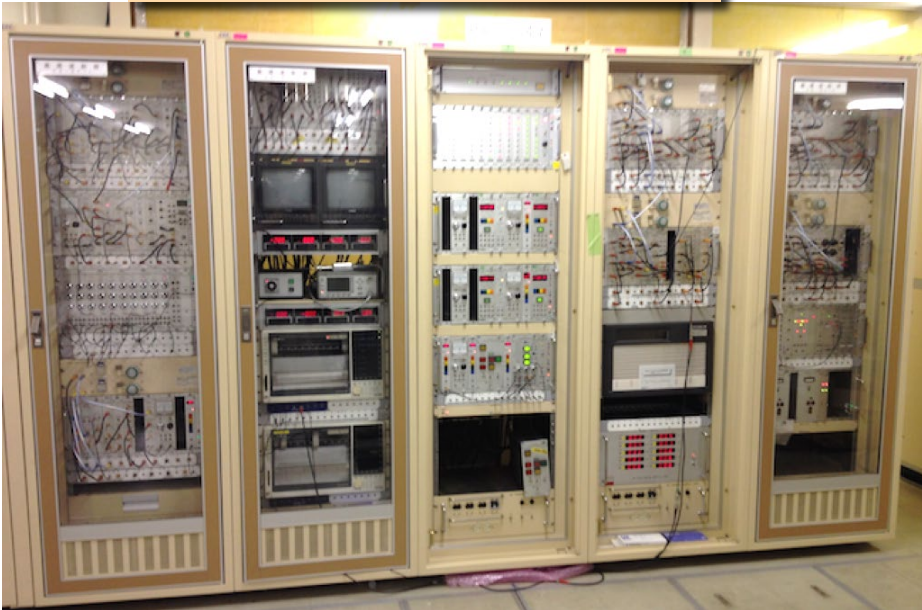
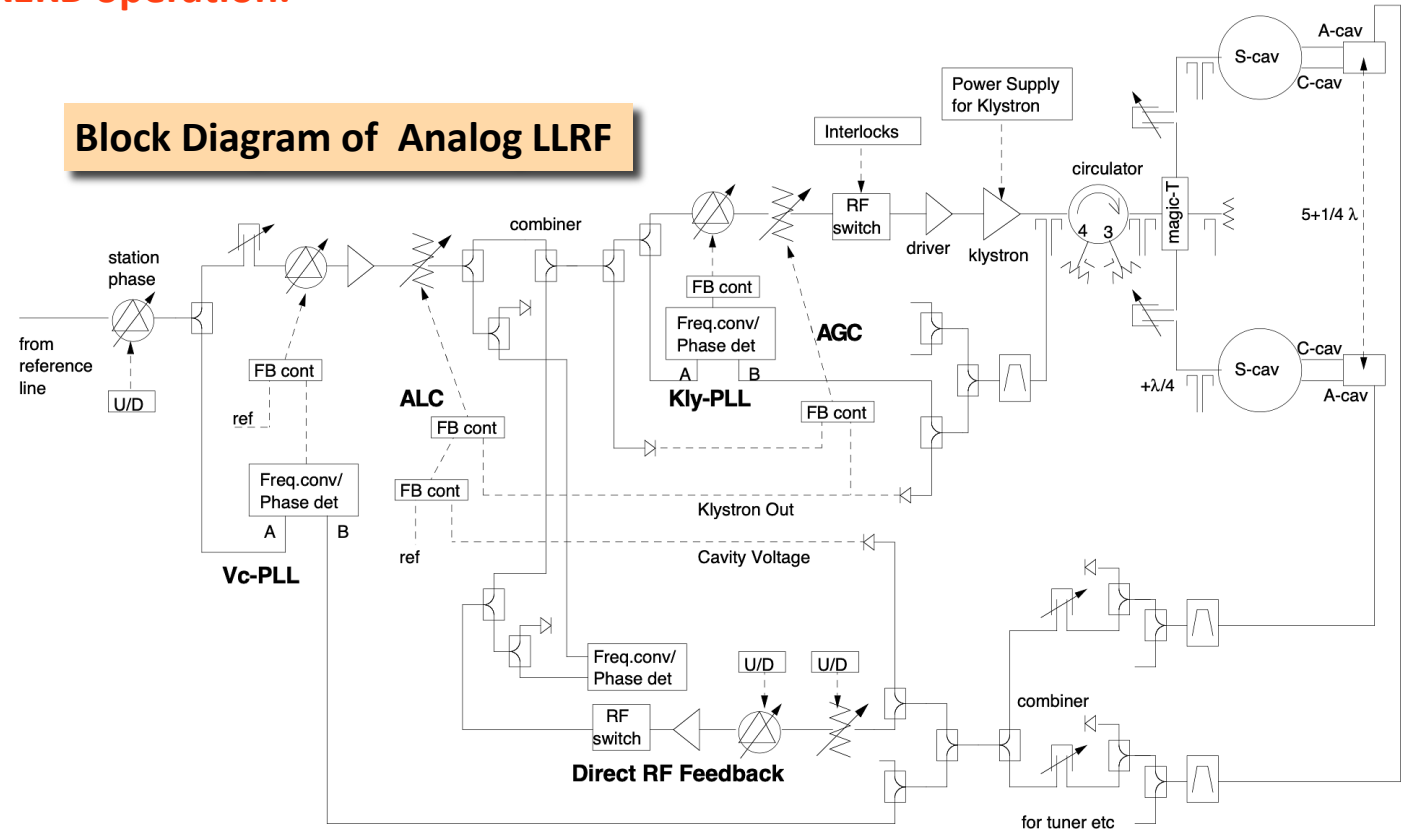
Block Diagram of Analog LLRF

Analog LLRF
used since the KEKB operation

- These systems are **composed of combination of NIM standard analogue modules.**
- They are **controlled remotely via CAMAC system.**
- All systems are barely working without serious troubles.

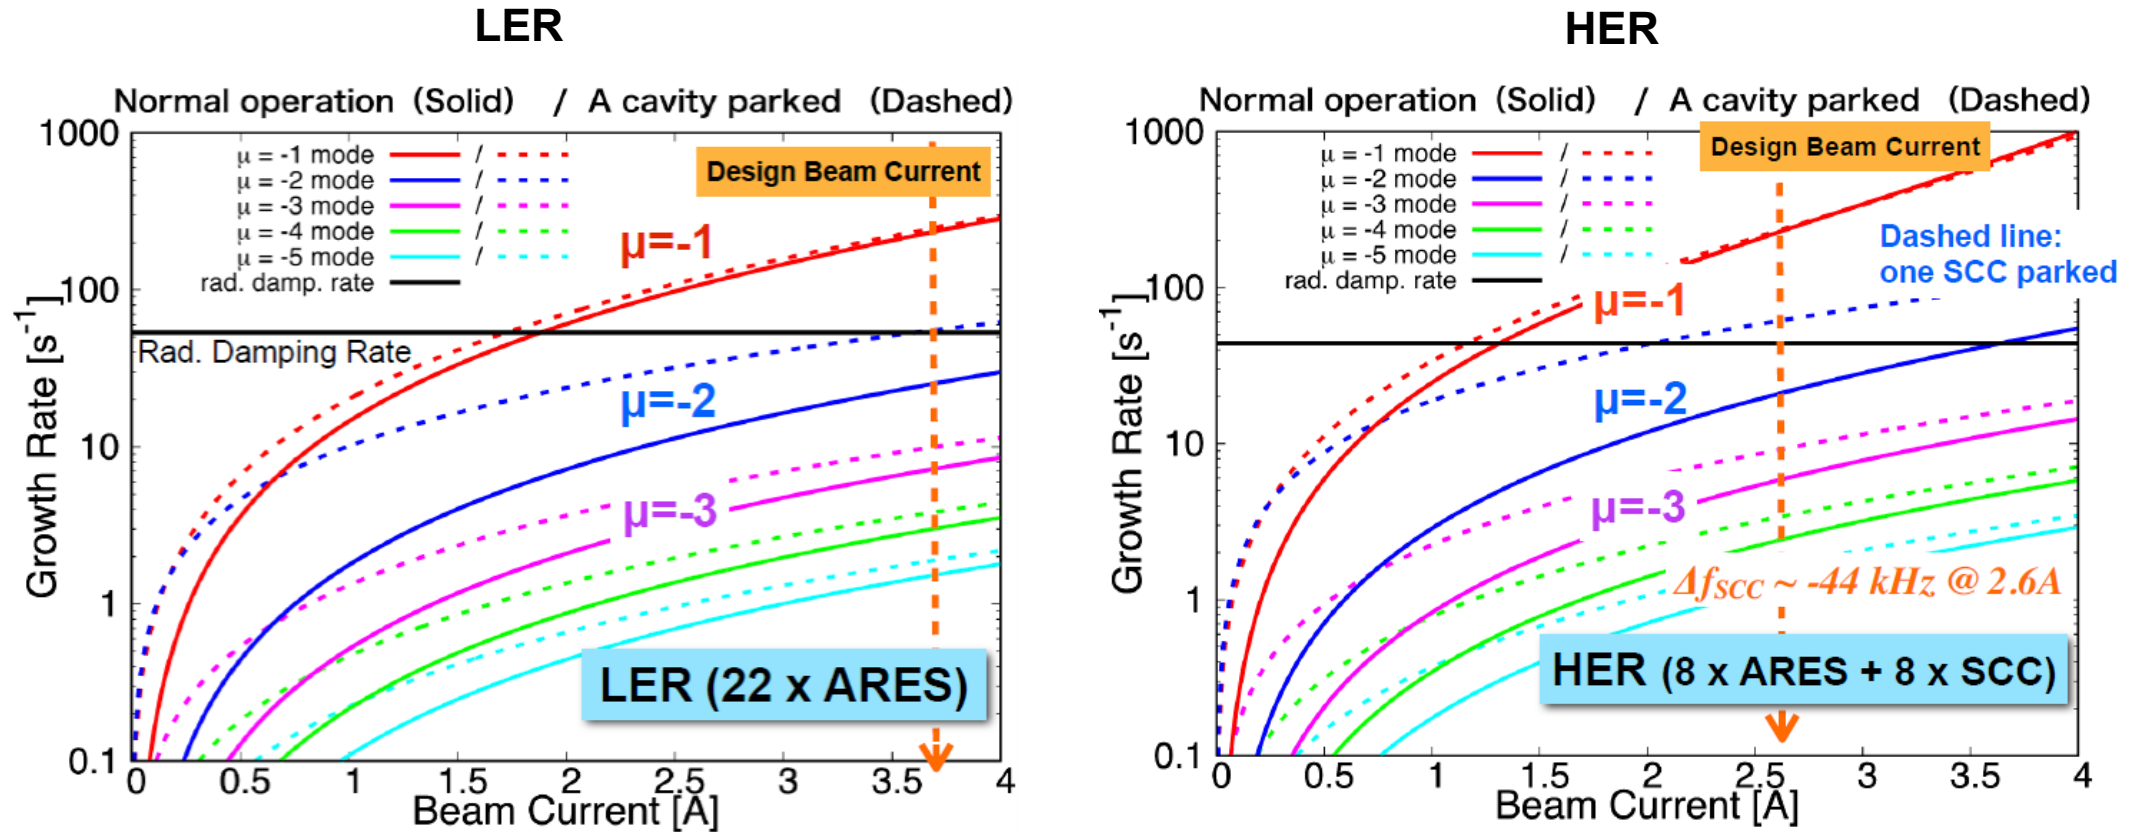
Threshold currents for $\mu = -1$ mode are quite below the design current.

When there are parked cavities, $\mu = -2$ mode also has no margin.

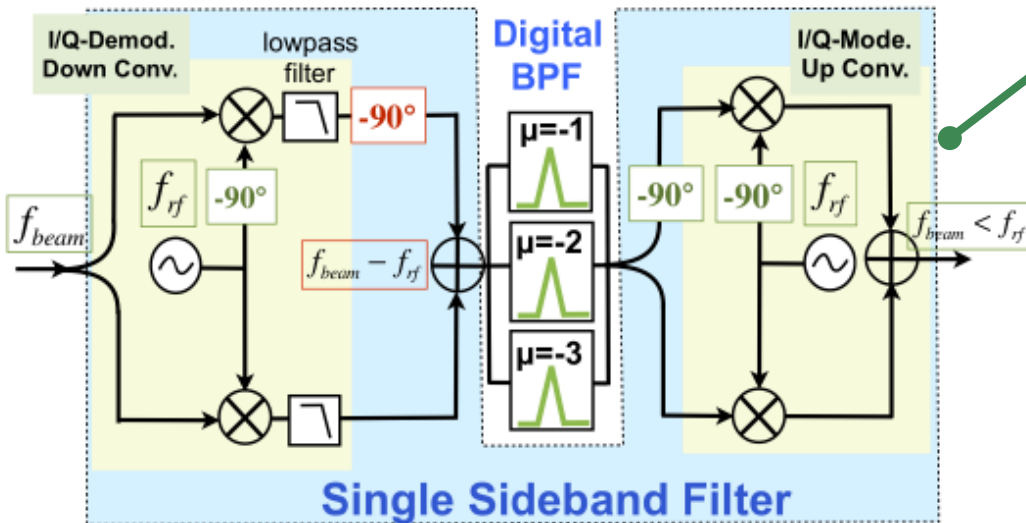
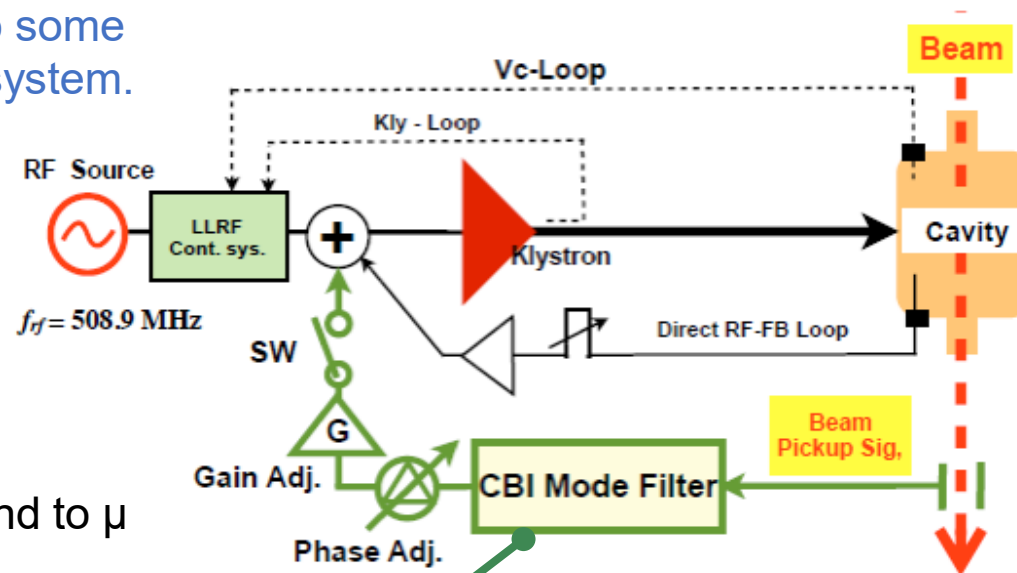
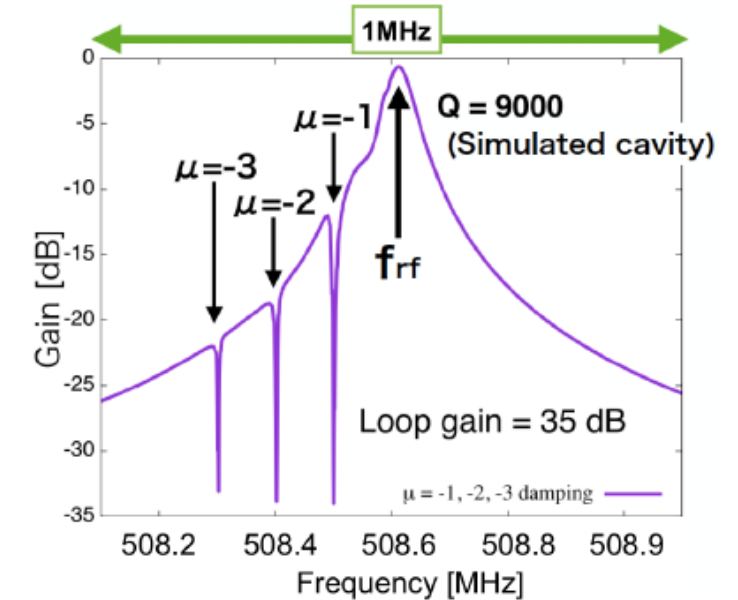
CBI Damper System

The damper system is installed to some ARES stations with digital LLRF system.

The damper system can correspond to $\mu = -1, -2$ and -3 modes in parallel.

FB loop test result of the CBI mode filter for a simulant cavity

Impedances at the frequencies corresponding to $\mu = -1, -2$ and -3 modes are suppressed by the damper.

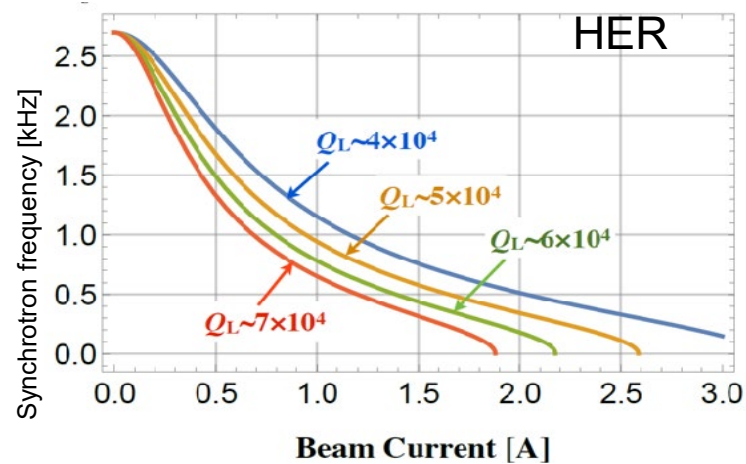
Calculated coherent oscillation frequencies with **simplified one SCC** for various Q_L (without FB for instabilities)

Synchrotron frequency reduction depends on Q_L . But, changing Q_L of SCC should be avoided due to the need for vacuum work and the risk of surface contamination.

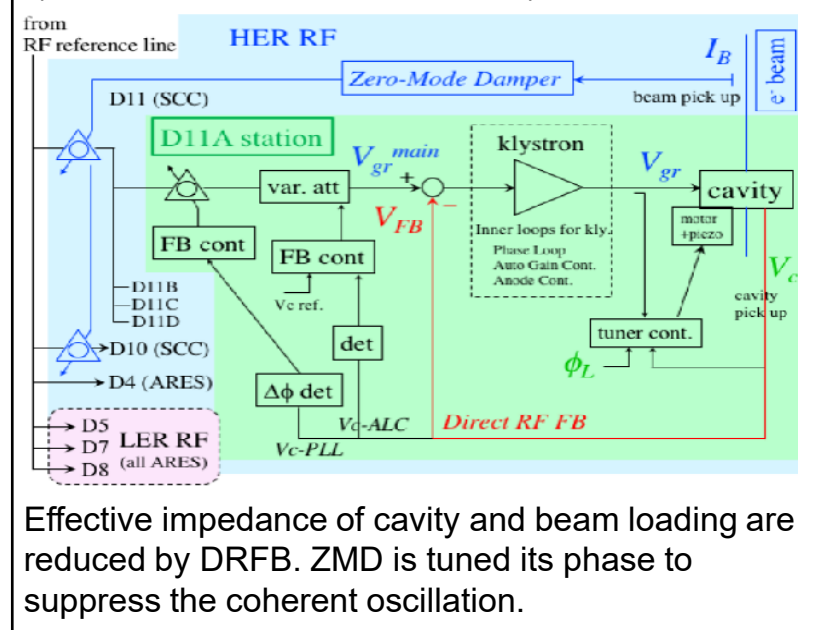
Block diagram of LLRF with DRFB and ZMD (Focused on SCC station in HER)

Effective impedance of cavity and beam loading are reduced by DRFB. ZMD is tuned its phase to suppress the coherent oscillation.

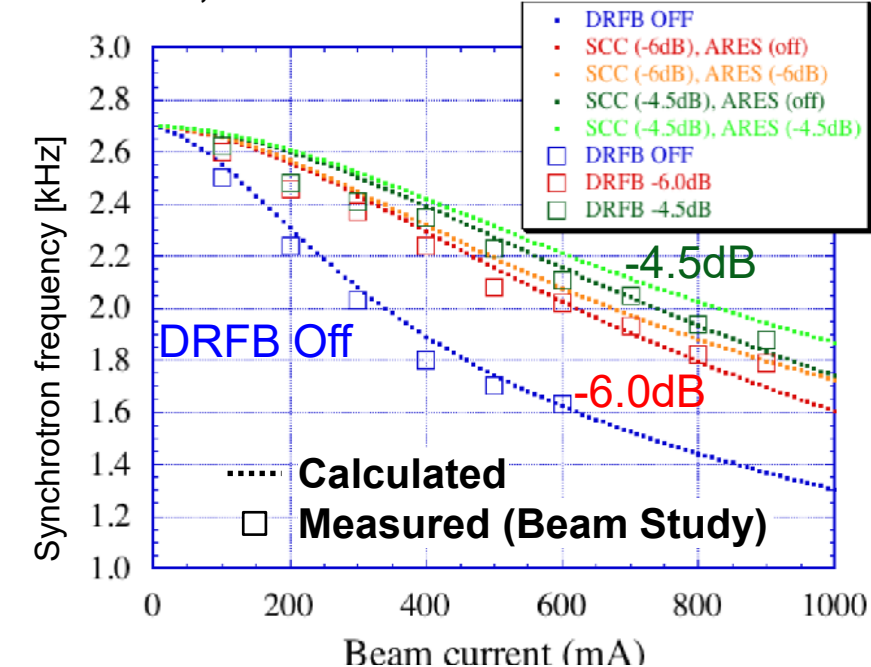
Calculated and measured coherent oscillation frequencies in **actual HER (ARES + SCC)** with **DRFB Off, -6.0dB and -4.5dB**

- ◆ The higher beam currents can be stored stably by DRFB and ZMD in beam study.
- ◆ There is no discrepancy between the quantitative analysis and the beam study results.
- ◆ Coherent oscillation instability can be suppressed by the DRFB and ZMD so far.

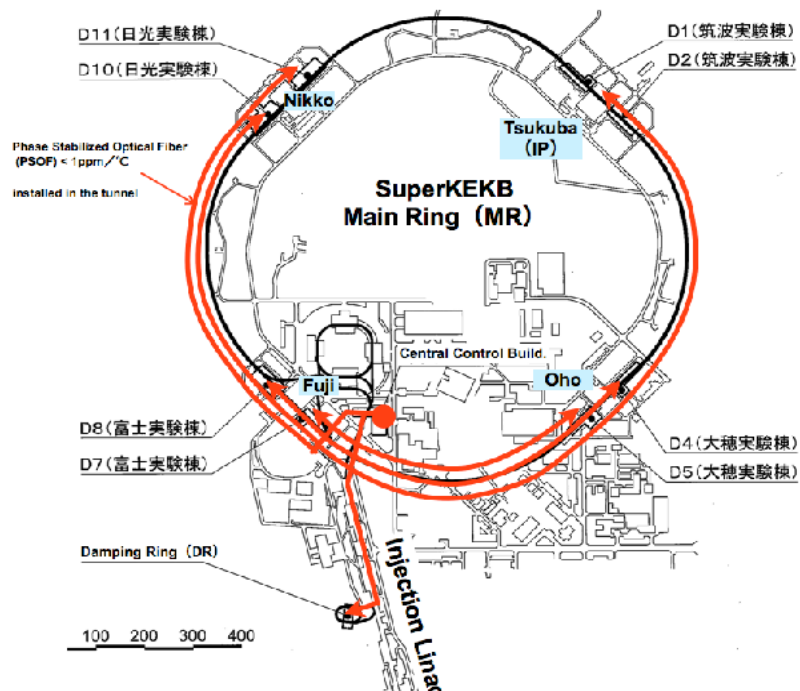
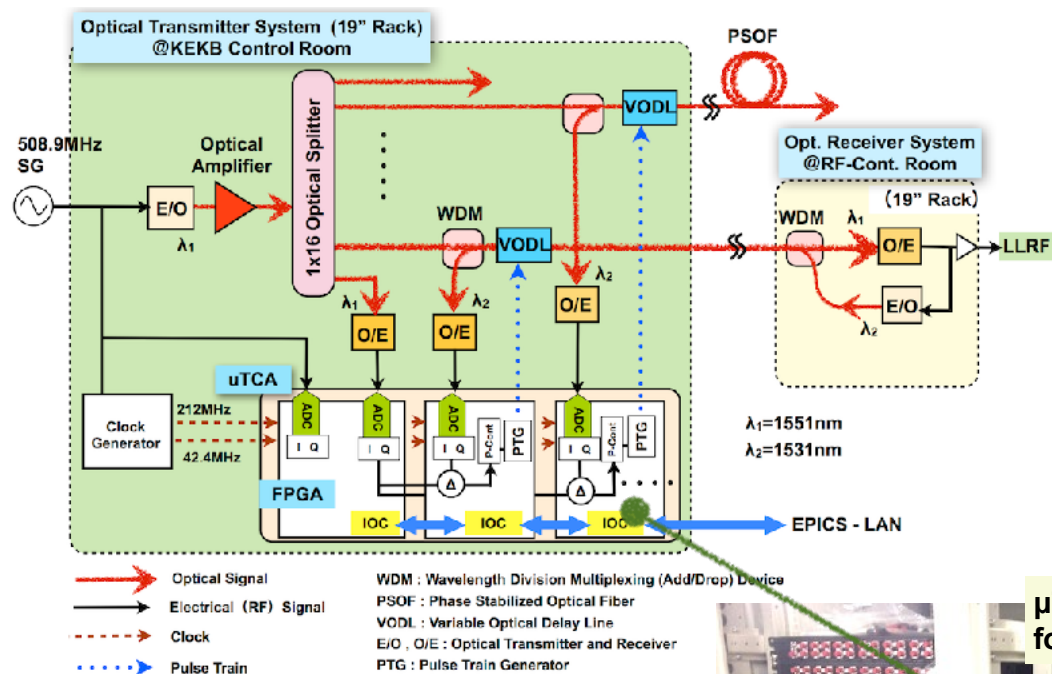
RF Reference Distribution System

- RF reference signal is **optically distributed** into 8 sections by means of “Star” topology configuration from the central control room (CCR).
- For the thermal phase drift compensation, **variable optical delay line (VODL)** is **controlled** digitally by using μ TCA board at CCR for all the transfer lines. The VODL is a mechanical type. The stepping motor is controlled by the μ TCA boards with pulse train outputs like cavity-tuner control.
- For the phase monitor, **direct sampling method** is applied by using 14-bit ADC boards. It is under sampling at 212 MHz for 509-MHz RF signal.

Low SSB Phase Noise

Short term stability (time jitter) : < 100 fs (rms)

Long term stability (pk-pk) : $\pm 0.1^\circ$ @ 508.9MHz = ± 0.55 ps

Variable Optical Delay Line (Mechanical type)

Variable Optical Delay Lines (VODLs) for 8 transmissions
