KEKB ARES CAVITY SYSTEM STATUS

Tatsuya KAGEYAMA

KEKB ACCELERATOR REVIEW

2/23/2001

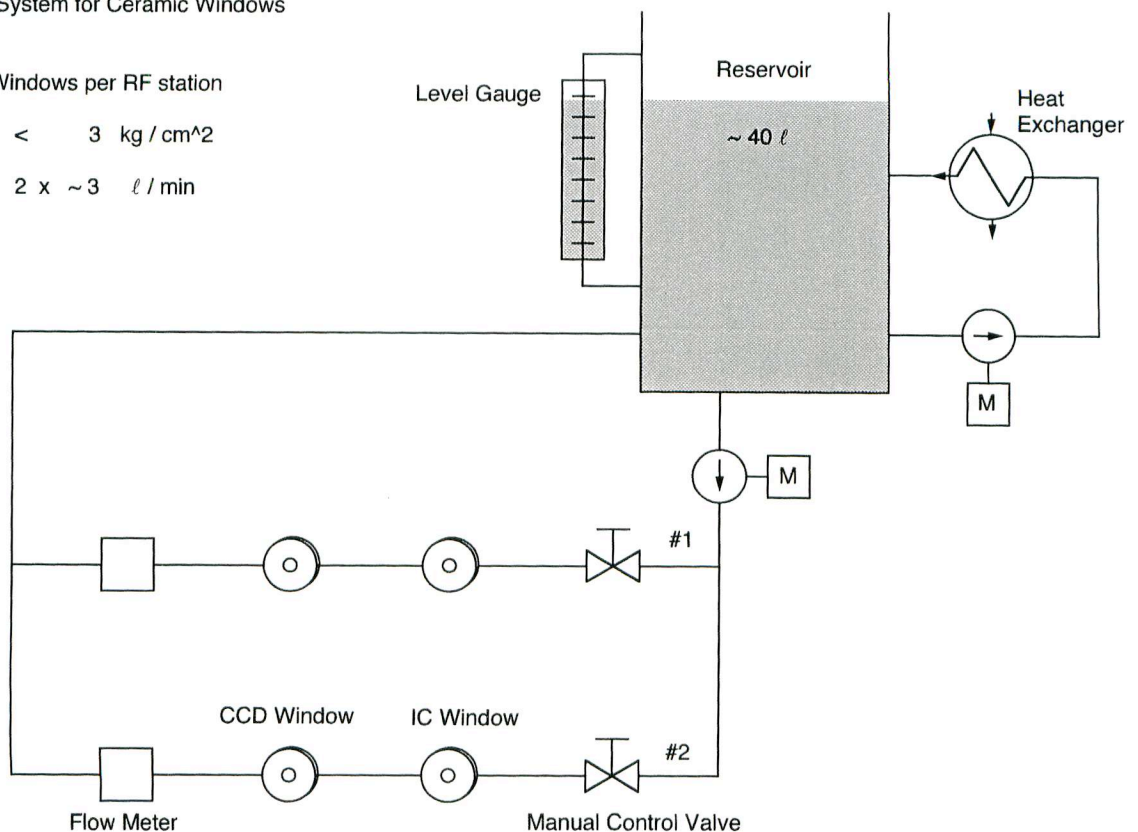
Cooling Water Channels for Ceramic Window

First, a leak was located at the inner cooling water circuit for the ceramic window of the coupling cavity damper (CCD) @ D4C2.

After replacing the bad CCD with a new one, another leak was found and also located at the inner circuit of the input coupler @ D4C2.

Those serious leaks were probably caused by erosion-corrosion of copper tubes. Erosion-Corrosion arises from a combination of chemical attack and the physical abrasion as a consequence of the fluid motion. Aggressive waters do not allow a protective film (oxides) to form inside the copper tube.

- Liquid velocity ~ 1 m/s
- Erosion-corrosion is probably accelerated by the presence of molybdenum oxide produced from the Mo wire exposed to the cooling water with dissolved oxygen gas.

- An RF contact failure at FC between CC and SC @ D7C2.
=> Inspection and repair (or replacement in the worst case) are scheduled in the summer of 2001.
- Erosion-corrosion of copper surfaces is probably accelerated by the presence of molybdenum oxide in the water cooling system for the coupler windows. => The investigation is under way.
