# Movable Mask Issues

## - History of Movable Mask System -

Y.Suetsugu, N.Akasaka, T.Kageyama, Y.Takeuchi, K.Kanazawa and K.Satoh

23/Feb/2001

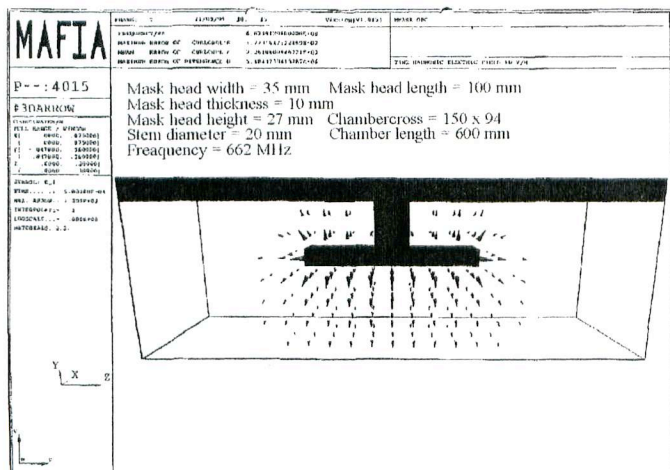
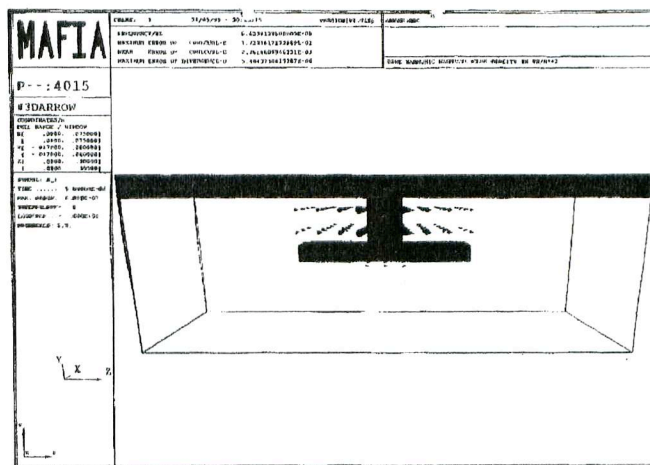
# Ver.1 Trapped mode

A example of mode calculation using MAFIA code

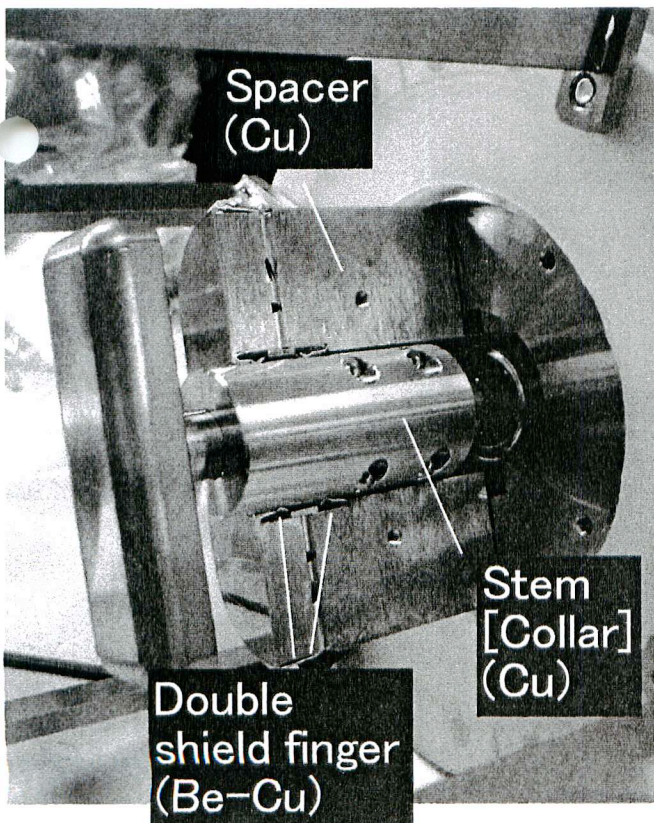
## Ver.2 (prepared to meet an immediate need)

- Low current density at the sliding shield finger  
(Stem diameter 16 mm  $\rightarrow$  36 mm)
- Double sliding shield finger

- Q factor is still high ( $\sim 2000$ )  
RF properties are the same as Ver.1

When the Ver.2 masks were approached to the beam,  
a strong synchrotron oscillation was excited.

Arcing occurred between the old stem (inside of collar)  
and the edge of spacer.

Vacuum leak !

All Ver.2 masks were  
immediately removed.

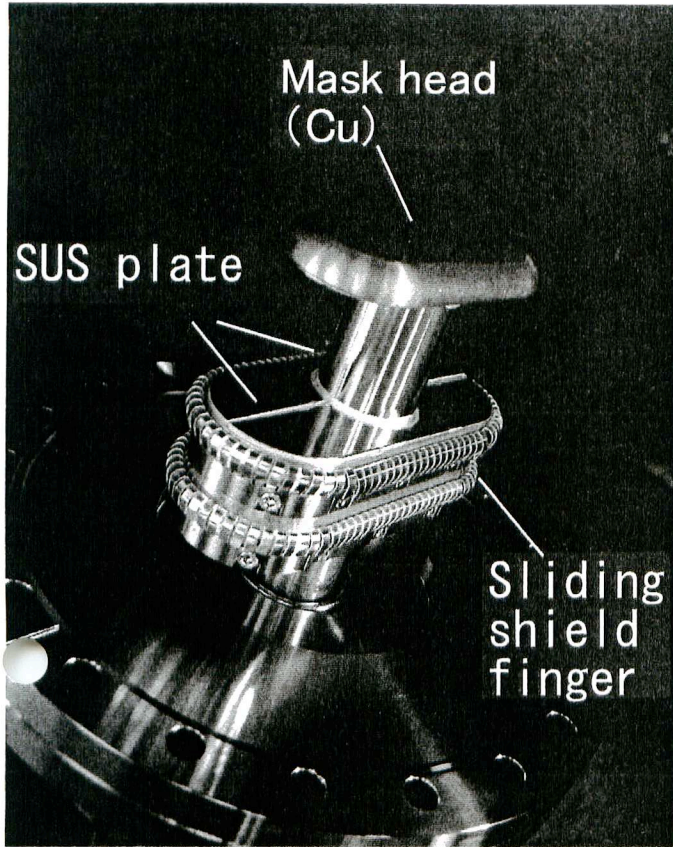
## Ver.3.0

- Low current density at sliding shield finger (around spacer)
- Double shield finger
- Low Q ( $\sim 600$ ) compared to Ver.1 with SUS plate
- Existing chamber is available
- Cu mask head (CuW  $\rightarrow$  Cu)

The Q-factor was still too high.

- A synchrotron oscillation was excited again.
- COD in a bunch train was observed.

The mask head was set at the full open position.

Ver.3.1 and Ver.3.2 masks with RF damping structure were developed.

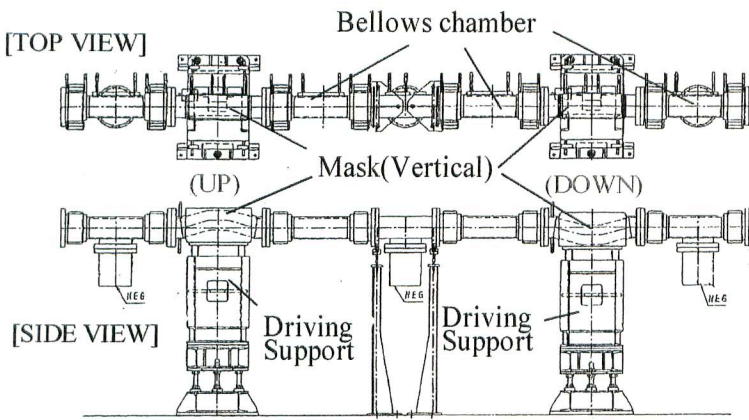
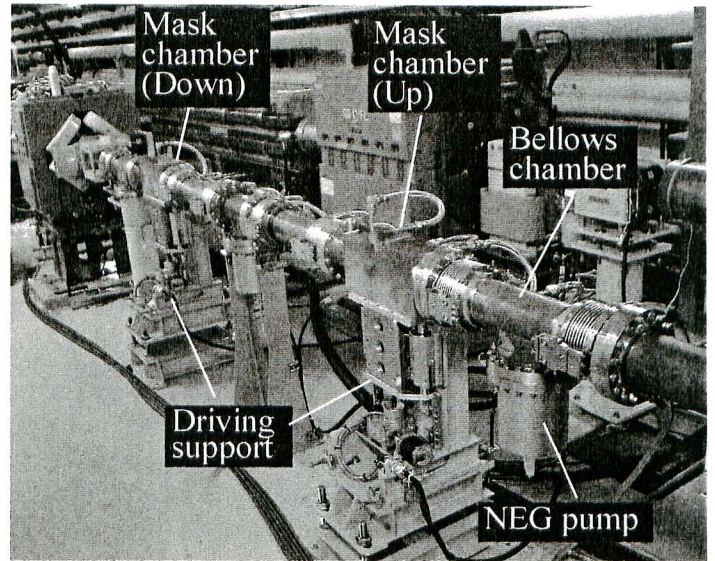
# Ver.4 set up in the tunnel (vertical)

## Temperature rises of bellows around Ver.4 masks

Temperature rises at bellows around Ver.4 masks are higher than other bellows.

Temperature rise at 600 mA (LER)

Max.  $\Delta t = 35^\circ\text{C}$
