Present Status of KEKB Movable Masks

25/Feb/2002

KEKB VAC Y.Suetsugu

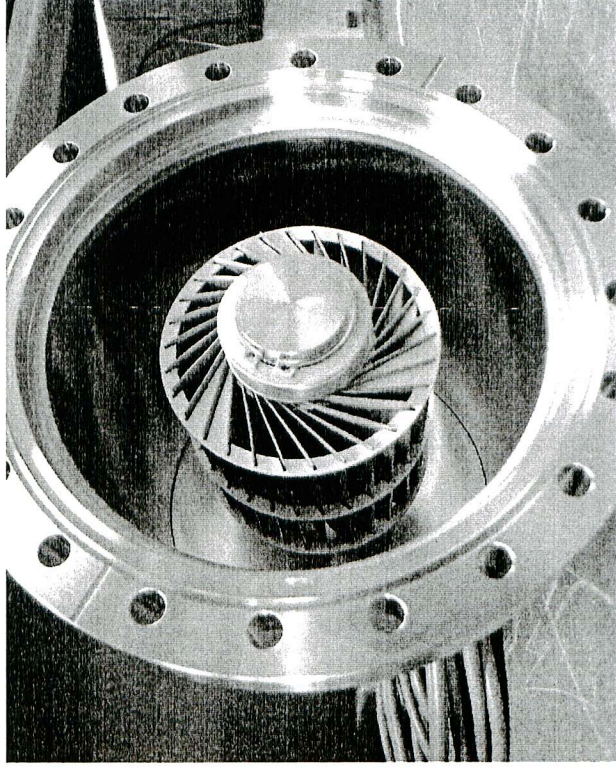
NEG inside chamber

- A suspect
 - NEG is heated by HOM generated at mask (same as bellows heating)
 - Heated NEG desorbs H₂ gas.
 - HOM intrude the NEG chamber through the RF shield at the pumping port.
 - The existing RF shield seems weak against TE mode HOM.
 - Cross bar has a thickness of only 0.5 mm. -> ~3 mm is necessary.

- On Pressure Rise : Install RF shield gaskets for NEG ports near masks.
 - Next month !!
- On Groove : Replace mask head material from Cu to Ti
 - HER mask will be replaced until this summer.
 - Countermeasure for LER masks is not fixed yet (depend on the results of HER).
 - It can serve as a test for KEKB upgrade plan.
- On Bellows Heating : Improve bellows structure to avoid HOM heating.
 - It serves also as a test for KEKB upgrade plan.
