Stability Upgrade of Injector Linac

Injector linac Group

H. Kobayashi

Upgrade of Linac Stability

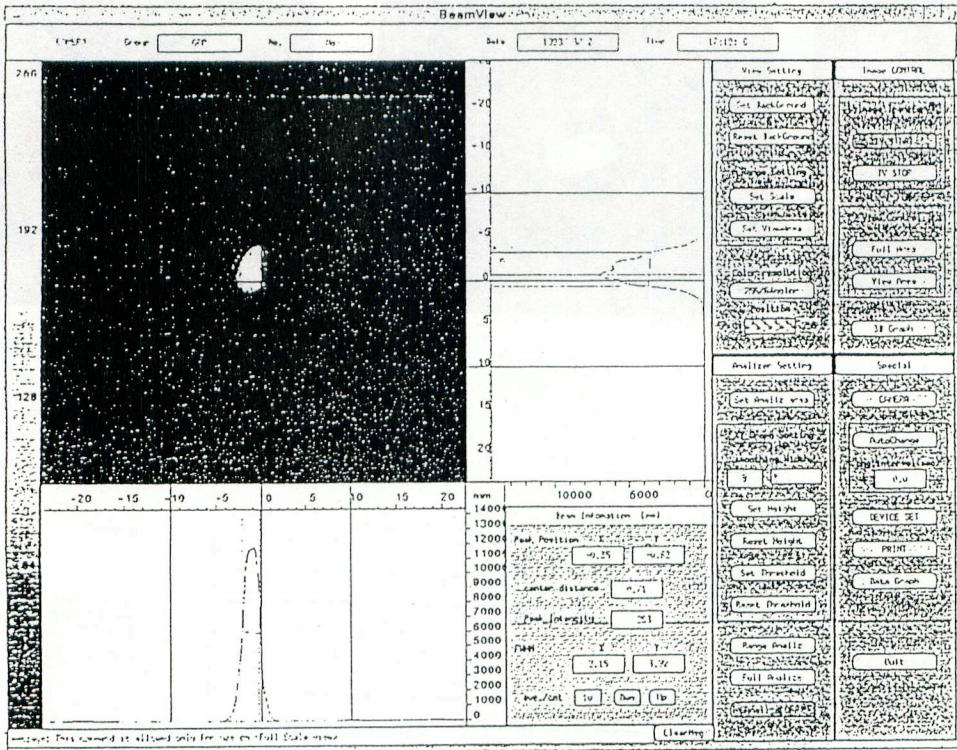
SHB1 258.1°

rms = 1.465 mm
 max = 3.565 mm
 @ SP1062
 min = -4.122 mm
 @ SP124
 @ SP17C4

rms = 1.184 mm
 max = 4.122 mm
 @ SP124
 min = -3.401 mm
 @ SP154

1.718 nC
 @ SP17C4

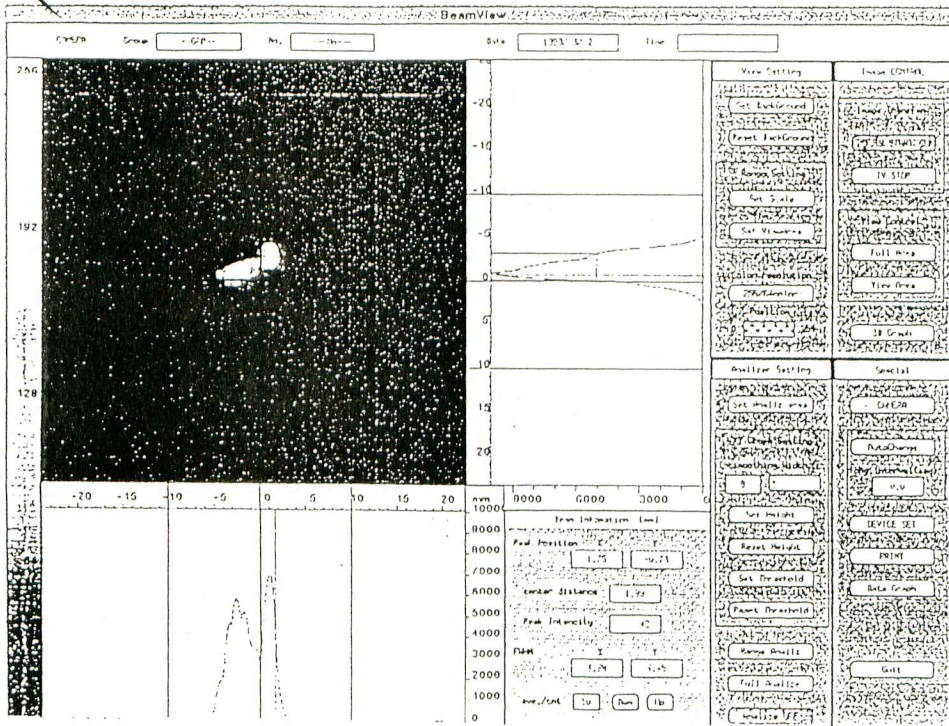
SHB1 256.1°

rms = 1.567 mm
max = 5.332 mm
@ SPR062
min = -5.151 mm
@ SP17C4

rms = 1.233 mm
max = 3.168 mm
@ SP124
min = -4.145 mm
@ SP164

Qe/bunch
1.716 nC
@ SP17C4

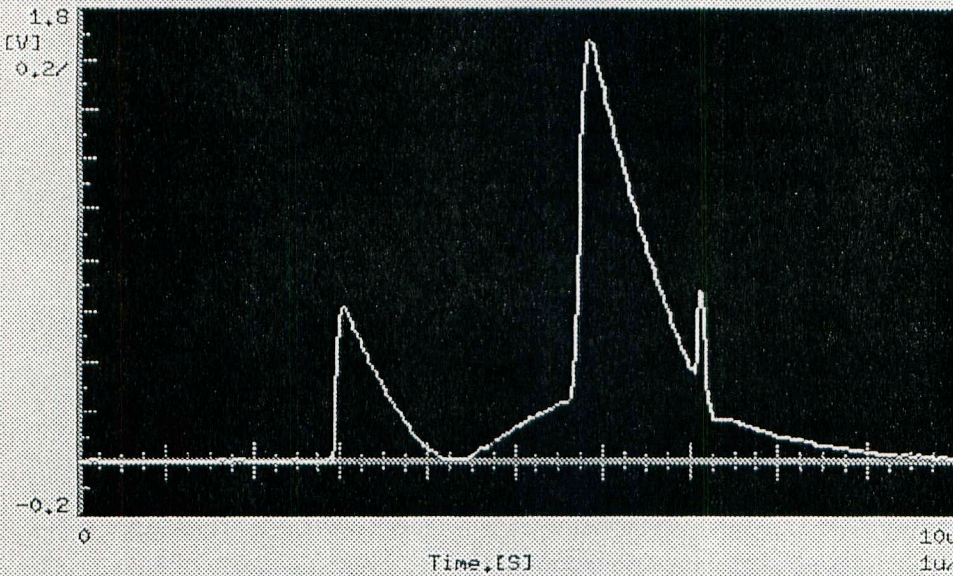
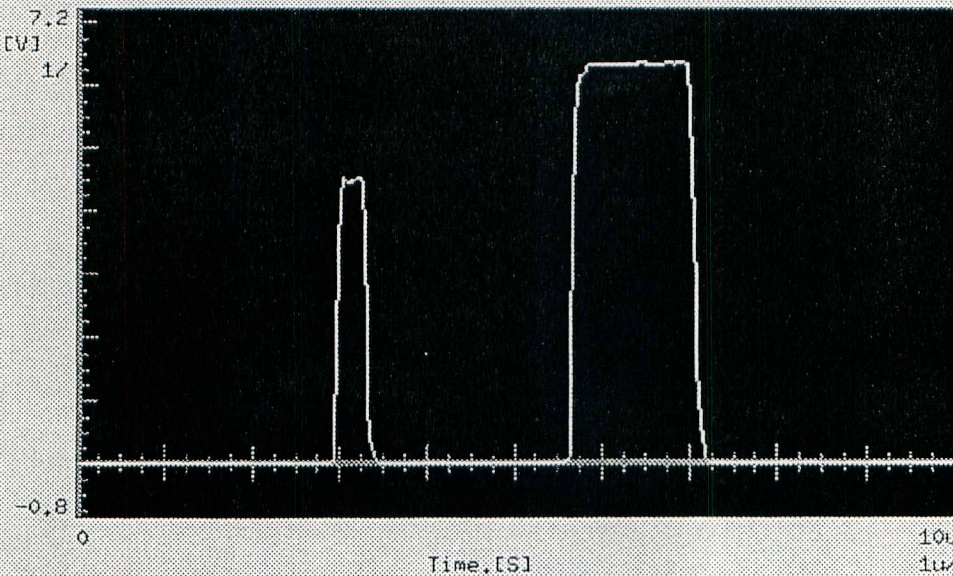
KLY.A-3

microwave monitor

very powerful tool for diagnostics

started operation at end of January this year

installed only in A, B, and a part of C sectors

install this microwave monitor in all sectors up to end of April

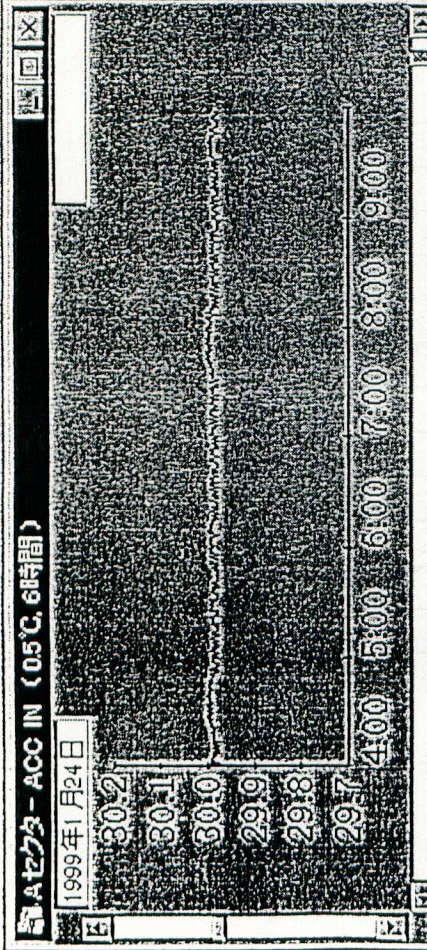
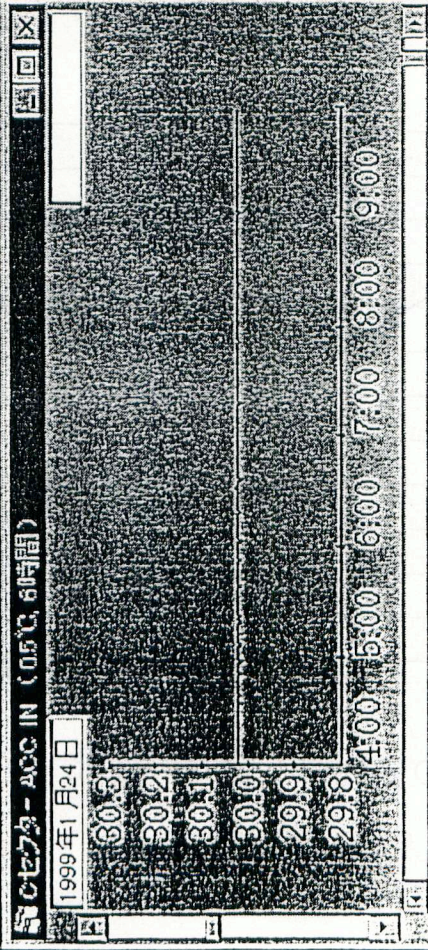
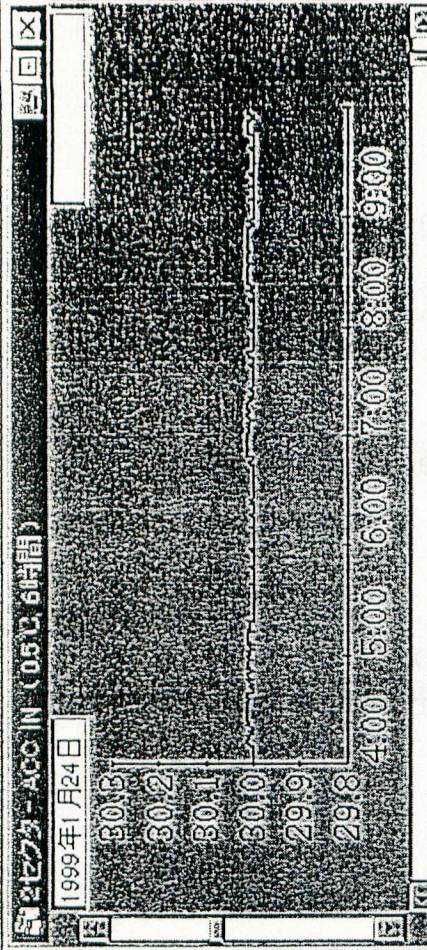
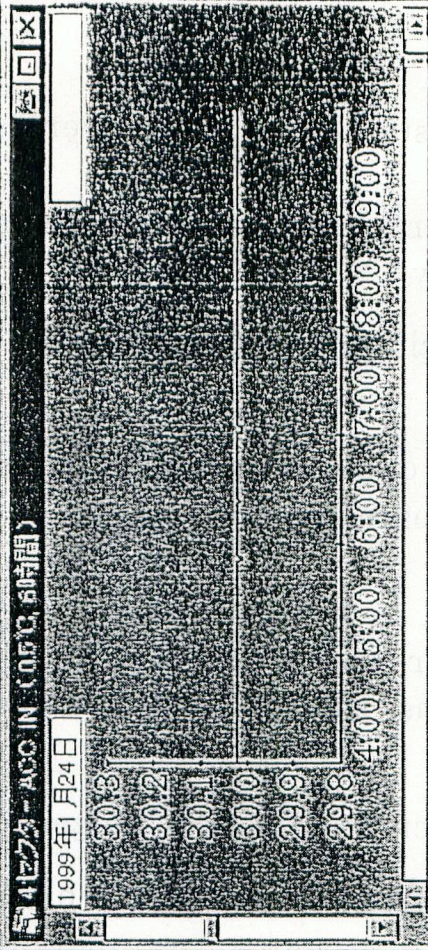
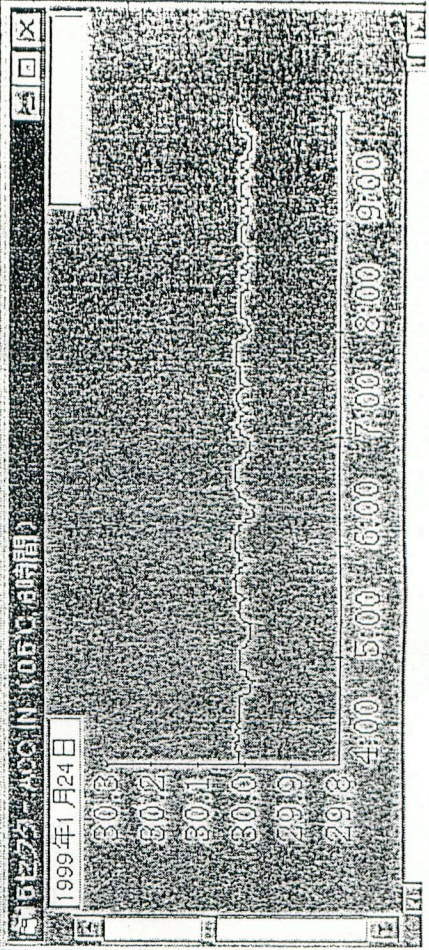
加送管系冷却水温度

Temperature of accelerating structures increased by 1 degree and affected beam stability.

Cause →lack of capacitor of heat exchange

stabilize temperature of cooling water for accelerating structures finished January (1 degree to 0.04 degree).

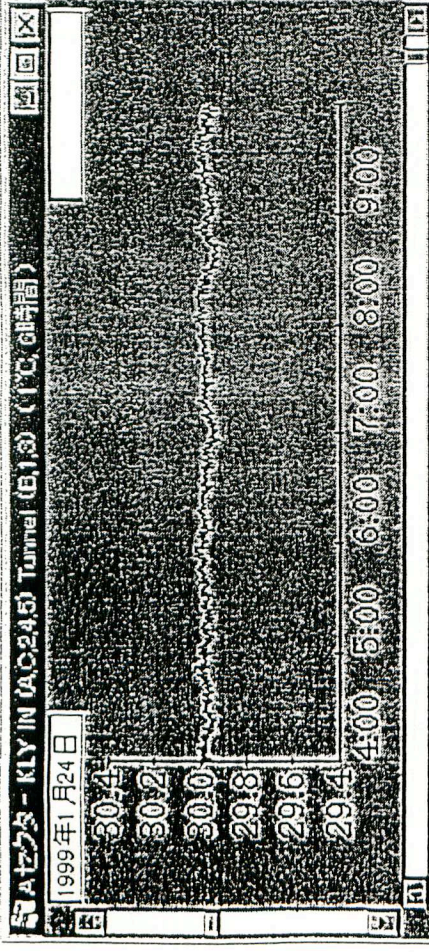
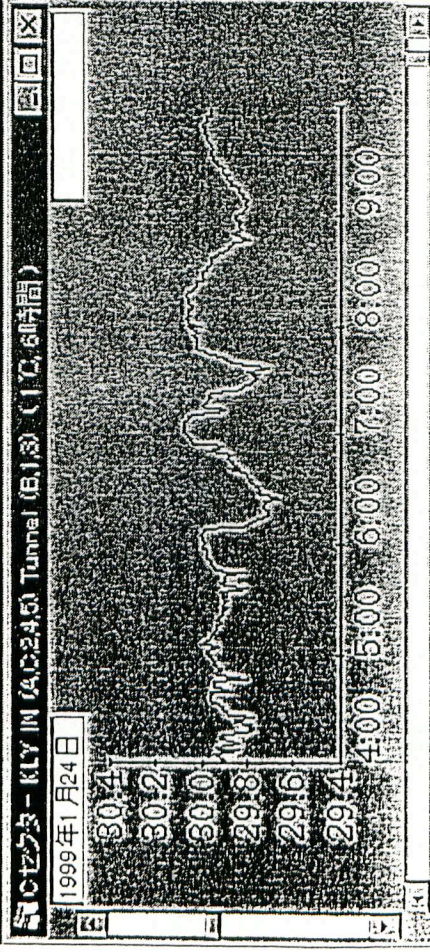
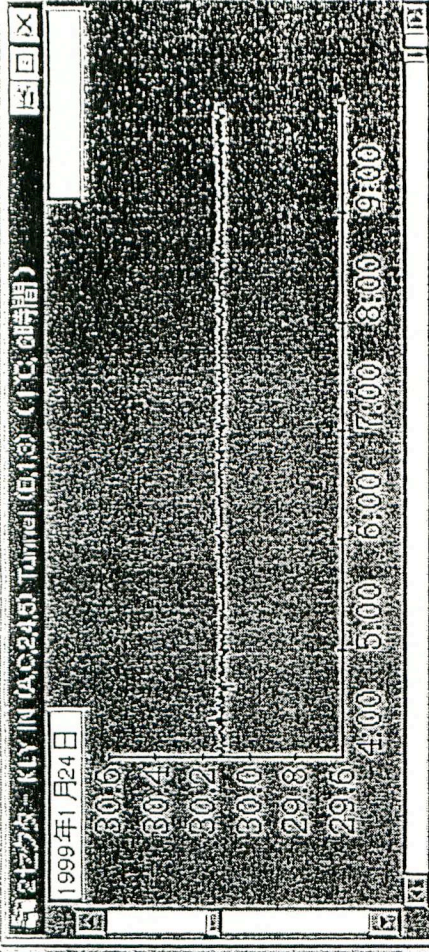
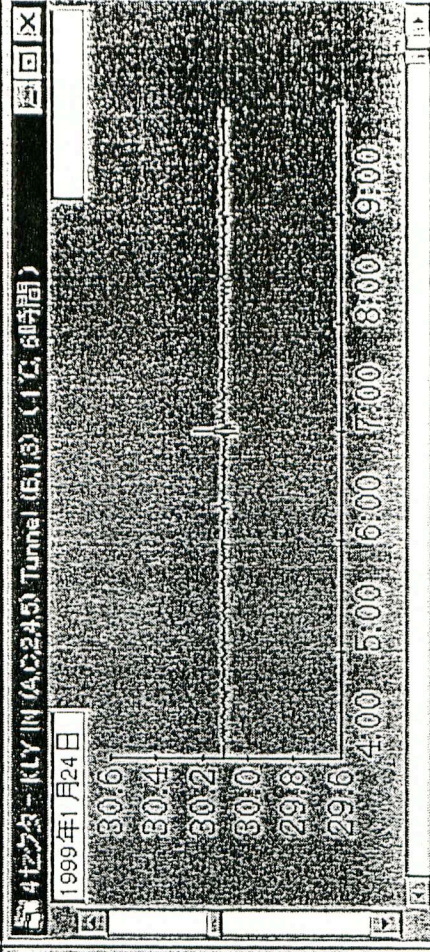
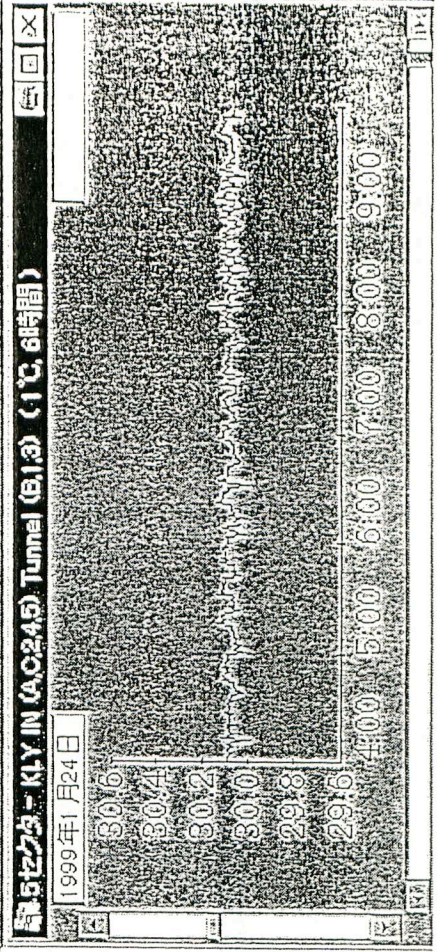
Klypton系冷却水温度

Recently, heat load for cooling water for klystrons increased then the same problem as that of cooling water for accelerating structures occur

Cause →lack of capacitor of heat exchange

stabilize that for klystrons during March by same process
