Special quadrupole magnets for KEKB IR

2/10/00
KEKB Review
M. Tawada

QC1LE Trouble

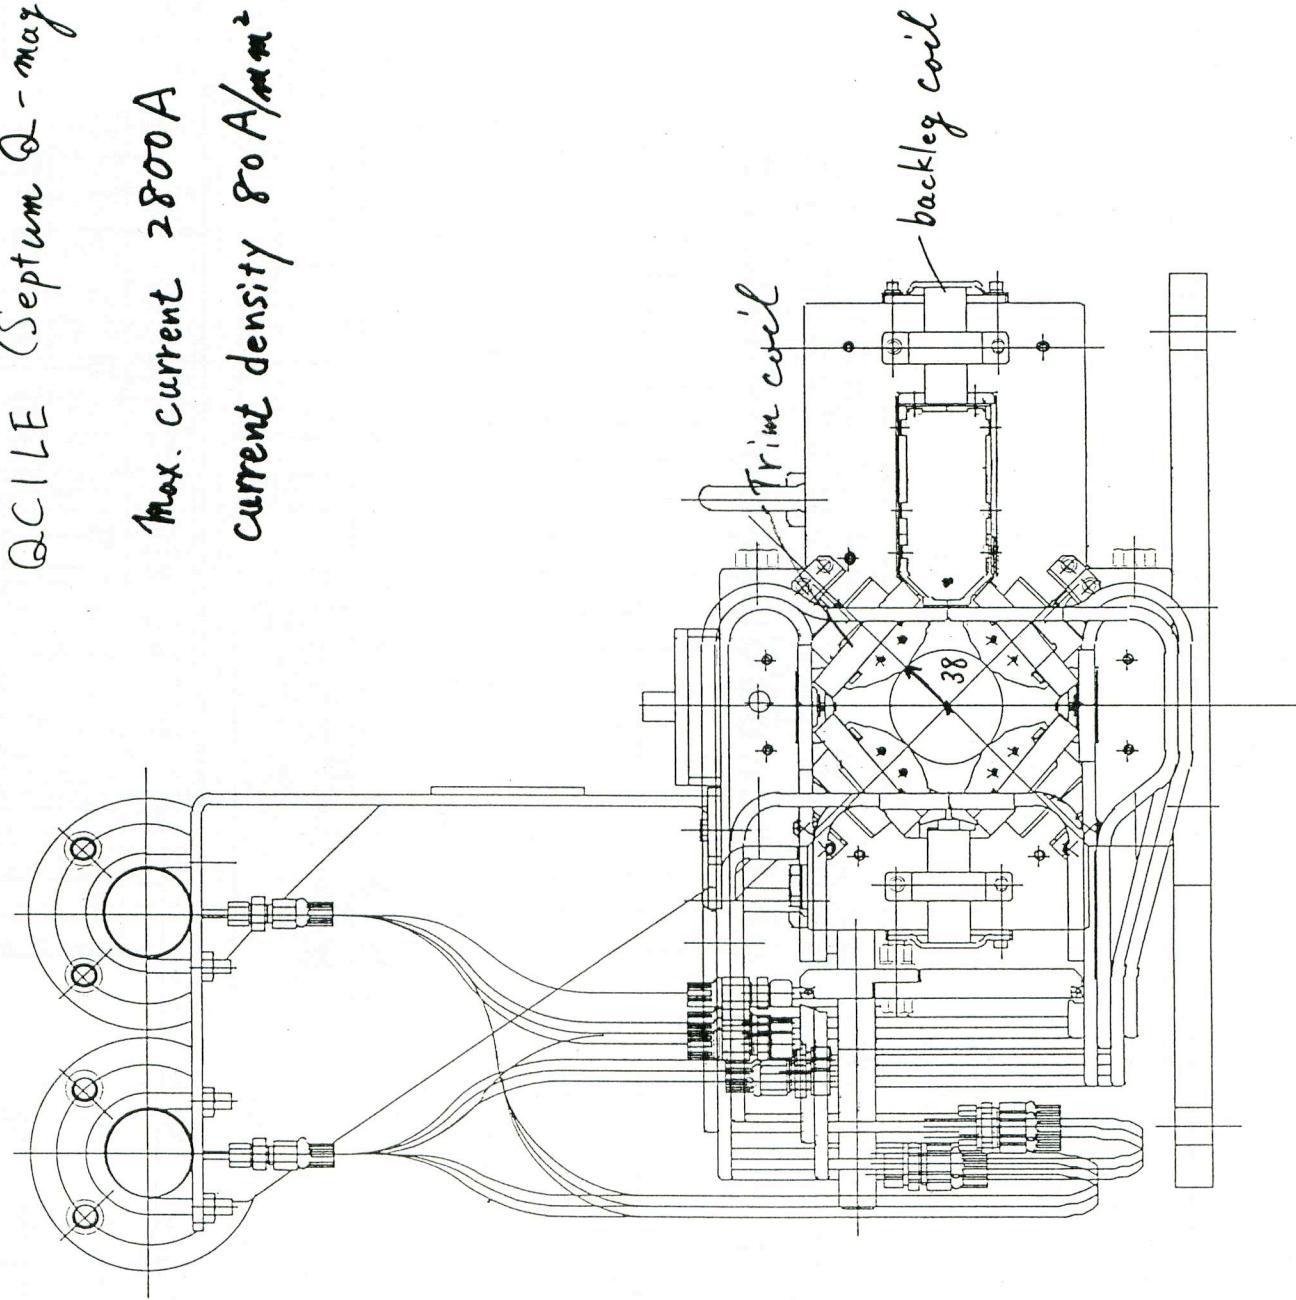
QC1LE (Septum Q-mag.) Vert. f for HER

Max. current 2800 A
current density 80 A/mm^2

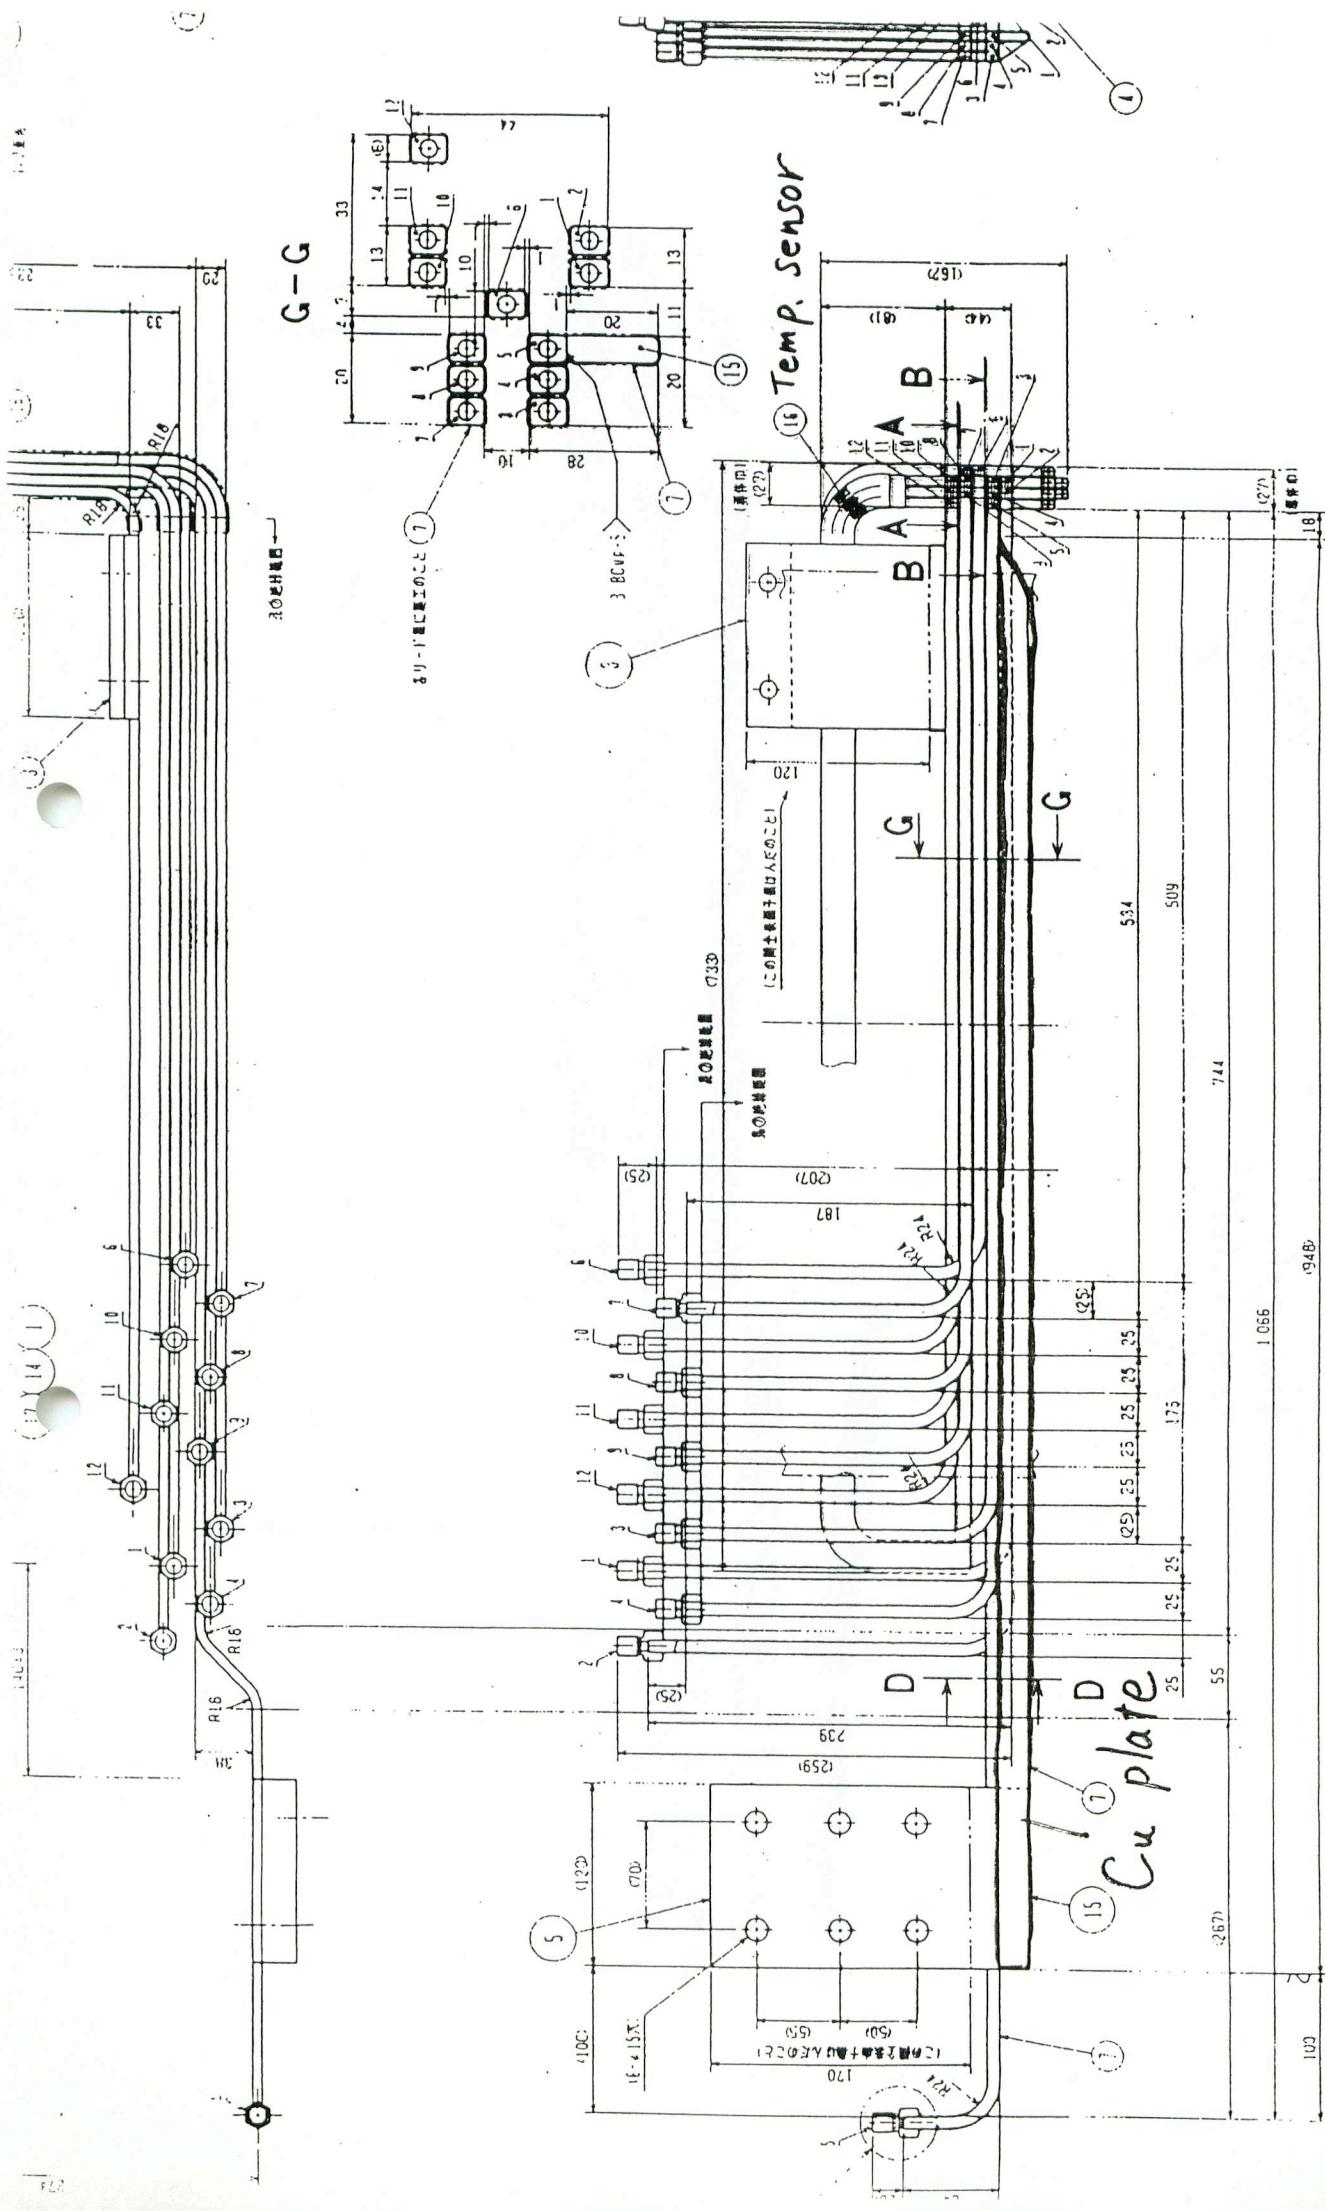
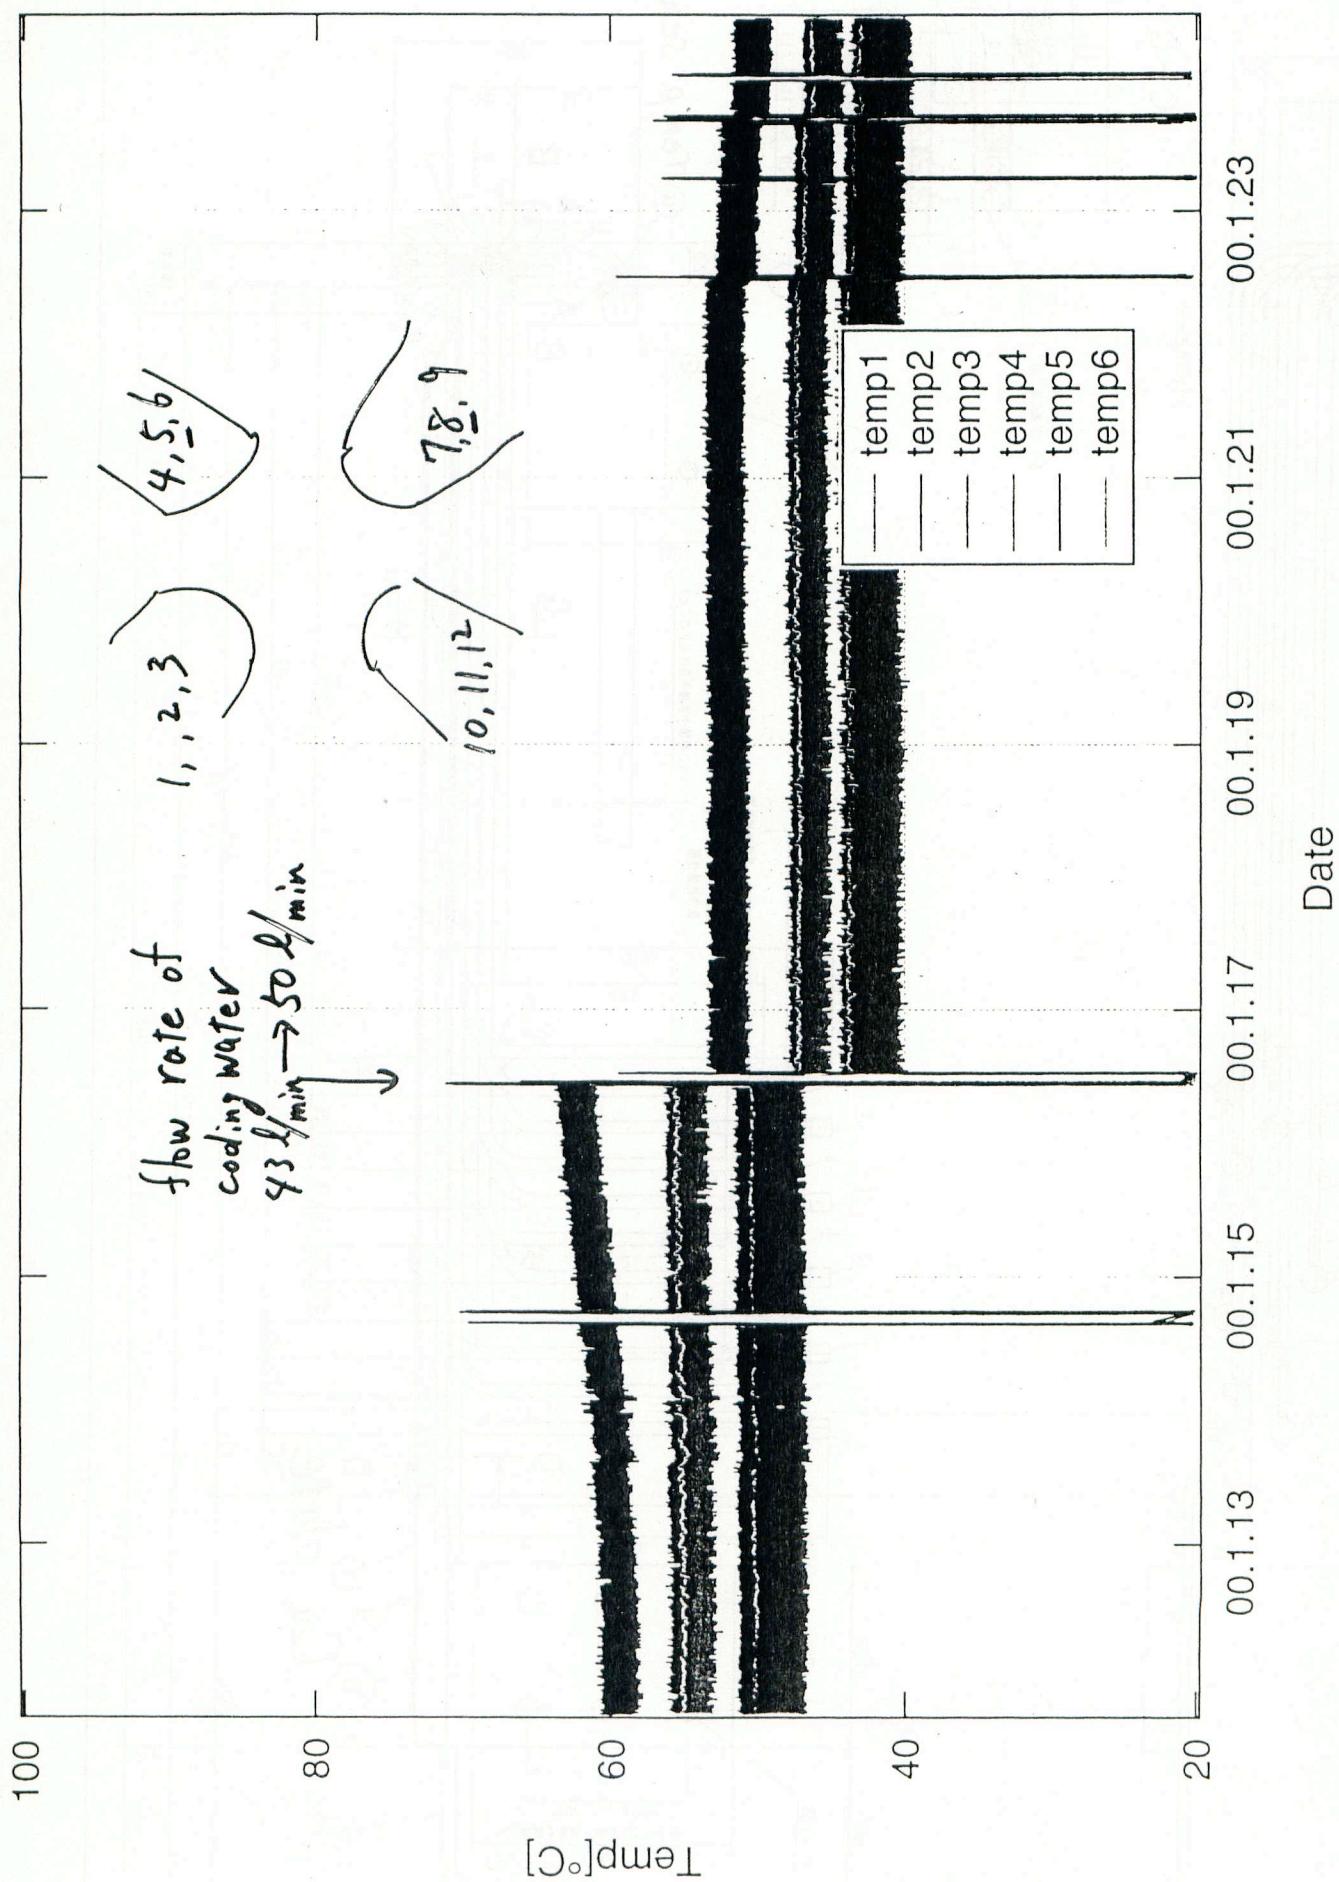
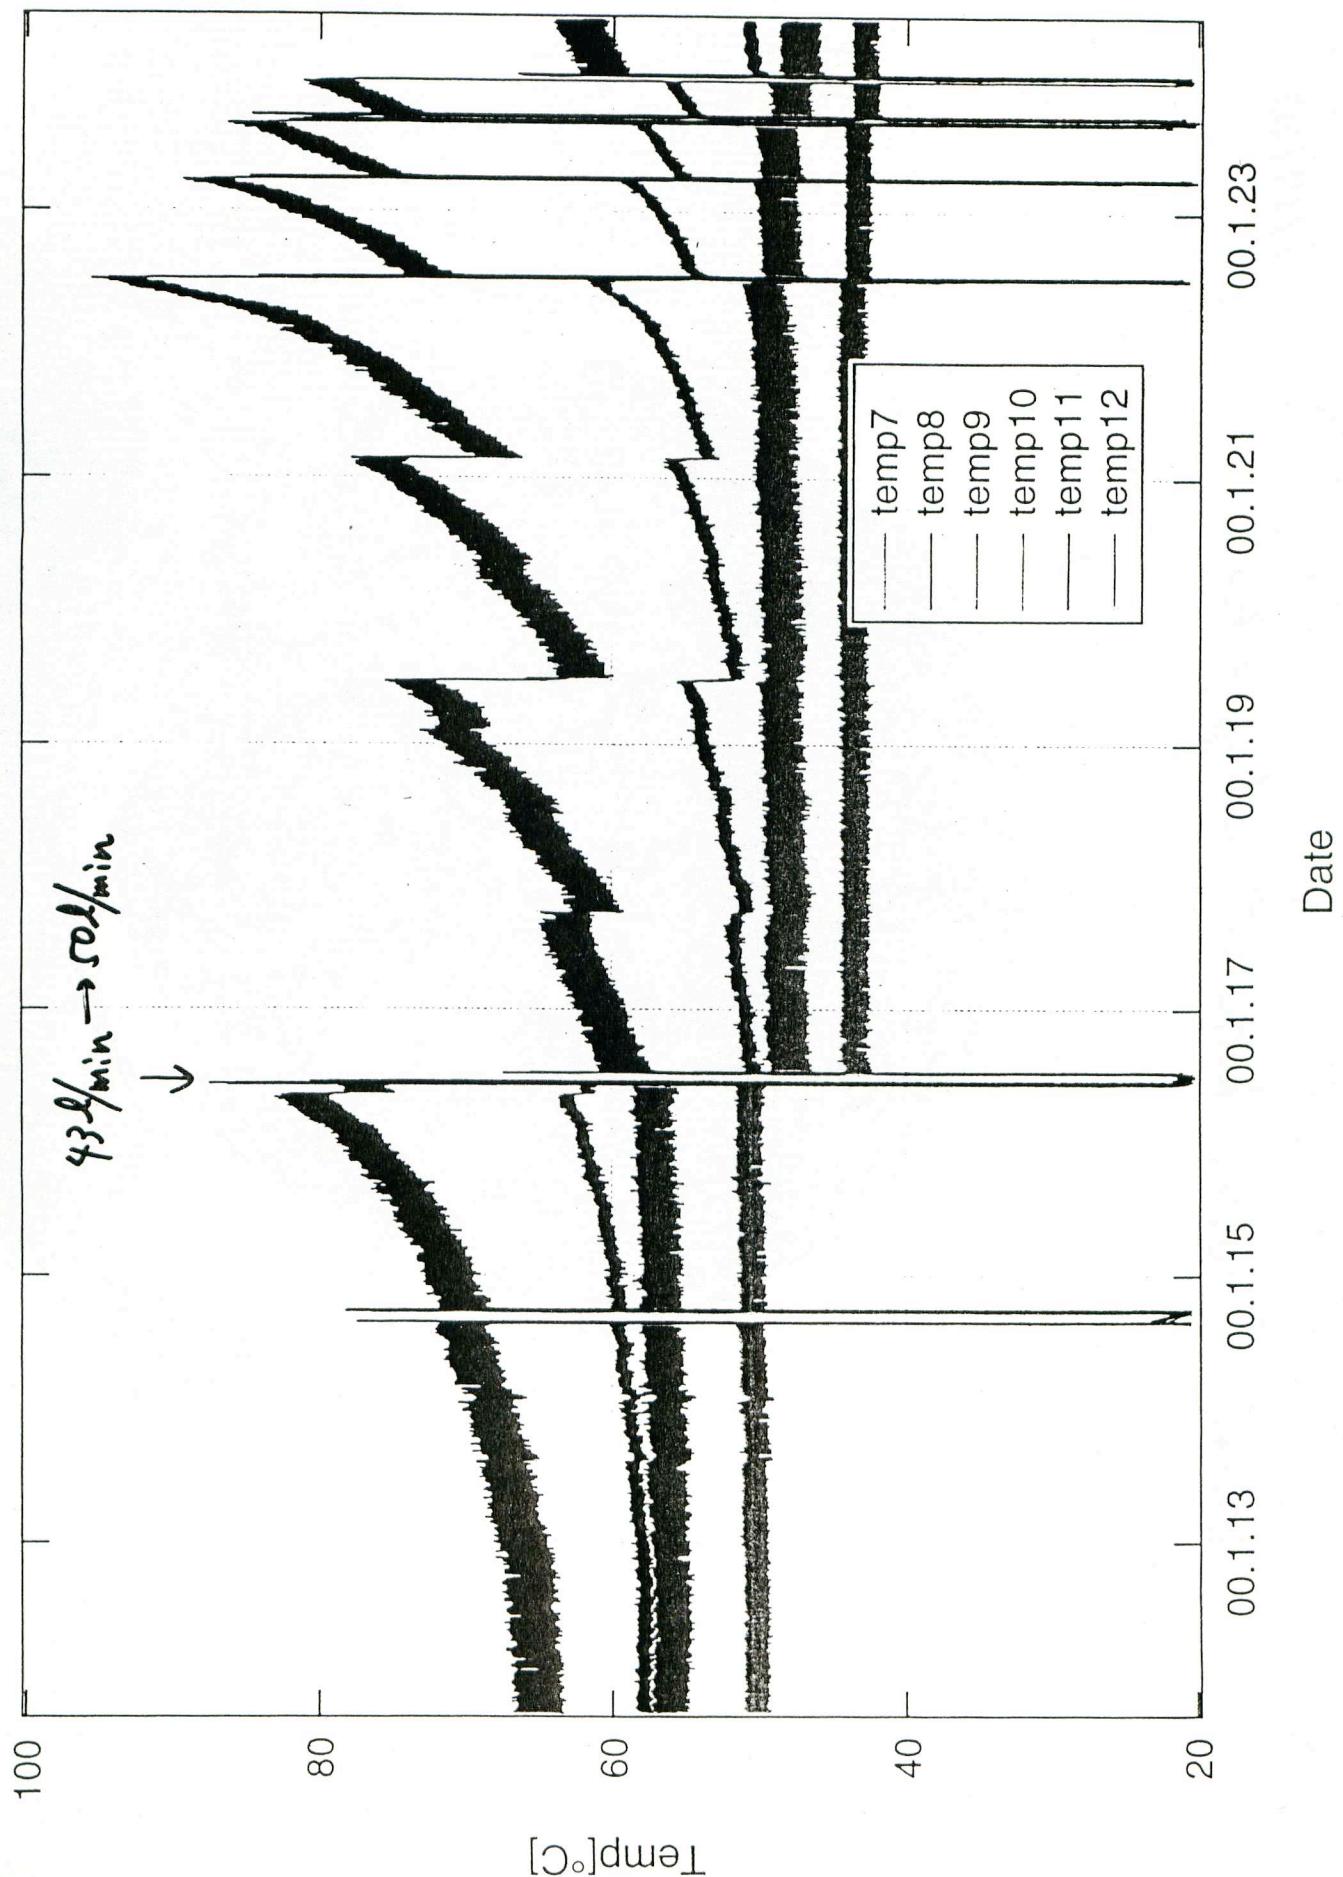
1/17/00

→ After all, the temperature rise of the coils was caused by CuO stuck at the outlet horses of the cooling water.

But we don't understand why CuO was stuck at the horse?

OCIE molten hollow conductor 12/18/99

OcillE. outlet house of cooling water
