### Vacuum Progress and Troubles of Upgrade Works

The 20<sup>th</sup> KEKB Accelerator Review Committee

February 23, 2015

Kyo Shibata (on behalf of KEKB Vacuum Group)

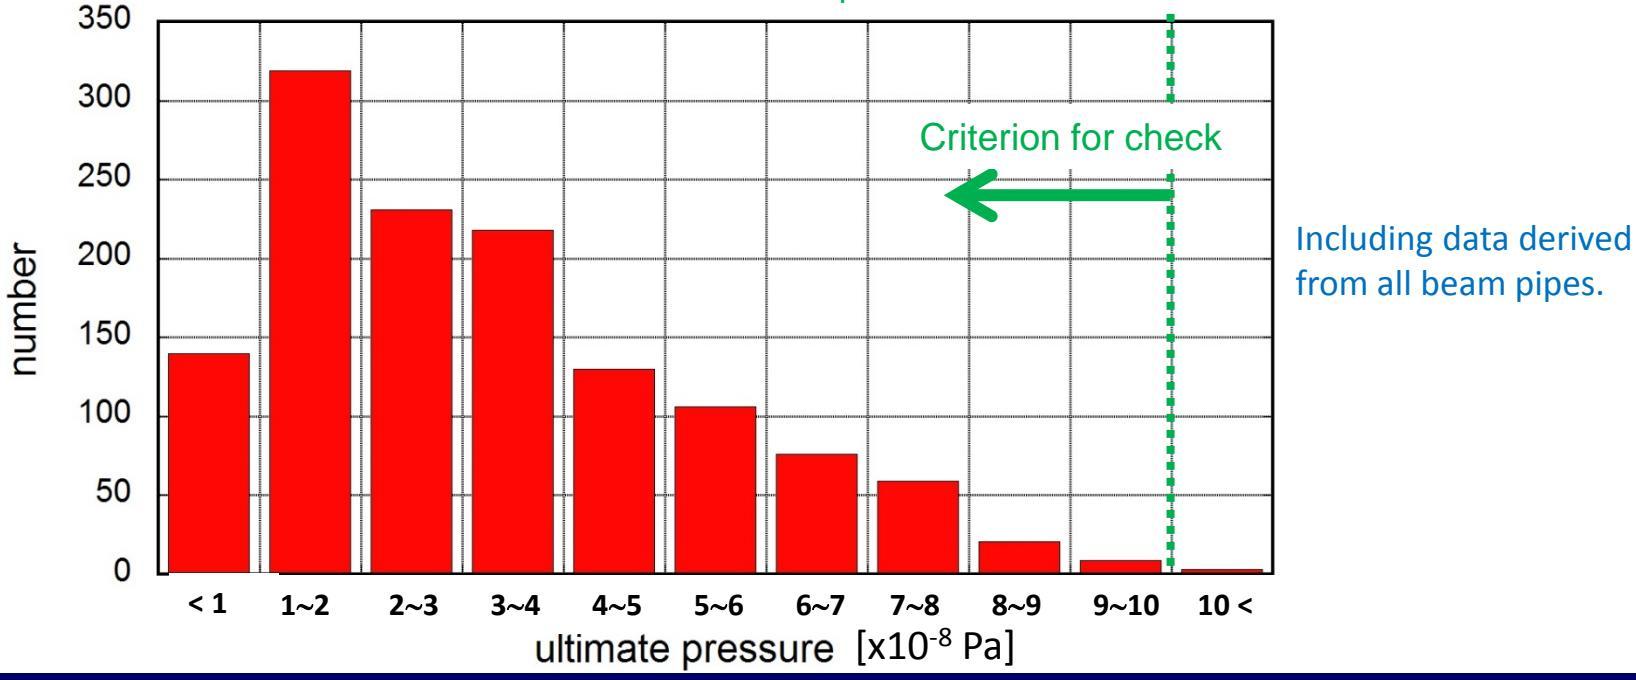
#### Distribution of ultimate pressures

- Ultimate pressure after baking
  - "Less than  $1 \times 10^{-7}$  Pa" is set as our criterion for check. (If not, beam pipe is re-baked.)
  - Almost all beam pipes meet our criterion for check.
    - Ultimate pressures higher than 5×10<sup>-8</sup> Pa have been measured for many beam pipes. (pointed out in last KEKB Review.)
    - No measurement of residual gas
    - A variety of beam pipes: long (~6 m) and short (~150 mm), w/wo NEG, Cu and Al

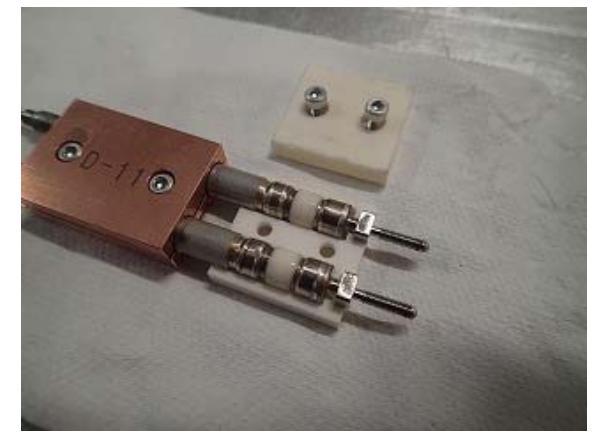
Feedthrough of heater with insulation ceramic block

- Trouble 2 : Leak at ceramic brazing of sheath heaters for NEG activation.
  - Cracks at the brazing between ceramics and stainless steel sleeve was found.
  - Gas desorption from the cracks leaded to high ultimate pressure even after NEG activation.
  - Low insulation resistance was also observed.
- Cause :
  - Fastening of ceramic block for insulation was too strong, and the excess stress (moment) was applied to the brazing part, if the ceramic was brazed with a slight angle.
- Cures :
  - Insert a thin spacer between ceramic blocks to avoid the excess stress on the brazing part.
  - Cracked heaters were re-fabricated.
