# Present status of the SuperKEKB Vacuum System

### Y. Suetsugu, KEK on behalf of KEKB Vacuum Group

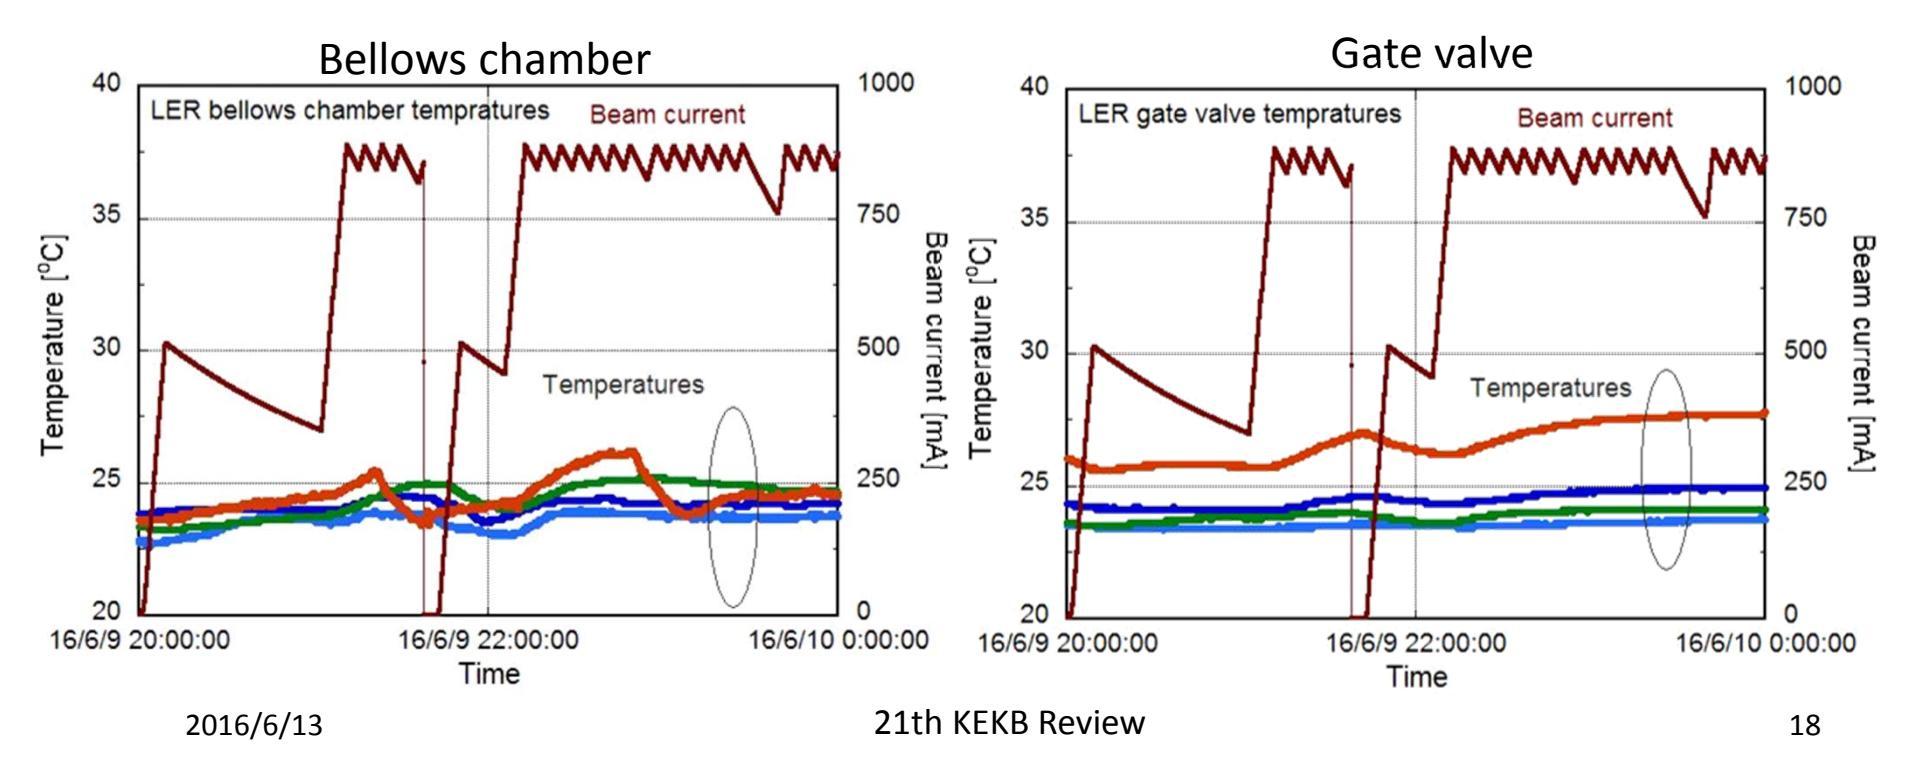
- Status of new vacuum components
  - Confirming the stability of the new vacuum components was a major subject for the Phase-I beam commissioning.
  - No extra heating or abnormal pressure rise in these components has been observed so far.
  - The temperature rises in the bellows chambers, gate valves and flanges are less than 3-4 °C at 890 mA, for example.

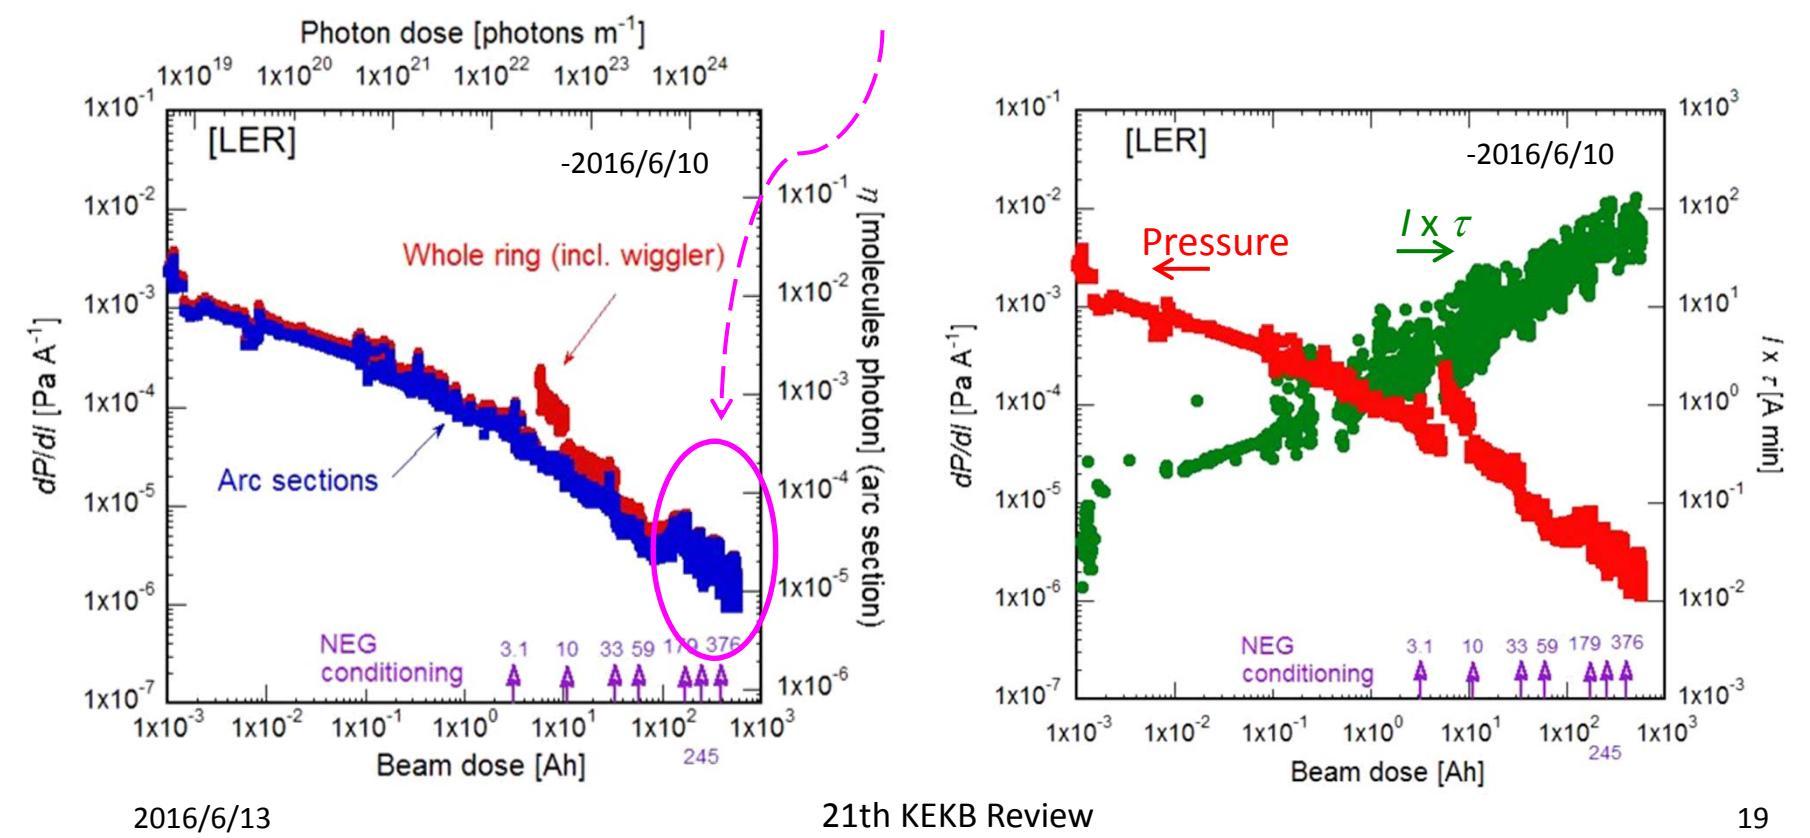
- Vacuum scrubbing: LER (1)
  - The *dP/dI* value for arc section, where all of the beam pipes were newly fabricated, was  $\sim 2x10^{-6}$  Pa A<sup>-1</sup> at the beam dose of 500 Ah. The  $\eta$  was  $\sim 1x10^{-5}$  molecules photon<sup>-1</sup> [for pumping speed = 0.4 m<sup>3</sup>s<sup>-1</sup>m<sup>-1</sup>].
  - The decrease rate of *dP/dI* slowed down from the beam dose of 100 Ah. -> Nonlinear behavior of pressures against the beam current (discussed later).

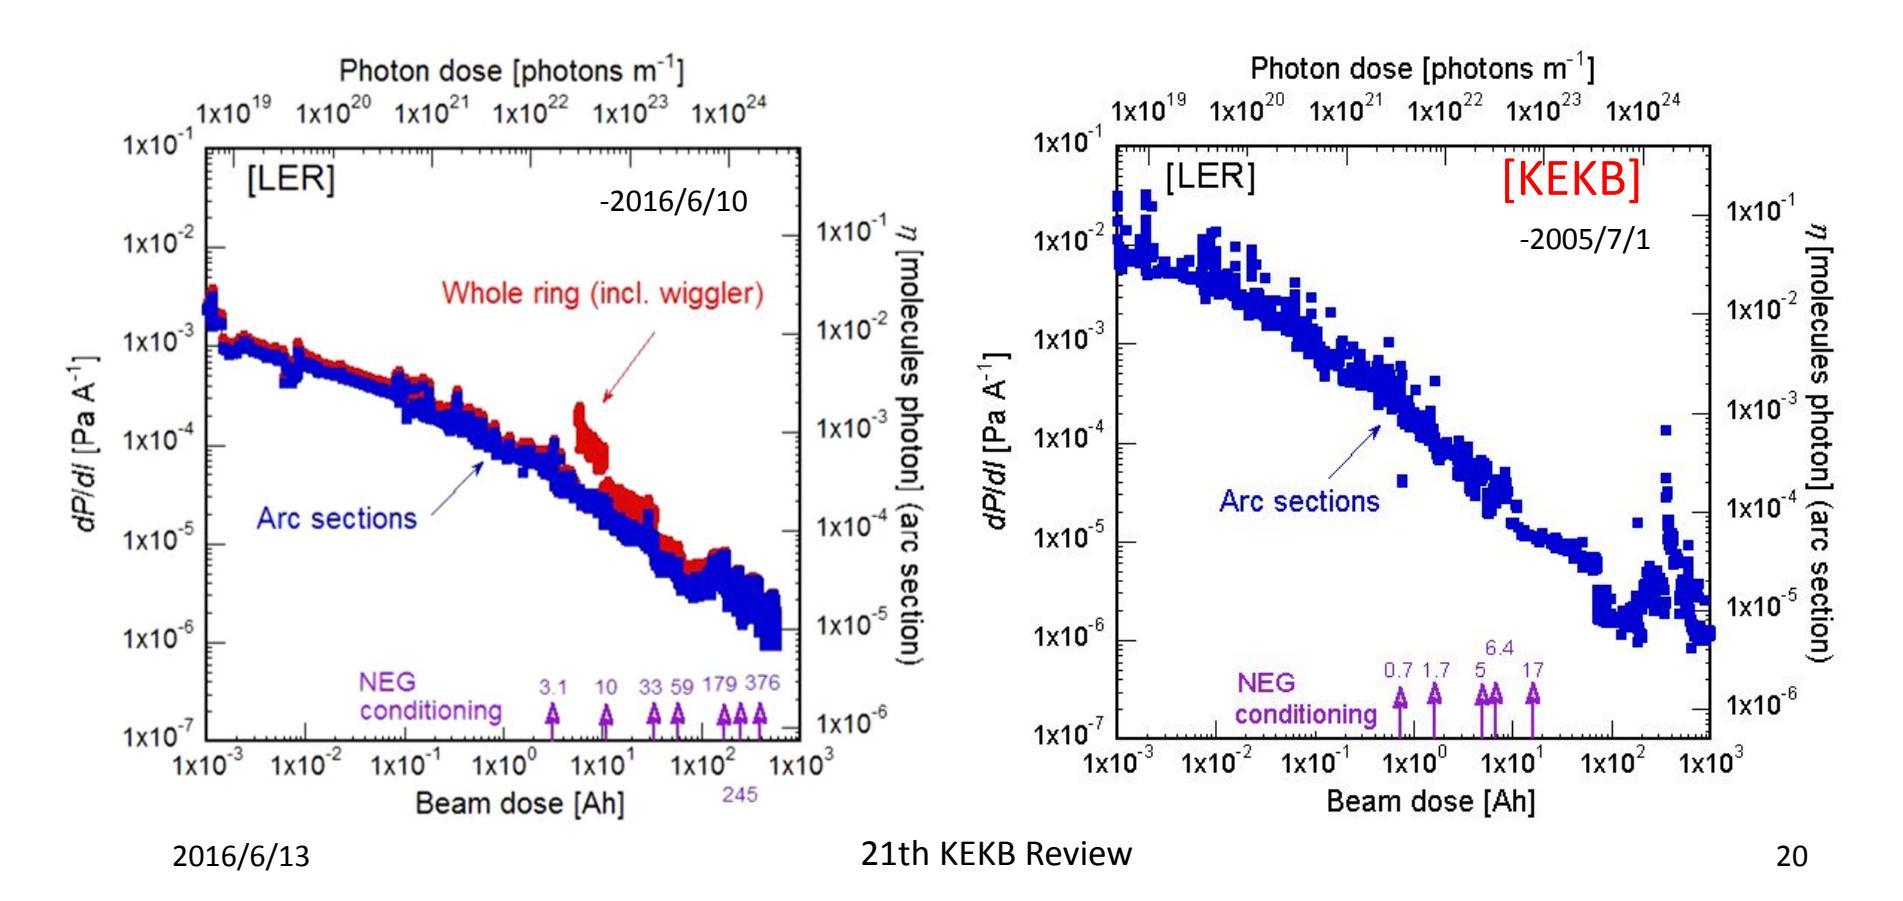
- Vacuum scrubbing: LER (2)
  - Compared to the case of the KEKB, which used circular copper beam pipes without any coating, *dP/dI* value at the initial stage was lower by several factors. Recently, however, *dP/dI* value is almost the same as the case of KEKB at the same beam dose.

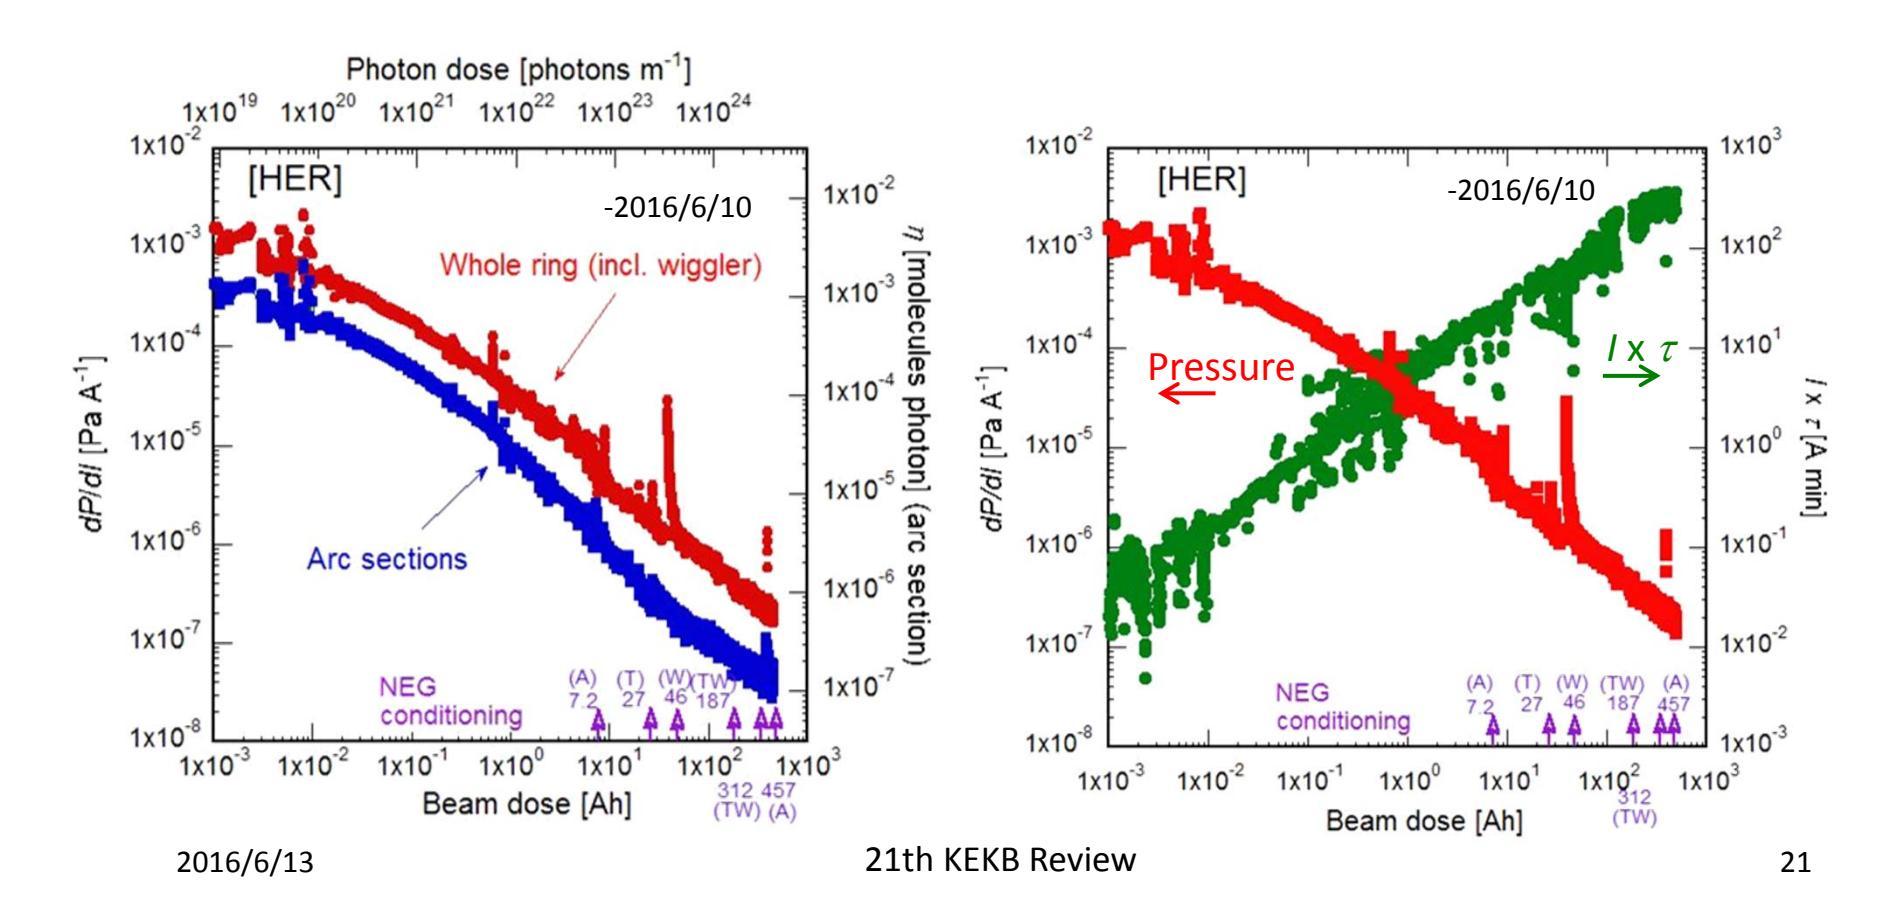
- Vacuum scrubbing: HER (1)
  - The *dP/dI* value at the arc section, where most of the beam pipes was reused from KEKB, was  $^{5}x10^{-8}$  Pa A<sup>-1</sup> at the beam dose of 500 Ah. The  $\eta$  was  $^{1}x10^{-7}$  molecules photon<sup>-1</sup> [for pumping speed = 0.3 m<sup>3</sup>s<sup>-1</sup>m<sup>-1</sup>]. The  $\eta$  is much smaller than that of LER.

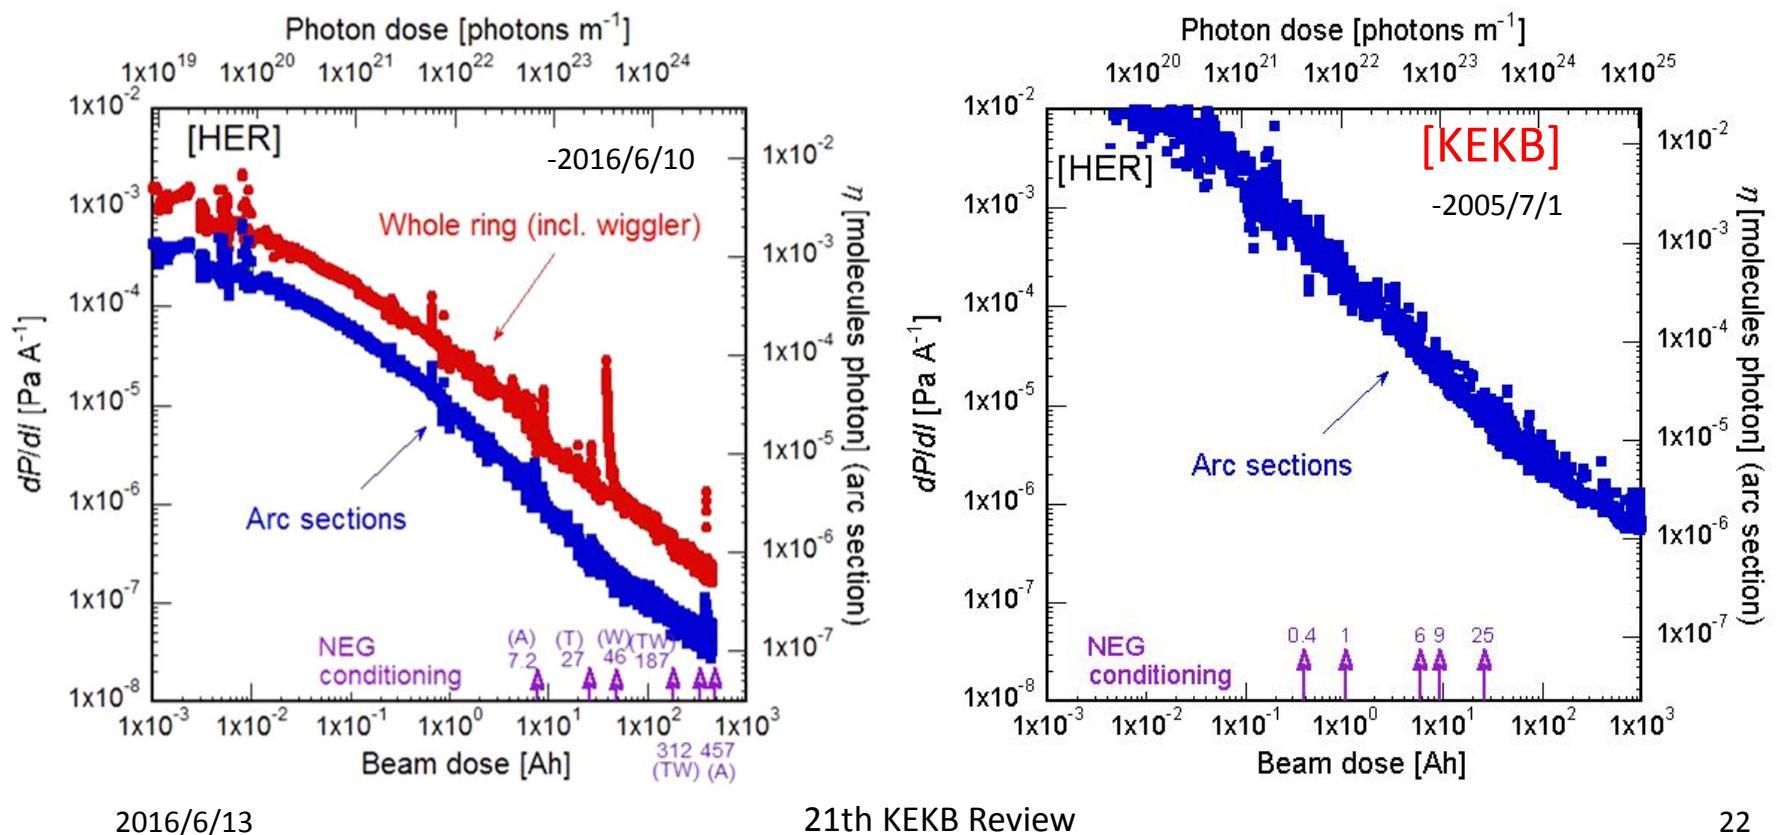
- Vacuum scrubbing: HER (2)
  - The *dP/dI* value is comparable to that in the case of KEKB at the final stage. This means that the surface of the reused beam pipes "remembers" the conditions in the KEKB, even though the beam pipes were exposed to the air for vacuum work.
  - Now  $\eta$  is almost the same value with the final value of the KEKB HER.

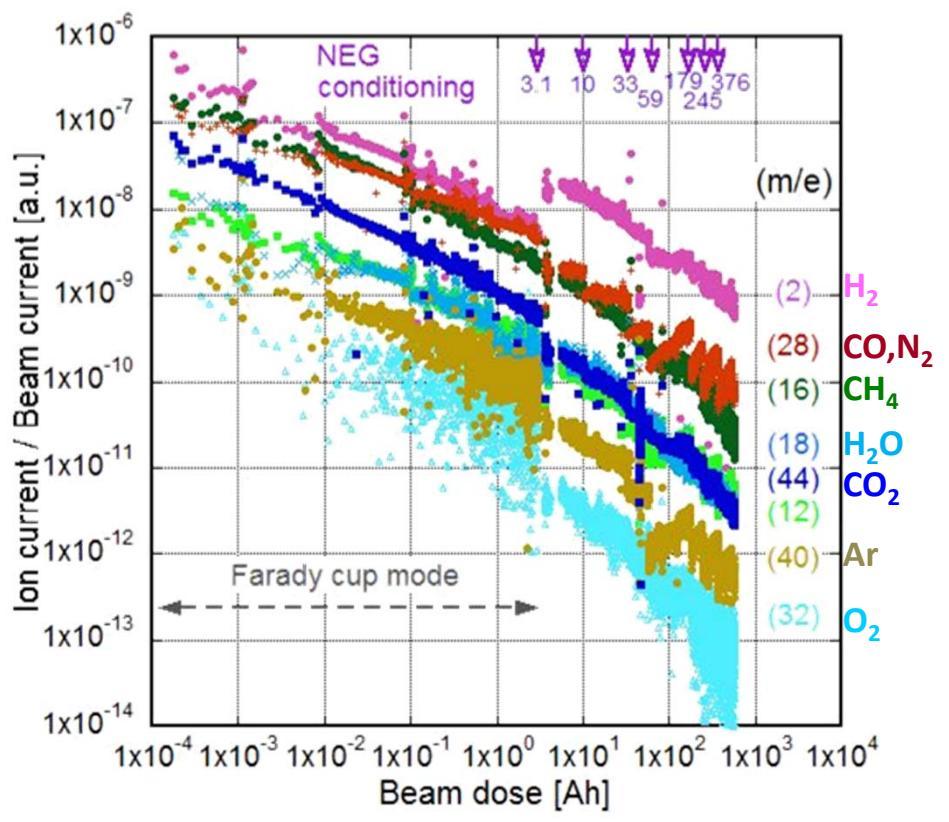
- Residual gases
  - Residual gases during the beam operation have been monitored with a quadrupole mass analyzer (QMA) at an arc section.
  - The QMA is located just above a sputter ion pump.
  - The main gases are hydrogen (m/e = 2), carbon monoxide (m/e = 28), methane (m/e = 16), water (m/e = 18), and carbon dioxide (m/e = 44).
    - The high partial pressure of methane should be due to the pumping system using NEG as a main pump.
    - Because the beam pipes were not baked in the tunnel, water vapor still remains in the beam pipe.

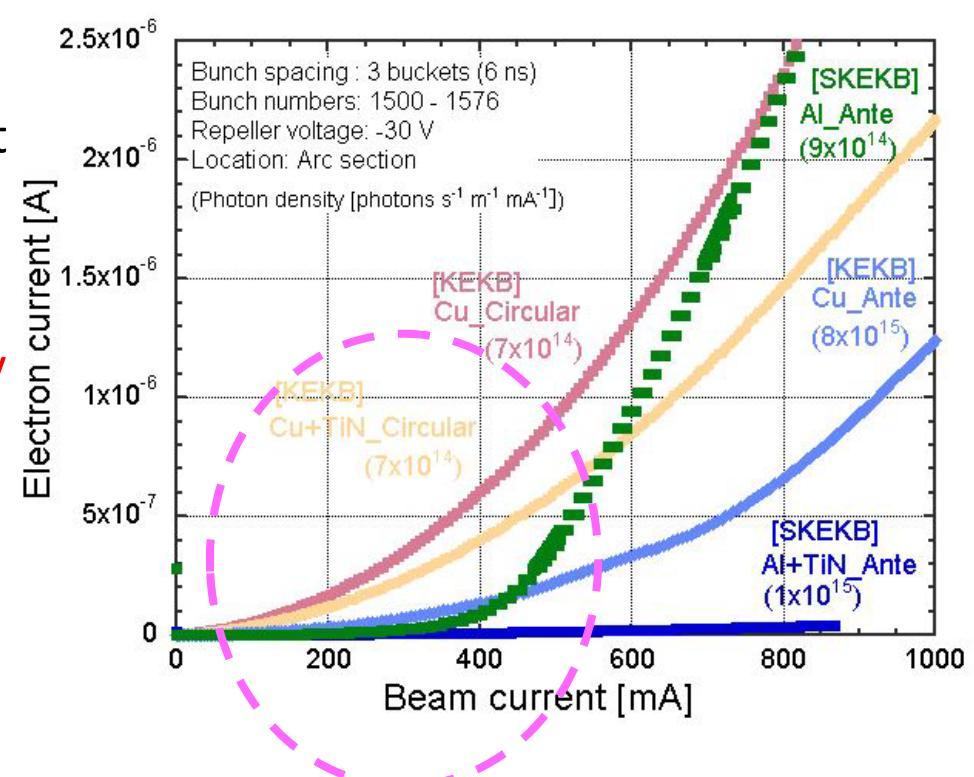
- Effect of antechamber and TiN coating (2)
  - The electron currents were measured during the beam operation, and compared with the data of KEKB.
- Low current region ( $I_e < 400 \text{ mA}$ )
  - Electron currents of the beam pipe with antechambers are much lower than those without antechambers.
  - Reduction of photoelectrons by antechamber structure was reconfirmed.

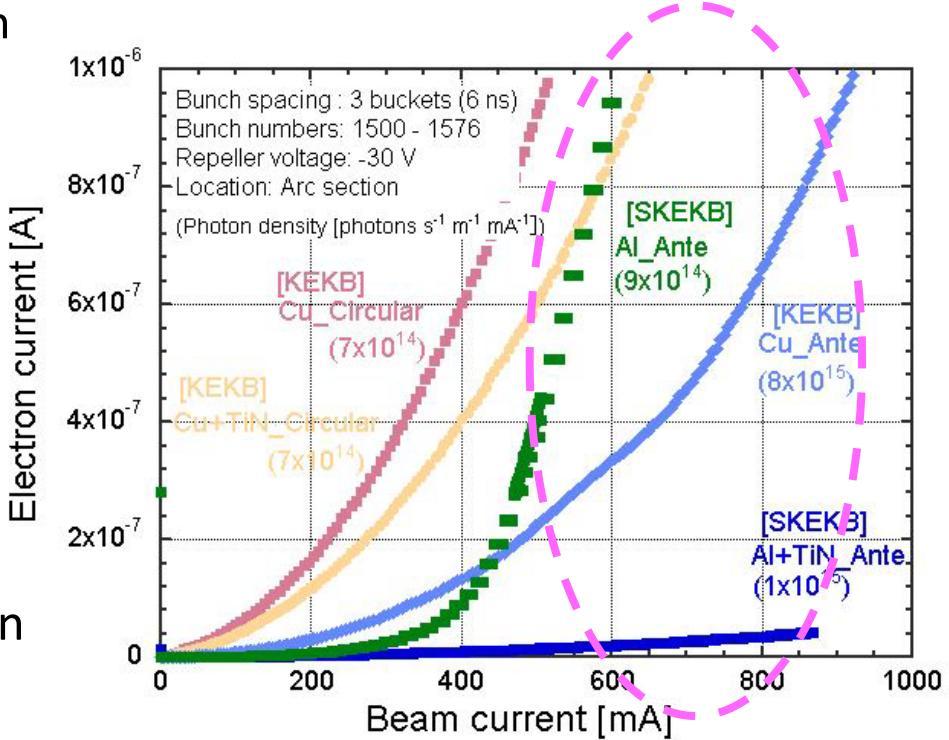
- Effect of antechamber and TiN coating (3)
  - The electron currents were measured during the beam operation, and compared with the data of KEKB.
- High current region ( $I_e > 500 \text{ mA}$ ) (1)
  - Electron current at aluminum with TiN coating is much lower than that without it, and is comparable with copper antechamber taking into account the difference of photon flux.
  - TiN coating on aluminum is working well.
  - The estimation of SEY is in progress. Furthermore, change in SEY of the TiN-coated surface after long time storage is now investigated in the laboratory.

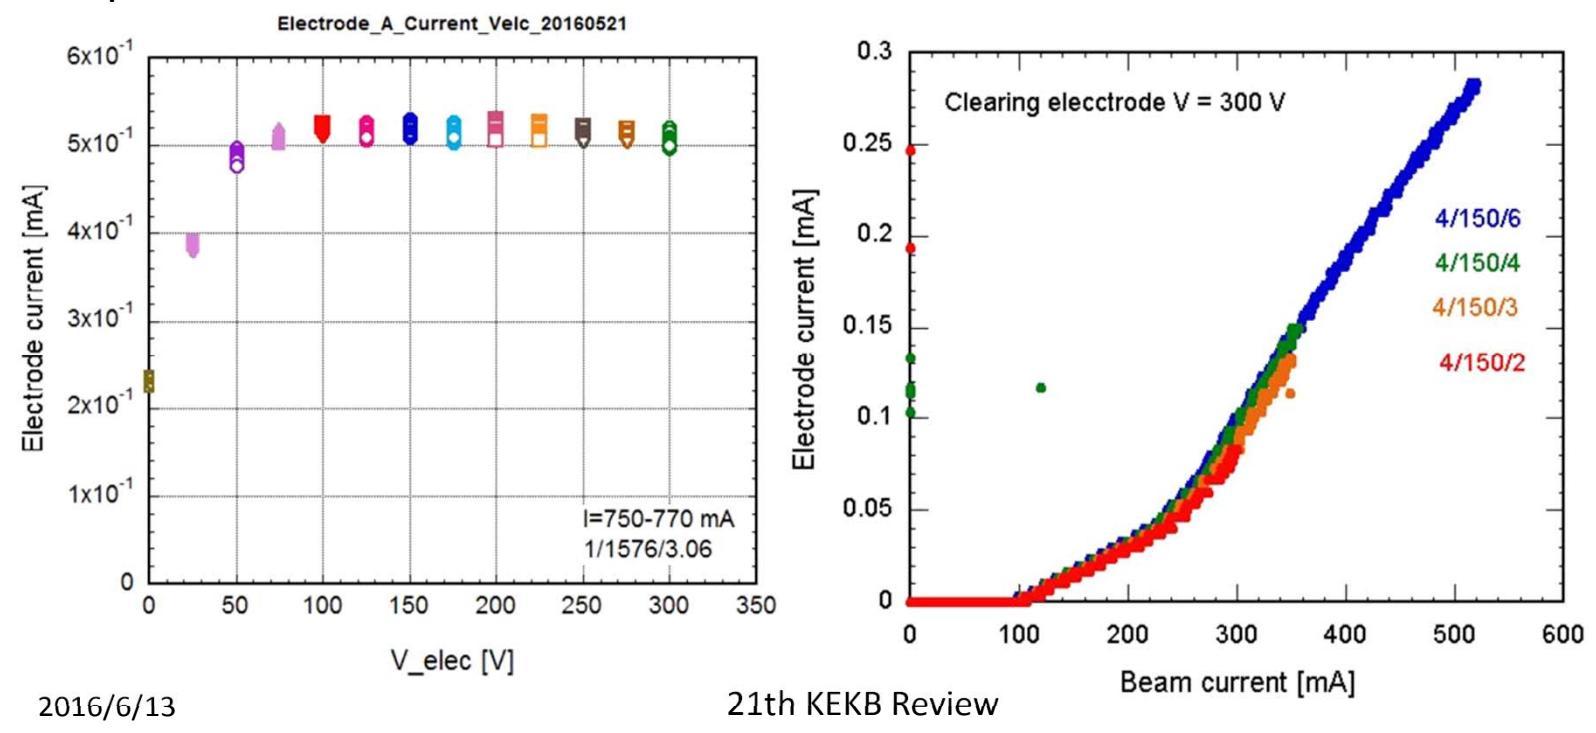
- Clearing electrode (preliminary results)
  - Clearing electrodes were prepared in the LER wiggler magnets to absorb electrons, as a countermeasure against ECE.
  - A DC voltage of 300 V were applied during the beam operation.
    - The voltage was stably kept at a beam current of 910 mA.
  - Electron current saturates at approximately 100 V.
  - Electron currents is still independent of the bunch fill pattern -> photoelectrons?

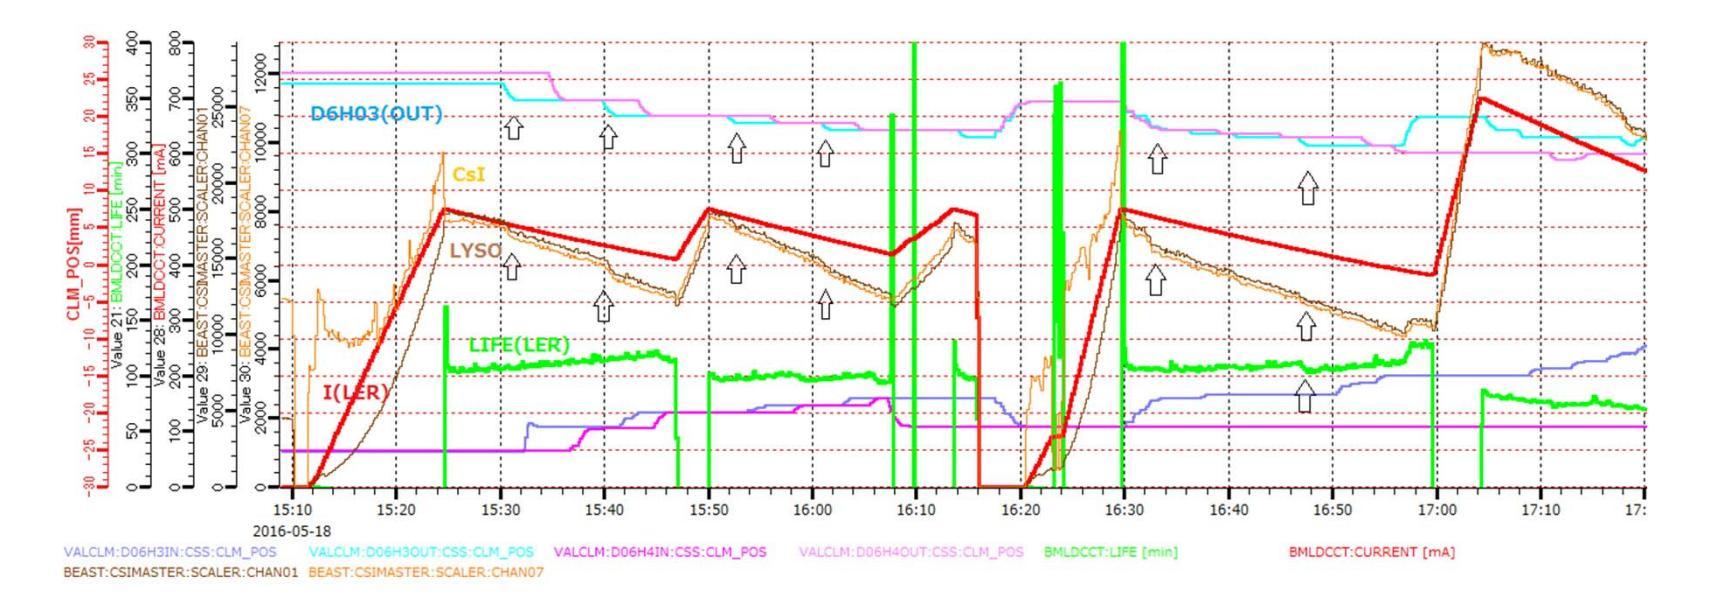
- Beam collimator(2)
- A result in the BEASTII study (by Nakayama-san)

As we change D06H3OUT width from 24mm to 17mm,

LYSO/CsI BG shows step-like decrease at every time collimator get narrower.

#### This is the clear evidence of BG suppression by the collimator!

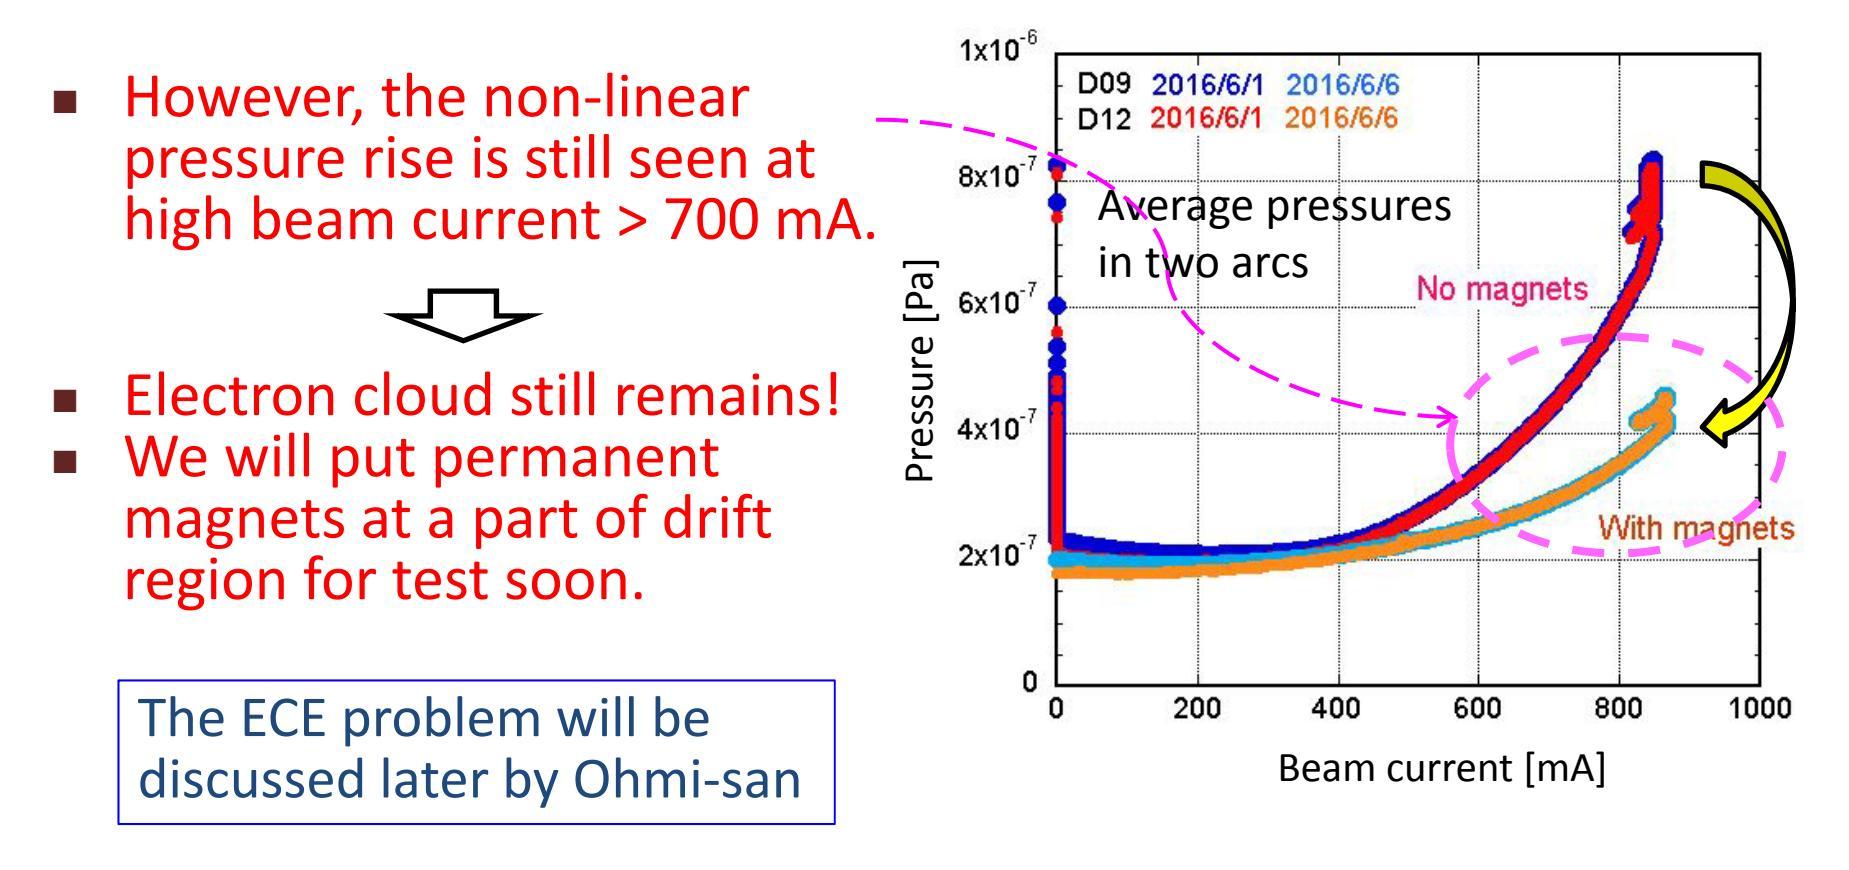
- Non-linear pressure rise against the beam current in LER 6
- We put permanent magnets on most of aluminum bellows chambers (~800) all around the ring (arcs) on 2 - 4, June.
- As a result, the rate of pressure rise relaxed in whole ring!

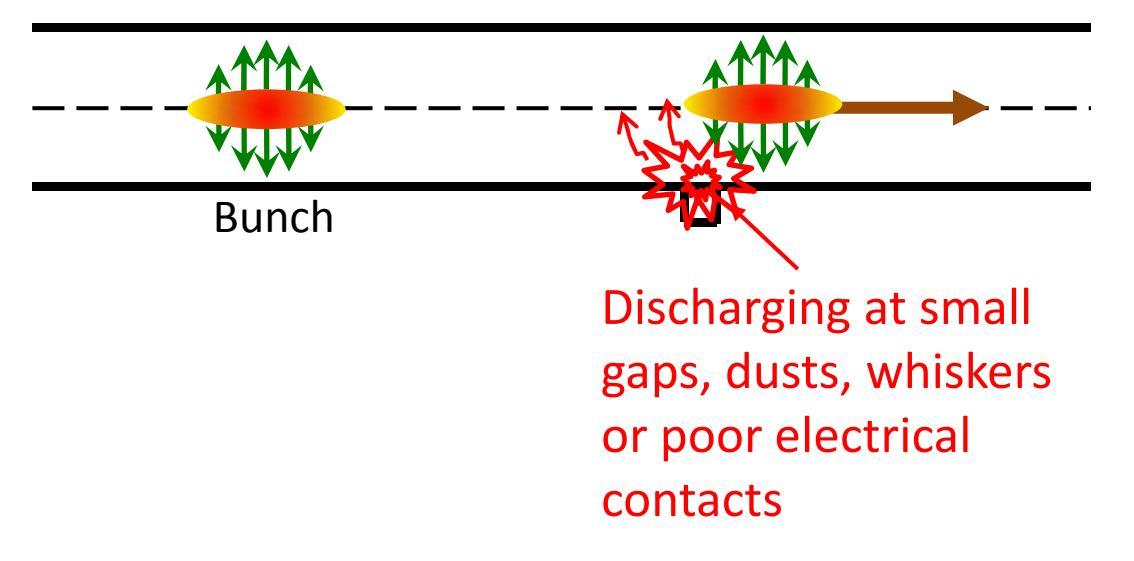
- Pressure bursts accompanying beam loss in LER 5
- One possibility was discharges by wall current at inner wall of beam pipes, but....
  - No extra heating around these points.
  - Almost no small pressure bursts, which should be likely observed in discharging phenomena.
  - Do discharges emit heavy materials leading to the beam loss toward beam orbit direction?

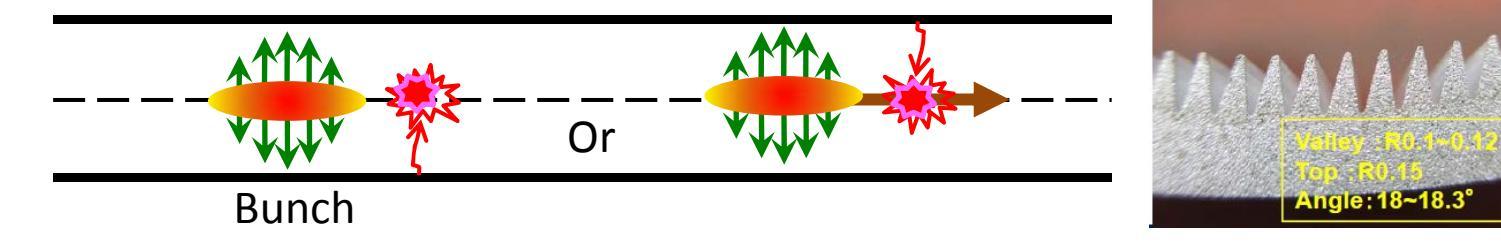
UFO problem!

- Pressure bursts accompanying beam loss in LER 6
- One possibility was discharges by wall current at inner wall of beam pipes, but....
  - No extra heating around these points.
  - Almost no small pressure bursts, which should be likely observed in discharging phenomena.
  - Do discharges emit heavy materials leading to the beam loss toward beam orbit direction?
- Another possibility: Collision of "dusts" with circulating beams.
  - Groove structure is likely to catch the dusts.
  - Aluminum grooves were formed by extrusion process, at the first stage of beam pipe fabrication.
  - Beam pipes in wiggler sections have clearing electrodes at the top side.
