Status of High-power rf system for MR and DR

High-power RF-G Ken Watanabe (3rd division)

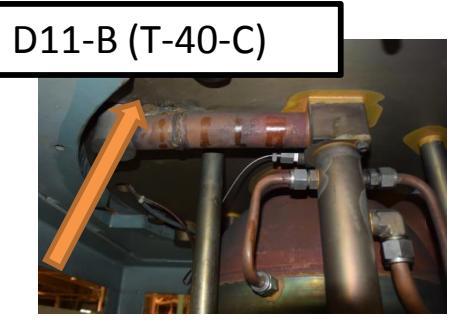
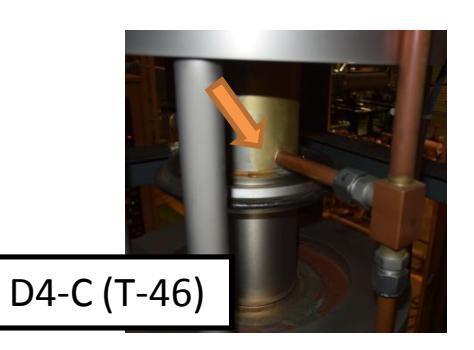
: Water leak was happened on the cooling pipe for two klystrons at Feb and Mar 2018. Now, the klystrons changed to spare.-> Now, planning repair in house.

: Fabrication of one klystron using new ceramic for RF window in output coupler (Manufacturers have changed) is planning at 2019-2020 or later. Currently used klystrons are of two types, Toshiba E3786 and E3732 (late-model). If the E3786 is broken, repair it to the E3732 specification.

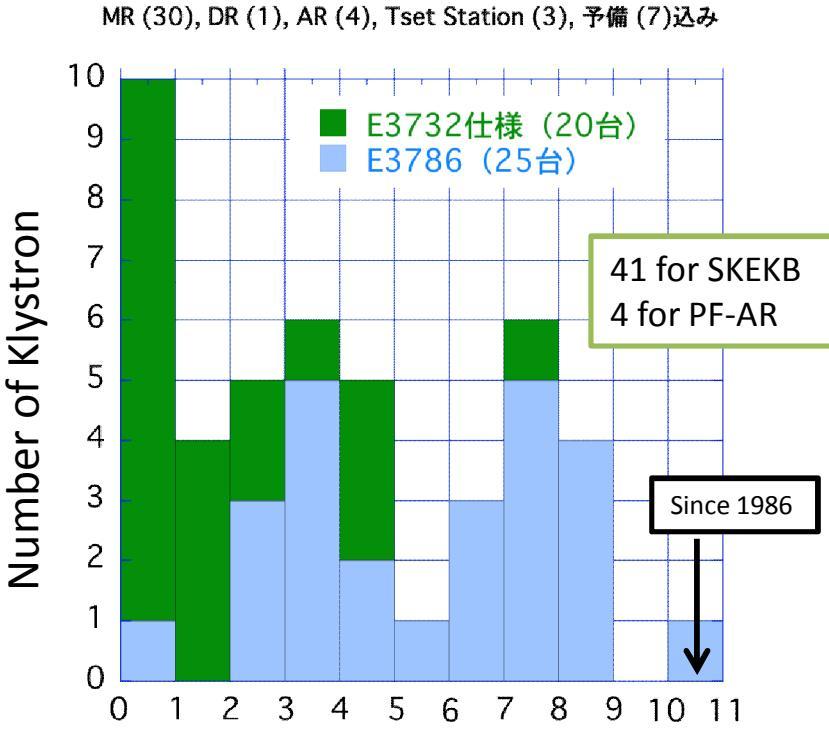
Operating time of Toshiba Klystrons before SuperKEKB Phase2

Operation time (E3786) since TRISTAN Average : 5.6 x 10^5 hours Maximum: 11 x 10^5 hours (since 1986)

Operation time (E3732) since 2003. Average: 1.8 x 10^5 hours Maximum: 7 x 10^5 hours

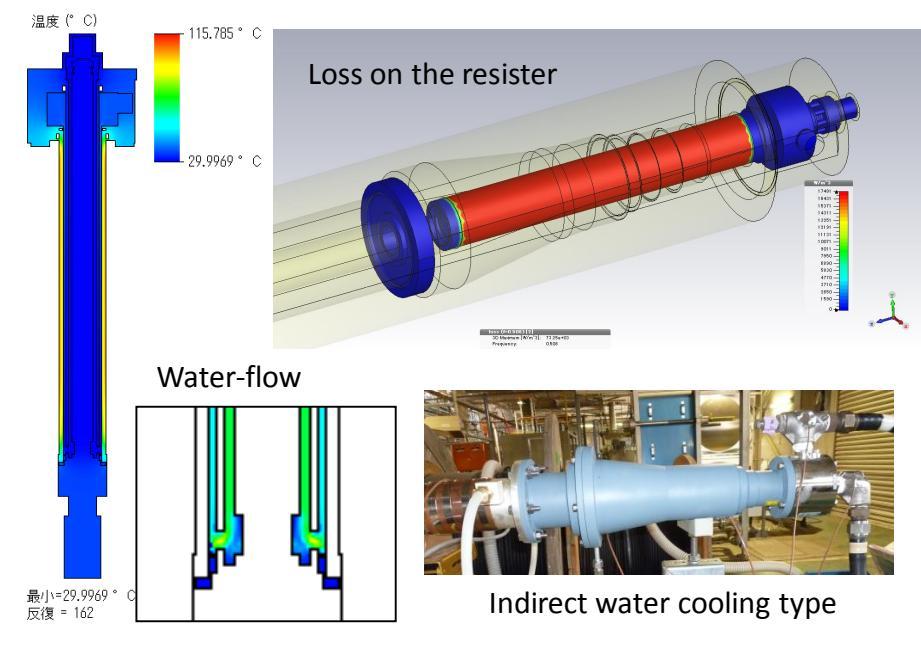
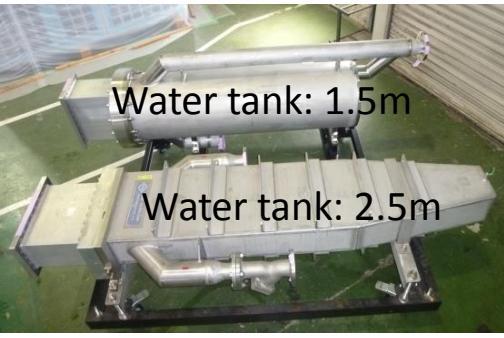
Water-loads Top: Cylindrical-type Bottom: Rectangular-type

: The water leakage due to corrosion of seal material was detected for all Rectangular-type water loads after the end of KEKB. The cause of corrosion is that tap water (~ 360 μ S/cm) was used as a microwave absorber. For the long operation without corrosion, "Water quality changes to mixed water (~ 20 μ S/cm) and controls the conductivity in water. " Gold coated on the surface of metal seal for improving sealing performance and corrosion resistance.

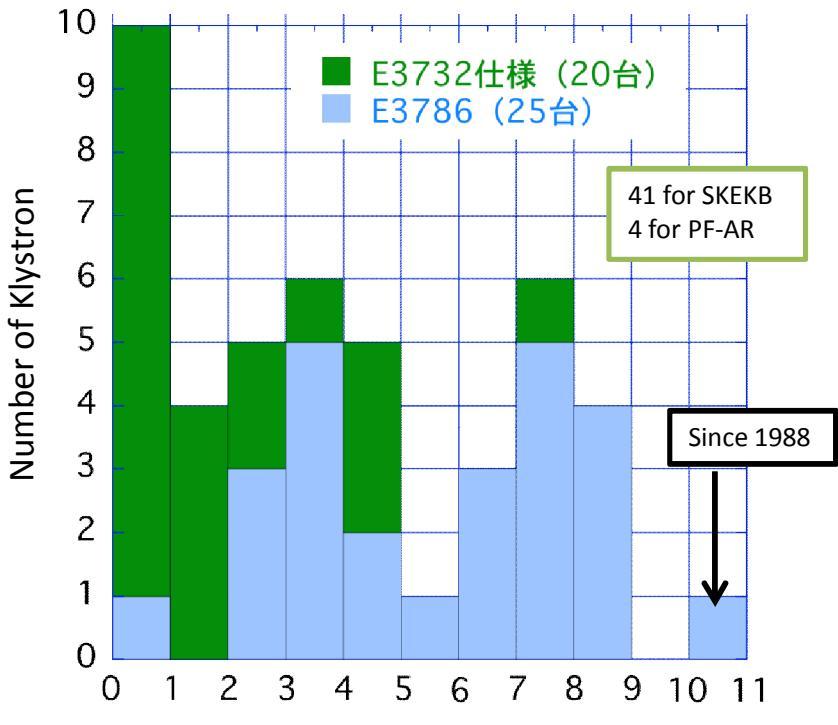
Average operation time (E3786) : 5.6 x 10^5 hours Maximum operating time: about 11 x 10^5 hours

Average operation time (E3732) : 1.8×10^{5} hours Maximum operating time: about 7×10^{5} hours

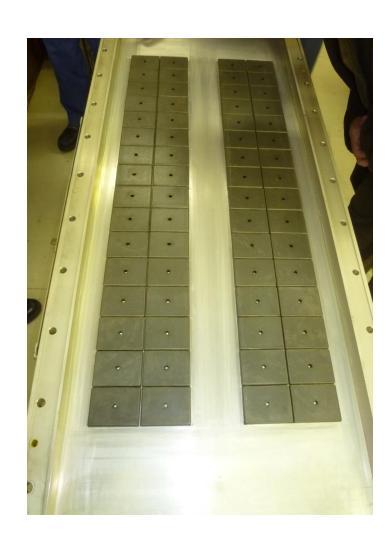
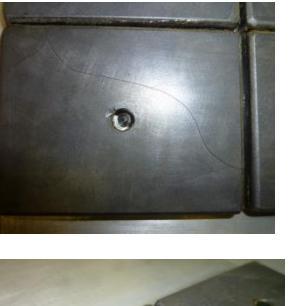
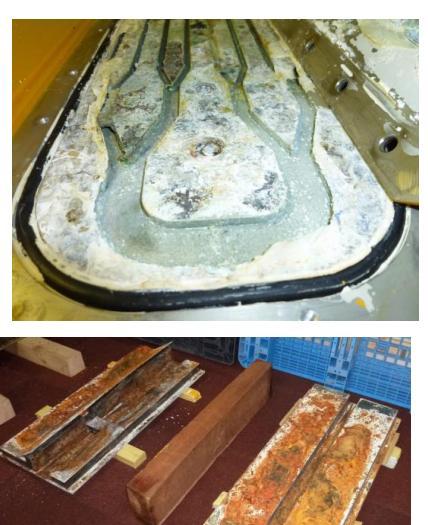
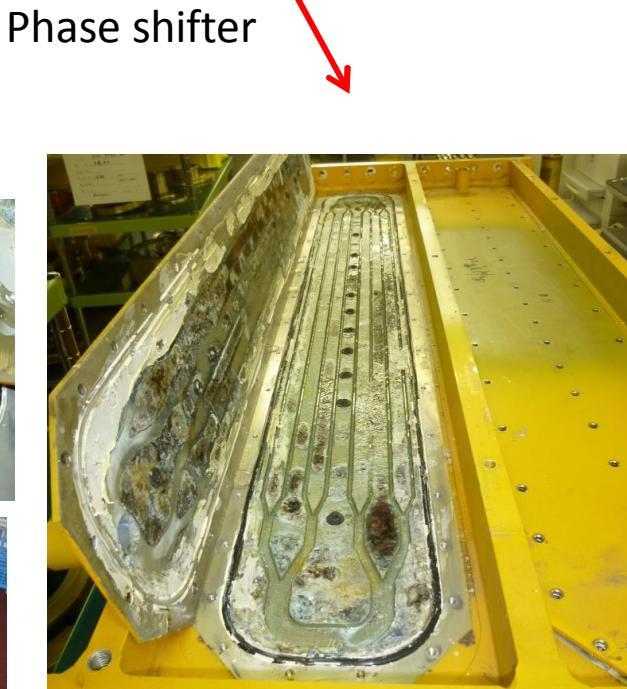
* Water-leak from cooling water channel in phase shifter

* Clack on the ferrite

The circulator continues to use it by repairing the cooling channel. However, the cuttable range of the cooling water channel has become low, some overhauling has come up.

Repair of the cooling water channel is done by machining and then subjecting the surface to alodine treatment.

As a current situation, the circulators are repairing (overhaul) at two pace per year using two spare parts.

We are planning to repair for two circulator, and to production new for one circulator.

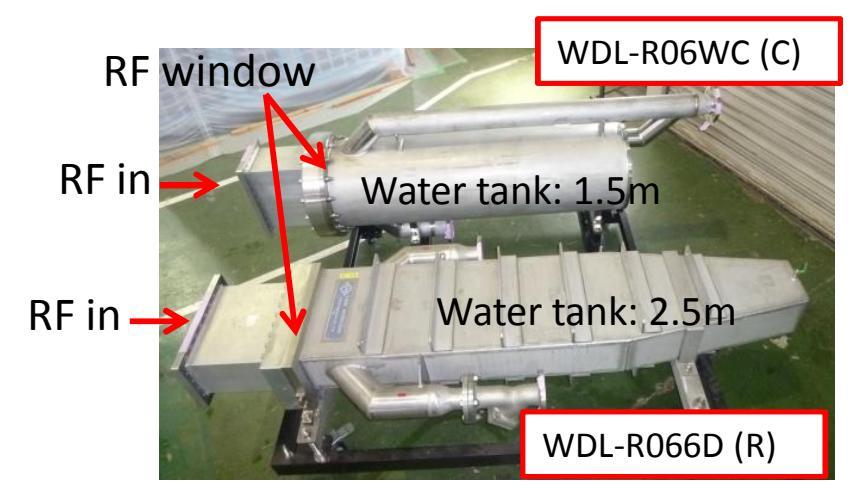
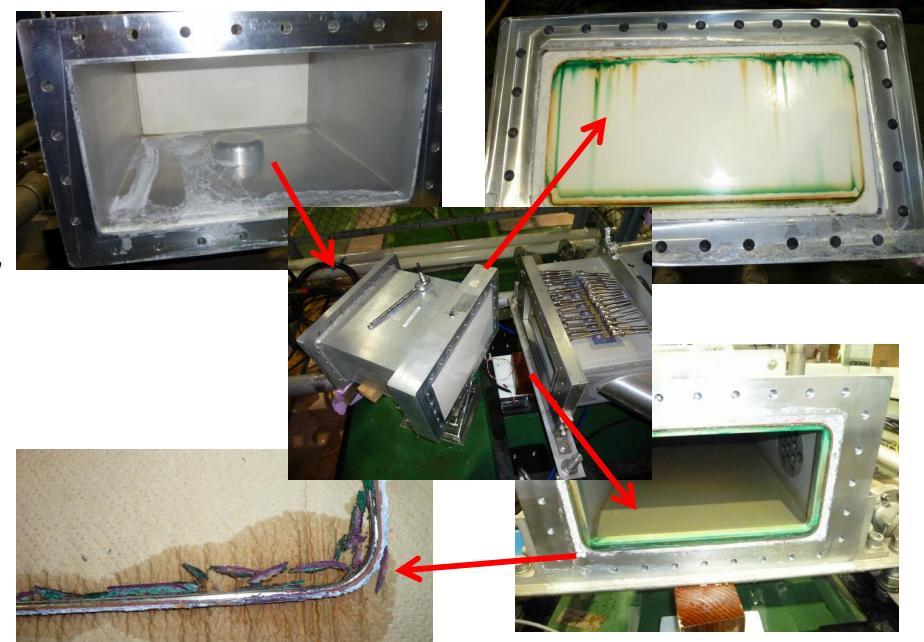
Water-load

The water leakage due to corrosion of seal material was detected for all Rectangular-type water loads after the end of KEKB. It is caused by using Tap water as microwave absorber. But, Tap water is good microwave absorber compared to pure water. Because of, the dielectric loss tangent of Tap water dose not decrease even at high-temperature. However, it turned out not to be suitable when considering to use for long-term.

Water quality of water was changed from tap water (~ 360 μ S/cm) to mixed water (~ 20 μ S/cm) in SuperKEKB considering prevention of corrosion and VSRW performance.

Regarding the surface of the metal seal used for the load, a conventional one plated is adopted for the purpose of improving sealing performance and corrosion resistance.

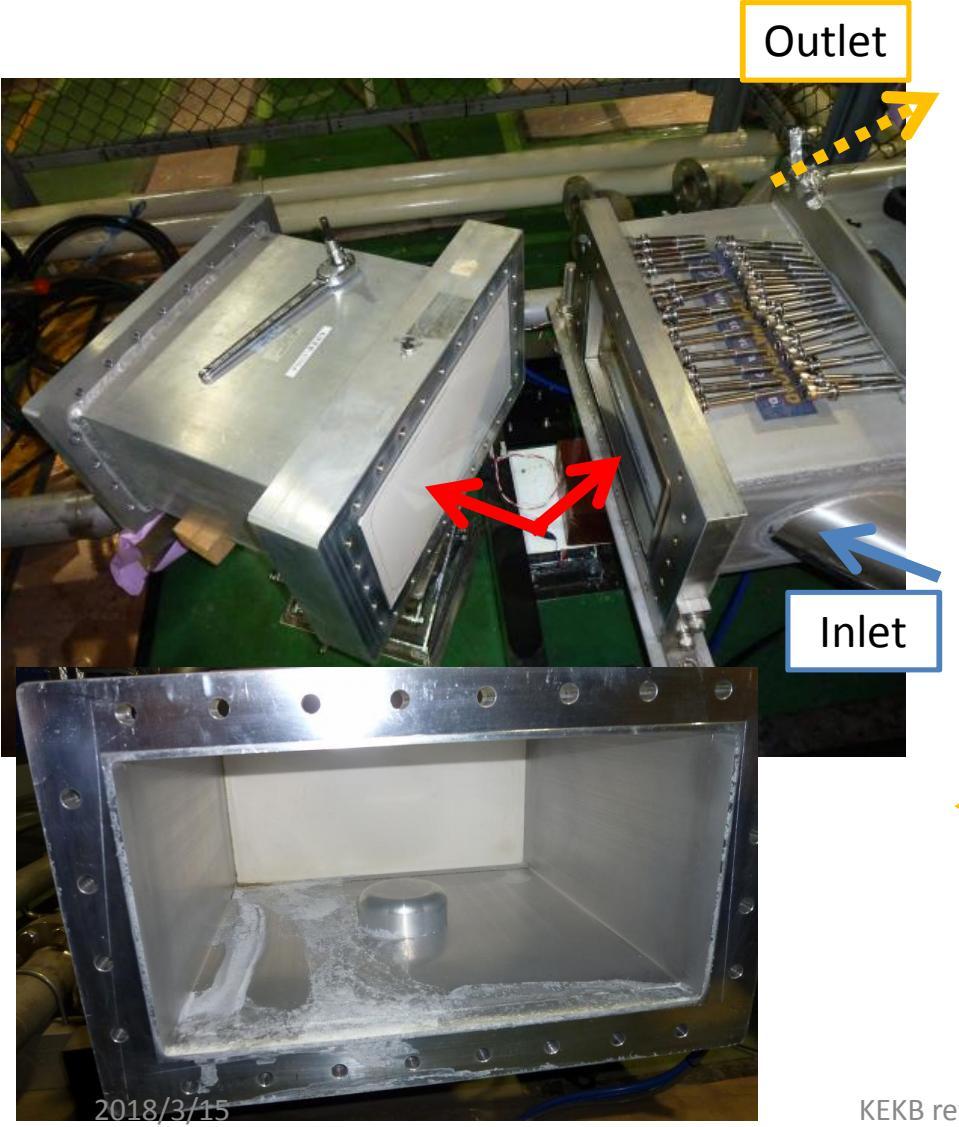
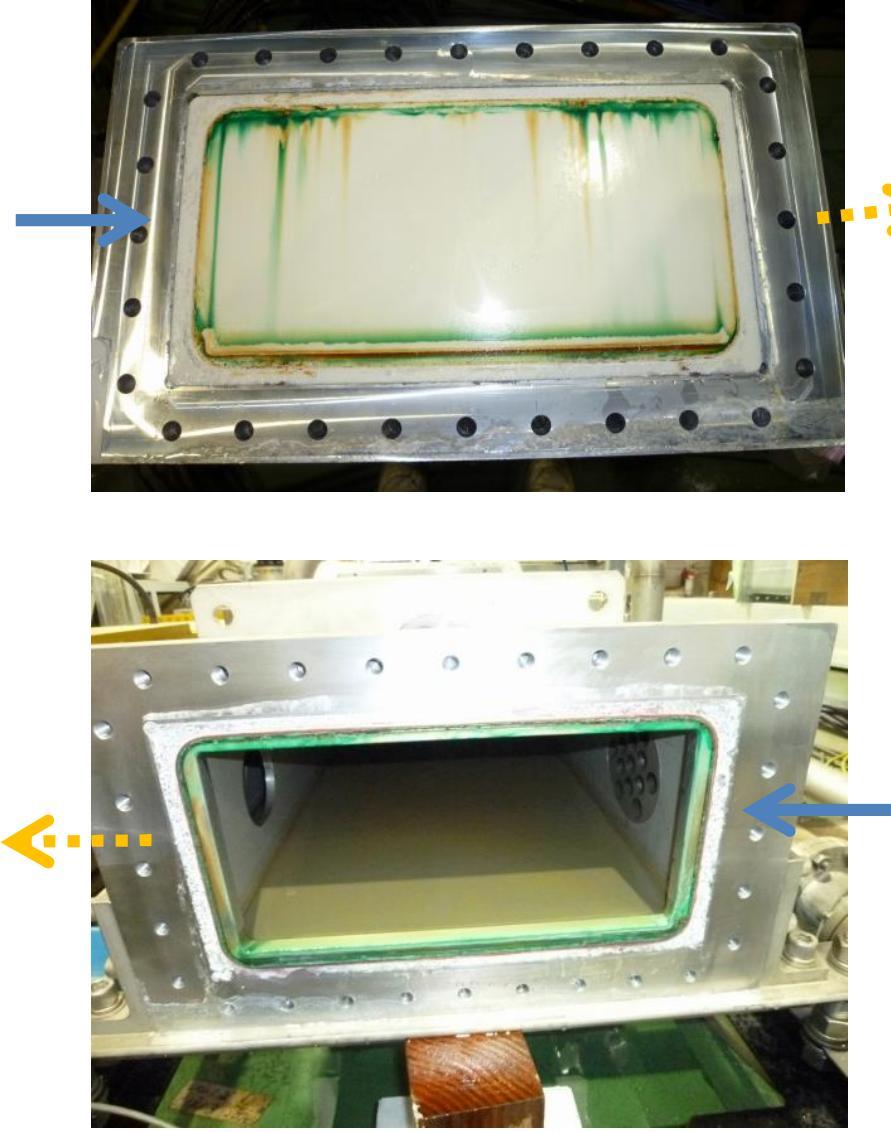
Rectangular-type water load

Corrosion of the metal seal compare with tap-water and pure-water

タール面まで浸食していた箇所があり、そこ 角とE面の外皮が剥がれた。H面は剥がれ から微量の水漏れあり。緑青のみ。孔食には る割含が少ない。緑青の他に孔食あり。 KEKB re 空っていない。 30
