Recovery of injector linac

**Kazuro Furukawa
for Injector Linac group
July 9, 2019**

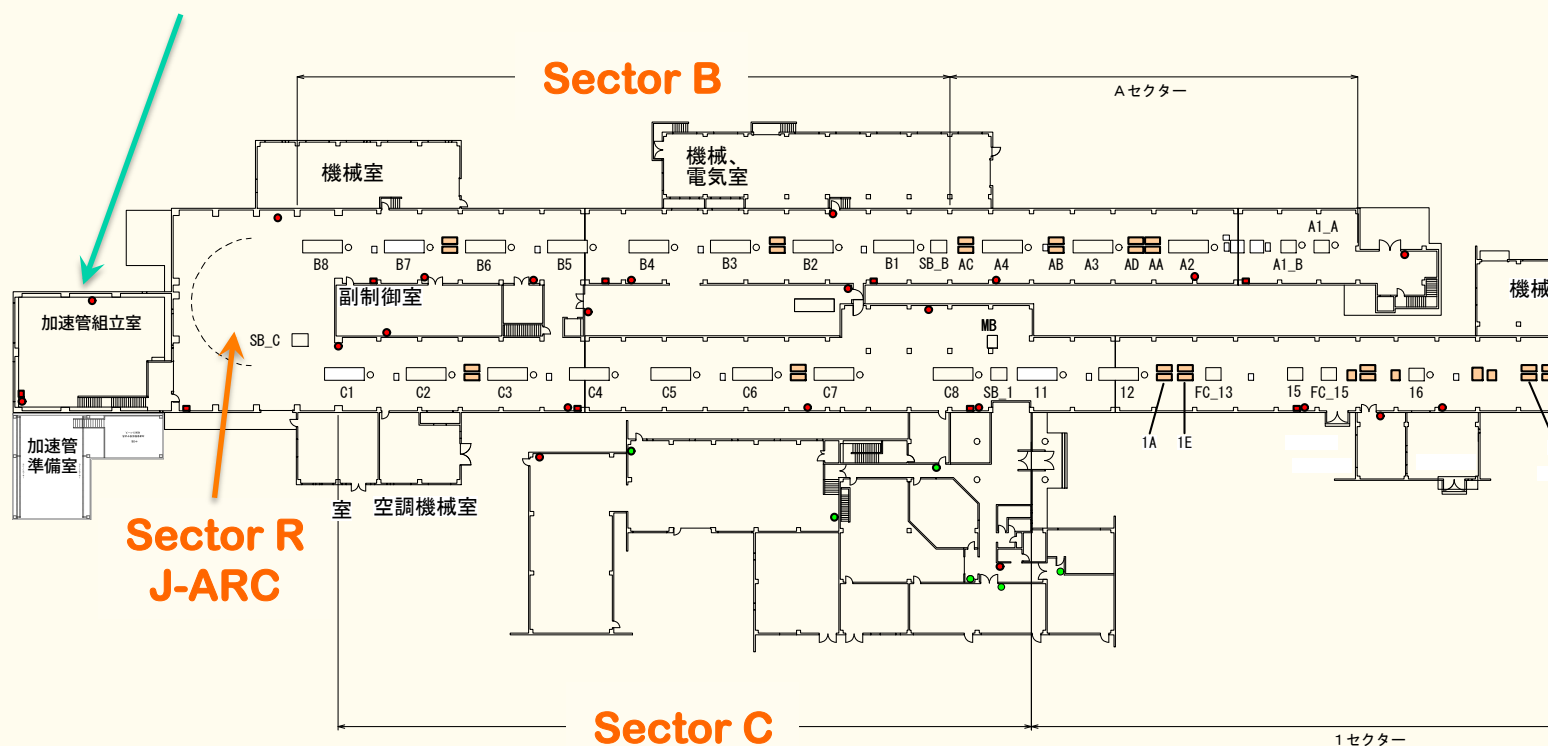
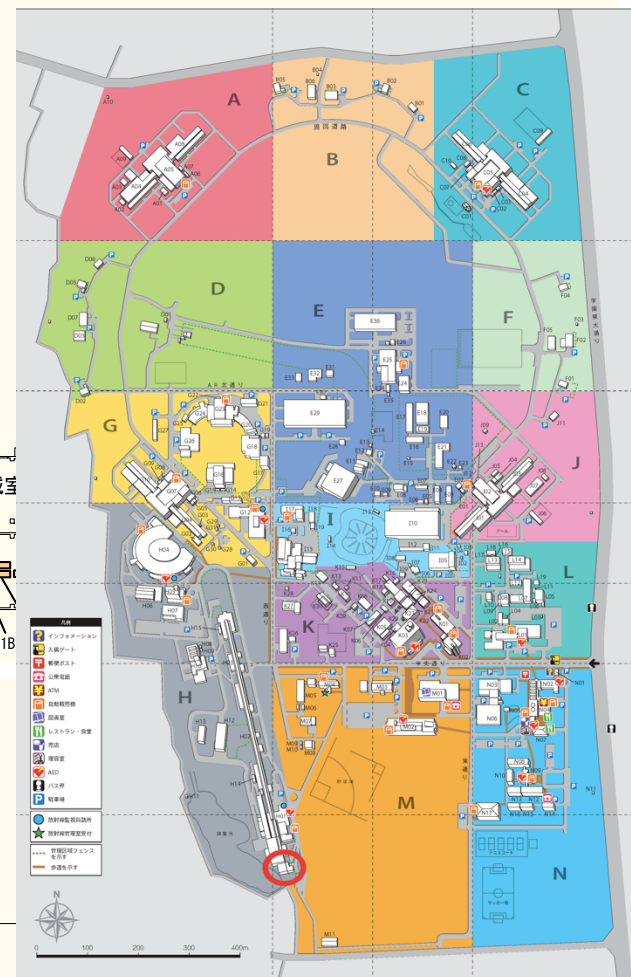
Injector Linac and Accelerating structure assembly room

Southern 1/3 of Injector

❖ Sectors B, R, C had to be recovered

✧ Approximately 25% of the Injector

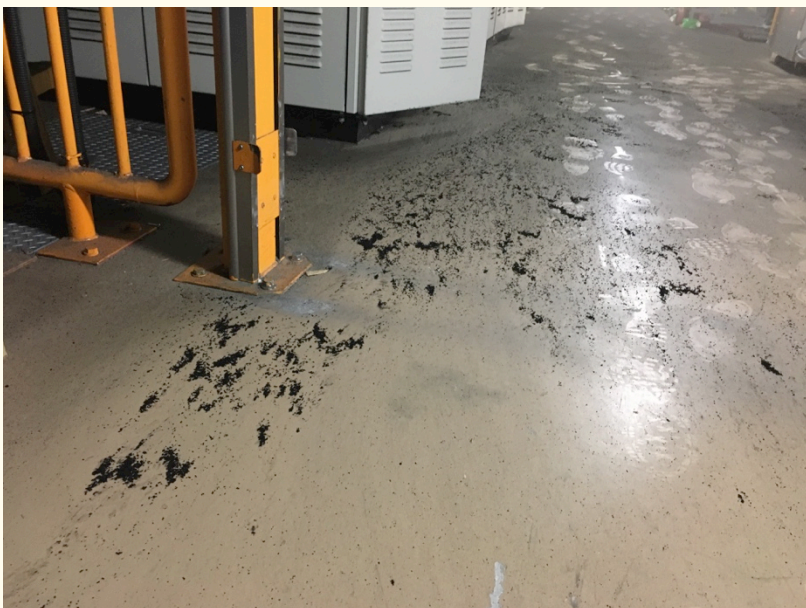
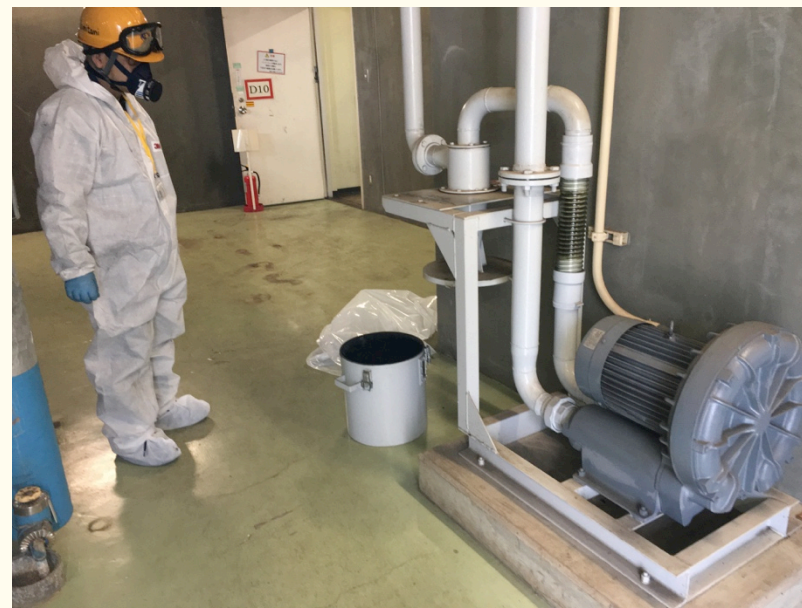
❖ Carbon soot sneaked through holes between rooms
