# Vacuum System Status

T. Ishibashi, KEK

on behalf of KEKB Vacuum Group

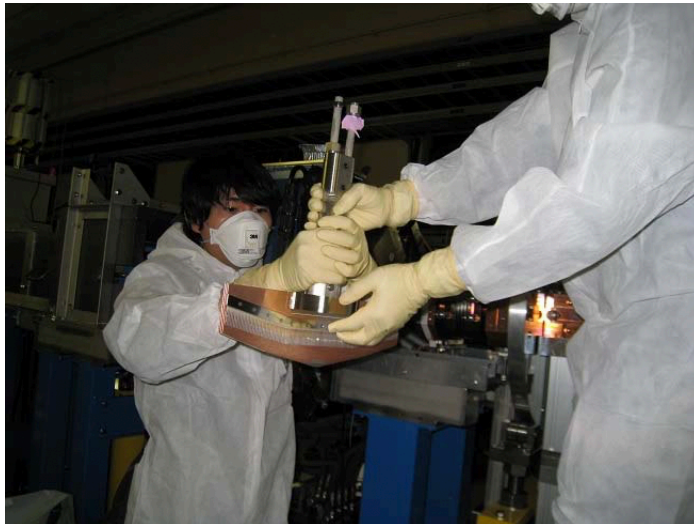
- Jaws of D02V1 top, bottom and D01V1 top were changed to new ones in the presence of Radiation Science Center.
  - D02V1:  $\sim 10 \mu\text{Sv/h}$
  - D01V1:  $\sim 30 \mu\text{Sv/h}$
- The damaged tungsten is likely to be crumbly by the embrittlement.
  - plan to change the material from tungsten to tantalum

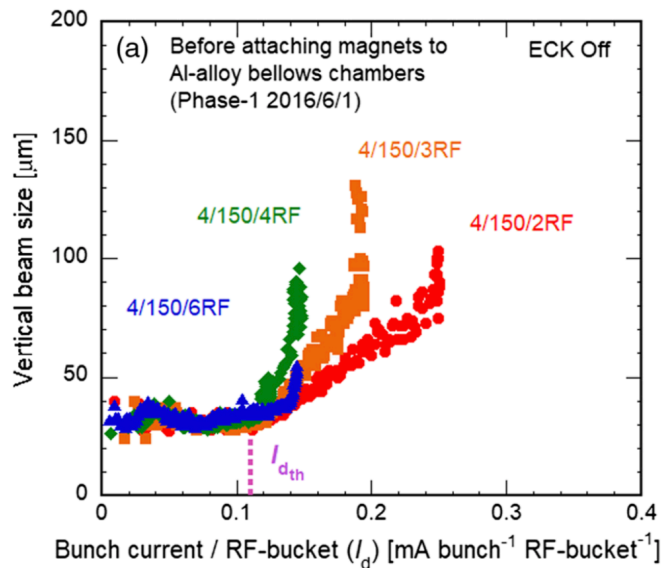
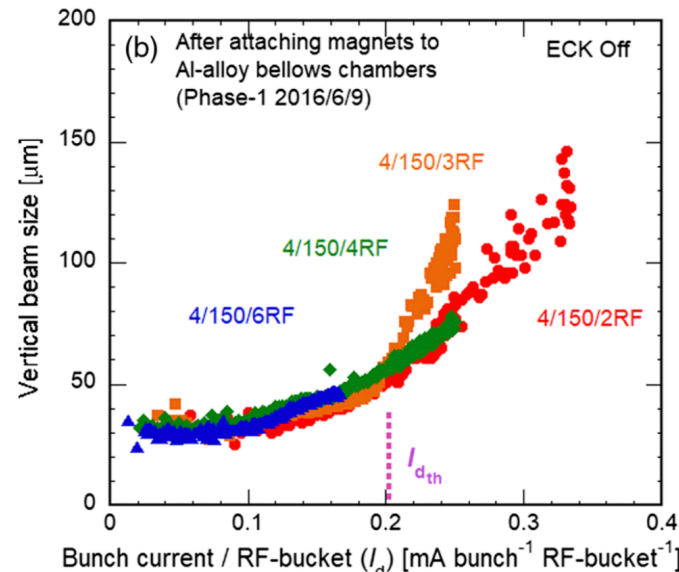
- In Phase-1, vertical beam size blow up and nonlinear behavior of pressures from  $I_d \sim 0.1$  by ECE were observed in LER.
  - The current linear density ( $I_d$ ) is the bunch current divided by the bunch spacing.
- The threshold was relaxed to  $I_d \sim 0.2$  by an installation of permanent magnets on bellows chambers.
- A threshold in KEKB without solenoids was approximately  $I_d = 0.04$ .

ECE in Phase-1 with/without permanent magnets in bellows chambers

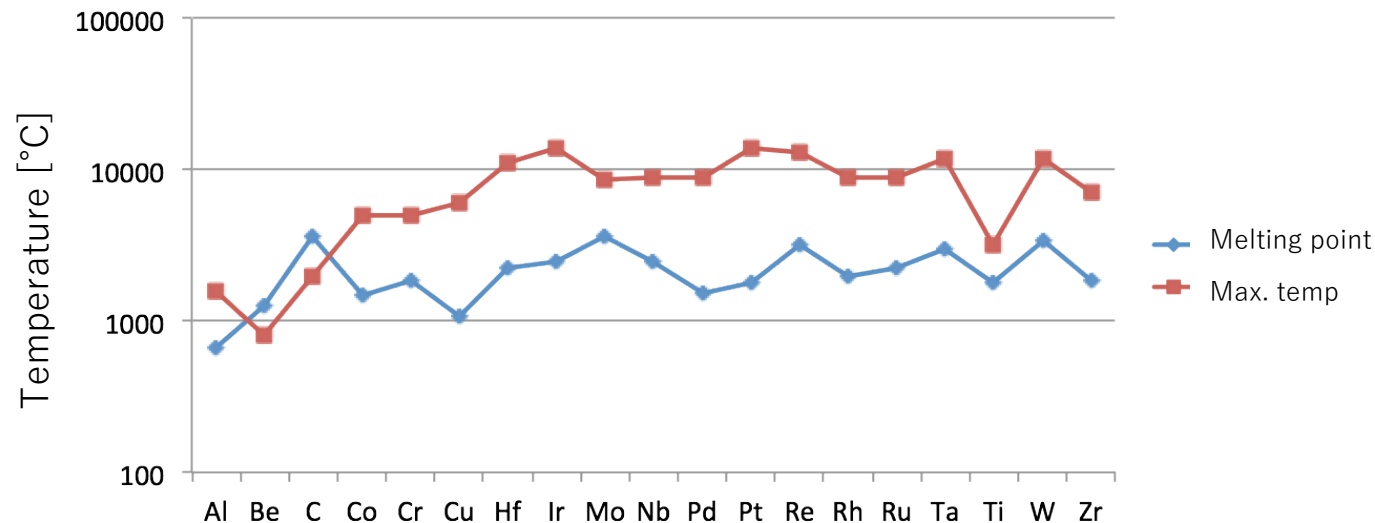
- At the same time, pressure bursts were observed in a beam pipe with a clearing electrode. → a dust event caused the beam energy loss?
- We are plan to knock the beam pipes in wiggler section by next commissioning.
- Any materials would melt if whole beams hit the jaw.
  - Need fast abort to avoid the damage!

Maximum temperature induced by beam hit  
( $1 \times 10^{12}$  e-/pulse (16 mA), effective bunch radius: 50  $\mu$ m, R.L. = 0.5)

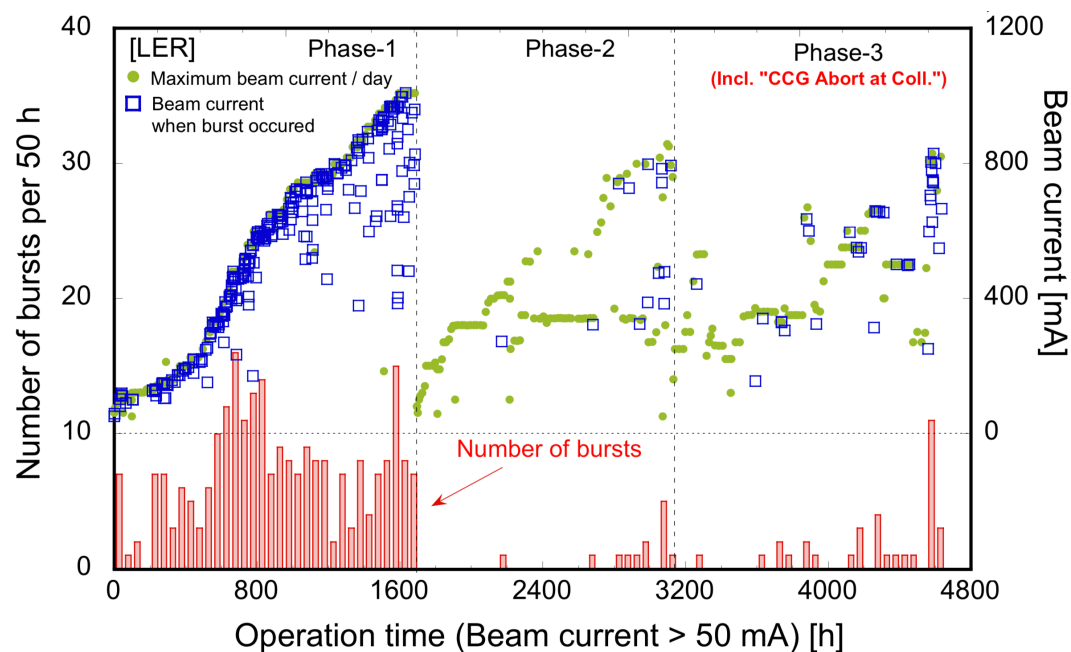
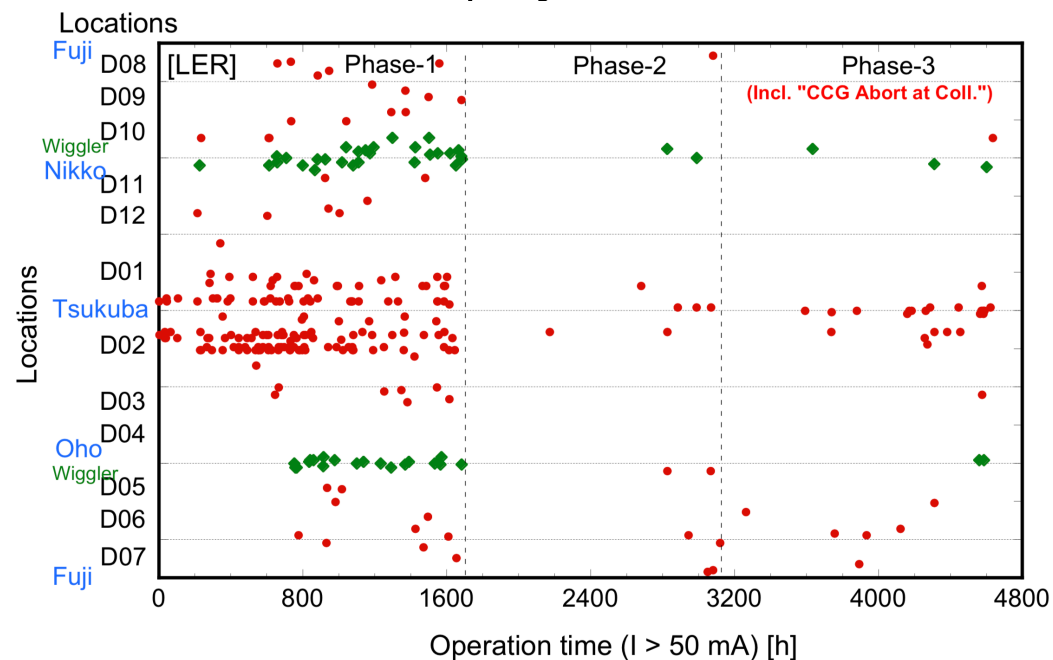
- Dust events

- The number of dust events has been decreasing with the operation time.

- However, it can cause beam energy loss.

→ drop dusts using the knocker before next commissioning

→ proposed an aging operation with high current before a physics run

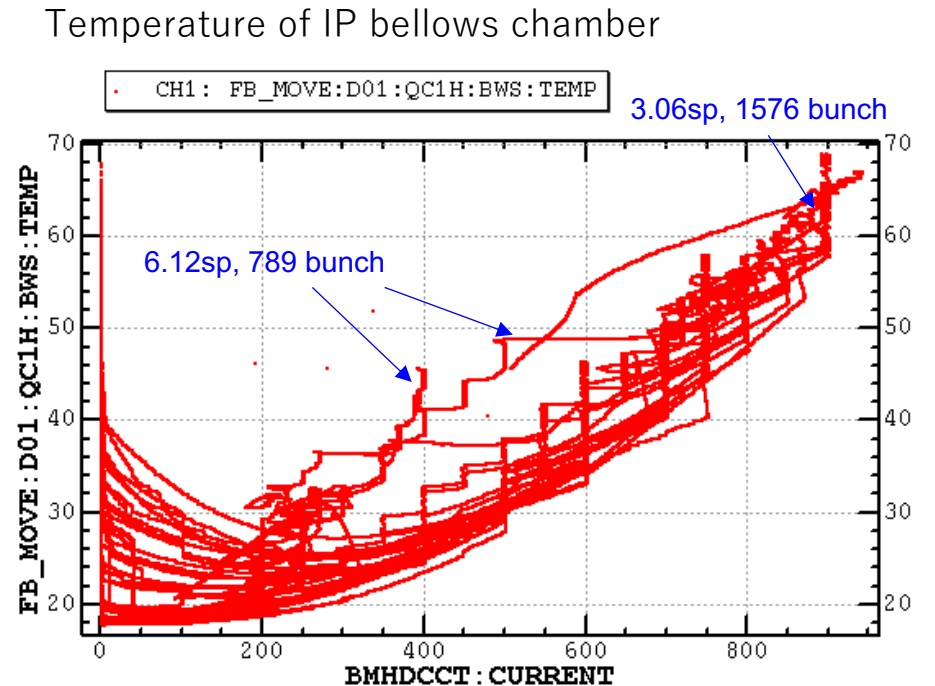
- Temperature of IP bellows chamber in HER in Phase-3, which is between a QCS beam pipe and an IP chamber.  $\sim 60^{\circ}\text{C}$  (850 mA, 3.06RF, 1578 bunches) . This happened in 1 of the 4 bellows chambers.
- The similar heating on an another one had also been seen in Phase-2. It was changed to new one before Phase-3.
- The RF shield is a conventional fingers type. Fault of the electrical contact?  
 → We have a plan to replace it with new one in this summer shutdown.

Discharged mark

- This finger was off after the installation and put it back before Phase-2.
- This happened in 1 of the 4 chambers.
