Sudden Beam Loss

The 28th KEKB Accelerator Review Committee

2025/1/14 H. Ikeda

on behalf of the SuperKEKB ACC. Group

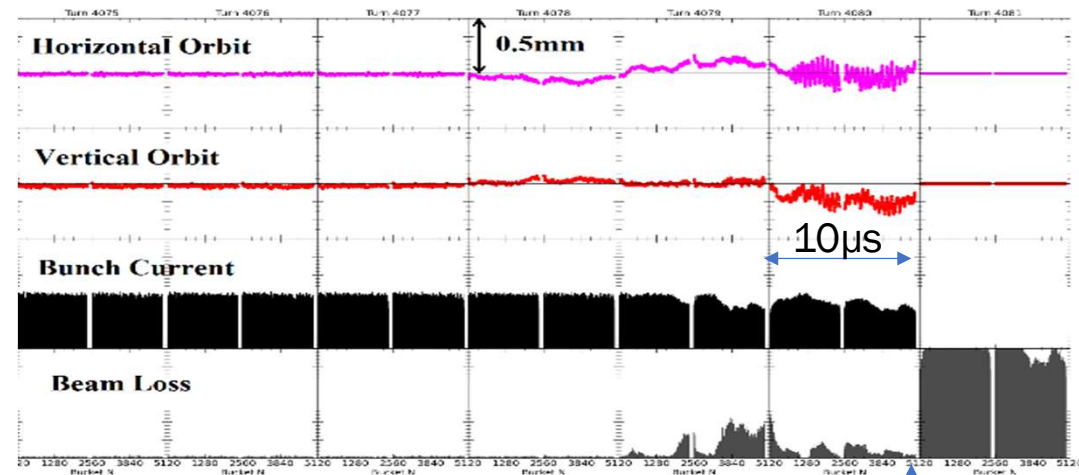
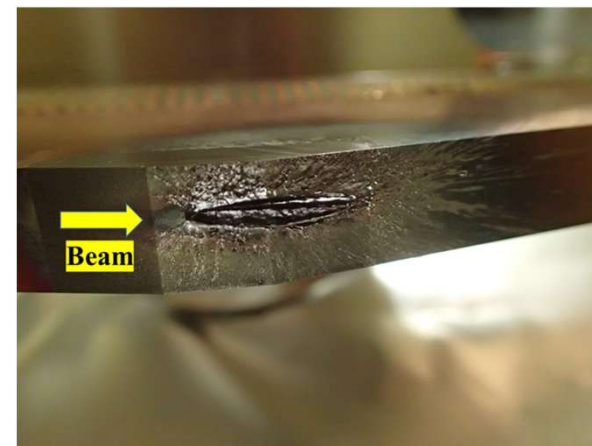
Beam loss that occurs suddenly within 1 turn (10 μ s) without precursory phenomena. = Sudden Beam Loss (SBL)

- A significant percentage of the beam is lost before the abort trigger is applied.
- Just before the beam loss begins, the orbit appears to move, but its value is small \sim 0(0.1 mm).

Beam signal measured by
Beam Oscillation Recorder(BOR) & Bunch Current Monitor(BCM)

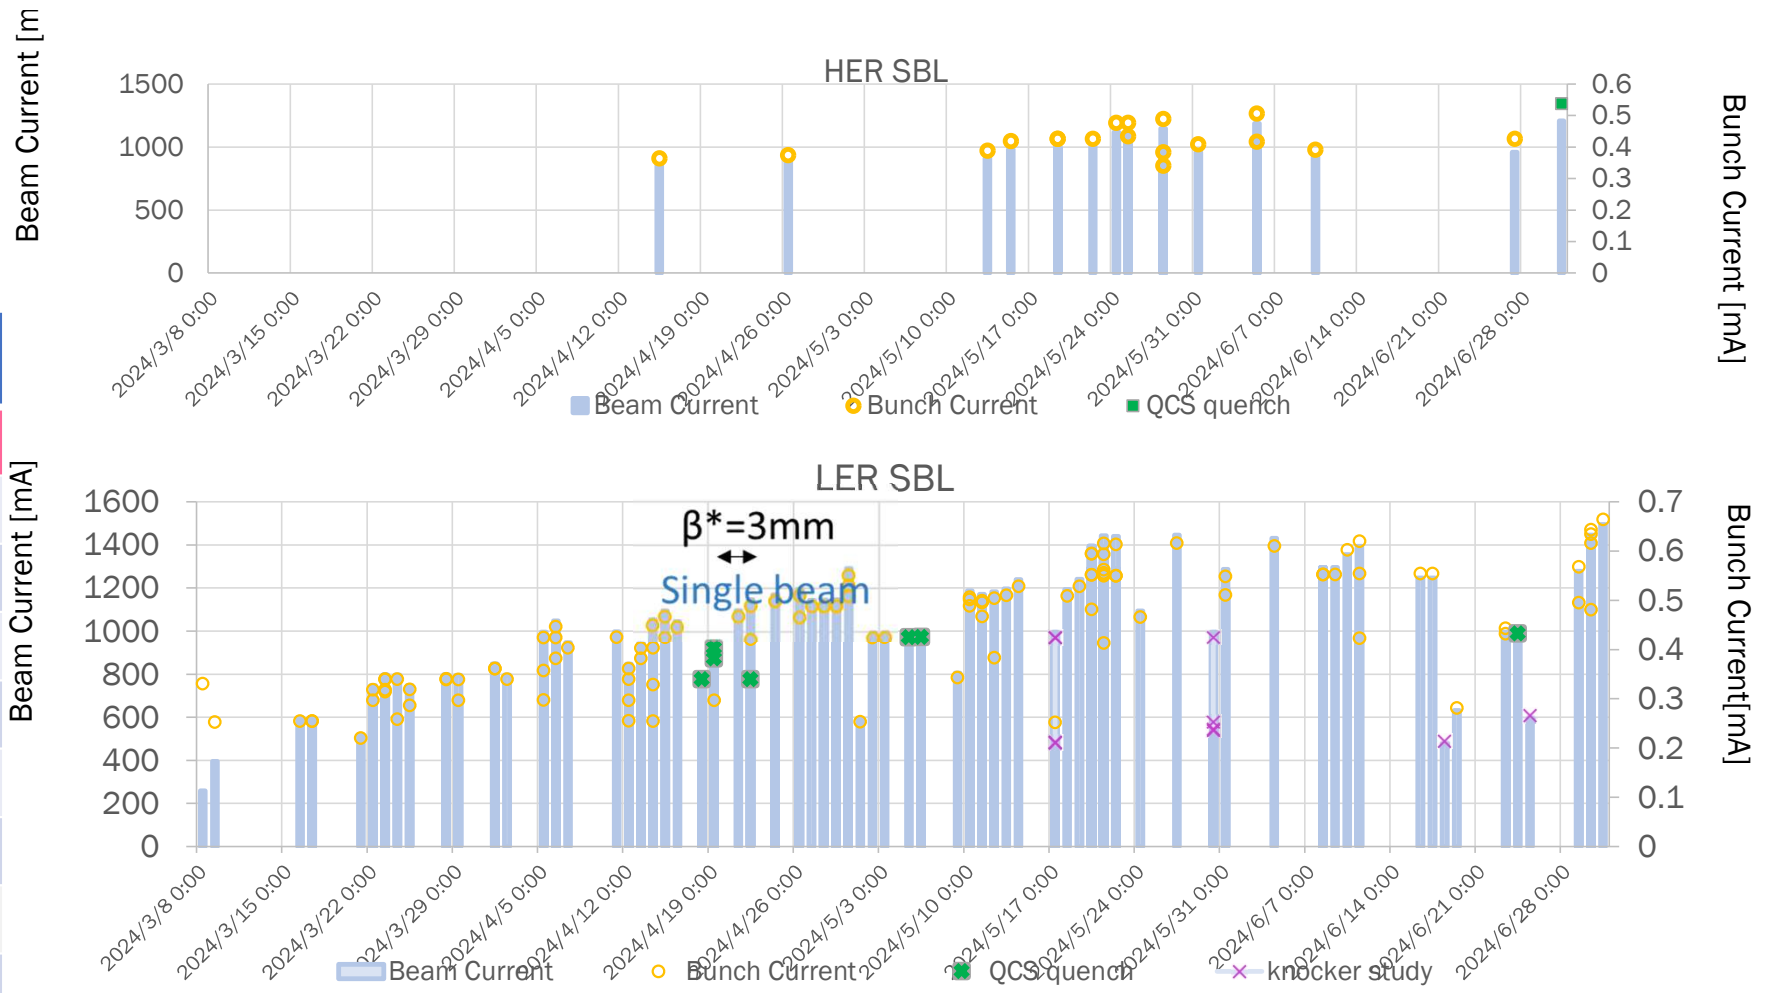
- HER 19
- LER 144
- QCS Quench 7

SBL occurs in both HER and LER, but the number is higher in LER and the damage to the hardware is particularly large when loss occurs in LER.

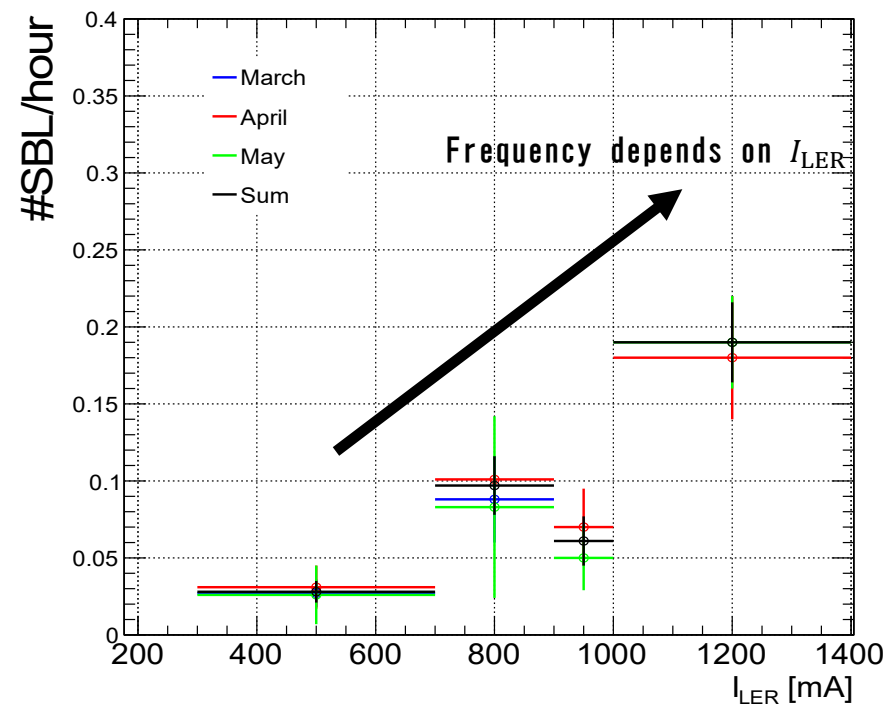
- Frequency (#SBL/hour) depends on the LER beam current

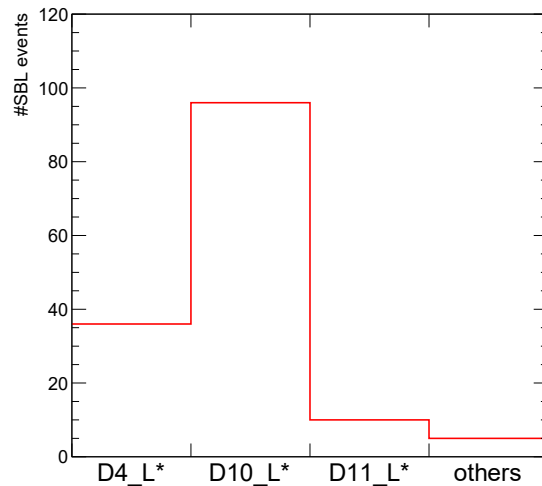
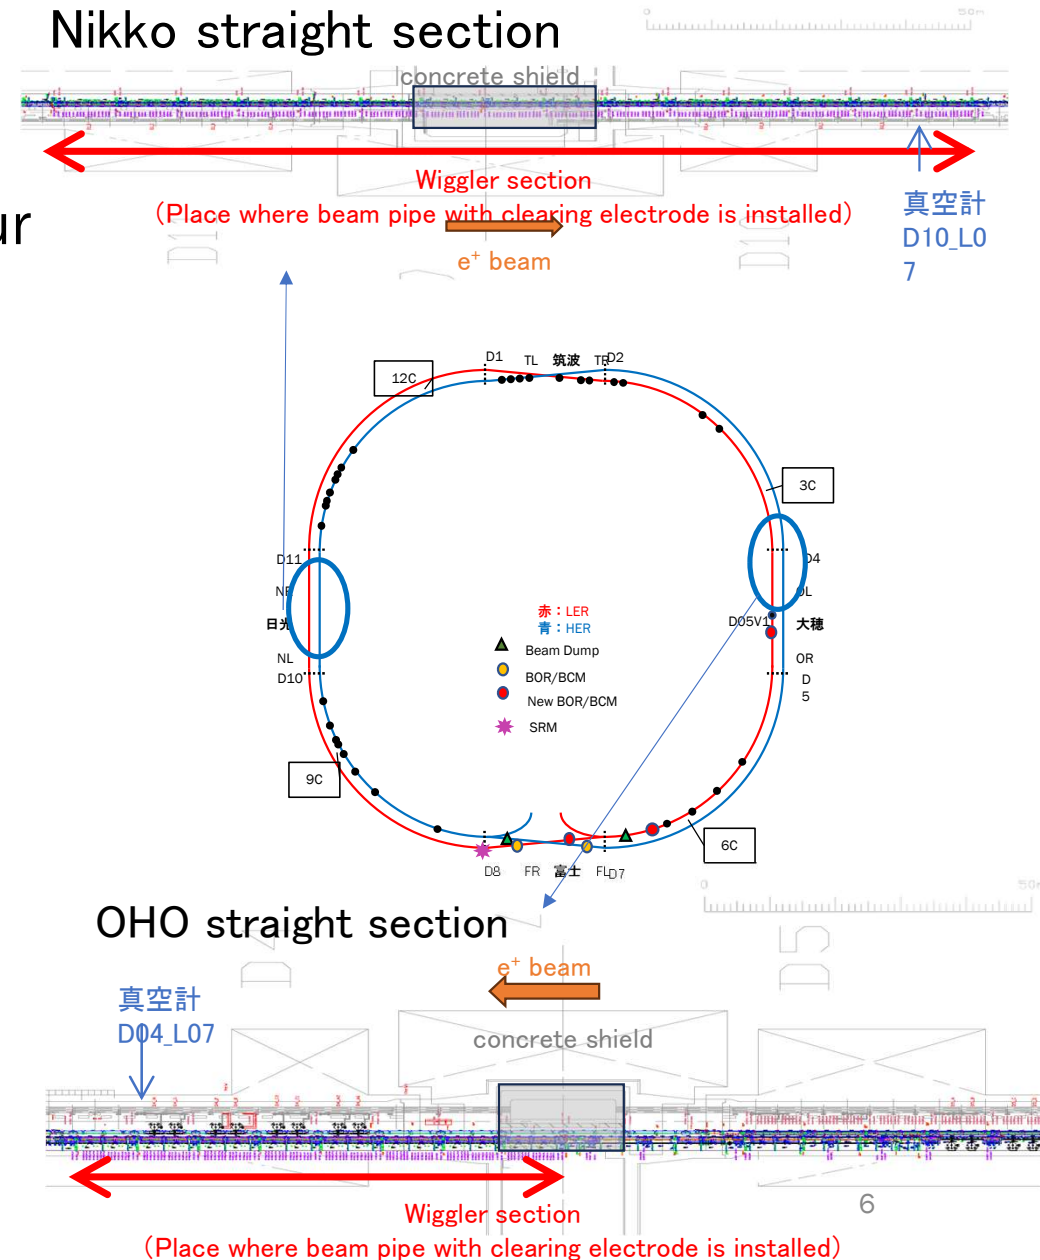
- There are many vacuum bursts in the **Wiggler(D10/D4) section**, but they also occur when SBL is not occurring.
 - The spike never coincided in D04 and D10.
 - The spike never coincided at different locations within D04 or D10.
- LM(PIN) were installed downstream of the Wiggler section, but no beam loss was observed.

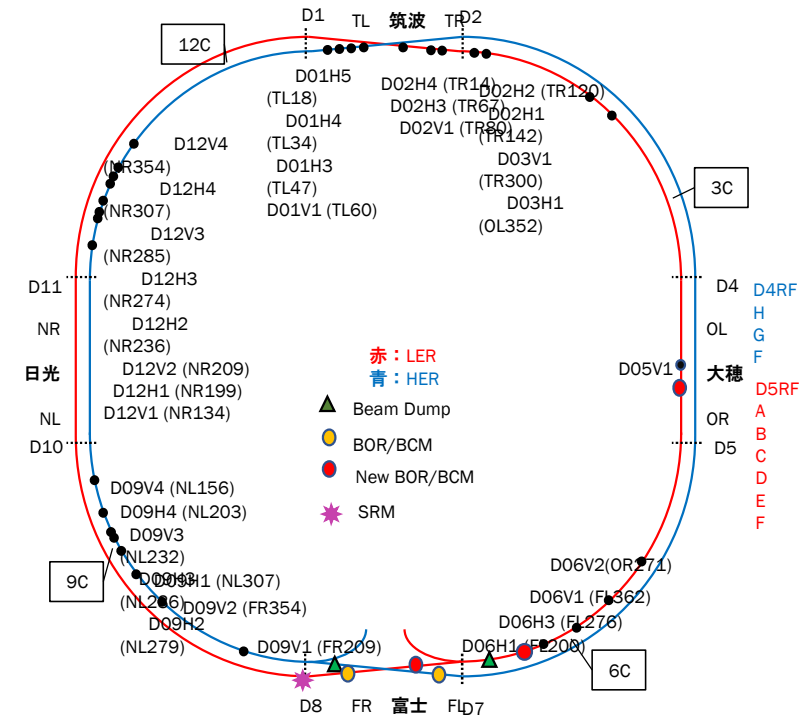
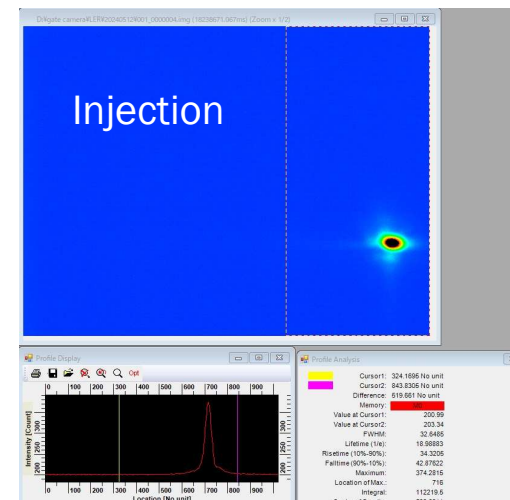
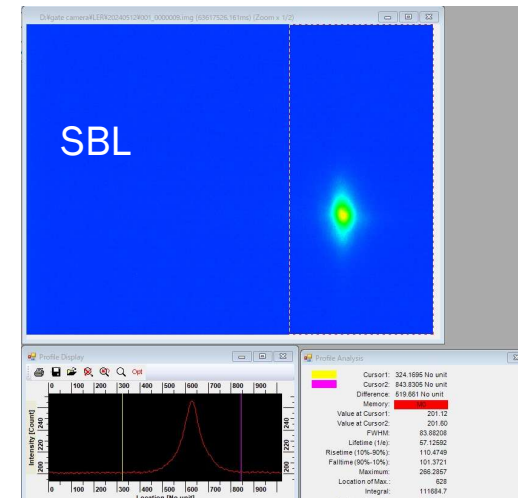
- A beam image at the abort timing was measured using a D8 SRM gated camera.
- trigger : Abort trigger
- Gate width : 10us
- When the Abort trigger is sent to the kicker, a signal is also sent to D8.
- The beam goes in the order of D8 → BOR → Abort kicker, so we should be able to see the image of the last turn.

- **Vertical Beam Size increases when SBL occurs compared to other aborts.**

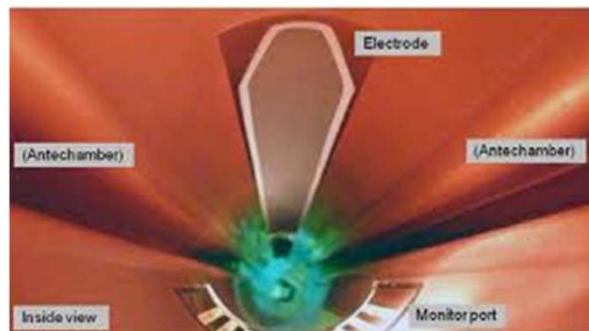
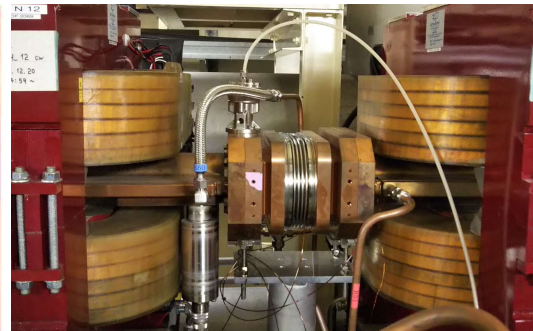
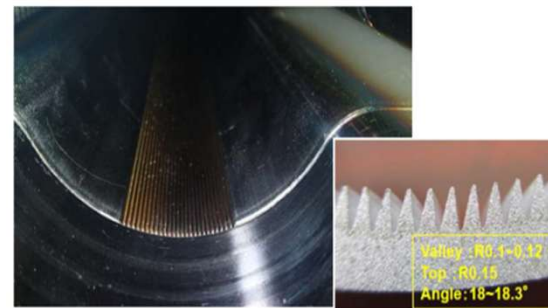
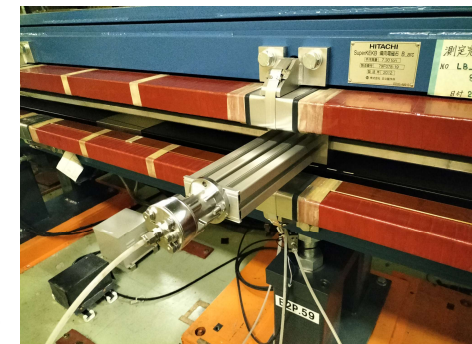
- ◆Beam pipe with clearing electrode in D10 Nikko Wiggler section :
Electrodes are formed by spraying alumina and tungsten onto copper beam pipes (electrodes are on top of the beam) in order to reject the photo-electron.
- ◆Aluminum beam pipe with grooves in bending magnet in D06 arc section.
- ◆Normal Drift chamber for comparison.

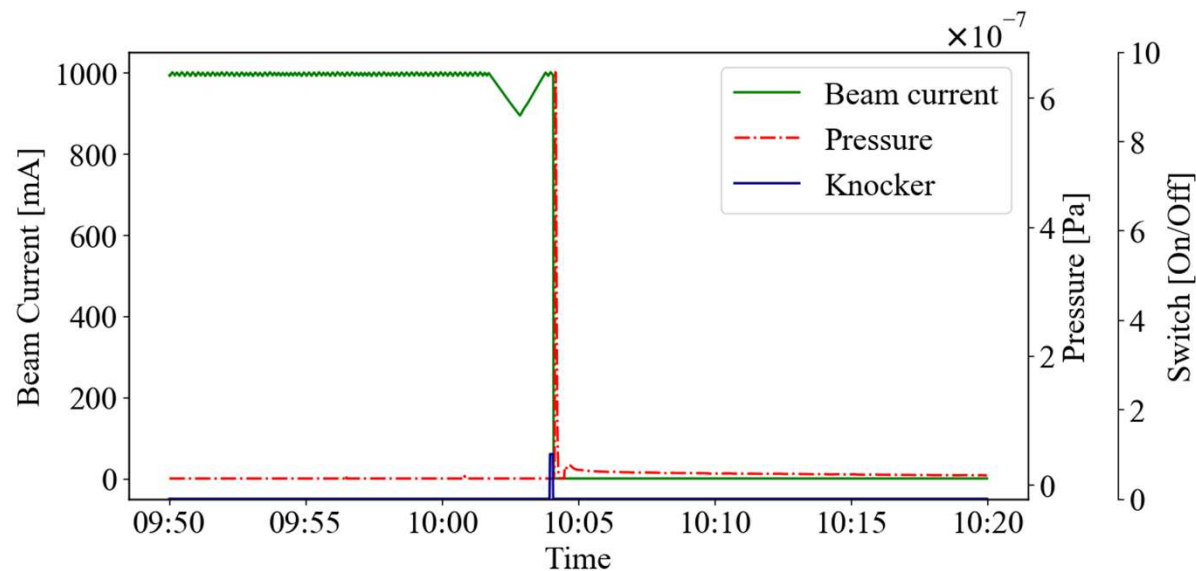
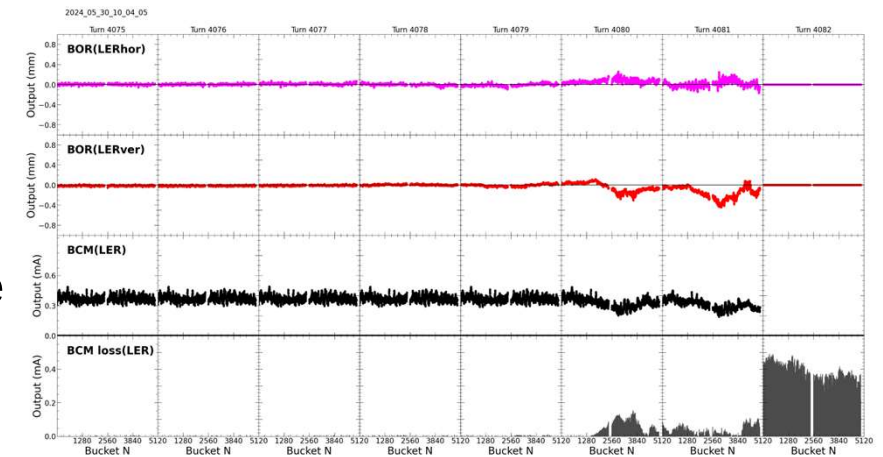
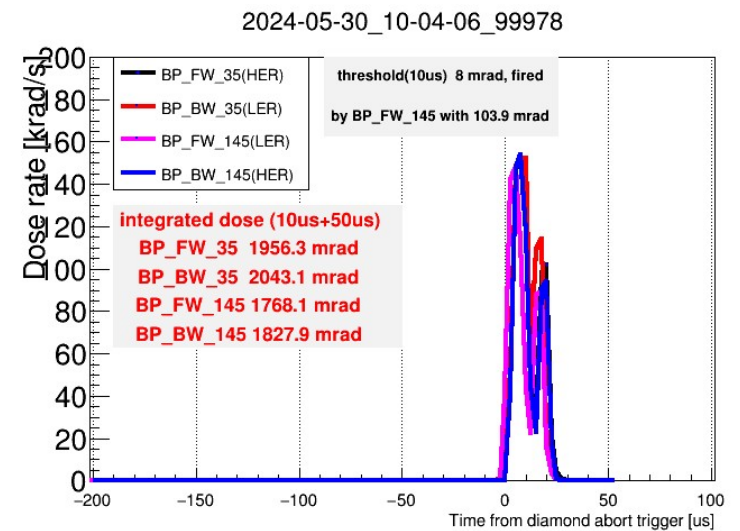
- SBL with pressure burst was observed during the knocker study at the wiggler section and LM abort with pressure burst at the grooved beam pipe.
- In particular, the beam pipe with clearing electrode was highly suspected because a large number of SBLs were observed with pressure burst in the wiggler section where the beam pipe with clearing electrode was installed.

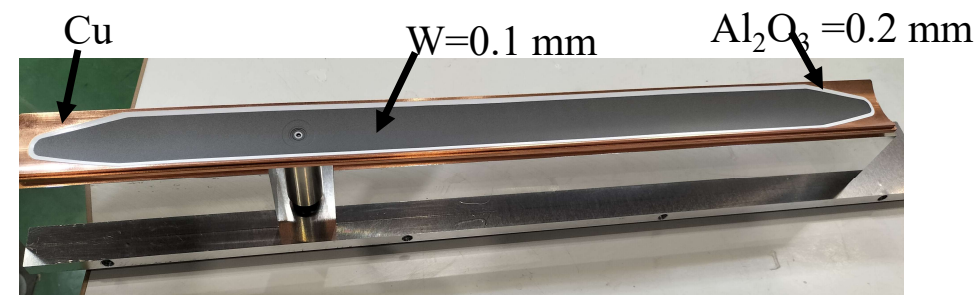
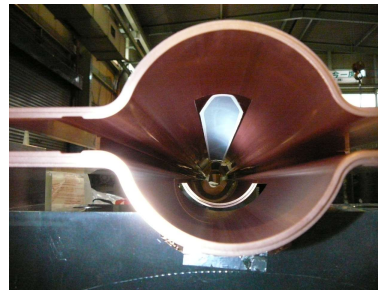
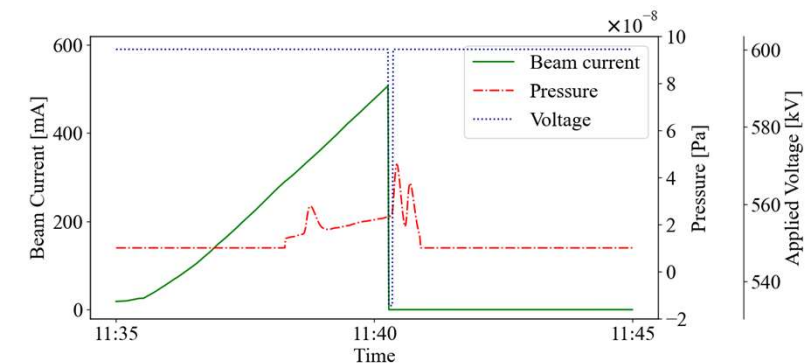
- The magnitude of the vacuum burst is not particularly proportional to the magnitude of Beam Loss.
- We checked the current dependence by knocking. At low currents, even if an abort occurs, it did not reach SBL.
- We tried applying voltage the cleaning electrode to prevent SBL, but the results were the same with no-voltage case.

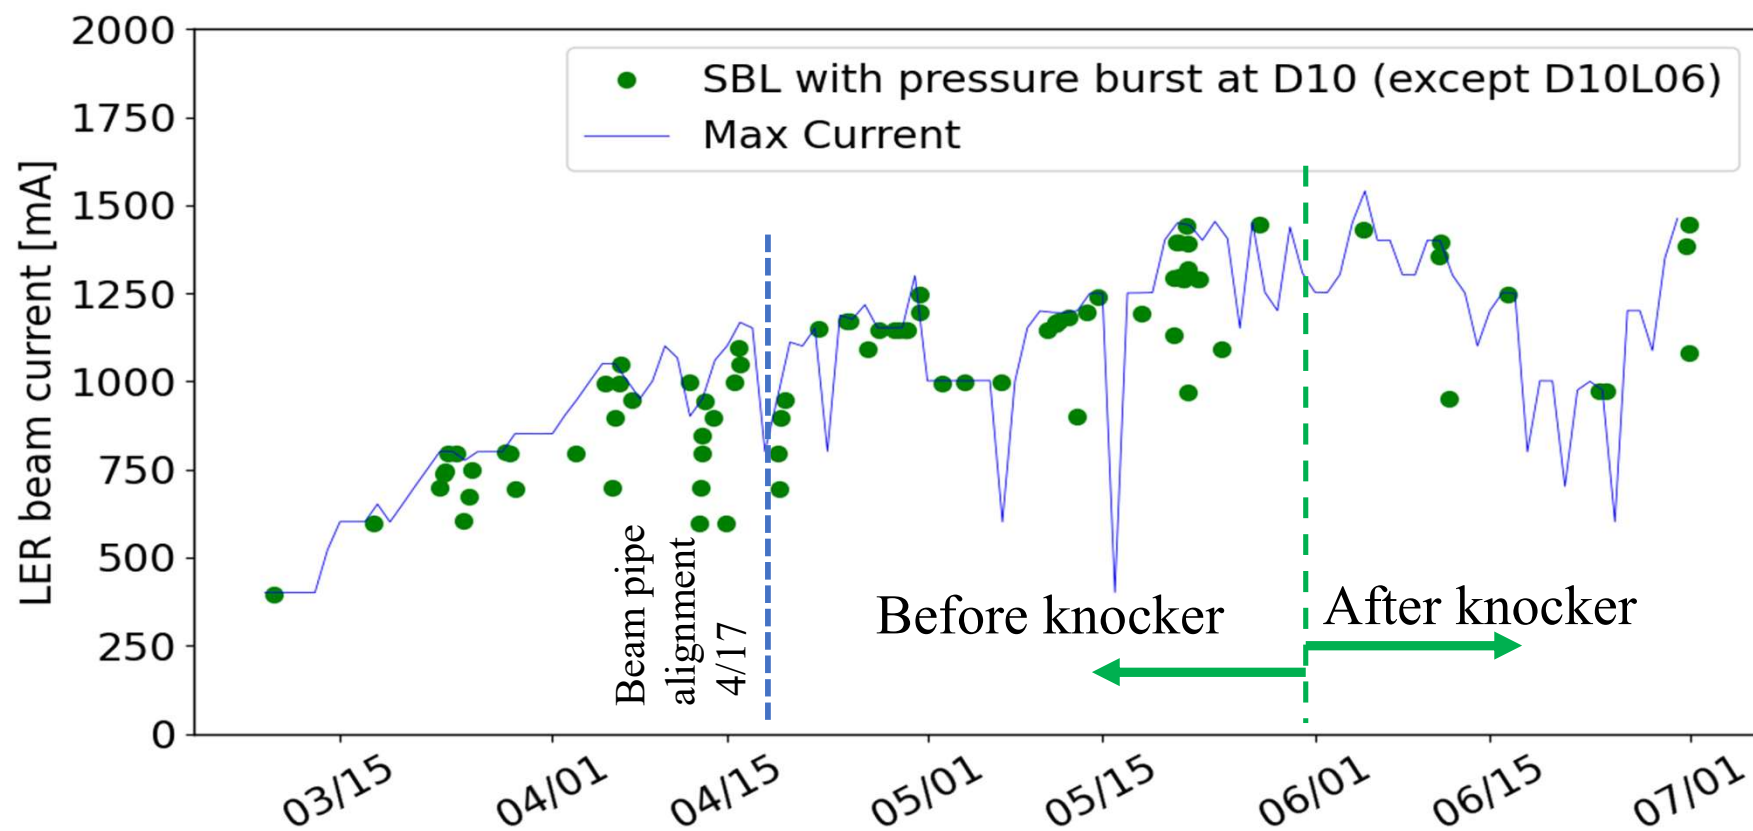
If the SBL is caused by dust falling into the beam pipe, it is best to knock it off when there is no beam. The D10 Wiggler section was knocked on a maintenance day. The number of SBLs decreased after that, but did not completely disappear.

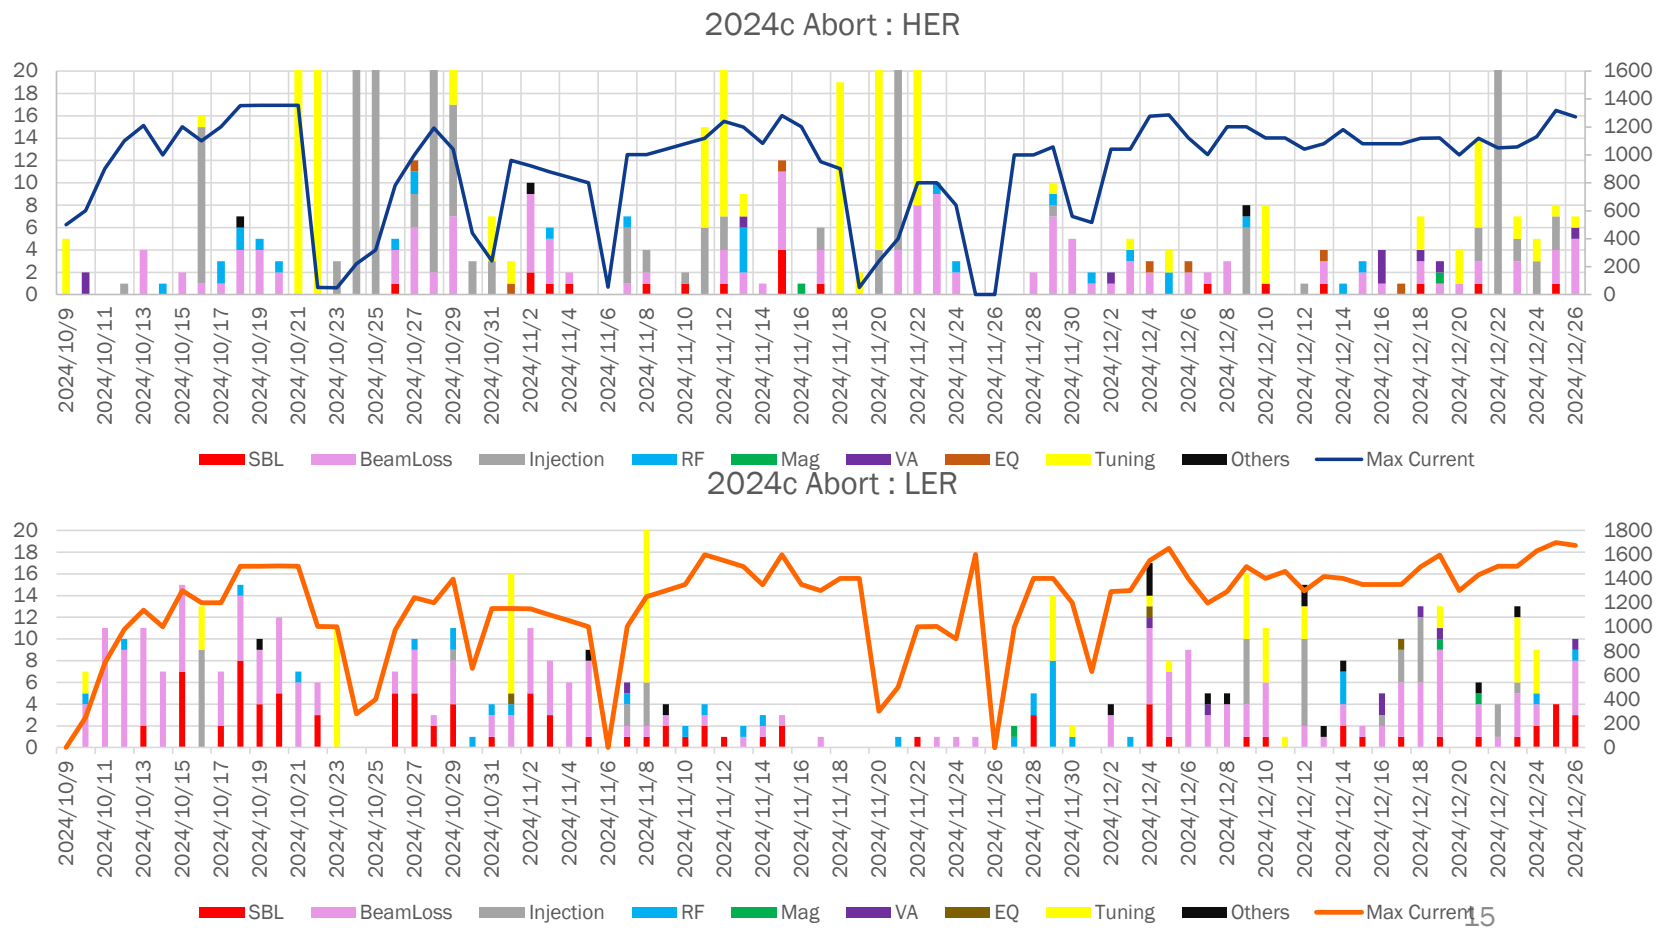
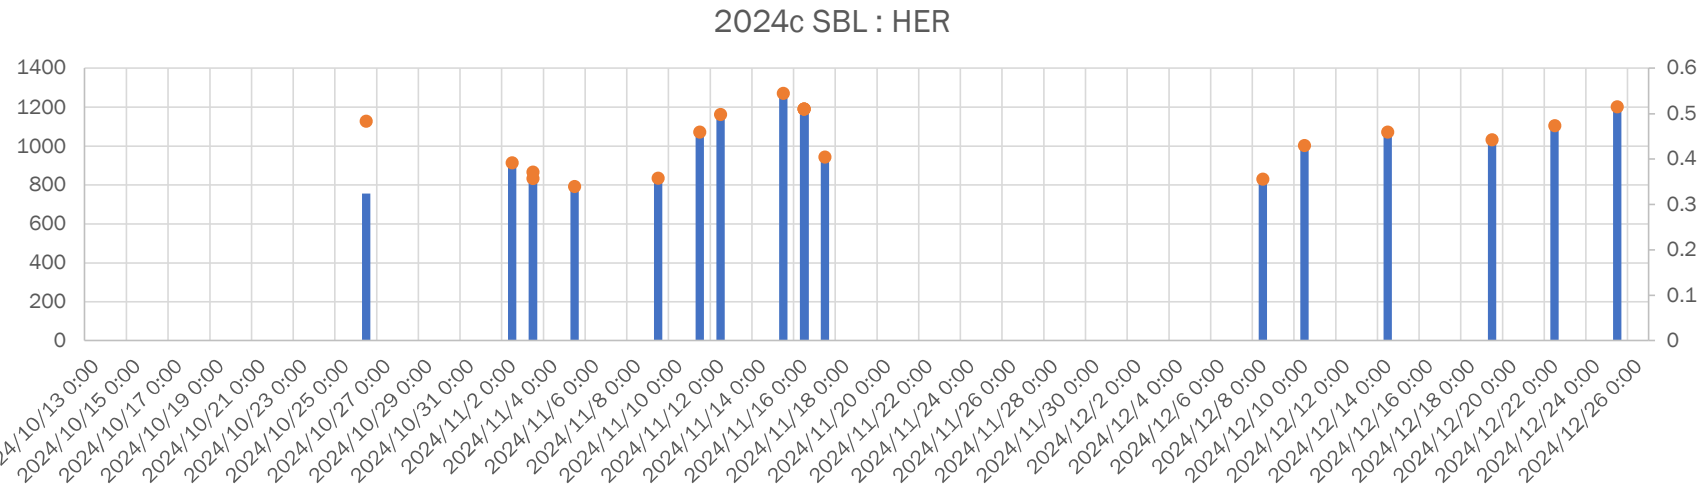
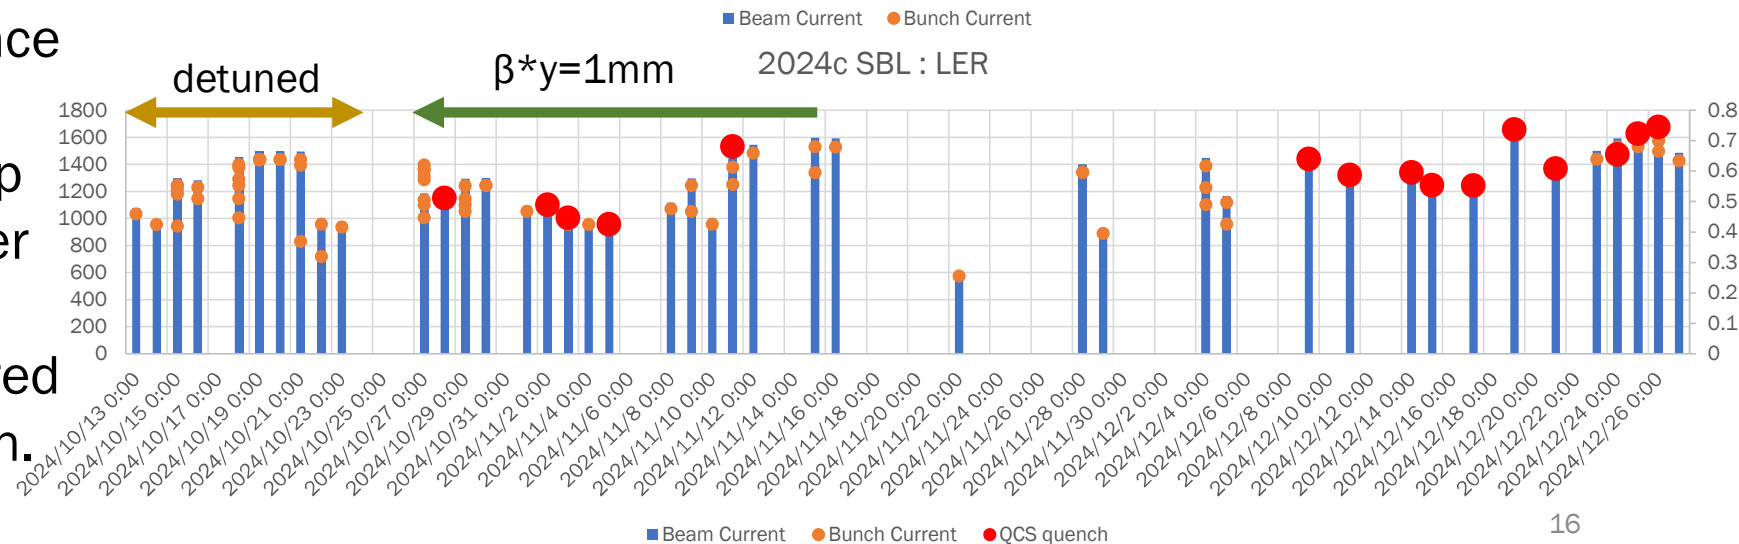
- HER 19
- LER 95
- QCS Quench 15

- SBL still occurs primarily in the LER.
- Current dependence is seen.
- During the start-up period, the number of SBLs was increased compared to the previous run.

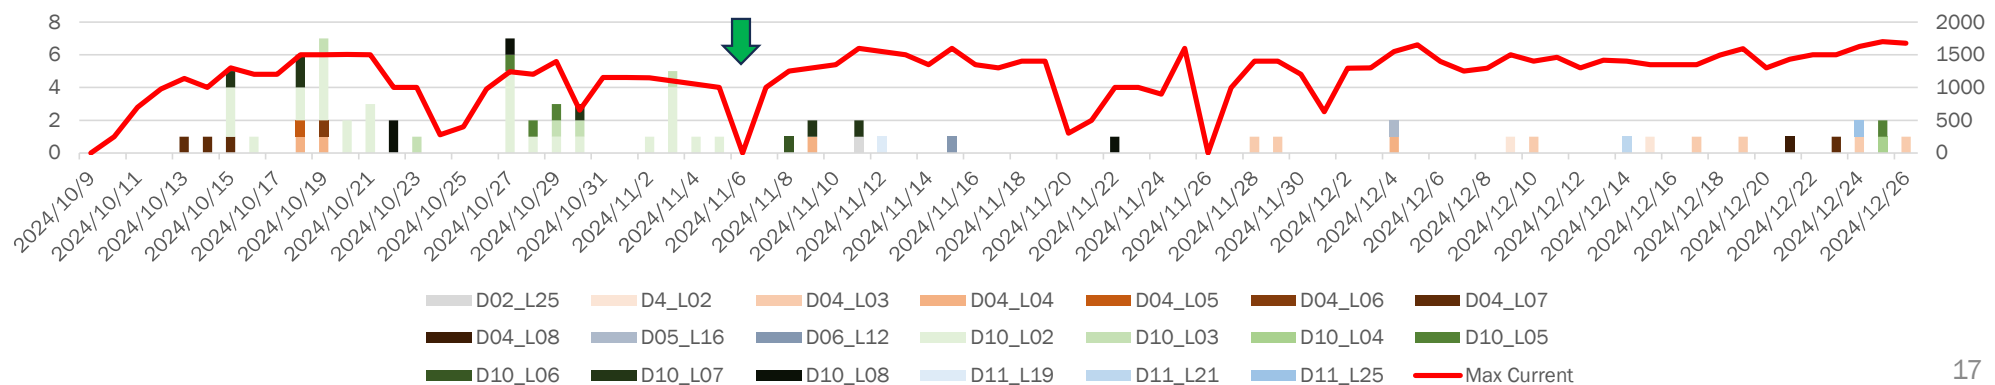
Pressure Burst with LER SBL

- There are many SBLs with pressure bursts at **D10L02/L03**. This place was opened to check the inside during the summer shutdown.
- 11/16**: Opened the bellows between L02 and L03 and found the black stain.
- After replacing the bellows and clean up the beam pipe, SBL with D10L02 or L03 pressure burst has not been observed.
- The main component of the black stain in the beam pipe was silicon, and since the main component of the vac seal is also silicon, this black stain is considered to have originated from the vac seal.

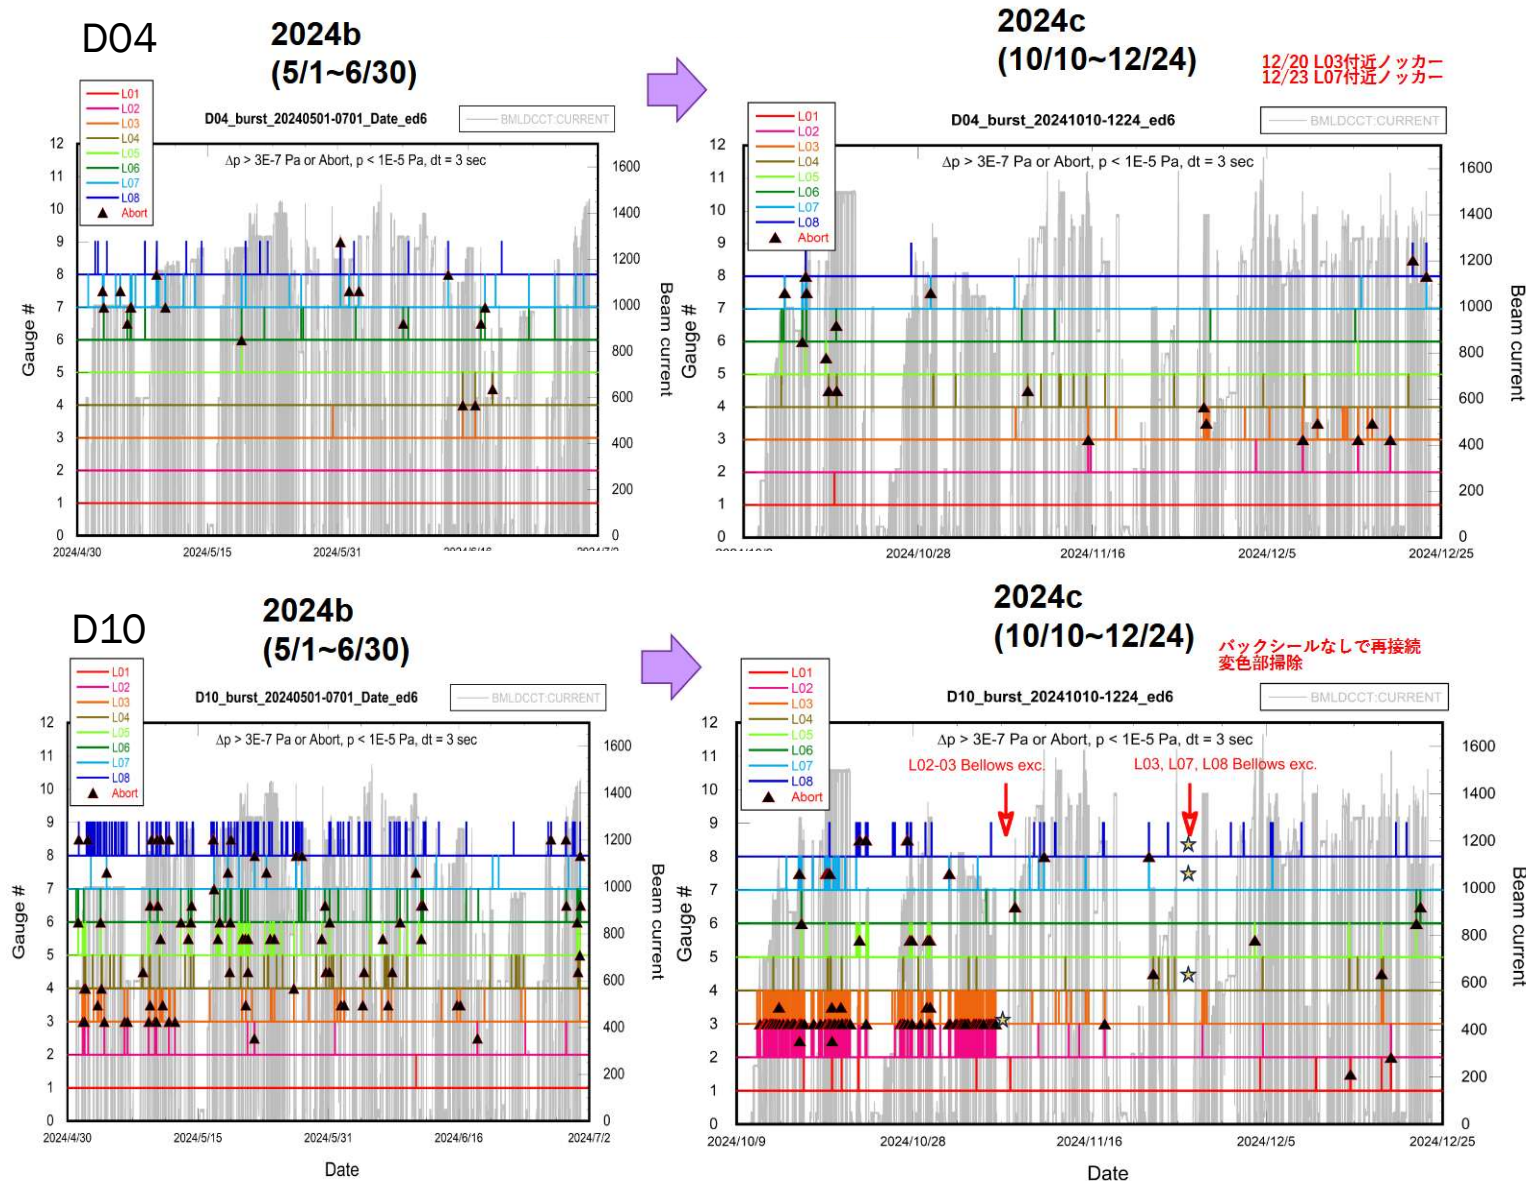
- Pressure bursts and beam aborts that have not reached SBL are checked.
- It shows that the effect of overturning the beam pipe is not clear.
- The effect of bellows replacement is obvious.

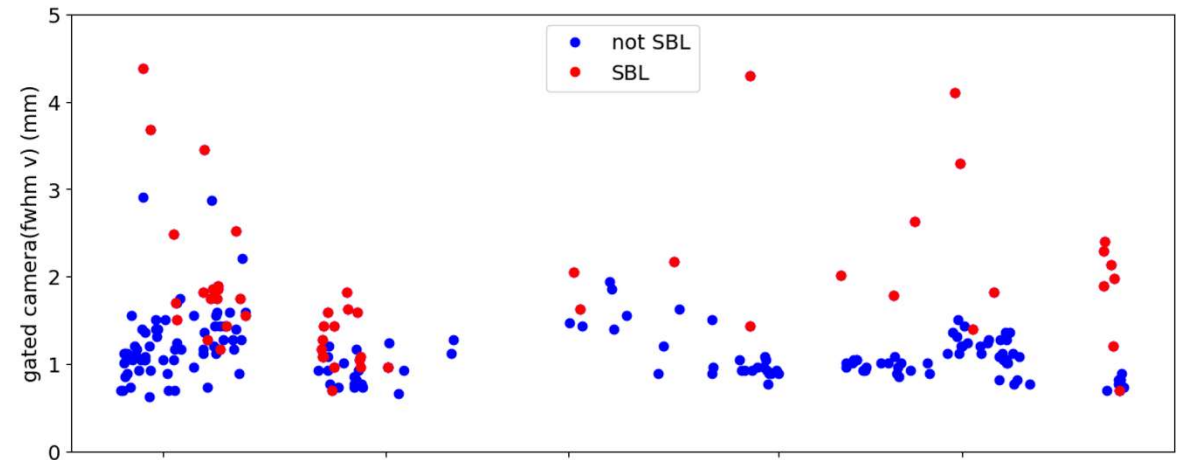
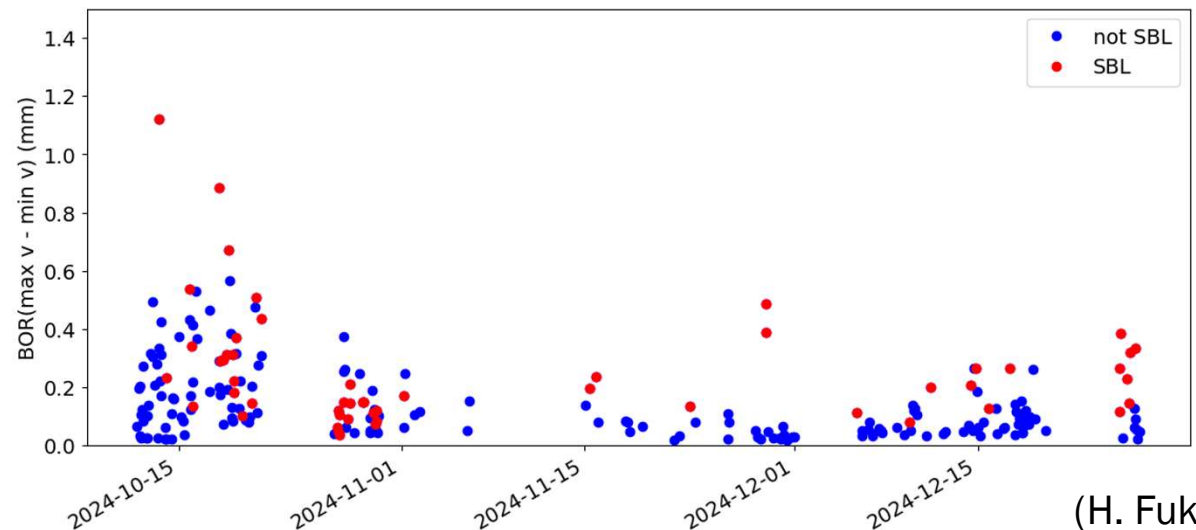
Beam Size @ SBL

- We measured the beam profile at that time of SBL using three types of cameras, and the results were consistent, with the size increasing compared to other aborts.
- The beam size increase is larger than the beam orbit change, and it looks increasing for each bunch from the streak image.

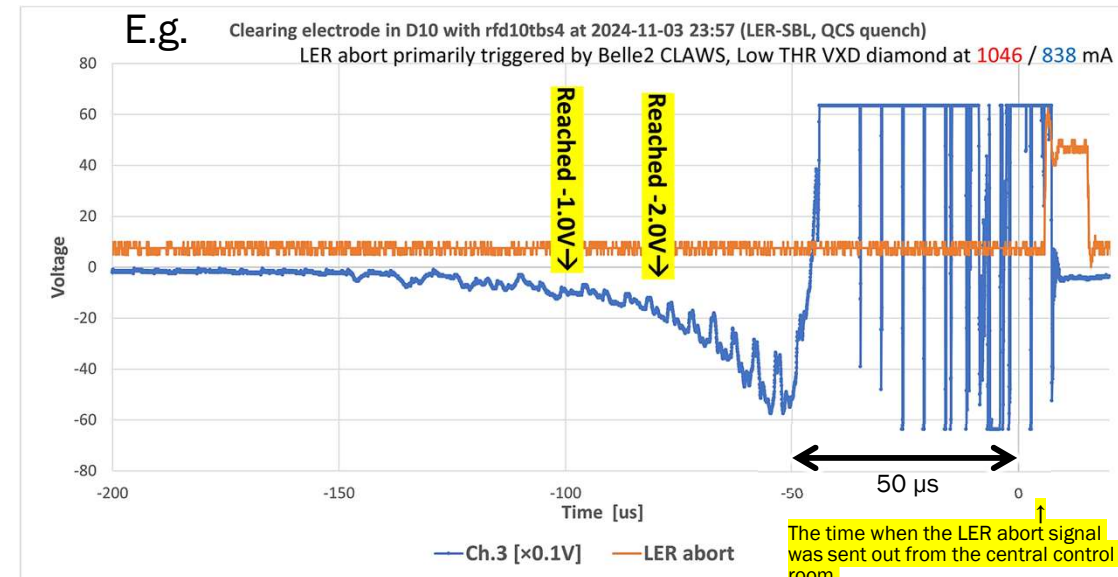
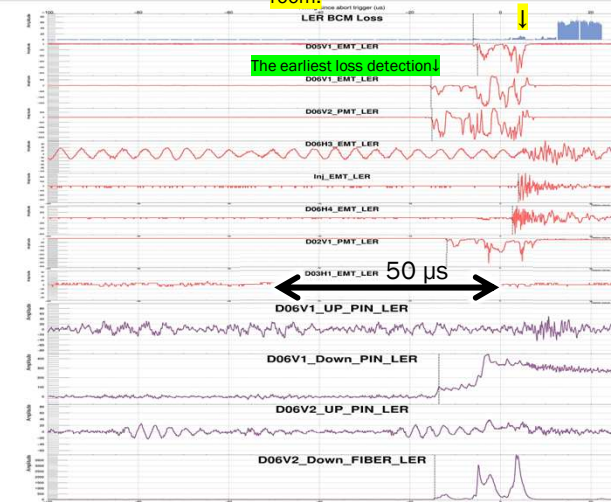
Discharge Signals from the Clearing Electrodes in D10 (@ SBL)

- We connected twelve of the clearing electrodes in D10 to the ground via 50Ω, then the voltages across the resistors were measured with oscilloscopes.
- At 38 LER aborts during 2024c, we detected significant voltages which should be a result of discharge at one of the clearing electrodes. 15 of the abovementioned 38 LER aborts were SBLs.
- Such voltages were never observed at more than one electrode simultaneously.
- The polarity of the detected voltages is negative and/or positive.
- Any LER abort with such abnormal voltage detection was accompanied by vacuum-pressure burst detected at the nearest gauge.
- In some events, the bunch-train structure was seen.
- In some events, the discharge signal appeared earlier than any beam-loss detection.
- We will try to simulate such events using CST.

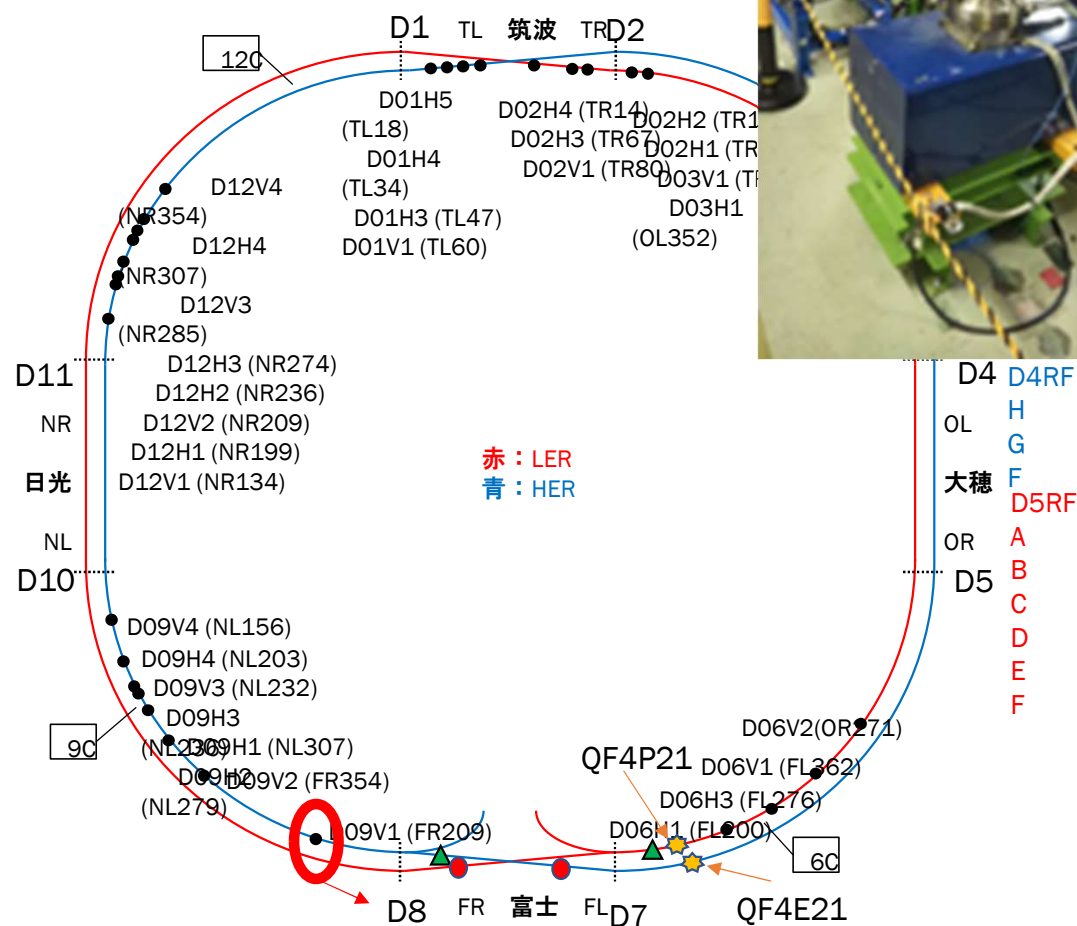
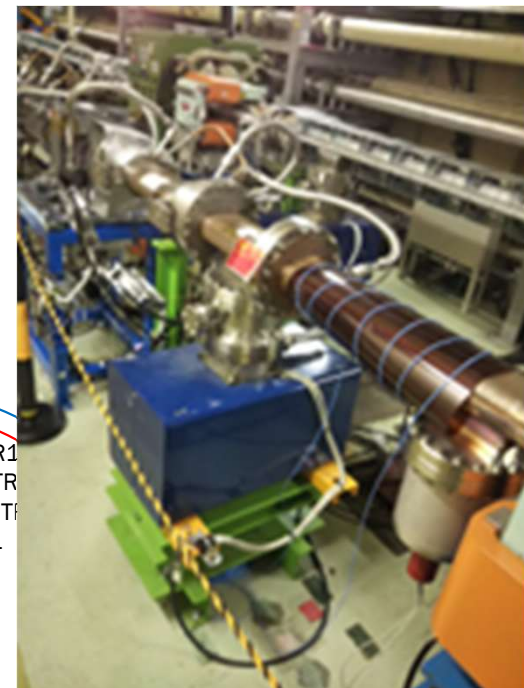
HER : LM (Optical Fiber)

- Starting in 2022, we introduced an LM using optical fiber near the LER D6V2 collimator and built a system that sends the abort trigger to the CCB as quickly as possible, and it is useful.
- Therefore, we decided to introduce a similar system to HER, and installed an optical fiber LM on D9V1, the most upstream of the HER collimators.
- The original loss monitor signals are collected in D10, so it can be sped up by going through D8.

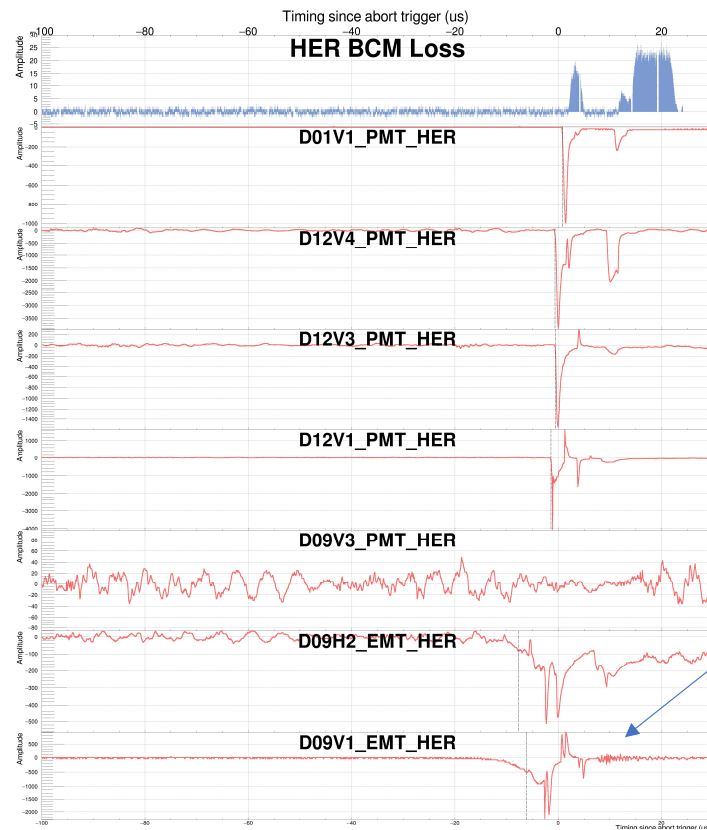
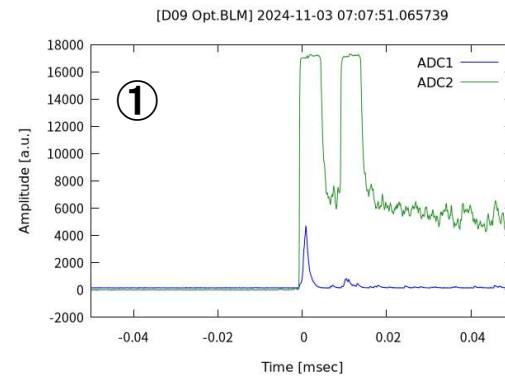
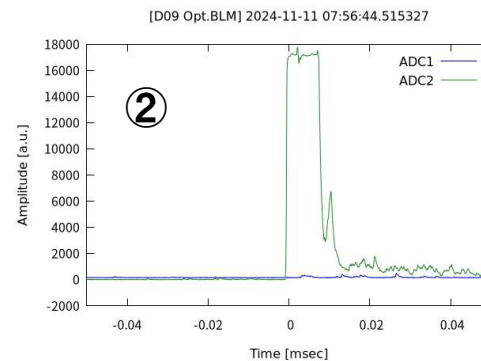
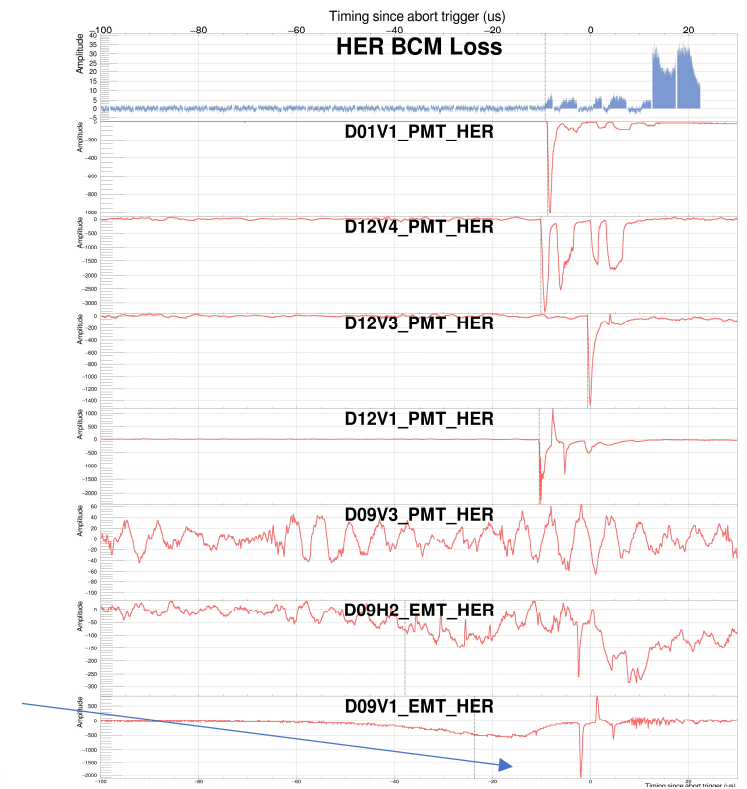
- ① HER SBL is triggered 13/18 times by optical fiber, especially useful because it is triggered earliest (6/13) for events with large beam loss.
- ② However, if the beam loss begins downstream from here, nothing can be done.
