Sudden Beam Loss

The 28th KEKB Accelerator Review Committee

2025/1/14 H. Ikeda

on behalf of the SuperKEKB ACC. Group

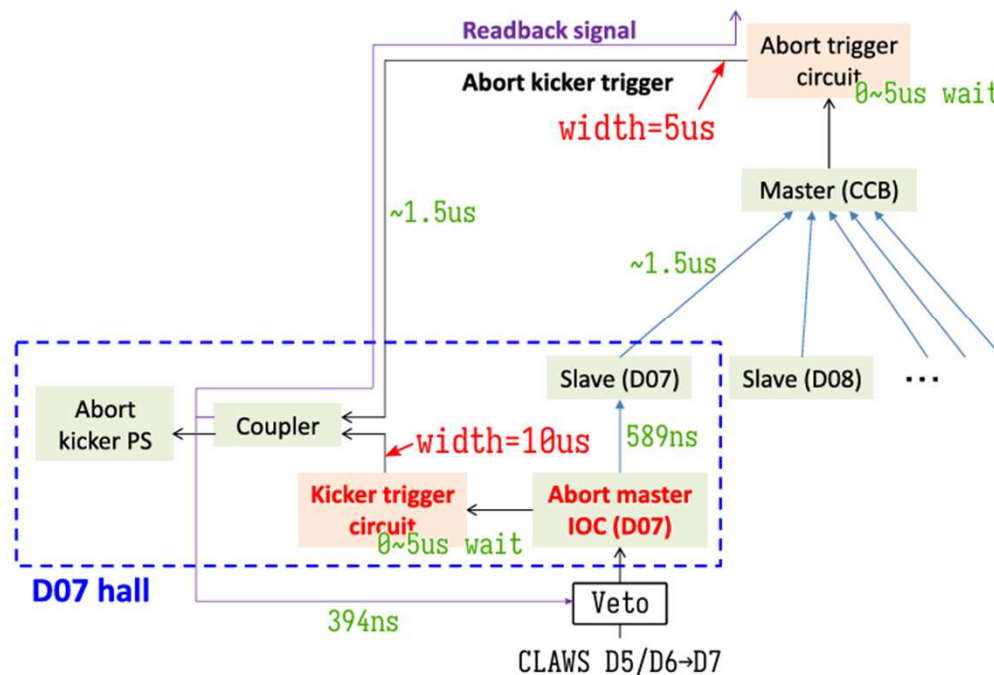
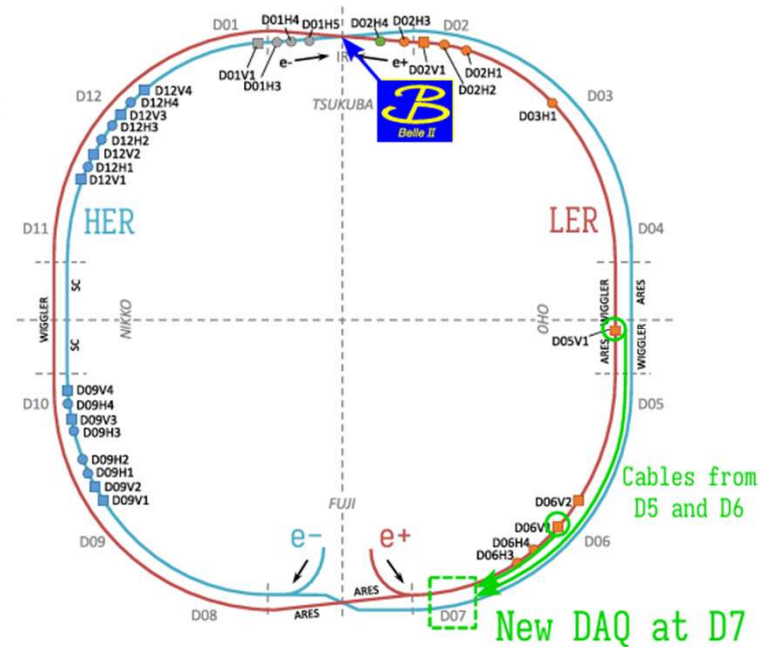
LER : D7 Master

- All abort triggers are collected in the central control building (CCB) and sent to the Abort kicker on D7 after taking OR.
- If we send the signal directly to the abort kicker without going through the CCB, we can fire the kicker faster.
- We introduced D7 Master system which send the LM signal from D6/D5 collimator directly to D7 abort site.
- The D7 Master had the earliest trigger with 16/28 SBLs since we turned it on.

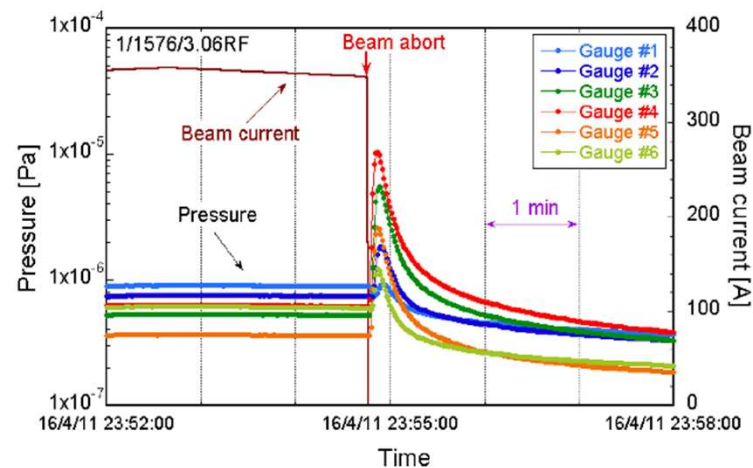
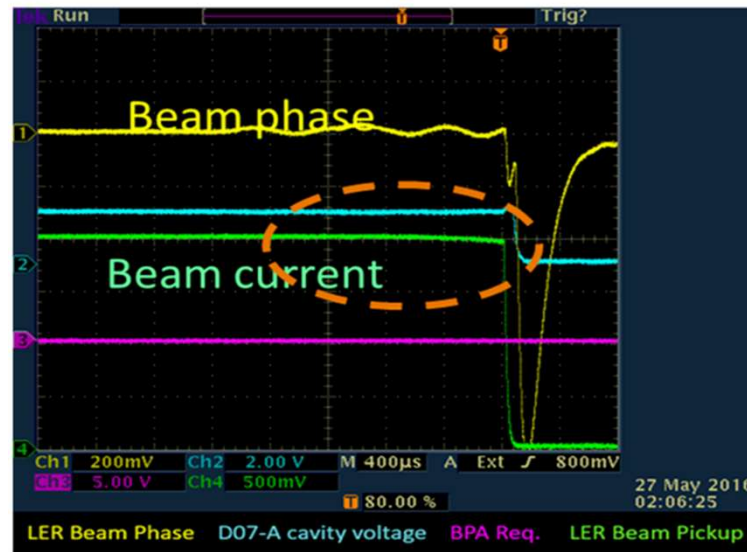
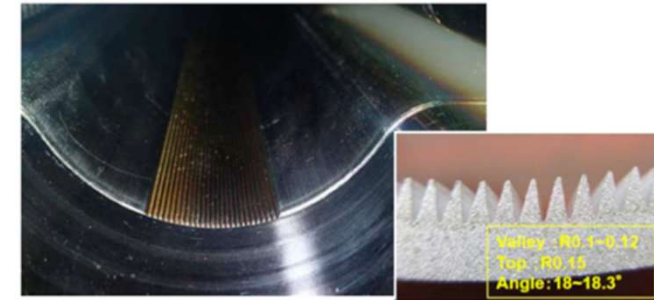
Dust event (our experience)

- At the Phase-1, pressure bursts with beam loss were frequently observed in the LER, which was an obstacle to beam current increase.
 - When a loss monitor was triggered and issued abort, the pressure momentarily jumps to the 10^{-7} - 10^{-6} Pa range in some parts of the ring at the same time.
 - The beam was lost over several 100 μ s, and oscillations in the beam phase were observed.
- Estimating the location of pressure bursts from the CCG indications, most of the pressure bursts occurred in the vicinity of the grooved aluminum beam pipes in the bending magnets.
- The beam current at which pressure bursts occurred increased with the maximum beam current at that time. The frequency of pressure bursts tended to decrease after a while of operation at the same maximum beam current (aging effect).

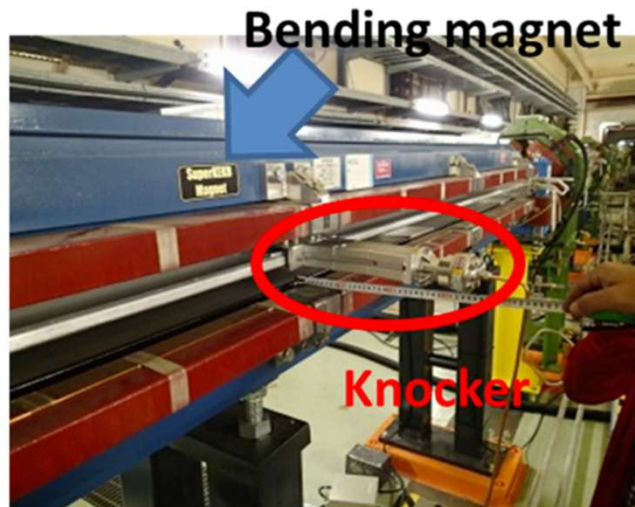
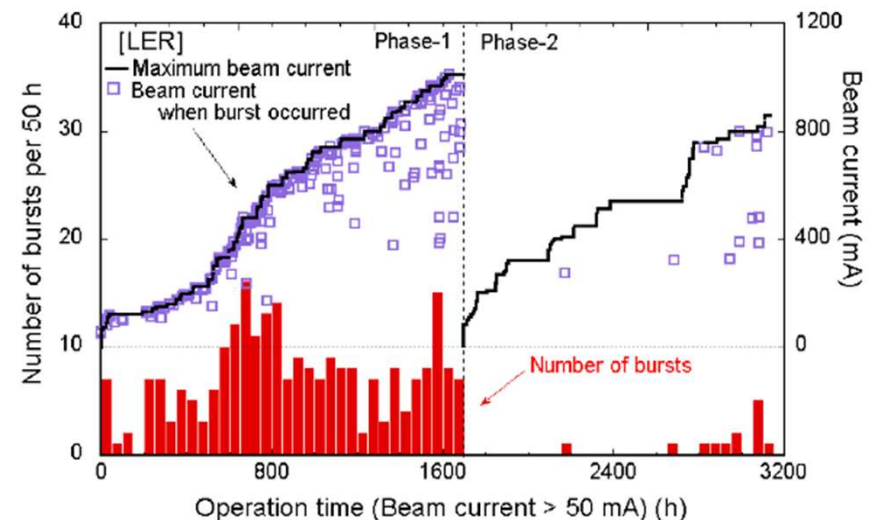
Dust event (our experience)

- We speculated that this phenomenon was caused by dusts trapped in groove structures falling into the beam. To verify this, a knocker was installed in the LER beam pipe.
- When this knocker was operated during beam operation and the beam pipe was struck, the above phenomenon was reproduced.
- As a countermeasure for Phase-2 operation, the grooved aluminum beam pipe was knocked around with a knocker during the shutdown period. As a result, the frequency of pressure bursts with beam loss was dramatically reduced.
- However, the frequency of occurrence has not been reduced to zero. Then, sometimes dust events occur even at low beam currents.

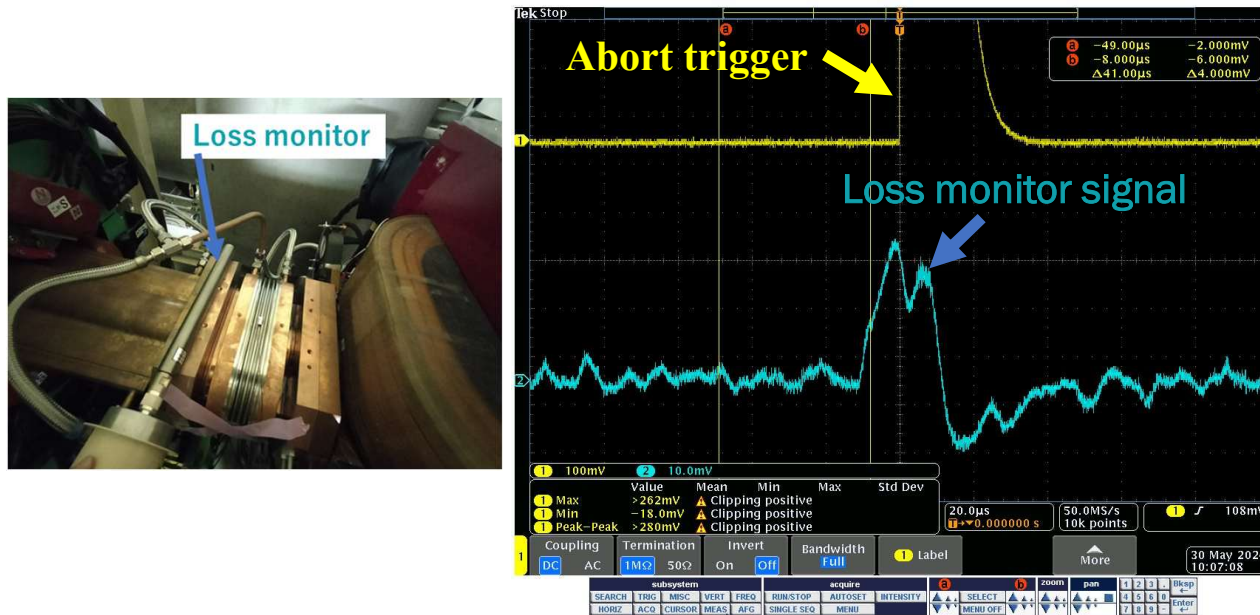
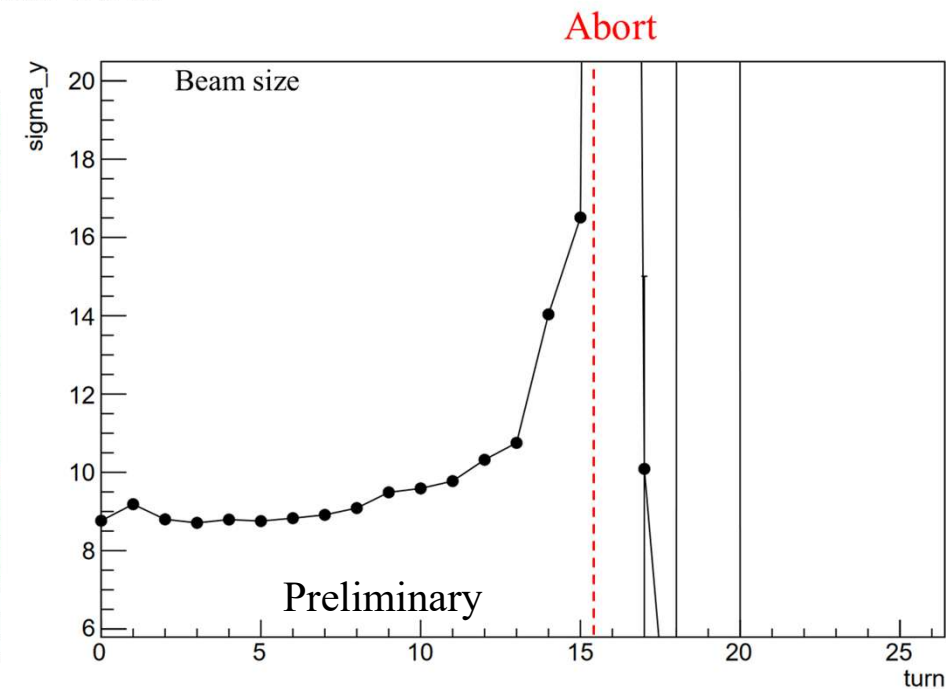
- When the knocker study was performed at the wiggler section, losses were observed downstream of the knocker installation.
- An increase in vertical beam size was also observed. This beam size increase was not observed during manual abort.

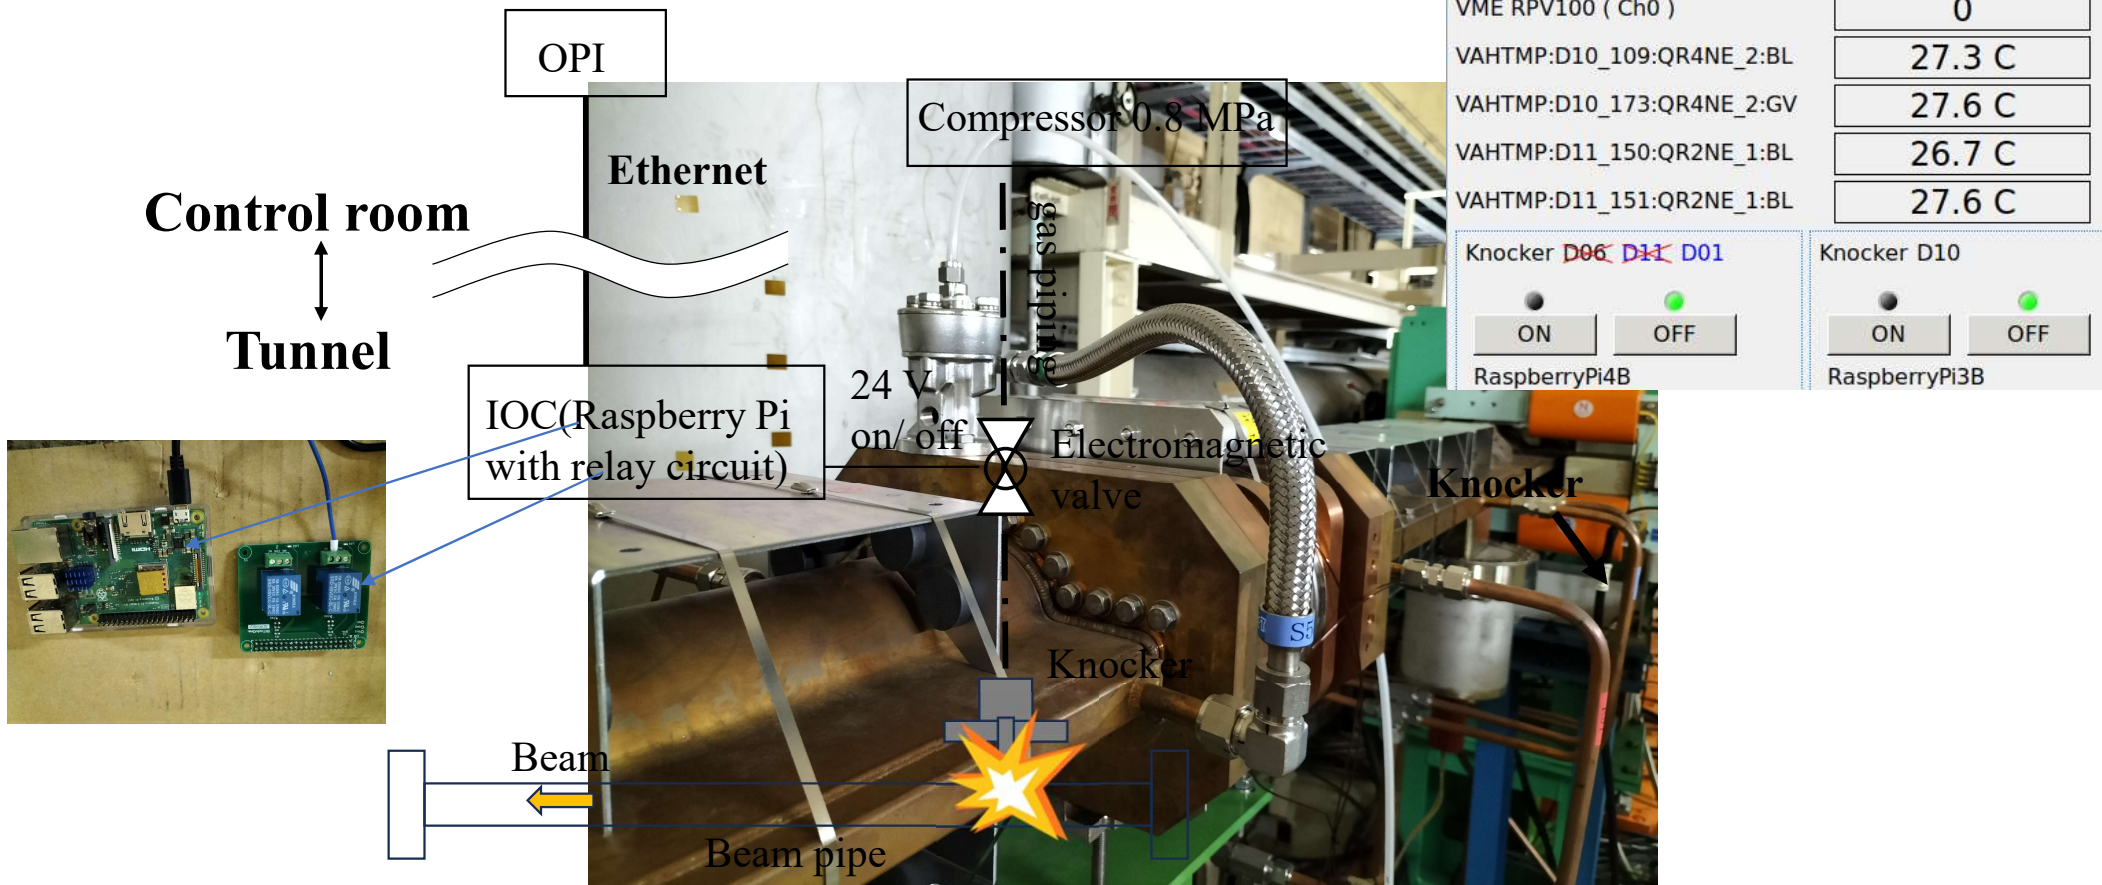
Aluminum beam pipe with grooves

Beam was aborted on the knock count =3.
However, it was not an SBL.
Pressure burst observed.

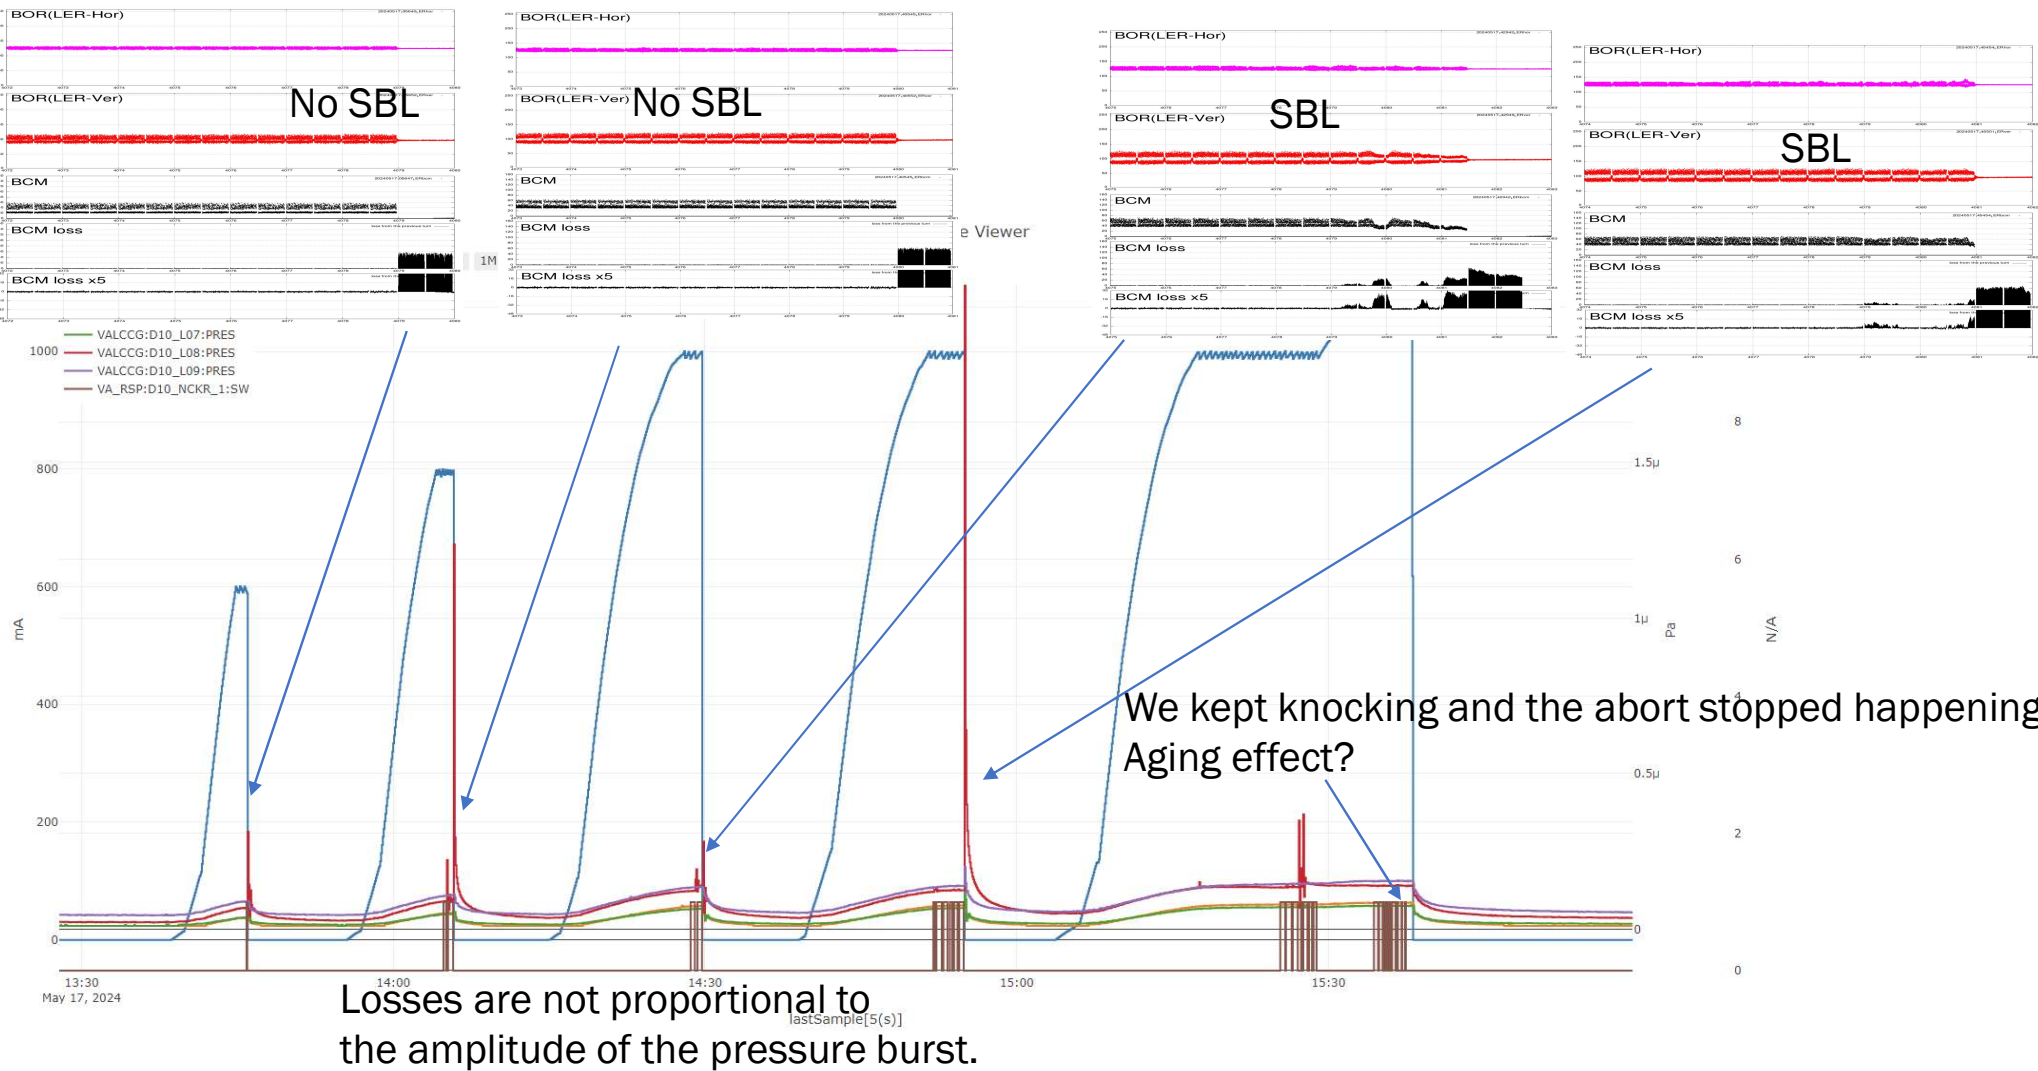
Beam pipe with clearing electrode in D10 Nikko Wiggler section

There seems to be a problem with the beam pipe with clearing electrode, so the vacuum group investigated in the experimental room with test-chamber (Chamber with electrodes taken out from tunnel at LS1).

Dust from chamber gotten by knocking was sent for chemical analysis, but no tungsten was detected in the dust.
