Vacuum

The 28th KEKB Accelerator Review Committee
14th January 2025

Mu-Lee Yao
On behalf of KEKB Vacuum Group

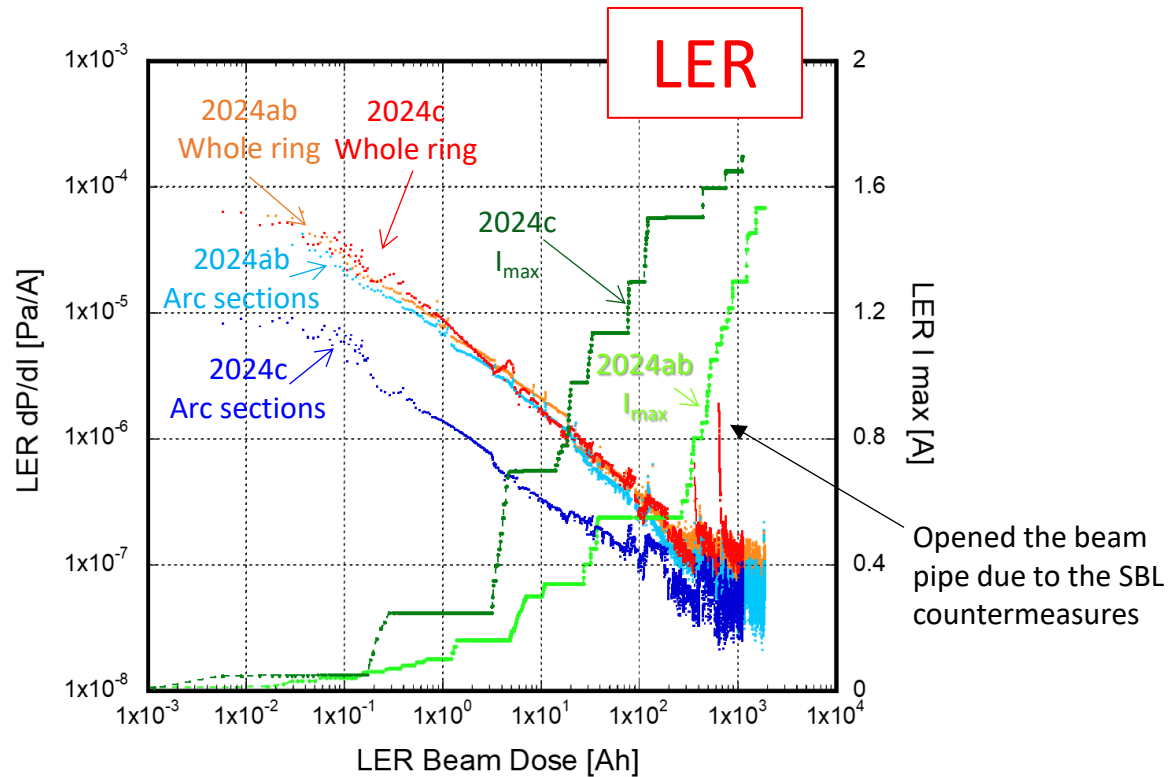
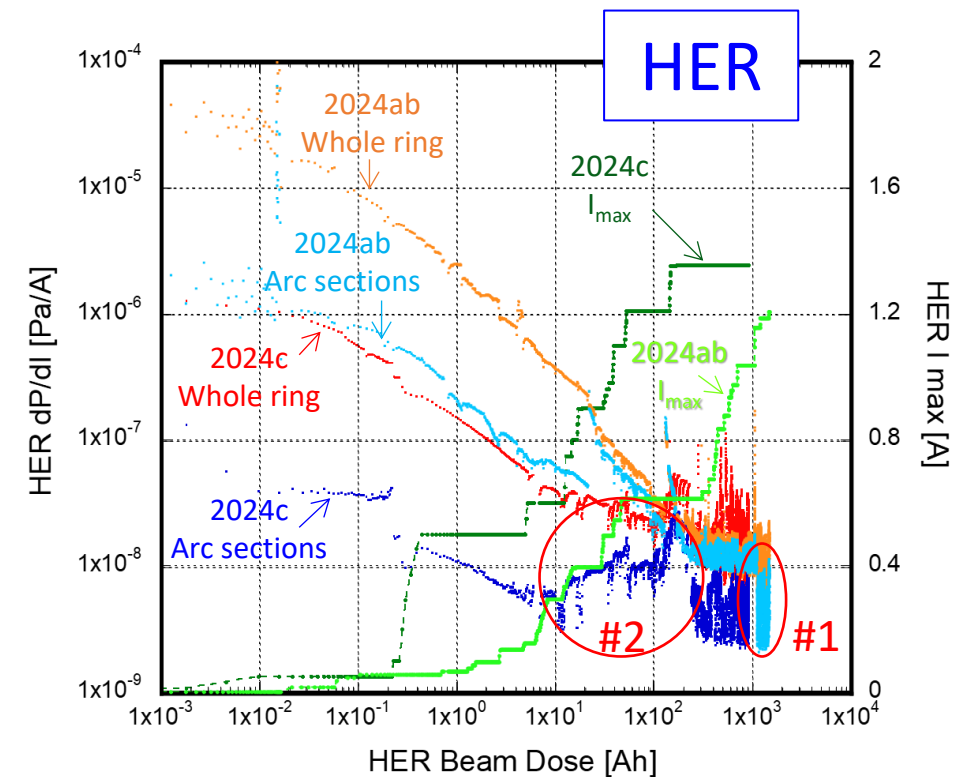
- #1 Pressure of gauge D09_H25 decreased after maintenance day (5/29). The cause remains unknown
- #2 Abnormal pressure rise near D09V3: The collimator was opened a little to reduce the pressure.

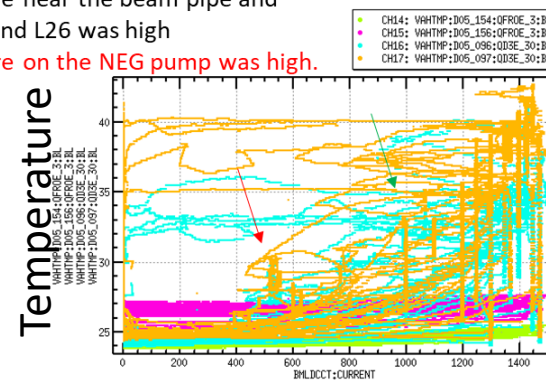
Temperature on the NEG pump was high.

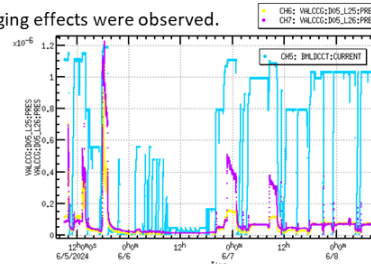
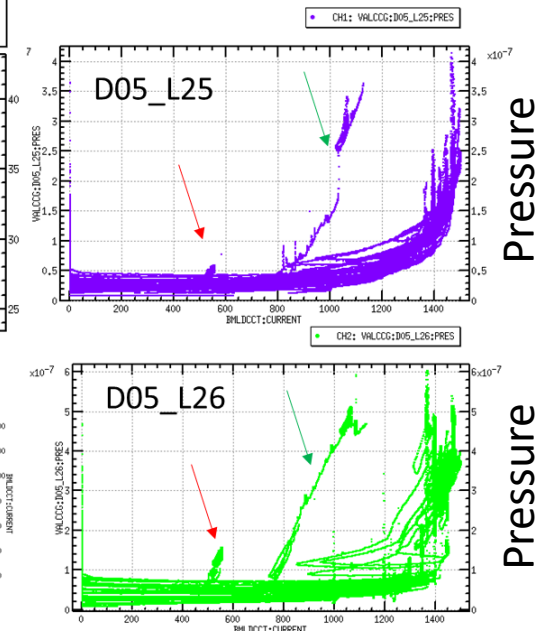
- The temperature and pressure increases are dependent on the number of bunches. At a certain beam current, the pressure rises sharply. Occasionally, L26 exhibits pressure spikes during injection. Aging effects have been observed.

Aging effects were observed.

- Gaskets with small holes (RF shielded) were installed on nearby ion pumps (D05_L25 and L26) in the summer shutdown.

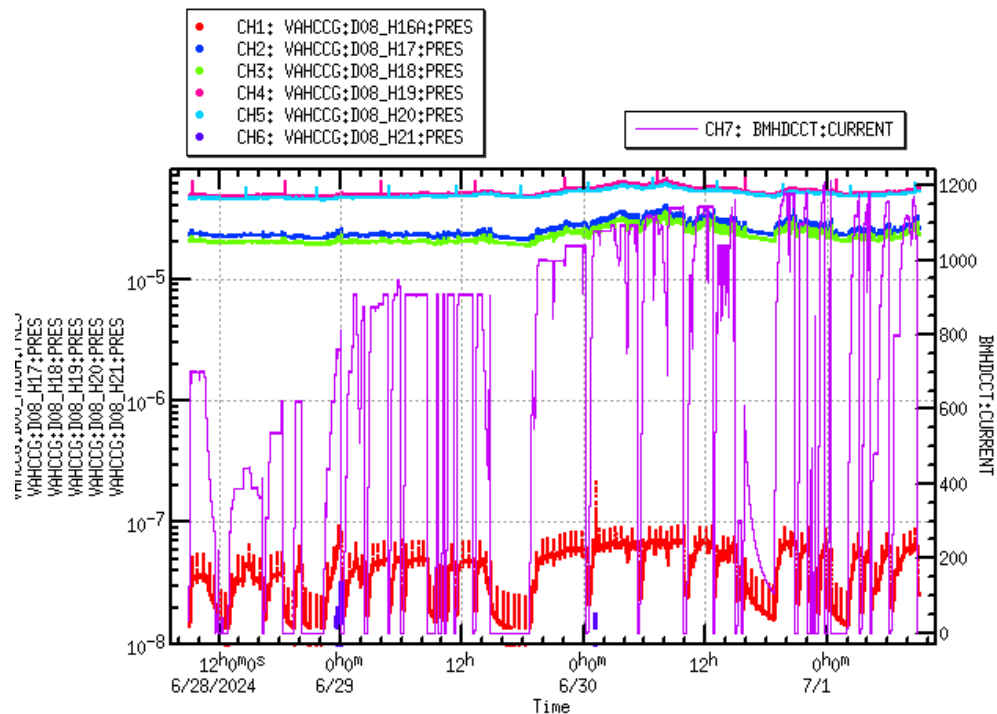
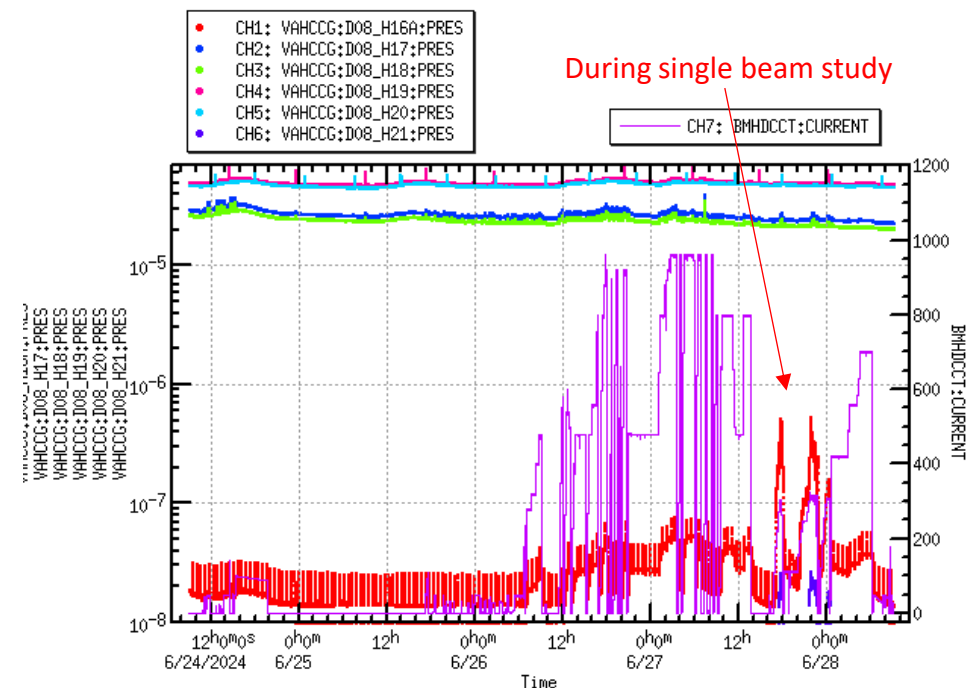
CCG D08_H16A, H21: Vacuum gauges near the septum in the MR section.

- During single-beam studies with a small number of bunches and high bunch current, the pressure rises sharply.
- The behavior depends on the number of bunches.

(CCG D08_H17, H18, H19, H20: Pressure in the septum vacuum chamber)

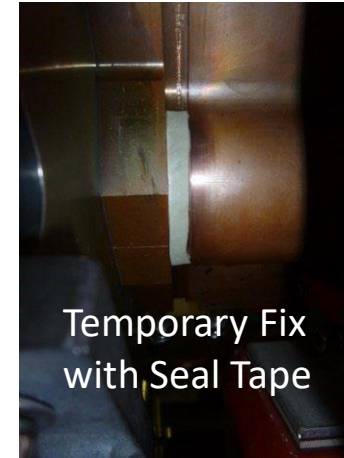
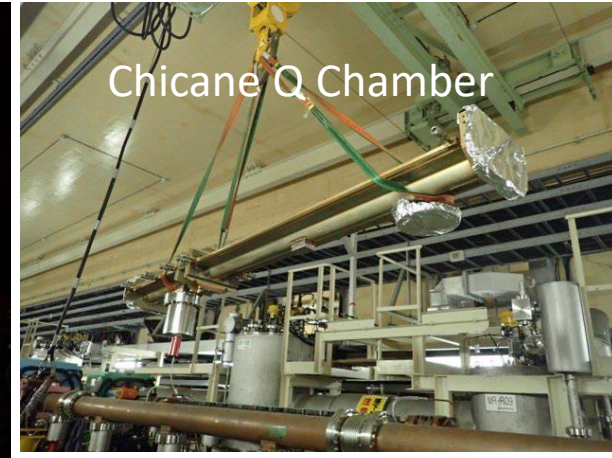
- LER D11 Chicane Q Chamber (QW5NRP) was replaced with new one.
- Beam Pipe Inspection and Cleaning:
 - D10 Clearing Electrode Beam Pipe: Interior was inspected and cleaned.
 - D04 Clearing Electrode Beam Pipe: Flipped upside down and cleaned. 13/16 beam pipes outside the Oho concrete shield were flipped.
- Result of inspection:
 - D10: No obvious damage to the electrode. Some dusts at the bottom of beam pipes.
 - D04: No obvious damage to the electrode. Black traces of (probably) burnt VACSEAL were found inside near most of flanges. Severe traces were cleaned before restoring.

D10: VACSEAL was used for sealing flange as before.

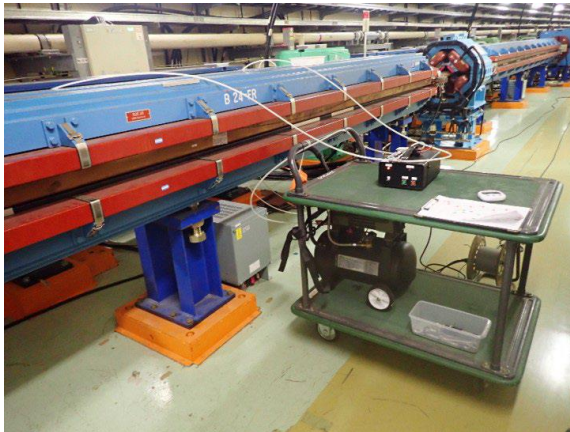
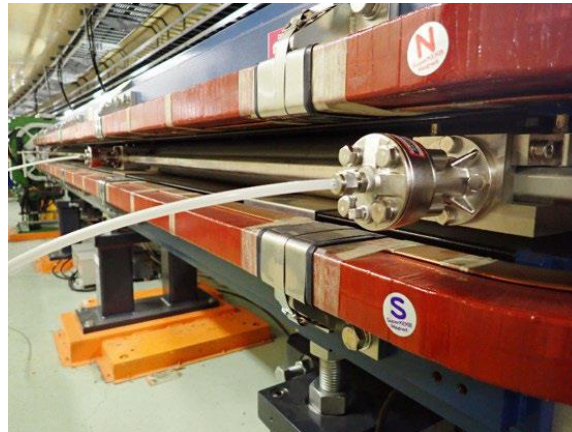
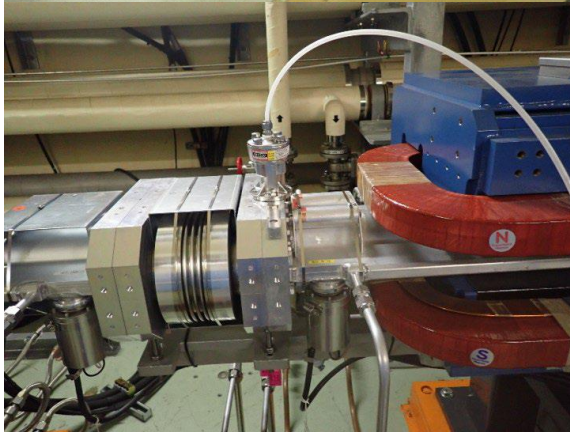
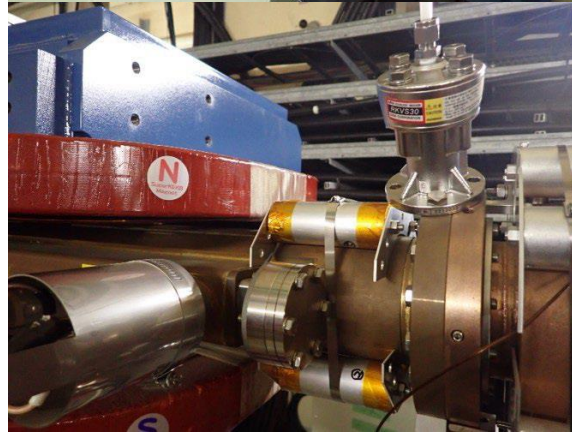
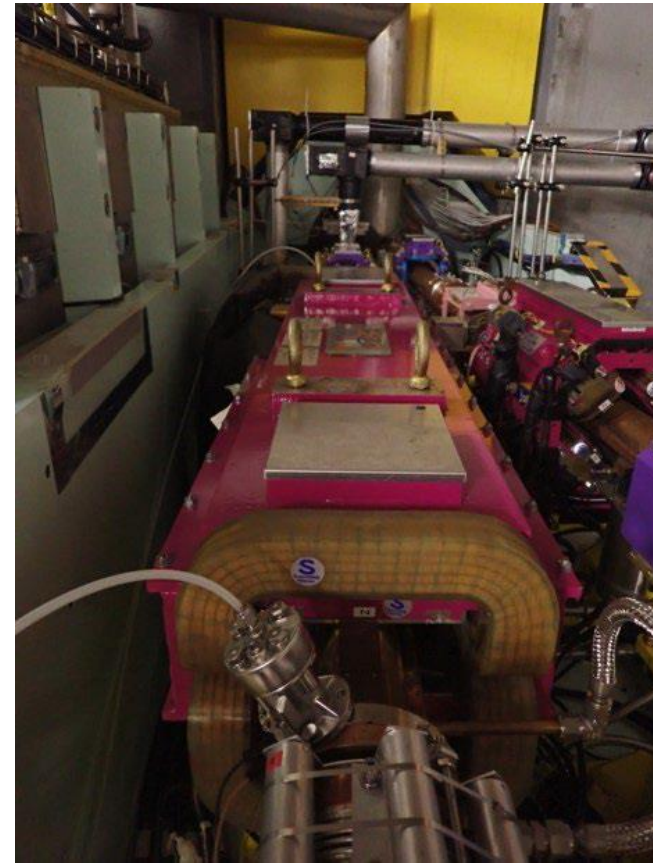
- Beam pipe Knocking: try to reduce the dust/beam interactions
 - Beam pipes were struck using the knocker, including all groove-type beam pipes and clearing-electrode beam pipes around the ring.

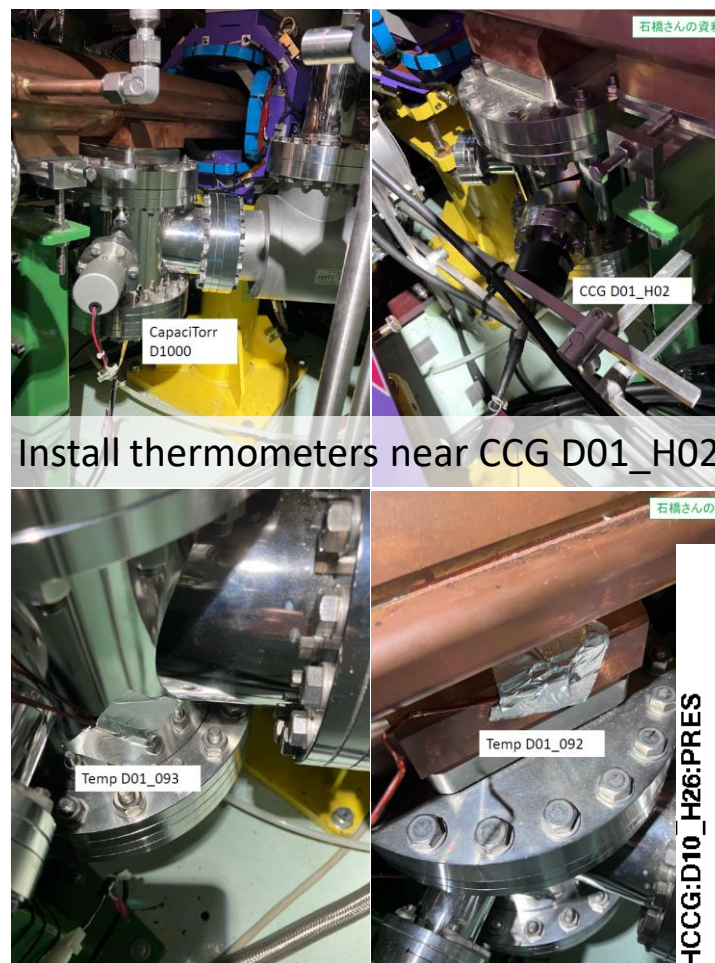
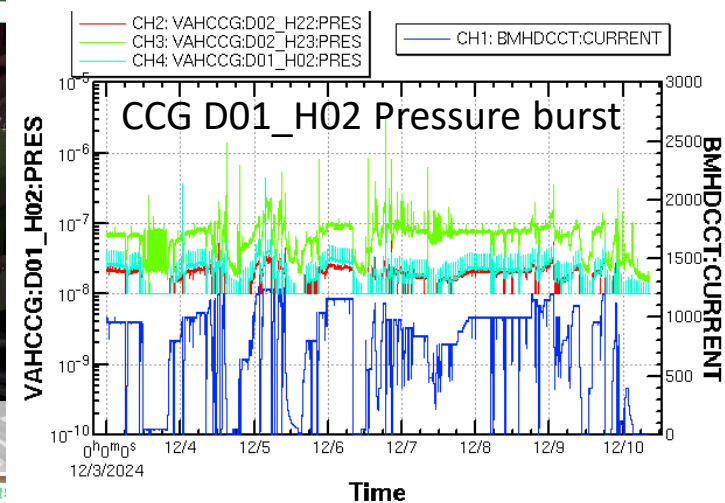
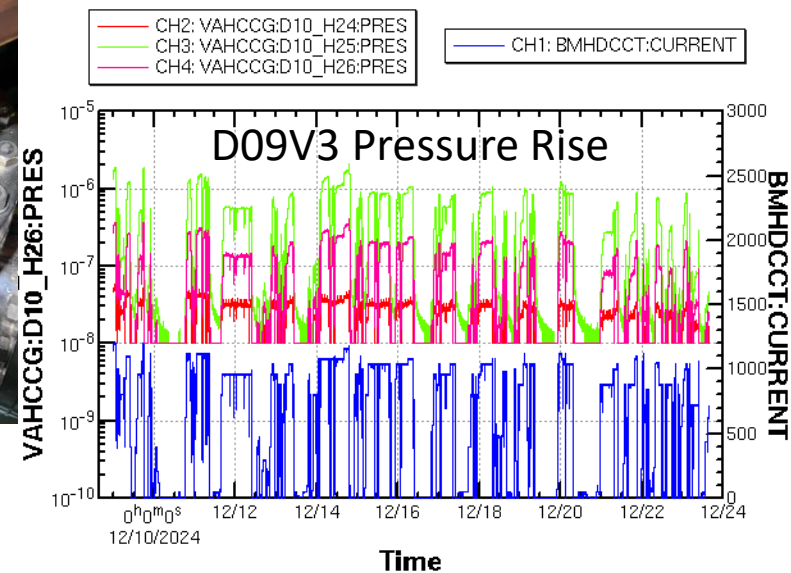
- Pressure bursts near IR region
→ Install thermometers near CCG D01_H02
→ No suspicious findings
- HER D05_H19 Wiggler Vacuum Leak (from connection flange)
→ Stop by additional flange tightening
- D09V3 Pressure Rise
3 RF-shielded gaskets were installed on NEG pumps near D09V3
→ Not so effective

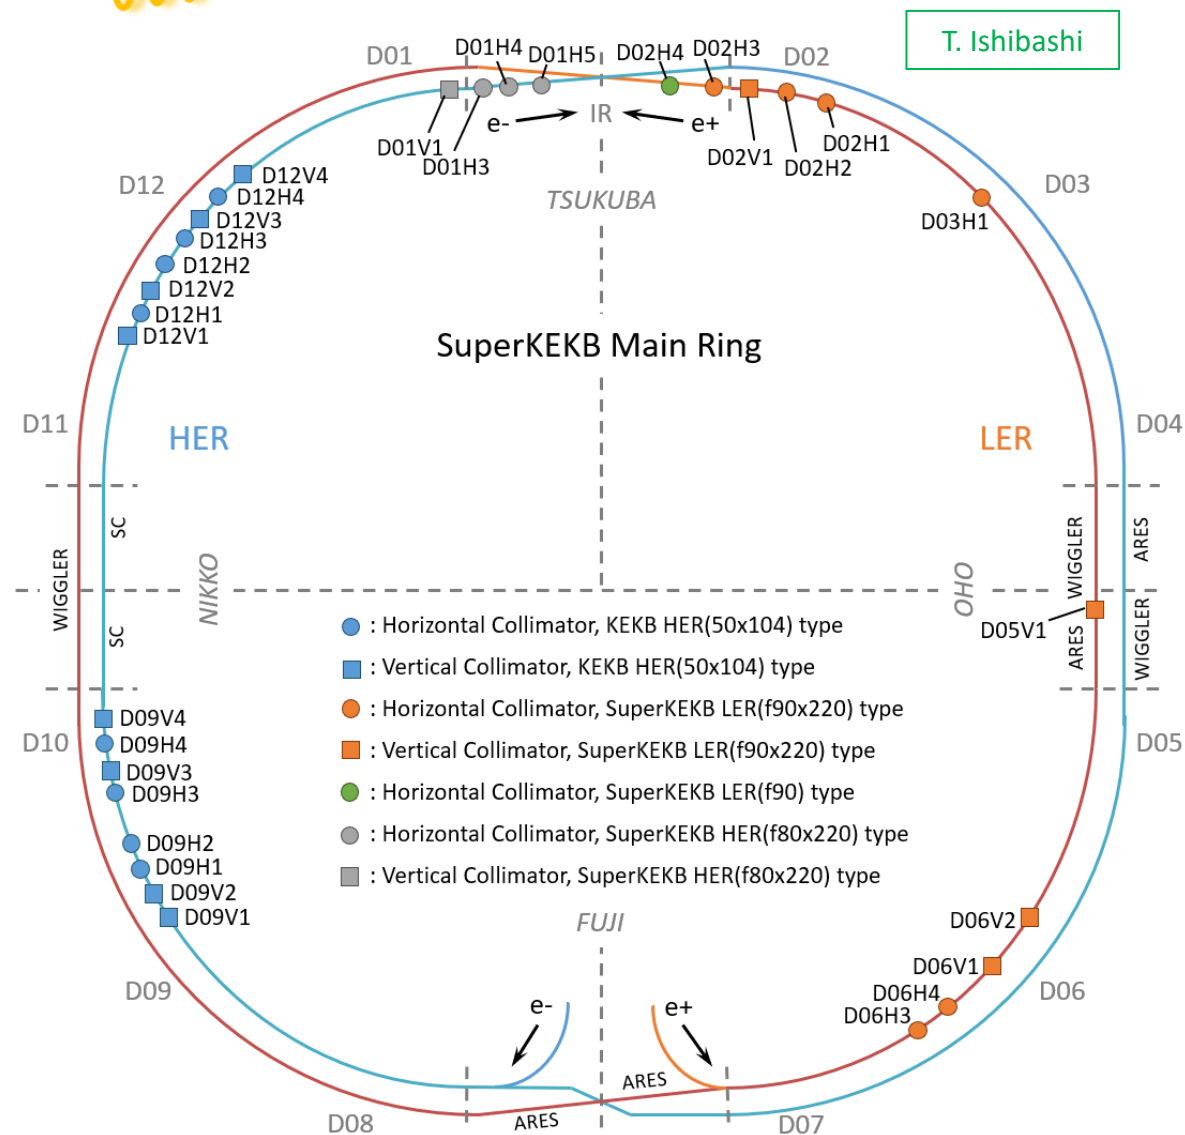
Status of LER collimator after 2024c

- D06H3 and D06H4 work as spoiler and absorber against inj. kicker accidental firings.
- D05V1 was damage.
- All vertical collimator heads are coated with Cu.
- D06V1 was change from Ta (damaged) to Ti (still healthy).
- D06H3. H4: Movement mechanism has become difficult to operate

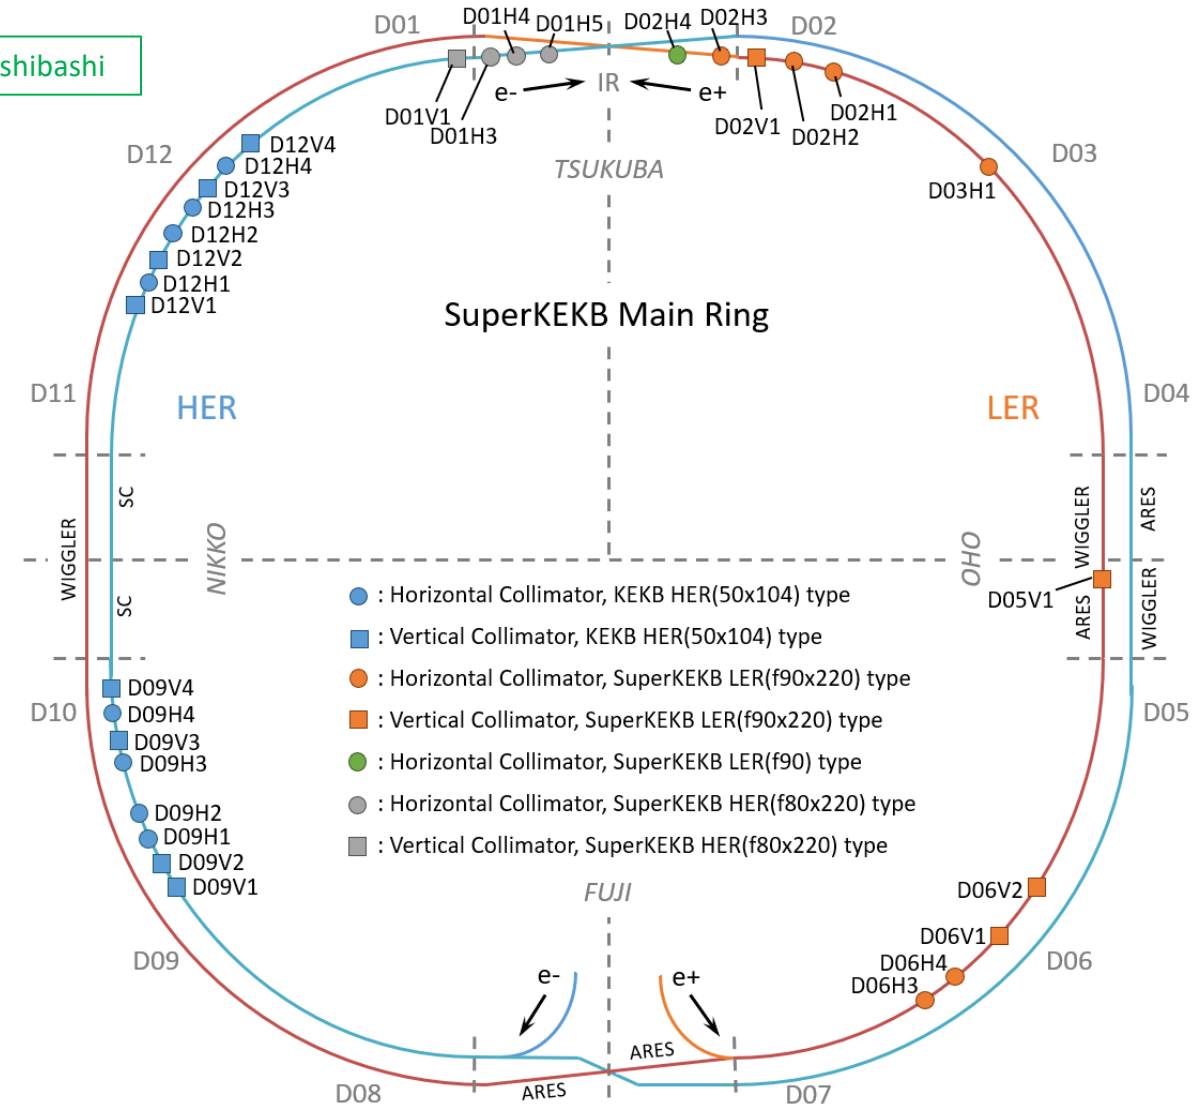
- Drive mechanism of some KEKB-type collimators has been upgraded for precise and stable adjustment.
 - D09V1, D12V1, D12V3, D12V4
