# **KEKB Beam Transport Line Issues**

**2001 February 24**

**Toshihiro Mimashi**

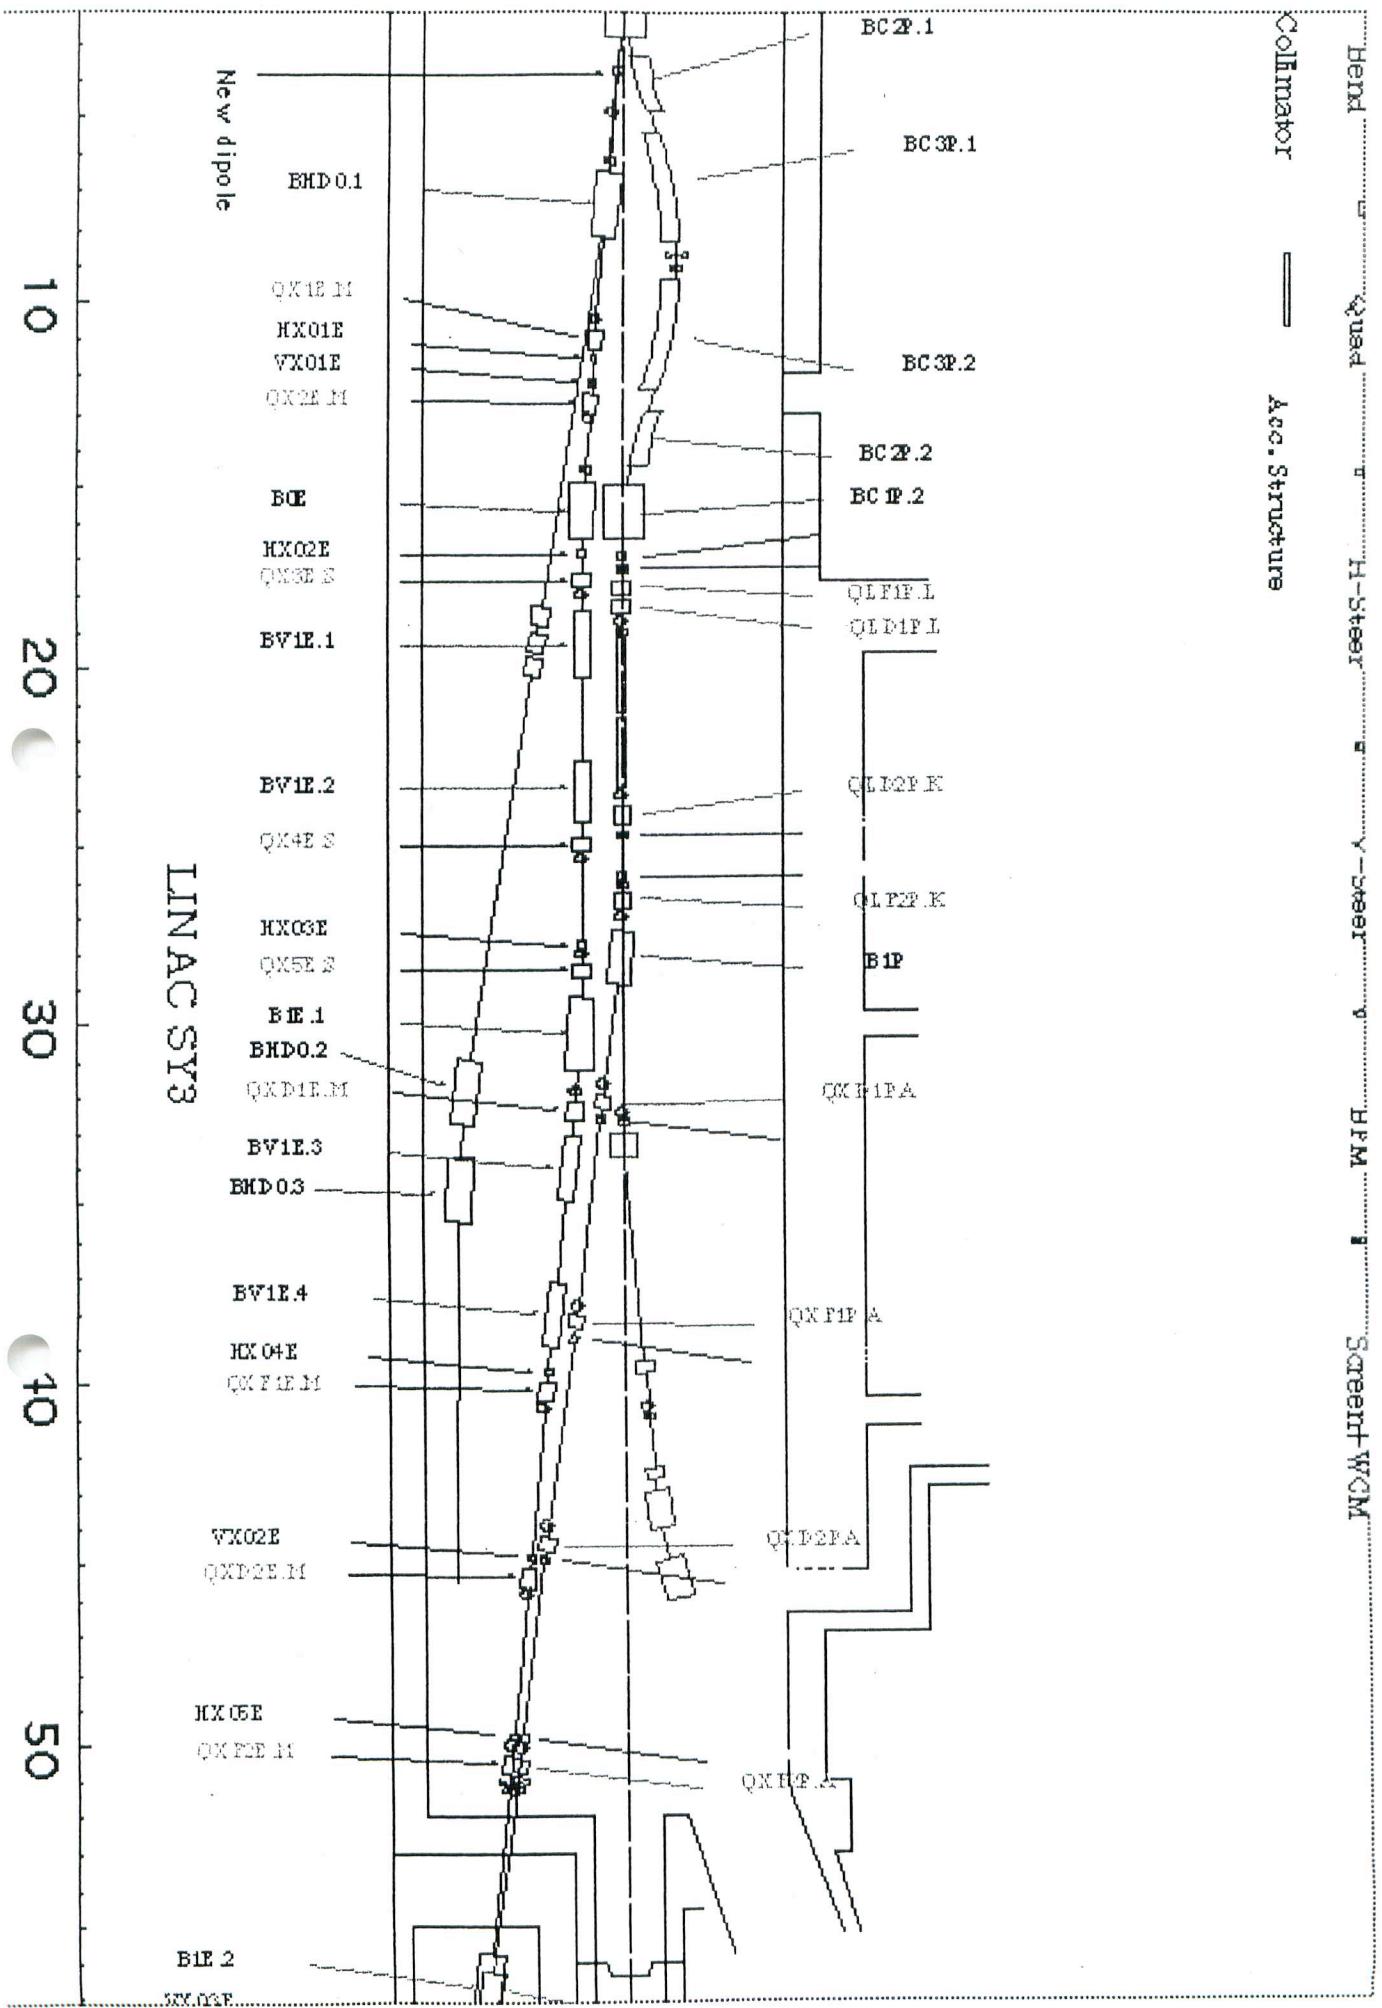
**(5) Poor transmission of positrons stems from the loss of low energy tails at the ECS bends.** To accommodate lower energy particles in the aperture of the bends, smaller bend angle is adopted than the nominal value, which produces 5mm excursion at the center of ECS bends. Since the first bend of ECS is common to electron beam this manoeuvre also generates 10mm excursion of electron beam, which sometimes results beam loss when the energy spread is accidentally large.

**In order to cure this situation we plan to install a small dipole after the first ECS bend, which serves as an energy adjuster. Also in order to decrease the loss of the positron beam replacement of the chamber with wider one is considered.**

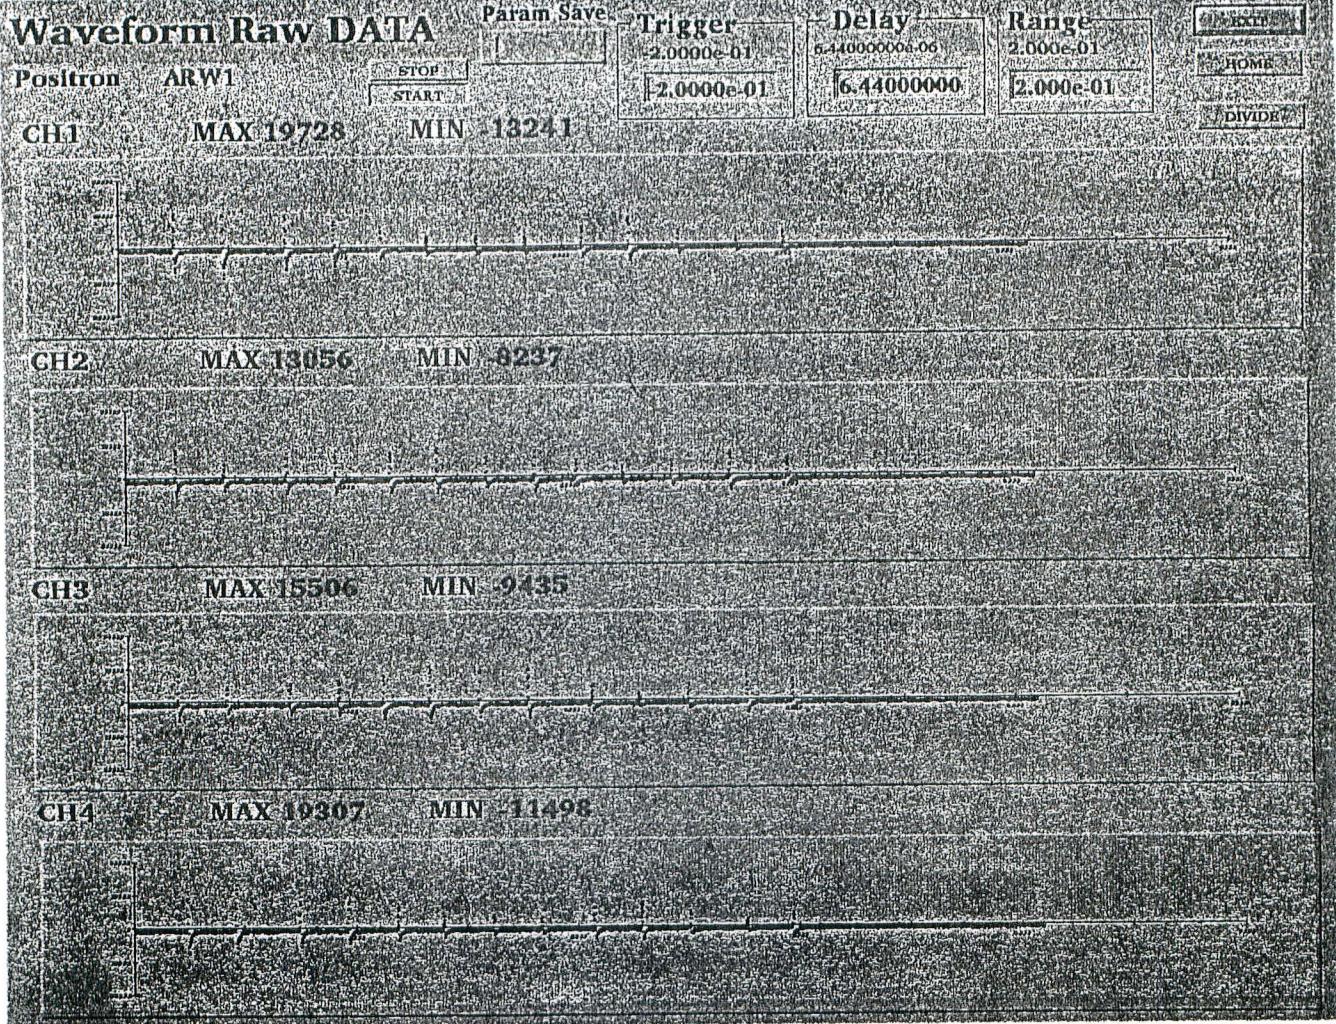
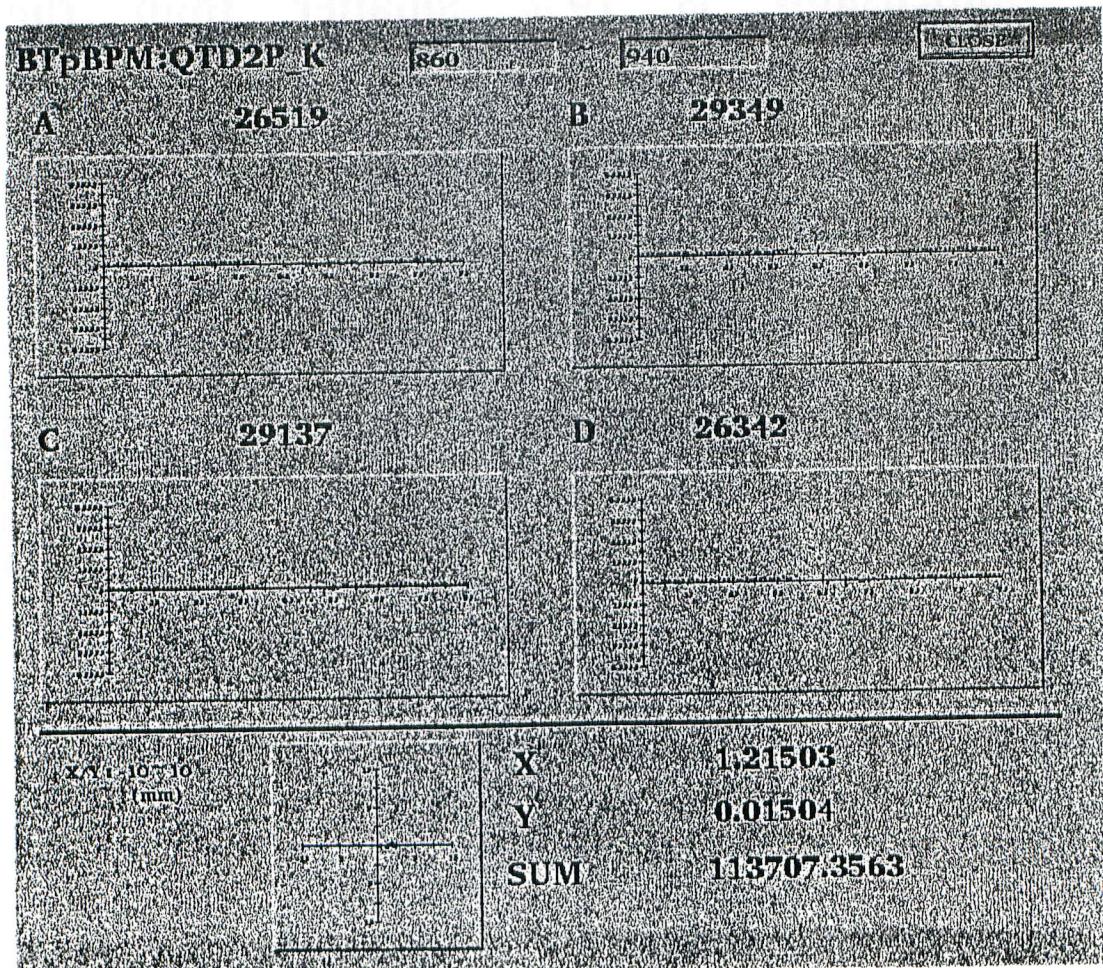
#### **3.2 Beam position monitor upgrade for 2-bunch acceleration**

- (1) Add another VXI digital oscilloscope**
- (2) Reorganized signal delay**

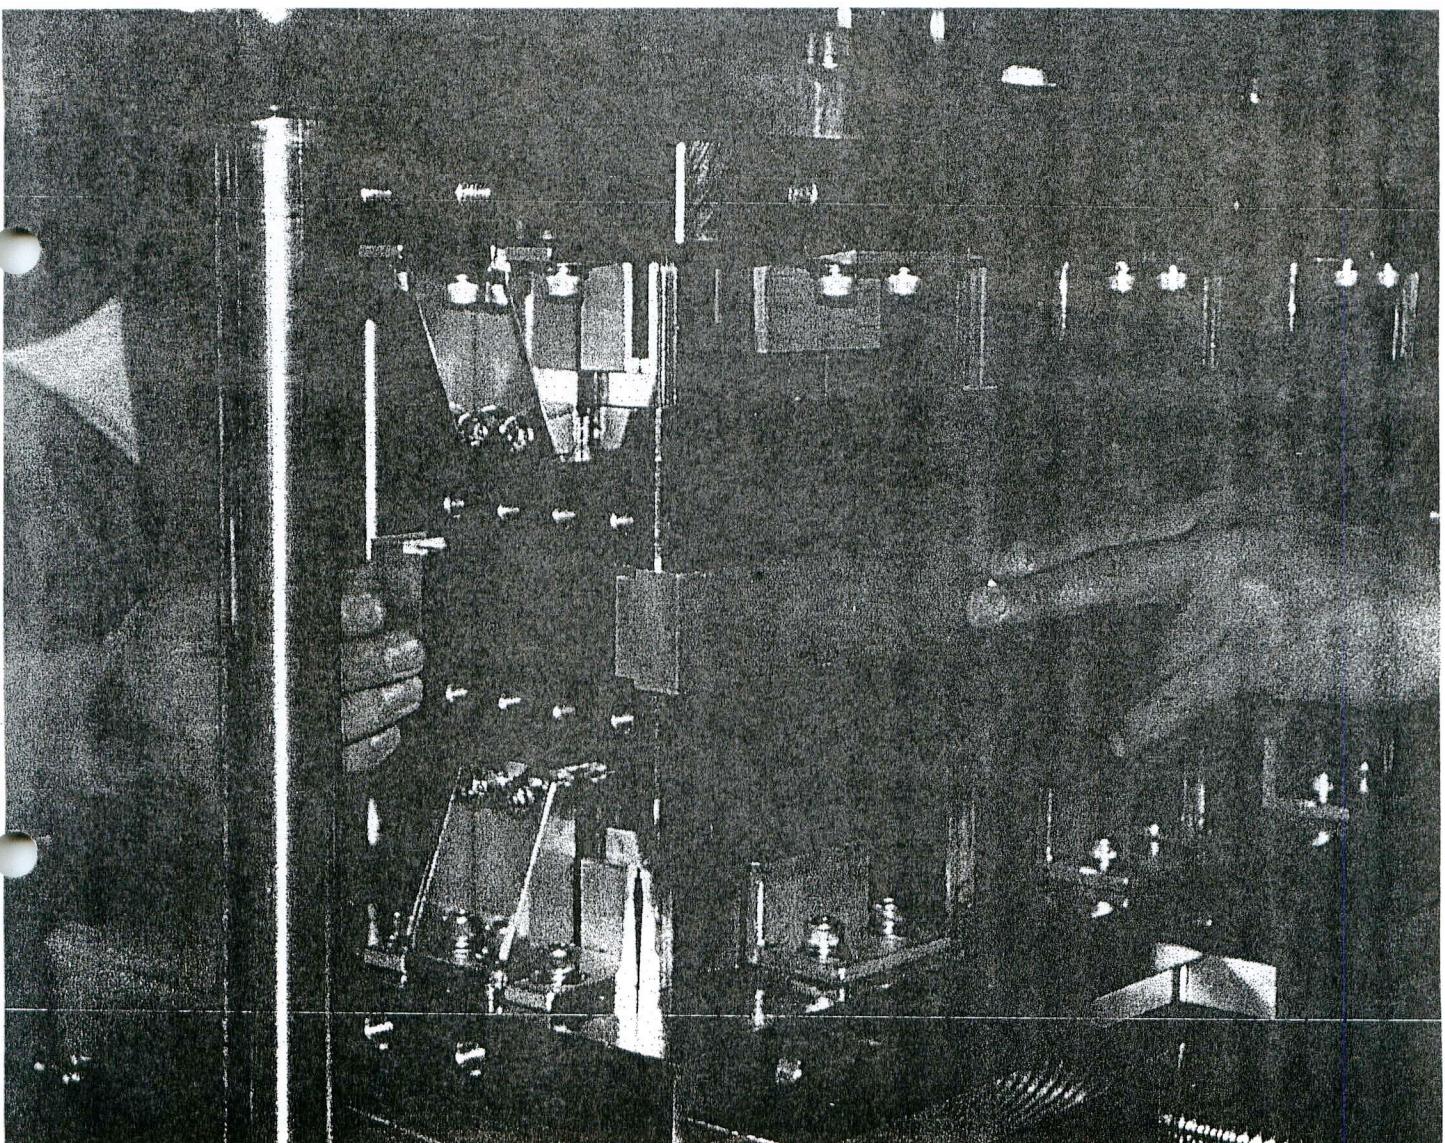
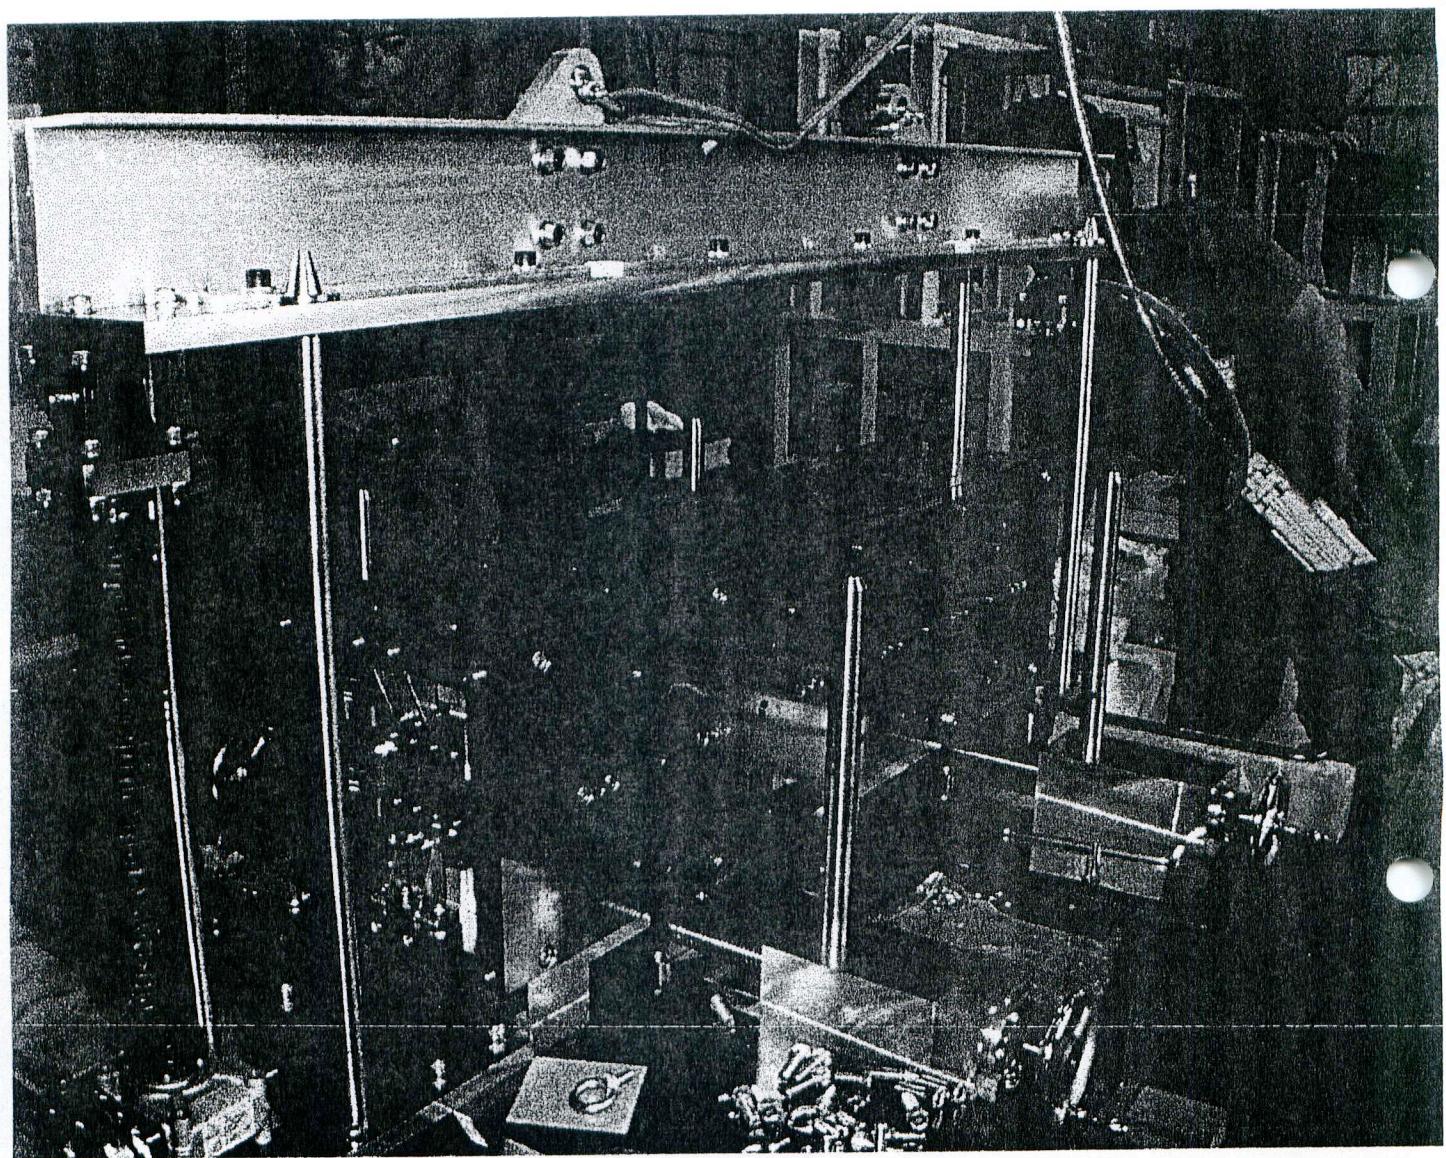
**R&D of the permanent-magnet dipole is underway.**

- (1) 1-m 0.25T dipole was constructed.**
- (2) Field strength was 10% lower than the design value.**
- (3) Temperature dependence of the field strength is approximately  $-5 \cdot 10^{-4}/\text{deg}$  that means temperature coefficient of the Fe-Ni alloy compensator is 10% smaller than the specification.**
