# *High Current Issues of KEKB*

**K. Akai (KEK)  
Machine Advisory Committee  
Feb. 25, 2002**

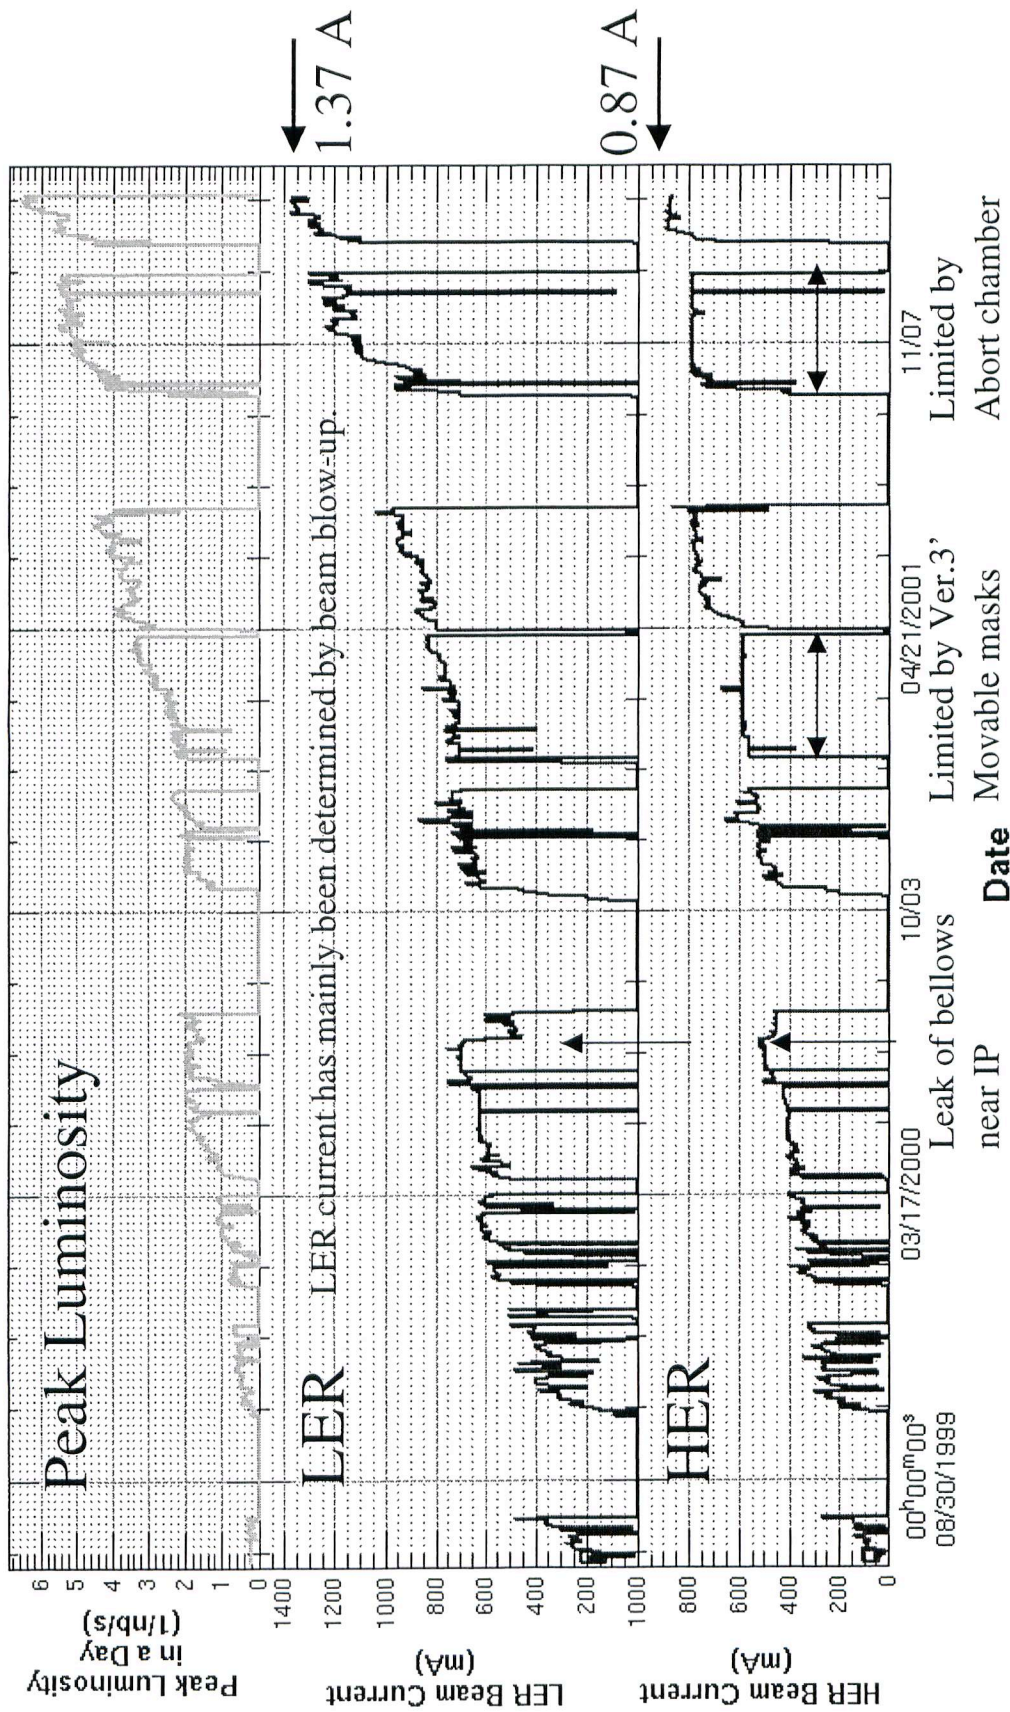
# Luminosity and Beam Current of KEKB July 1999 – Feb. 2002

- **LER**
  - Most of the time beam current has been set to optimize luminosity, rather than hardware problems. As the beam blow-up is reduced by solenoid windings, the current has been increased.
- **HER**
  - Sometimes beam current was limited by hardware problems. However, the current has been increased by improving the hardware.

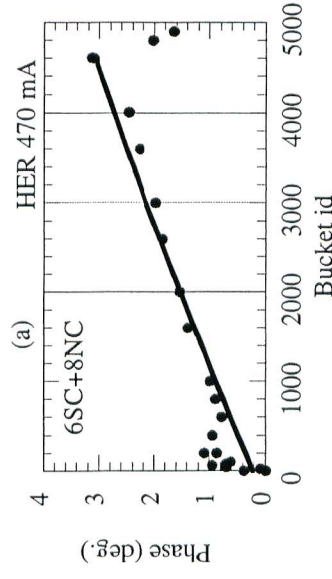
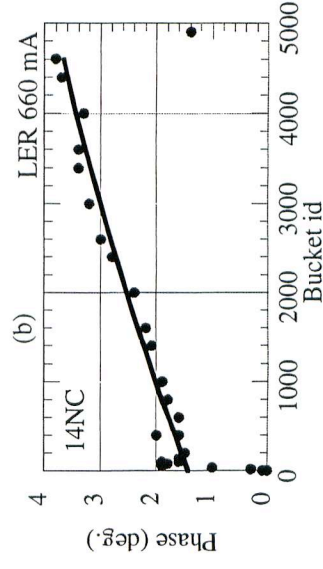
- Beam phase modulation due to abort gap is small, owing to large stored energy of cavities.
- Recently, gap length was reduced from 10% to 5%.
- No compensation is required.
- Measured and calculated phase modulation for 10% gap (T. Ieiri et al.)

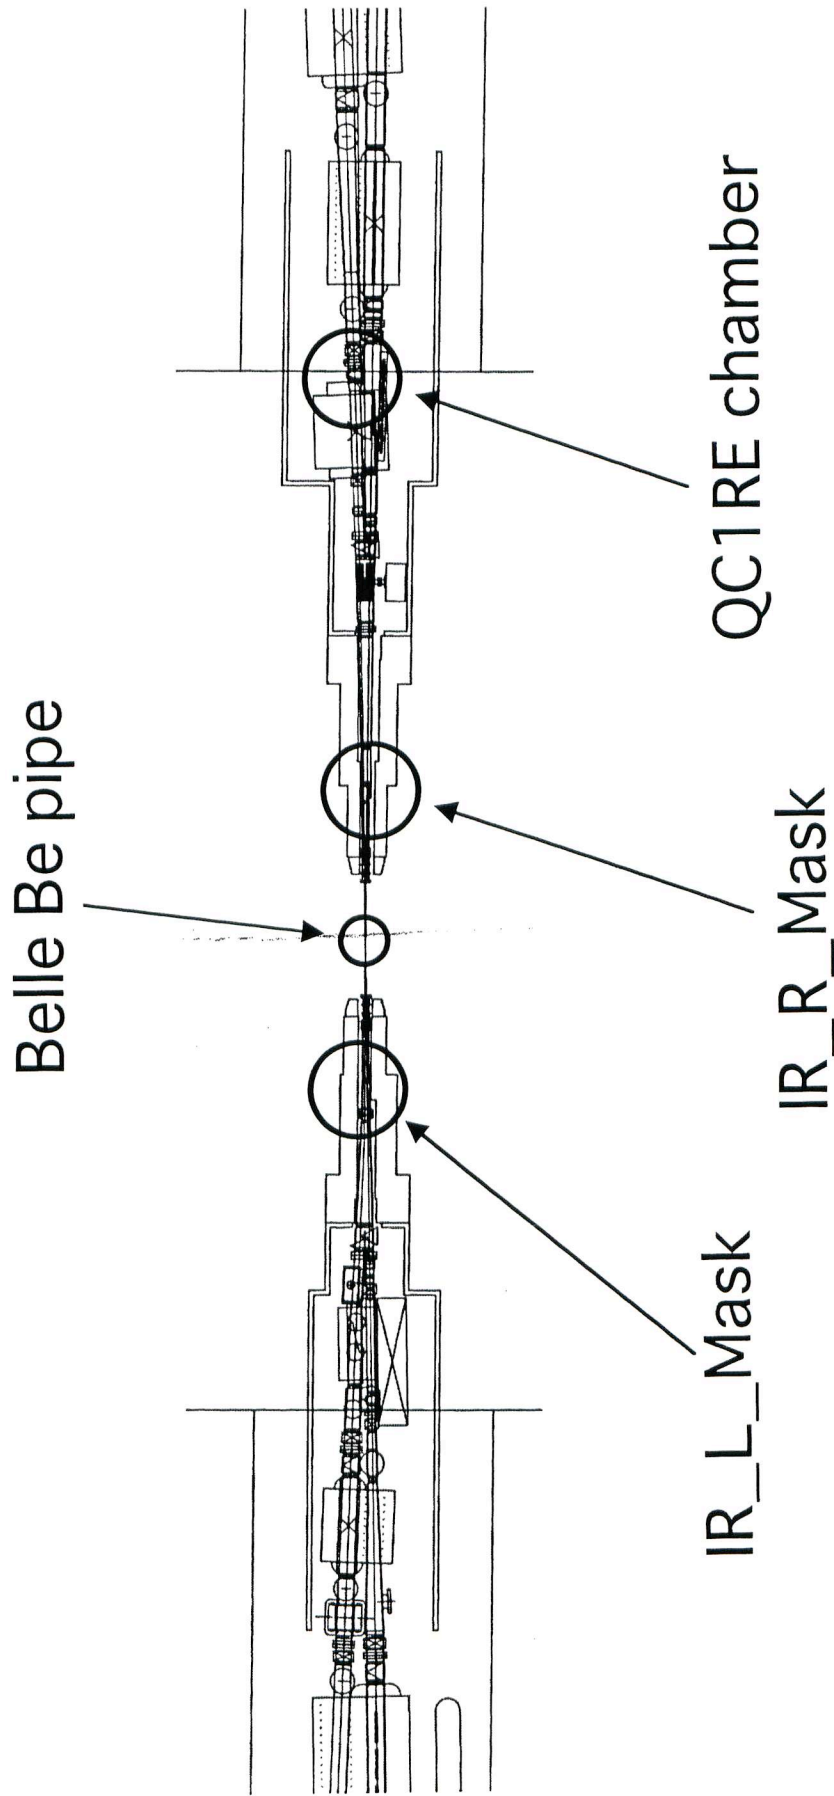
*Temperature rise around IR vacuum chambers*

- **IR vacuum components**
  - **Bellows near IP (HOM)**
    - Water cooling was reinforced in summer '00. It is moderate now.
  - **Beryllium beam pipe of Belle detector (HOM)**
    - Abnormal heating due to resonant build-up with 5 bucket spacing pattern. Since then this kind of pattern has been forbidden.
    - Broadband HOM seems OK up to the design current.
  - **Chambers downstream of HER (SR)**
    - Water cooling was reinforced.
    - Reduced by orbit change (QC1RE) and/or realignment of the chamber (QC2RE). It is moderate now.
  - **Masks for SR at QCS chamber (SR+HOM)**
    - No cooling now.  $\sim 110^{\circ}\text{C}$ . Water cooling is planned this summer.

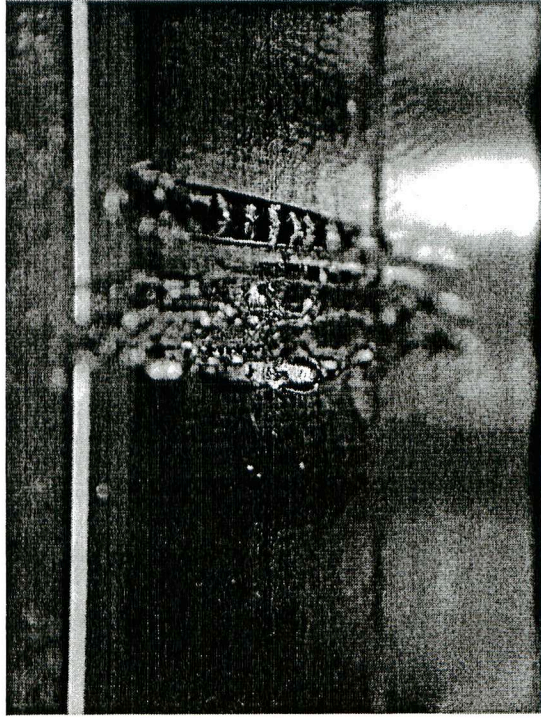
# *Movable masks damaged by beam abort*

- Mask heads were damaged by beam aborts.
- Suspected cause:
  - RF trip → beam energy shift → abnormal orbit when abort kicker fires.
- Cures:
  - Abort as fast as possible
    - BPA (Beam Phase Abort) + Loss monitor abort.
    - After the threshold of BPA was set to 1 degree (Dec.'01), no damage has been observed.
    - Additional protection is being installed.
  - Various material tested for mask head.
    - Ti seems promising.

- **Damage on hardware caused by aborts and/or RF trips**
  - A large amount of radiation hit Belle (5 kRad worst case!).
  - Mask heads were damaged. (HER injection and beam life deteriorated.)
    - Cause suspected: RF trip → beam energy shift → abnormal orbit when abort kicker fires or even the bunch slips out of RF bucket.
- **Measures taken (abort faster and more reliably)**
  - Beam Phase Abort (When beam phase is shifted, abort is requested.)
  - Loss Monitor Abort (Fast loss monitors using PIN diodes)
- **Results of the improvements**
  - Very few radiation hit Belle of more than 100 Rad recently.
  - No damage of masks observed since Dec. 2001 (1 degree set BPA).

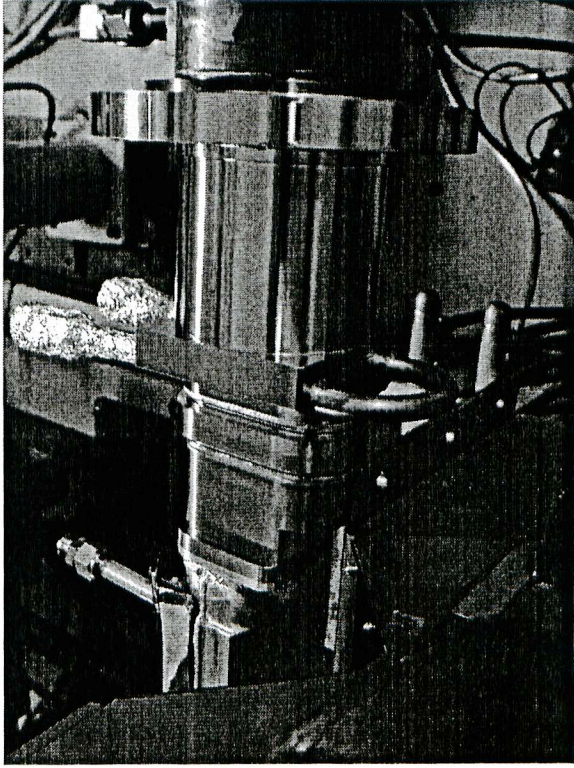
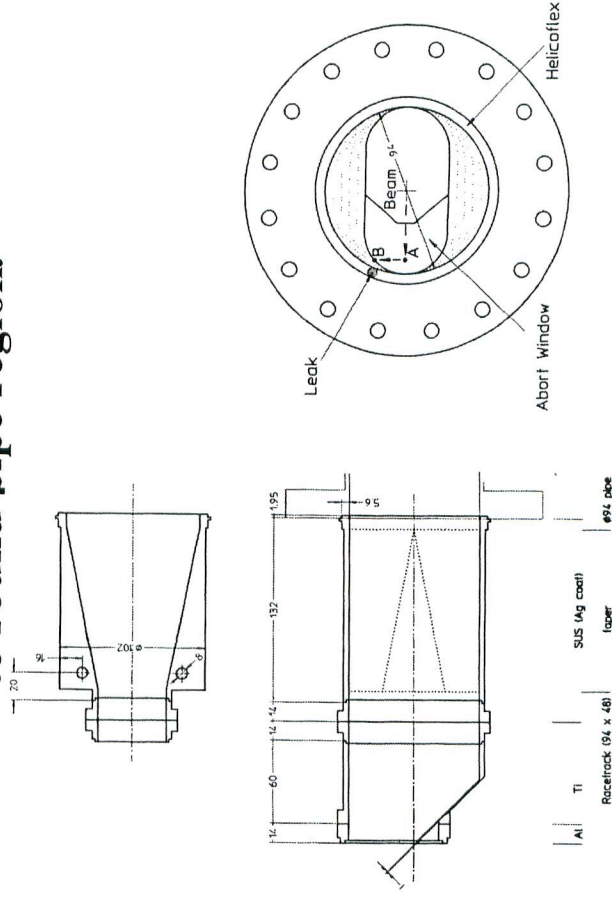
# Troubles of abort chambers

- Leaked at flange connection.
  - Replaced with new one with no flange or bellows attached.
  - However, the new one also leaked at SUS-Ti transition.
- Suspected cause:
    - aborted beam runs too close.
  - Cures:
    - The transition will be moved to round pipe region.

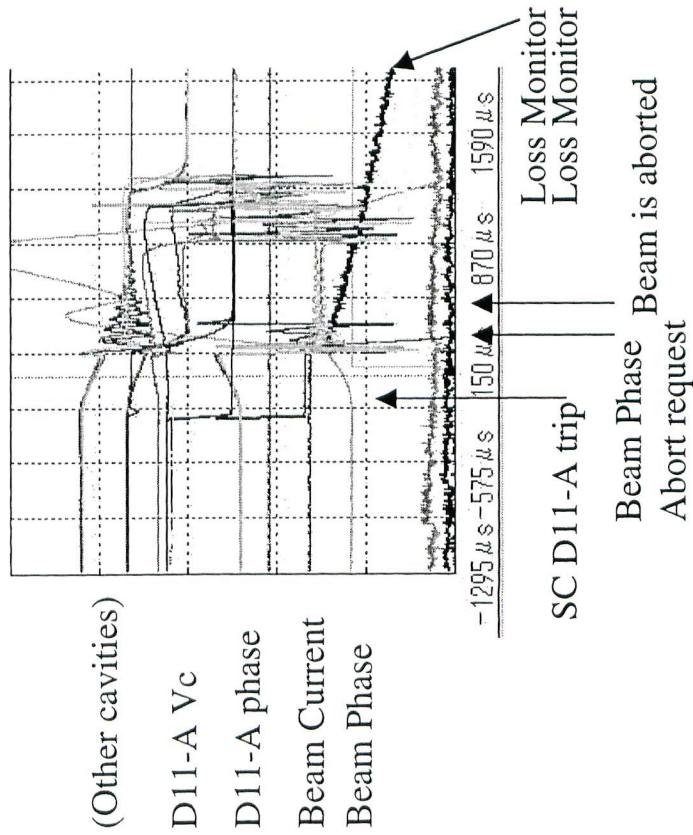
Every beam abort is monitored and analyzed to find the cause so that measures can be taken quickly. (Akai, Furuya, Ikeda, Stanic)

- HER abort monitor

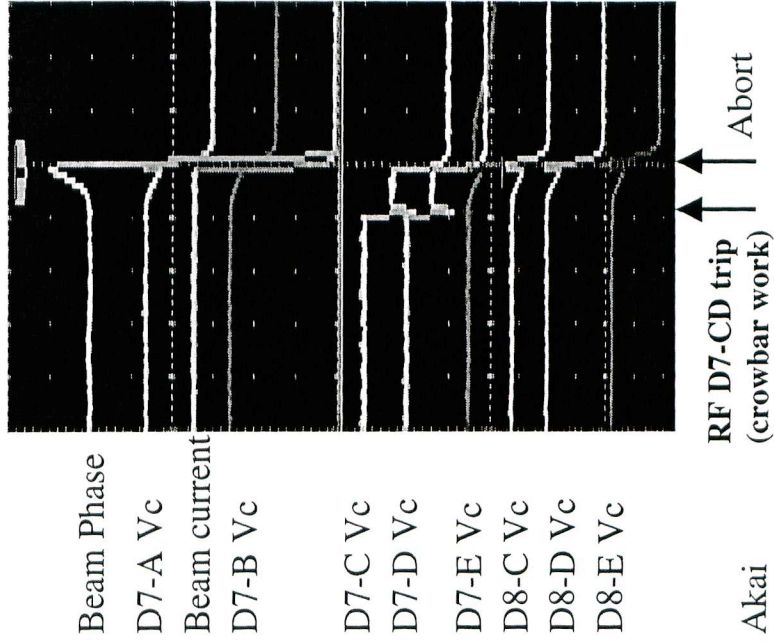
- LER abort monitor

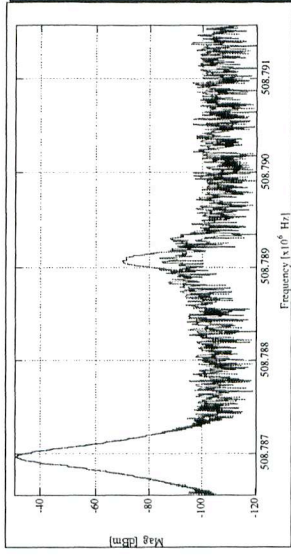
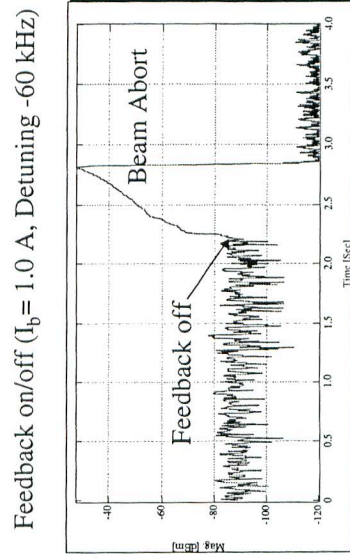
- Successfully operating in KEKB.

Feedback on/off ( $I_b = 890$  mA, Detuning -60 kHz)  
 BW = 1 kHz, Gain = 15 dB

- Longitudinal instability
  - -1 mode due to large detuning of cavities
    - Even with ARES or SCC, growth rate is marginal at high current.
    - -1 mode feedback is successfully operating to suppress it.
  - 0 mode stabilization
    - Oscillation due to random noise was reduced by zero-mode damper (from  $\pm 1$  degree to  $\pm 0.1 \sim 0.3$  degree).
    - Higher RF voltage is preferred for higher beam current.
      - Once instability was excited at 1A in LER. Cured by increasing RF voltage to 6.5 MV and tuning RF feedback.
  - No sign of instability due to HOM's
    - So far longitudinal bunch-by-bunch feedback is not needed.
      - Once instability was excited by old type of movable masks (Jan'00). Cured by replacing them with new type with absorbers.
