MR magnets & Superconducting magnets(QCS)

on behalf of the SuperKEKB magnet Group and QCS group

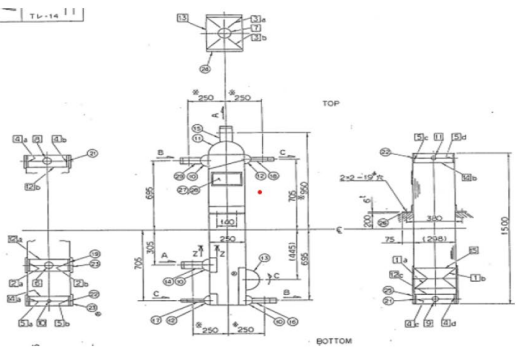
1st Heat Exchanger between high and low-pressure helium gases and nitrogen gas .
The additional heat exchanger is expected to be one third of the 1st H.X..

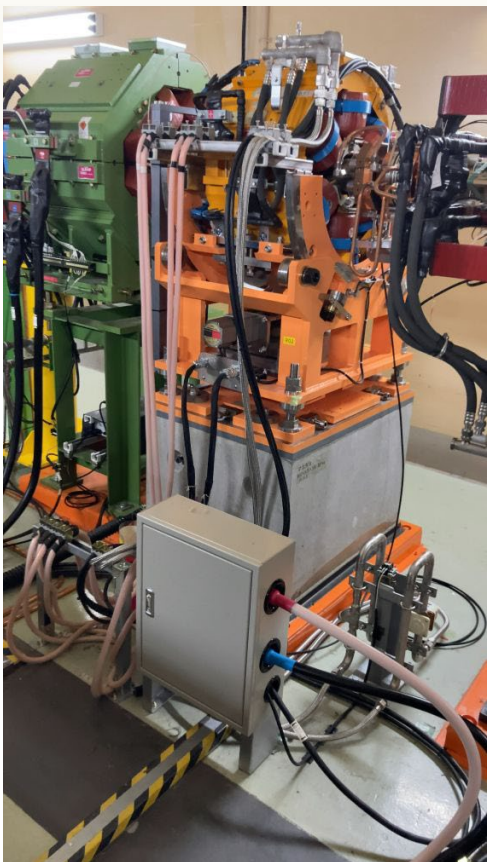
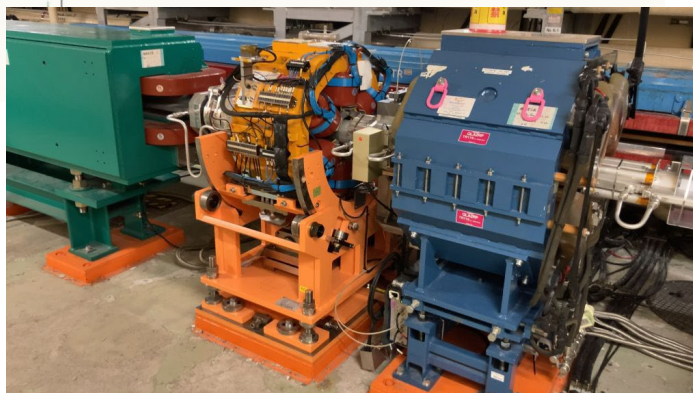
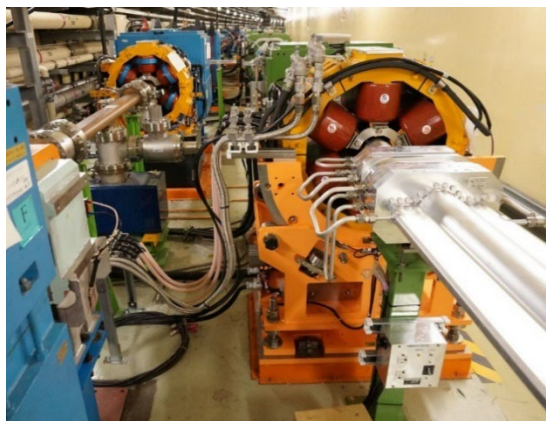
Sextupole Magnets on Tilting Tables

In LER, twenty-four skew sextupole magnets are installed on the tilting stage to tilt those magnets which generate sextupole and skew sextupole magnetic fields. A pulse motor which is fixed on the base frame, rotates the straight worm gear. The worm gear is engaged with the helical gear on the rotating frame, and then the sextupole magnet fixed on the rotating frame are tilted. The rotation center and the magnetic center are adjusted within 0.1 mm.

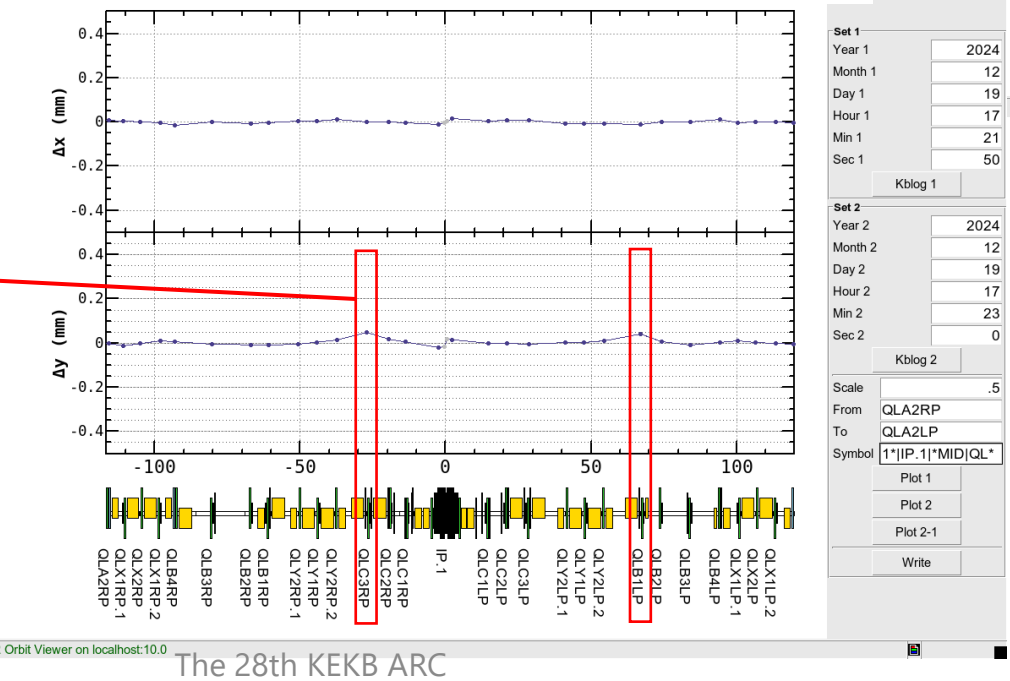
Orbit difference between A and B (IP)

ΔY s at QLC3RP, next to SLYTRP.2, and QLB1LP, next to SLYTLP.2, are a bit larger than the others (~0.05mm).

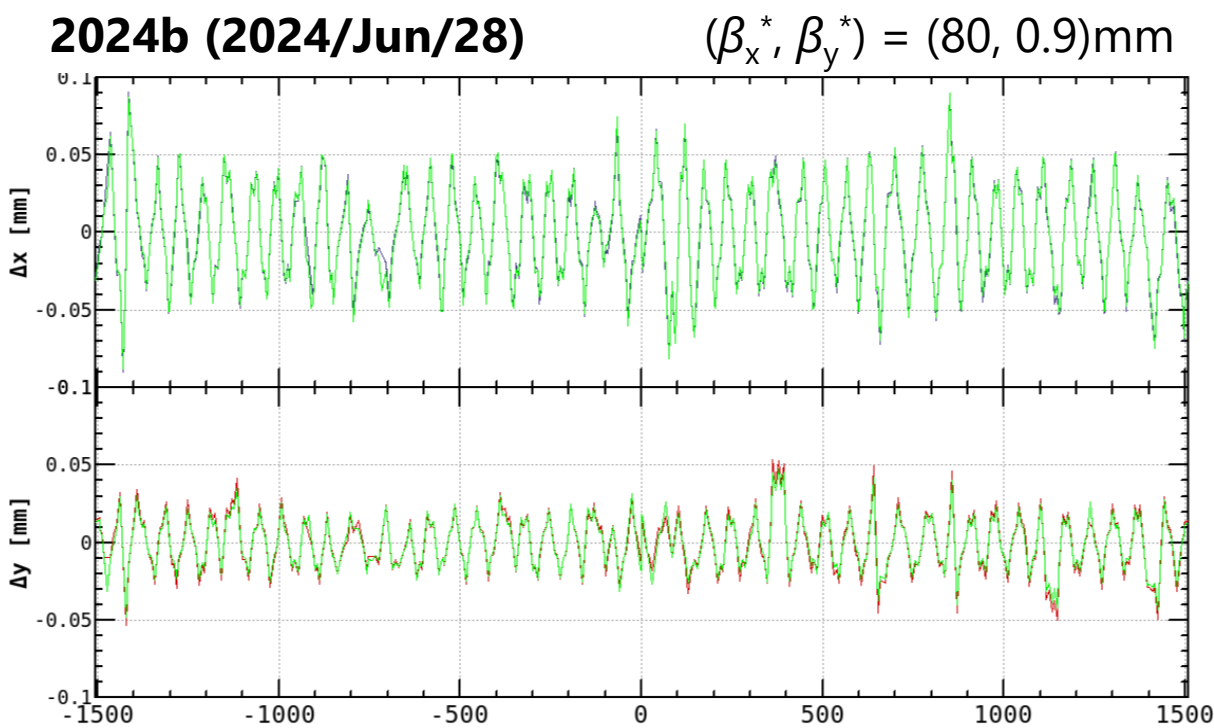
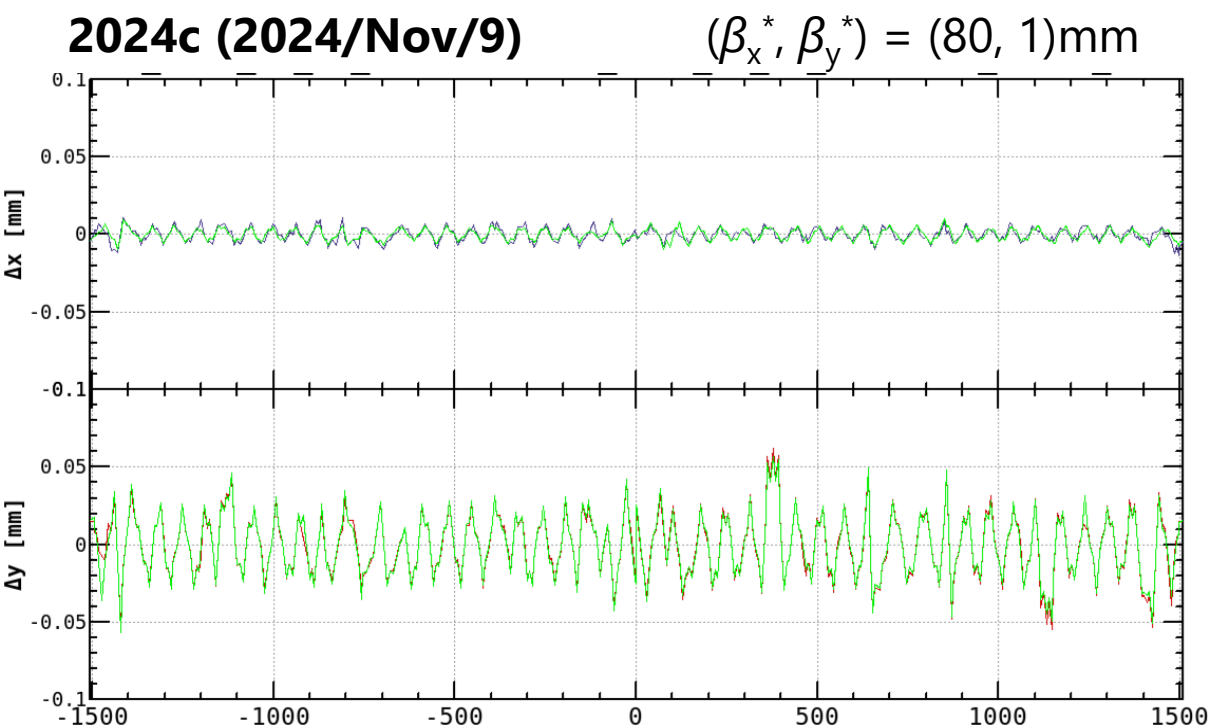
The orbit difference when the QKARP's K1 changes $+1\text{e-}3\text{ m}^{-1}$.

The horizontal orbit fluctuation in 2024c has been smaller than in 2024b.

This improvement results from moving QKARP vertically by -1.9mm during the summer shutdown.

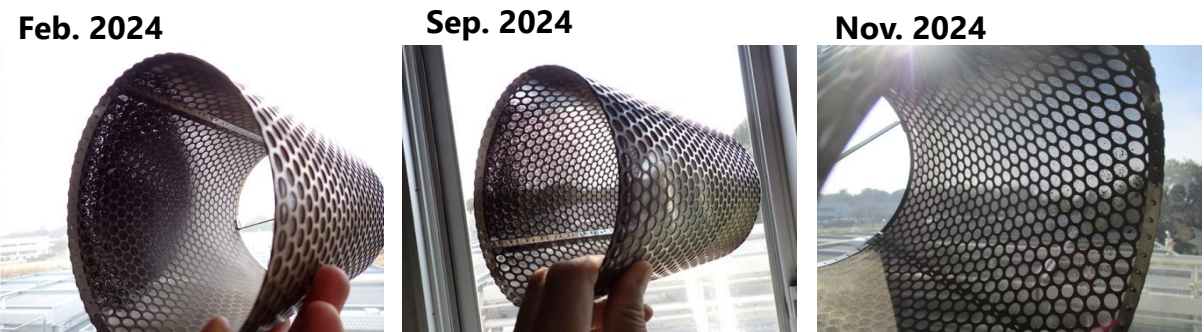
Strainer just before a pump

Although this incident was unfortunate, regular maintenance ensures the system remains healthy.
Thanks to the maintenance, water purity is improving in one pump system.

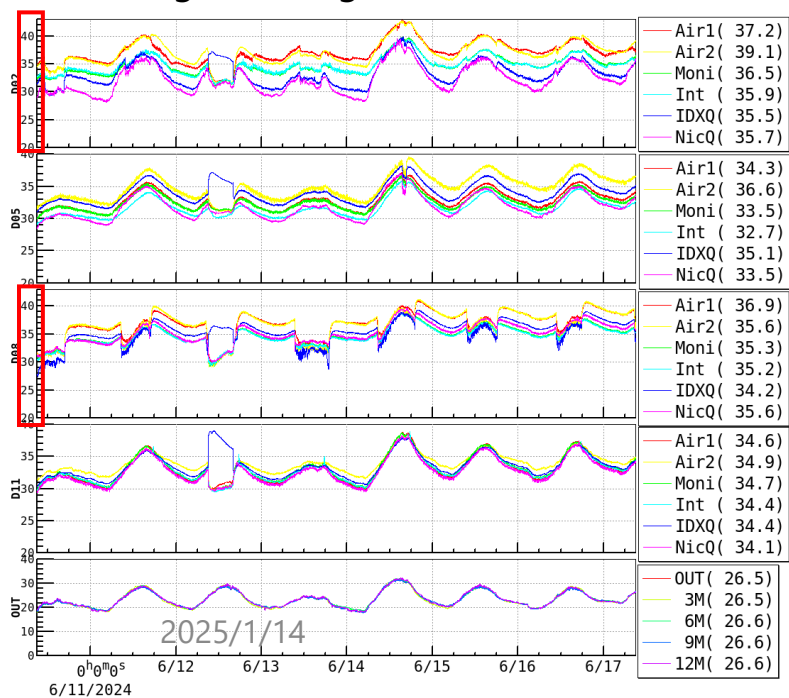
Room temp.
in the large buildings without air conditioners .

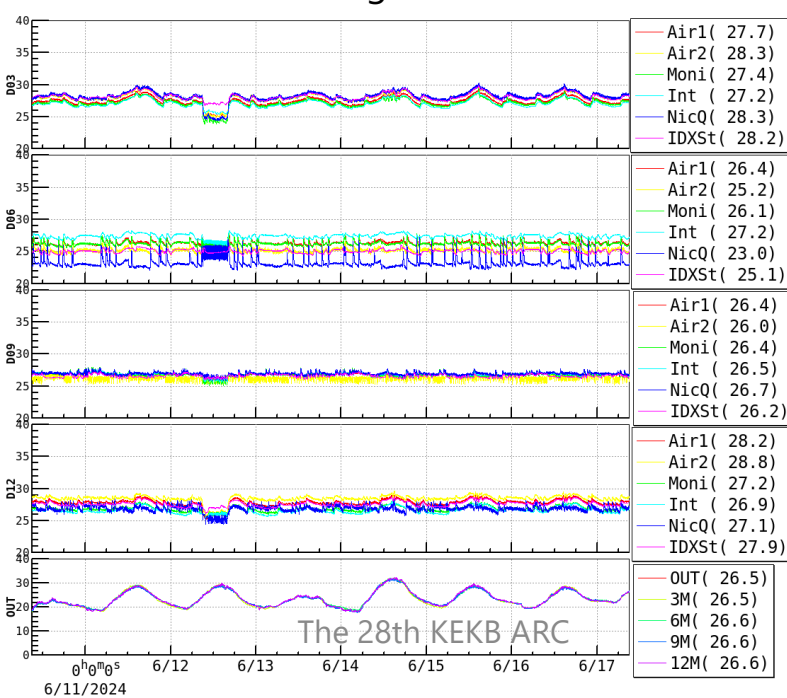
Room temp.
in the small buildings with air conditioners .

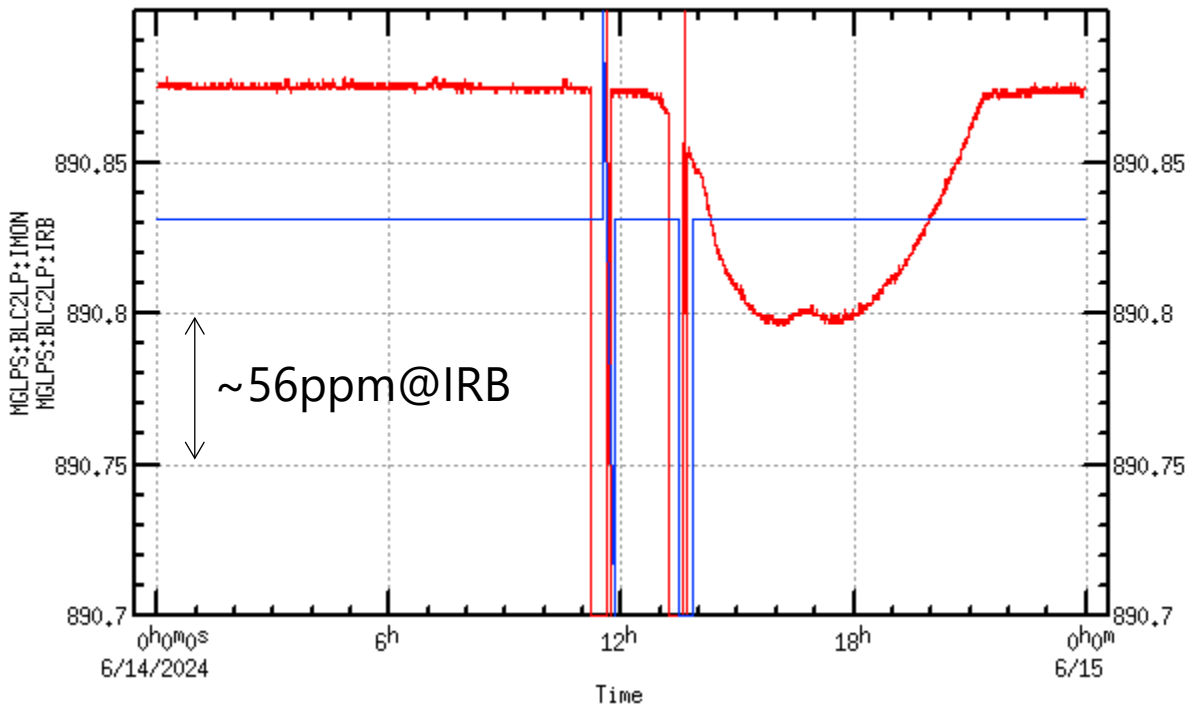
BLC2LP@D2
Rated current : 1100A

CH1: MGLPS:BLC2LP:IMON
CH2: MGLPS:BLC2LP:IRB

This PS stopped twice in a short time due to an interlock caused by the switching device error. The output current drifted.

The thermostat in the power supply does not seem to stabilize the temperature.

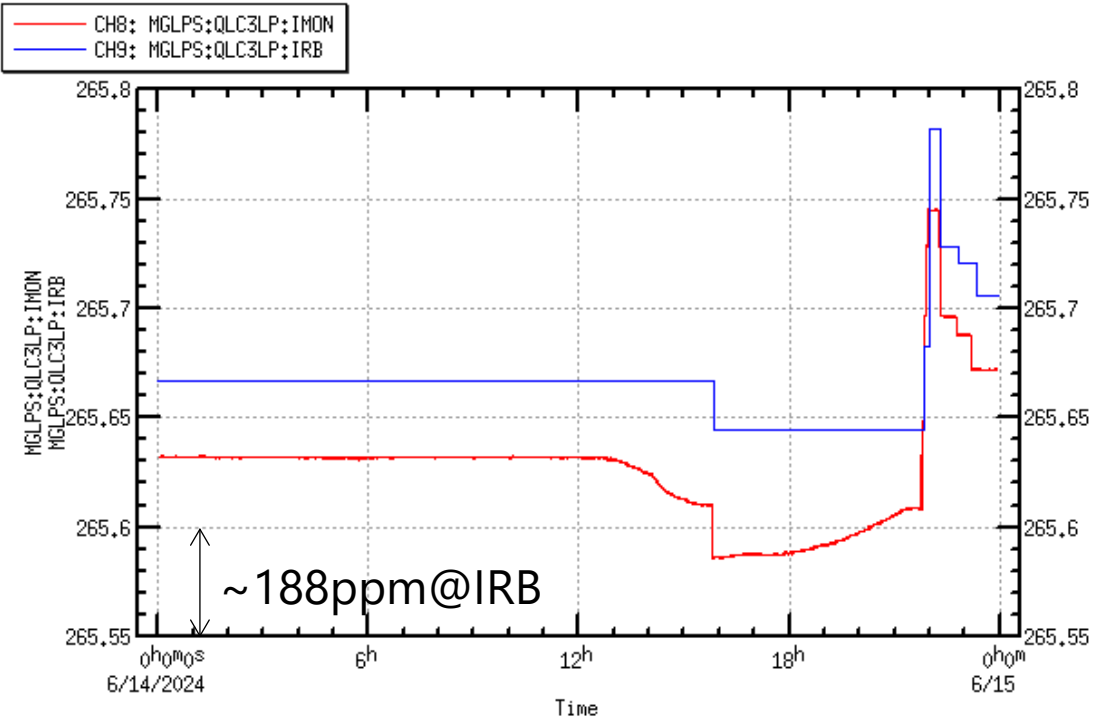
QLC3LP@D2
Rated current : 500A

The PS did not stop, but the output current drifted regardless of the command value.

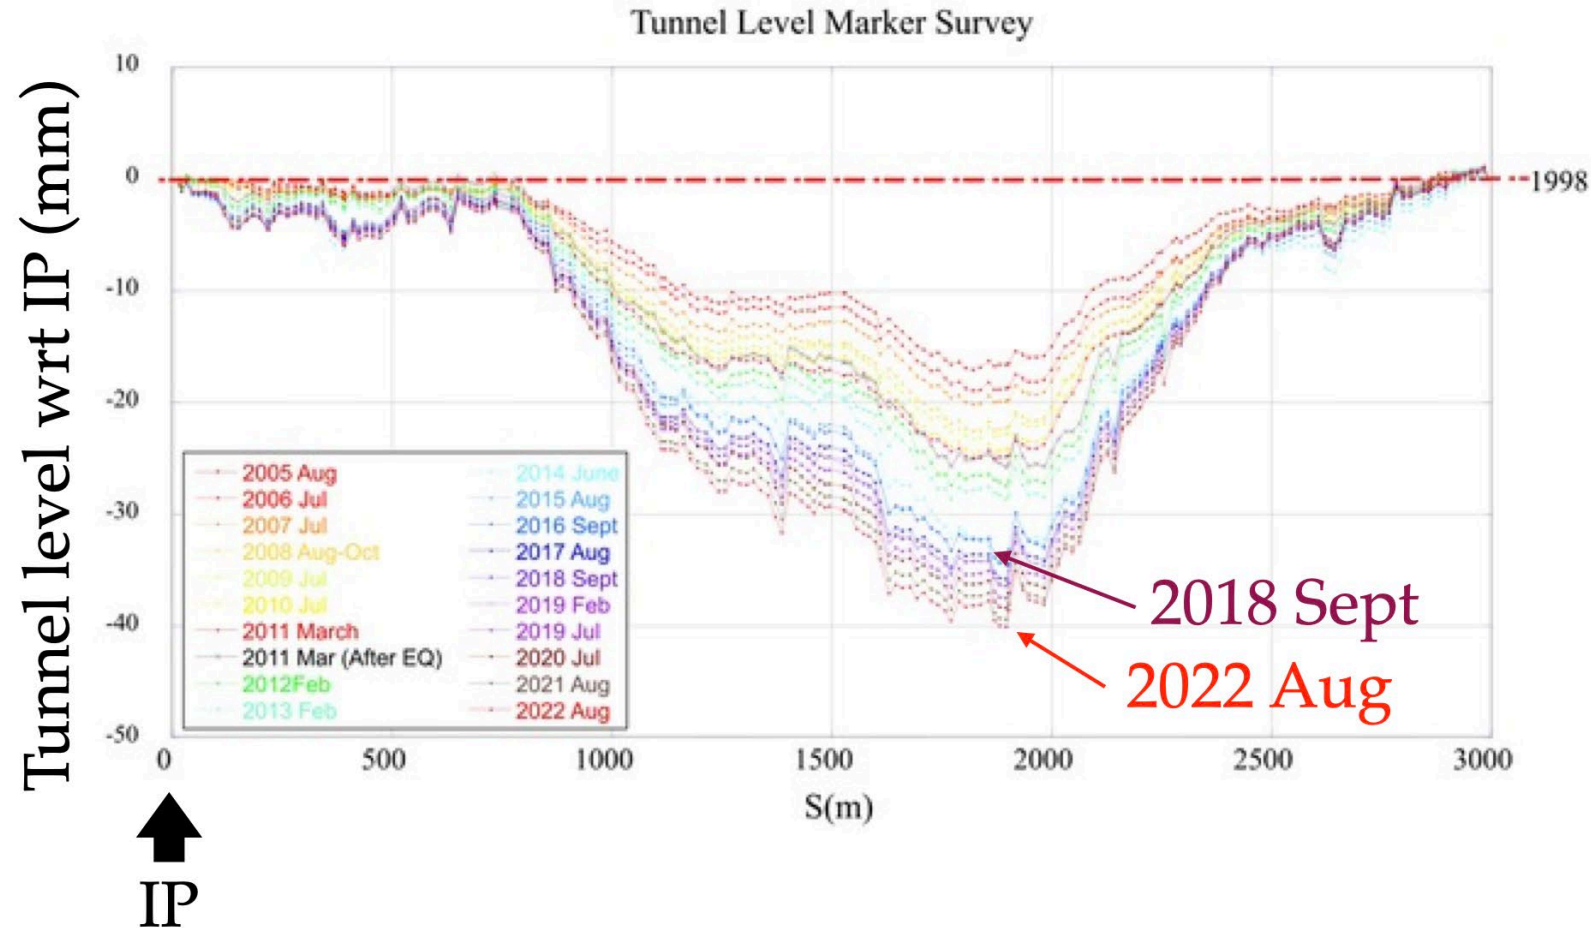
Tunnel level variation every year wrt IP

- The tunnel level goes down about 5 mm from 2018 to 2022.

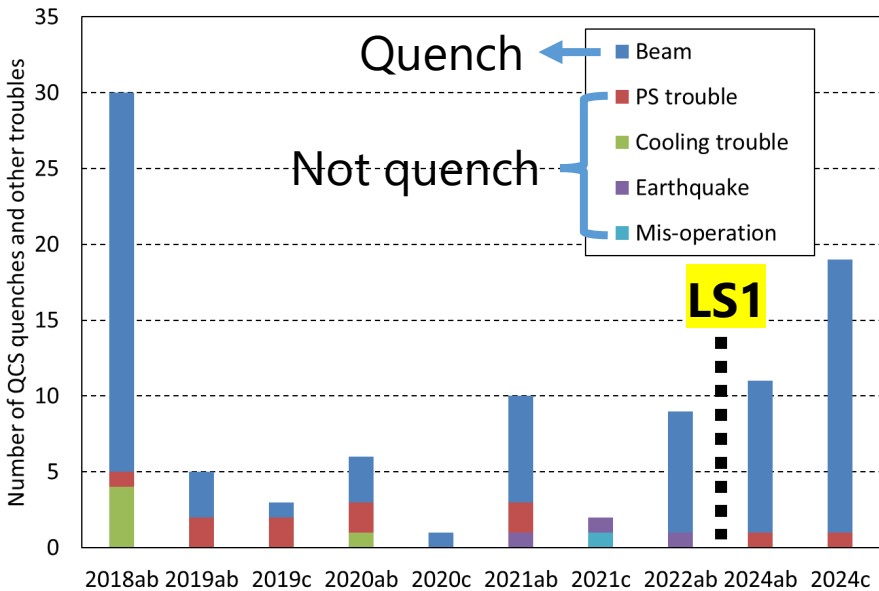
Number of QCS quenches and other troubles

Quench / Operating period
2022ab	8 / 5 month(Feb.-Jun.)
2024ab	10 / 5 month(Feb.-Jun.)
2024c	18 / 2.5 month(Oct.-Dec.)

Frequency of QCS quenches in 2024c was 3.6 times higher than that in 2024ab.

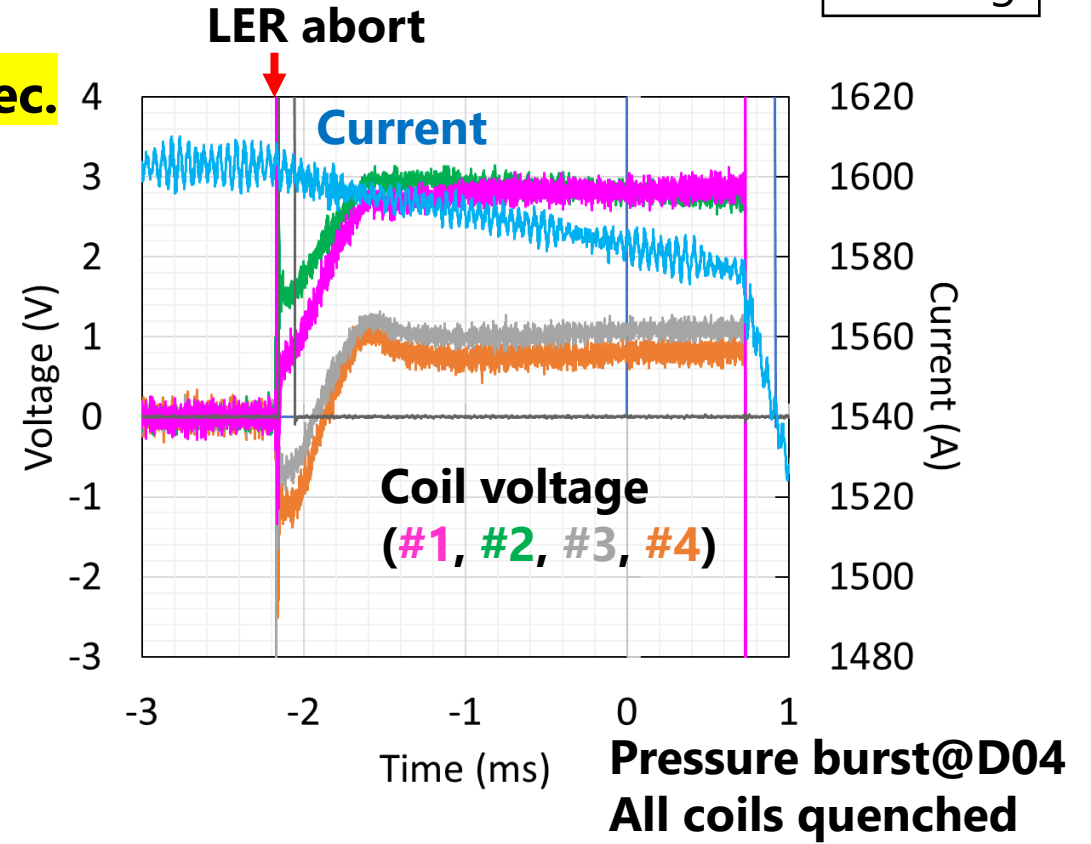
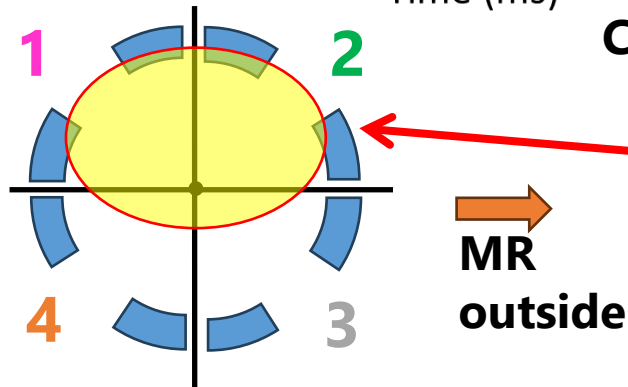
17 Dec.

**Magnet cross-section
from LER upstream**

From the quench voltages, it is estimated that the beam loss to the QC1RP coil mainly occurred at the top half of the magnet.

When the pressure burst occurs at D4, closer to the IR, all coils of QC1RP quenched in most events.

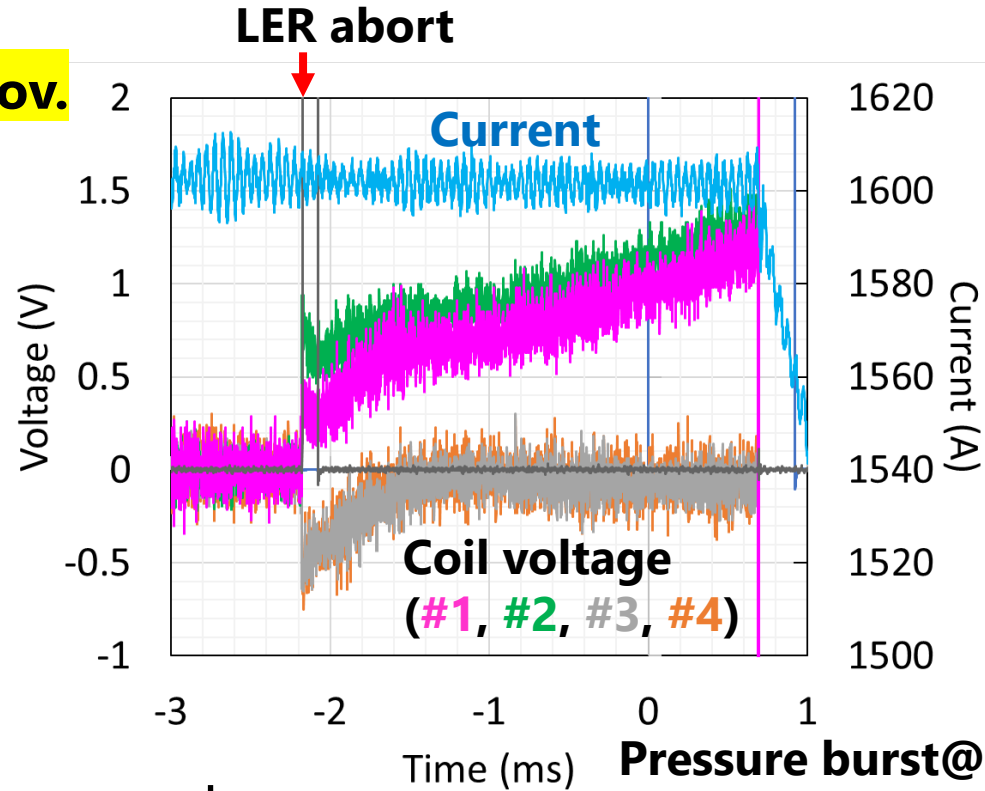
2 Nov.

Pressure burst@D10
Coils #1 and #2 quenched

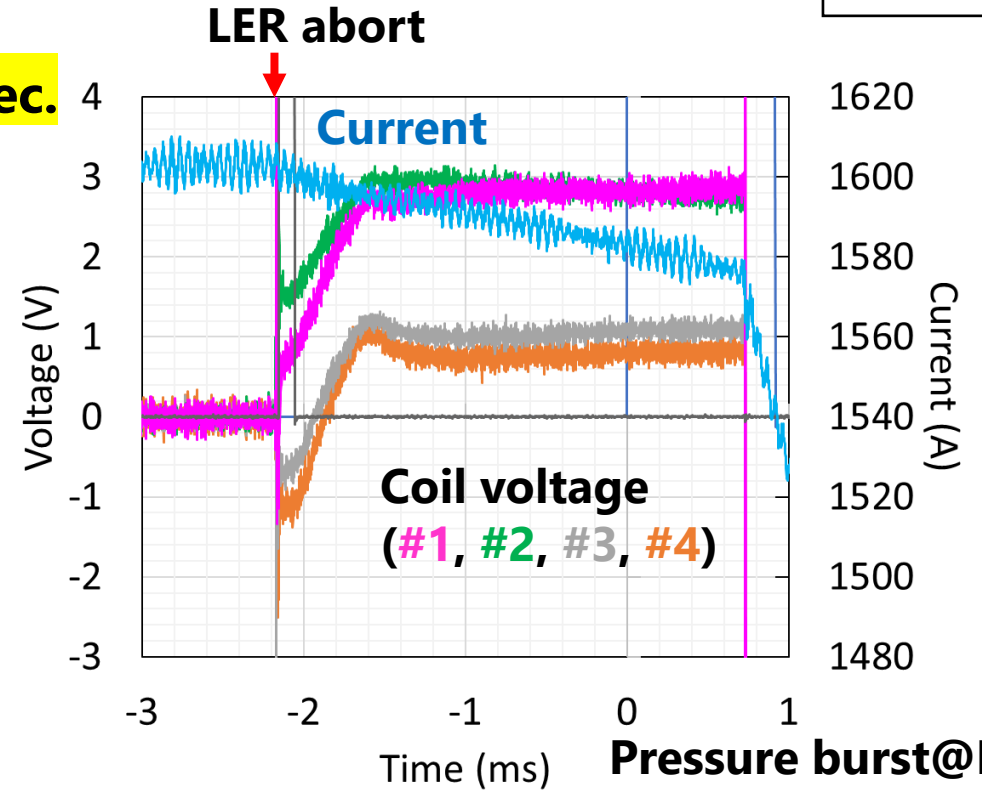
17 Dec.

From the quench voltages, it is estimated that the beam loss to the QC1RP coil mainly occurred at the top half of the magnet.

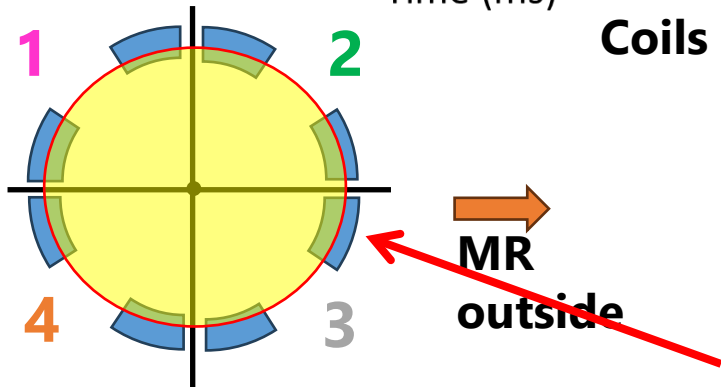
Pressure burst@D04
All coils quenched

Magnet cross-section
from LER upstream

When the pressure burst occurs at D4, closer to the IR, all coils of QC1RP quenched in most events.

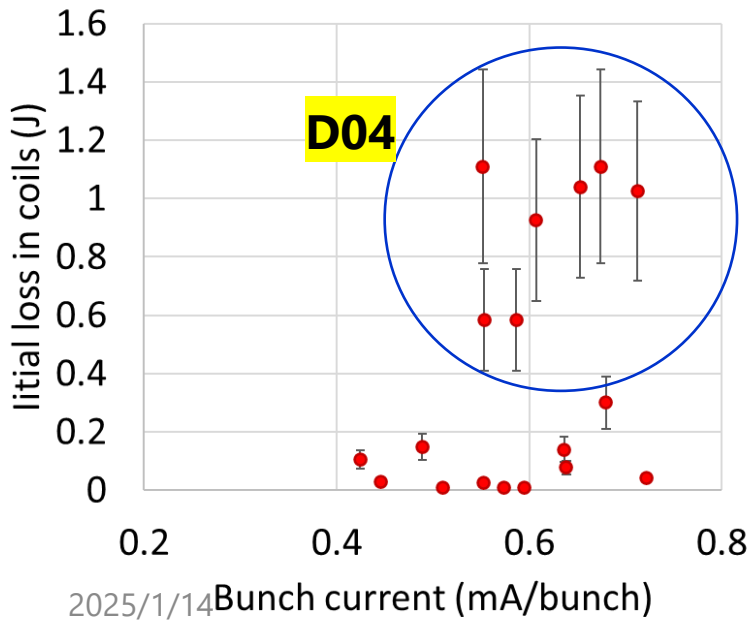
Comparison with bunch current

When the pressure burst occurred at D4, the initial loss and quench region in the coil were larger than that of other quenches in most events.

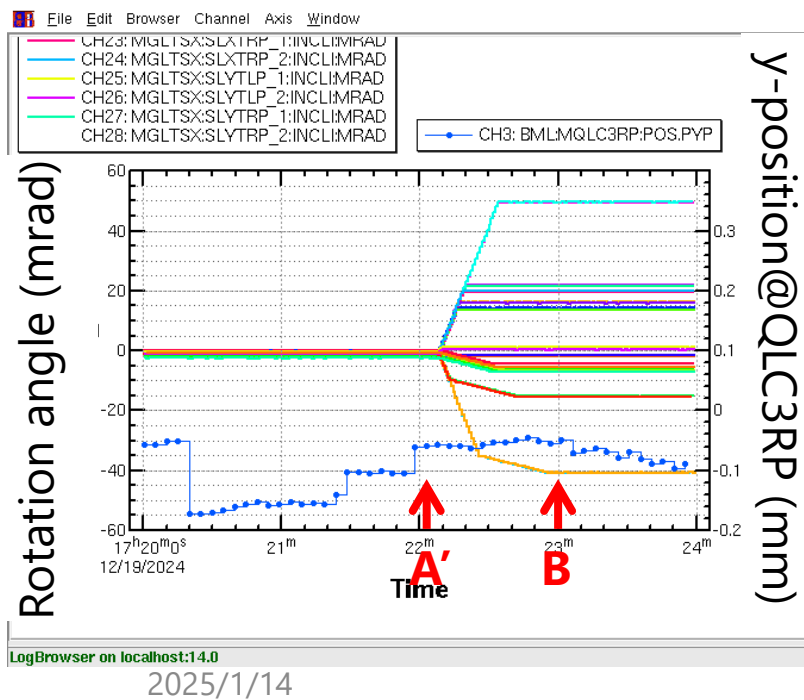
2024c, we performed a resonance correction study with a new sextupole set and a magnet rotation study on the beam.
($\beta_y^* = 1\text{mm}$, LER current = 50mA)

The trial of a magnet rotation on the beam succeeded.

- No beam abort
- Negligible orbit disturbance

ΔY around SNAP.1 and SNAP.2 is a bit larger than the others.

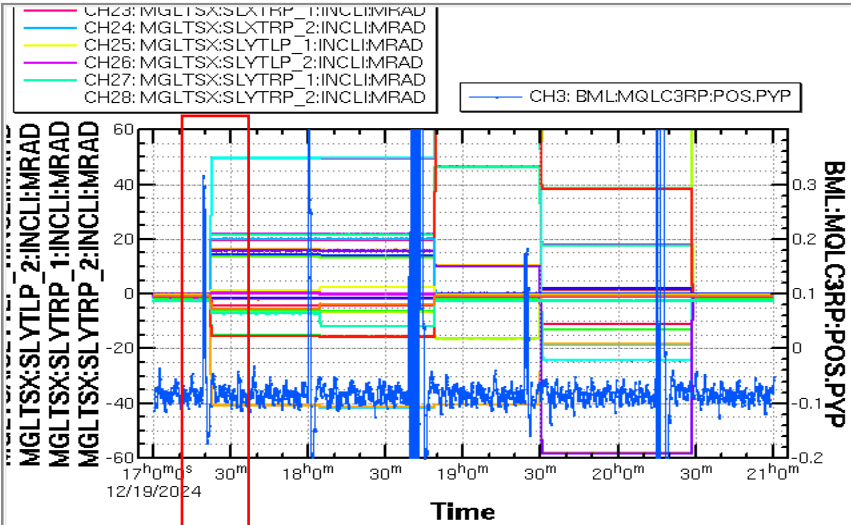
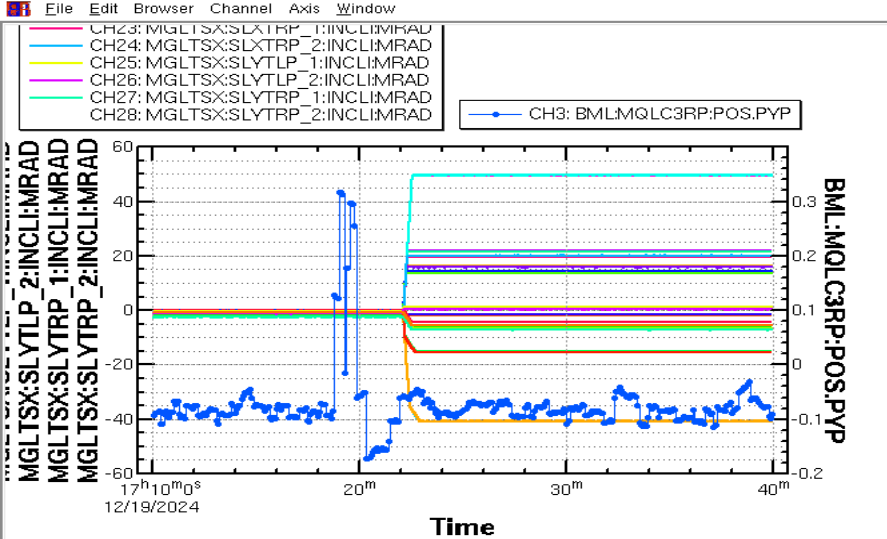
Rotation angle vs Beam y-position@QLC3RP

dY@MQLC3RP moves significantly when the V tune is changed dramatically.
The orbite fluctuation is slight when the rotation angle changes.

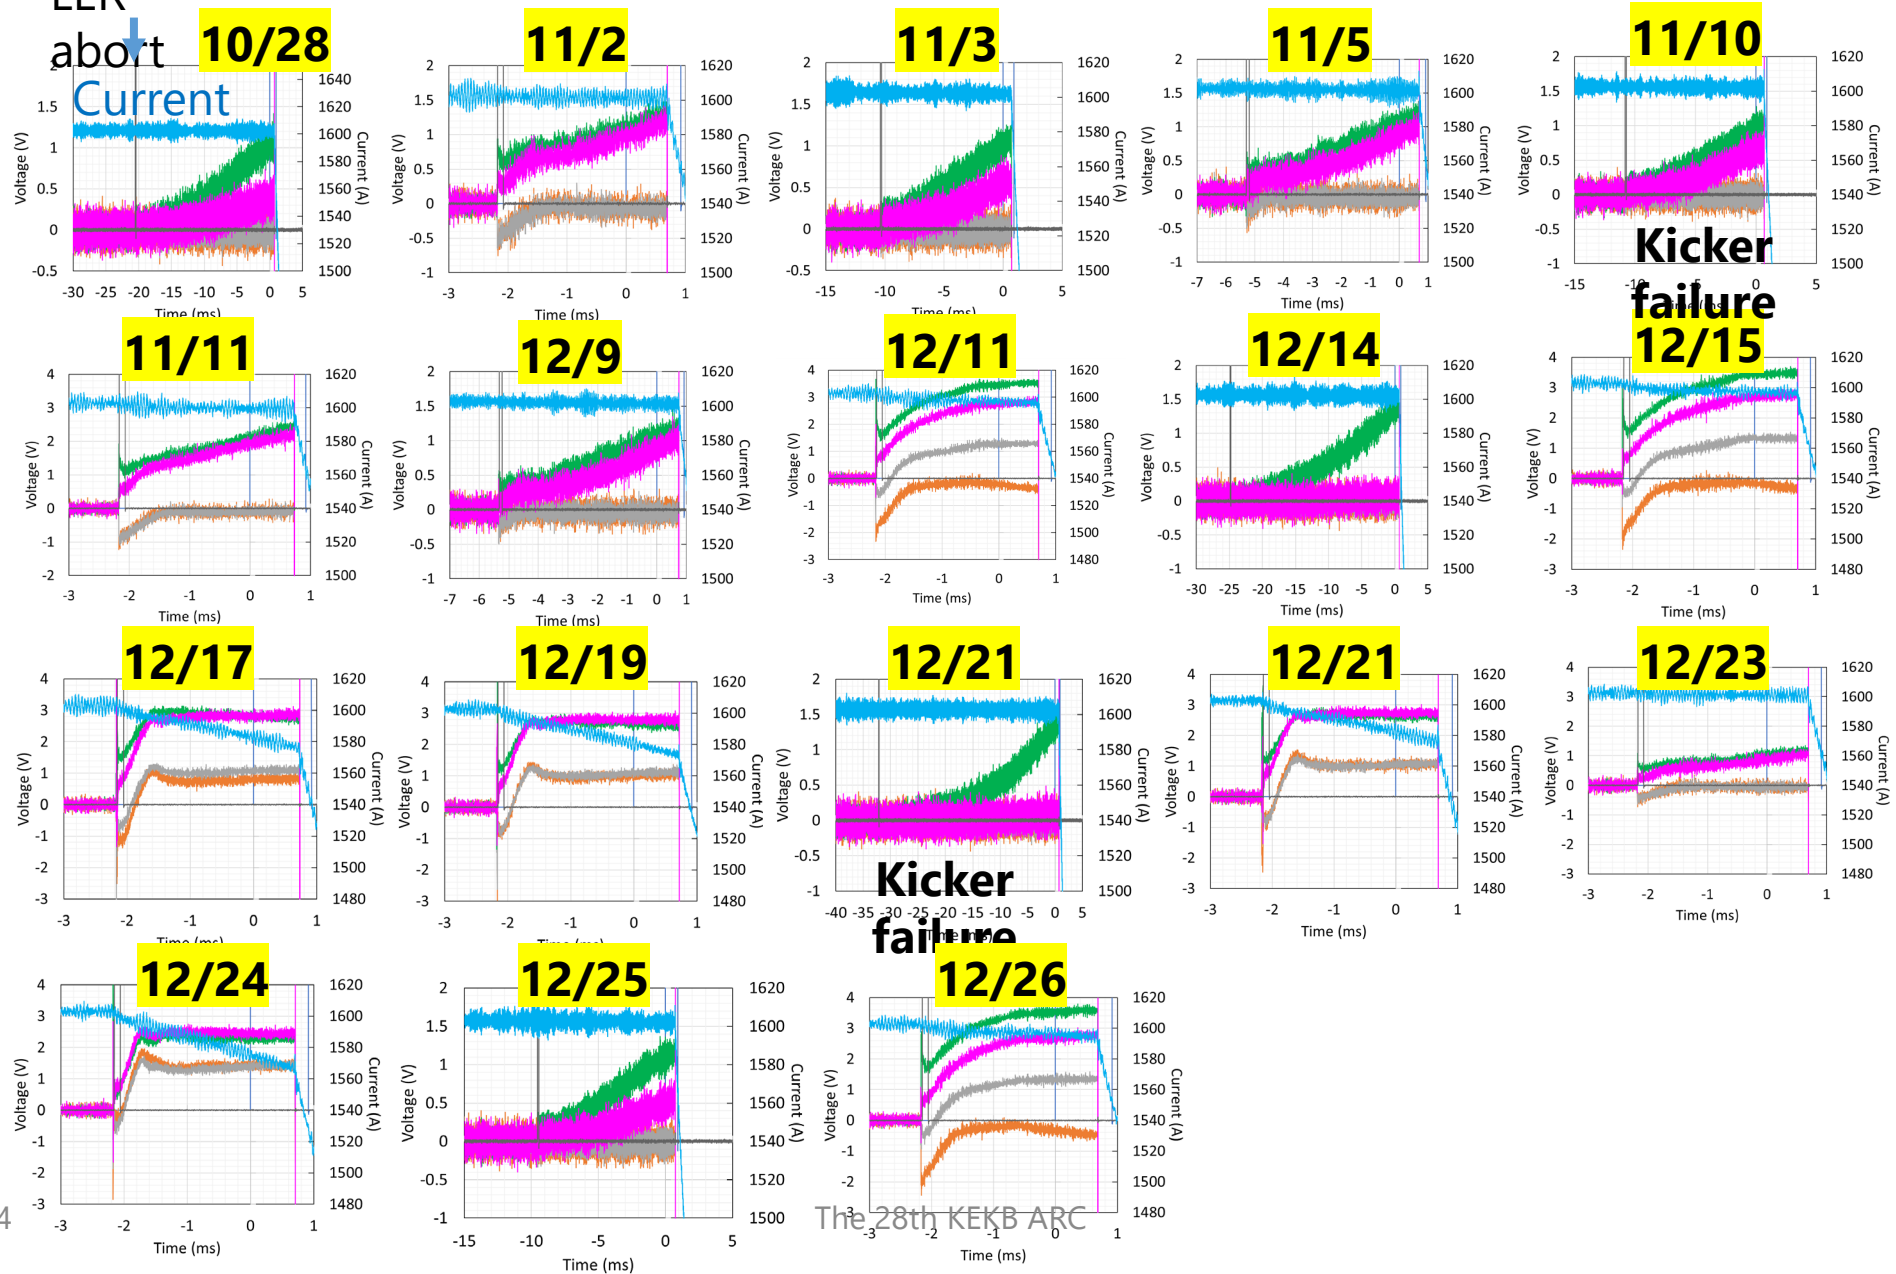
Quench voltage waveform of QC1RP

LER

about 10/28
