Injector Status (1)

Masanori Satoh (Acc. Lab. Div. V, KEK)

on behalf of Injector Linac Group and Linac Commissioning Group

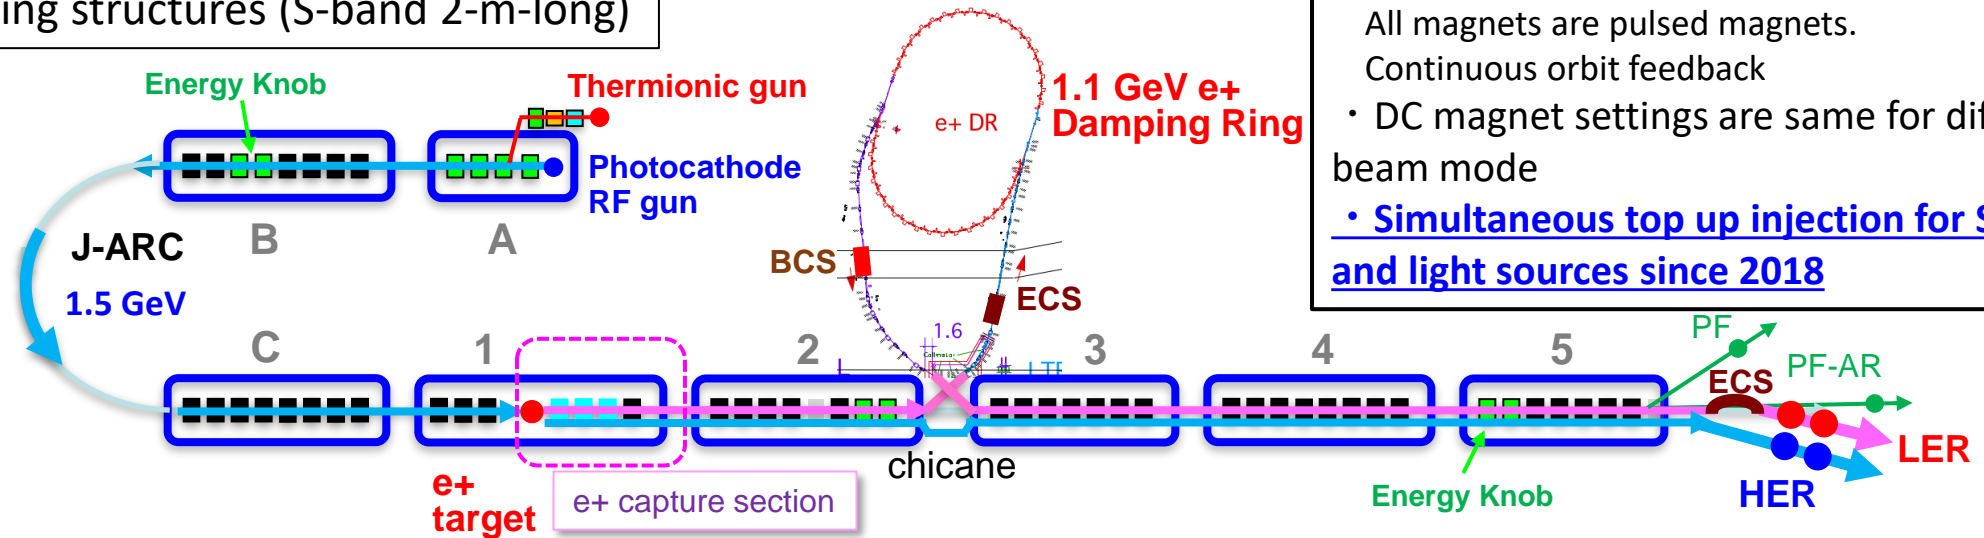
Injector Linac Layout

Four rings share 50 Hz beam from injector
60 klystron units
240 accelerating structures (S-band 2-m-long)

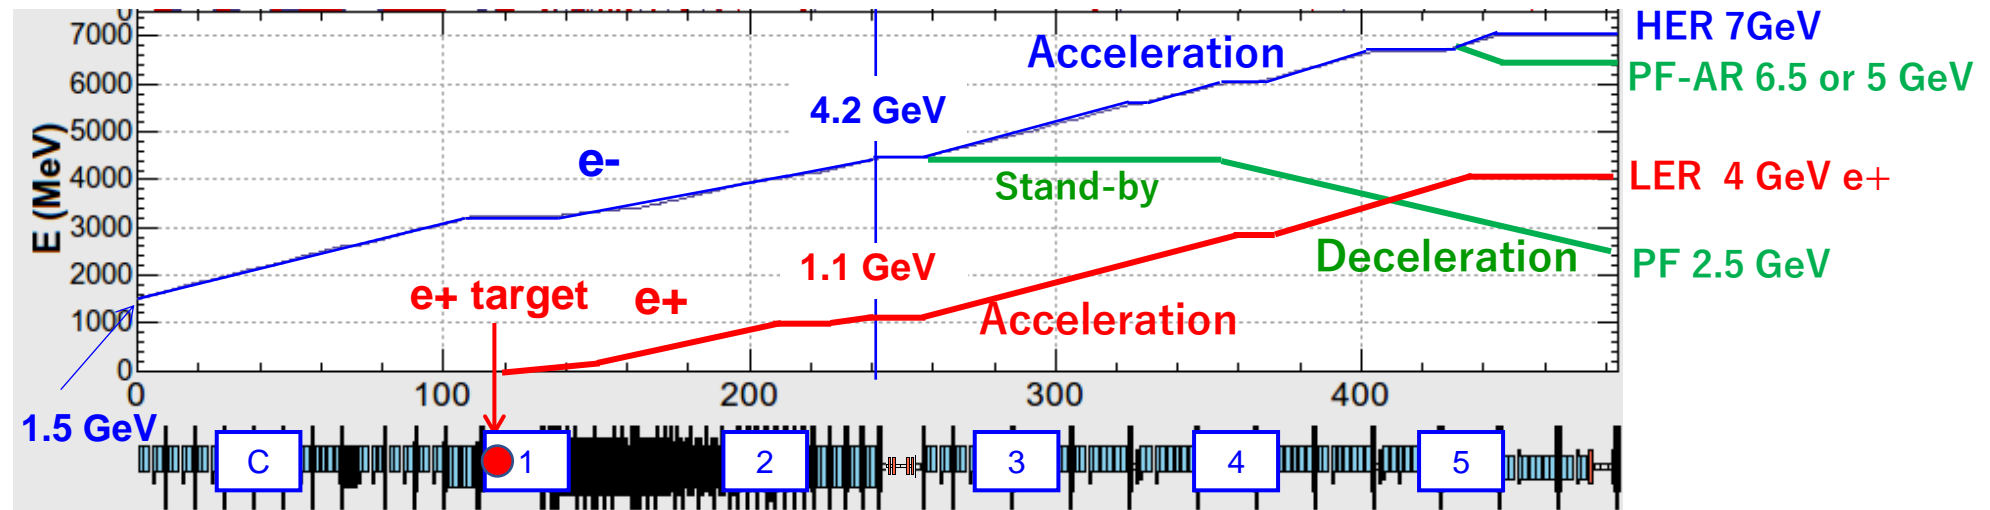
Beam energy variation for each beam mode along the beam line after J-ARC

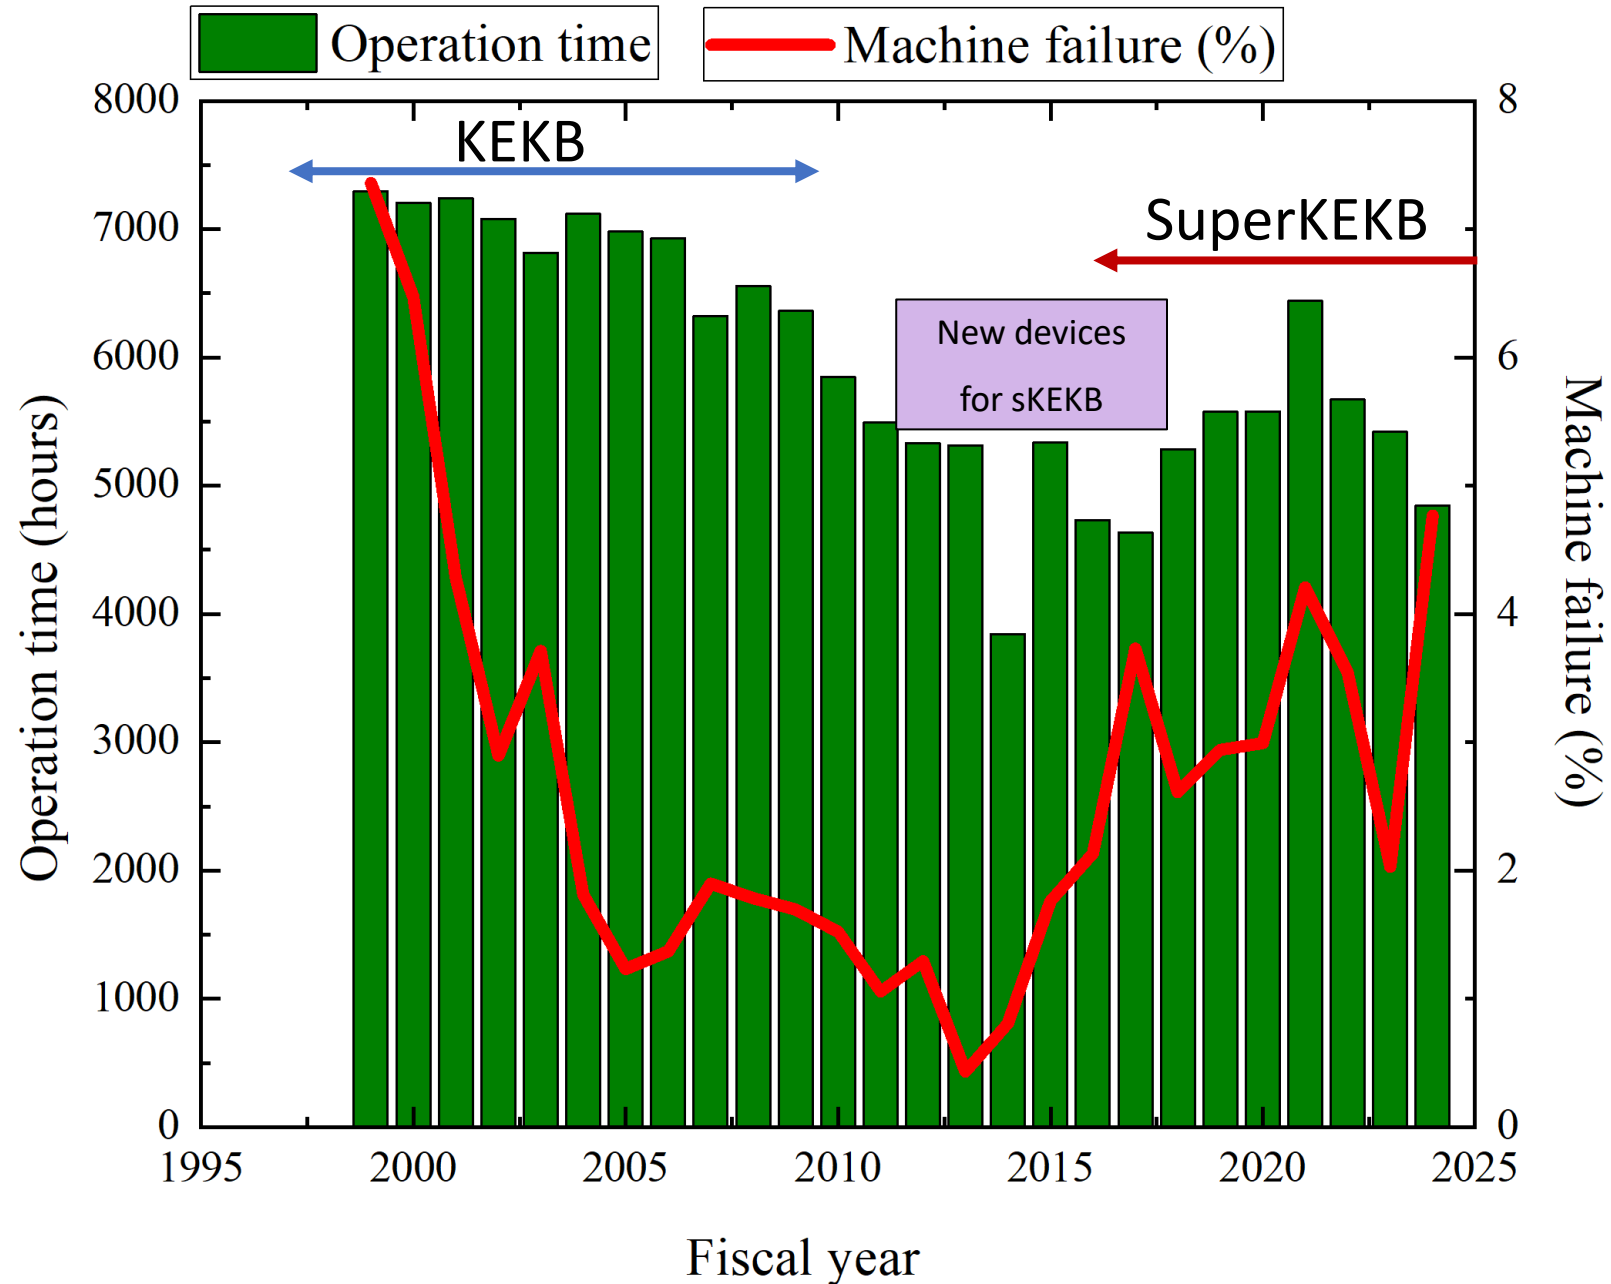
Operation statistics

- Operation time has been gradually decrease due to High electricity cost.
- Machine failure rate increased from 2% (FY2023) to 4.7% (FY2024)

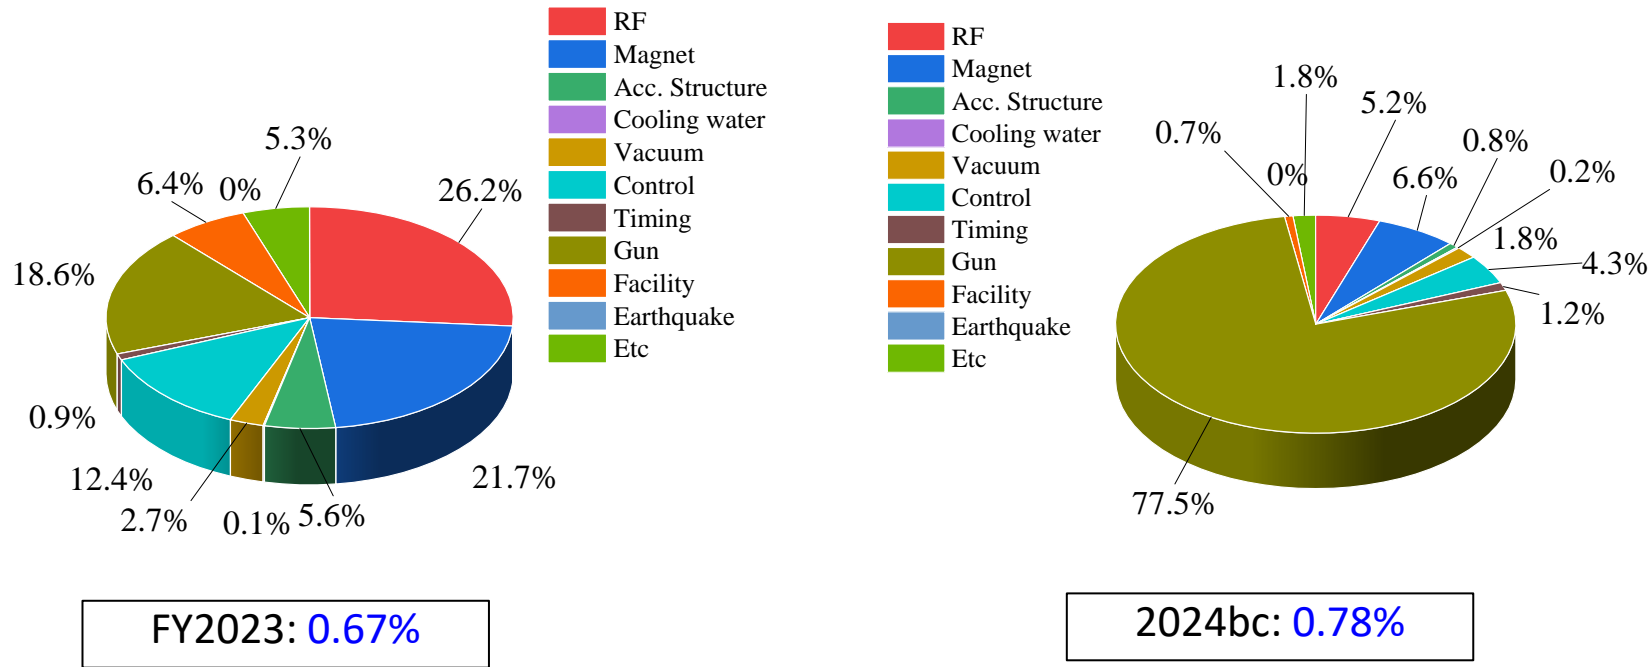
Injector beam loss time statistics

- In 2024c, all pulsed magnet control PC and software (18 units) have been replaced by new one.
 - It reduced the beam loss time due to the pulsed magnet trouble.
- In 2024c, most of gun trouble are caused by cavity discharge.

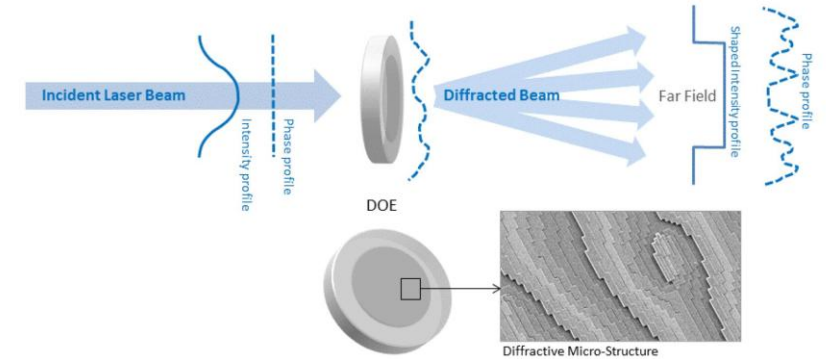
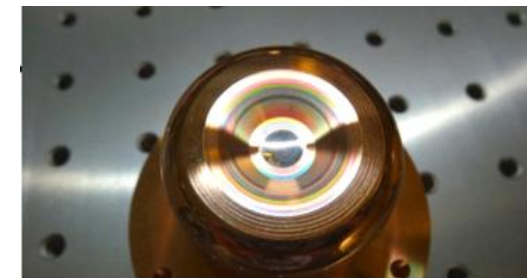
Example : Conversion Gaussian to Top-Hat profile

DOE Basics : principle

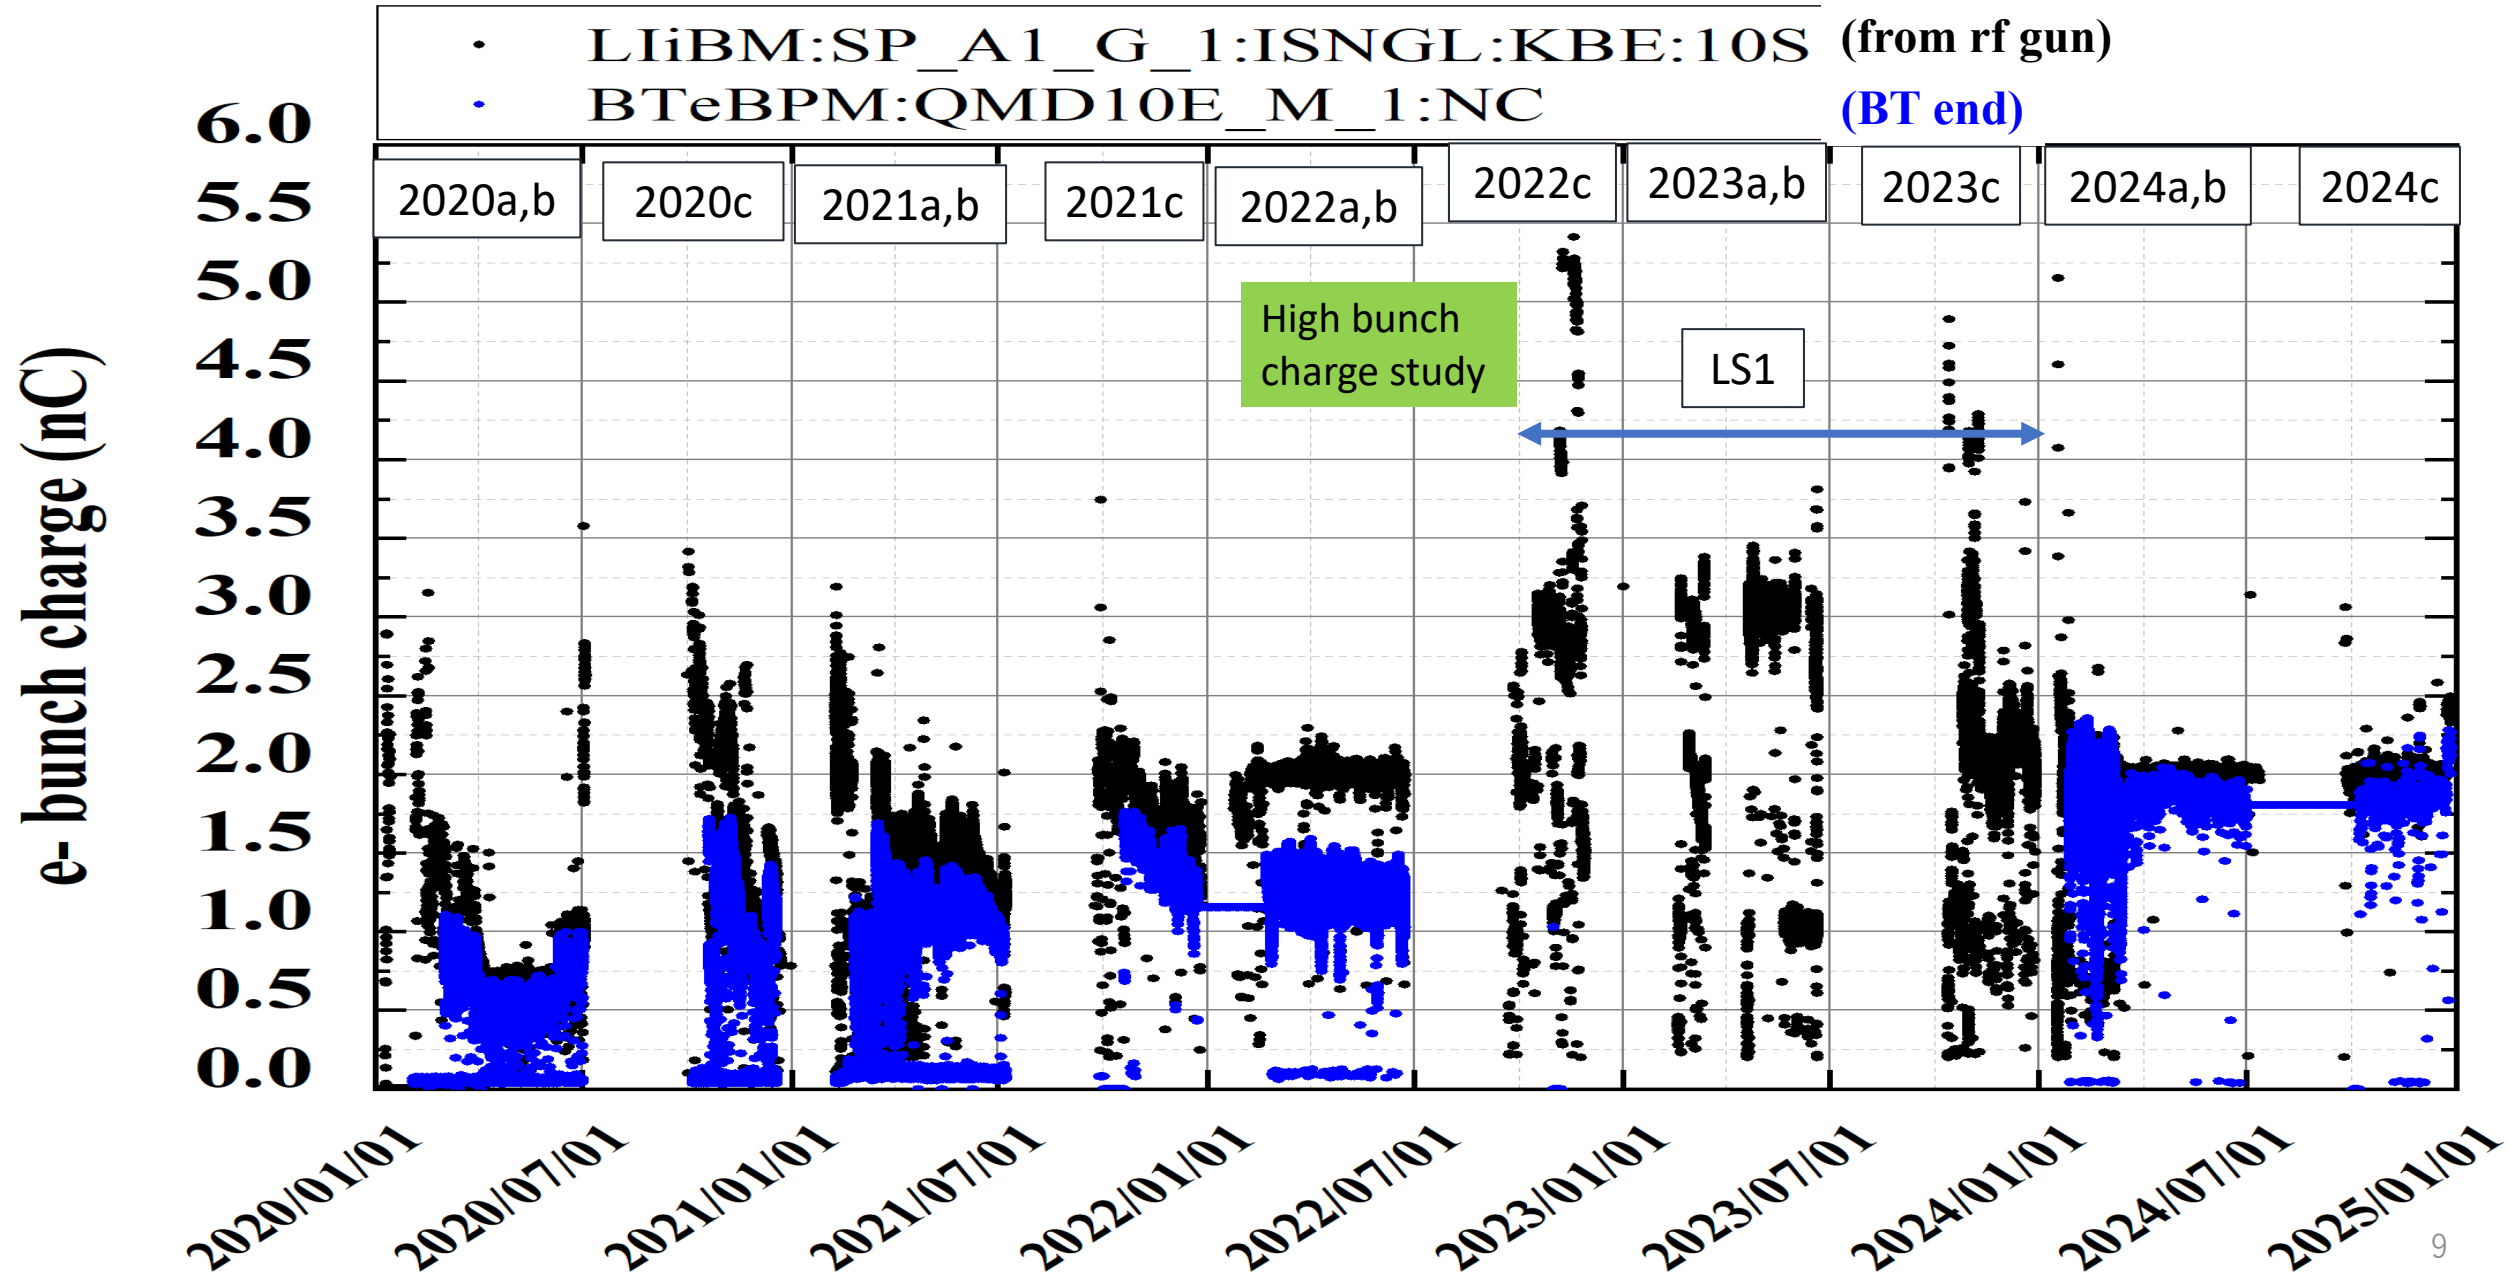
e- bunch charge history (2020a to 2024c)

- Photocathode rf e- gun laser system has worked fine without any significant trouble.
- Bunch charge of 2 nC has been stably delivered to BT end w/ bunch charge feedback.
- Laser position feedback has also worked fine.

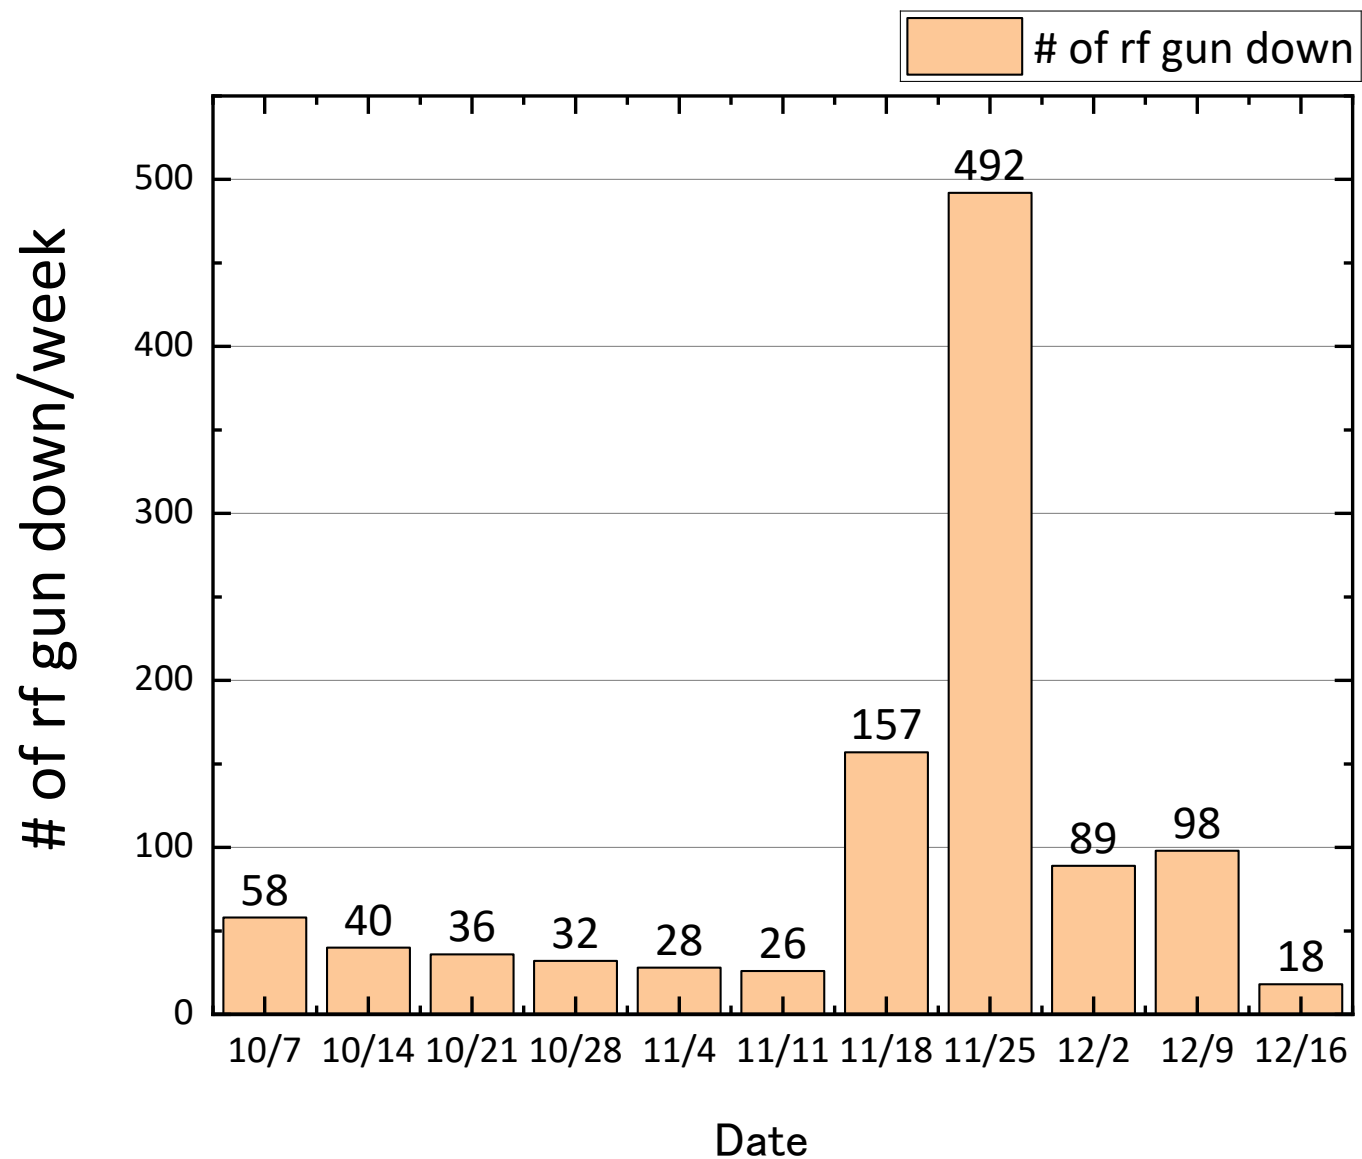
RF gun down due to cavity discharge in 2024c

- Current rf gun cavity has been in operation since Oct. of 2013. Breakdown rate of rf gun cavity has gradually increased.
- In the previous run 2024c, rf gun down rate increased after the end of Nov. Rf conditioning of cavity was required 2 ~ 3 days to get back to operation.
- Rf gun cavity should be replaced by new one for stable e- beam operation.
- Reproducibility of the beam quality is also issue. Expanding the ML based auto beam tuning and a big data analysis could help this.

- **Frequent rf gun cavity down due to discharge in the previous run 2024c. Rf gun cavity should be replaced by new one in the near future for stable e- beam operation.**

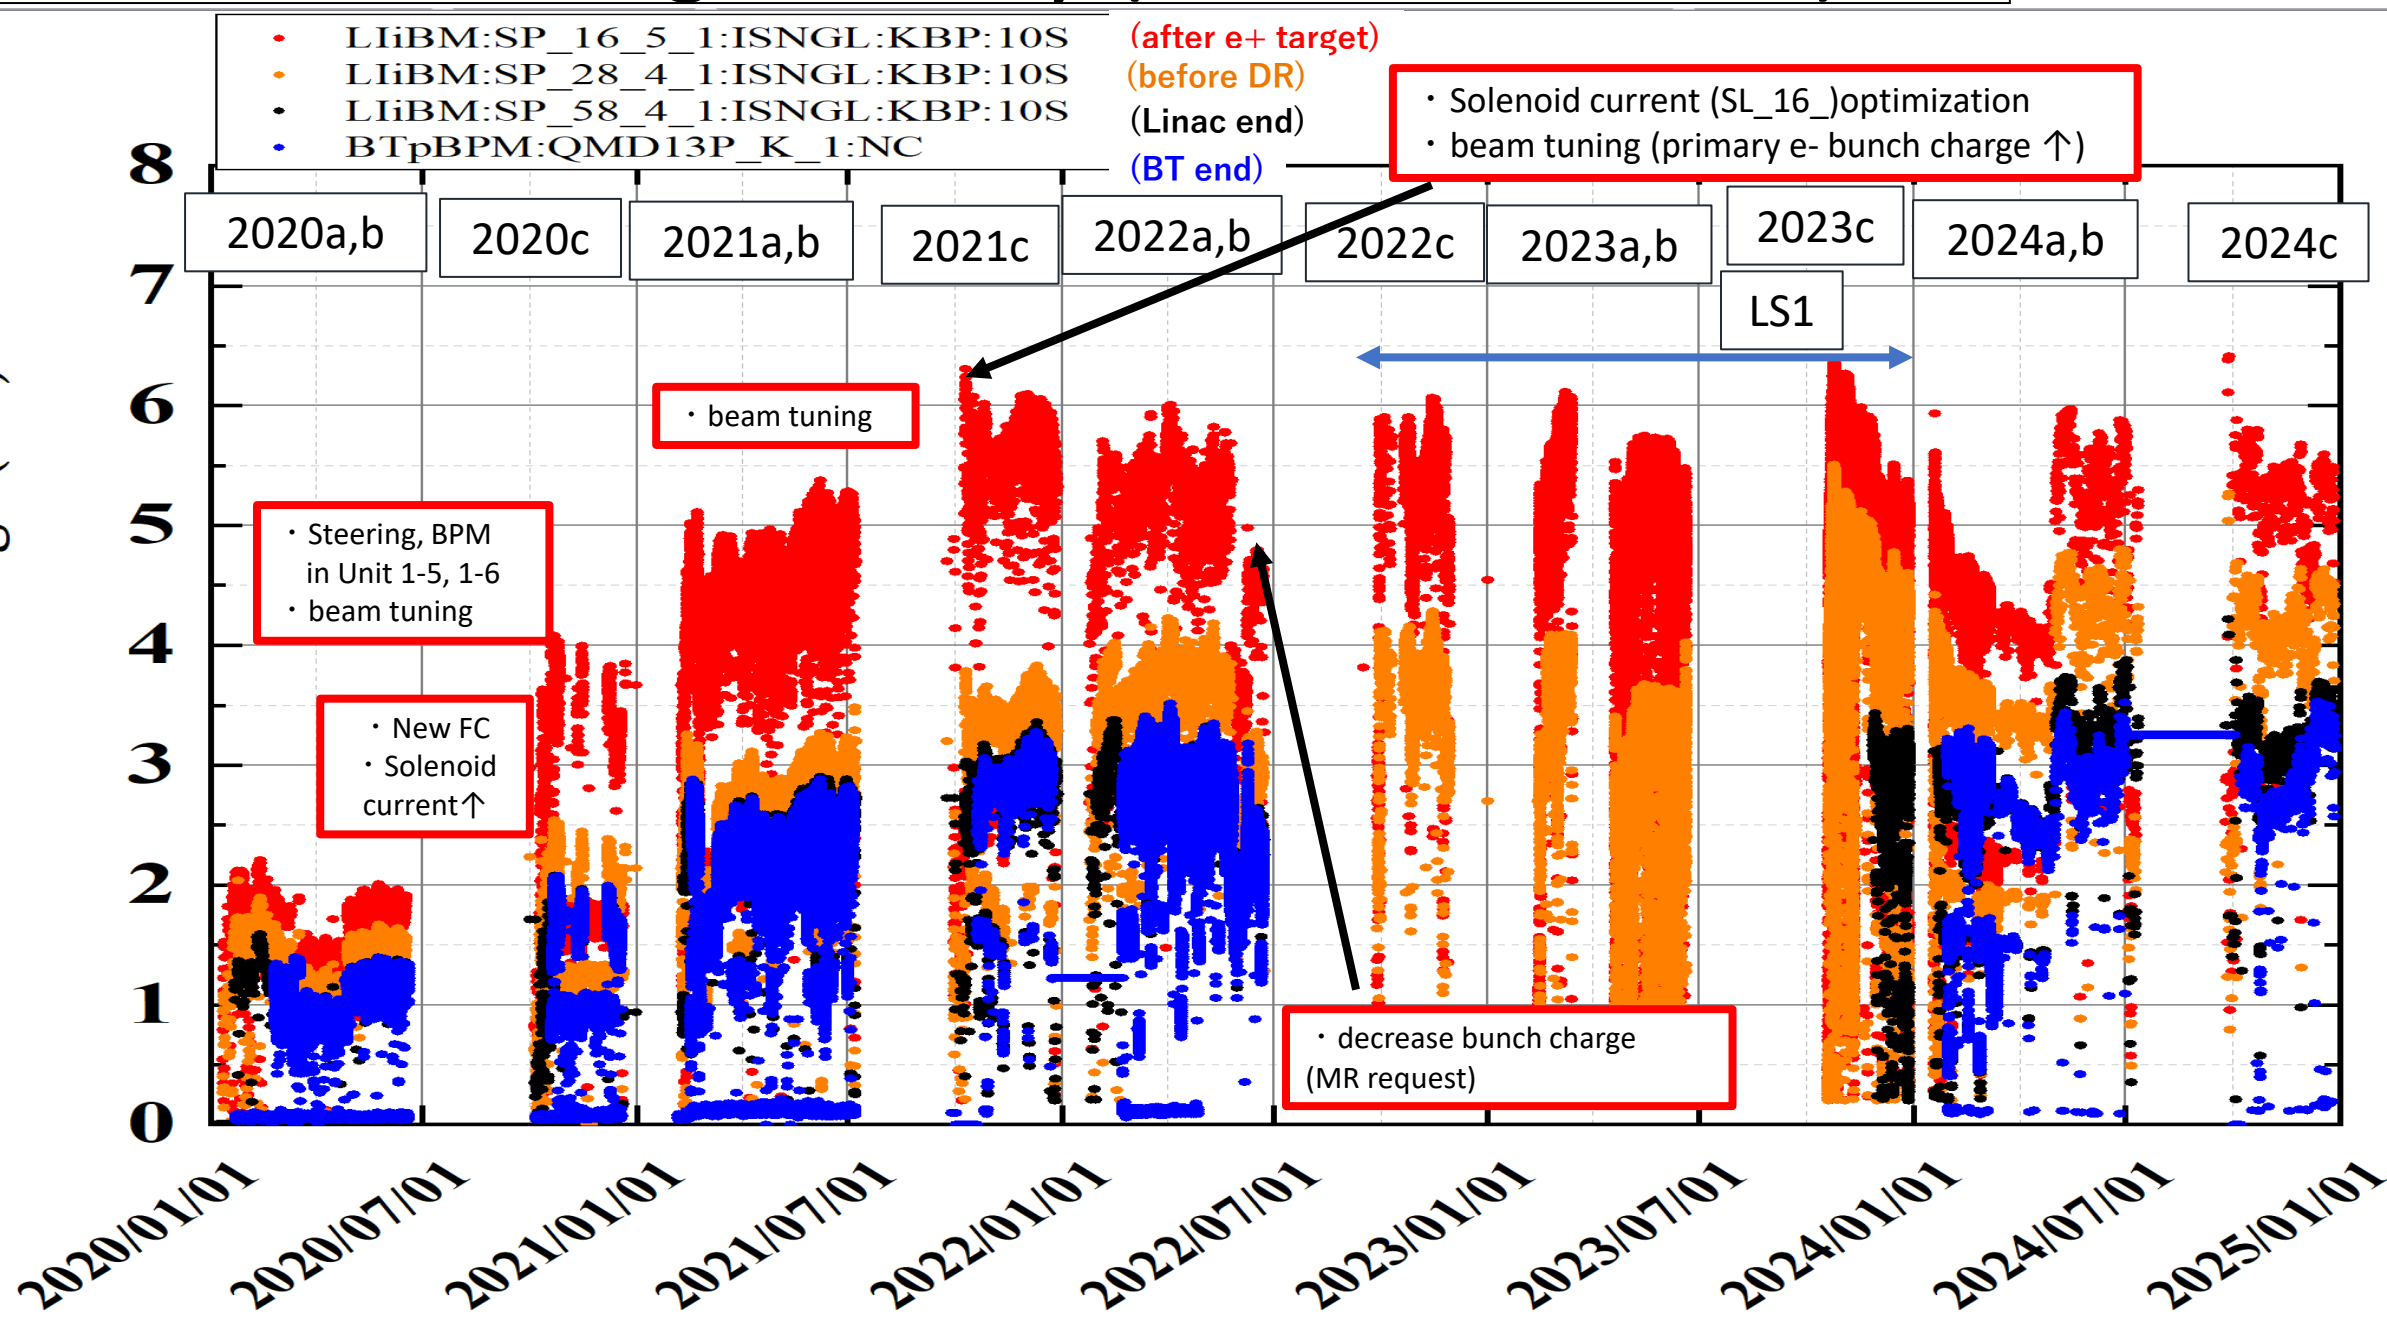
e+ bunch charge history (2020a to 2024c)

- Machine learning based automatic tuning can help to increase the e+ bunch charge (current design goal is 4 nC)
 - 5.5 nC at the end of Sector2
 - 4.2 nC at linac end
- DR stored current is limited up to 35 mA (radiation safety). This restriction will be increased in the next run.
- Flux concentrator operation has been very stable.
 - A few times HV down due to controller problem (PXI based digitizer).

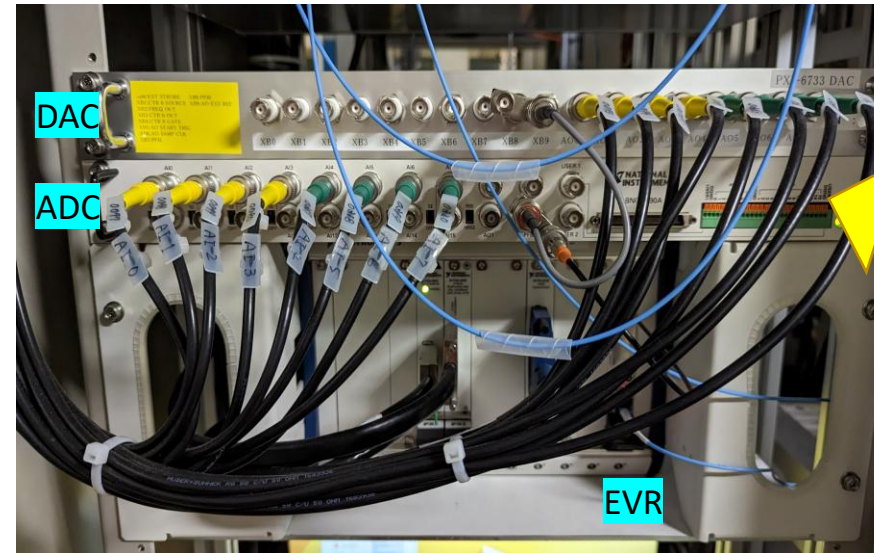
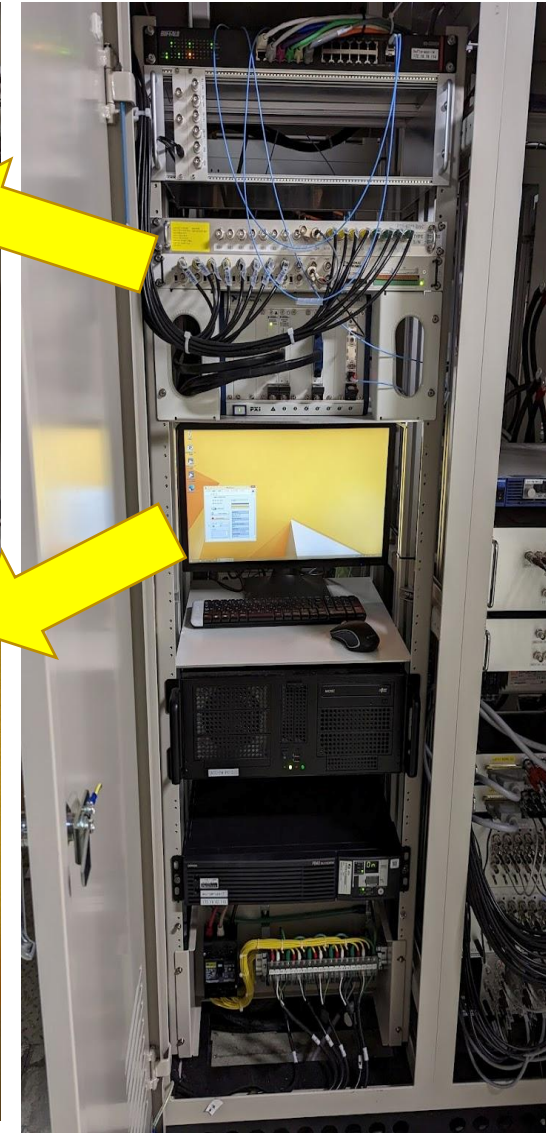
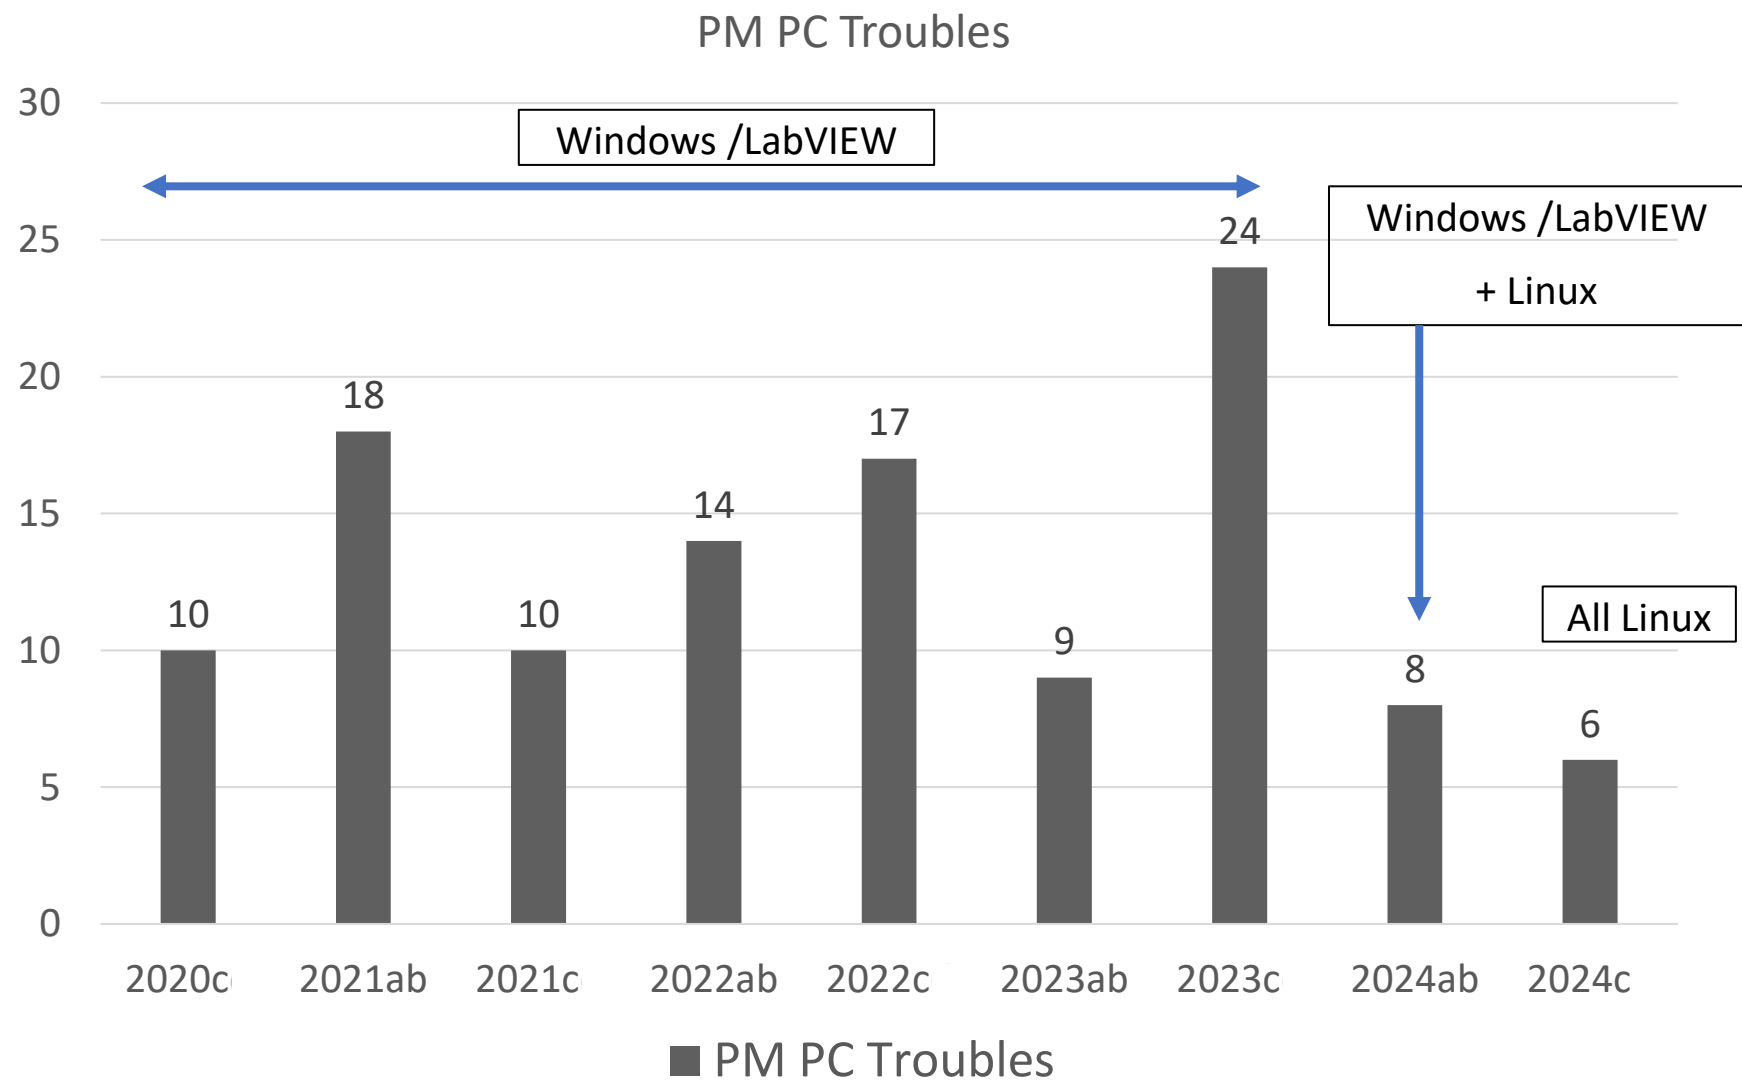
Pulsed magnet control system update

- Windows/LabVIEW/PXI system
 - Started since 2017
 - Sometimes control PC or LabVIEW program freeze.
 - It takes around 10 minutes or more for restarting system.
- Linux/EPICS IOC/PXI
 - Decided to migrate to Linux/EPICS IOC (2022/12)
 - NI DAC&ADC driver (2023/02)
 - EVR driver (2023/03)
 - EPICS IOC (2023/04)
 - OPI & Monitoring (2023/05)
 - Experiment (2023/06)
 - Revision (2023/07)
 - Stability test (2023/07)
- All system were replaced by new PC and software in 2024 summer shutdown.

(*) The PM PC troubles caused by timing system/network packet increase are not included.
